NUREG/CR-4596
SAND86-0394
RP
Printed June 1986

Screening Tests of Representative Nuclear Power Plant Components Exposed to Secondary Environments Created by Fires

Mark J. Jacobus

Sandia National Laboratories
Albuquerque, NM 87185
operated by
Sandia Corporation
for the
U. S. Department of Energy

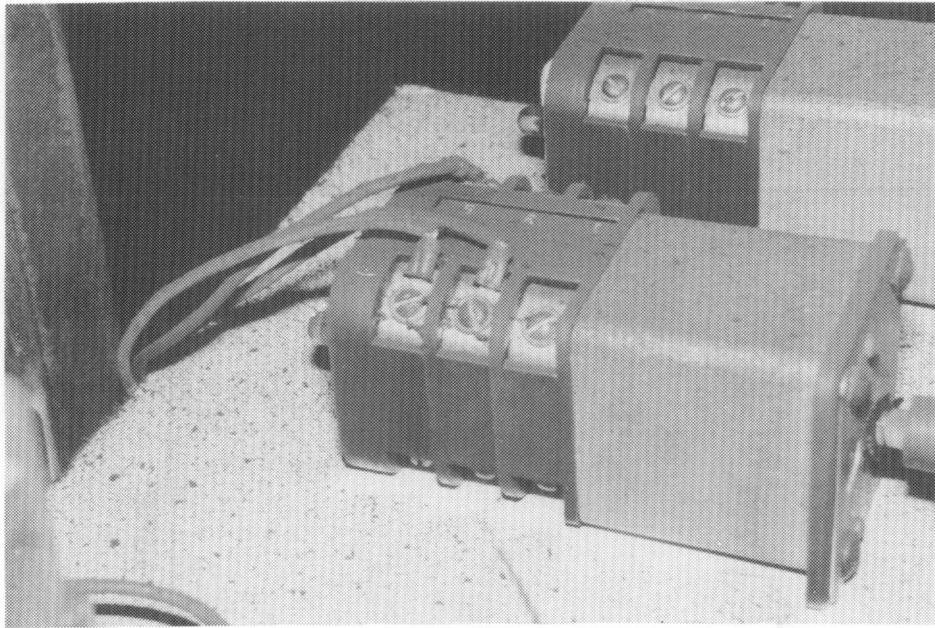
The switches were tested in various orientations with some panel mounted in a cabinet with an open back, some mounted on their sides to allow more particulate deposition in the contact area, and some put upright on horizontal surfaces. The amount of particulate deposition varied significantly with different tests, with ventilation rate and room size apparently the most important considerations with a given size fire. With higher ventilation rates and the larger room, much less particulate was deposited on the switches. In fact, the switches in test 5 were found to be virtually free of particulate. The particulate which did appear in test 5 was very light and could be removed with very little effort (light blowing or even just picking up the switch). In contrast, the lower ventilation rate of test 4 produced more particulate on the switches. The switch that was powered in test 4 was noted to have particulate polarized between adjacent powered and grounded terminals as shown in Fig. 6; similar behavior was not noted in test 5.

Fig. 6 Polarized Particulate Between Adjacent Terminals of Switch

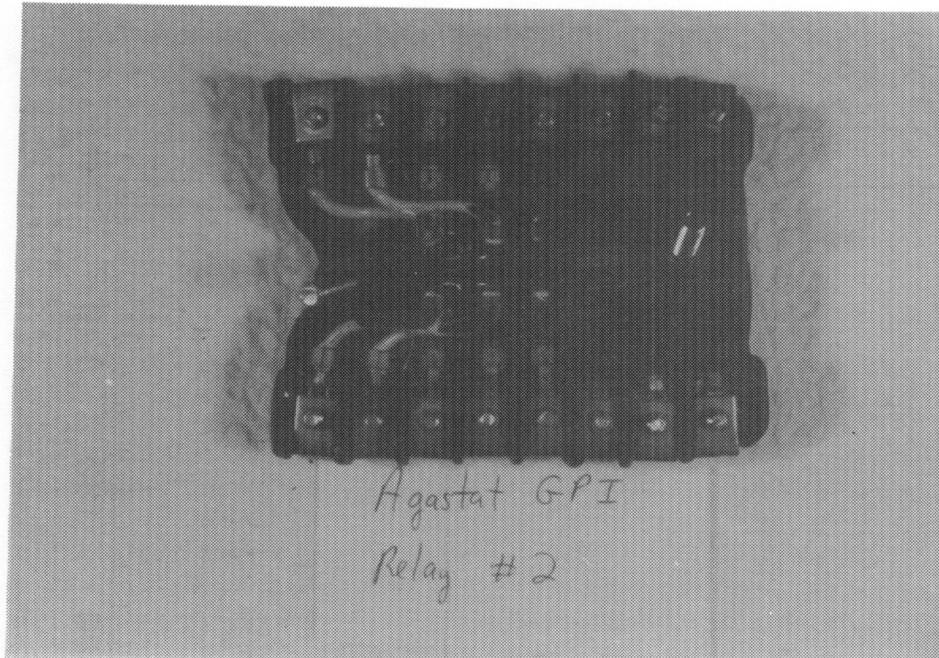
Fig. 16 Shorted Wires in the Socket from the First Thermal Failure Test

failure had to be a short between the hot side of the relay coil and the normally closed terminal of contact #2. No such failure could be found in examining the relay after the test. However, the base of the relay was so severely warped that apparently two or more of the terminal screws on the socket came into contact with the metal baseplate and shorted together. This was partially confirmed by checking continuity of different terminals when the socket was held onto a metal plate; several definite possibilities of shorting terminals were found.

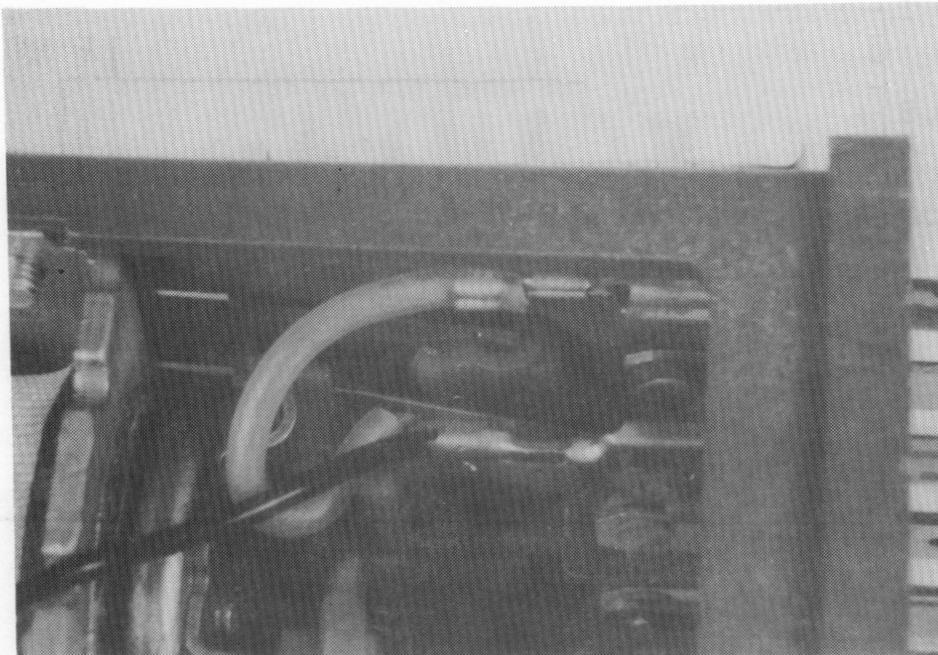
Fig. 22 Melted Contact Support from Second Thermal Failure Test

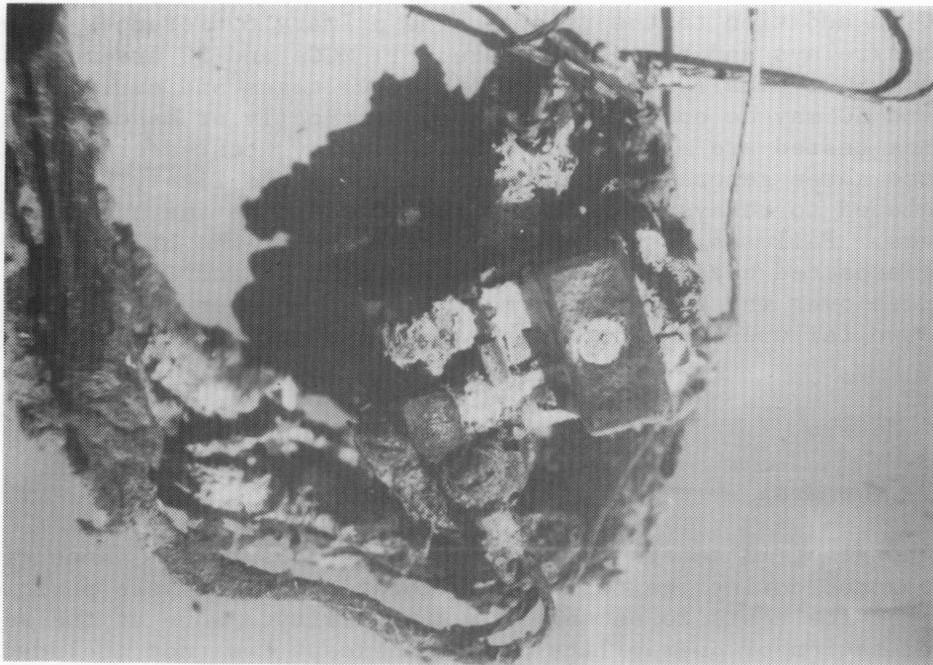
Finally, the relays tested to thermal failure experienced various failure modes, all at temperatures ranging from 150°C to above 350°C. Two Agastat GPI relays tested both had failures associated with the relay sockets warping severely. Both short circuits and open circuits were observed in the sockets. One additional failure of the Agastat relays was a melted contact support on the contact carrying a load current. One General Electric model HMA relay had its coil lead wires shorted above 350°C, resulting in a fire in the test chamber.

Fig. 26 Post-test Photograph of HMA Relay After Fire Occurred

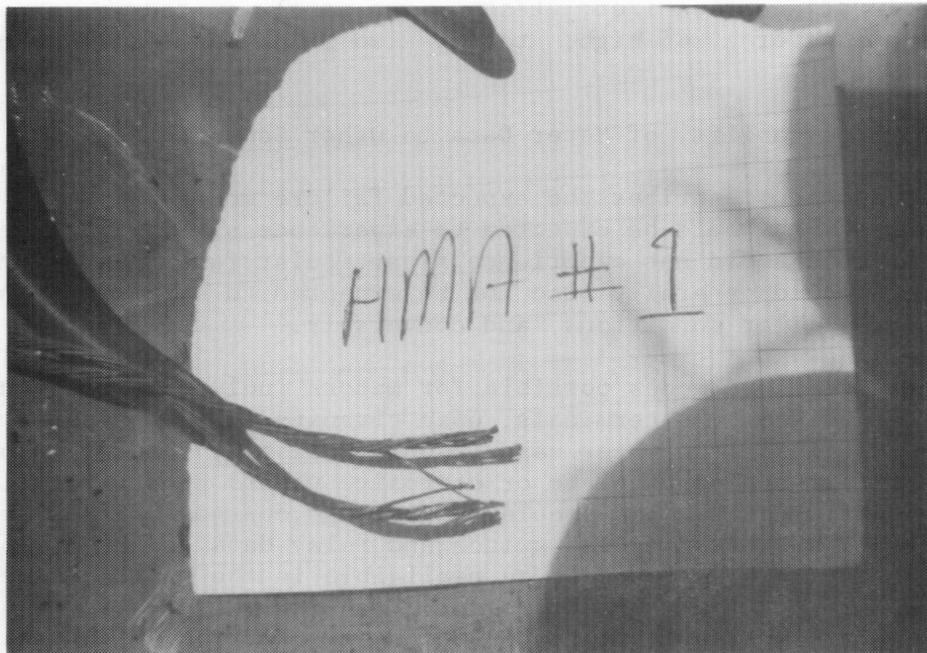
Fig. 27 Coil Wires Shorted Together to Cause Fire

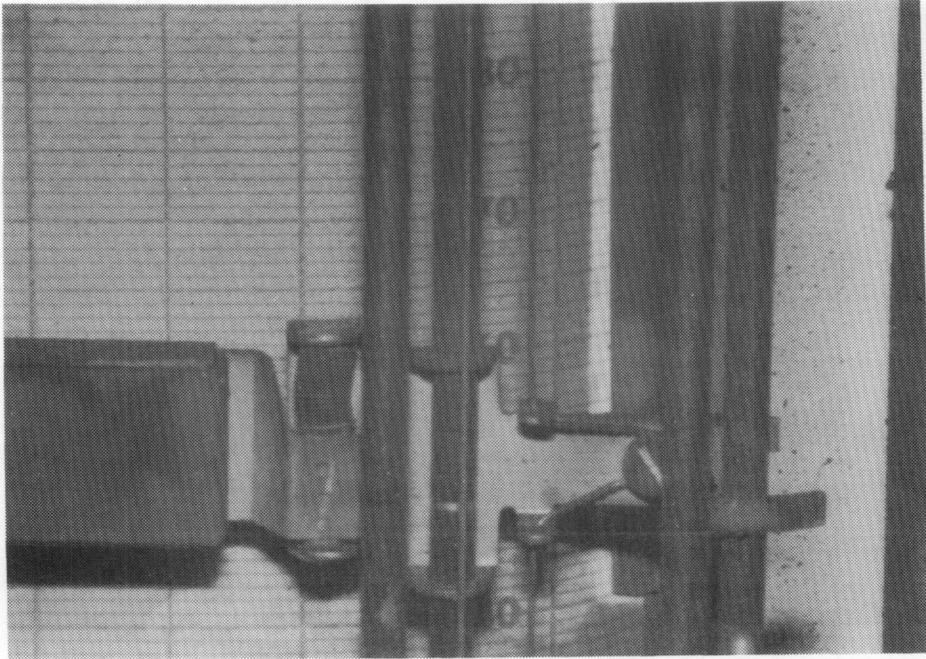
The general failure modes expected for strip chart recorders are corrosion or particulate buildup between moving parts (failure mode actually observed), thermal failure or degradation of electronic components, or low level leakage currents on the circuit boards leading to loss of correct recorder operation.

Fig. 29 Failed Slider Mechanism of Strip Chart Recorder

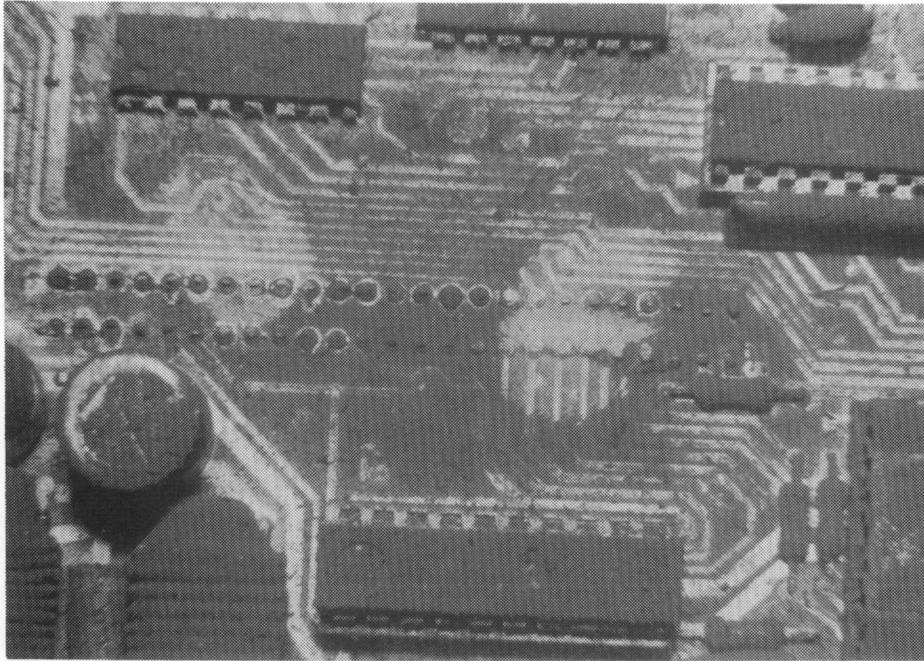
Fig. 30 One Location of Leakage Currents on Counter Circuit Boards

normally again. The counter was returned to the humidity chamber to see if the problem would return. The counter was powered and the conditions were 40°C (104°F), 95% relative humidity for 18 hours. The counter was found failed as before, again not knowing the exact time of failure. The problem was eventually traced to what appeared to be a transistor failure in the power supply. Based on examination of the counter schematics, failure of the transistor, manifested as high base-emitter leakage current, could cause the noted failure. Replacement of the transistor returned the power supply to normal, but curve traces of the original transistor did not show any problems. Subsequently, the original transistor was reinstalled and worked correctly. The only conclusion is therefore that a conductive media (probably corrosion related) had formed in the vicinity of the transistor and had allowed leakage currents. The transistor replacement must have removed enough of the conductive media to reduce the leakage current and allow the circuit to work properly.
