SANDIA REPORT

SAND86-2710 • TTC-0704 • UC-71

Fire Testing and Analysis of TRUPACT-I Thermal Test Article

This report documents the fabrication and thermal test of a full-scale prototype of the revised TRUPACT-I design (herein referred to as a full-scale Thermal Test Article or Test Article). The fire test demonstrated that the response of the Test Article to a jet-fueled pool fire, subsequent to the impact and puncture tests defined in DOE Order 5480.3 and 10CFR71, meets the impact, puncture, and thermal performance requirements of the regulations governing transport of radioactive materials.

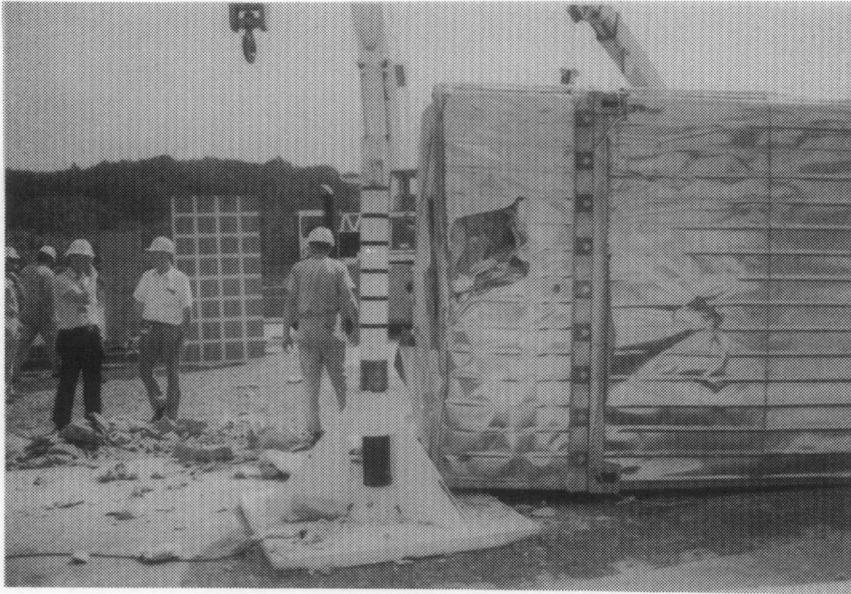
a. Unit 0 Damage (top view of outer door/body following Filter Puncture Test)

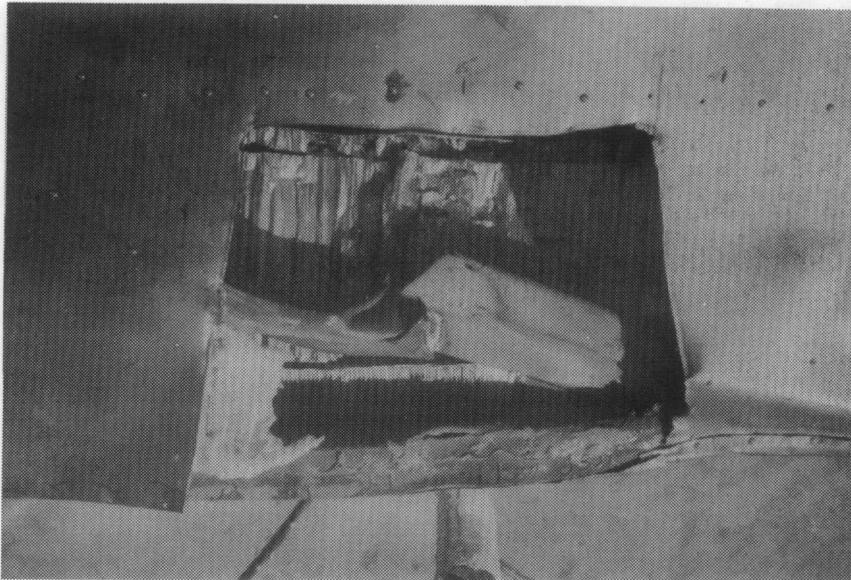
1. Outer Door Hole: A hole was cut through the exterior skin on the top surface of the outer door and the honeycomb material was deformed to create a direct path for fire flames to reach the Kevlar in the outer door puncture protection system. The hole was the same size as the Unit 0 puncture hole. Dimensions of the opening in the outer skin are shown in Figure 2.3-3.
2. Outer door puncture plate: Based on results from 1/4-scale model puncture tests the redesigned outer door puncture plate attachment would not fail. Therefore, a puncture plate tear was not modeled in the Test Article. However, deformations in the puncture panel and outer frame were retained.

b. Test Article Damage (view rotated 90° counter-clockwise from view of Unit 0 Damage)

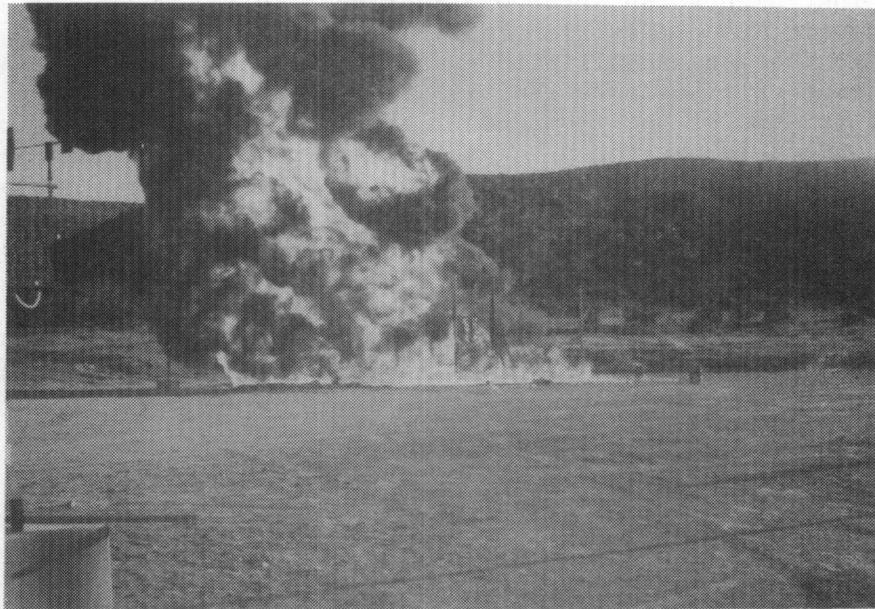
Figure 5.2-2. Wind Blowing Flames Away From Test Article

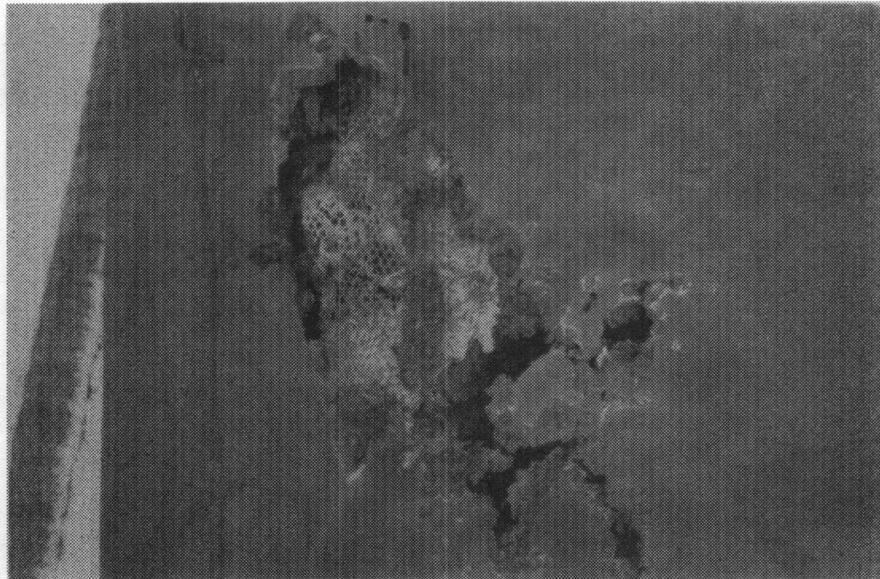
Figure 5.5-1. Condition of Outer Door Stainless Steel Skin, Post-test

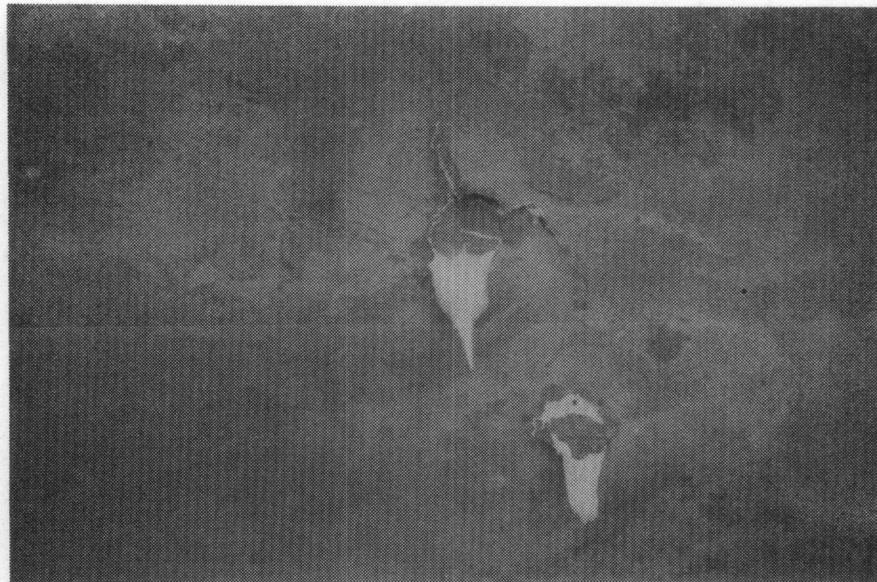
Figure 5.5-2. Solidified Aluminum Through Outer Door Stainless Steel Skin, Post-test

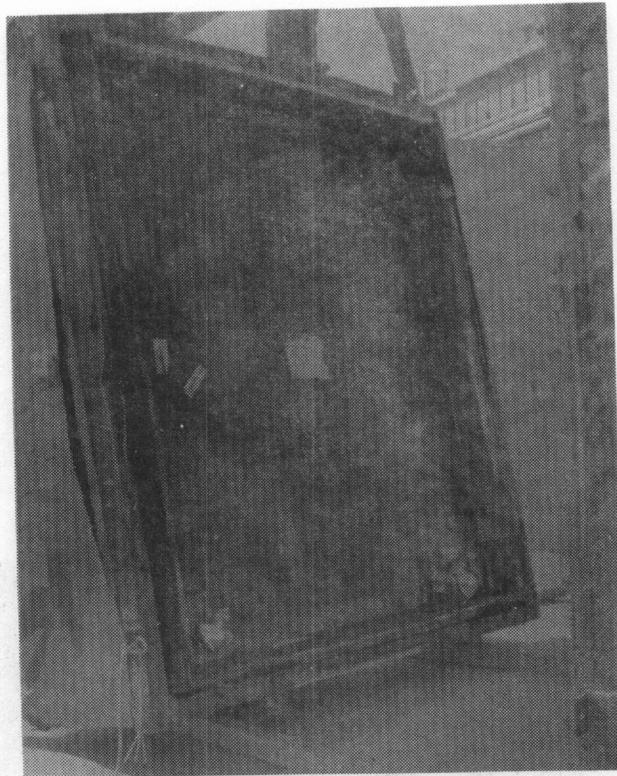
Figure 5.5-3. Side View of Outer Door Skin Pulled Away

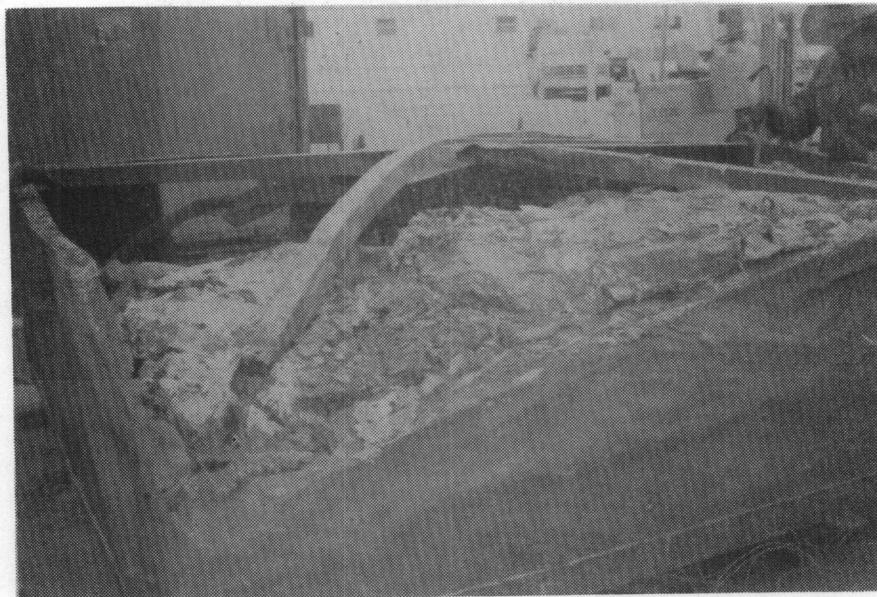
Figure 5.5-4. Side View of Condition of Outer Door Aluminum Honeycomb Post-test

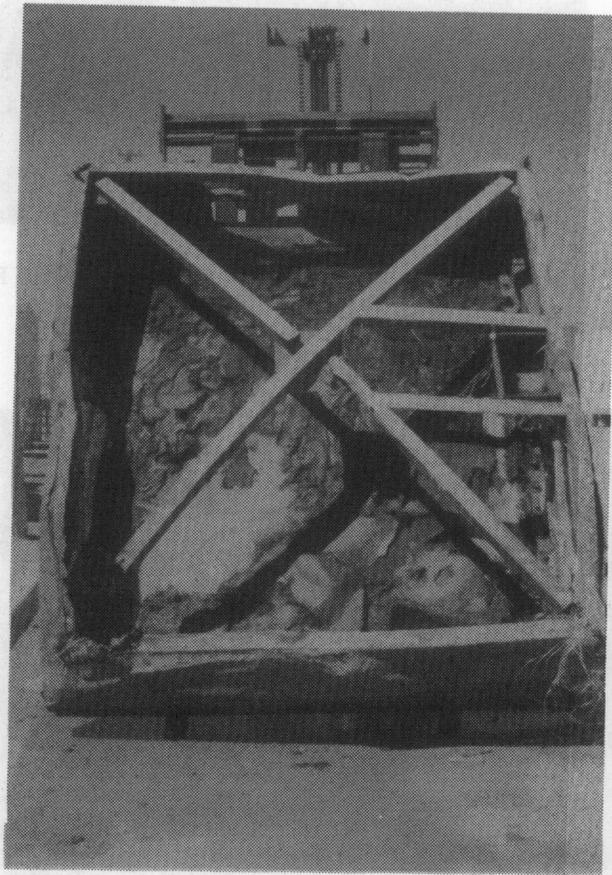
Kevlar remaining in the outer door appeared black and was totally delaminated. In some areas of the Kevlar all 44 of the original layers had been charred away, Figure 5.5-5; in other areas there were 19 layers of Kevlar remaining. Approximately one-fourth of the surface of the stainless steel puncture panel was visible where the Kevlar had been totally consumed. Figure 5.5-6 maps out these regions. Table 5.5-1 gives a brief description of the areas shown in Figure 5.5-6.

Figure 5.5-5. Front View of Outer Door, Post-test Condition of Kevlar

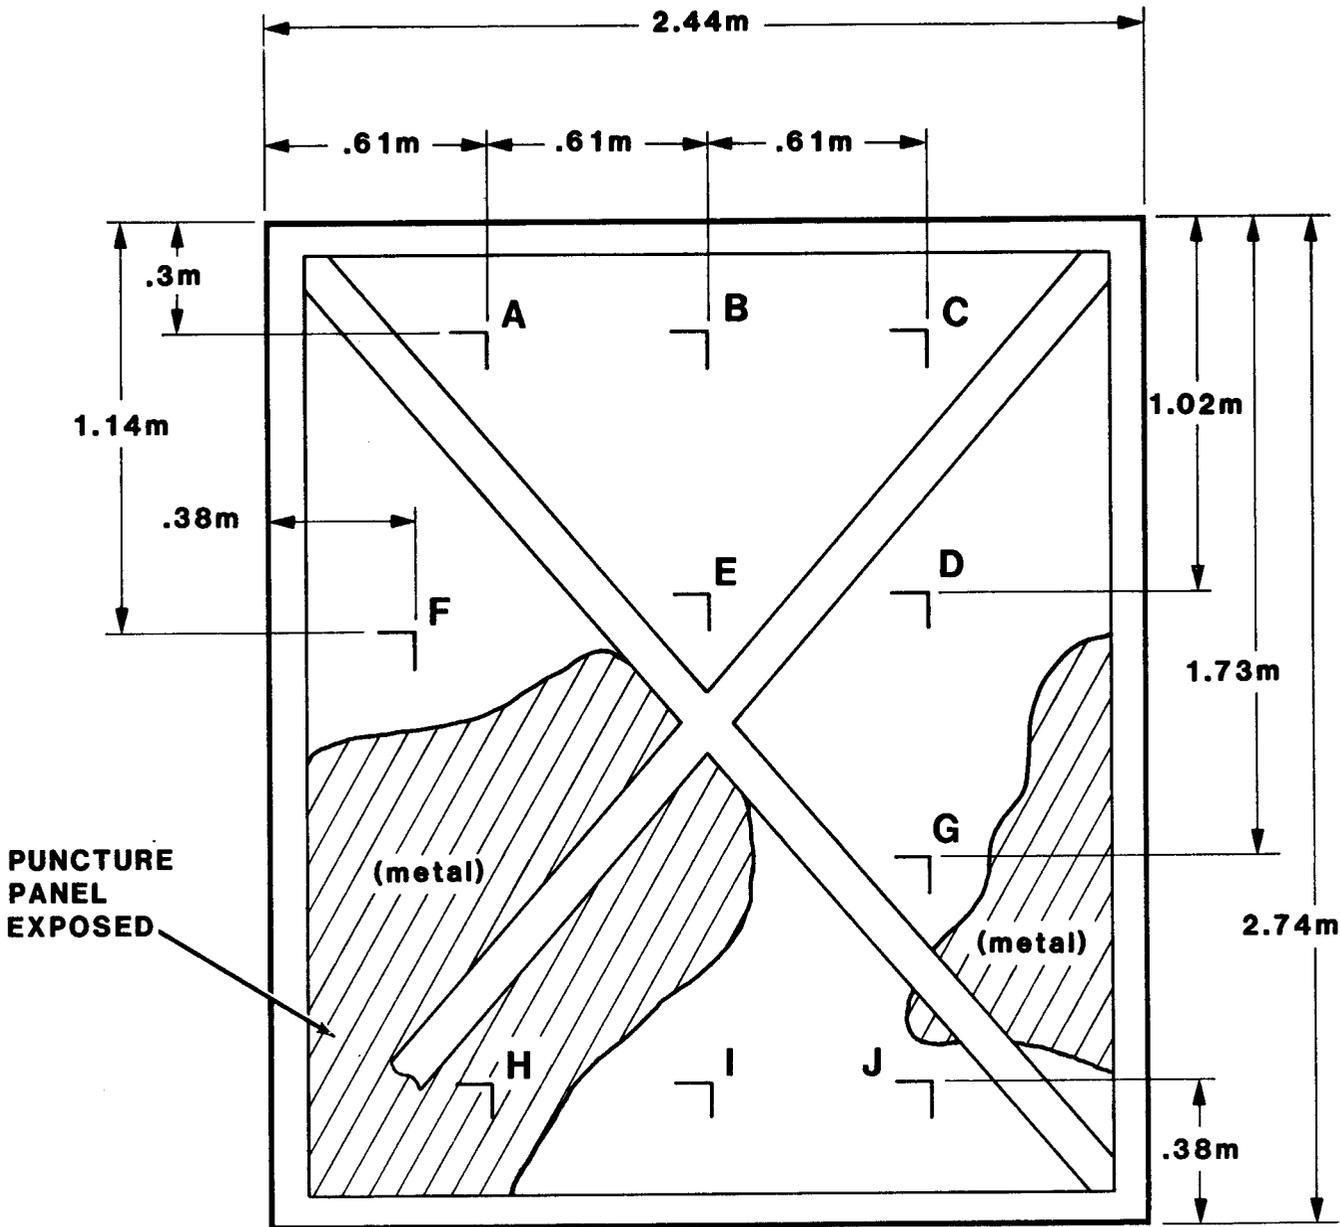
Figure 5.5-6. Post-test Regions of Remaining Kevlar, Outer Door (regions of exposed puncture panel are cross-hatched)

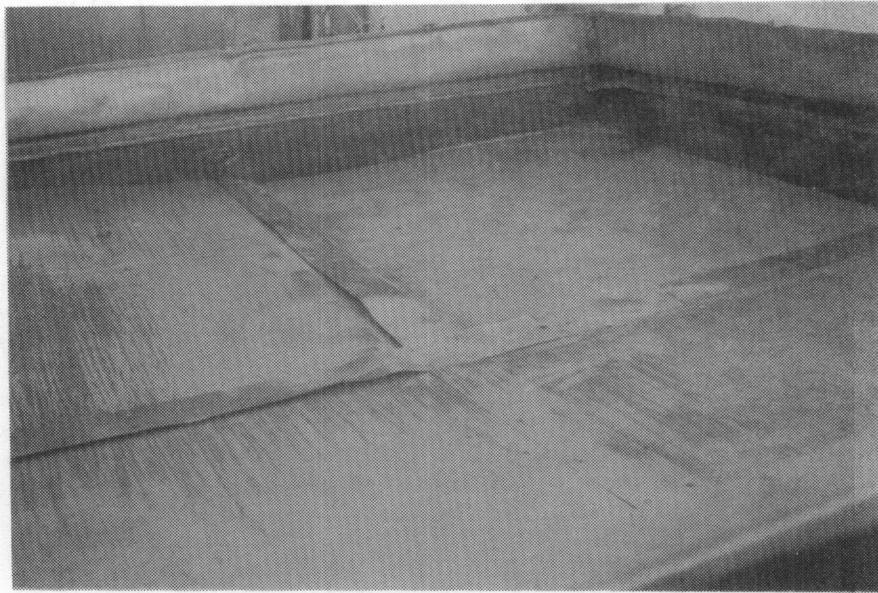
The interior surface of the stainless steel covering on the inside of the outer door was discolored, covered with a thin layer of dark

Figure 5.5-7. Post-test Condition of Outer Door Stainless Steel Honeycomb

brown soot, and streaked. The streaks were black while the remaining surface was a dull metallic color. It appeared as though water droplets had formed and collected soot as the droplets ran down the surfaces of the honeycomb cap and left the residue after the moisture had evaporated.

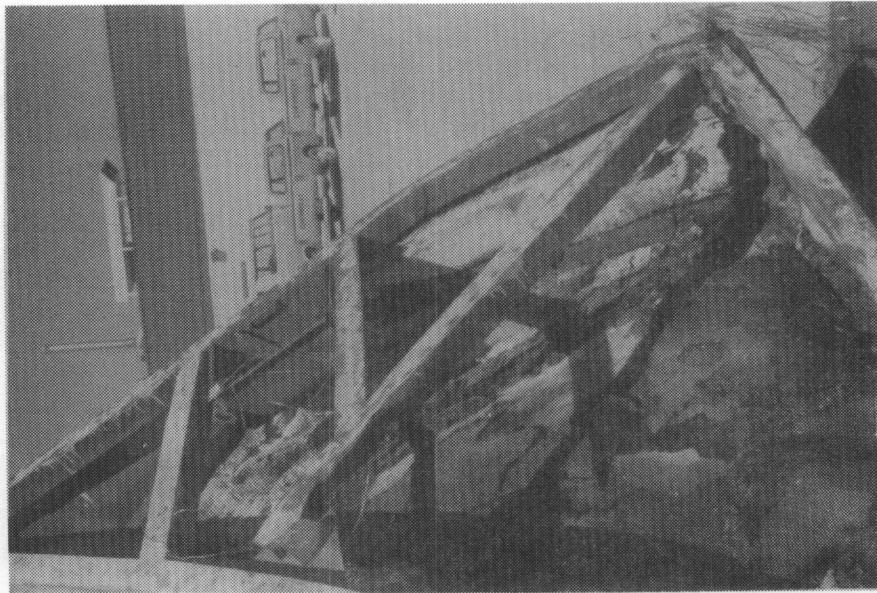
Figure 5.5-8. Post-test Condition of Outer Door Structural Tubes

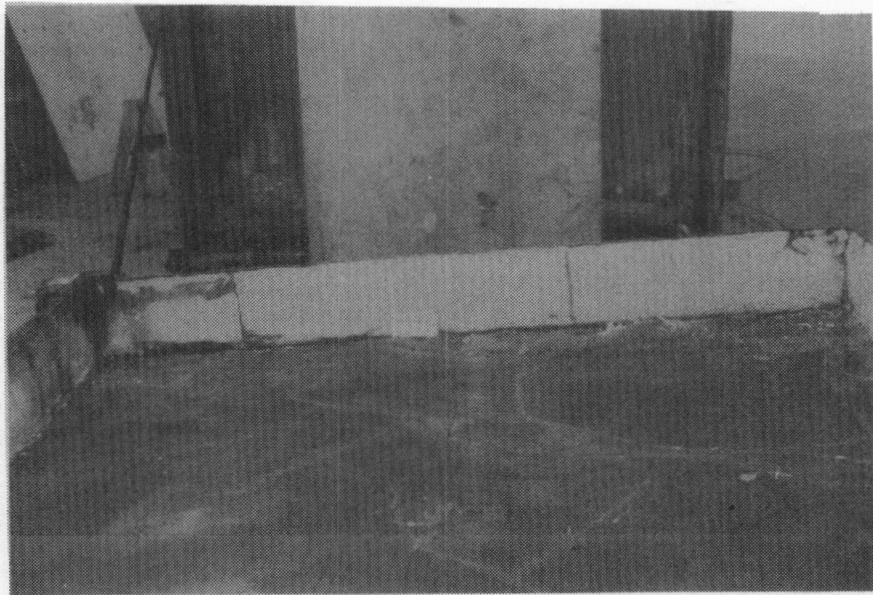
The furnace seal located on the surface of the thermal radiation shield was white with some black areas where soot had been deposited. There were no obvious indications of gas paths past the seal itself. The surface of the furnace seal had a hard crust in areas but the seal itself was still very flexible.

Figure 5.5-9. Post-test Condition of Thermal Radiation Shield

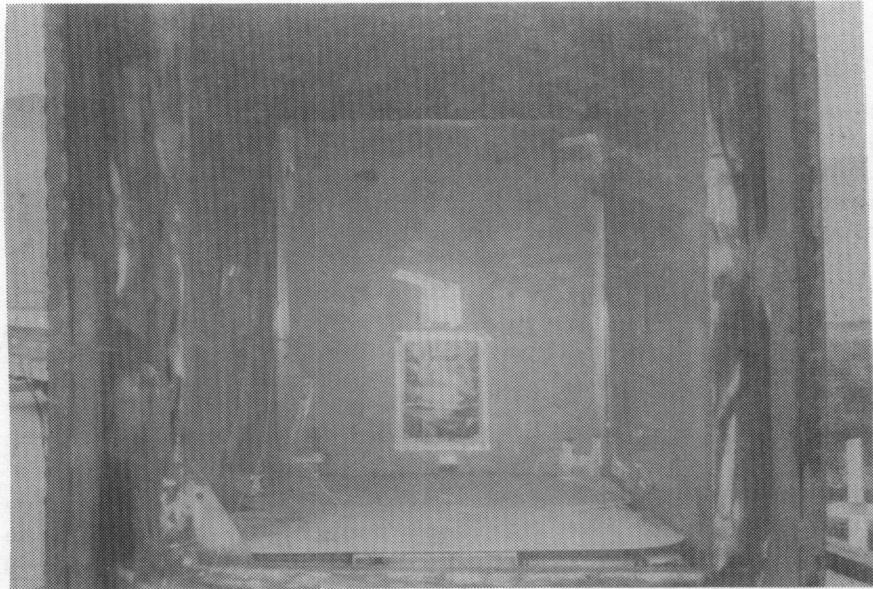
Figure 5.5-11. Post-test Condition of Inner Cavity

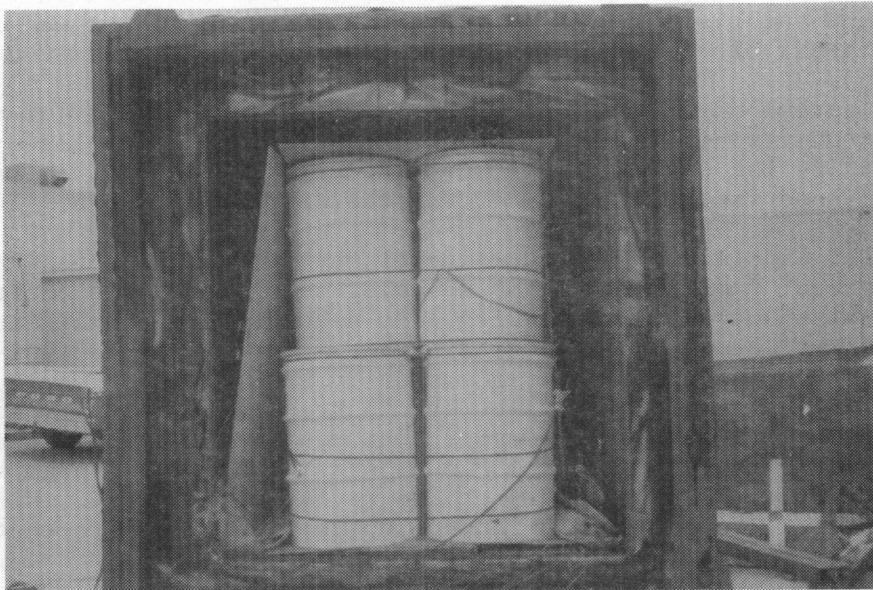
Figure 5.5-12. Post-test Condition of Drums and Dunnage

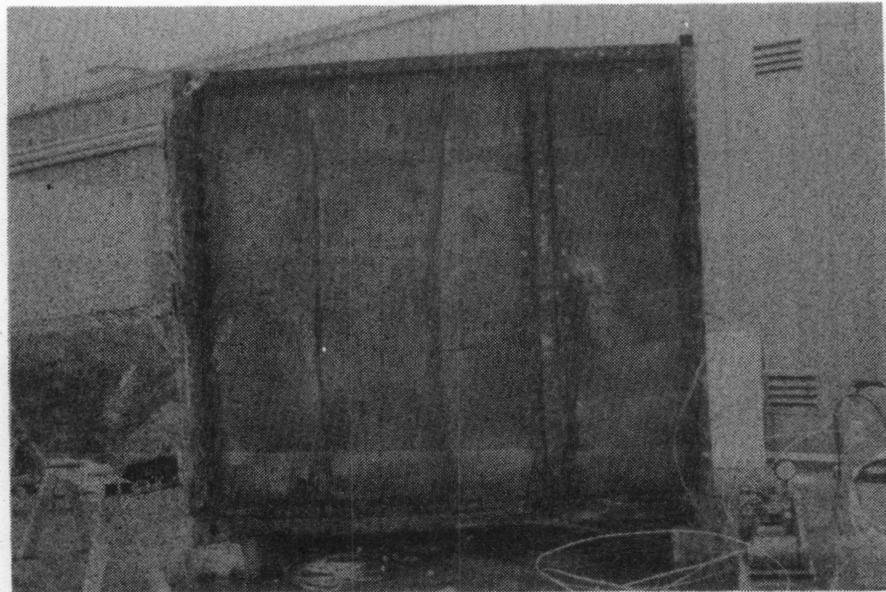
Figure 5.5-13. Post-test Condition of Insulation Blankets

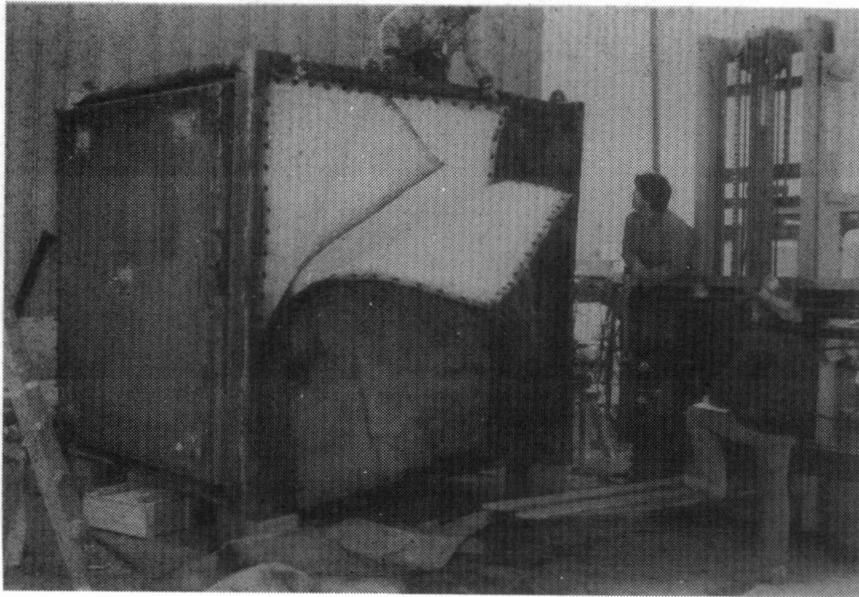
Figure 5.5-14. Post-test Condition of Main Body Kevlar, Right Side
