SAND93-2453 • UC-235

Operational Experience and Evaluation of a Dual-Element Stretched-Membrane Heliostat

Operational Experience and Evaluation of a Dual-Element Stretched-Membrane Heliostat¹

Abstract

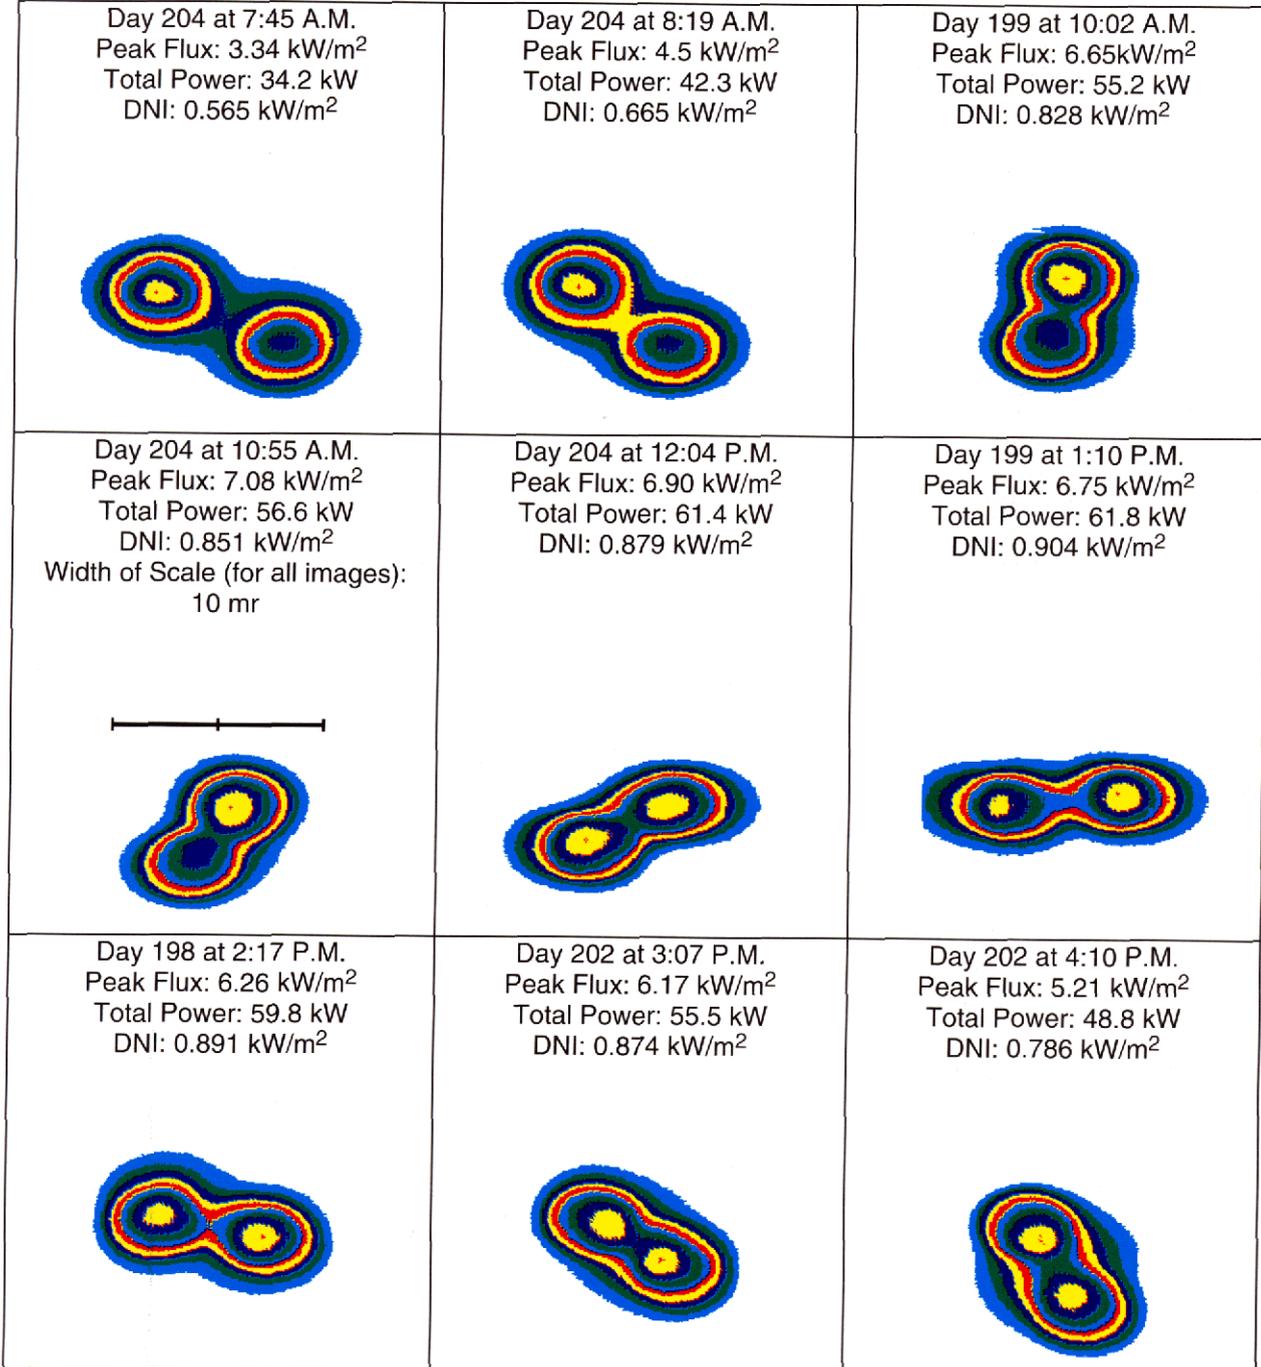
Figure 4: All-Day Optical Performance
(note scale in 4th image)

The mirror modules were canted (aimed at a common point of the flux target) in mid-January at about 2.5 hours before solar noon.

solar noon in mid-January of 1991. The consequences of this non-optimal canting were evident when the all-day beam quality test was performed in mid-July 1992. The module beams did not overlap one another (Figure 4) and the peak flux levels observed (Figure 5) corresponded to the flux produced by a single module.

Attention will have to be given to the canting strategy for dual-element stretched-membrane heliostats in order to minimize the pointing error due to a fixed canting. An analysis of this issue is recommended and could be performed using a heliostat modeling tool such as HELIOS. If that analysis should indicate the need, a means (manual or motor-driven) of adjusting the module aim points could be incorporated into the heliostat's design.

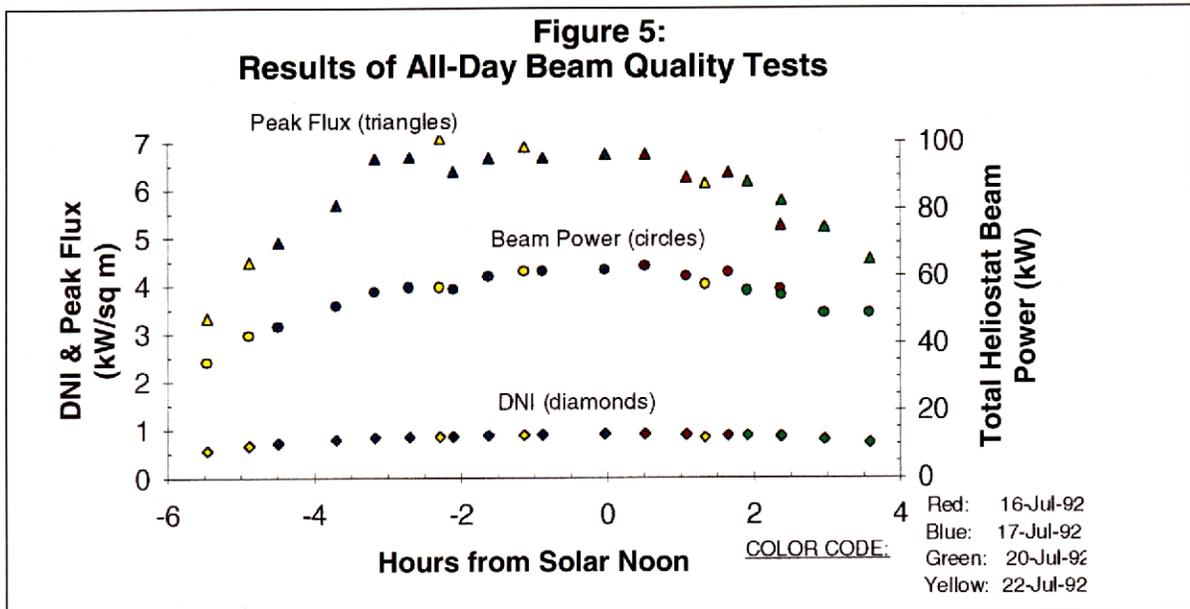
An analysis of the BCS data provided estimates of the total power, the peak flux, and the beam diameter for each BCS image obtained. These test results are plotted together in Figure 5. Color coding has been used to differentiate the four test days.

In the four hour-period centered around solar noon the average total power produced by the heliostat was 60 +/- 6 kW with an average insolation level of 0.88 +/- 0.04 kW/m². When normalized to "one sun" (1.0 kW/m²) this yields an average noontime performance of 68.2 kW of total power or 0.70 kW per square meter of heliostat collector area. The average peak flux during the same four-hour period was 6.5 +/- 0.6 kW/m². (We did not normalize this performance figure with respect to the heliostat's cosine losses, but in this evaluation the point on the elevation axis half-way between the heliostat's two mirror modules was located 50.3 m west, 249 m north, and 18.6 m below the beam tracking aimpoint.)

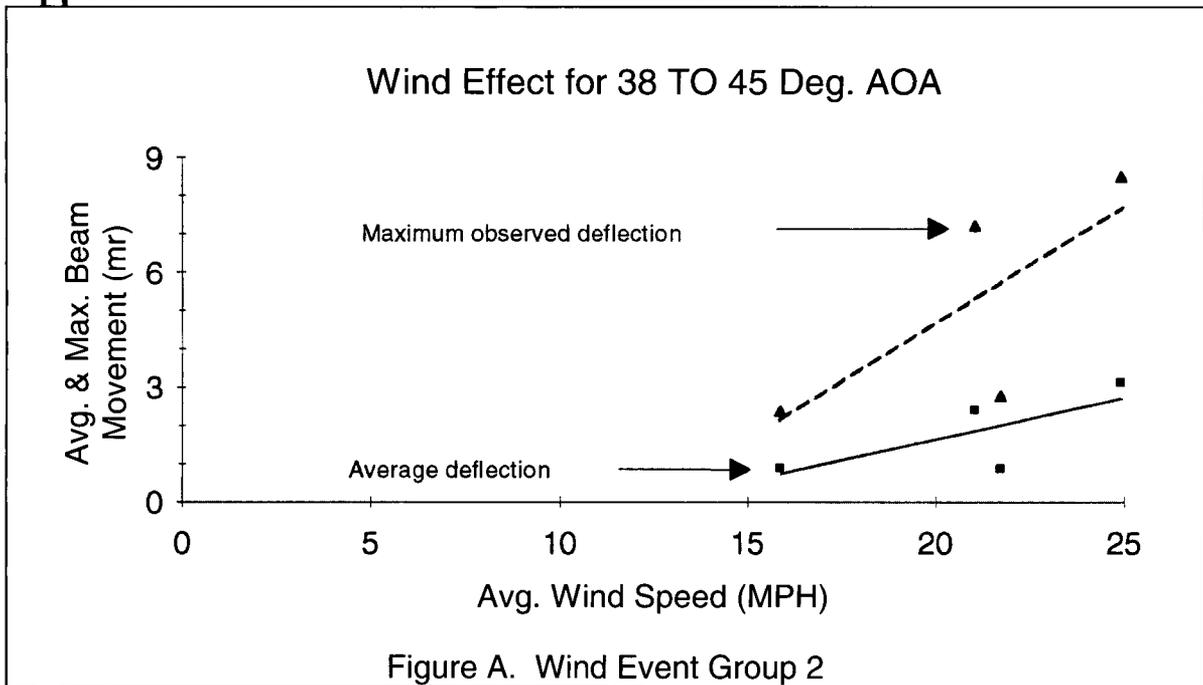
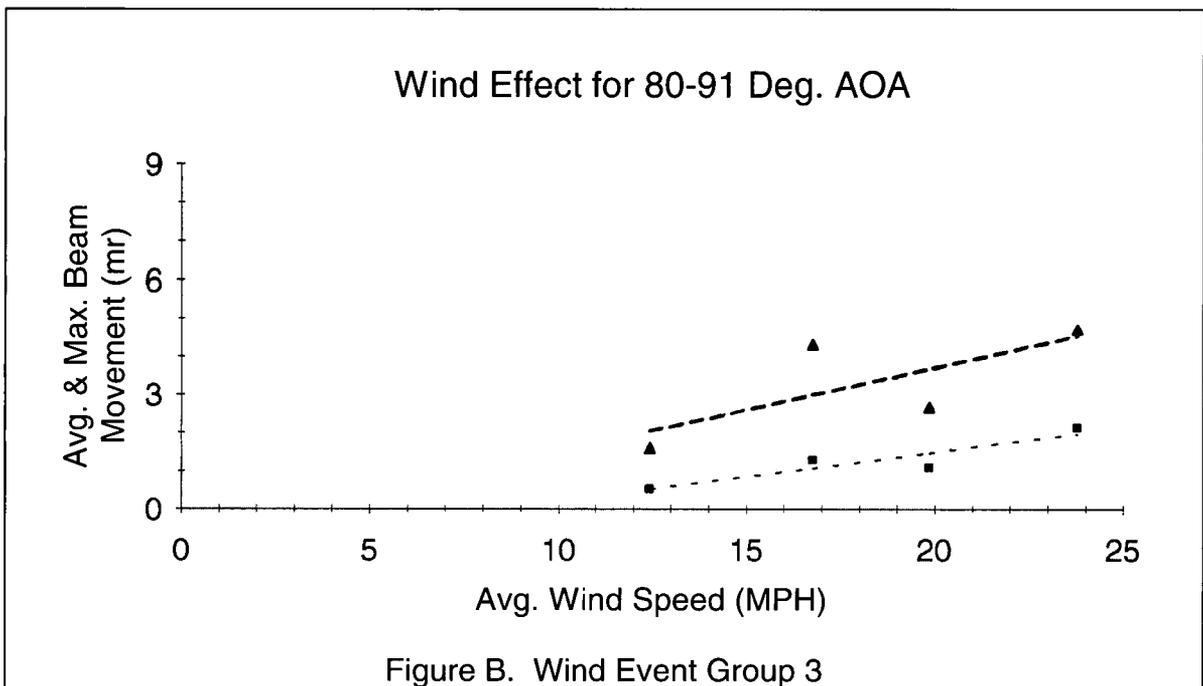
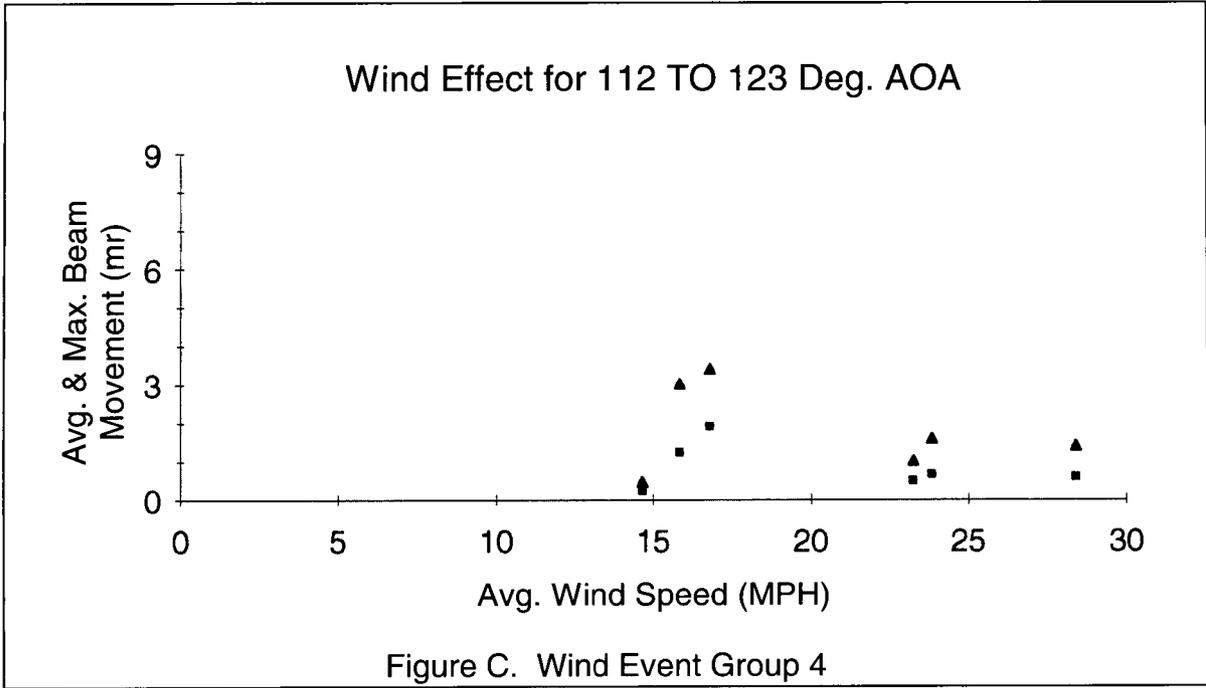
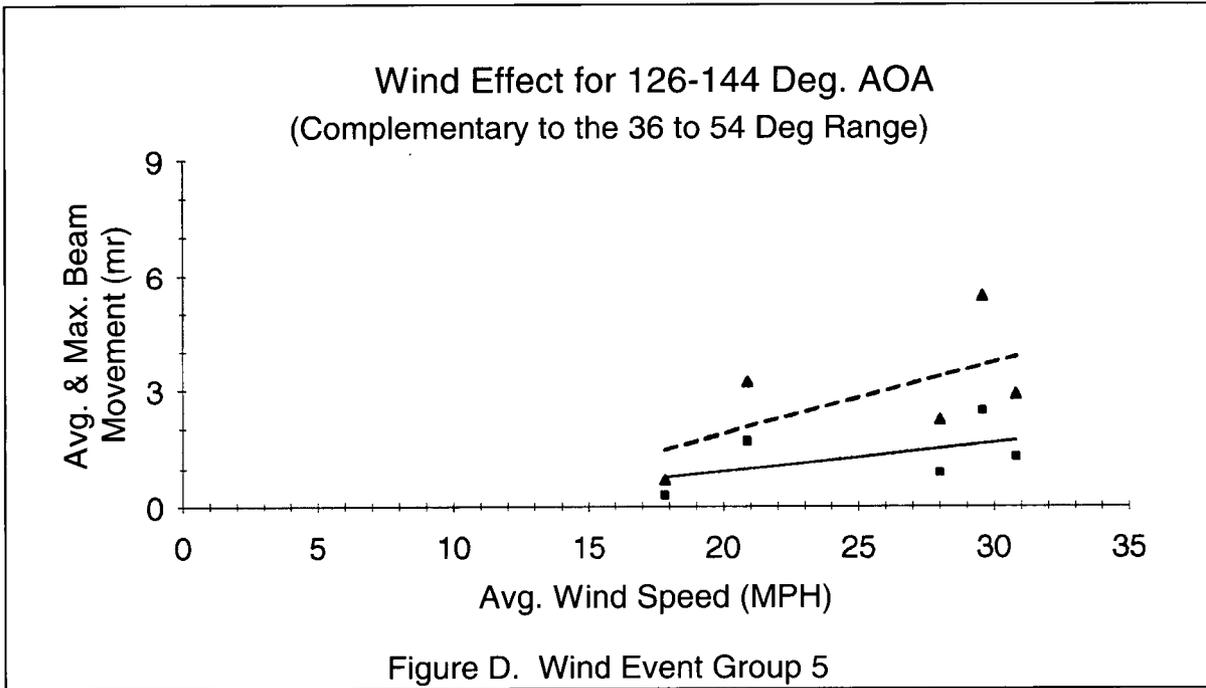
Appendix A: Plots of Wind-Induced Heliostat Beam Deflections

In all of the plots, the triangular data symbols represent the maximum beam deflection (in milliradians) observed during the wind event, while the square symbols represent the average deflection during the event. The straight lines are linear curve fits of the beam deflections. The decision to use a straight line fit rather than a second-order fit was arbitrary. No attempt was made to curve-fit the data in the 112° to 123° AOA range because, for that collection of observations, there was no observable relation between the beam deflections and the recorded wind speed.

Measurements of the total effects of structural deflection under windy conditions suggests that the SAIC heliostat conforms to the second generation heliostat specification [2]¹¹ which proscribes a maximum wind-induced deflection of the reflective surface of 3.6 mr RMS in a 27 MPH wind. Only once (in a 25-mph wind with an AOA of 33°) was the average beam deflection observed to exceed 3.6 mr, and during that event the average deflection was 3.73 mr. The average beam deflection observed in all the events recorded in the 25 to 31 mph range (there were seven of them) was 1.9 mr.
