**NUREG/CR-6412  
SAND97-3170**

# **Aging and Loss-of-Coolant Accident (LOCA) Testing of Electrical Connections**

Prepared by  
C.F. Nelson

**Sandia National Laboratories**

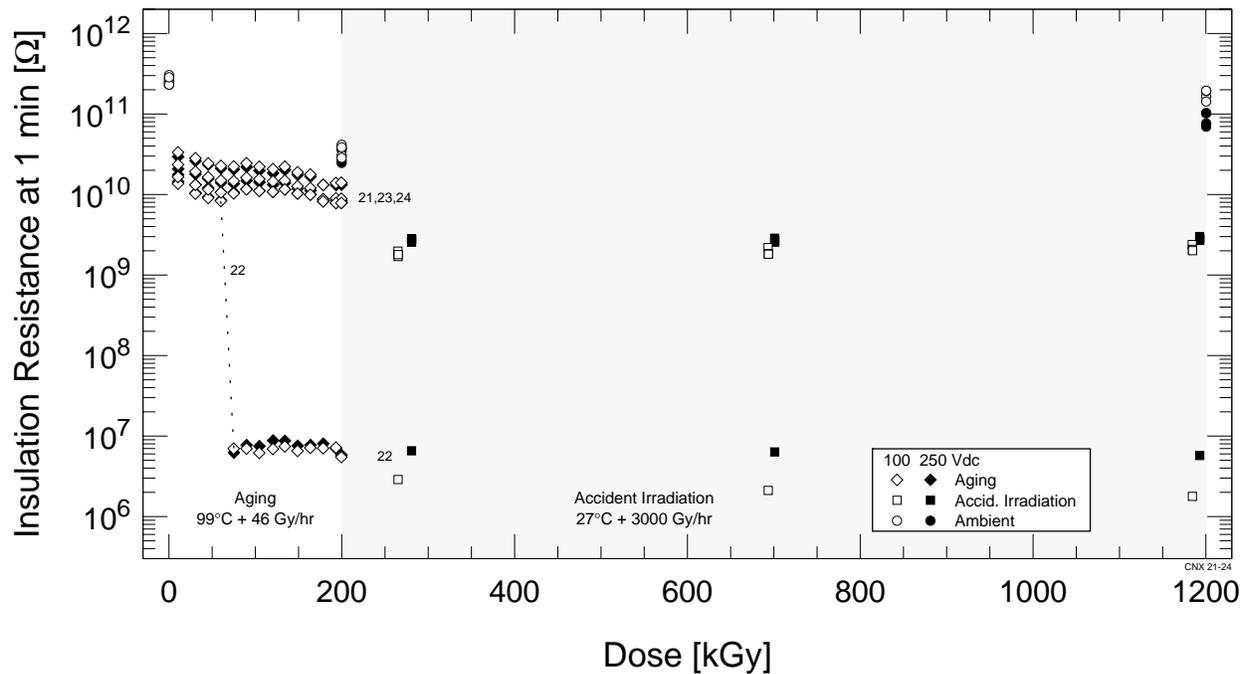
In general, there was no meaningful degradation in the measured insulation resistance (IR) of the connections during the aging and accident irradiation exposures. Of the 55 connection conductors, only the IR of one Conax Buffalo ECSA conduit seal conductor and two Rosemount 353C conduit seal conductors fell below  $10^7 \Omega$  during aging and the accident irradiation exposure. In addition, the snap-on plastic covers used on the EGS Grayboot connector quickly became very brittle during aging, and will easily break apart and fall off. This had no effect on the measured IR values and the covers are not required by the manufacturer. However, if the covers are required for seismic reasons or to

Figure 3.2: IR of the Conax Buffalo ECSA conduit seal conductors during aging and accident irradiation.

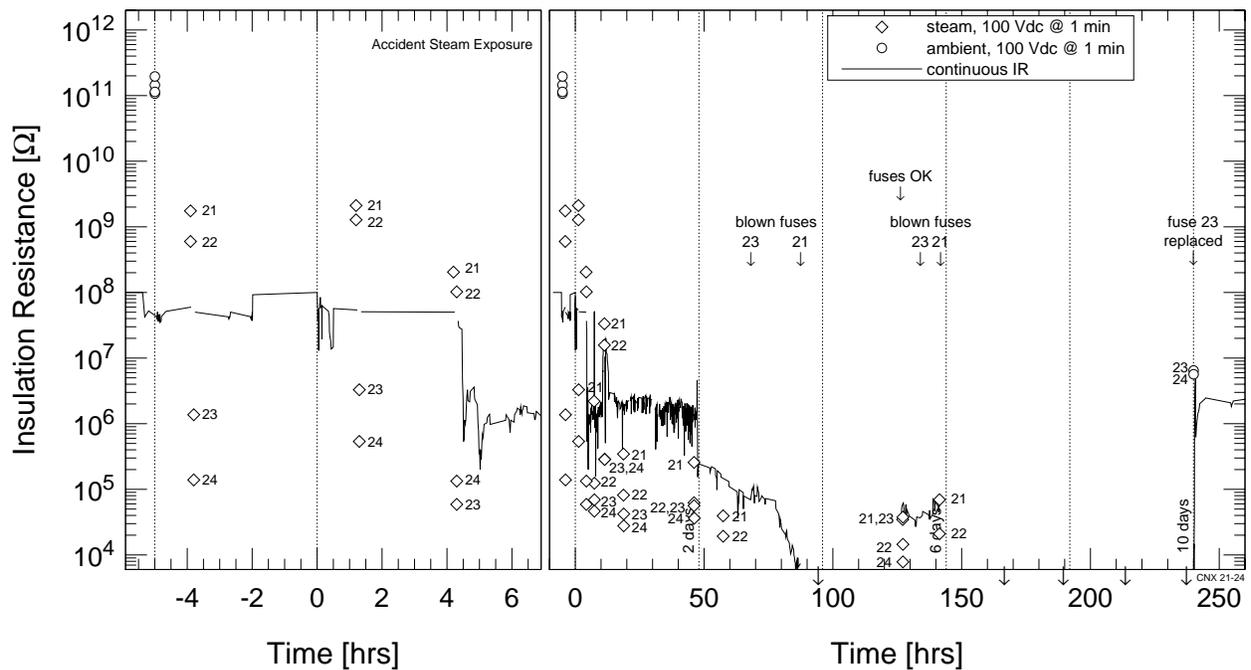
The IR for most of the connections also remained high during the accident steam exposure. Only the four Conax Buffalo ECSA conduit seal conductors gave extremely low IR values ( $< 100 \Omega$ ); the two nongrounded conductors repeatedly blew 1-A fuses when energized at 110 Vdc. However, post-test examination showed that these low IR values were produced by degraded Kapton-insulated cable leads; the IR of the actual conduit seals remained at levels above  $10^{10} \Omega$ . After the initial steam transients, only 3 of 6 Litton-VEAM connector conductors and all four Amphenol coaxial connector conductors had IR values that fell below  $10^7 \Omega$  (in addition to the four Conax Buffalo ECSA conduit seal conductors).

Figure 3.14: IR of the Conax Buffalo ECSA conduit seal conductors during the accident steam exposure.

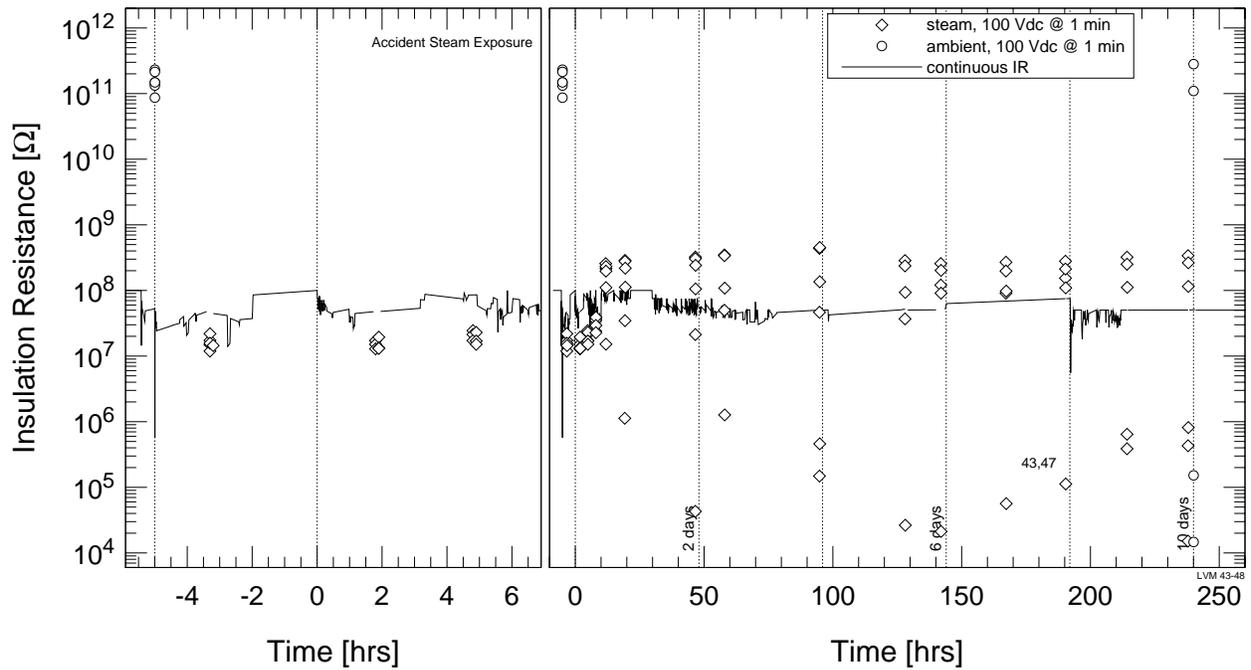
Post-test examination showed that the O-ring seals used in the Litton-VEAM connector were brittle and had experienced compression set, thereby reducing their sealing ability and allowing moisture to enter the connector body. The Rockbestos coaxial cable used with the Amphenol coaxial connector appears to allow moisture to permeate its jacket and then get into the unsealed connector by wicking along the braided shield. No explanation for the behavior of the Rosemount 353C conduit seal was found during the post-test examination.

Figure 3.20: IR of the Litton-VEAM connector conductors during the accident steam exposure.
