SANDIA REPORT

SAND98-0029

W88 Integrated Circuit Shelf Life Program

Jerry M. Soden and Richard E. Anderson
Failure Analysis Department

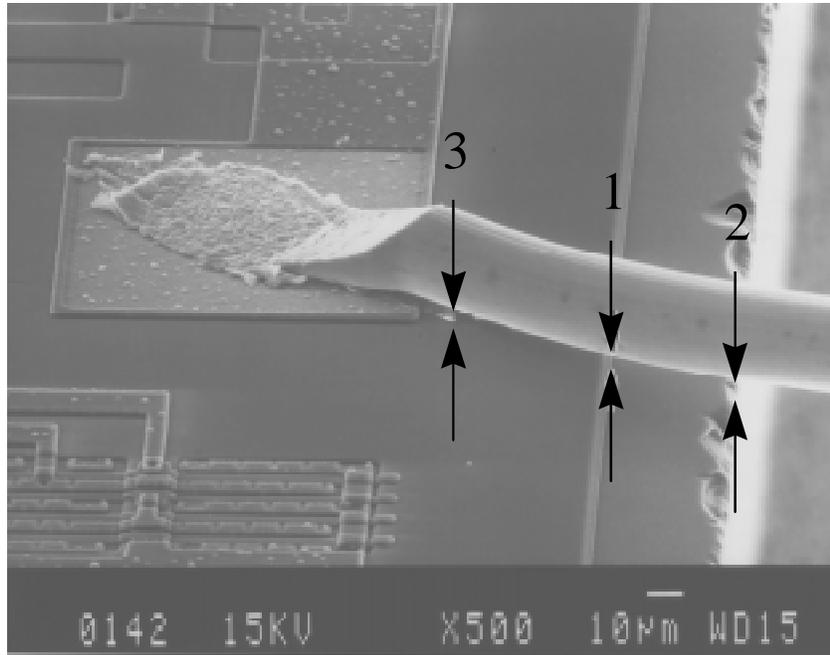
Fig.1 shows the bondwire clearance concern. This condition is in violation of MIL-STD-883/2010, 3.2.2a, Condition A, Class S, which requires a clearance of at least 1 mil between bond wires and unglassivated operating (biased) materials.

Fig. 1. SEM image of the poor bondwire clearance (~ 0.15 mil) between a bond wire and the passivation edge (location 1). Arrows point to measurement locations. Image from DPA 9305.297-D (pg. 16).

In Fig. 1, the arrows at location 1 show the clearance from the bottom of the wire to the passivation edge. This is the location where ASI usually measured the clearance, since the region beyond the passivation edge to the die edge (to the right of the arrows at location 1 in Fig. 1), is exposed silicon substrate biased at V_{DD} . This region, the die street, is where the overlying dielectric layers have been removed to delineate the die boundaries and to improve the die separation process (sawing for this packaging process). However, AMO measured the clearance from the bottom of the wire to the die edge (location 2 in Fig. 1). In several of the bondwire clearance failures identified by ASI, it appears that the wires had acceptable clearance using the AMO clearance location (die edge) because of the upward angle of the bond wires. In other cases, such as that shown in Fig. 1, the wires fail using either the passivation edge or die edge location. AMO used a reverse bonding process (package pad bond first, die bond last) which, combined with the type of packages used for these ICs, may have increased the likelihood of low clearance of the wires at the die bond pads.

Risk #2 of a conductive particle lodging between the wire and the die, resulting in a short, is a more significant concern for these ICs. The reduced clearance between the wire and the die increases the likelihood of short if a loose, conductive particle is present in the package cavity. Particles were observed in packages of DPAs 9409-873-D and 9409-875-D. For DPA 9409-873-D, the particle was an aluminum sliver about 1.1 mil long at a wire bond to the IC pad. For 9409-875-D, the particles were AuSi slivers up to about 1.1 mil in length on the top of the AuSi die attach surface adjacent to the die. These particles are long enough to potentially cause a short if they were to come loose (both types of particles were described as “loosely attached”).

This concern may be offset to some extent by the use during production of wire lifting to improve the wirebond clearance (resulting in the wire “kinks” noted in some DPAs). The wire lift procedure was used during production when deemed necessary to achieve the required wire clearance about the chip surface.

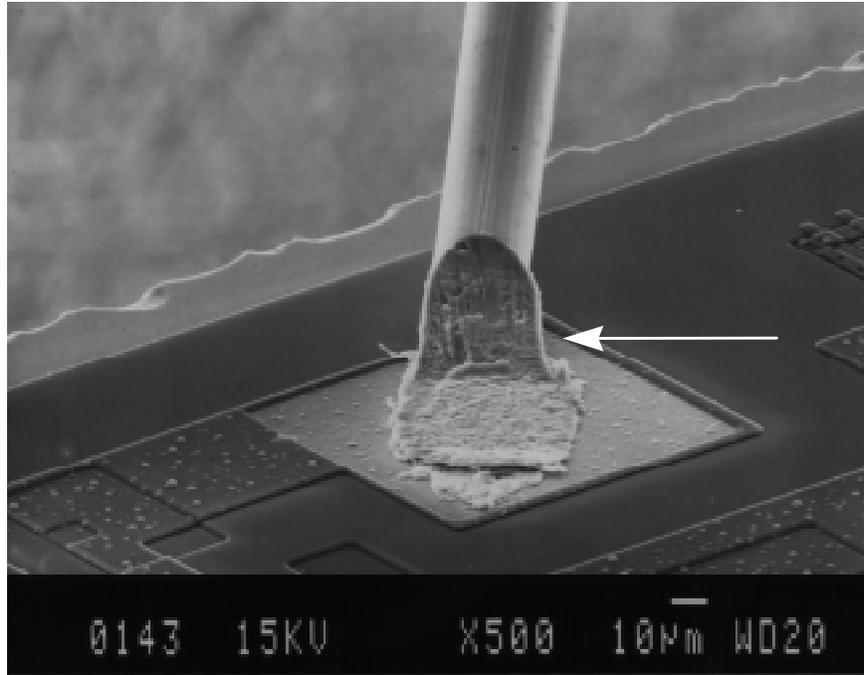
Fig. 2 shows the poor bondfoot thickness concern. Although the deformation of this particular bond is acceptable per the MIL-STD-883/2010 requirements, there is significant thinning of the bond. The bond foot thickness is less than 25 % (actually less than 10 %) of the wire diameter (1 mil). This condition is in violation of MCR-72-241, 5.1.1.4.3 (this is not a required specification for the DPA, but is used by ASI as a guide because it provides more detailed inspection criteria than MIL-STD 883 and has been used by Sandia satellite departments). This raises a significant concern about the strength and reliability of the wire bonds. For DPA 9305-297-D, the wirebond pull testing resulted in six bond wires of one IC fracturing at low forces (1.1 to 1.4 g). This fails the MIL-STD-883/2011, 3.2 requirement of 1.5 g. For this DPA, a total of 98 wires on the two ICs were tested with all other bonds fracturing from 1.6 to 4.8 g. These bond pull failures appear to be directly related to the overbonding observed during the DPA.

Fig. 2 SEM image of poor bondfoot thickness (same wire as that shown in Fig. 1 but from a different direction). Arrow points to bondfoot. Image from DPA 9305-297-D (pg. 15).

The bonding problems observed during the DPAs are interrelated in the following ways. The concern discussed previously of a wire moving down into physical and electrical contact with the die may be increased due to the observed low bondfoot thickness and pull strengths, since these may indicate an increased risk of the wire “sagging” into contact with the die. In addition, the observation of the disturbed bondwire (9409-881-D) indicates that there is a possibility that some wires may have been pushed closer to the die unintentionally during wirebonding or subsequent process operations prior to lid sealing.

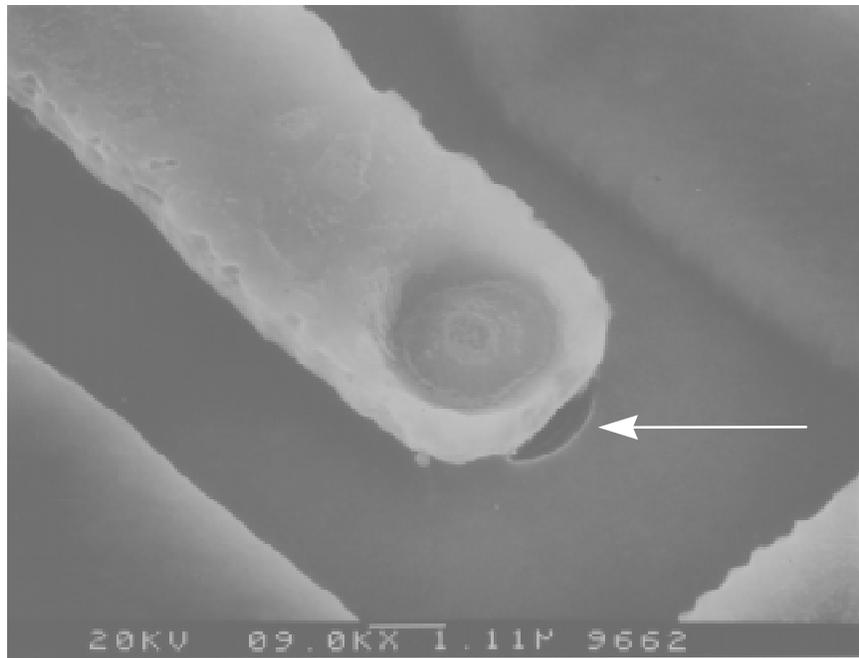
The other area of possible reliability risk involves the observation of low contact window area coverage. Misalignment of the metal contact windows to silicon and polysilicon resulted in significant overetching of the silicon and polysilicon for some ICs. This is shown in Figs. 3-6. The etch pit into silicon is a concern because it extends a considerable distance through the n^+ or p^+ junctions, creating the possibility of high junction leakage or junction shorting. The etch cut into the polysilicon appears deep enough to raise the concern that it might go all the way through the polysilicon. However, this is probably not as serious a concern, since it is likely that there would be sufficient intact polysilicon on at least one side of the contact window to assure electrical continuity even if the polysilicon were etched completely through. This might increase to some extent the electromigration risk for those sections of polysilicon that are used as interconnections (versus those used only as transistor gates).

During production, the criteria for contact window coverage was 75% or more coverage. This means that misalignment of the metal over silicon and polysilicon contact windows was allowed, permitting up to as much as 25% of the contact window area to not be covered. The exposed contact window areas shown in Fig. 3 and Fig. 5 are less than 25%, so they illustrate conditions that met the inspection requirement during production. In addition, no electrical failures are known to have occurred during production or W88 assembly testing due to mechanisms involving insufficient contact window coverage.

Fig. 3. SEM image of poor metal coverage of a contact window to silicon. Arrow points to contact window region not covered by metal. Image from DPA 9305-438-D (pg. 21).

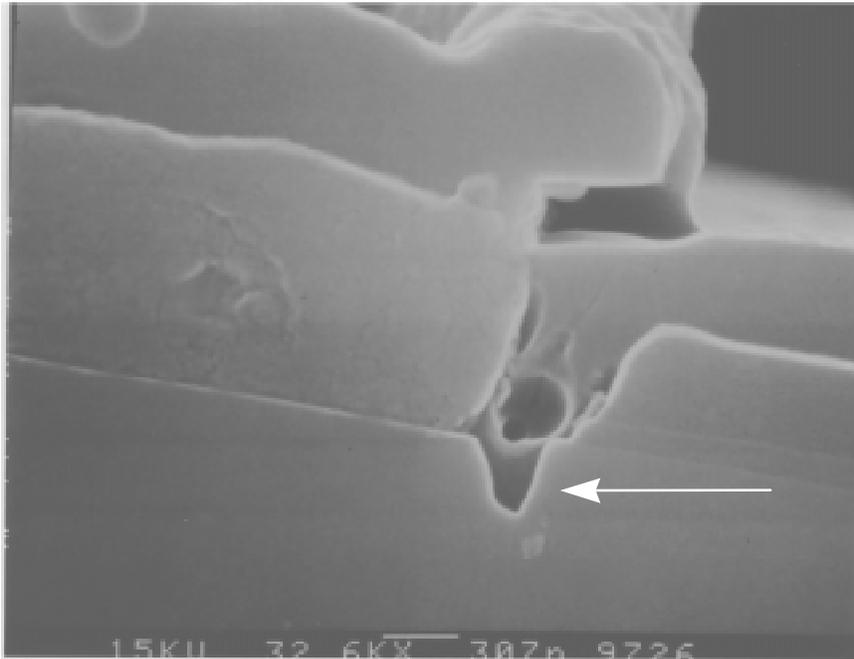
Fig. 4. SEM image of cross section of silicon etching due to poor metal coverage of contact window to silicon. Arrow points to etched silicon region. Image from DPA 9305-438-D (pg. 23).

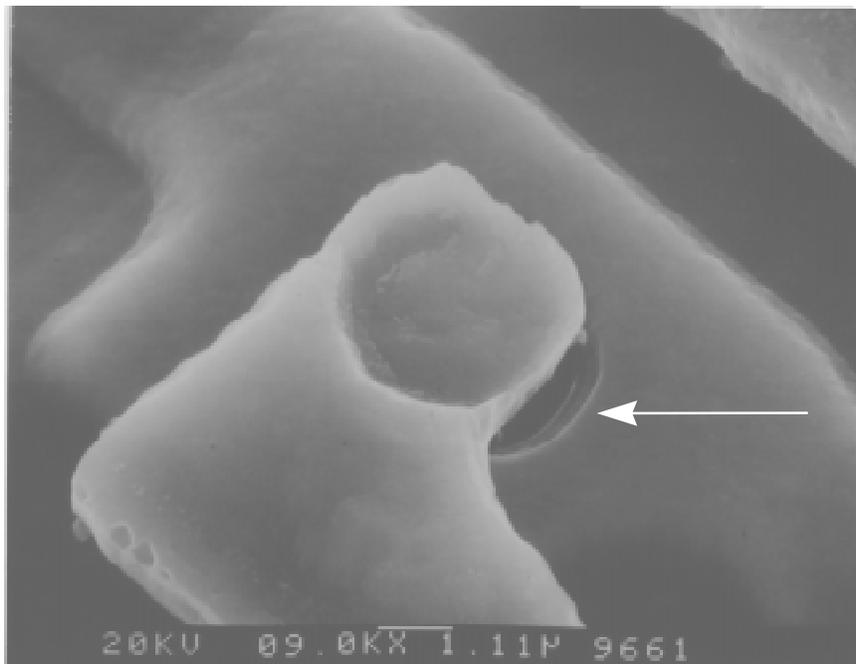
Fig. 5. SEM image of poor metal coverage of a contact window to polysilicon. Arrow points to contact window region not covered by metal. Image from DPA 9305-438-D (pg. 20).

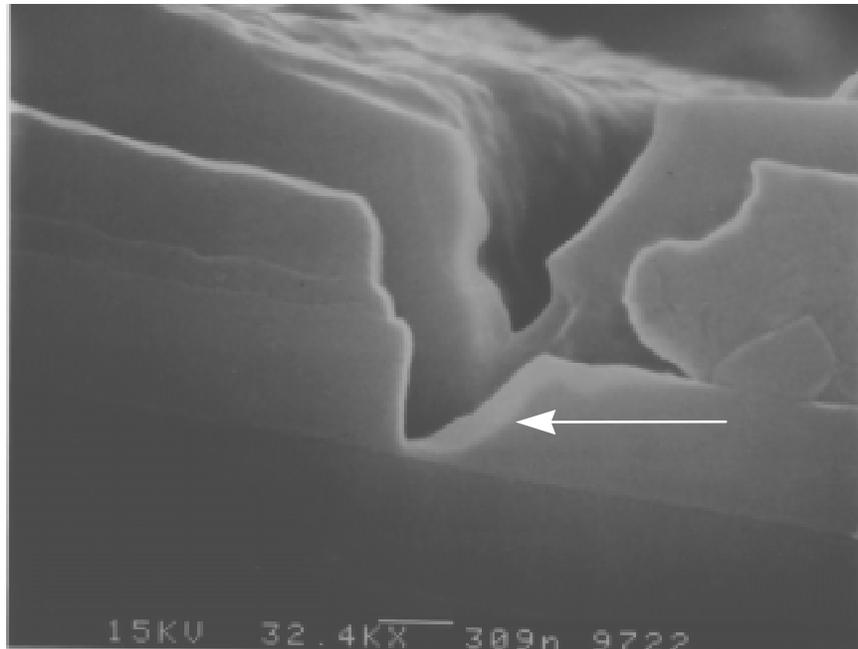
Fig. 6. SEM image of cross section of polysilicon etching due to poor metal coverage of contact window to polysilicon. Arrow points to etched polysilicon. Image from DPA 9305-438-D (pg. 24).
