SANDIA REPORT

SAND98-1086

H1616 Supplemental Compliance Test Report

Sandia National Laboratories designed the H1616 container for transport of Type B quantities of radioactive materials. During the most recent recertification cycle, questions were raised concerning the ability of drum type containers with locking rings to survive the hypothetical accident sequence when the puncture test was oriented to specifically attack the locking ring. A series of tests has been performed that conclusively demonstrates that the specially designed locking ring on the H1616 performs adequately in this environment.

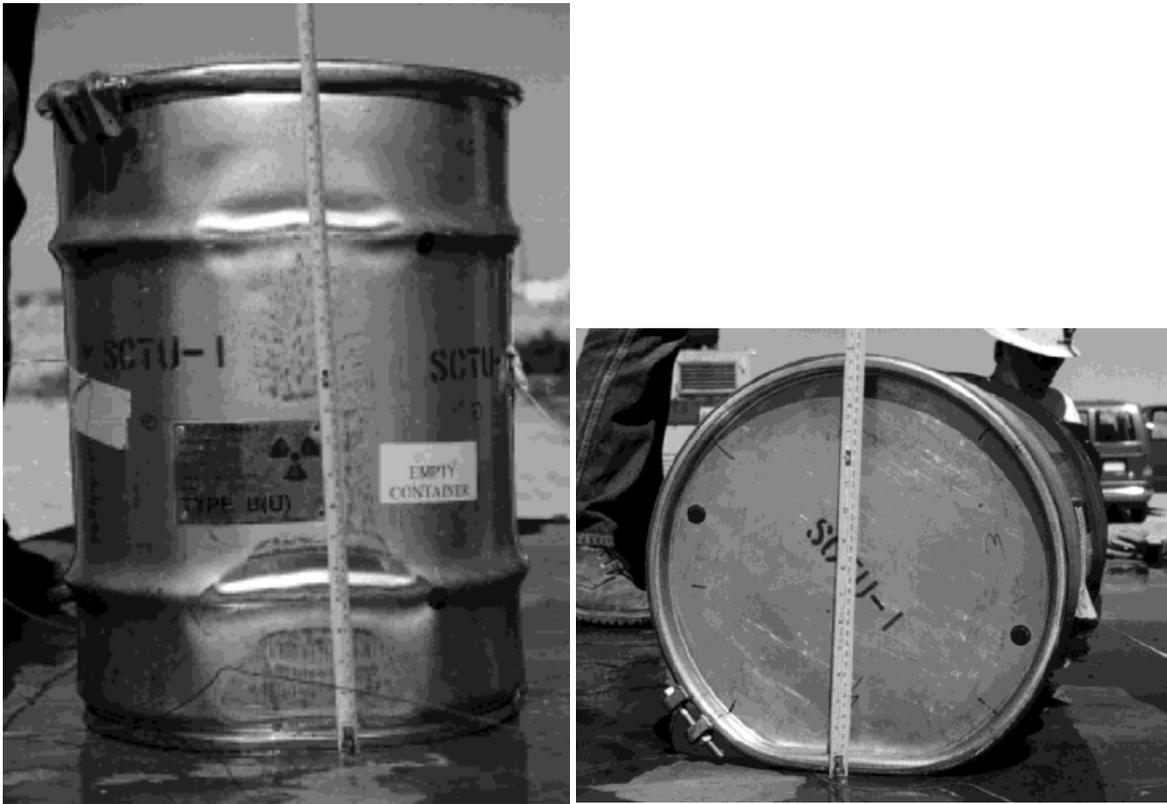
Figure 1: SCTU-1 Side Drop Results

For the hypothetical accident sequences, the impact damage incurred in SCTU-1 is shown in Figures 1 and 2. Figure 1 shows that the flat side drop test at the 45° circumferential location resulted in flattening of the overpack along the impact line. There was no observable loosening of the locking ring as the locking ring and overpack body had the same general deformation. The impact of the lug on the puncture bar, as shown in Figure 2, did result in a prying action that rotated the lug away from the overpack body. This impact did not result in the failure of any components of the locking ring and the lid remained attached to the overpack body.

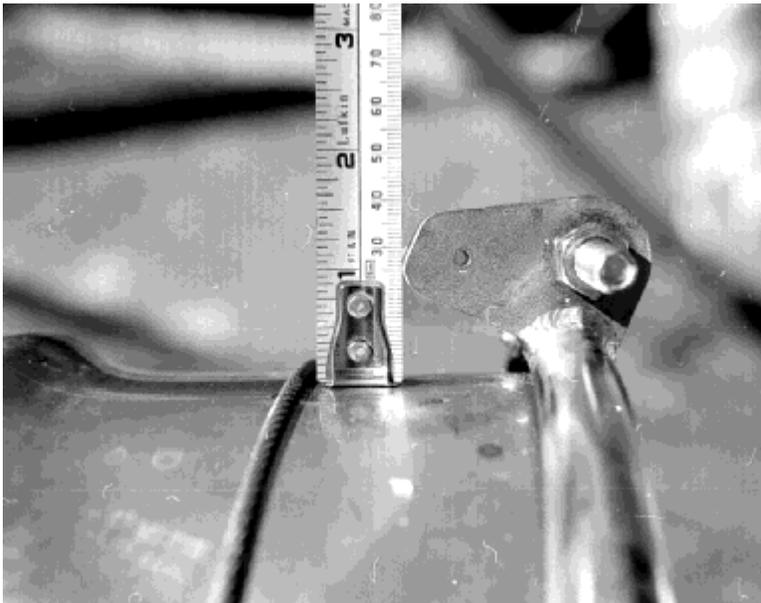
Figure 2: SCTU-1 Puncture Test Lug Deformation

Table 3 shows the effect of the puncture test on the gap between the lug and the overpack body for SCTU-1. The prying action of the puncture bar in this test resulted in increased gaps between the lugs and the overpack body. Both lugs were deformed even though only the right side lug was attacked. The maximum increase in the gap was incurred in the attacked right hand lug. The gap increased from 0.2 to 0.8 inches for a total increase in the gap of 0.6 inches.

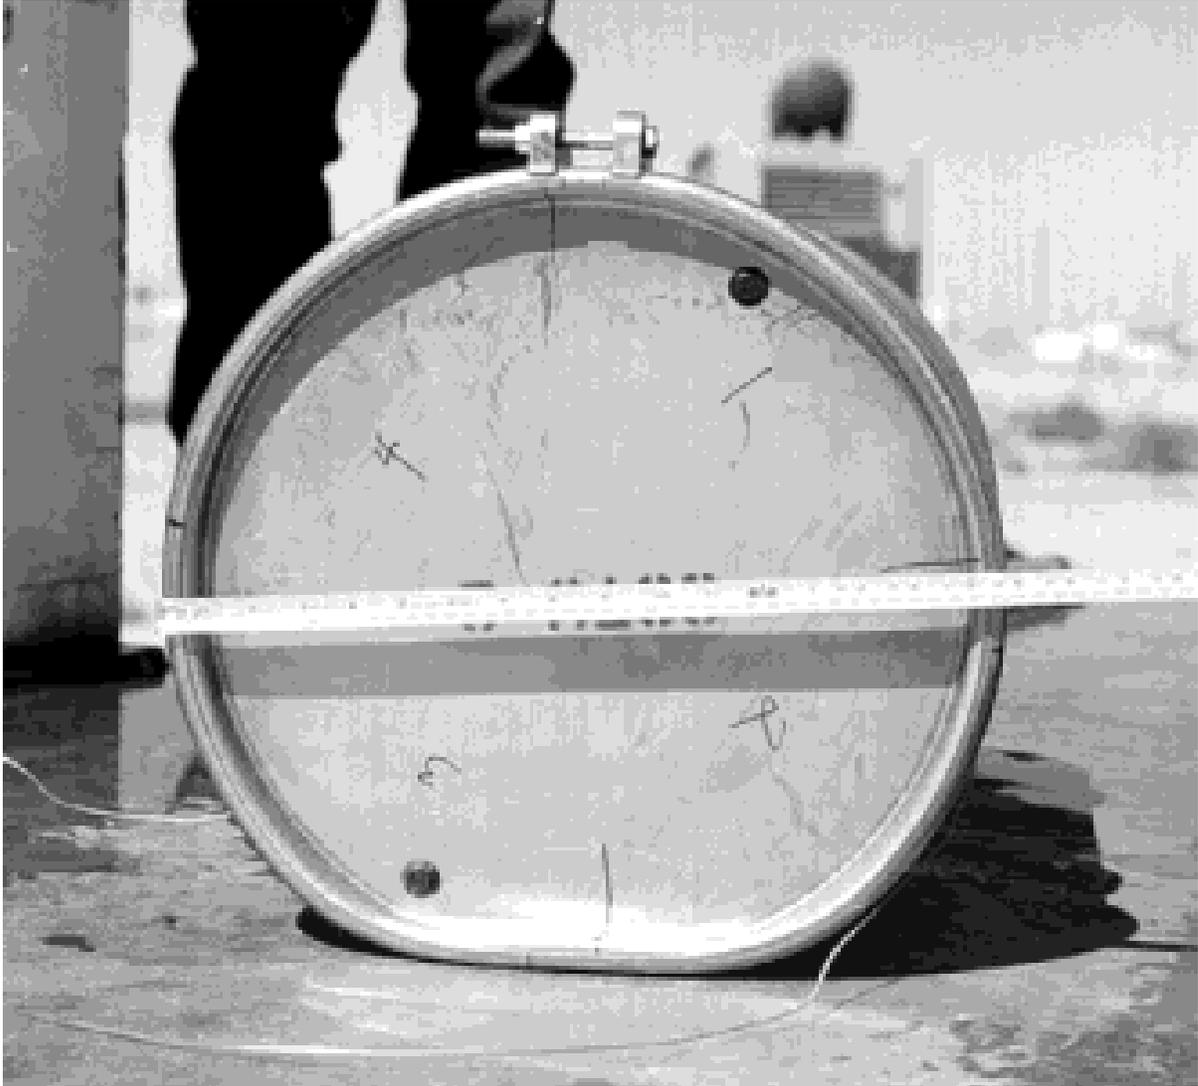
Figure 3: SCTU-2 Side Drop 180° from Lugs

Figure 3 shows the results of the flat side drop at the 180° circumferential location. Again there was a flattening at the impact location, but no discernable loosening of the locking ring. Results from the puncture test were also comparable to those from SCTU-1.

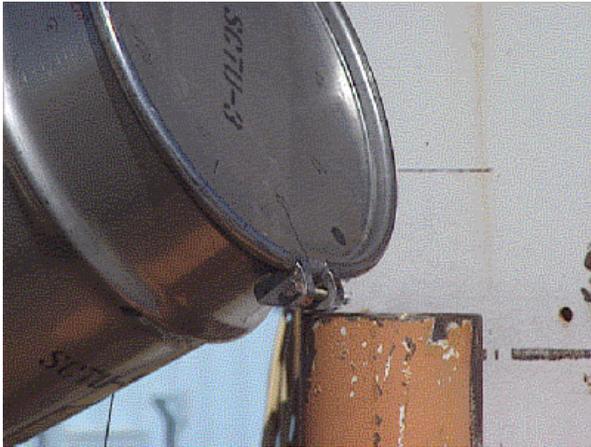
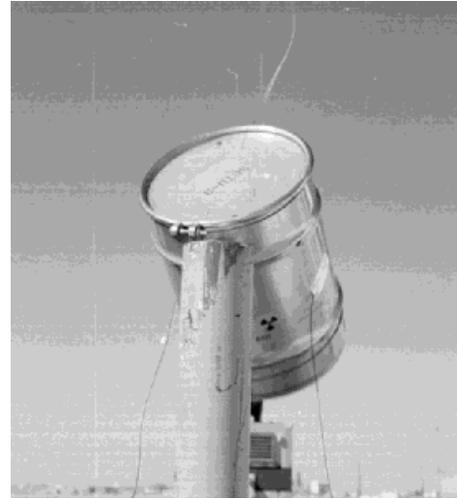
Figure 4: SCTU-3 Impacting the Puncture Bar

Figures 4 and 5 show the results of the puncture test on SCTU-3. Figure 4 shows the impact on the single lug. Figure 5 shows that the deformation of the lug is smaller than the deformation shown in Figure 2 and again there is no discernable loosening of the locking ring.

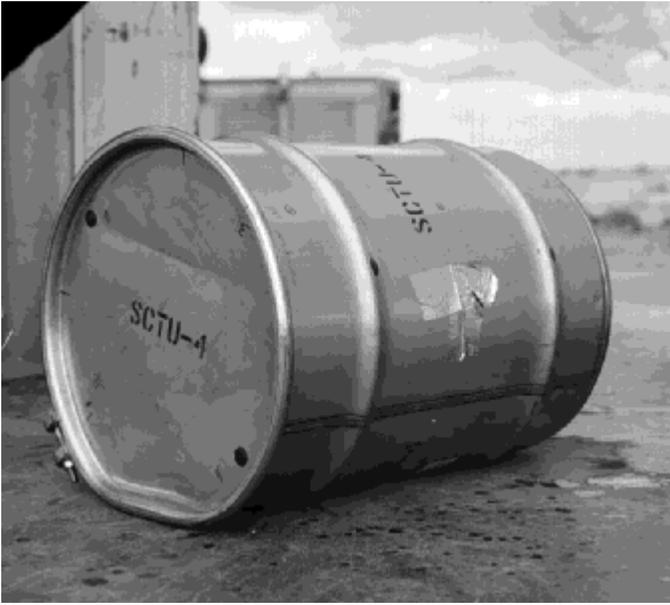
Figure 6: SCTU-4 Drop Test Results

Figure 6 shows that the damage to SCTU-4 is comparable to that shown in Figure 1 for SCTU-1. Figure 7 captured the lug as it was being deformed during the puncture test. Figure 8 shows the post test deformation. Note that the damage again is comparable to that shown in Figure 2 for SCTU-1.

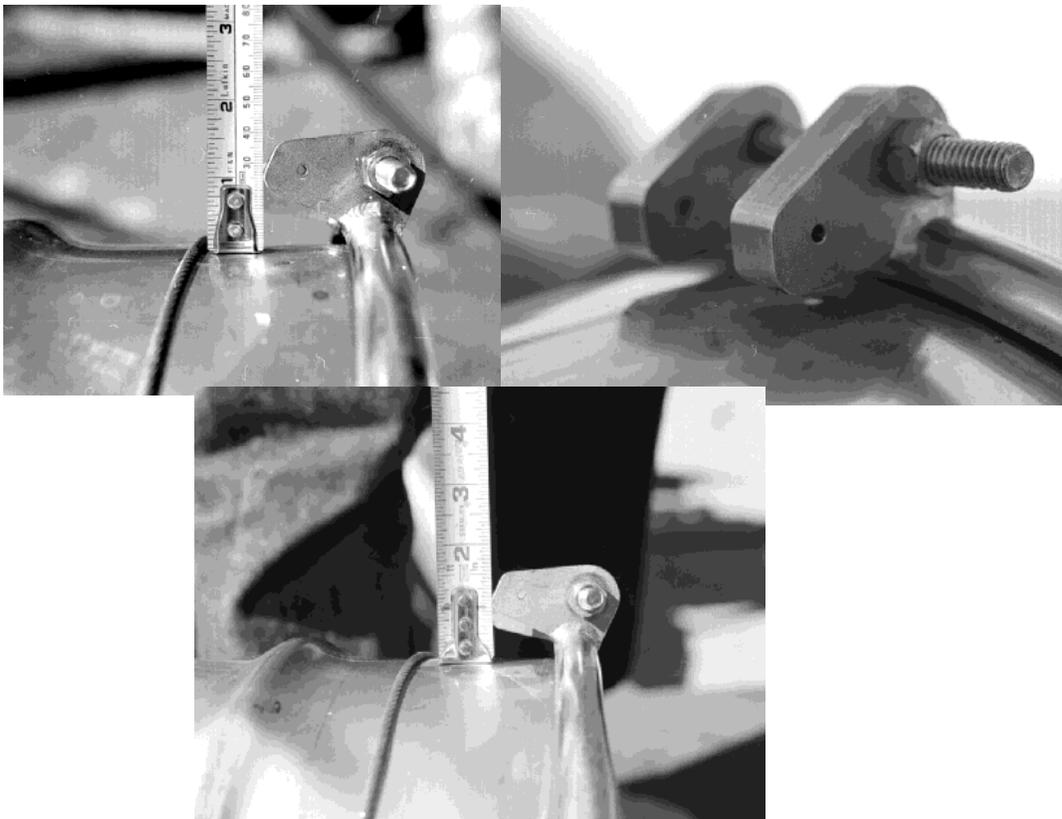
Figure 9: Comparative Lug Deformation

Figure 9 shows a comparison of the deformation of lugs given in the previous figures. SCTU-1 and 4 when subjected to the vertical impact on a single lug had comparable damage. SCTU-3 that was impacted in a stiffer orientation has substantially less deformation.

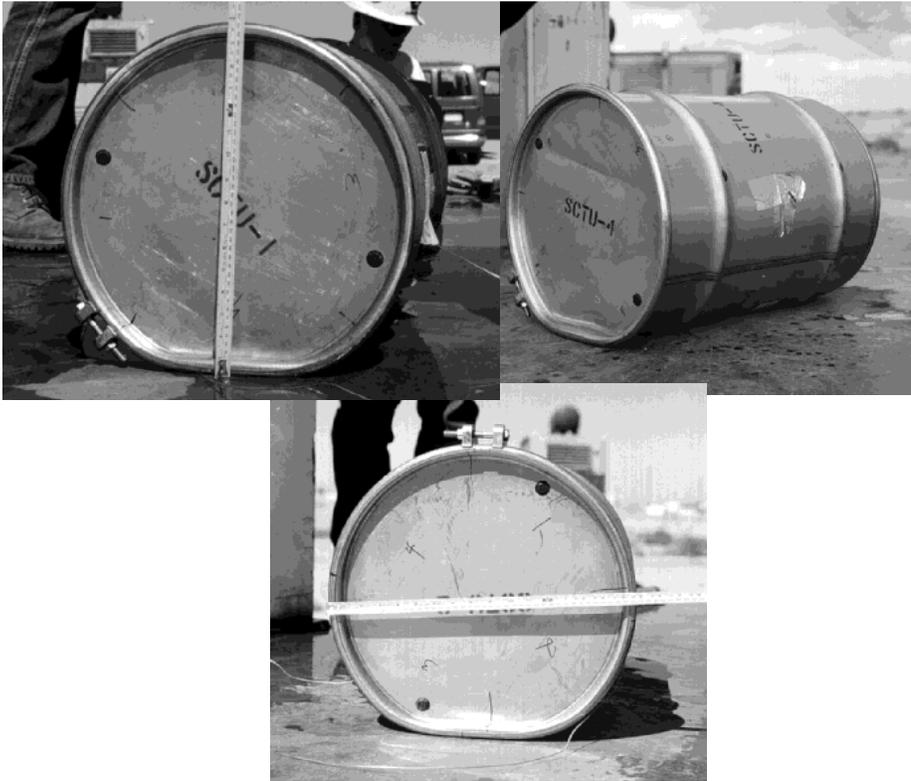
Figure 10: Comparative Drum Deformation

Figure 10 shows the deformation resulting from the side impacts. All had comparable deformation patterns irrespective of the circumferential impact location and none of the locking rings were loosened by the impacts.

The visual inspection of the locking rings indicated no loss of locking ring engagement, no fractured welds on the impacted lugs and no fractured lug bolts.

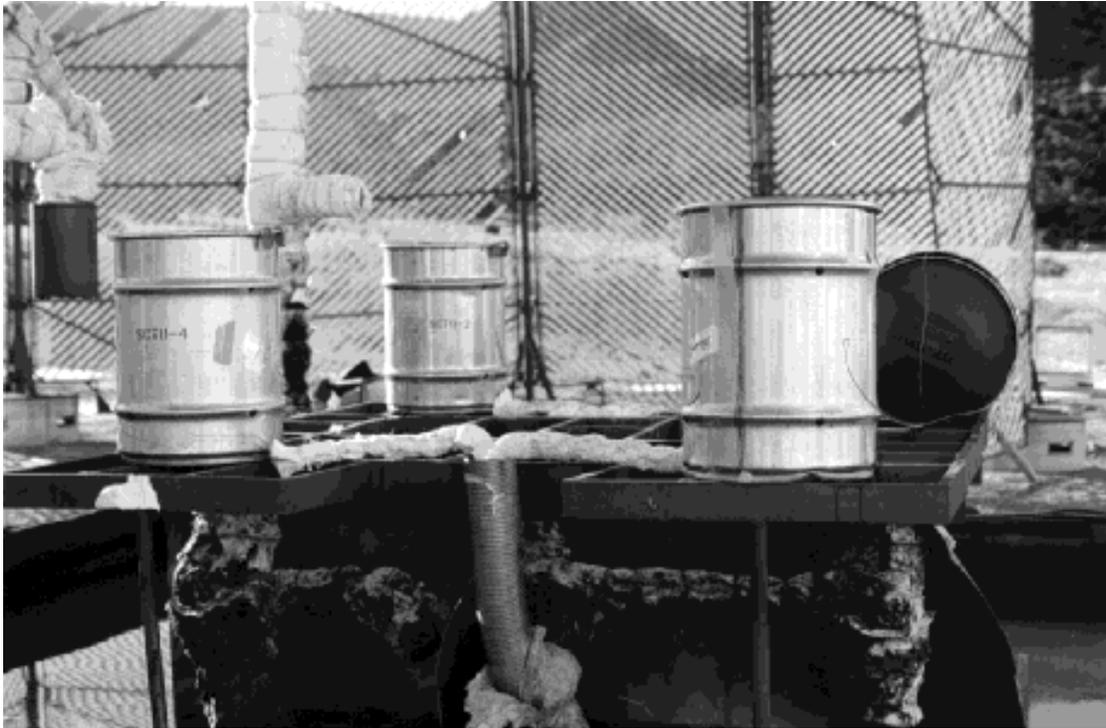
Figure 11: Pool Fire Test Set Up

The three supplemental compliance test units configured for the pool fire test are shown in Figure 11. All the units were vertical with the lid up. Since there was no tearing of the stainless steel drum or loosening of the lid, the container orientation was not critical to the test results.

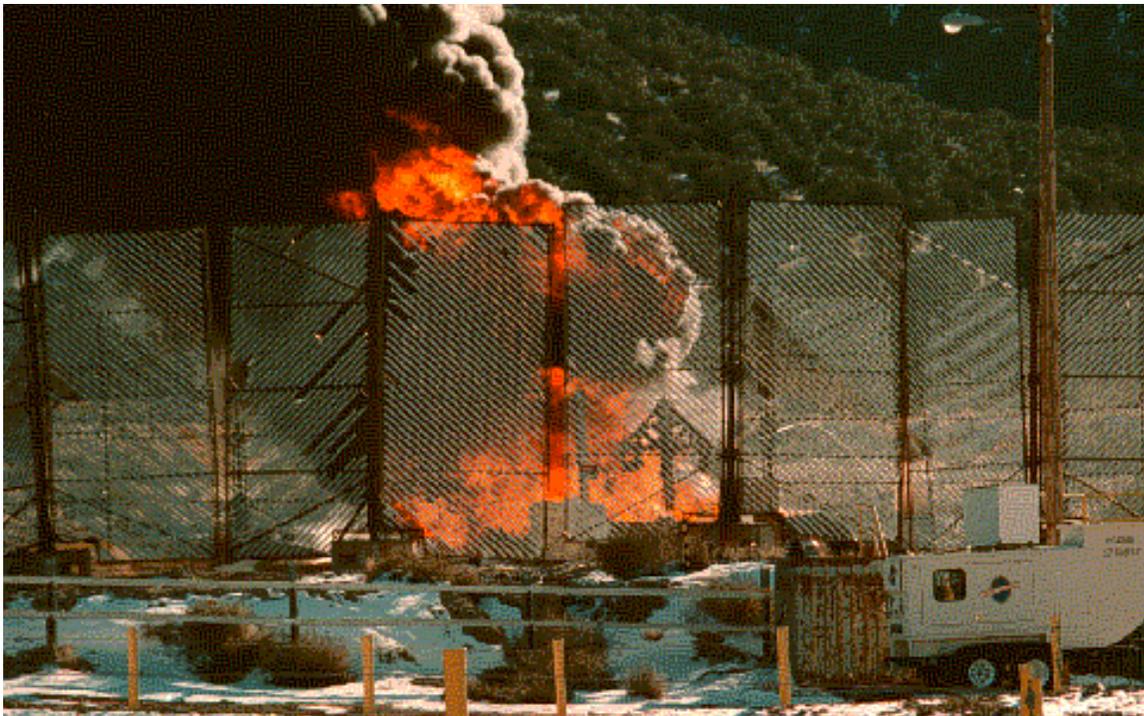
Figure 12: Pool Fire Test

Figure 12 shows the pool fire engulfing the three containers. The data presented in the Temperature Data section will demonstrate that the temperature and time conditions specified in 10CFR71 were met.

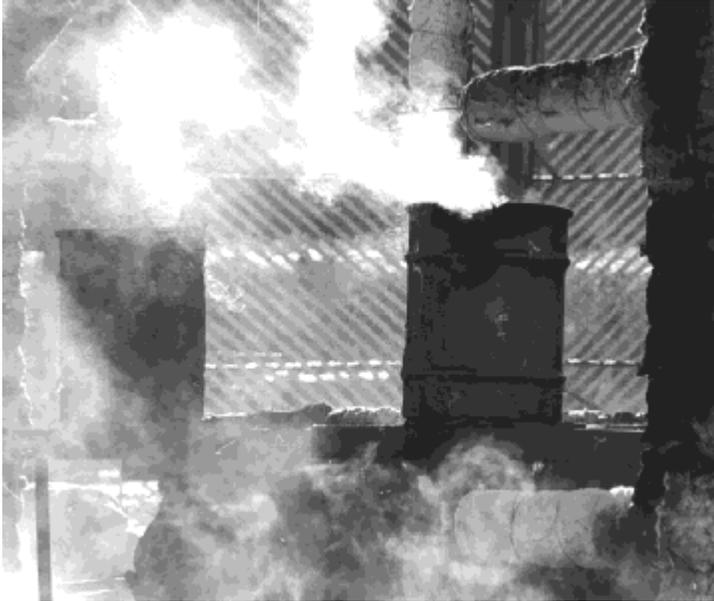
Figure 13: Post Fire Results

After the fire self extinguished, the foam within the containers continued to smolder as shown in Figure 13. After one day, the containers were cool enough to handle. At that point the containers were prepared for leak testing.

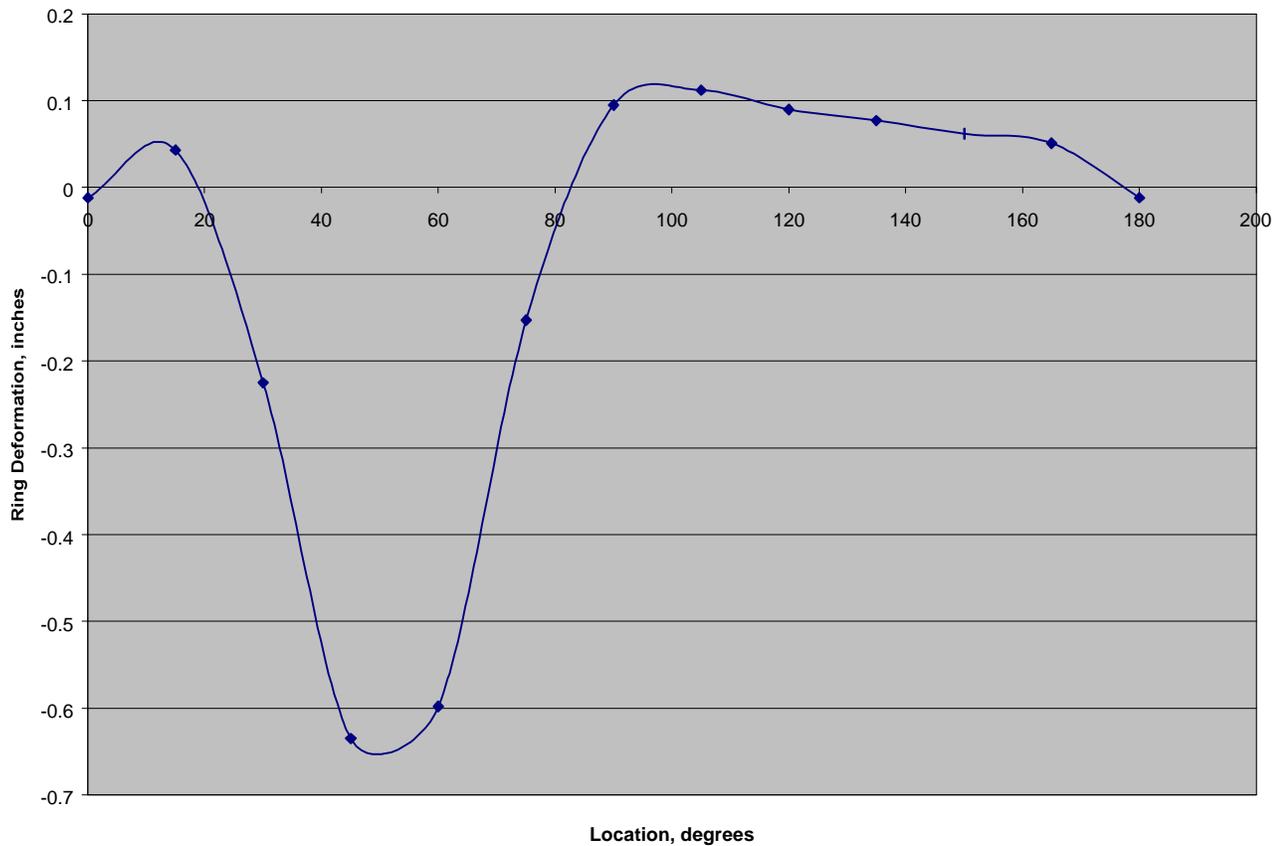
Figure 14: SCTU-1 Ring Deformation

Table 2 and Figure 14 show the results of the diameter measurements of SCTU-1 before and after the impact testing. The first column in Table 2 gives the circumferential location in degrees with the midpoint between the lugs designated

as the 0° point. All measurements were taken with the locking ring as assembled on the container. The pre-drop measurements show the initial configuration of the locking ring. The post puncture test data shows the configuration of the locking ring after the drop and puncture tests. The final column is the difference between the post test configuration and the pretest configuration. This final column is shown graphically in Figure 14. The maximum change in the diameter is 0.635 inches at the 45° impact point. In addition to the decrease in diameter at the impact point, there is also some ovalization of the ring as demonstrated by the increased diameters away from the impact location.

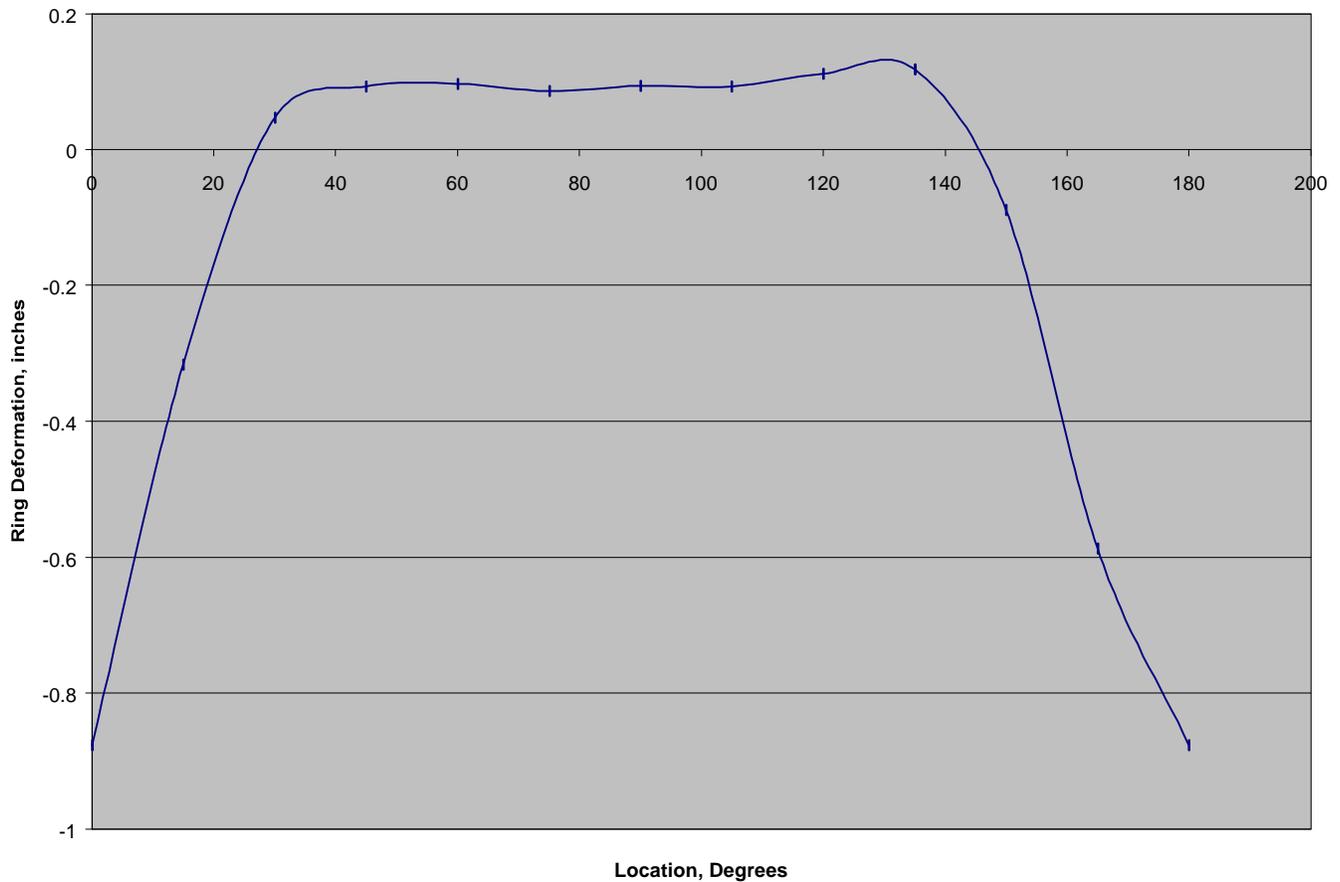
Figure 15: SCTU-2 Ring Deformation

Table 4 and Figure 15 show the effects of the impact tests on SCTU-2. This container was impacted at the 180° location. As can be seen in both the Table and the Figure, the maximum deformation is 0.877 along the 0, 180° diameter.

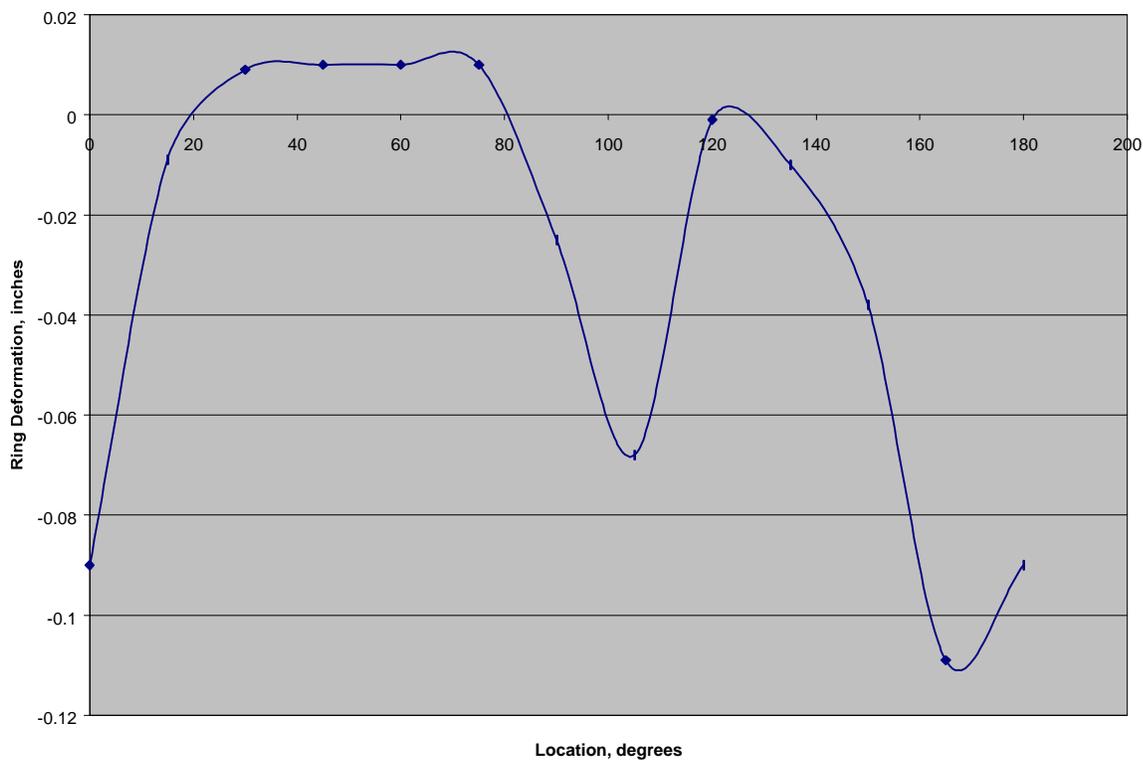
Figure 16: SCTU-3 Ring Deformation

Table 6 and Figure 16 show the deformation in the locking ring for SCTU-3. This test consisted of only the puncture test during which the right locking ring lug was impacted normal to the flat surface in an attempt to drive the locking ring off an undamaged container. The results show that there were deformations of up to 0.109 inches. These deformations are much smaller than the other three containers due to the lack of a drop test.

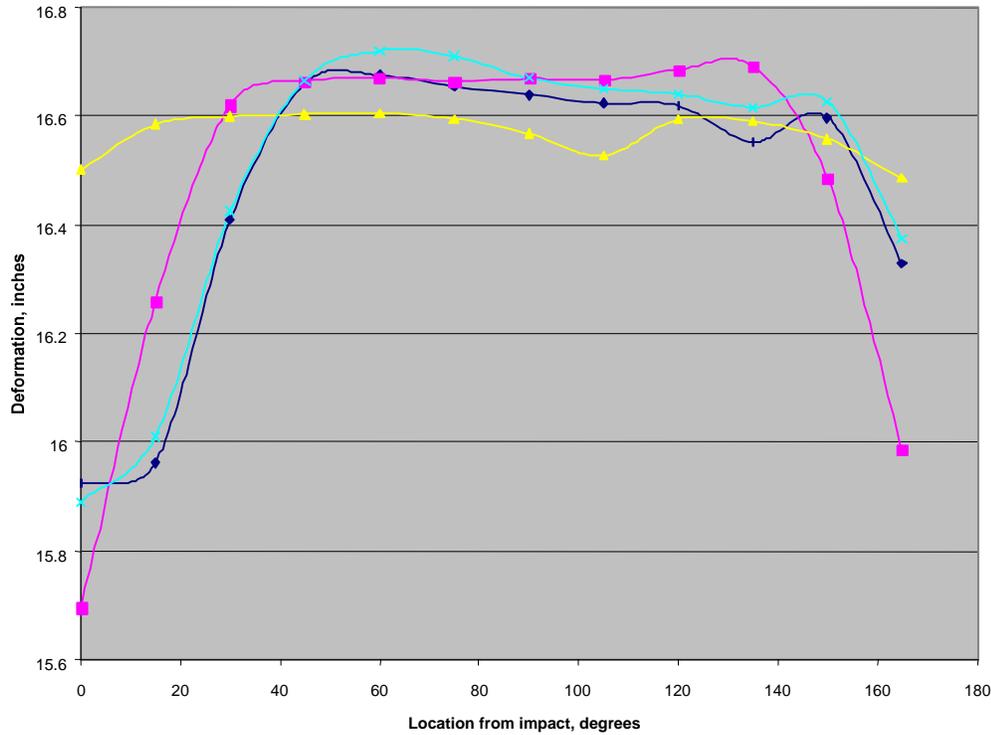
Figure 17: Comparison of Posttest Deformations

In Table 8 and Figure 17, a comparison is made between the posttest configurations of all four test units. Figure 17 is graphed with each containers' impact locations designated as 0°. This comparison shows that each of the containers subjected to a drop test (SCTU-1,2,4) had comparable deformations resulting from the impact events. SCTU-3 had much less deformation. SCTU-1 and SCTU-4 had very similar post impact configurations and so having only SCTU-4 in the pool fire was representative of both of those containers.
