SAND2004-4584

Failure Analysis of Rutile Sleeves in MC3080 Lightning Arrestor Connectors

Chad S. Watson, Alice C. Kilgo, Terry L. Ernest, Sandy L. Monroe, Bruce A. Tuttle,
and Walter R. Olson

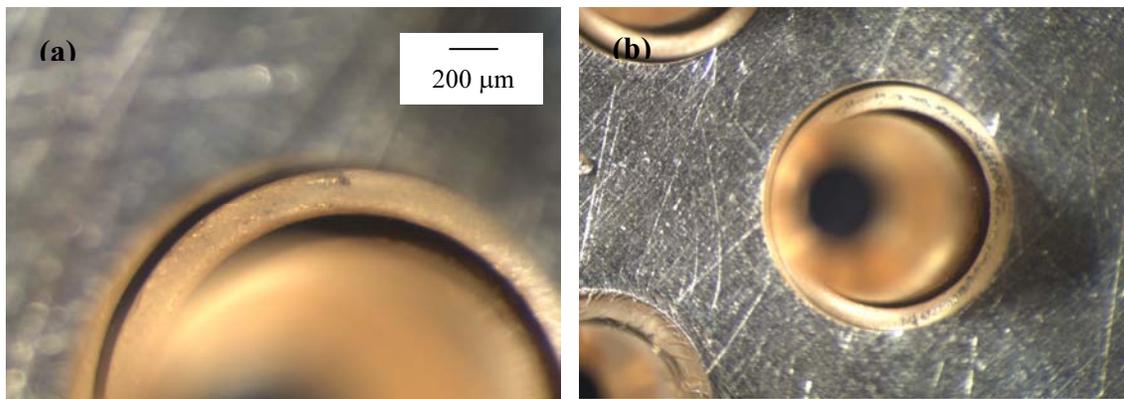
LAC SN902045-D79 was cross-sectioned at the glass/epoxy interface and polished for initial inspection (1st Polish). At this point, any debris in the air chamber that is trapped by the back-filled epoxy is noted. No trapped debris was observed. The LAC was polished to the web/epoxy interface for closer inspection of the rutile sleeves (2nd Polish). The 2nd polish is conducive to the use of vicinal lighting which helps delineate cracks. Any anomalous pin/sleeve symmetry (perfectly symmetric), cracked sleeves or contamination were noted during the inspection after the 1st and 2nd polish. All sleeves and pins appeared to be asymmetrically aligned within the slots in the stainless steel webbing. The ends of some of the sleeves had what appeared to be metallic contamination. The concentration of the silver-looking contamination ranged from a few specs (Fig. 6a) to a light coating (Fig. 6b). This metallic-looking contamination could be from handling during the assembly of the LAC. In particular, if tweezers were used to place the sleeves in the appropriate slots, residual metal could have easily been transferred to the sleeves. This contamination did not appear to influence FRB/IR/DCW results.

Fig. 6 Representative images of metallic-looking contamination on the ends of sleeves associated with (a) Sleeve R and (b) Sleeve U.

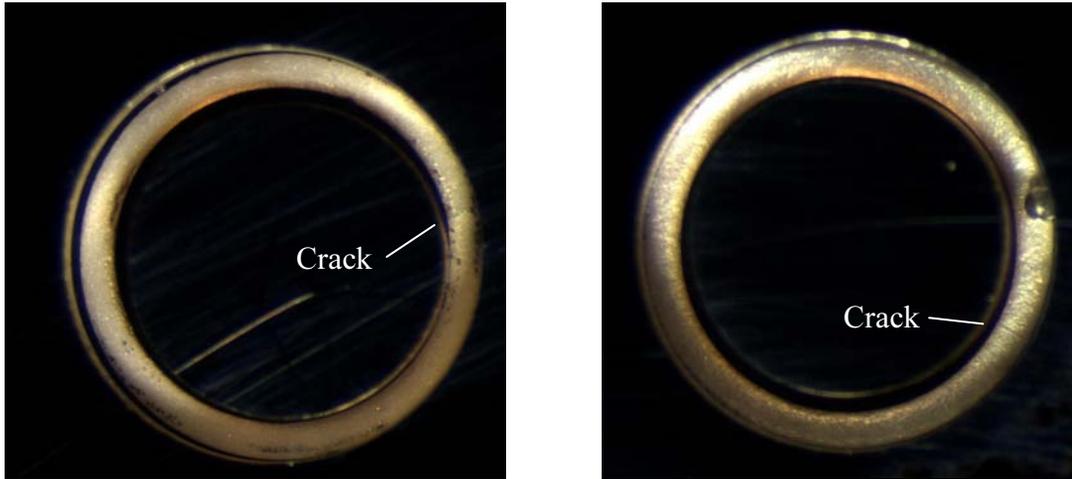
Fig. 8 Cracks observed in sleeves after the 2nd polish: (a) Sleeve b and (b) Sleeve k. Wall thickness of the rutilite sleeves is approximately 225 μm .

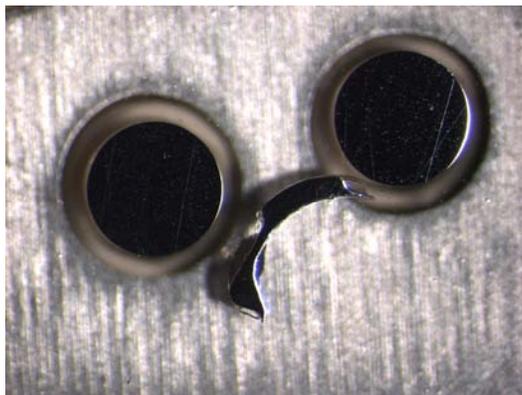
After the 1st polish, a large metal flake was observed between Pins L and M (Fig. 9). The flake was introduced during the removal of the set screw in the rear tubulation. The set screw could not be removed using an Allen wrench; as a result, a hole was drilled through the rear tubulation. The flake is scrap from the drilling process. If metallic

Fig. 9 The metal flake is an artifact of drilling into the rear tubulation to gain access to the air gap between the glass seal and the stainless steel webbing. The diameter of the web hole is approximately 2.32 mm.

debris were present in the air chamber and in contact with the web and pins, the LAC would fail DCW and pins in contact with the debris would fail IR. One apparent affect of metallic debris in the air chamber would be variability in which pin failed IR, because it could easily be dislodged to another region in the air chamber. Subsequent removal of the setscrew was accomplished by carefully heating the rear tubulation with a blowtorch and quickly unscrewing the set screw with an Allen wrench. The setscrew cannot be removed with an Allen wrench at room temperature because it is “glued” into place.

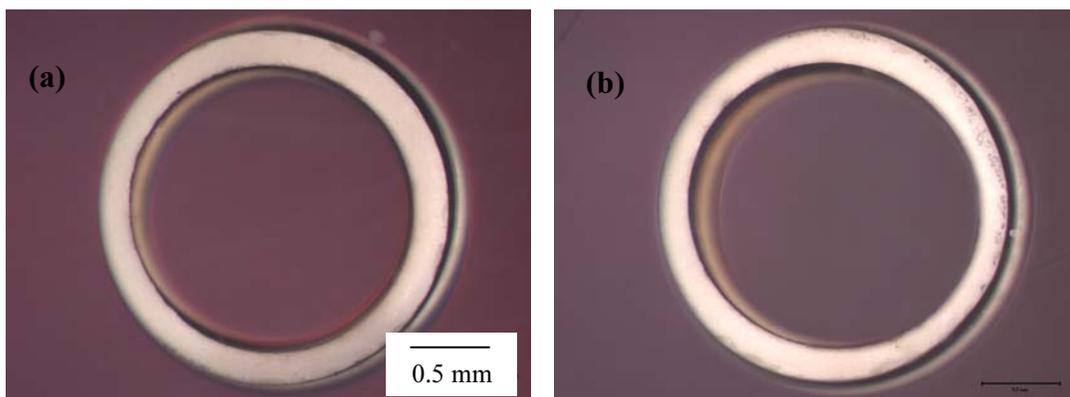
All pins/sleeves exhibited asymmetric alignment. No cracks were observed after the 1st polish. The 2nd polish revealed that some sleeve ends contained metallic-looking contamination (Fig 10). In addition, a majority of the rutile sleeves in LAC SN805036-F78 exhibited a higher frequency of edge chipping and higher surface roughness than sleeves from the other LACs that were examined as part of this study. Representative images of sleeves with extensive surface damage are shown in Fig. 11. Even though there is variability in chip out, surface roughness and metallic contamination, all of the pins in LAC SN805036-F78 passed FRB/IR/DCW. Only one sleeve (Sleeve W) had a crack (Fig 11a).

Fig. 10 Representative images of metallic-looking contamination on (a) Sleeve L and (b) Sleeve H .

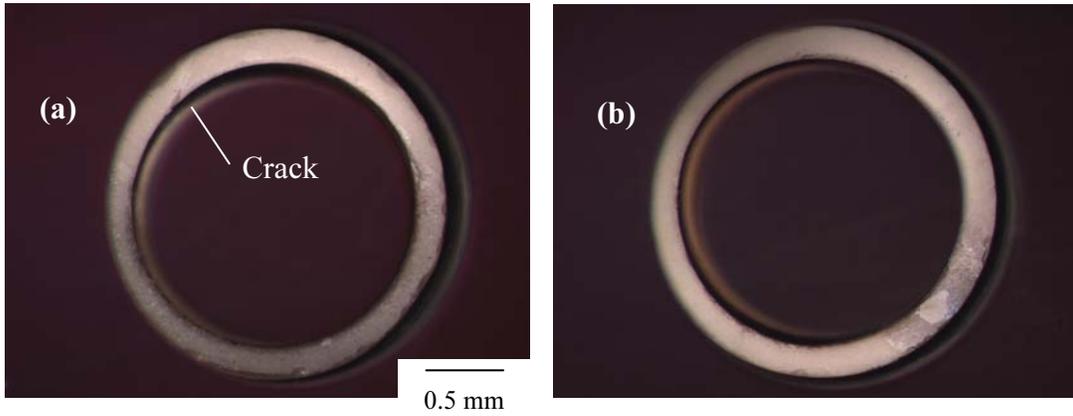
Fig. 11 Example of a sleeves (a) W and (b) B with surface damage. Sleeve W also appears to be cracked.

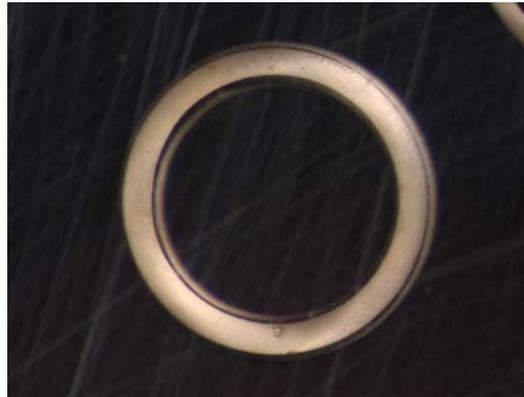
Pin m from LAC 902093-D79 failed FRB at a breakdown voltage of 2199 V. To pass FRB, a breakdown voltage of 2000 V or less must be achieved. After the initial cross-section no obvious anomalies were observed with respect to Pin m. It has been hypothesized that FRB failures are the result of symmetrical alignment of the pin within the sleeve and the sleeve within the web hole.³ Nearly symmetrical alignment of Pin and

Sleeve m was observed (Fig. 13). The asymmetry of the Sleeve m assembly was not nearly as extensive as seen in most sleeve/pin/web assemblies that were examined as a part of this study.

Fig. 13 For Pin m, both the pin and sleeve are nearly symmetrically aligned within the stainless steel web slot. This pin failed FRB at 2199 V. Wall thickness of the rutilite sleeves is approximately 225 μm .

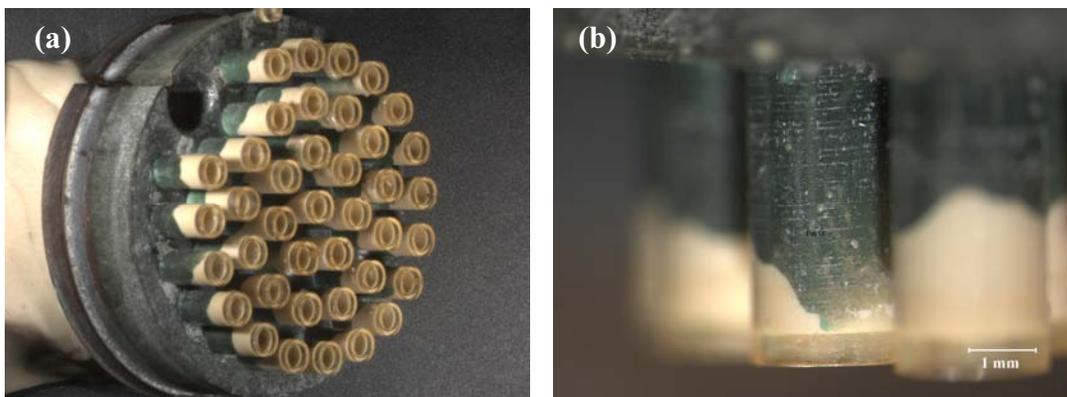
The stainless steel was dissolved in diluted aqua regia for a closer examination of Sleeve m and to observe other characteristics of this LAC. Amicon height was noted to reach the ends of Sleeves T, S, R, P, M, L, K, G, a, e, k, and n. Representative images of amicon height are shown in Fig 14. The amicon height on Sleeve m nearly reached the end of the sleeve (Fig. 15a). Sleeve m remained intact during isolation and epoxy dissolution (Fig. 15b).

Fig. 14 (a) LAC assembly after epoxy dissolution (note amicon height) and (b) a representative image of amicon that reached the end of the sleeve (Sleeve G). Sleeve outside diameters are ~ 2.25 mm.

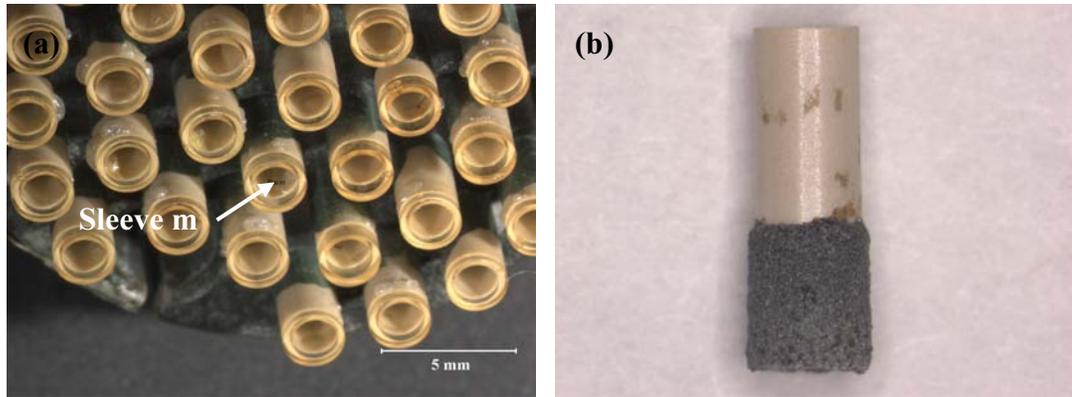
Fig. 15 Photomicrographs documenting (a) amicon height on Sleeve m and (b) the intact sleeve after epoxy dissolution. Note the flame sprayed metal on the sleeve. Sleeve outside diameters are ~2.25 mm.

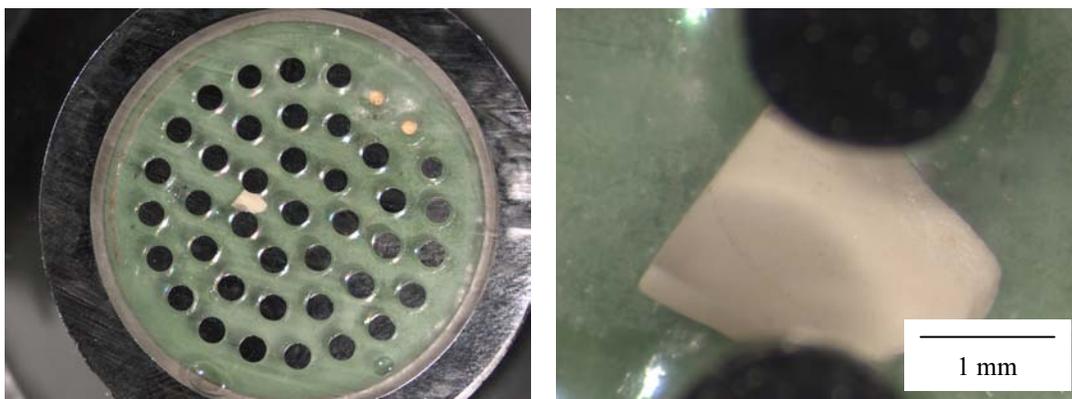
After the 1st polish, a chunk of rutile was observed in the air chamber (Fig. 16). This piece of rutile sleeve is not associated with any of the sleeves in this LAC. All of the sleeves were intact as observed from sleeve ends. Of the six LACs that were disassembled, this is the only LAC that contained a foreign material in the air chamber that was not inadvertently introduced during the disassembly process.

Fig. 16 A piece of rutile was found in the air chamber after the 1st cross-section.

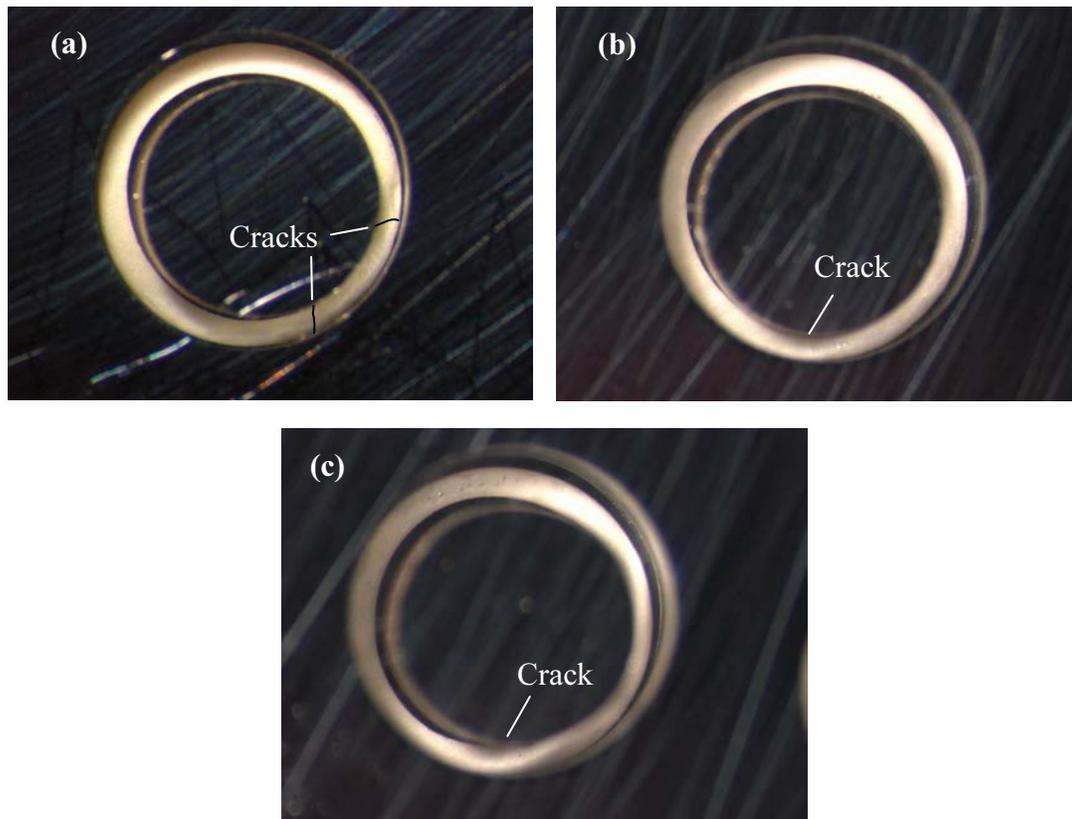
All pins and sleeves appeared to be asymmetrically aligned and slight metallic-looking residue was observed on the ends of some sleeves. Cracks were located in Pin A (Fig. 17a) after the 1st polish and Pins E (Fig. 17b), F (Fig. 17c), and n after the 2nd polish. As noted before, cracks tend to be located within the sleeve that is in contact with the web and/or pin. These cracks are typically very fine and very shallow.

Fig. 17 Cracks in sleeves (a) A, (b) E, and (c) F. The cracks in Sleeve A are highlighted. The diameter of the web hole is approximately 2.32 mm.

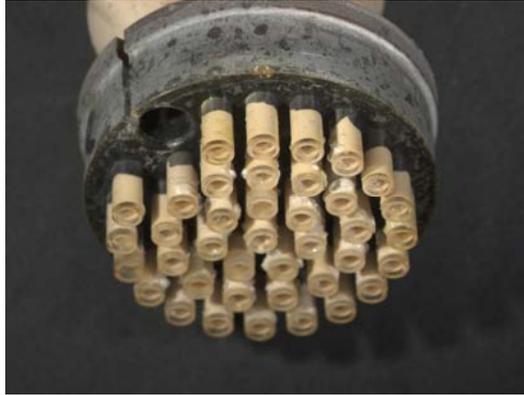
Overall the amicon height was slightly above the amicon base (Fig 18). Sleeve X was the only sleeve to have amicon at the sleeve end. Examination of the sleeves after the acid dissolution process revealed nothing unusual with Sleeve W; however, the cracks in Sleeve A shown in Fig. 17a were relocated. What appeared to be two cracks in Fig. 17a are actually the ends of one crack (Fig. 19). The crack is outlined with a red dotted line in Fig. 19 to help visualize the crack trajectory. Sleeve A fractured during the epoxy dissolution process. The crack in Sleeve A caused the cracked portion of the sleeve to chip out (Fig. 20). A blackish mark is observed on the crack surface (Fig. 20). The black mark is indicative of an electric breakdown track. During electric breakdown, very high temperatures can be reached, resulting in localized melting and possibly vaporization.

Fig. 18 Representative image showing rutilite sleeves protruding from the amicon as well as the degree in which amicon wicked up the rutilite sleeves (LAC SN102178-D81). Sleeve outside diameters are ~ 2.25 mm.

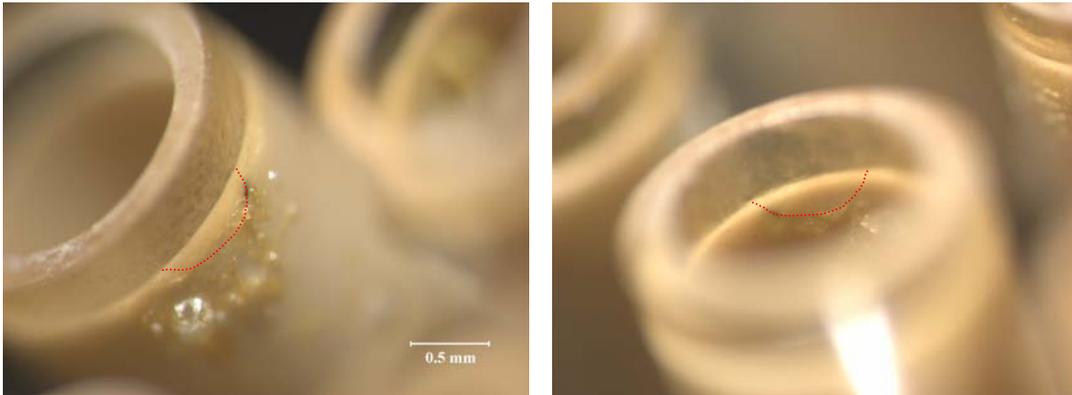
Fig. 19 Images outlining the trajectory of a crack in Sleeve A.

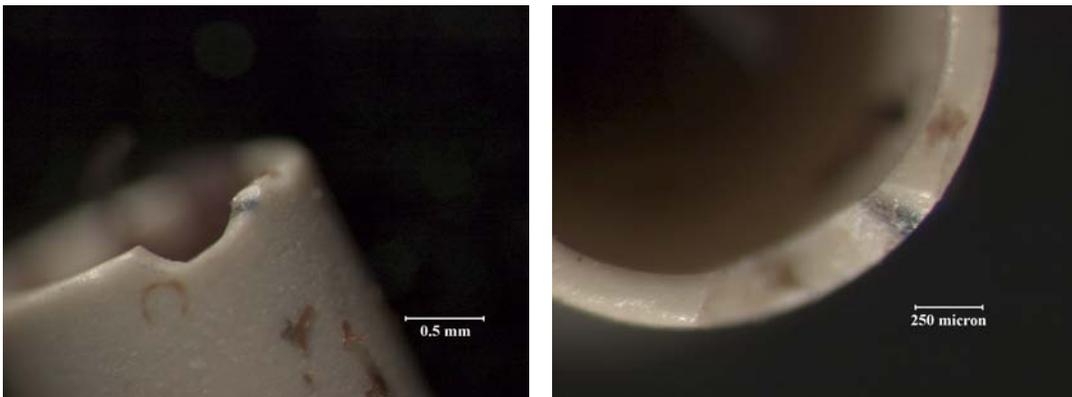
Fig. 20 During epoxy dissolution, the cracked portion of the sleeve fractured along the plane of a black mark. This black mark is evidence of a breakdown track.

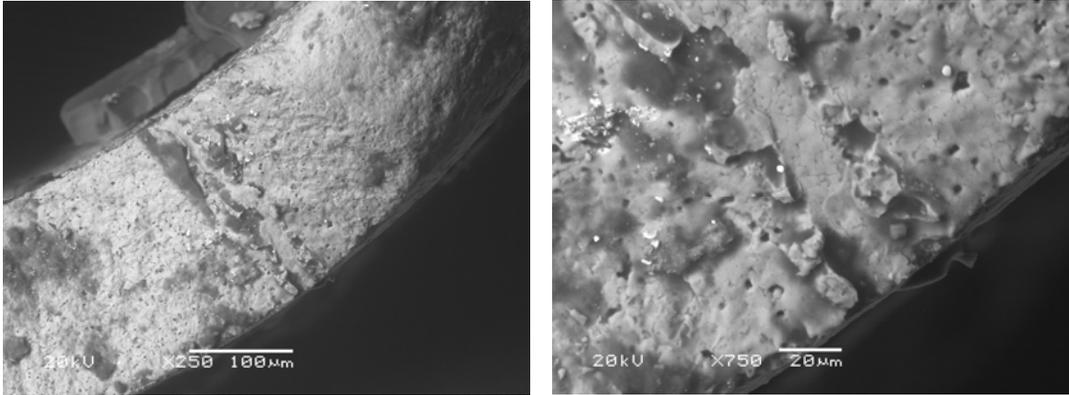
Scanning electron microscopy was utilized to characterize the morphology of the ceramic in and around the black mark (Fig. 21). Photomicrographs within the black mark show an area with a fused character and less porosity than the surrounding, undamaged

Fig. 21 SEM photomicrographs of the breakdown track in Sleeve A. Organic residue on the track surface is darker and should be ignored, it is an artifact of the air-chamber epoxy backfill and epoxy dissolution process.

ceramic. In the center of the black mark, a track extends through the thickness of the ceramic. The breakdown area has a fused character which is expected due to the high temperatures that are generated during a breakdown event. It appears the breakdown temperature was high enough to melt this portion of the rutile sleeve. The black track may be a thin layer of graphitic carbon or reduced titania on the surface.

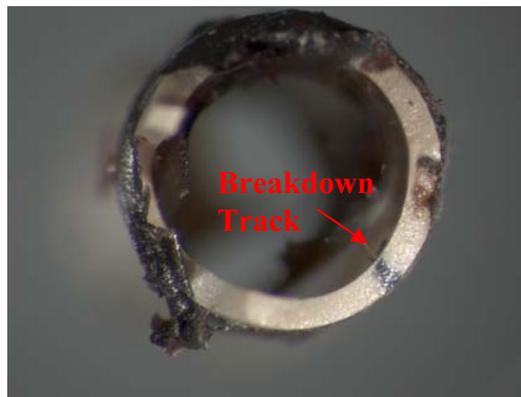
Fortuitously, Sleeve W fractured (near the amicon base) during the epoxy dissolution process exposing a black mark on the crack surface (Fig. 22). As with Sleeve A, the black mark is evidence of high voltage breakdown occurring during the DCW test resulting in IR failures.

Fig. 22 Photomicrograph of a breakdown track in Sleeve W. Wall thickness of the rutile sleeves is approximately 225 μm.

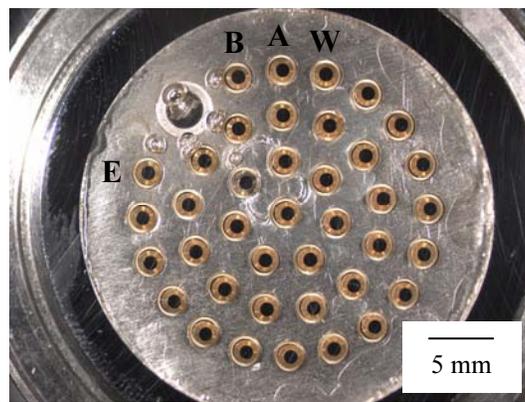
the Pin E assembly (Fig. 23). This pin passed FRB at 1725 V, which was the highest FRB of all the pins. The average was 1210 V. Most of the sleeves had small amounts of metallic contamination at their ends.

Fig. 23 Photomicrograph of LAC SN105251-K81 after the 1st polish. The Pin E assembly was symmetric with respect to the web, sleeve and pin resulting in the highest FRB of 1725 V.

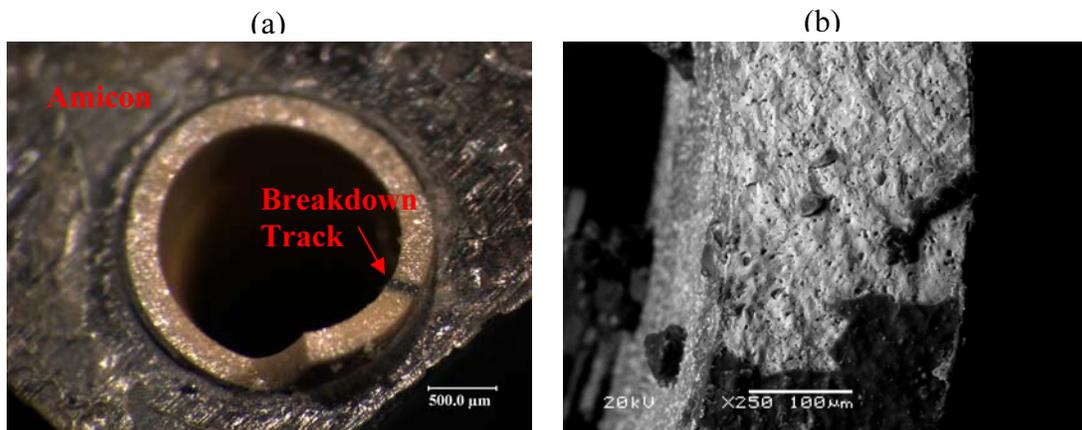
Sleeve B was isolated for additional characterization by carefully cutting around the Pin B assembly. During the cutting process, the sleeve fractured close to the amicon base. Along the fracture plane a black mark was observed (Fig. 24a). A similar mark, which is assumed to be a breakdown track, was also observed on sleeves A and W. However, Pins A and W did not register IR failures. SEM investigation of the black marks on Sleeves A, B (Fig. 24b), and W revealed the fused character associated with electric breakdowns. Fig. 25 illustrates the difference in microstructure of a breakdown area compared to the typical microstructure.

Fig. 24 (a) Optical photomicrograph illustrating the breakdown track on Sleeve B and (b) a SEM photomicrograph of the breakdown track in Sleeve B.

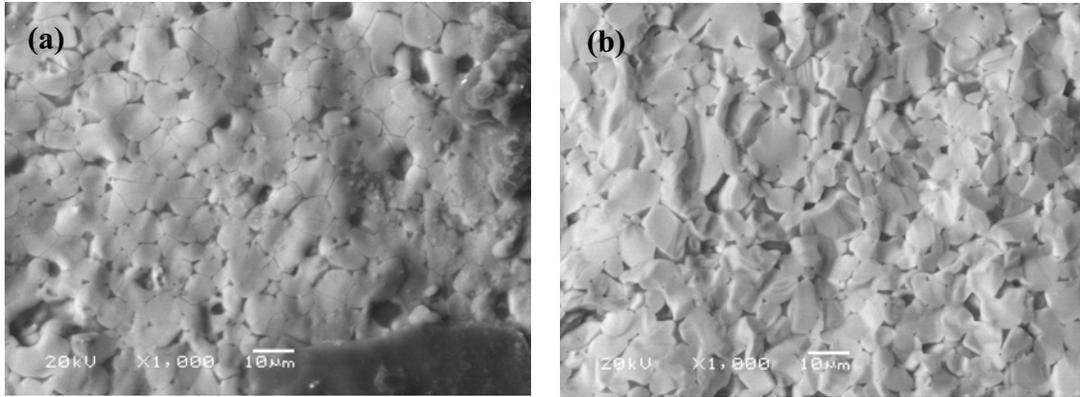
Fig. 25 SEM photomicrographs of the (a) breakdown track and of a (b) region away from the breakdown track in Sleeve B.

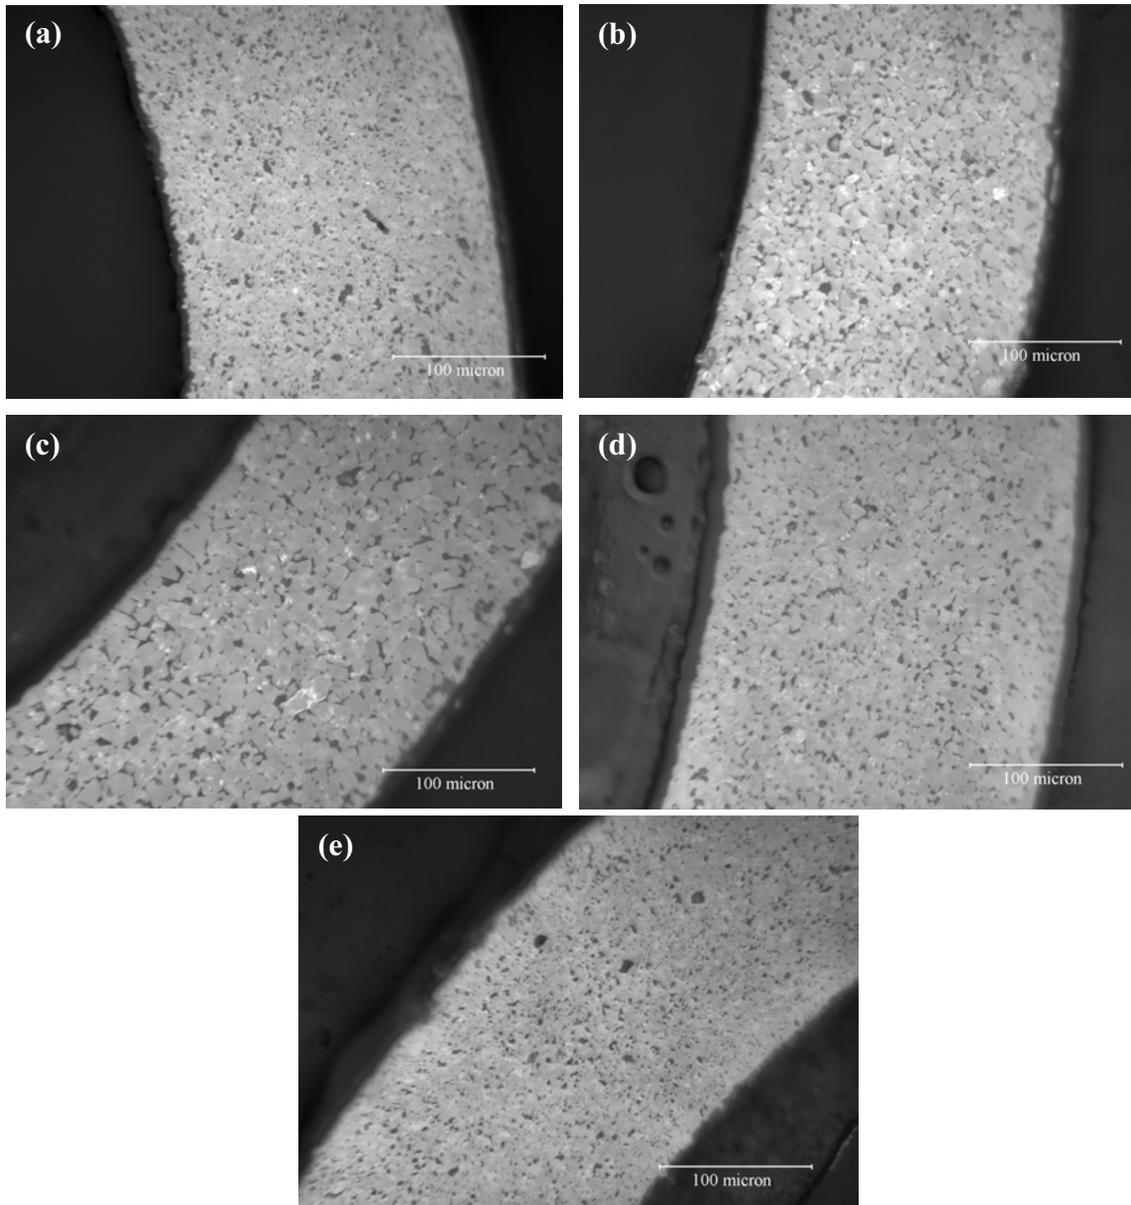
Representative photomicrographs of polished cross-sections of rutile sleeves are shown in Fig. 26. All of the sleeves have a large amount of intergranular porosity. Qualitatively, all of the cross-sectioned sleeves have a wide range of pore size and geometry. Pore size and geometry appears slightly different for the sleeves in Figs. 26b & c compared to those in Figs. 26a, d, & e. The sleeves cross-sectioned and polished from LACs 902093-D79 and 105251-K81-1 appear to have a larger average grain size than the sleeves shown in Figs. 26a (LAC 805036-F78), d (105251-K81-2) and e (102178-D81). The difference in apparent grain size between LACs 105251-K81-1 and 105251-K81-2, underscores the fact that significant variations in microstructure should be expected even for sleeves used in the same LAC. With this variability in microstructure in mind as well as process variables (amicon height, sleeve wall thickness, sleeve surface finish, sleeve alignment and pin alignment), a large distribution in breakdown strengths would not be an unreasonable expectation.

Fig. 26 Optical photomicrographs of cross-sectioned, mounted and polished rutile sleeves from LAC (a) 805036-F78, (b) 902093-D79, (c) 105251-K81-1, (d) 105251-K81-2 and (e) 102178-D81
