SAND2005-6237

Analysis of Chlorinated Polyvinyl Chloride Pipe Burst Problems: Vasquez Residence System Inspection

Billy D. Black, David F. Menicucci, and John Harrison

Prepared by
Sandia National Laboratories
Albuquerque, New Mexico 87185 and Livermore, California 94550

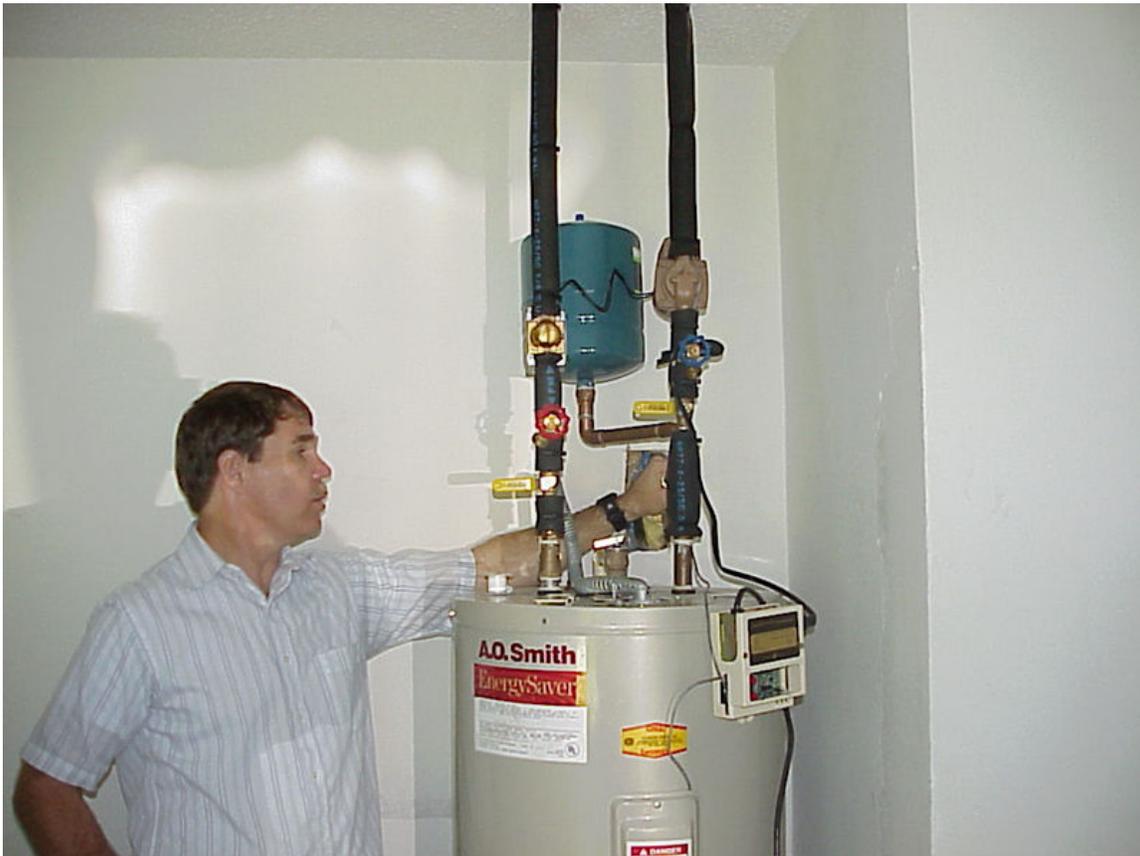
Figure 1. Overall view of the tank area plumbing on July 18, 2001. Note that the pressure tank was removed from the system when the solar system was initially installed. The solar system was installed on April 9, 2001.

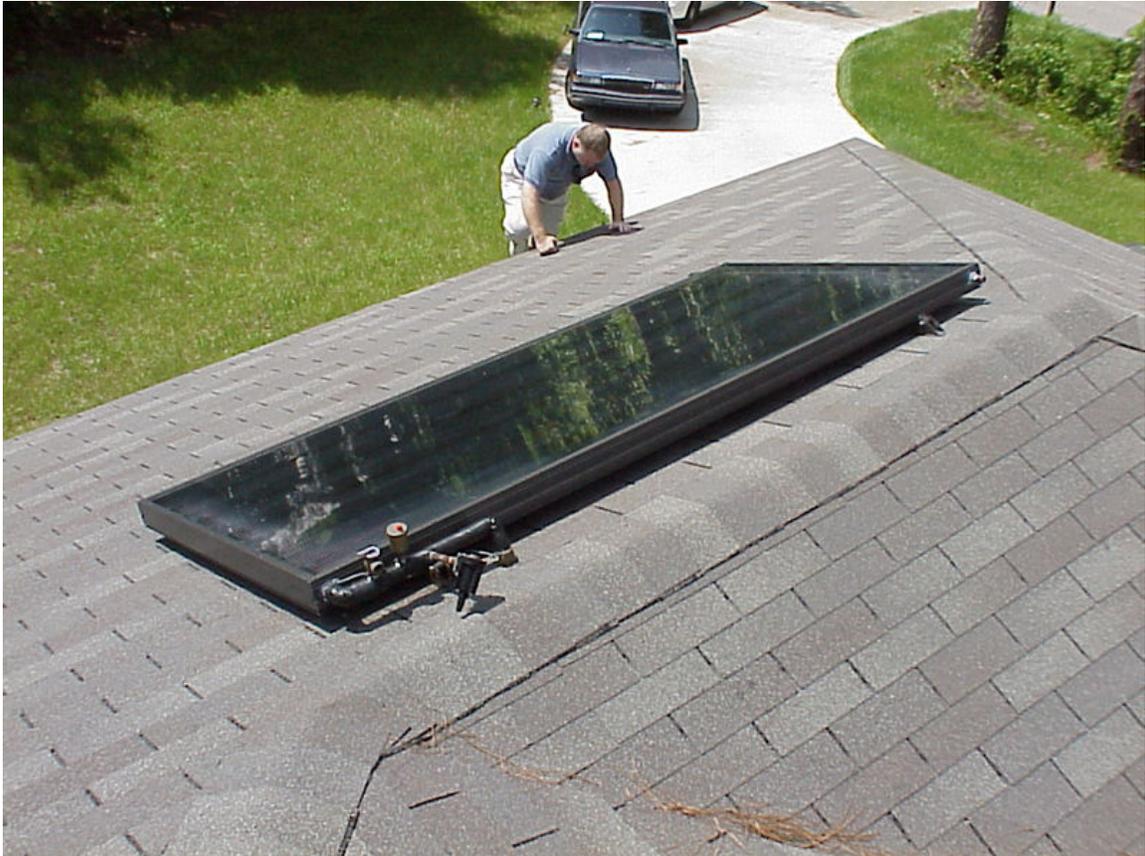
Figure 2. View of the flat plate collector July 18, 2001. Collector and ancillary valves were installed properly.

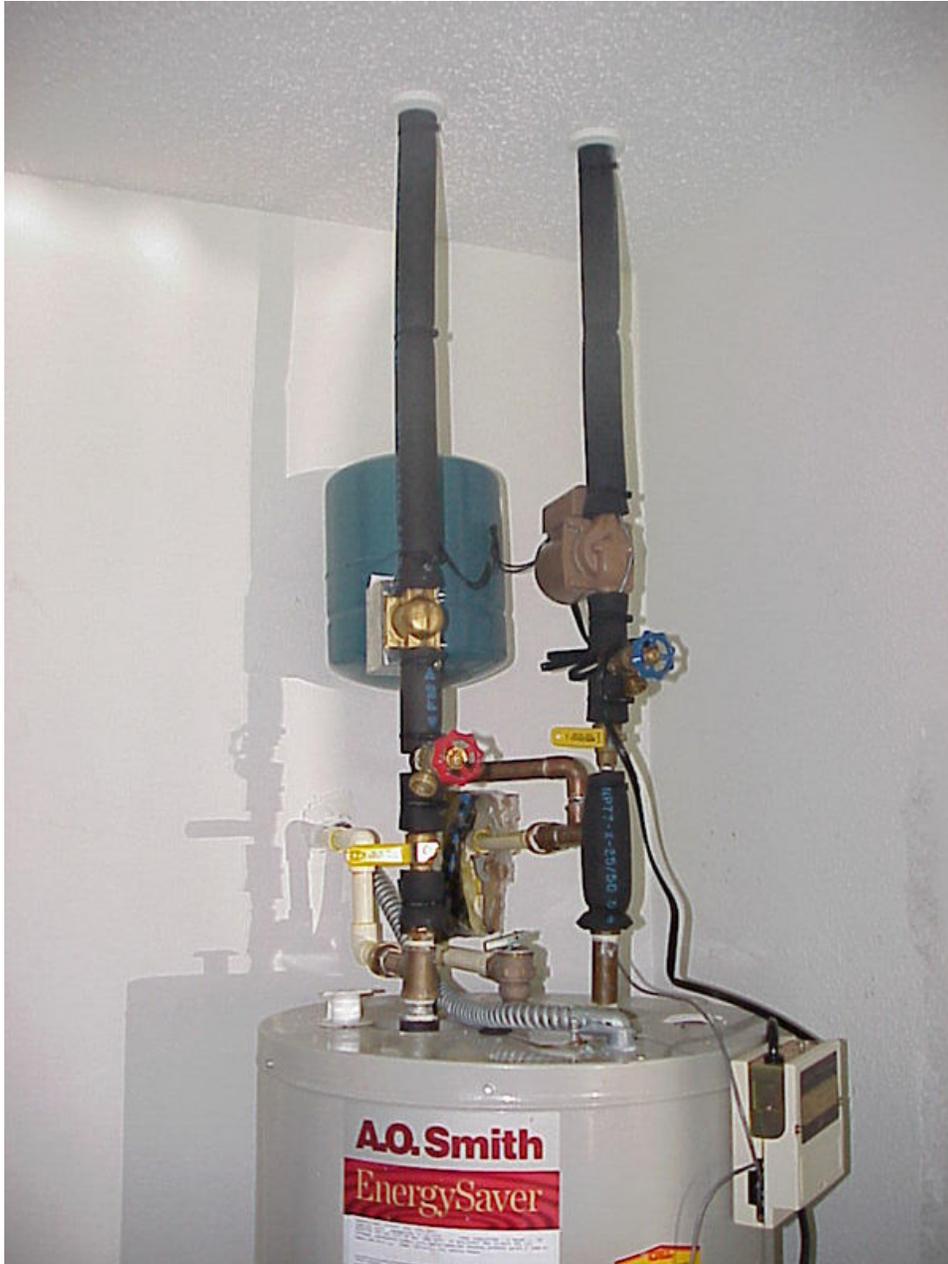
Figure 3. Additional view of the tank plumbing. July 18, 2001.

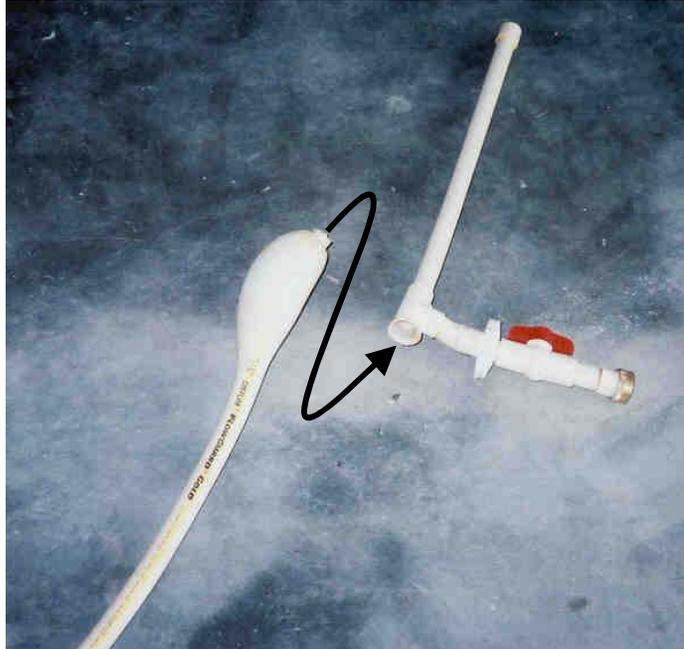
The first section of cold-water service CPVC line pipe burst (see Figure 4).

Figure 4. The section of pipe on the left with the balloon expansion is the first section of pipe that burst. The photograph indicates how the sections of piping were plumbed together. Note that the “bubbled” section of pipe was connected to the section of pipe on the right. This section, with the isolation valve, is the tee in the section that was located horizontally above the tank and plumbed into the collector feed line. Therefore, instead of a burst pipe, the two sections of piping shown above could have been separated from the coupling, which caused the leak.

The homeowner called the plumber who had originally installed the cold-water service CPVC line plumbing. The plumber repaired the broken pipe. It appears from a photograph (Figure 4) provided by Mrs. Vasquez that the plumber removed the horizontal cold-water service line above the water heater while repairing the leak in the vertical cold-service line between the wall (garage and bedroom). In any event, at this point, the plumber re-plumbed the horizontal section of the cold-water service line with the isolation valve. It is not known whether he also incorporated the existing water hammer trap as well. According to the homeowner, the section reinstalled by the plumber did not have the water hammer pipe – only the isolation valve. Mr. Vasquez stated that the water hammer section was not there when he repaired the second leak at the fitting. A fitting was used in the isolation valve that connected directly to a brass fitting. It was this connection that failed in the second pipe burst.

The operating pressure was the normal city water main pressure of 40 to 50 psi but that exceeded the operating parameters for CPVC at elevated temperatures. The operating pressure limits of CPVC approach 0 psi as the temperature approaches 210 degrees F. Reference CPVC specifications section 4. The pipe failed by bulging rather than cracking as shown in Figure 4 and 6.

Discussions with the CPVC manufacturer indicated this type of bulging failure is typical of over-temperature (greater than 200°F) at normal water line pressures. A failure mode due strictly to overpressure at normal operating temperatures was eliminated since the pipe did not “crack” and burst in a way that indicates an overpressure failure. In addition, the home and the water meter did not have a back flow prevention device that would have allowed a large pressure increase during thermal expansion.

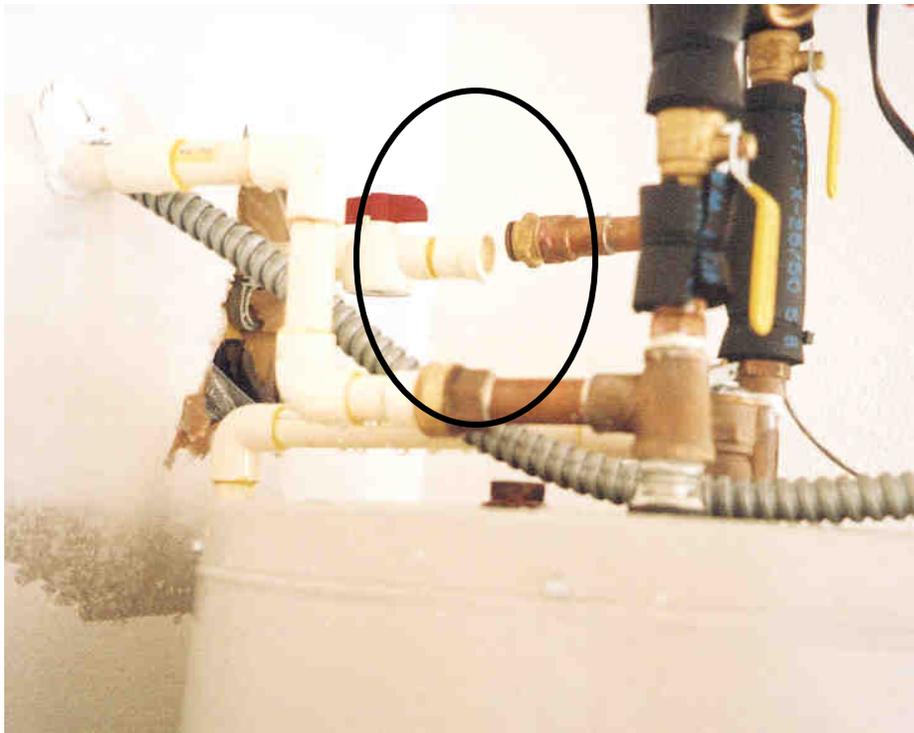
The solar salesperson informed FSEC that on this day, another section of cold-water service CPVC line burst (see Figure 5 for the location of the second leak).

Further discussion with Mr. Vasquez on the evening of 19 July 2001 revealed that a pipe did not burst – instead, a fitting on the horizontal cold-water service line came apart. (See Figures 5, 6, and 7.) This was the “pipe leak” referred to by the solar salesperson. Mrs. Vasquez nevertheless indicated that a small section of pipe not far from the fitting (to the left of the isolation valve) did exhibit “some small swelling on the bottom of the pipe.” Note that this might have occurred with the first leak, since both may have been a fitting separation that included pipe expansion in the close vicinity of the separation. Mr. Vasquez felt that the plumber who had reworked this plumbing after the first leak did an inadequate job with the fitting connection.

Figure 5. This photograph was taken by the homeowner after the second leak shows the coupling that separated from the pipe union. Once this happened, a tremendous amount of water poured into the garage.

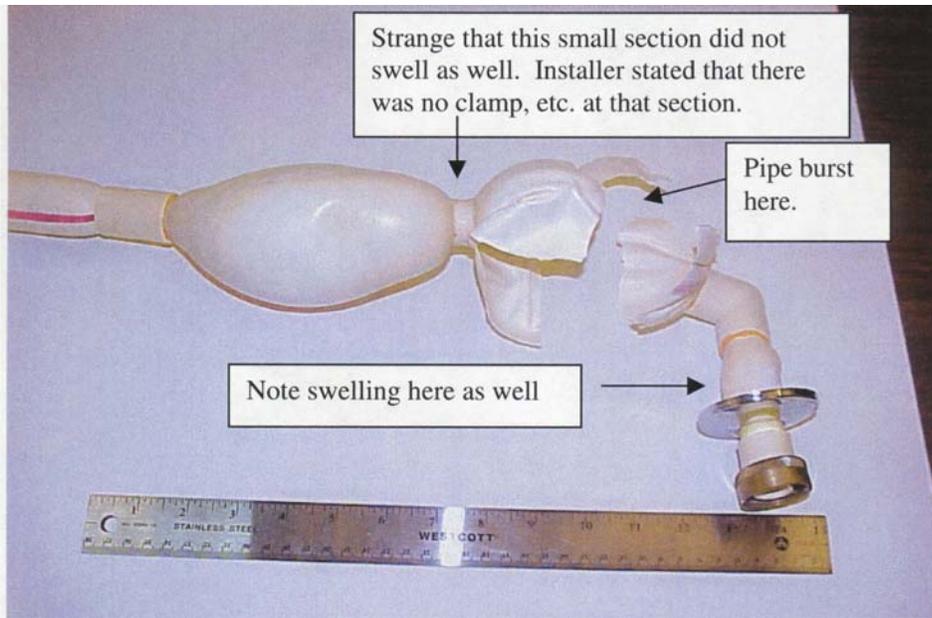
Figure 6. House X piping cold feed line.

Markings on long section of piping: 3/4 in., CPVC Coastline Premium, CPVC 4120, SDR11, NSF-pw, 100 psi at 180°F, 400 psi at 73°F, ASTM D2846, B1, Made in USA, 14APR97, 233804, 2338, shift 33, Potable Water. Markings on bubble/burst section of piping (that could be made out): Made in USA, 15APR97, 095514, 0955, Shift 02, Potable Water

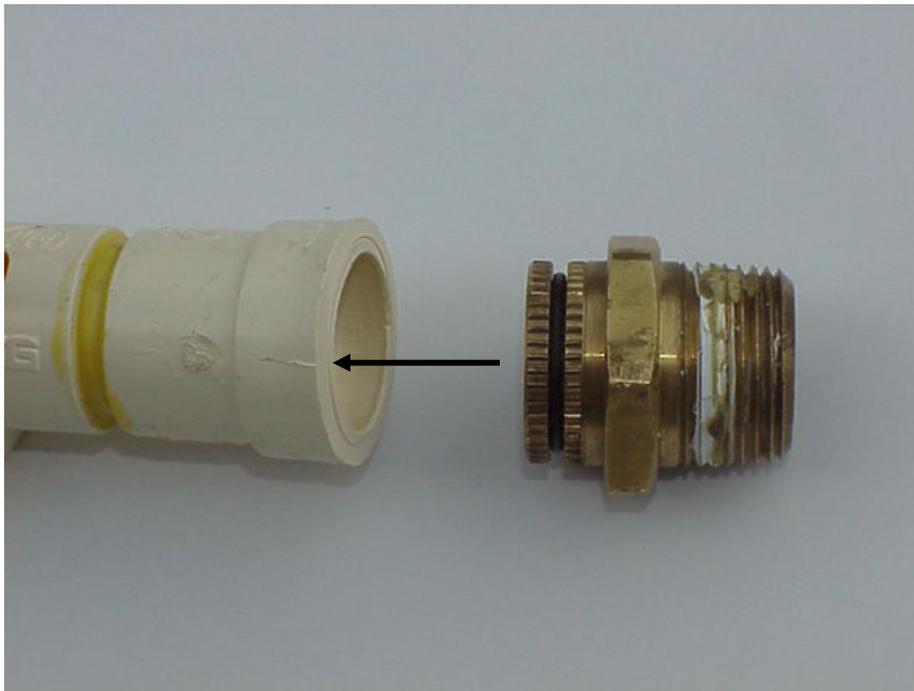
Figure 7. Close-up of the union that came apart and caused the second leak on July 20, 2001. (Actual components were provided by Mr. Vasquez to FSEC staff.) The brass section with the o-ring does not, at this time, fit into the opening of the CPVC pipe section. A check of plumbing catalogs indicated that CPVC couplings with brass connectors are available.

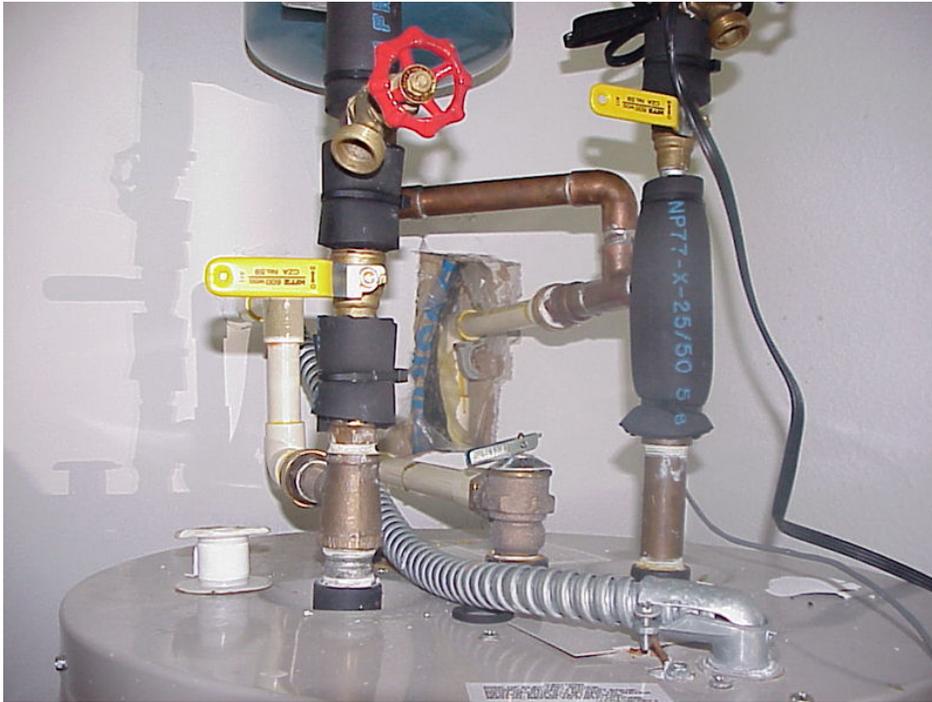
Figure 8. Close-up view of the tank plumbing on July 18, 2001.

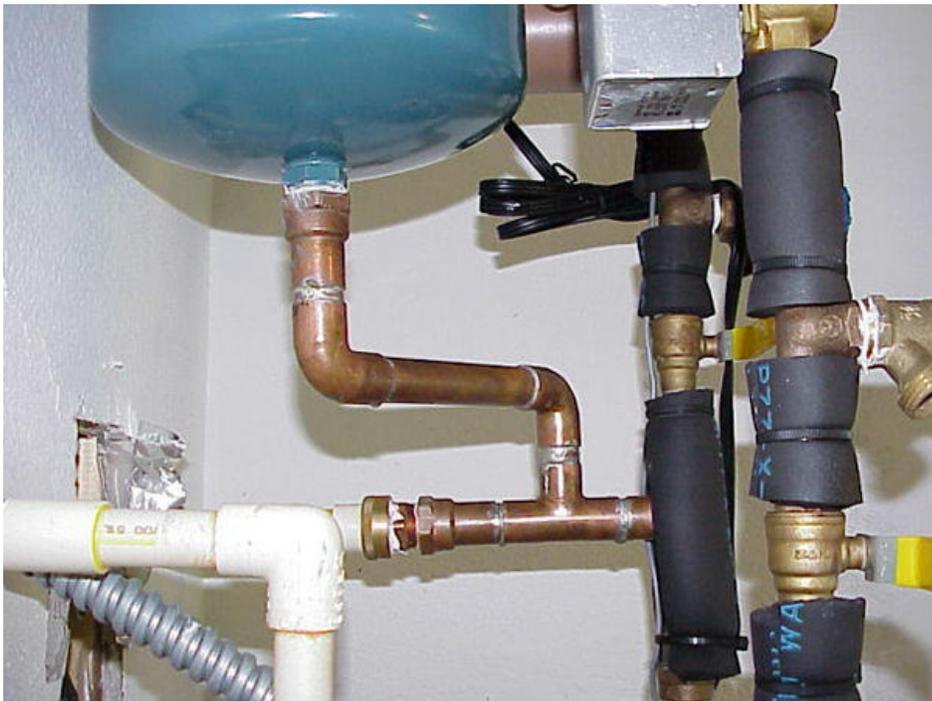
Figure 9. Close-up view of the tank plumbing on July 20, 2001.

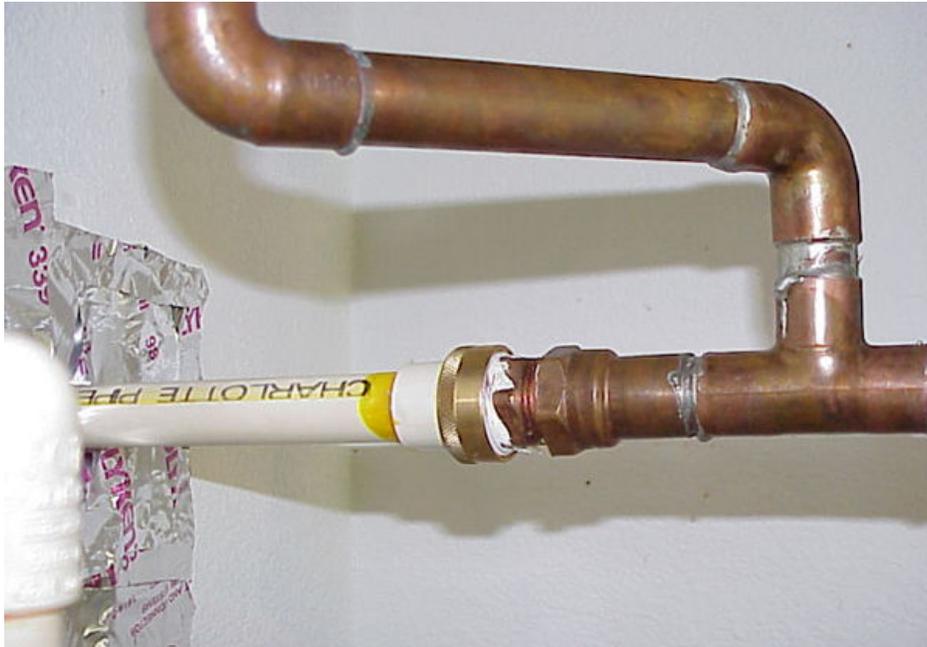
Figure 10. Another close-up view on July 20, 2001.

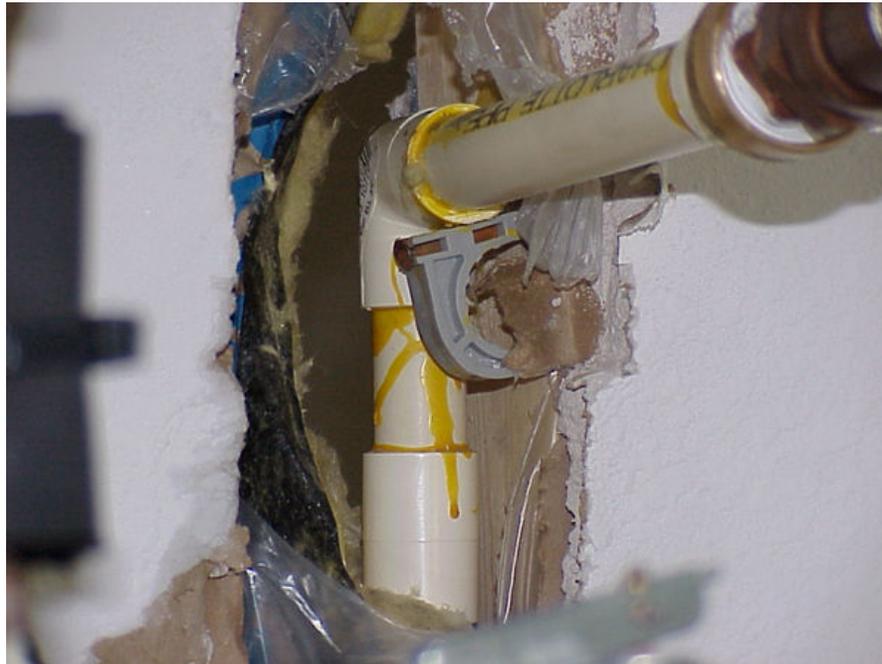
Figure 11. View of the approximate area where the first piping system leak occurred on April 10, 2001, as seen from the tank side. Note the coupling at the bottom of the picture. It is believed that this coupling was used by Mr. Vasquez to repair the second leak. (July 18, 2001)

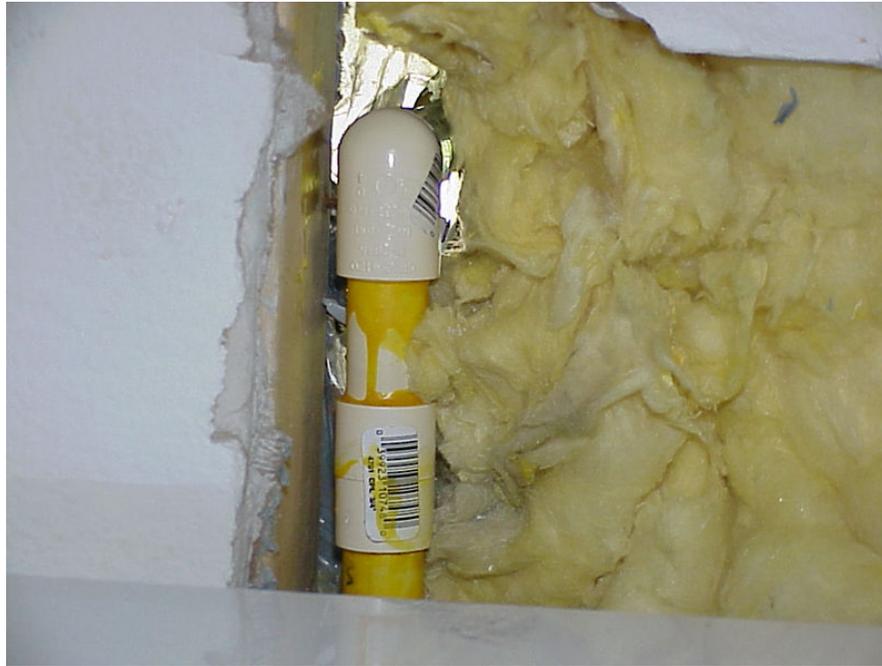
Figure 12. View of the approximate area where the first April 4, 2001 pipe burst occurred, as seen from the bedroom wall side. The plumber had to cut away the bedroom wall almost to the floor to repair this first leak. Note the straight coupling at the bottom of the picture. This coupling is believed to be the coupling that Mr. Vasquez procured and installed when repairing the piping after the second leak. (July 18, 2001)

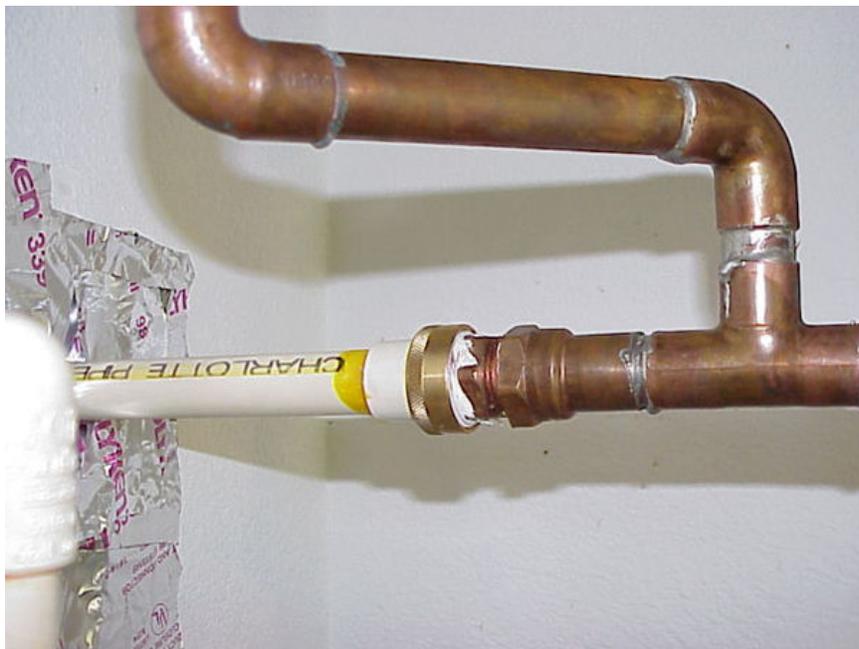
Figure 13. This is the fitting that Mr. Vasquez replaced himself after the plumber refused to fix the second leak. (July 20, 2001)

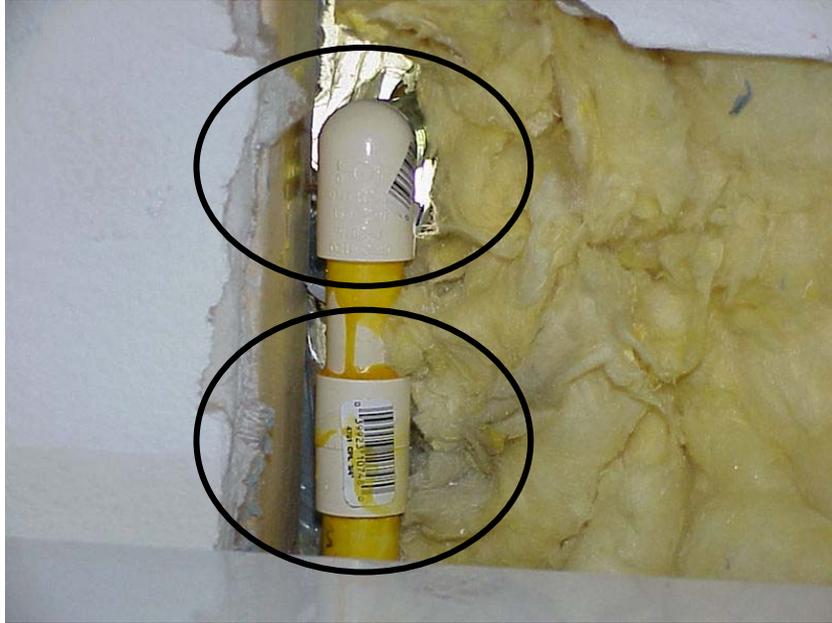
Figure 14. Note the CPVC couplings with the register scan tags. From telephone conversations with Mr. Vasquez, it is believed that this is the location where Mr. Vasquez cut the line to plumb the new section after the second leak. He replaced the whole line from the bottom coupling to the CPVC/brass connector on the horizontal line. (July 20, 2001)

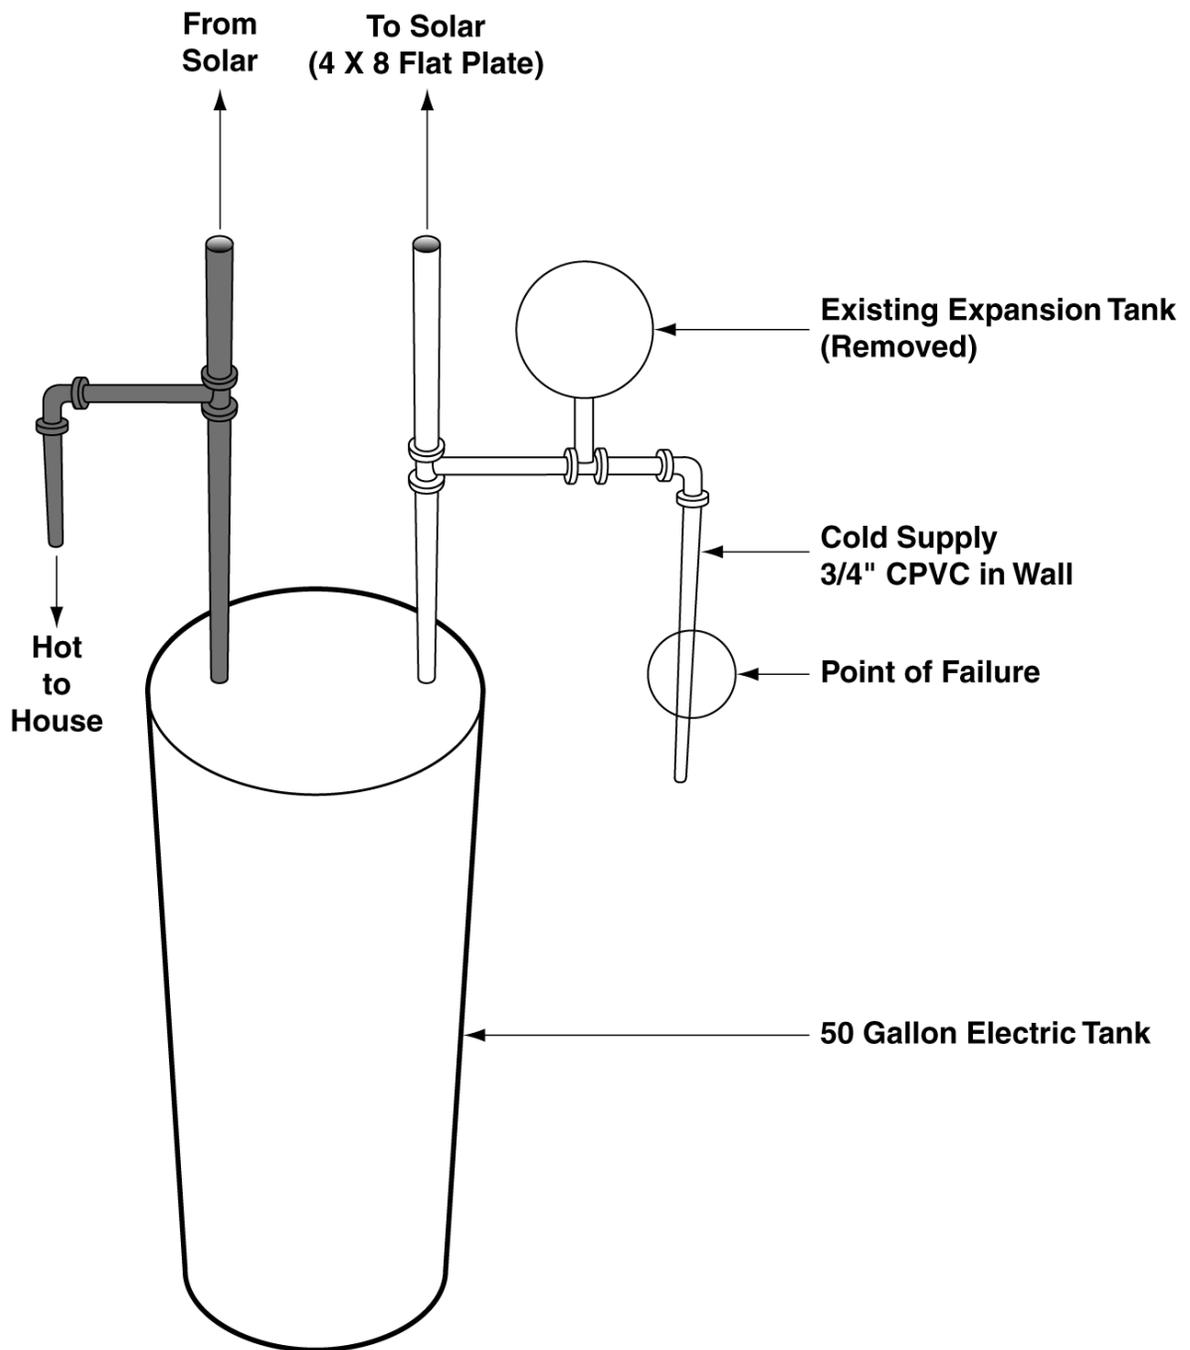
Figure 15. Installation drawing.

An expansion tank was installed. Note that the solar installer had removed the existing expansion tank when the solar system was installed. The solar installer installed a new expansion tank after the second pipe burst. The current expansion tank is a Water Worker G-5 Safety Tank with a 40-psi pre-charge (see Figure 15).

Solar high limit set to 155°
 Electric T-STAT set to 130°
 House plumbed in 3/4" CPVC

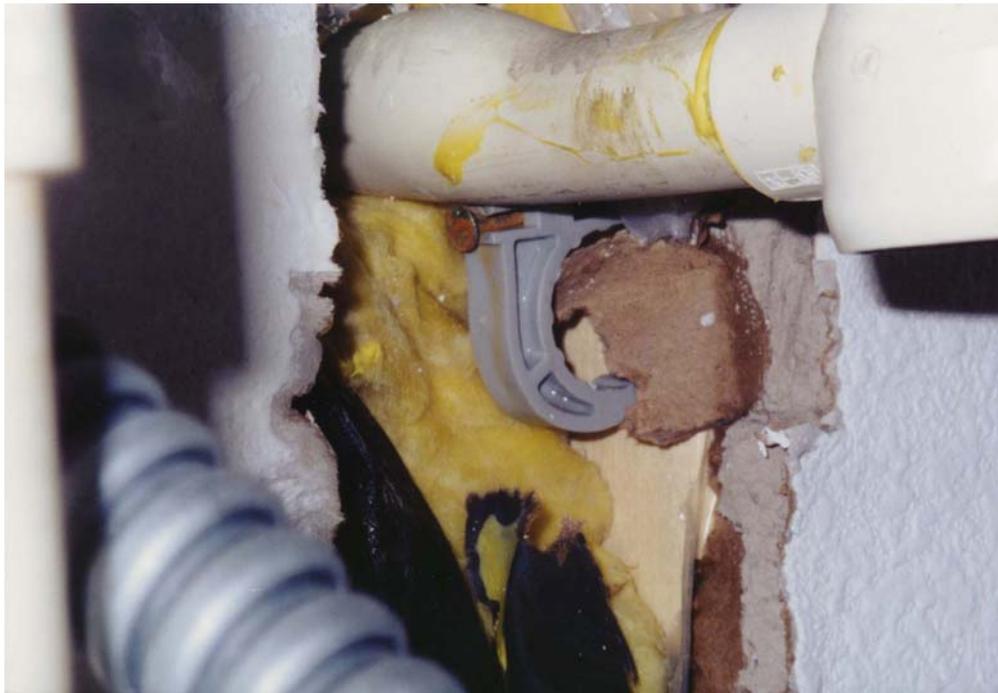
Rubatex $\frac{1}{2}$ in. wall thickness pipe insulation. The piping was not completely insulated. See Figures 16 and 17.

Figure 16. Insulation adjacent to pipe.

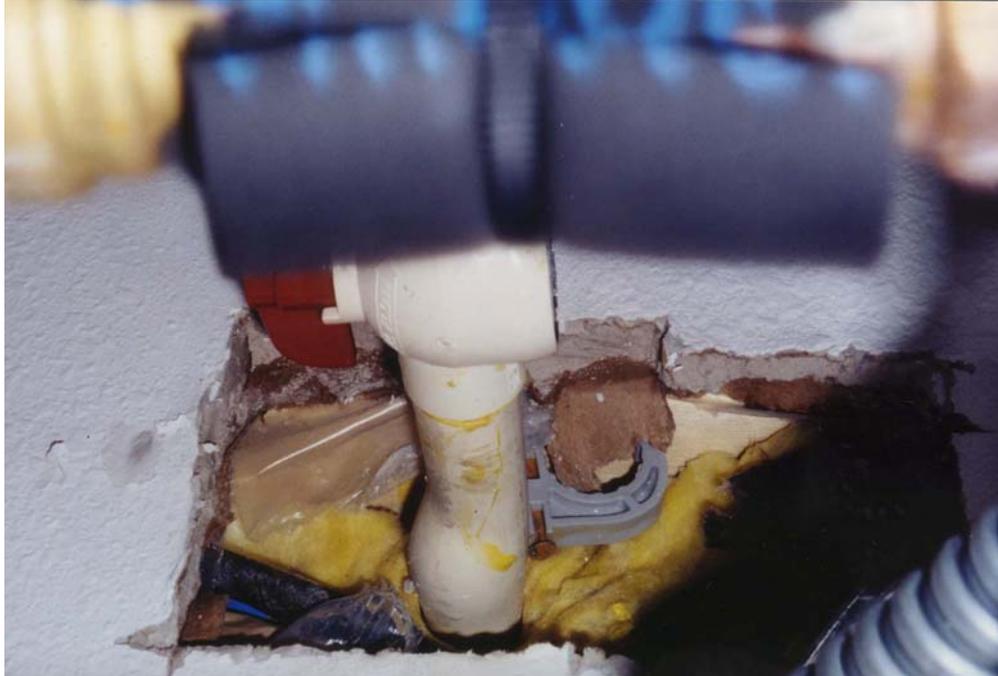
Figure 17. Insulation was not completely installed.
