SAND2006-4154

An Evaluation of the Spring Finger Solder Joints on SA1358-10 and SA2052-4 Connector Assemblies (MC3617, W87)

Paul T. Vianco, Alice C. Kilgo, Gary L. Zender, and Paul F. Hlava

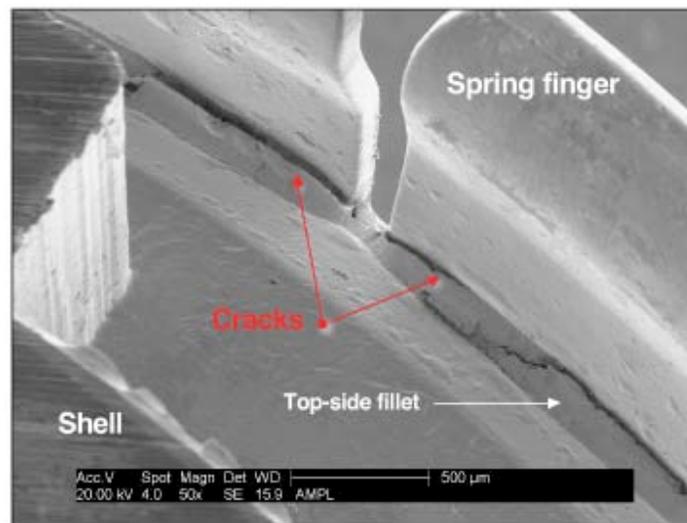
(2) *The morphology of some of the cracks (locations "A" and "B" in Fig. 4a) indicated that the tin-silver (Sn-Ag) solder used to attach the spring fingers to the shell had remelted during next-assembly processes performed at Honeywell/KCP.* The uncontrolled remelting of previously formed solder joints is not permitted in WR and JTA components or sub-assemblies¹. In the absence of a flux, the solder can dewet from the surface, resulting in an unacceptable fillet. The fact that the spring finger solder joints could not be visually inspected for such degradation lent further unacceptability to a remelting occurrence.

Fig. 4 Stereo photograph showing cracks in the top side fillet of the spring finger solder joint from an SA1358-10 connector (S/N6000). The locations “A” and “B” suggest remelting of the 96.5Sn-3.5Ag solder had occurred. (b) SEM photograph illustrating the cracking of the spring finger solder joint at higher magnification on a different SA1358-10 connector (S/N1430).

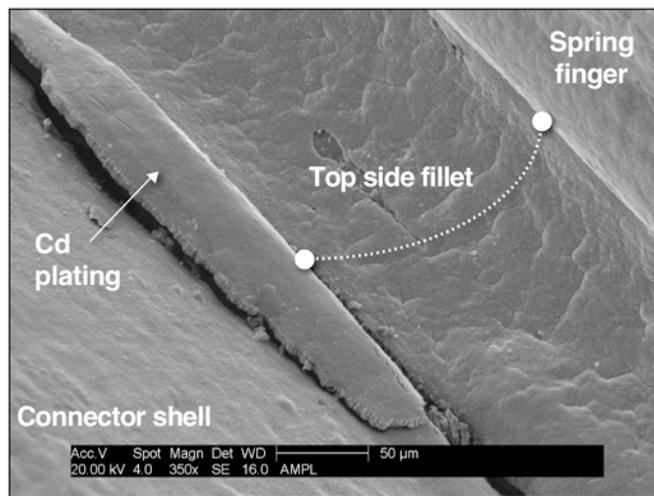
The last phenomenon was that of flaking of the Cd layer from the connectors and, in particular, from the spring finger solder joint fillet. The prevalence for Cd flaking in the earlier connectors is illustrated by the SEM photographs in Fig. 7. Lifting of the Cd coating is observed.

Fig. 7 SEM photograph showing flaking or spalling of the Cd coating from the top side fillet of the spring finger solder joint. The SA1358-10 connector was S/N 1430.

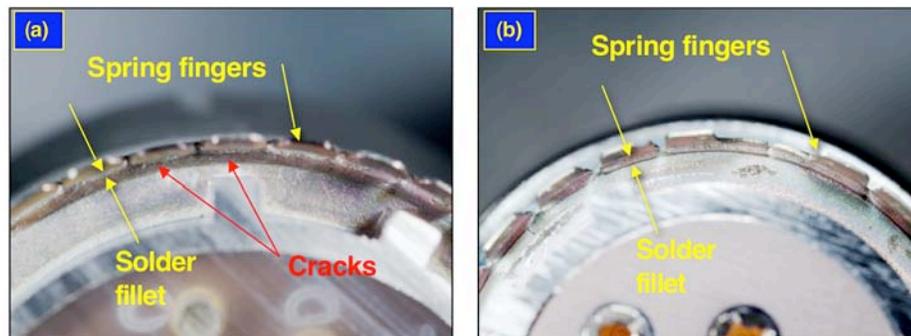
Fig. 8 Stereo photographs showing the top side fillet on the spring finger solder joints of (a) the SA1358-10 connector and (b) the SA2052-4 connector. Isolated cracks were observed in the solder fillet of the SA1358-10 unit; there were no obvious defects to the SA2052-4 solder joint.

There appeared to be some isolated cracking in the same fillets, as well. There was no damage to the spring fingers, themselves, nor was there degradation to the bottom side fillet. There were no obvious defects to the fillet of the SA2052-4 connector solder joint as shown in Fig. 8 (b). The solder surface had a more frosty appearance as compared to the SA1358-10 solder fillets. The spring fingers exhibited no indications of damage to them.

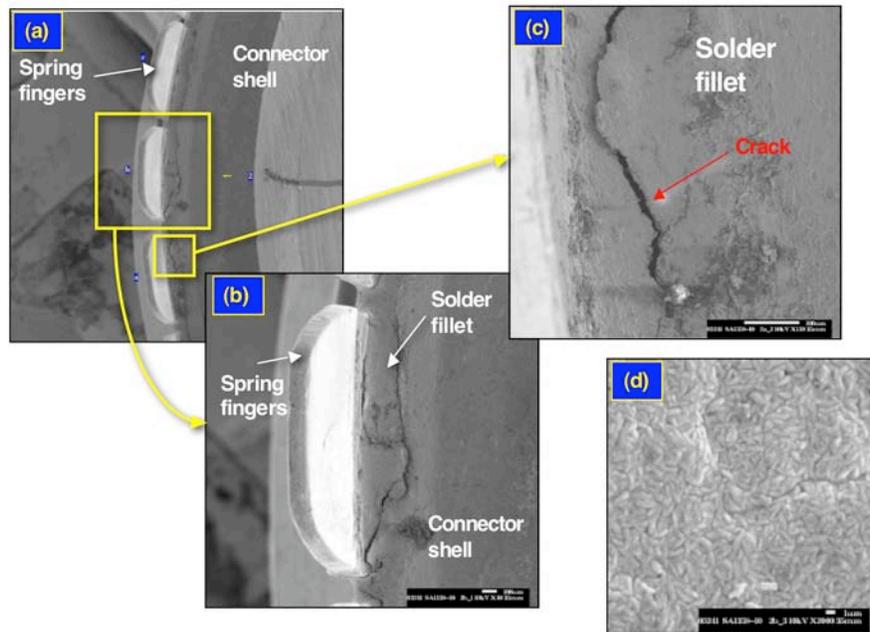
Scanning electron microscope photographs were taken of the spring finger solder joints. Shown in Fig. 9 are representative SEM photographs from the SA1358-10 unit. Cracks appear in the top side solder fillet at a number of locations around the spring fingers as shown in (a), (b), and (c). It could not be determined from the SEM photographs whether the cracks represented through-cracks into the solder fillet or were the result of fissures in the plated Cd (Cr) layer. The surface morphology of the Cd (Cr) coating is shown in Fig. 9 (d).

Fig. 9 SEM photographs showing the top side fillet on the spring finger solder joints of the Item #1 SA1358-10 connector: (a) low-magnification view showing several spring finger tines; (b) and (c) medium magnification views showing the extent of cracking on the fillet surface; and (d) high magnification view showing the surface morphology of the Cd (Cr) plating.

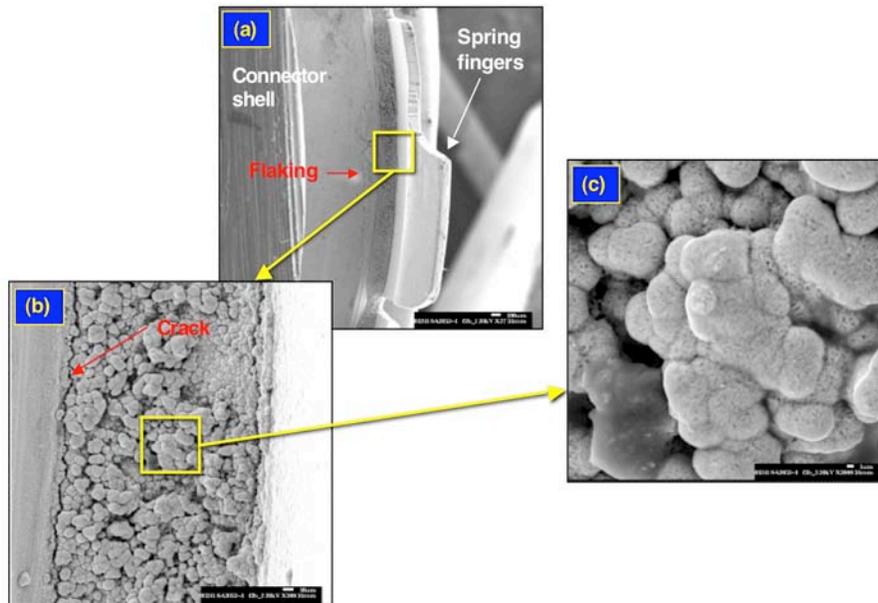
The top side fillet region of the spring finger solder joints from the SA2052-4 connector were shown in Fig. 10. Flaking of the Cd (Cr) plating was observed on the connector shell *near* to the solder fillet (Fig 10 (a)). Large-scale cracks were absent from the fillets; rather, smaller cracks were present as is illustrated in Fig. 10 (b). At this surface view, crack propagation occurred between the Cd (Cr) nodules. The surface morphology of the Cd (Cr) plating on the SA2052-4 connectors was further illustrated in Fig. 10 (c). It is clear that the Cd (Cr) plating on these connectors had a coarser structure than that on the SA1358-10 connector.

Fig. 10 SEM photographs showing the top side fillet on the spring finger solder joints of the Item #1 SA2052-4 connector: (a) low-magnification view showing several spring finger tines; (b) medium magnification views showing minor cracking at fillet/connector shell interface; and (c) high magnification view showing the surface morphology of the Cd (Cr) plating.

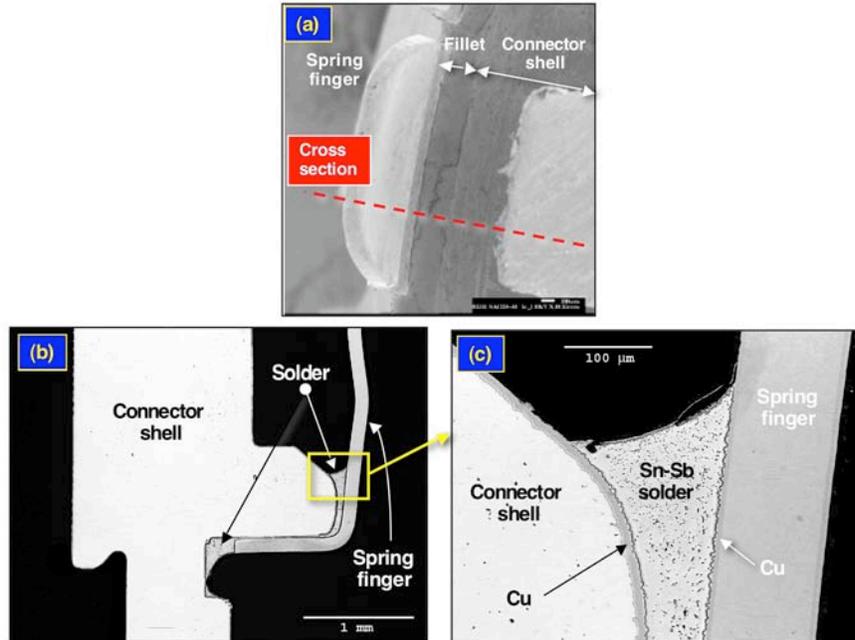
Fig. 12 (a) SEM photograph showing the location of the cross section on the connector. Optical micrograph (b) showing one of two spring finger solder joints that were obtained by a diametrical section through the Item 1, SA1358-10 connector. The higher magnification view in (c) shows the top side fillet and identifies the Cu coating used on the connector shell and spring finger.

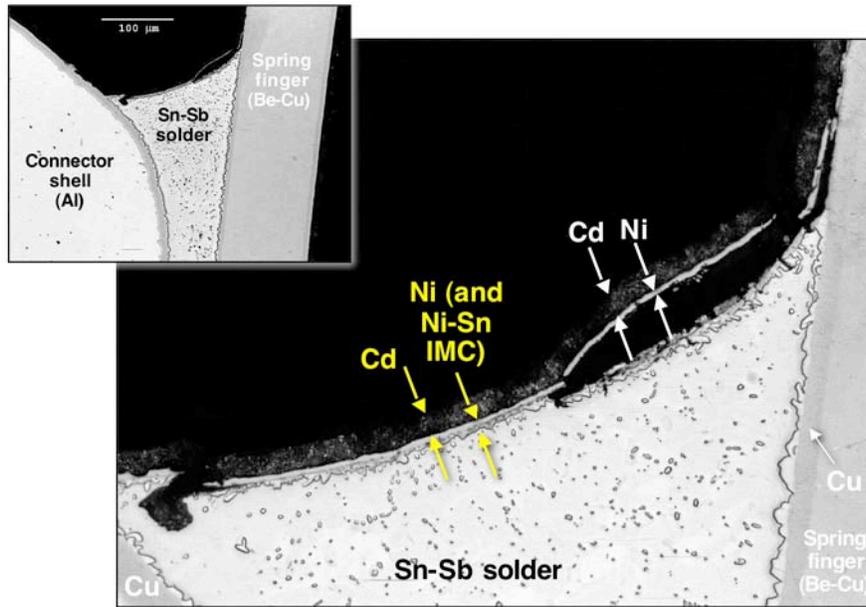
Fig. 13 Optical micrographs showing a high magnification view of the top side fillet shown in Fig. 12b. Spalling of the combined Ni and Cd layers was evident over a part of the fillet. A Ni-Sn intermetallic compound (IMC) layer had developed between the Ni coating and the Sn-Sb solder.

The Cu, Ni, and Cd (with Cr) layers had excellent adhesion to the connector shell and spring finger structures. However, as was evident in Fig. 13, the combined Ni and Cd (Cr) layers had locally spalled away from the solder fillet surface. Specifically, the separation occurred at the interface between the Ni layer and the Ni₃Sn₄ intermetallic compound (IMC) layer that developed between the Ni coating and the solder. The blocky morphology of the Ni₃Sn₄

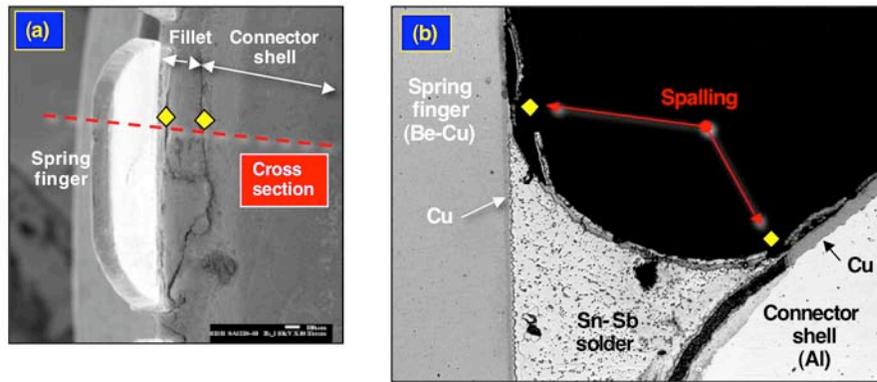
Fig. 19 (a) SEM photograph showing a third spring finger solder joint (F2) on the Item #1 SA1358-10 connector. (b) Optical micrograph of the cross section of the top solder fillet of the joint, along the red dotted line in (a). The yellow diamonds indicate areas of spalling by the plating layer, which appeared as cracks in the SEM image.

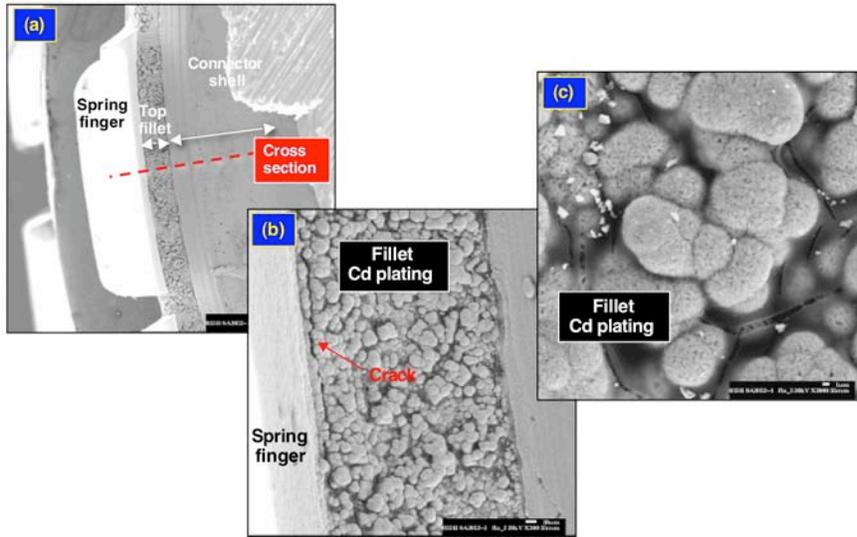
Fig. 23 (a), (b), (c): SEM photographs of the spring finger solder joints on the SA2052-4 connector (at location F1a). A small crack was observed between the solder fillet and the spring finger. The nodular nature of the electroplated coating was clearly evident.

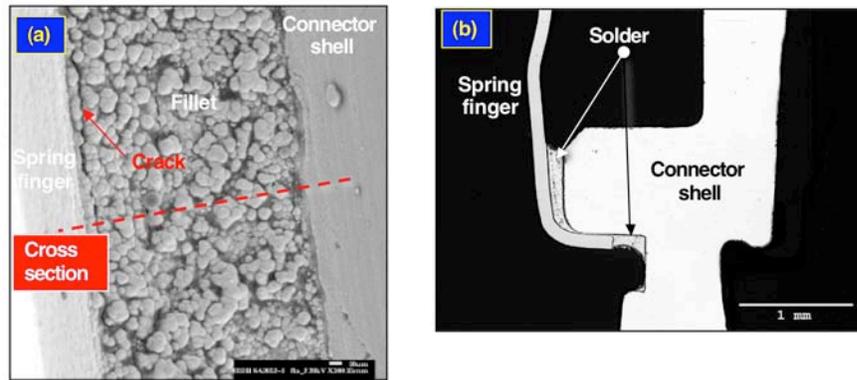
Fig. 24 (a) SEM photograph of the top side spring finger solder joints on the SA2052-4 connector at location F1a showing the location of the cross section. **(b)** Low-magnification optical micrograph showing the entire solder joint at the F1a location. There were no indications of large scale degradation to the joint or nearby structures.

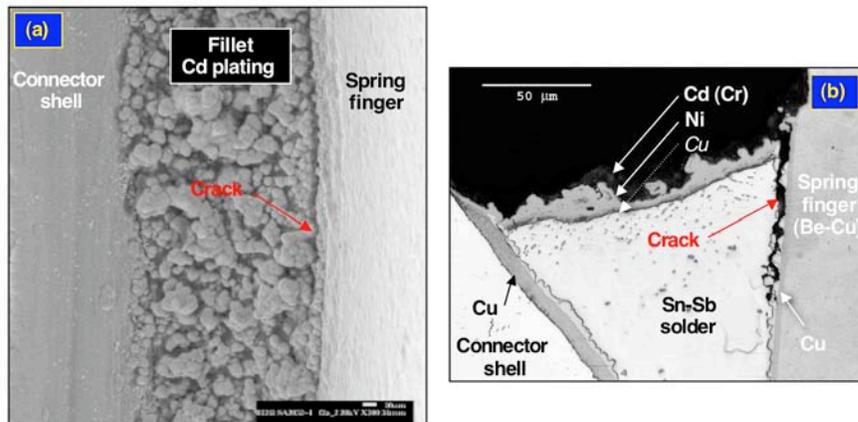
Fig. 26 (a) SEM photograph of the spring finger, top side solder fillet on SA2052-4 at location F2a. (b) Optical micrograph of the cross section performed through the spring finger solder joint of the SA2052-4 connector at location F2a. A significant crack was observed at the spring finger/solder interface. The Cd layer was also covered with a Cr (chromate conversion) coating

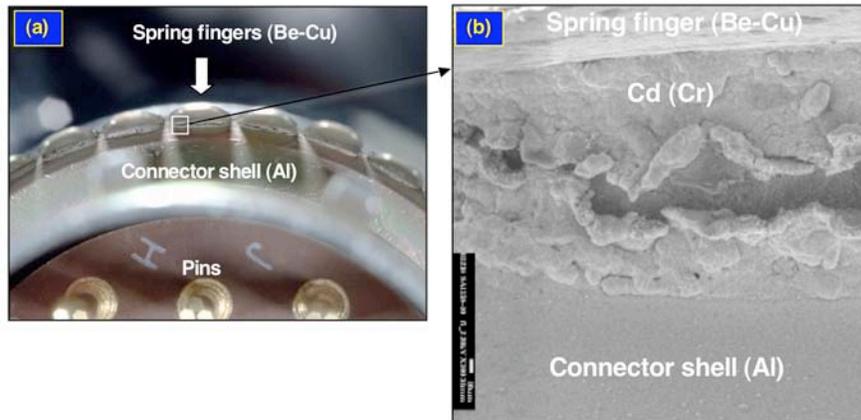
Fig. 30 (a) Stereo photograph showing the location of section F1a on SA1358-10. (b) High magnification SEM photograph of the fillet showing the fissure that formed in the Cd (Cr) electroplated coating on the top side fillet.

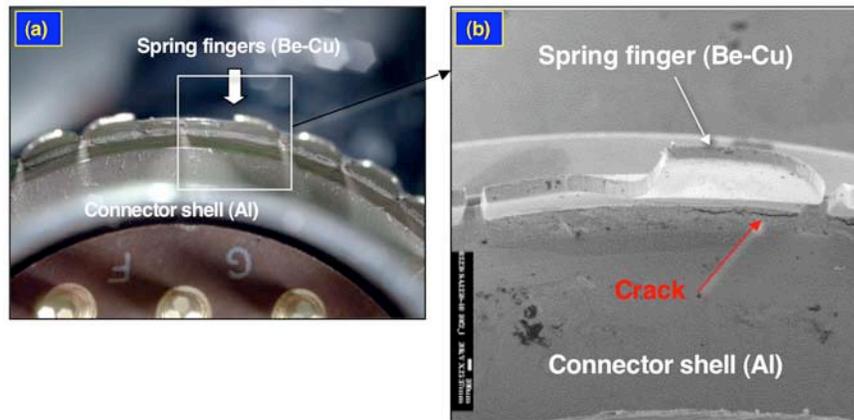
Fig. 31 (a) Stereo photograph showing the location of section F2 on SA1358-10. (b) Low magnification SEM photograph that identifies a crack in the top side fillet.

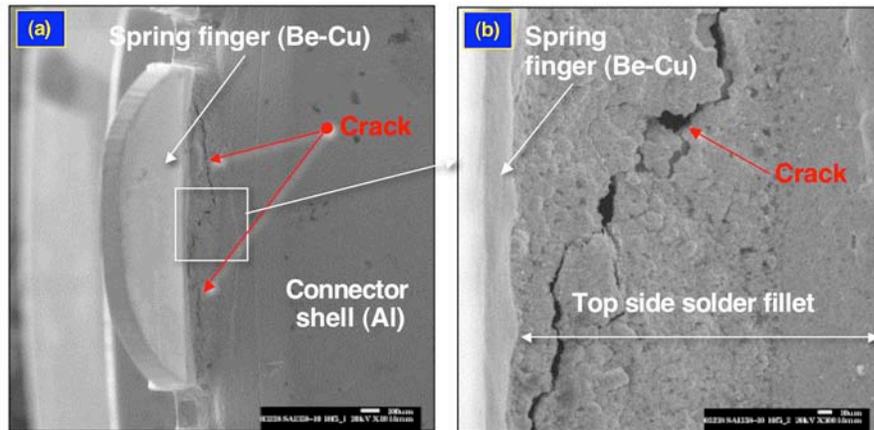
Fig. 32 (a) Stereo photograph showing the location of section F5 on SA1358-10. (b) Low magnification SEM photograph that identifies a crack in the top side fillet.

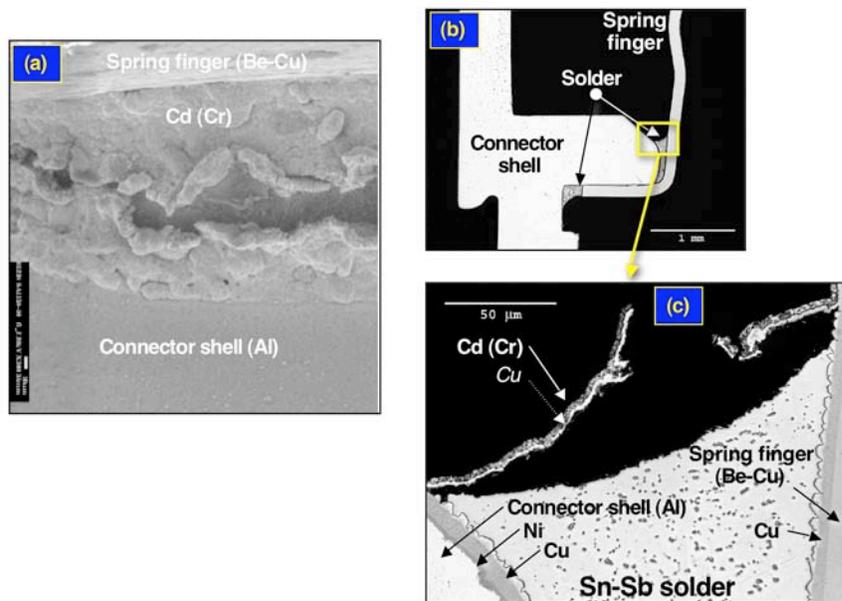
Fig. 33 (a) SEM photograph showing the top side fillet surface of section F1a on SA1358-10. (b) and (c) Low magnification and high magnification optical micrographs showing the cross section of the top side fillet at the same location as the SEM photograph.

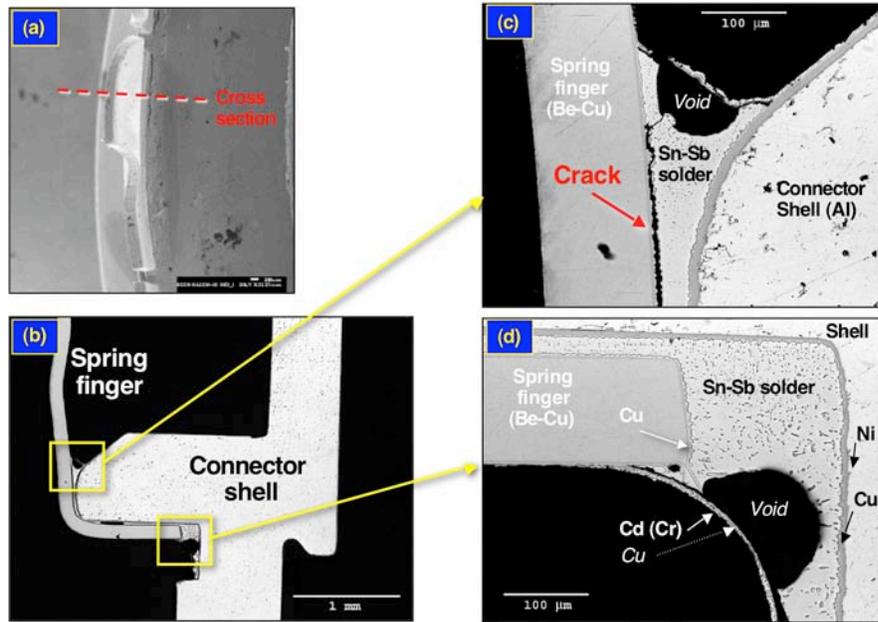
Fig. 38 SEM and optical micrographs showing the juncture between the top side fillet and SA1358-10 connector housing at the *diametrically opposite location* of the F2 as was shown in Fig. 37: **(a)** SEM photograph showing the location of the cross section through the spring finger solder joints; **(b)** low magnification optical micrograph of the solder joint cross section, showing the top and bottom fillet locations that were examined at higher magnification in micrographs **(c)** and **(d)**, respectively.

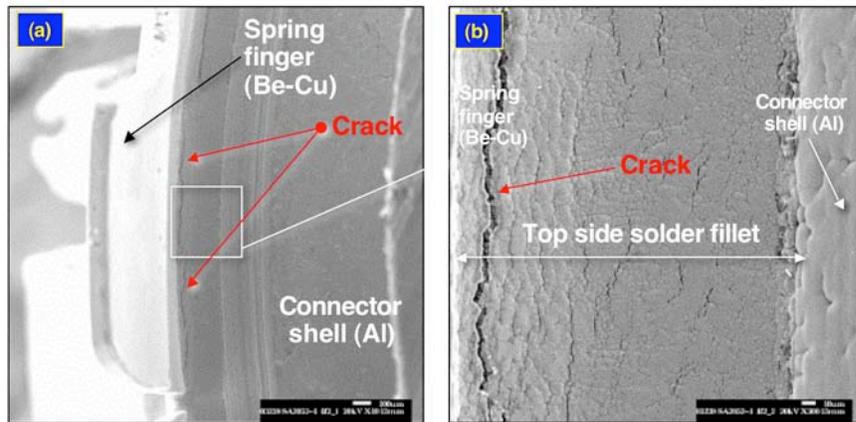
Fig. 39 (a) Low magnification SEM (SE) photograph showing the top side fillet surface of location F2 on SA2052-4. (b) High magnification SEM photograph of the top side fillet surface, showing a crack where the solder fillet joined the spring finger.

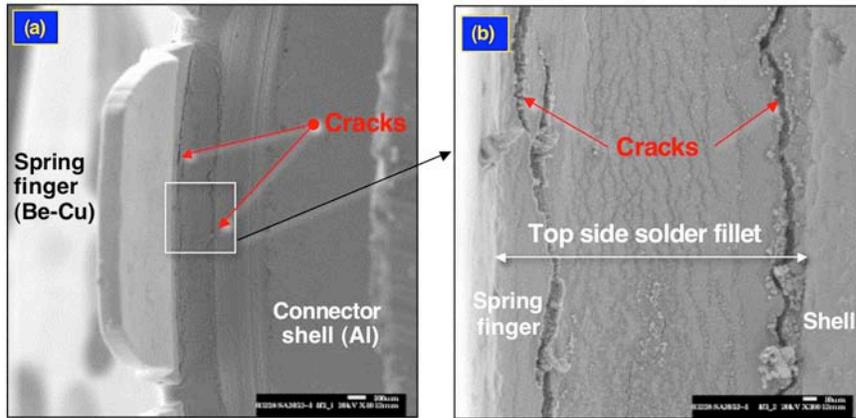
Fig. 41 (a) Low magnification SEM (SE) photograph showing the top side fillet surface of location F3 on SA2052-4. (b) High magnification SEM photograph of the top side fillet surface, showing two cracks where the solder fillet joined the spring finger and connector shell.

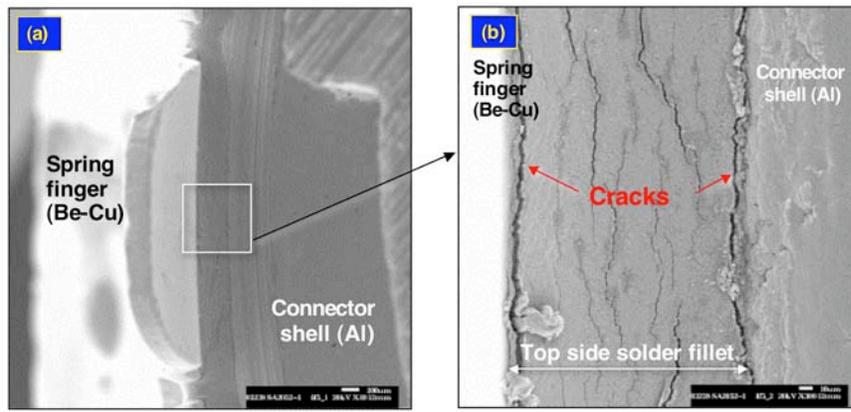
Fig. 43 (a) Low magnification SEM (SE) photograph showing the top side fillet surface of location F5 on SA2052-4. (b) High magnification SEM photograph of the top side fillet surface, showing two cracks where the solder fillet joins the spring finger and connector shell.

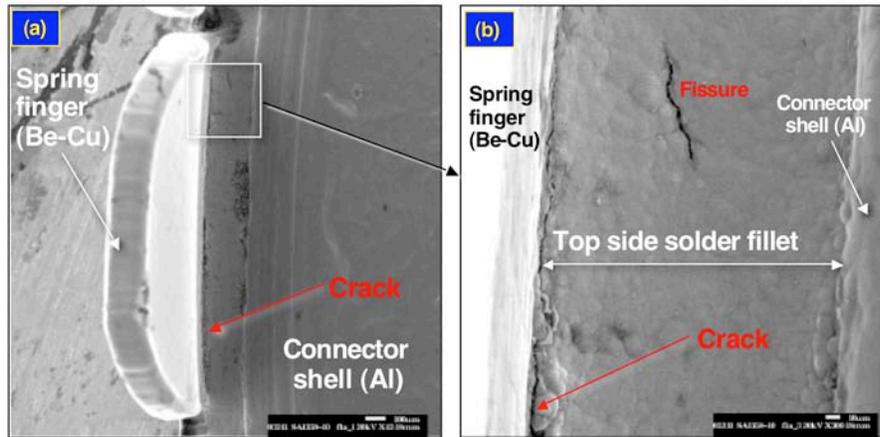
Fig. 47 (a) Low magnification SEM (SE) photograph showing the top side fillet surface of location F1a on the SA1358-10 (item #4). (b) High magnification SEM photograph of the top side fillet surface, showing a crack where the solder fillet joins the spring finger and small fissure in the electroplated layer.

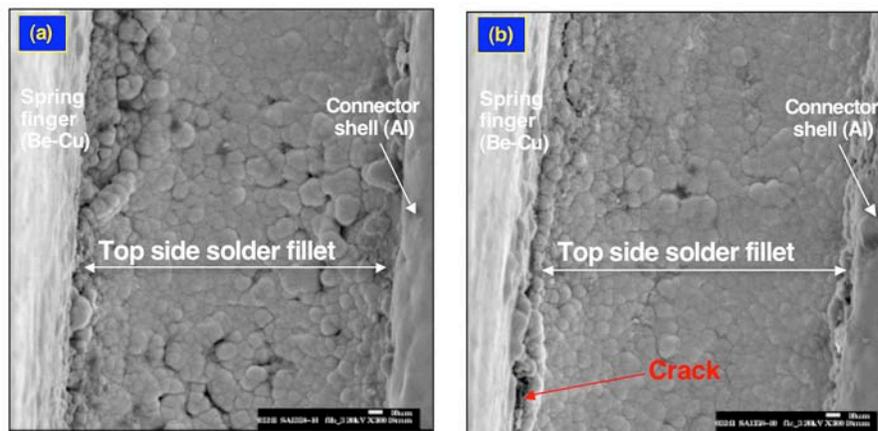
Fig. 48 (a) (b) High magnification SEM photograph of the top side fillet surface at locations F1b and F1c, respectively, on the SA1358-10 connector. A small crack appeared at F1c where the solder fillet joins the spring finger. Numerous, small fissure were observed in the electroplated layer.

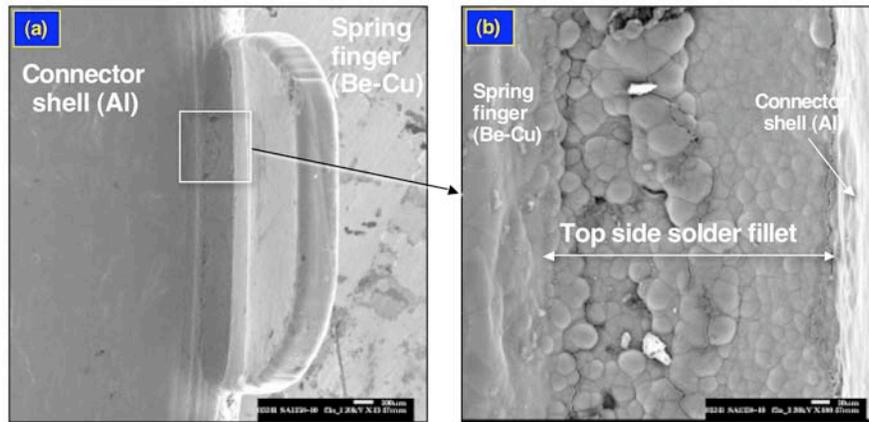
Fig. 49 (a) Low magnification SEM (SE) photograph showing the top side fillet surface of location F3a on the SA1358-10. (b) High magnification SEM photograph of the top side fillet surface, showing a change to the morphology of the overplating layer caused by an alteration of the local throwing power of the plating process.

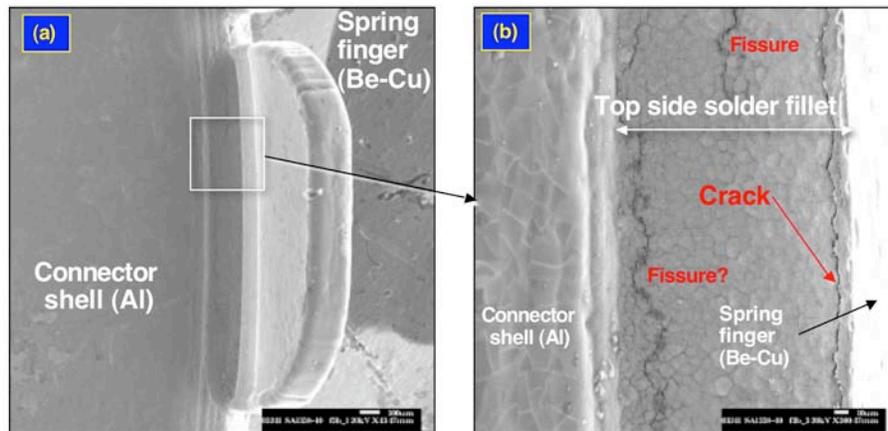
Fig. 50 (a) Low magnification SEM (SE) photograph showing the top side fillet surface of location F3b on the SA1358-10. (b) High magnification SEM photograph of the top side fillet surface showing a crack where the fillet met the spring finger. Fissures were observed in the electroplated coating. One such fissure may have been a crack where the top side fillet joined to the connector shell. It was difficult to decipher the source of the opening.

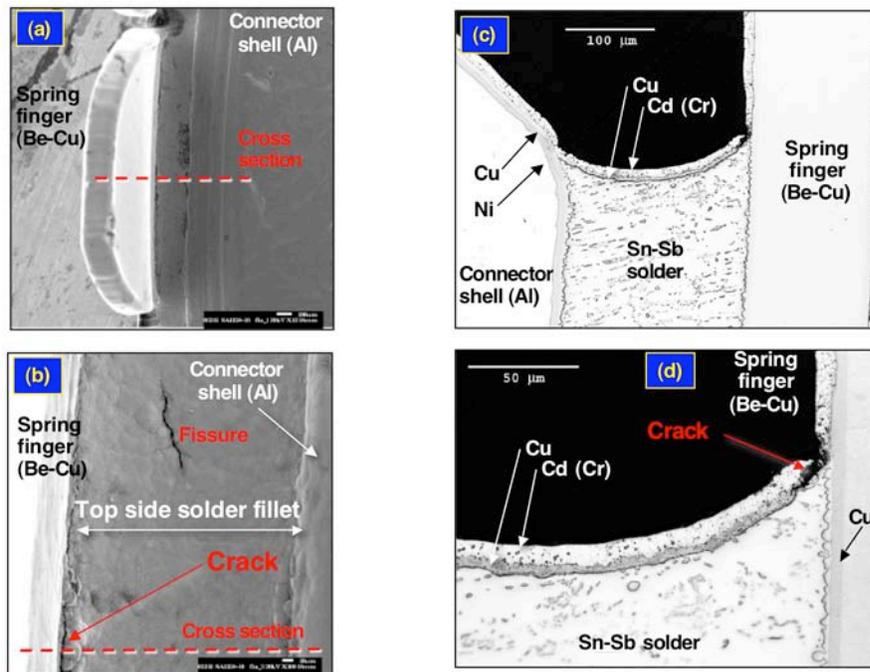
Fig. 52 (a) Low magnification SEM (SE) photograph showing the top side fillet surface of location F1a on the SA1358-10. (b) High magnification SEM (SE) photograph of the top side solder fillet surface. (c) High magnification optical micrograph of the top side fillet. (d) High magnification optical micrograph of the top side fillet showing the integrity of the bond between the overplating layer [Cu, Cd (Cr)] and Sn-Sb solder.

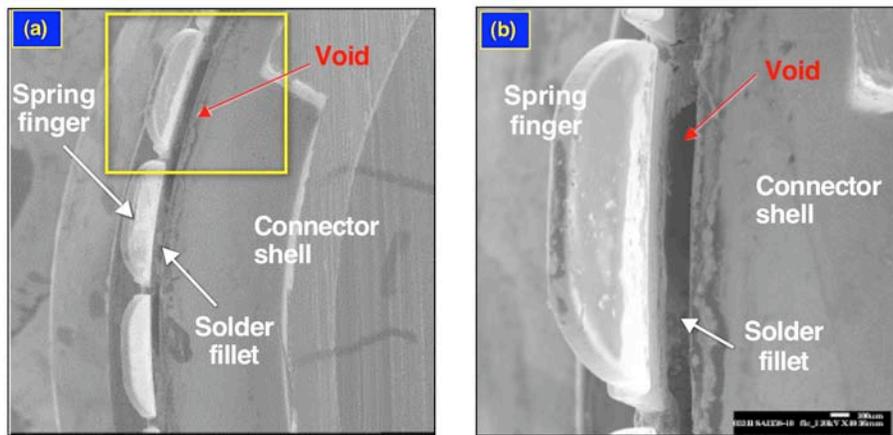
Fig. 60 (a) Low magnification and (b) high magnification SEM photographs showing the void in the top side fillet of the Item #3, SA1358-10 connector at F1c. The exact location can be referenced to the yellow box in Fig. 59 (c).

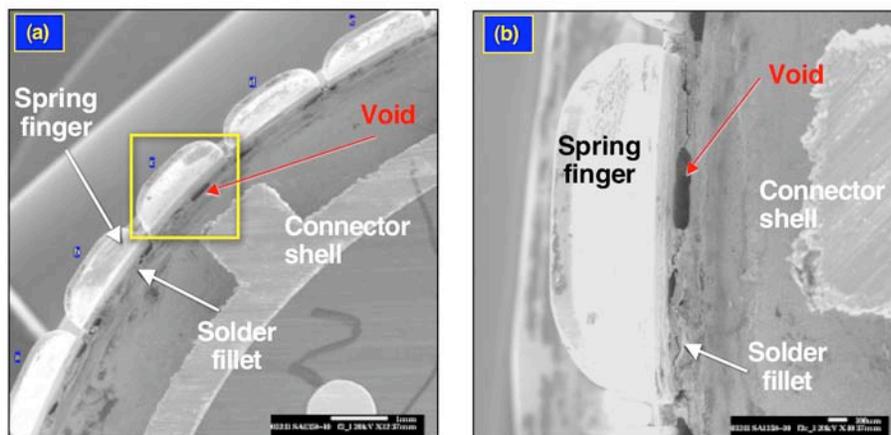
Fig. 61 (a) Low magnification and (b) high magnification SEM photographs showing the void and other degradation to the top side fillet of the Item #3, SA1358-10 connector at F2c. The exact location can be referenced to the yellow box in Fig. 59 (d).

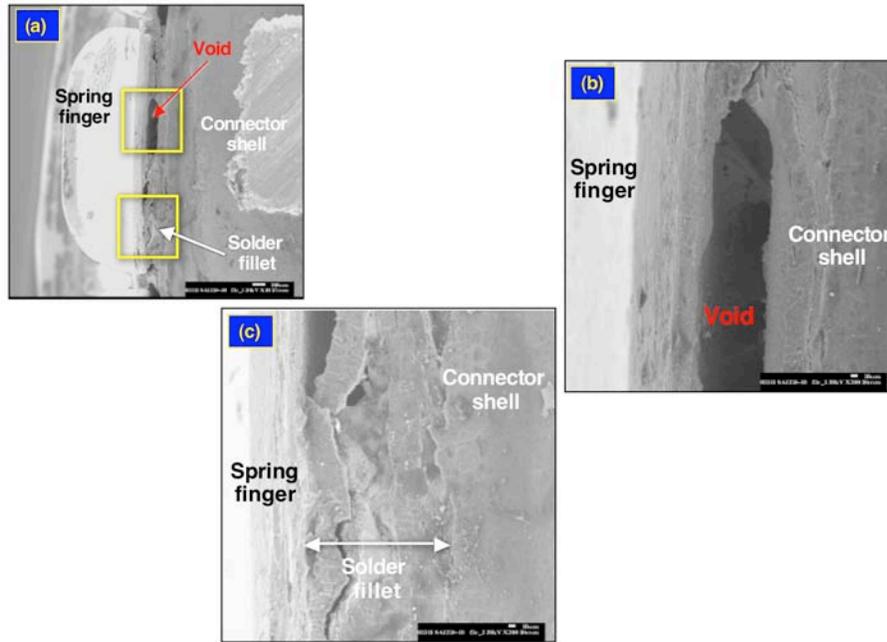
Fig. 62 (a) Low magnification SEM photograph of the top side spring finger solder fillet at location F2c on the Item #3, SA1358-10 connector. High magnification, SEM images appear in (b) and (c) that further illustrated the surface damage.

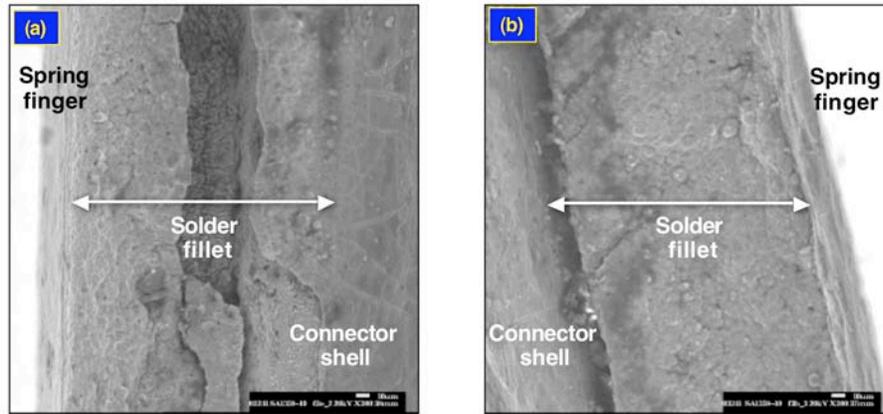
Fig. 63 (a) and (b) SEM photographs at location F2e and F3b, respectively, showing degradation to the top side .
