SANDIA REPORT

SAND2007-3531
Unlimited Release
Printed May 2007

An Investigation of Corrosion in Semiconductor Bridge Explosive Devices

Sandra E. Klassen & N. Robert Sorensen

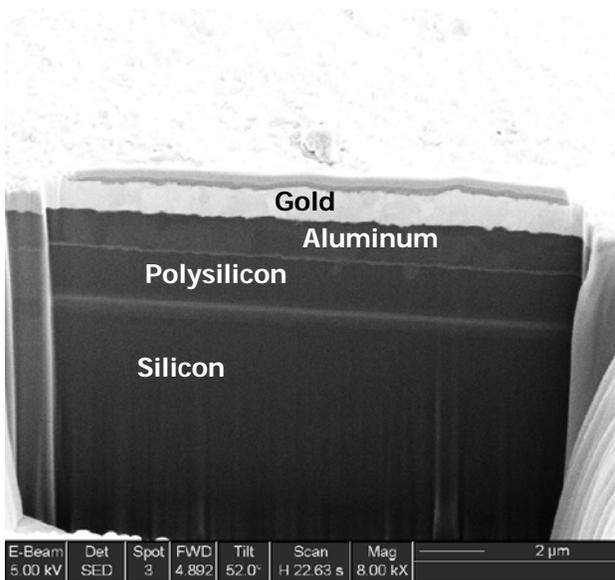
Figure 2 shows a scanning electron micrograph of a focused ion beam (FIB) cut of an uncorroded land. The cross section shows the layers of polysilicon, aluminum, and gold as they should appear. Notice that the thicknesses of the gold and aluminum layers are approximately equal. The layers above the gold layer are platinum and gold/palladium layers that are applied during sample preparation. In comparison, Figure 3 shows a scanning electron micrograph of a FIB cut of a corroded land. The aluminum layer shows the swelling and cracking that is typical of corrosion due to the conversion of aluminum to aluminum corrosion products (hydrated oxy-chloride). The intimate contact of the gold layer with corroded aluminum along with the uniform thickness of the gold layer provides compelling evidence that gold was applied to corroded aluminum. If the aluminum layer had corroded after the gold layer was deposited, one would expect to see evidence for thinning or tearing of the gold layer as it was deformed by an expanding and corroding aluminum layer, and this was not observed in any of the corroded detonators or igniters.

Figure 2. A FIB cut through an uncorroded land. The FIB cut shows a cross section of the aluminum, gold, and polysilicon layers.

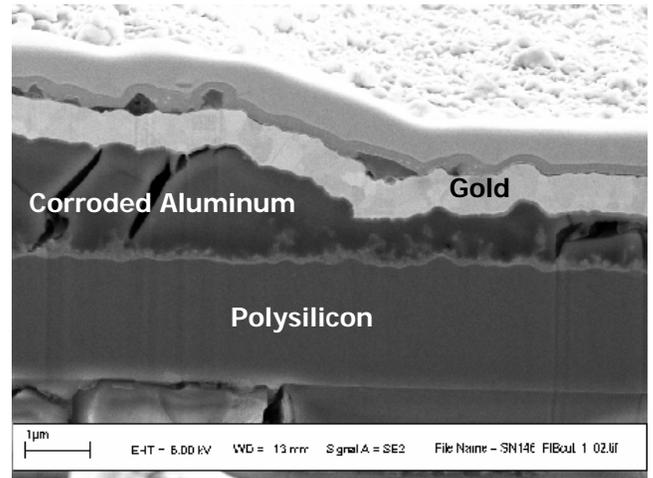
Figure 3. A FIB cut from the corroded land of an igniter.

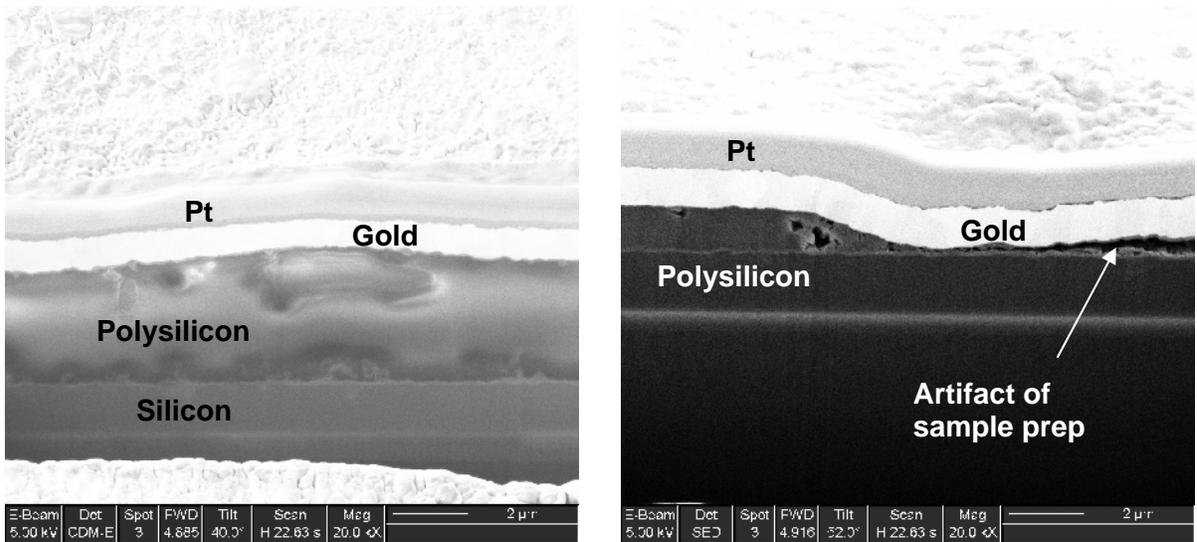
Figure 4 shows FIB cuts from two different detonators that show the gold layer in direct contact with the polysilicon layer. In the figure on the left, there is no evidence of aluminum on top of the polysilicon. In the figure on the right, Al is present in part of the sample and is missing in other areas. Again, the intimate contact and uniform thickness suggests that the gold layer was deposited on an area where the aluminum was so corroded that areas of it were missing. The aluminum layer in the right hand micrograph shows areas where the aluminum is not corroded (left hand side), where it is corroded (middle), and where it is missing (right hand side). The gap between the gold and polysilicon layers at the right hand side of the figure is an artifact of sample preparation.

Figure 4. FIB cuts from detonators that show the gold layer in contact with the polysilicon layer.

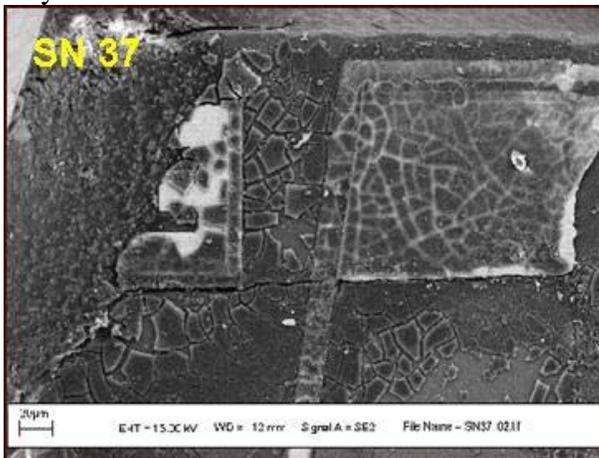
In some of the detonators, it was evident that corrosion also took place after the gold was deposited because aluminum corrosion products were found on top of the gold layer. See, for example, the scanning electron micrograph in Figure 5 of a portion of a die. The mud-cracked material on top of the gold is made up of aluminum corrosion products that have dried, and implies that enough moisture was present at one time to allow transport of corrosion products over the surface of the die. Both the detonator and igniter are hermetic devices, and the mud-cracking most likely appeared after device disassembly exposed the corrosion products to air. Figure 6 shows the FIB cross section of a land from a detonator that looks similar to that in Figure 5, and corroded aluminum is found both above and below the gold layer.

Figure 5. Top view of a detonator die that shows corrosion on the surface of the gold.

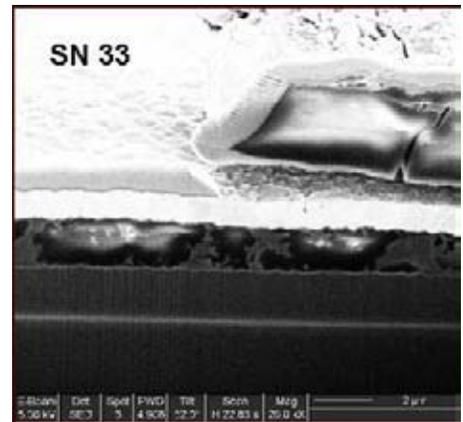
Figure 6. A FIB cut that shows corroded aluminum both above and below the gold layer.

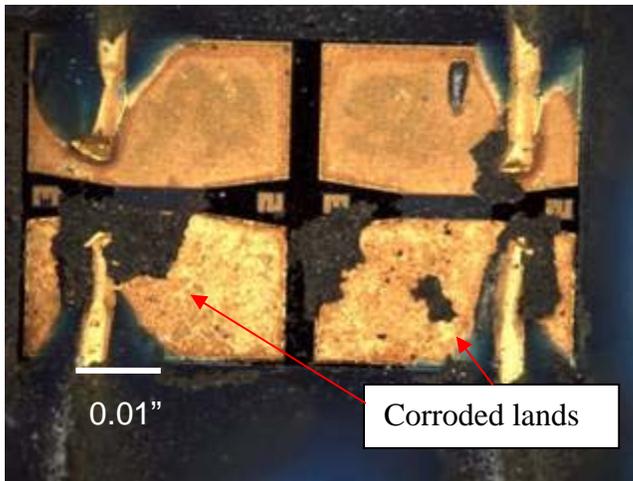
Figure 7. A dual Type 3-2 SCB from an igniter showing two corroded lands in close proximity to two uncorroded lands.

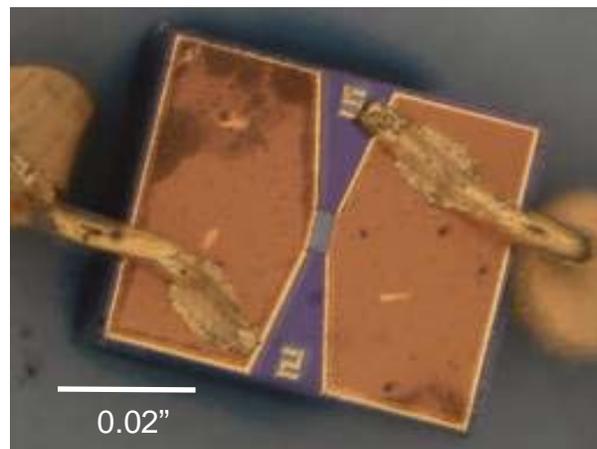
Figure 9 shows an example of a detonator header from Group 1. Dies from approximately 20 headers that had previously been subjected to ESD testing were available for inspection and were examined for the presence of corrosion. No corrosion was found, but other issues were noted that could contribute to corrosion during the lifetime of the device such as contamination of the lands and manufacturing defects (discussed in the next section). The stains on the SCB shown in Figure 9 are typical of those that were found on the lands of some dies. FTIR analysis was attempted but only poor spectra could be obtained that indicated the possibility of a carboxylic acid salt. It could not be identified further—even after examination of the MSDSs of the die processing chemicals. Other spectra were consistent with human skin oil, but at least one stain was a well delineated rectangle located at

Figure 9. A Type 52 SCB that shows several areas of contamination.

the center of the die. One could speculate that a smear at the edge (such as shown in Figure 9) could be caused by handling the die/header without wearing gloves, but it is difficult to envision the scenario that would leave a well defined mark of skin oil in the center of a die. Perhaps the most likely scenario for contamination is the practice of using a community oven to cure parts after the application of Ablebond™. Notice that these wire bonds are not supported by adhesive.

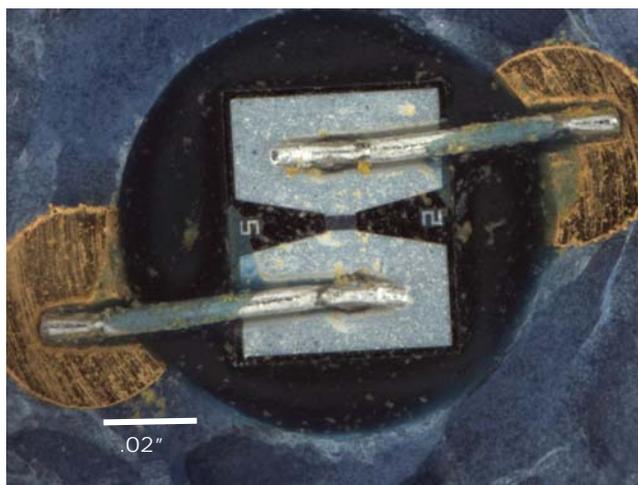
Five detonators from Group 3 were thermally cycled a total of 30 times⁵ and compared to five controls. None of these ten detonators showed any evidence of corrosion. An optical micrograph of one of the cycled headers after disassembly and powder removal is shown in Figure 10. Leak tests were also performed on these ten detonators to determine if moisture could be entering the device during thermal cycling. The leak rate was 4×10^{-9} std cc/sec for the control group, and 2×10^{-9} std cc/sec for the cycled group. These data show that all of the devices were hermetically sealed.

Figure 10. A Type 52 SCB with aluminum lands that had been thermally cycled 30 times.

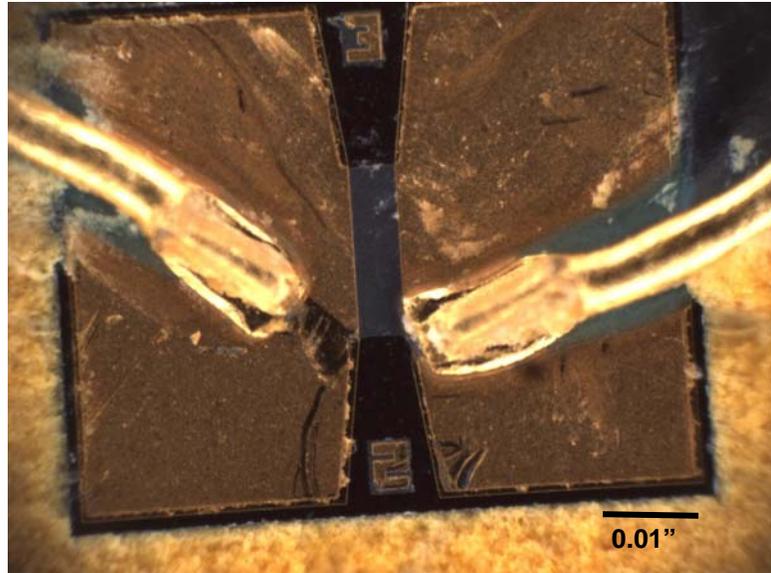
Finally a total of eleven detonators from Group 4 were examined. Two were controls, three had been through one set of thermal cycles, three through two sets of thermal cycles, and three through three sets of thermal cycles.¹ Each set involved thirty thermal cycles; thus, the three detonators in the last group were cycled ninety times. An optical micrograph of a die in the last group is shown in Figure 11. No evidence of corrosion was seen on any of the dies in any of the sets. A number of manufacturing defects were readily apparent and are discussed in the next section.

Figure 11. A Type 3-2 SCB with gold coated aluminum lands that had been manufactured about ten years ago and had been cycled a total of ninety times.

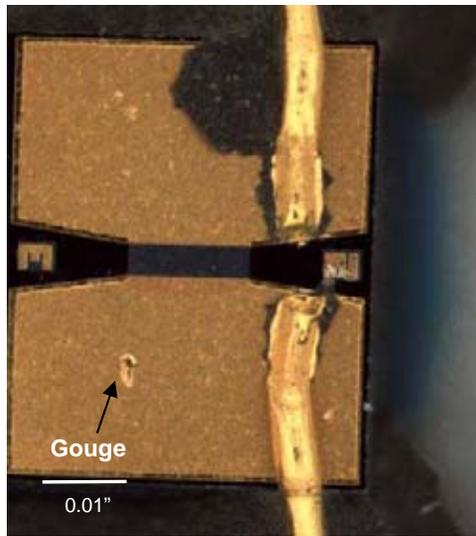
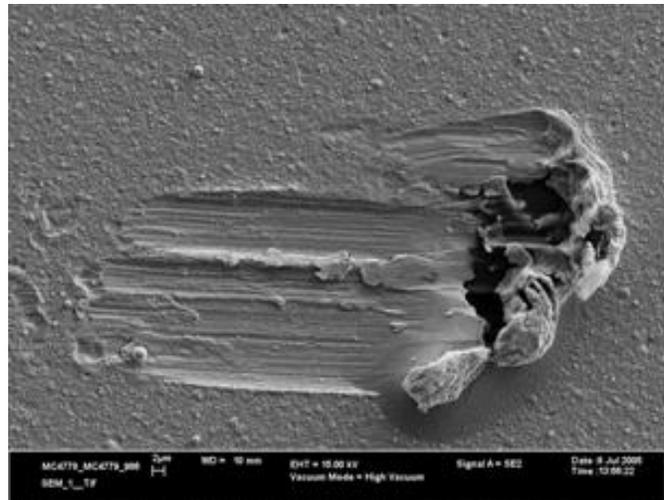
Observations of manufacturing defects have been made to different extents in all of the groups of SCB devices discussed thus far except for the Group 3 detonators with the aluminum lands that were not coated with gold. Because gold is a soft metal, it is easily deformed. After the gold layer is applied, the SCB bridge resistance is measured using a four point probe. Some amount of pressure must be applied to obtain a reading, but the operation tends to leave marks in the gold that sometimes go through to the aluminum layer. The probe appears to have a “snow plow” affect as shown in Figure 12. The gouges that were observed are probably caused during wire bonding when the die is being incorporated into a device header. Some of these go through to the polysilicon layer.

Figure 12. Optical and scanning electron micrographs of a mark left in the gold by application of a resistance probe.

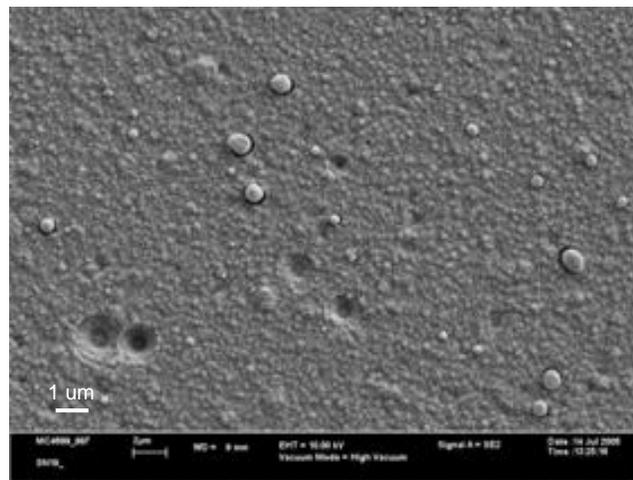
In addition to breaches in the gold layer due to processes and tools, the gold layer in the recently fabricated dies appears to be somewhat porous. Figure 13 shows a scanning electron micrograph of the gold layer from a dual SCB. It looks as if the gold spheres are leaving craters which, in some cases, are deep enough to expose the aluminum layer. Figure 14 shows a scanning electron micrograph taken on a gold surface that was tilted and shows the columnar nature of the gold. The FIB cross section in Figure 15 shows several undesirable characteristics of the plated gold layer. The thickness of the layer is extremely variable. In the bottoms of the “craters”, the gold is extremely thin. It is likely that the layer is porous in the craters. In addition, a crack in the gold can be seen in the right crater. Again this suggests that the gold layer may, in fact, be porous. Neither craters nor spheres are observed in the gold lands of the devices made about ten years ago. Once again in this investigation, the evidence is conflicting. Gold spheres typically form when the gold layer is deposited too quickly, but the records for the dual SCB wafer do not show a rapid rate, and if one looks closely at the scanning electron micrograph in Figure 12, one can see a sphere on top of the “snow plow” track. This can not be if the spheres resulted

Figure 13. Scanning electron micrograph showing the surface of the gold layer on the SCB. Note the presence of “craters” (some of which contain spheres of gold) across the surface.

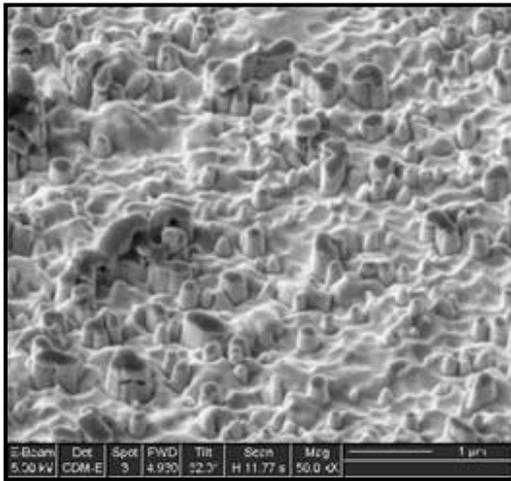
Gold and aluminum form a galvanic couple in which aluminum is the anode and gold is the cathode. This process accelerates corrosion of aluminum. For galvanic corrosion to be active, both the anode and cathode must be exposed to the environment. In addition, an electrical connection between the anode and cathode is required. The gold-plated aluminum structure that is used in these SCB detonators provides an excellent example of galvanic coupling. In this case, if the gold layer is porous, it will actually enhance corrosion of an aluminum land rather than protect it as a solid layer of gold would.

Figure 14. Scanning electron micrographs of the gold surface after tilting the sample at a small angle. Note the columns which contribute to excessive surface roughness.

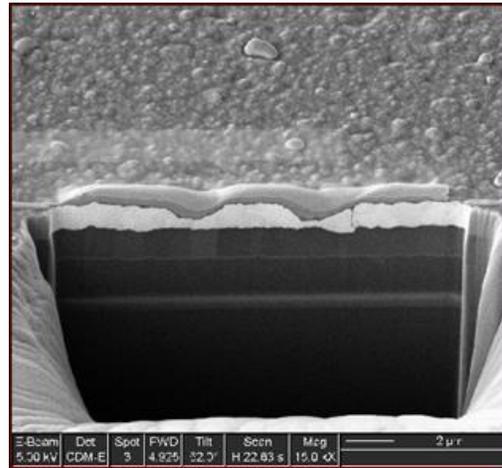
Figure 15. FIB cross sections of the gold plated land. Note the differences in gold thickness across the surface.

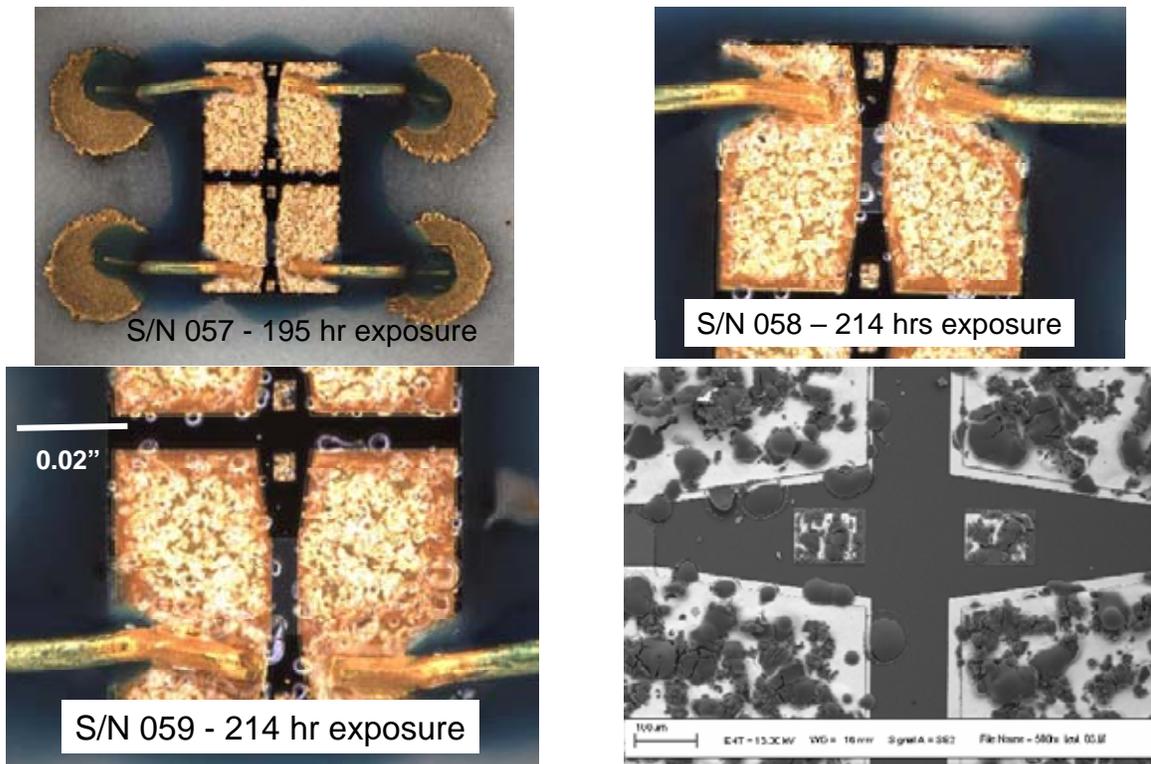
defects in the gold layer expose the underlying aluminum) and spreads outwards from each initiation site. Corrosion products are visible across the surface of the device. The SEM image (lower right) shows that the corrosion sites (dark regions) are, in fact, isolated.

Figure 17. Optical and scanning electron micrographs of SCB headers exposed to 70% relative humidity and 10 ppb chlorine gas. The resistance plots are given in Figure 16.

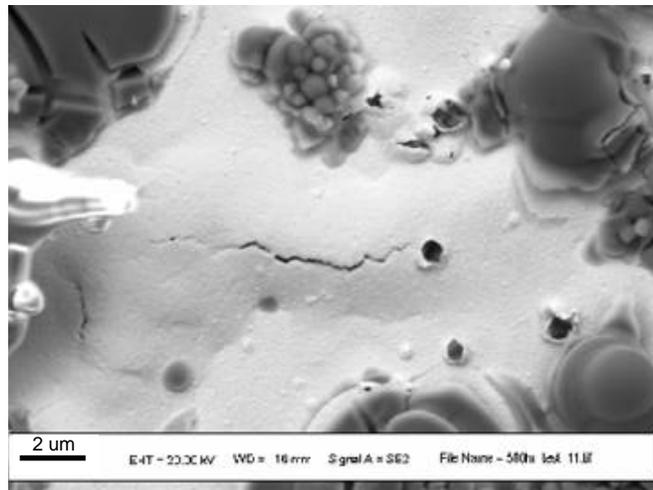
These data are consistent with the observations of the previous section regarding porosity in the gold layer. Examination of the gold layer at high magnification also showed that rips and tears were present in the gold layer as shown in Figure 18. This is expected when the aluminum layer corrodes after the gold layer is deposited. Recall that earlier in this report the uniform thickness and lack of rips or tears in the gold layer were presented as evidence that the gold layer had been deposited after corrosion of the aluminum layer. The results of the corrosion experiments show that significant numbers of defects are present in the gold layer on these SCB igniter headers. Corrosion of aluminum was also observed at the edge of the lands. The gold layer is known to be thinner at the edges of the lands—in particular when the land is next to the bridge area.

Figure 18. Scanning electron micrograph showing a rip in the gold layer due to expansion of the aluminum layer below as it corroded.

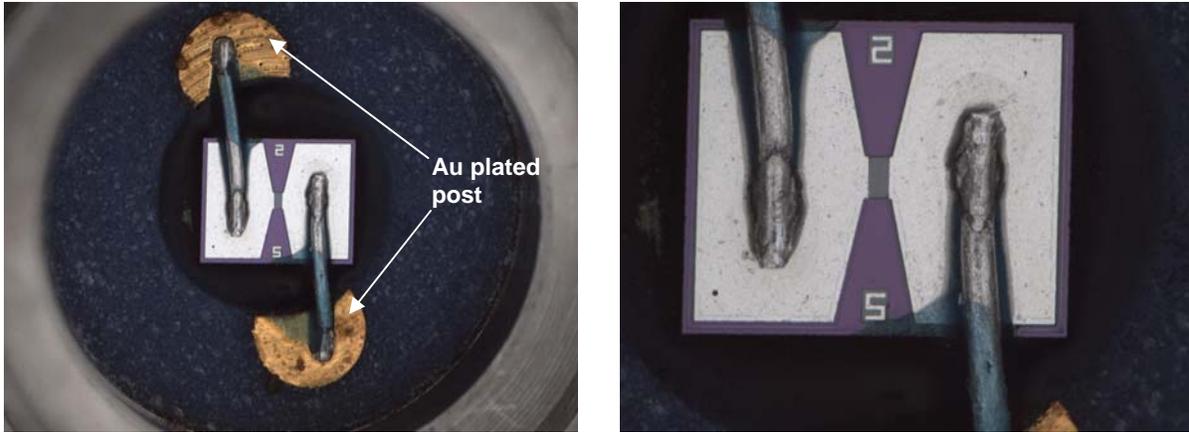
Figure 23. Optical images of all aluminum (no gold) SCB headers after exposure to humid chlorine environments. Note lack of attack of lands or bond wires. Some corrosion is seen on the gold-plated posts.
