SANDIA REPORT

SAND2007-4347
Unlimited Release
Printed July 2007

Copper Corrosion and Its Relationship to Solar Collectors: A Compendium

David F. Menicucci and A. Roderick Mahoney

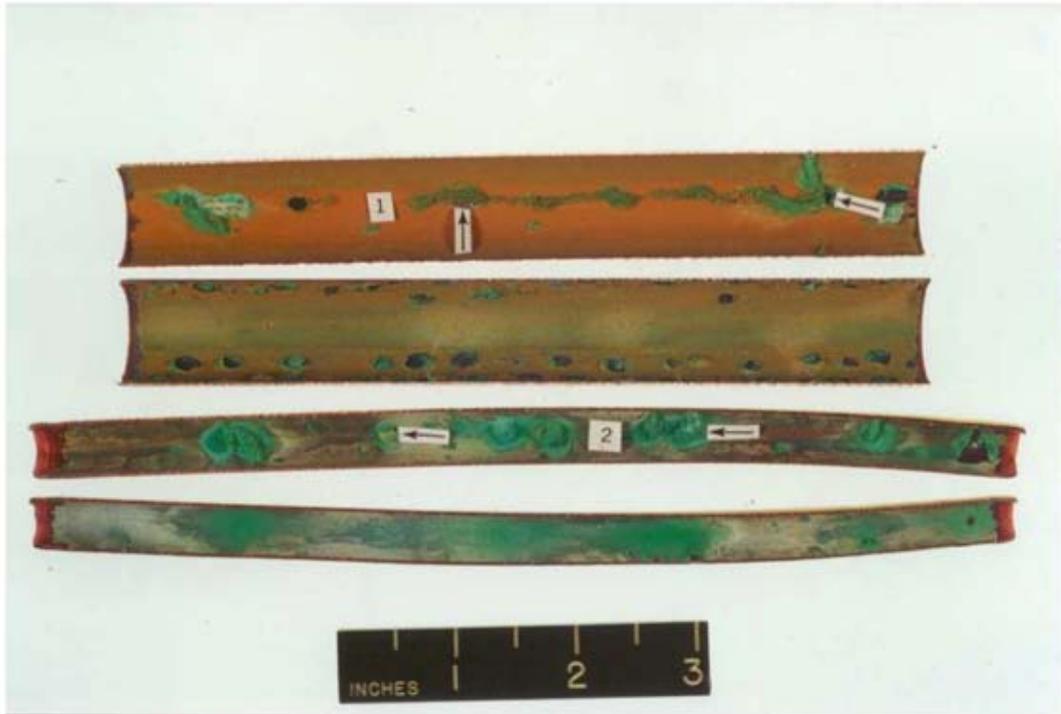
Figure 1 – The soldering flux-induced pits were covered with friable, greenish-colored tubercles of copper corrosion products. The perforations through the tube walls (i.e., see arrows) and most of the pits existed along relatively narrow bands, which were nearly parallel to the longitudinal axes of the tubes (i.e., along the “ghosts” of flux runs).

Soldering flux-induced pitting can be effectively mitigated by requiring plumbing technicians to use industry-standard materials and workmanship when installing copper tube systems. Fluxes used for soldering copper water tube systems should satisfy the requirements of American Society for Testing and Materials (ASTM) Standard Specification B813² and soldered connections must be made in accordance with the guidelines presented in ASTM Standard Practice B828³ and the CDA Copper Tube Handbook.

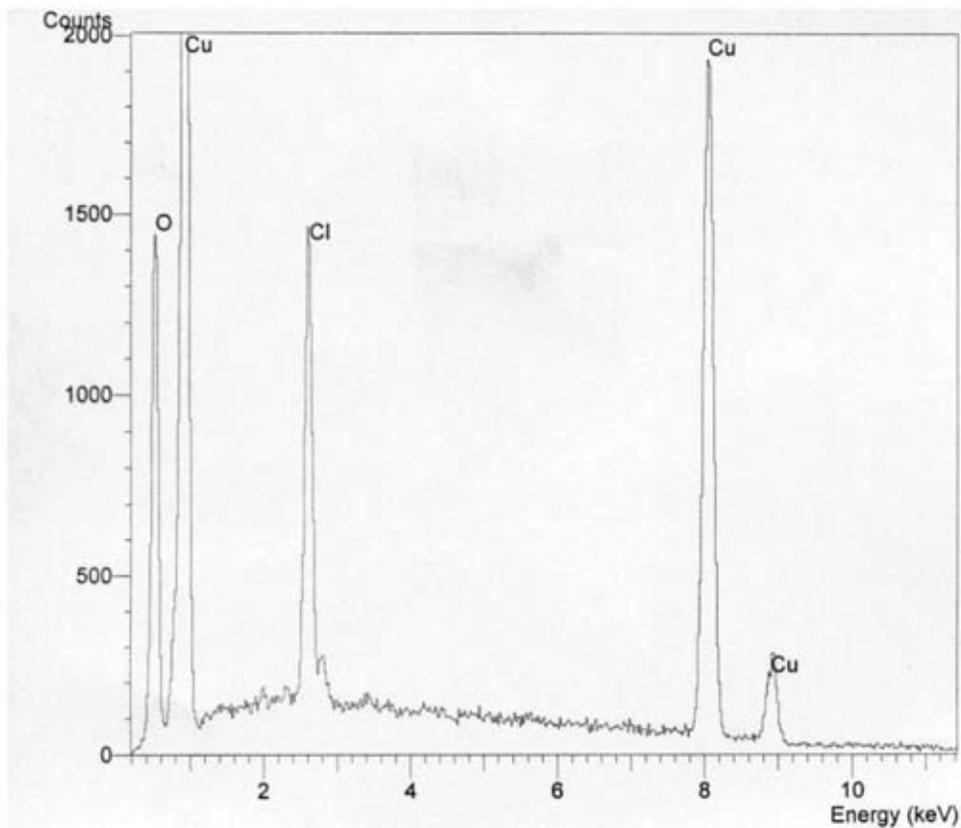
Figure 2 - Energy dispersive spectroscopy normally reveals the presence of major amounts of chloride at the pit sites when the localized attack is soldering flux-induced.

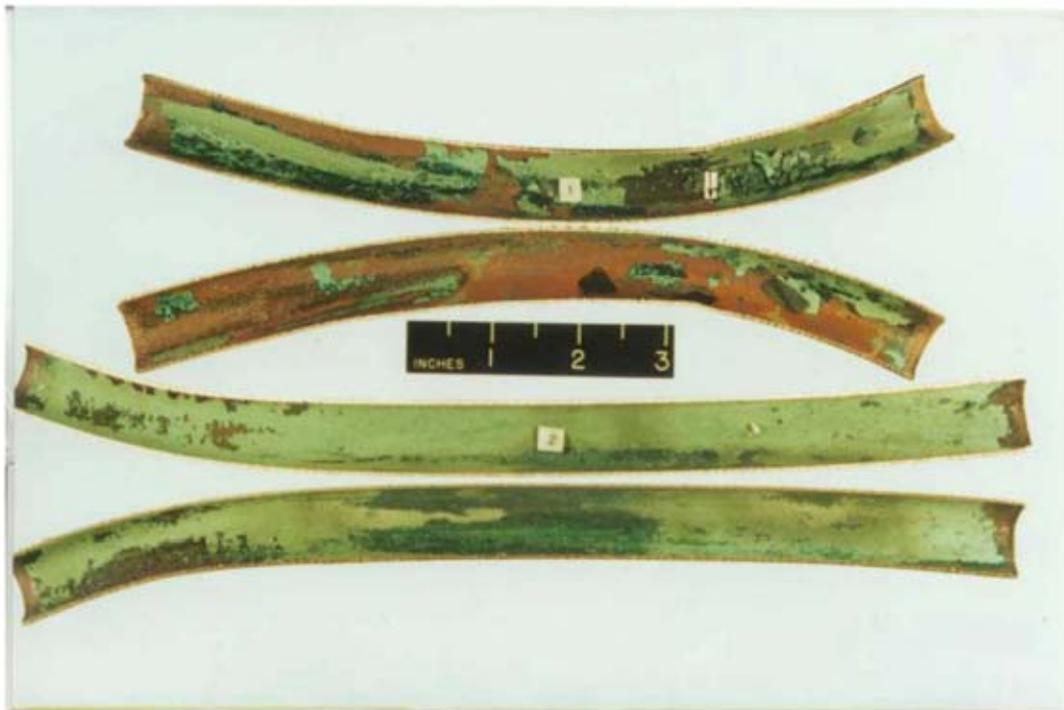
Figure 3 - Hydrogen sulfide-induced pits are typically overlaid with friable, greenish-colored to blackish tubercles of copper corrosion products. Loosely adherent and porous layers of copper sulfide(s) are associated with the pitting attack (e.g., see upper two tube half-sections where these products had, in part, broken loose).

Hydrogen sulfide can be effectively removed from water supplies at the treatment plant by a number of techniques.^{4,5} For example, it has been successfully accomplished by reducing the pH of the well water followed by aeration in a forced-draft tower(s). Aeration removes the sulfide by the scrubbing action of the air and by oxidation. Lowering the pH of the water greatly reduces the size of the aerating equipment required.

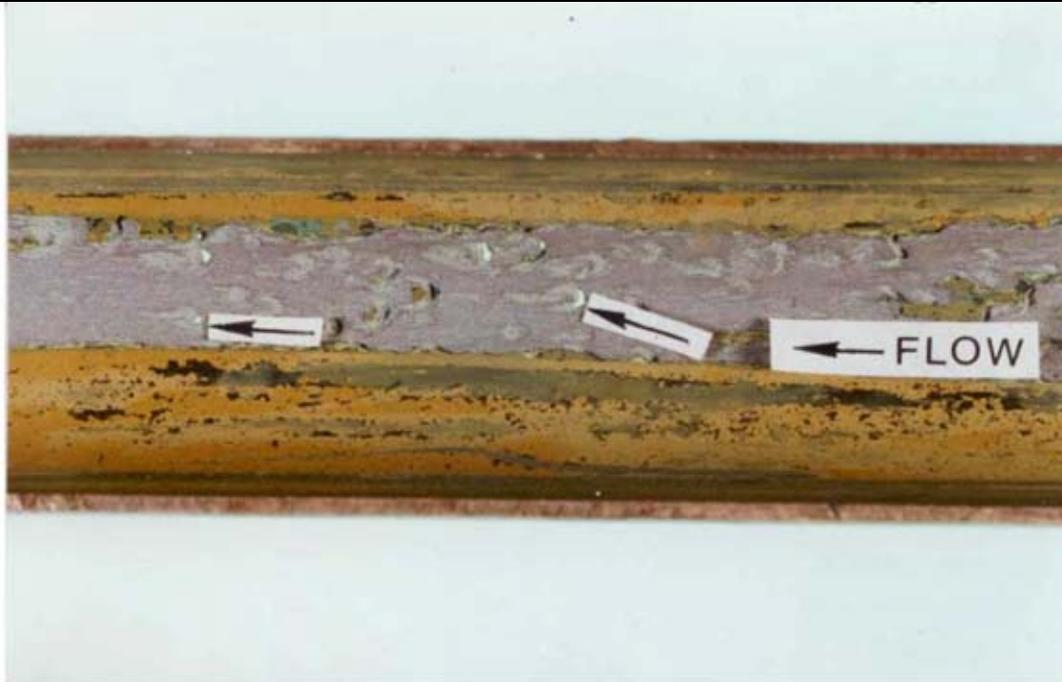
⁽²⁾ Excessive velocity in circulating systems is often associated with an oversized circulating pump(s) and/or undersized tubes and fittings. Sometimes these conditions result from a design deficiency or when the original design was altered during installation of the system.

Figure 4 - The U-shaped pits and associated perforations through the tube wall (i.e., see arrows) in the localized, corrosion product free area of erosion-corrosion were sufficiently distinct that the direction of former hot water flow could be determined.

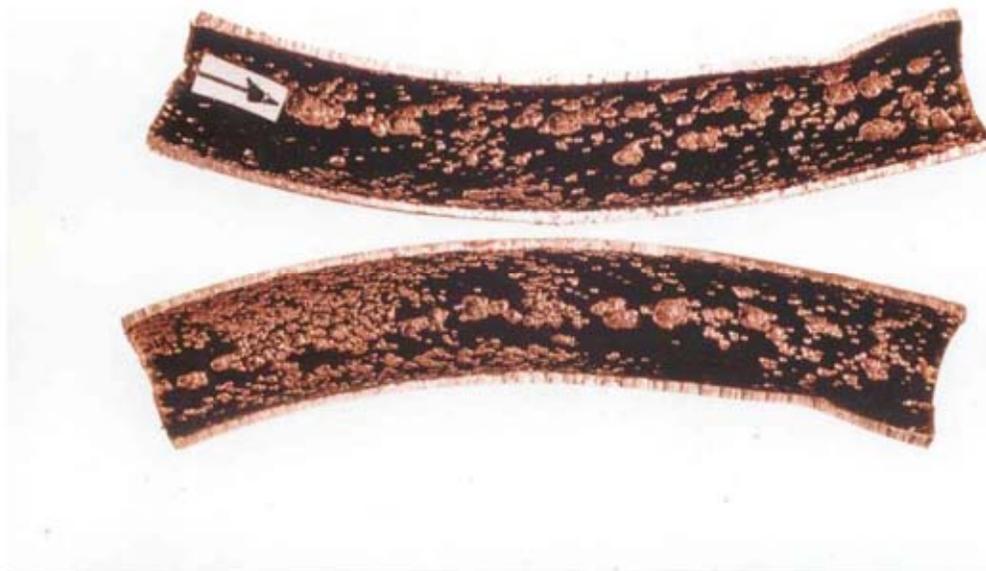
Figure 5 - The perforation through the tube wall (i.e., see arrow) existed in a localized area of severe cavitation. Surface heating by the cavitation process caused the formation of black cupric oxide on the copper where cavitation had not occurred in the cold water line.

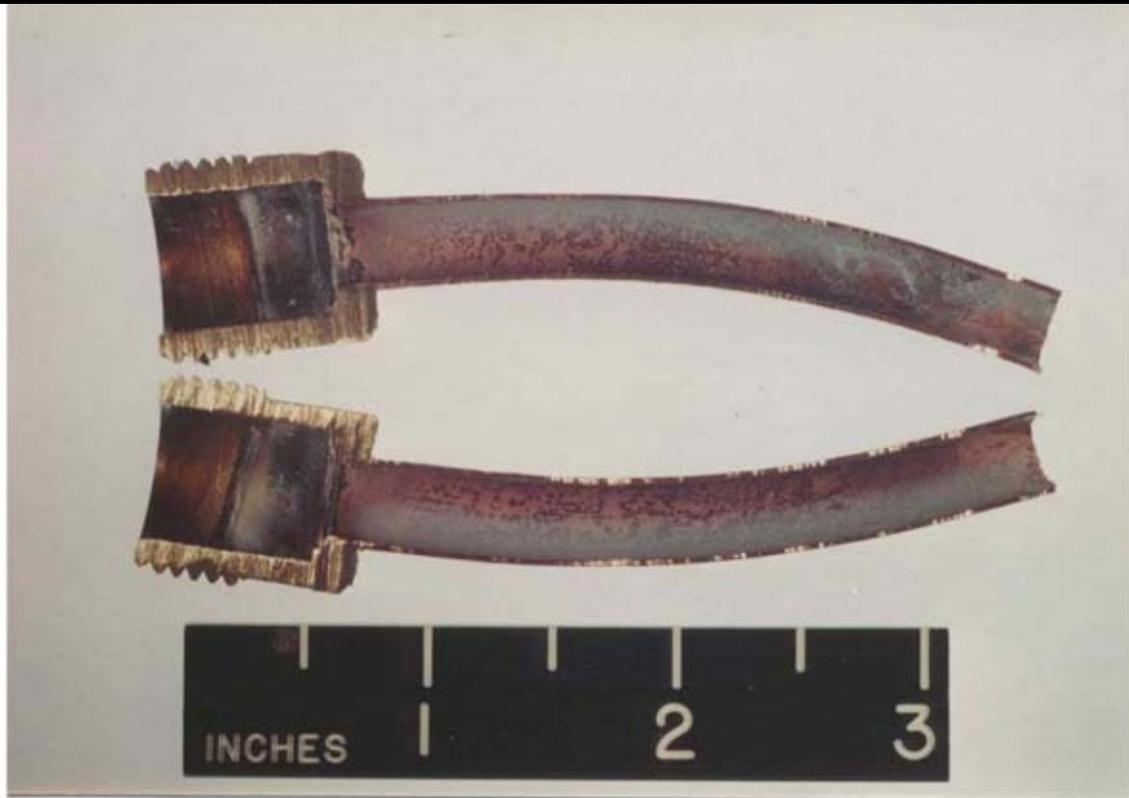
Figure 6 - A loosely adherent, flocculent-type layer of bluish tinted copper corrosion products existed on the waterside surface of the tube. The cuprosolvency was clearly evident to be associated with failure of the copper water tube to completely passivate (e.g., see speckled appearance of the copper tube surface).

Cases are known, however, where the cuprosolvency was soldering flux induced. Instead of developing corrosion-induced pits, the flux causes the slow, nearly uniform dissolution of copper. Water treatment has not been known to be of any significant benefit in mitigating the cuprosolvency concern in these incidents.

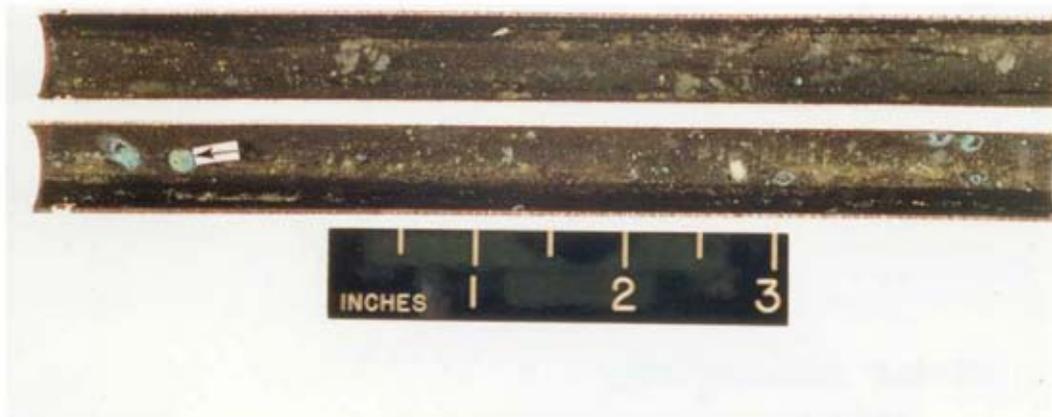
Figure 7 - Concentration-cell corrosion in the form of pitting attack had occurred preferentially under the thicker layers of hydrated hematite (Fe_2O_3) and silica (SiO_2) deposits on the waterside surface of the cold water line. The perforation through the tube wall (i.e., see arrow) was covered with a friable tubercle of greenish-colored copper corrosion products.

Once the source of the corrosion-causing deposits is positively identified, suspended solids in water can normally be effectively eliminated. For example, the corrosion of cast-iron/ductile-iron mains and galvanized-steel service lines can be viably and cost-effectively mitigated by proper water treatment,¹² normally by the water purveyor. It is also well established that suspended solids in water can be removed by filtration,¹² either at the treatment plant or the affected building/residence and that improved dwell time at the treatment plant can help eliminate the post-precipitation of suspended solids in the water distribution system.

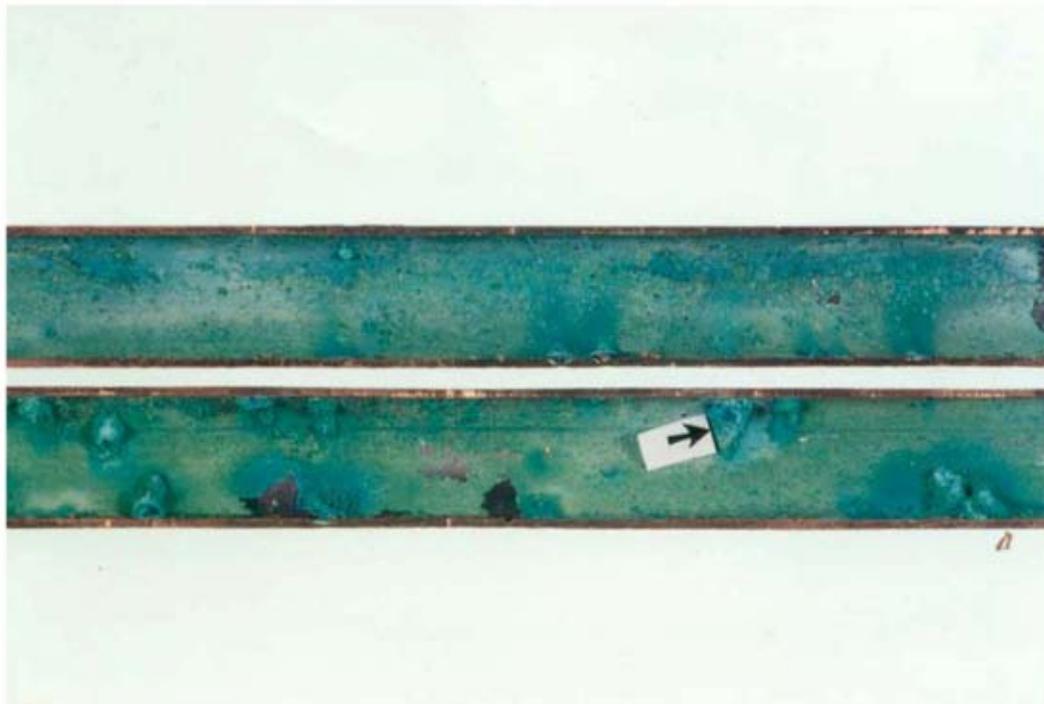
Figure 8 - Randomly-occurring, tubercle-covered corrosion-induced pits (e.g., see arrow where a perforation through the tube wall existed) existed on the waterside surface of the tube which had conveyed a domestic cold water containing appreciable amounts of dissolved carbon dioxide in conjunction with dissolved oxygen.

The most viable and cost-effective solution to overcoming chemistry-related cold-water pitting in copper domestic water systems is to reduce the dissolved carbon dioxide content of the offending water to a sufficiently-low level.¹⁴⁻¹⁷ Raising a water's pH to about 8 while concurrently reducing its carbon dioxide content to less than about 5 mg/l will successfully mitigate the concern. Environmentally acceptable chemical additions for achieving this objective include caustic soda, lime, and soda ash. These are usually added to the offending water at the treatment plant. For a private residence, the same objective usually can be achieved by the installation of a neutralizing filter.

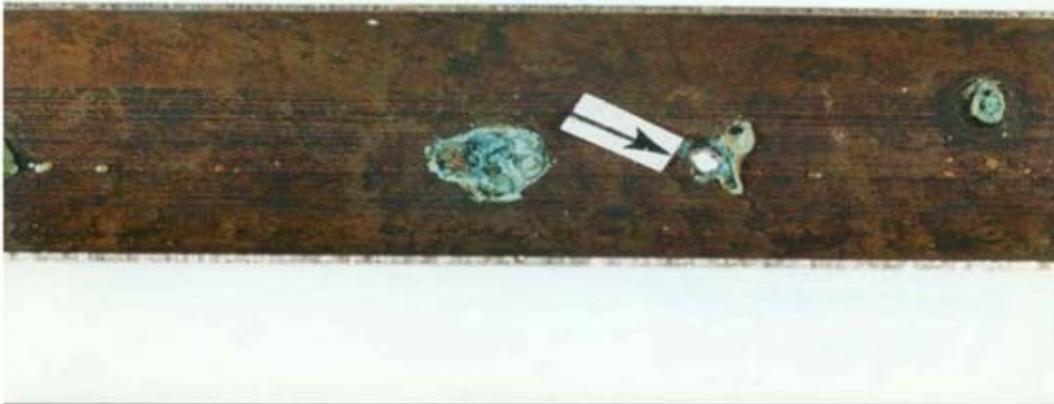
Figure 9 - The pits were covered with friable tubercles of greenish-colored copper corrosion products. Loosely-adherent layers of brownish-colored hydrated hematite deposits covered the black cupric oxide which existed on the waterside surface of the hot water line.

The hot-water pitting associated with the presence of aluminum in the water has been effectively mitigated by raising the pH of the water to about 8.5 while reducing the aluminum content to less than about 0.1 mg/l. Often, the aluminum content of a water, as well as its sulfate content, can be reduced to an acceptable level by simply reducing the amount of aluminum sulfate used for coagulation at the treatment plant and/or insuring adequate coagulation, settling, and filtering of the water before it is distributed. Reducing the temperature of the hot water from 165°F to 130°F has also been known to correct the pitting concern. Recent studies also suggest that the aluminum contents of domestic hot waters can be reduced to acceptable levels by avoiding the use of sacrificial aluminum-alloy anodes in the hot water heaters.

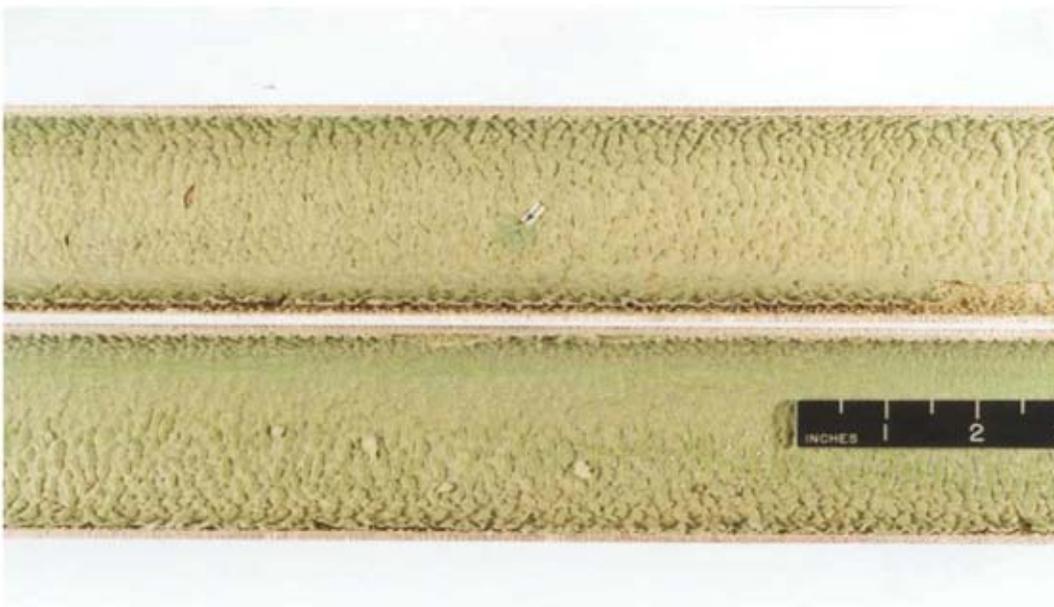
Figure 10 - The perforation through the tube wall (i.e., see arrow) was covered with a friable tubercle of greenish-colored copper corrosion products. In general, the cupric oxide on the copper tube surface was covered with a relatively-thick, loosely-adherent layer of brownish-colored deposits from the hot water conveyed. EDS revealed that the brownish-colored products contained significant amounts of aluminum.

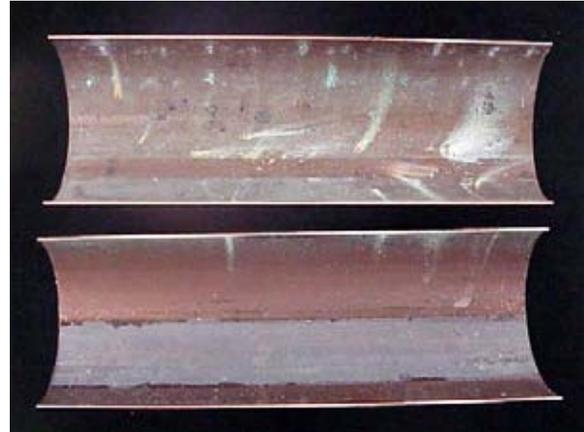
The TCT collector samples were visually inspected for evidence of pitting corrosion. Fig. 4 shows sites observed on the tube walls.

Fig. 4: Photo of Corrosion on the Tube Walls.

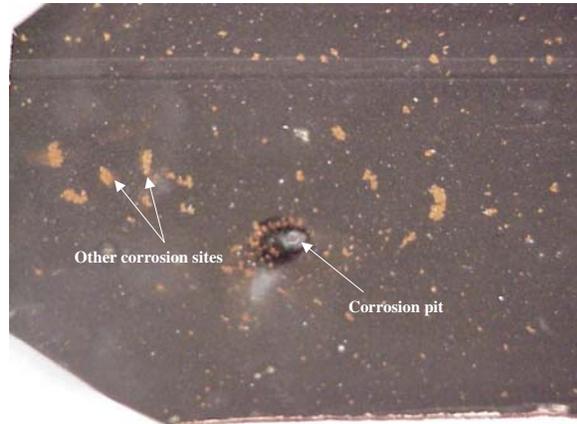
The cold water tubing showed numerous, small surface corrosion sites. However, the hot water supply tube showed a significantly greater amount of corrosion products and possible pitting.

Fig 5: Closeup of Corrosion Pit.

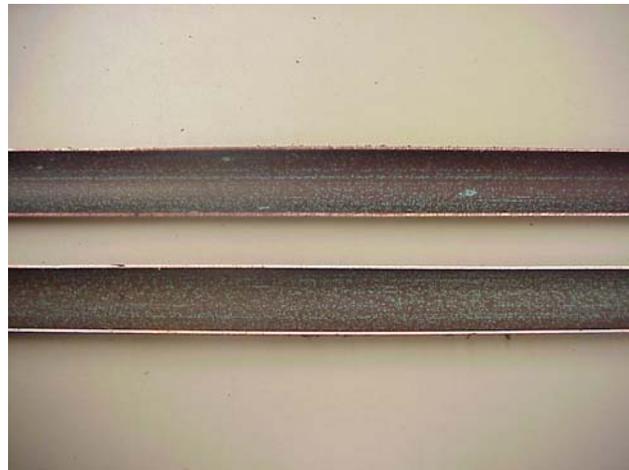
Fig. 6 clearly show the differences in the amount of corrosion on the cold supply tubing and the hot return tubing. An analysis of some potential pitting sites on the hot tube showed that the corrosion had begun to penetrate the tube wall.

Fig. 6: Pictures of Corrosion on Hot and Cold Tubes.

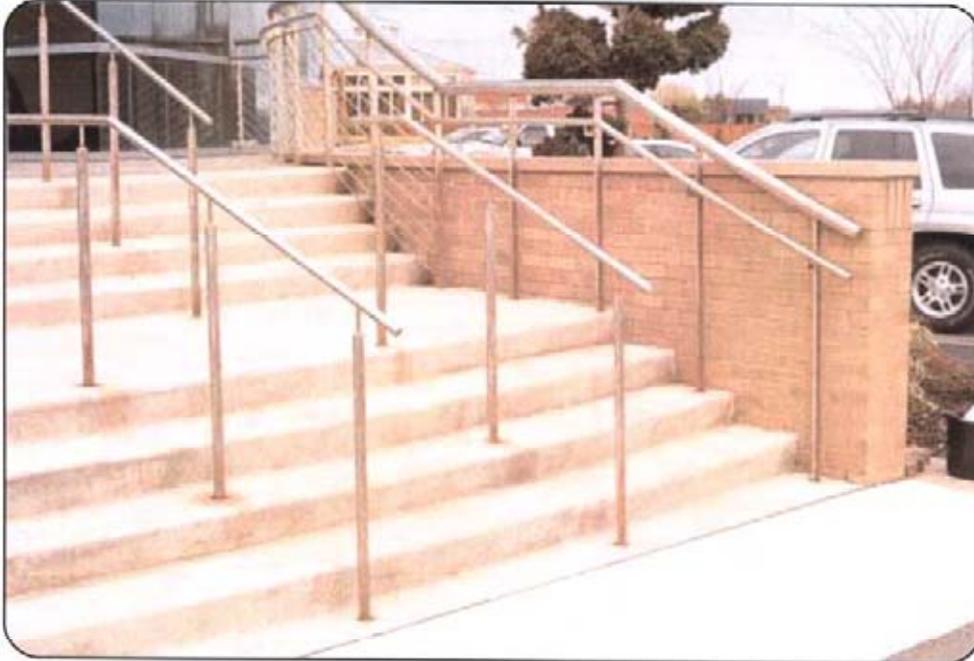
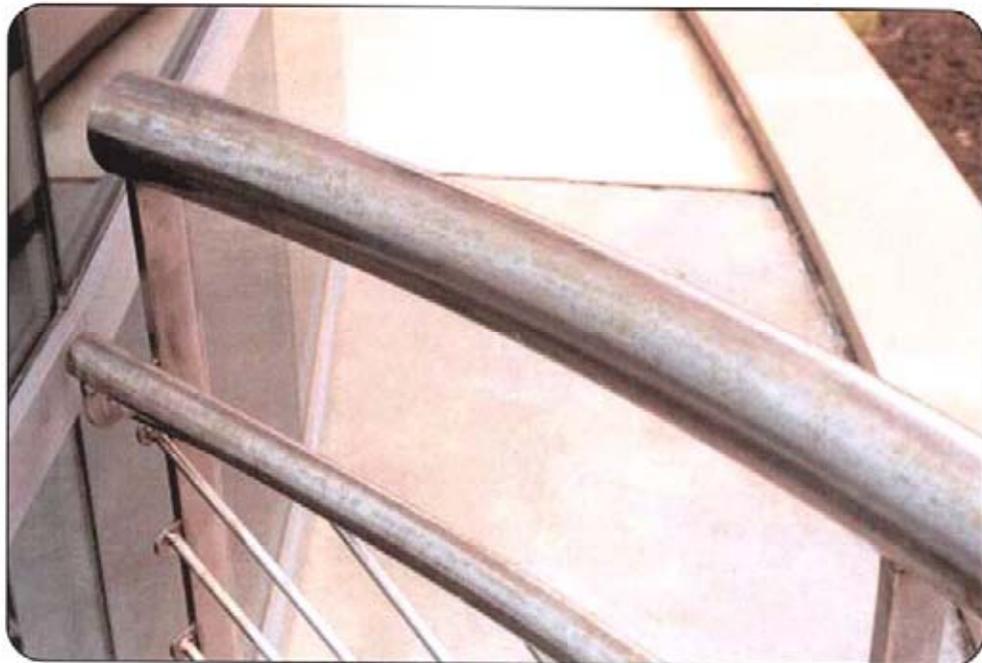
The deicing salt damage visible on this welded Type 304L railing occurred after only one winter in Pittsburgh, Pennsylvania. Although there was some deicing salt used on the parking lot and stairs, the primary source of salt is a busy highway several hundred feet downhill from the building. Salt-laden road mist was blown onto the railing by the

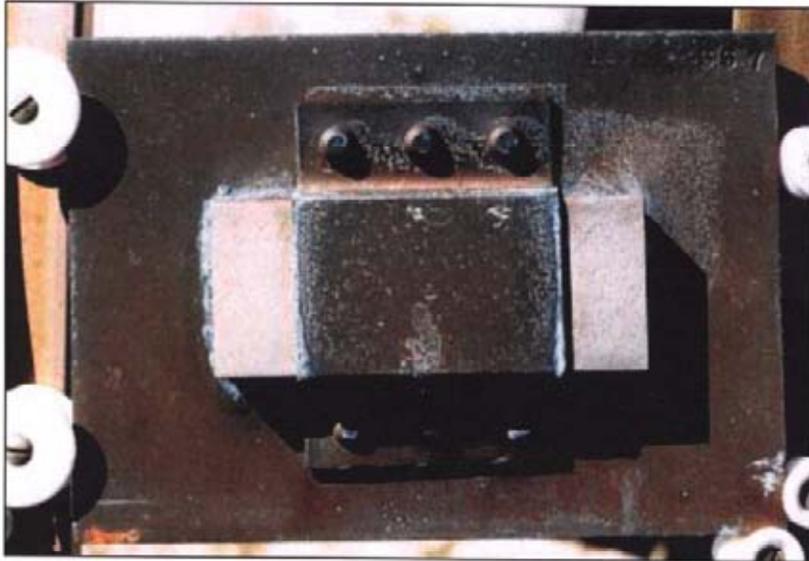
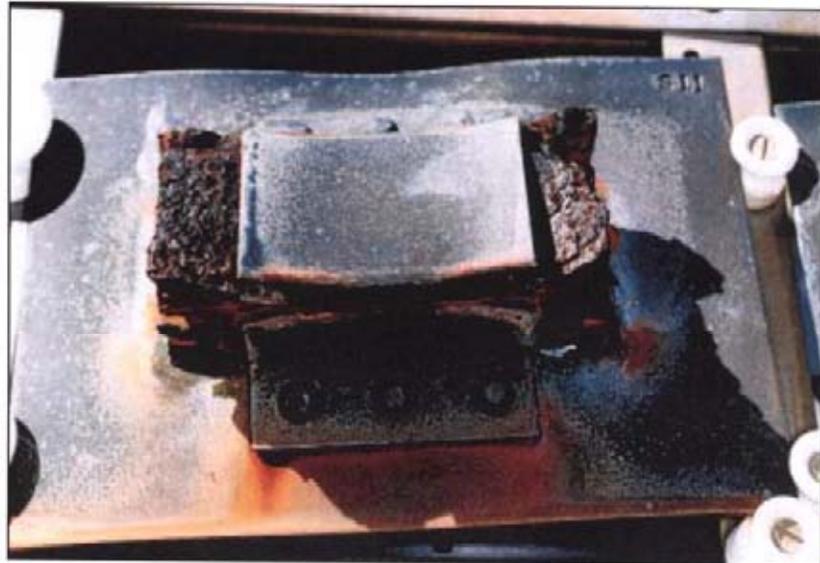
Type 316 stainless steel and copper combination is performing well.

The mild steel plate's corrosion product has expanded and broken the copper saddle.

The above Statue of Liberty corrosion demonstration panels have been in place since 1984. Type 316 and carbon steel plate samples were attached to copper sheets with a saddle which is riveted in place.

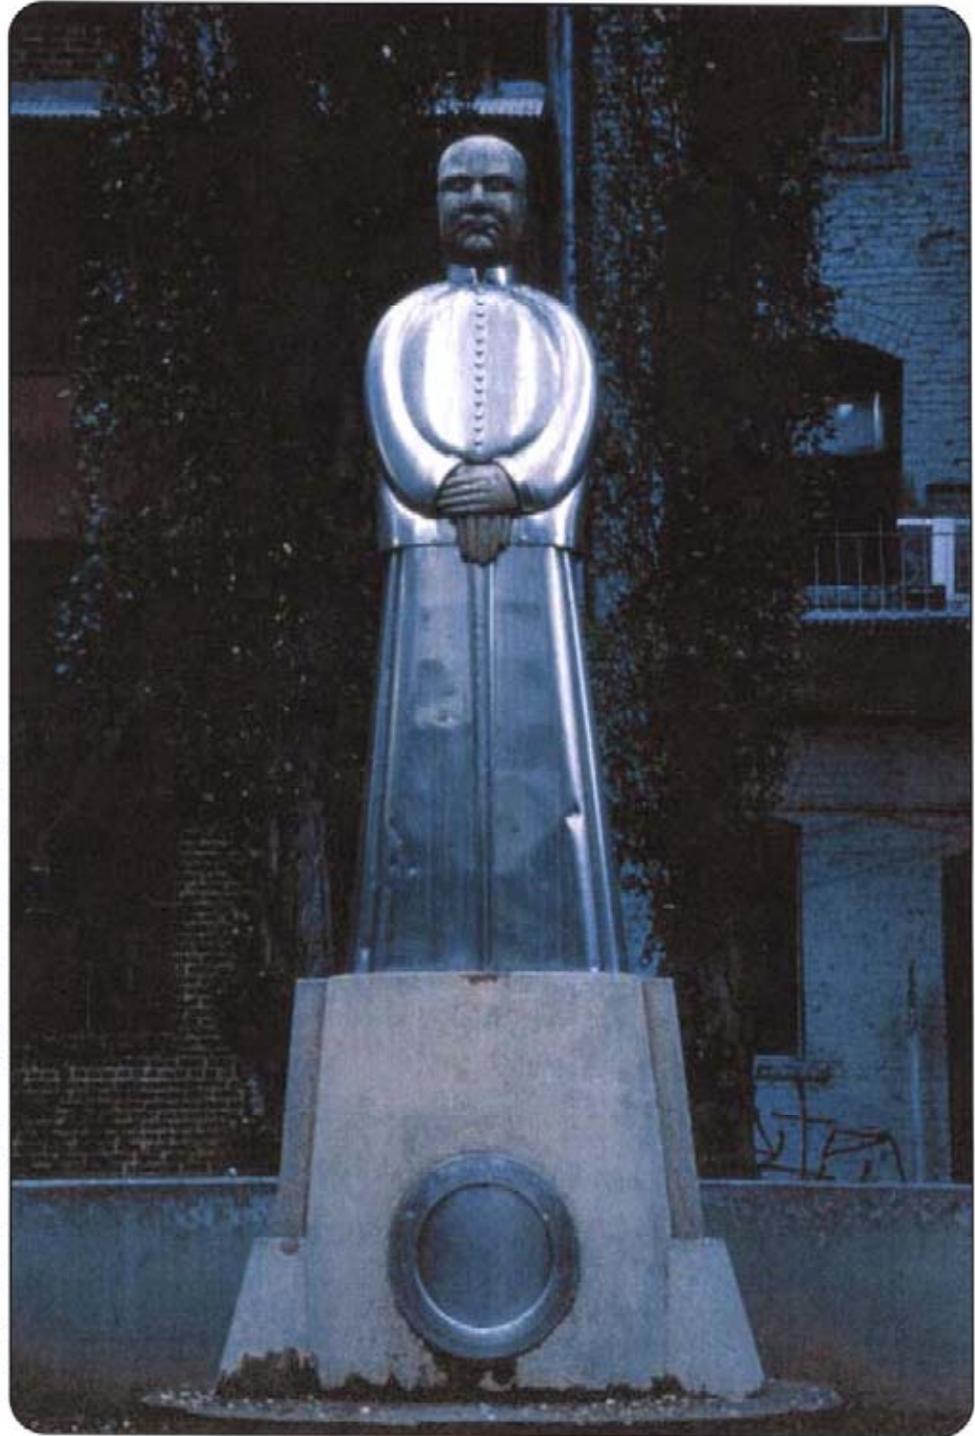
This infrequently cleaned statue of Sun Yat Sen (installed in the 1930s) in San Francisco's Chinatown combines stainless steel (body) and copper (hands and head). Moisture is only present for short periods of time. The two metals are in close proximity in the galvanic series and there is no sign of galvanic corrosion.
