SAND2009-1630

Pedestrian and Traffic Safety in Parking Lots at SNL/NM: Audit Background Report

This report supplements audit 2008-E-0009, conducted by the ES&H, Quality, Safeguards & Security Audits Department, 12870, during fall and winter of FY 2008. The study evaluates slips, trips and falls, the leading cause of reportable injuries at Sandia. In 2007, almost half of over 100 of such incidents occurred in parking lots. During the course of the audit, over 5000 observations were collected in 10 parking lots across SNL/NM. Based on benchmarks and trends of pedestrian behavior, the report proposes pedestrian-friendly features and attributes to improve pedestrian safety in parking lots. Less safe pedestrian behavior is associated with older parking lots lacking pedestrian-friendly features and attributes, like those for buildings 823, 887 and 811. Conversely, safer pedestrian behavior is associated with newer parking lots that have designated walkways, intra-lot walkways and sidewalks. Observations also revealed that motorists are in widespread noncompliance with parking lot speed limits and stop signs and markers.

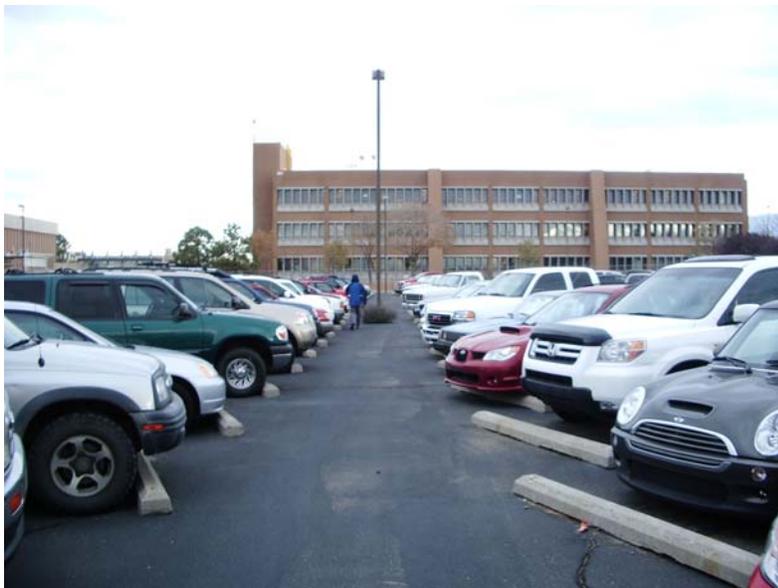
Figure 3: Example of pedestrians using natural spacing between bumpers as walkways, when the walkways are oriented in the direction of the pedestrian's shortest route to their destination.

Pedestrian-features recommended as a result of this study include intra-lot sidewalks and pathways, redesign of parking bumper spacing to allow room for designated walkways, encourage their use, and facilitating snow removal and ice remediation. Consideration should include alignment of parking aisles and crosswalks with the pedestrian's natural walking paths and destinations to encourage safety.

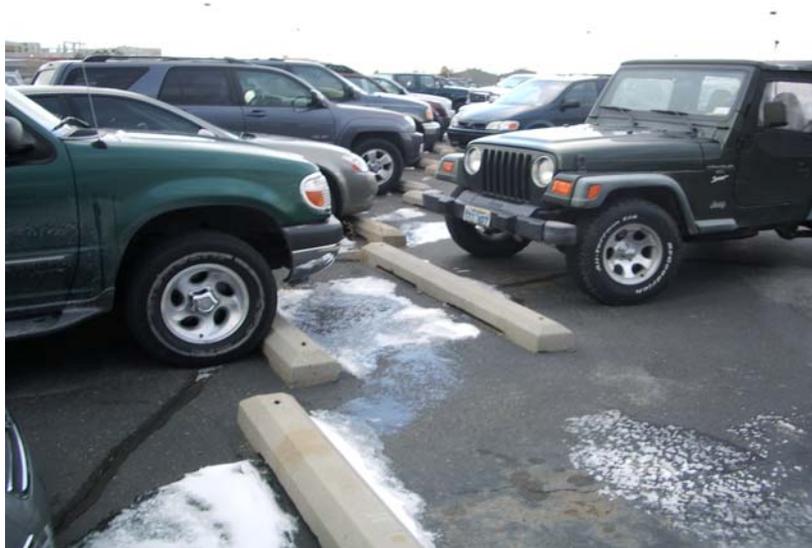
In the building 823/825 parking lot the following day, pedestrians again began to take diagonal paths across parking bumpers. Figure 4 shows how icy conditions persisted between the parking

Figure 4: Remaining snow and ice between parking bumpers following the snowstorm.

bumpers, probably a result of pedestrians walking between the parking bumpers on the previous day. Presumably, the probability for slipping would increase as pedestrians walked across the parking bumpers. Notably, there were no ice-related slips reported either day.

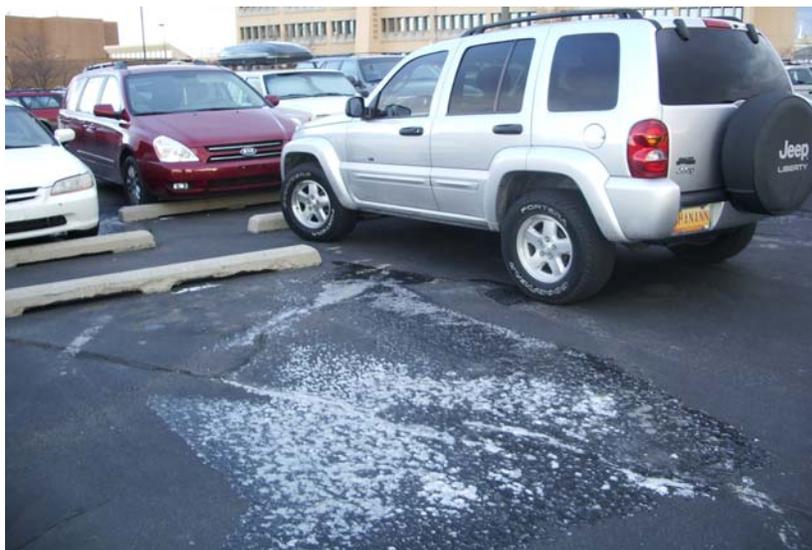
Figures 4 and show a common observation in the building 823, 898, 887 and 802/811 parking lots: ice not only remained between parking bumpers, but also where pedestrians exit their vehicles. We observed no evidence of sand or salt remediation for these areas. Arguably, applying salt may not be effective if the ice melts, since the water may not evaporate and refreezes over night, especially in an uneven parking lot that has no internal drainage features.

Figure 5: Remaining snow and ice on parking spaces one day following the weather event.

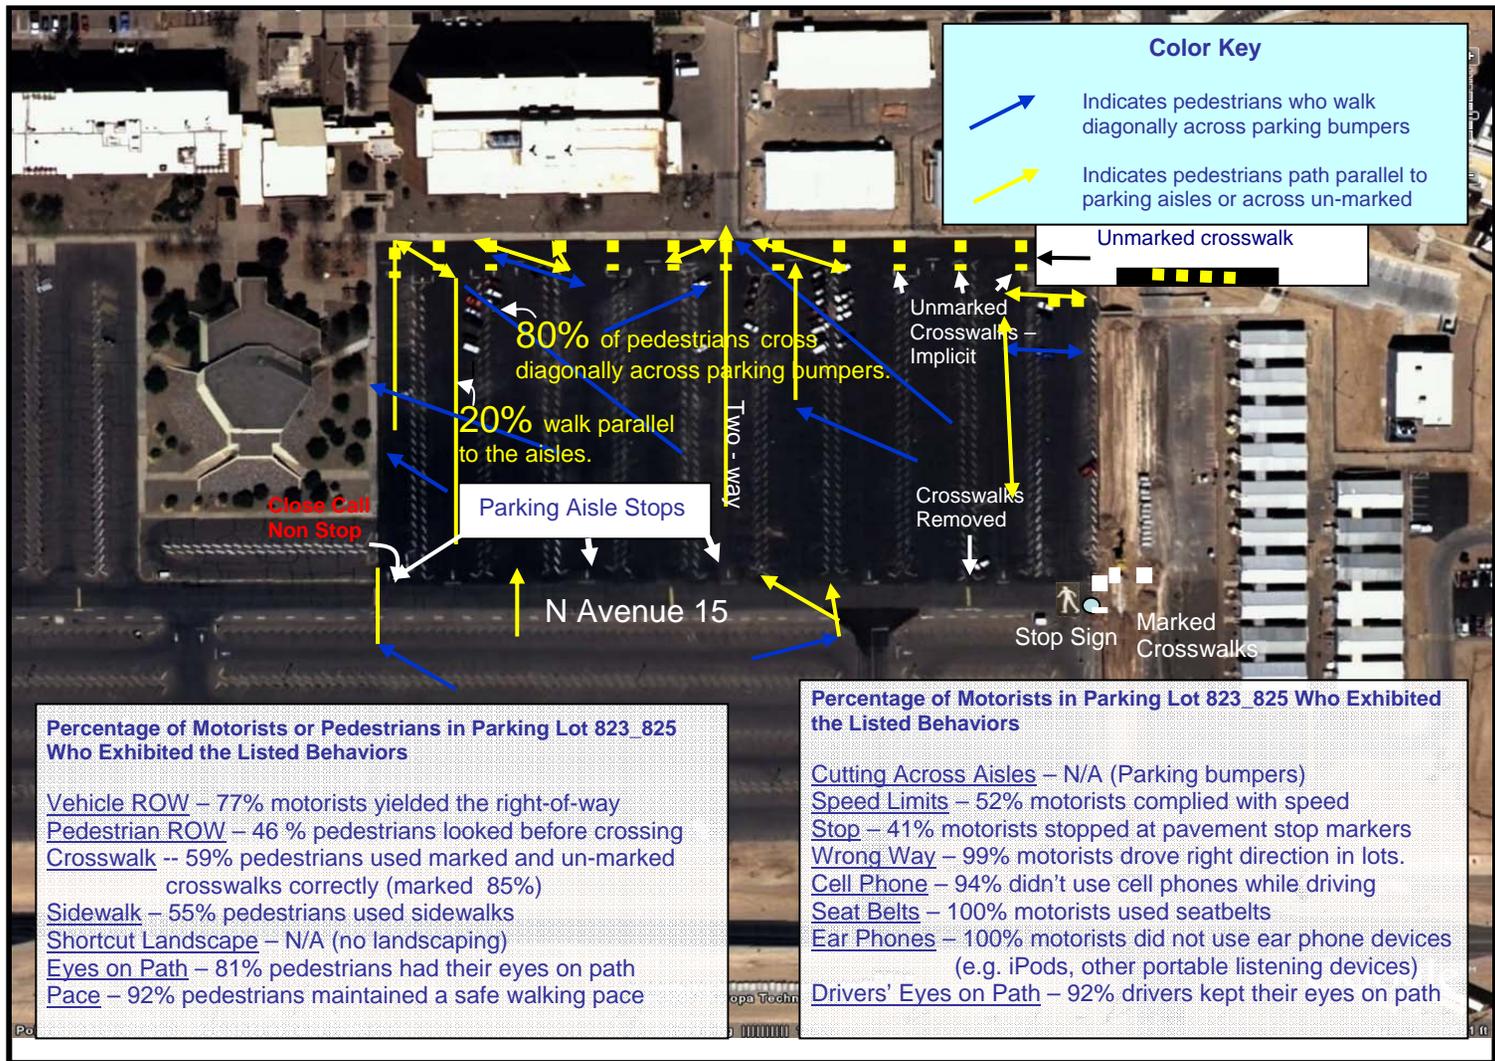
Three close calls were observed when motorists used rolling stops or otherwise failed to yield to other motorists. One close call occurred at the west end of the building 825 parking lot, at a stop marker on the end of a parking aisle that accesses N Avenue. A motorist rolling past that stop caused a west-bound motorist on N Avenue to break suddenly. The second close call involved a motorist exiting the east end of a parking lot 897 aisle (no stop marked on end). This motorist did not yield to another motorist entering the parking lot off 20th Street, and the action resulted in sudden braking. A third close call involved a motorist making a rolling stop at the exit of the 810 parking lot onto 7 Street. The locations of these close calls are marked (Appendix A, Diagrams A1, A4, and A6).

Diagram A1: The Building 823/825 parking lot layout includes no designated pedestrian walkways within the parking lot, no marked crosswalks, and parking aisles oriented so that 80% of pedestrians walk across parking bumpers.

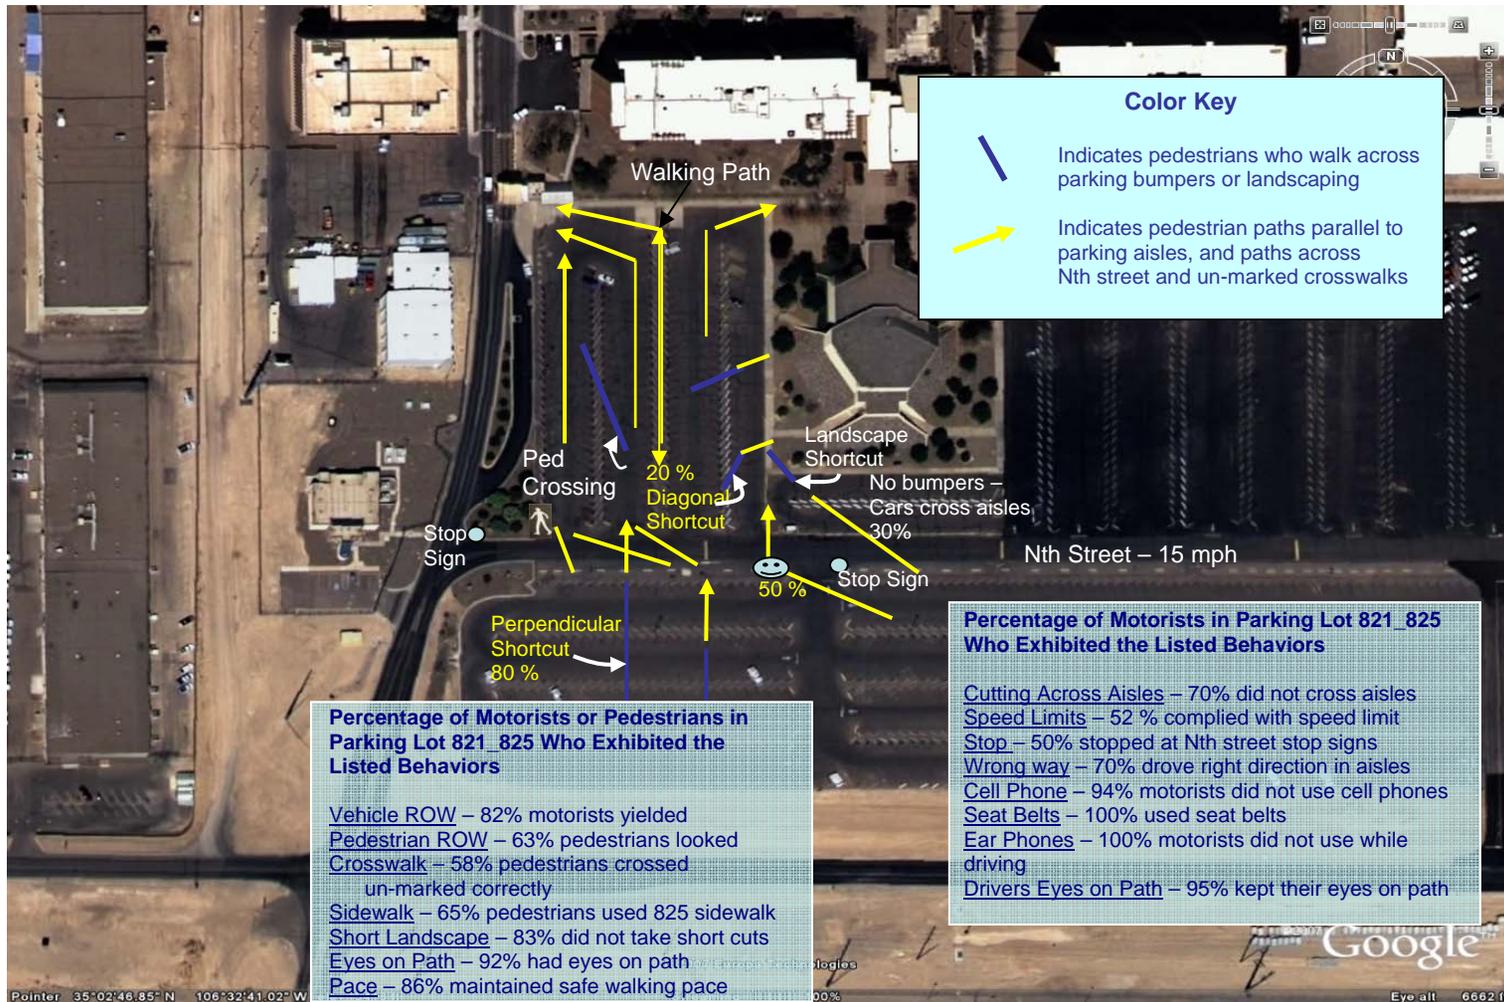
Diagram A2: The Building 823/825 parking lot layout is smaller and mostly aligned with destinations. Only 20% of pedestrians walk across parking bumpers in the northern lot. Pedestrians walk parallel to parking aisles and within a walkway between parking bumpers. Conversely, 80% of pedestrians cross the parking bumpers in the south lot, as pedestrians naturally take the shortest walking path. About half cross N Avenue correctly at the smiley face in line with the 825 sidewalk. The other half cross diagonally.

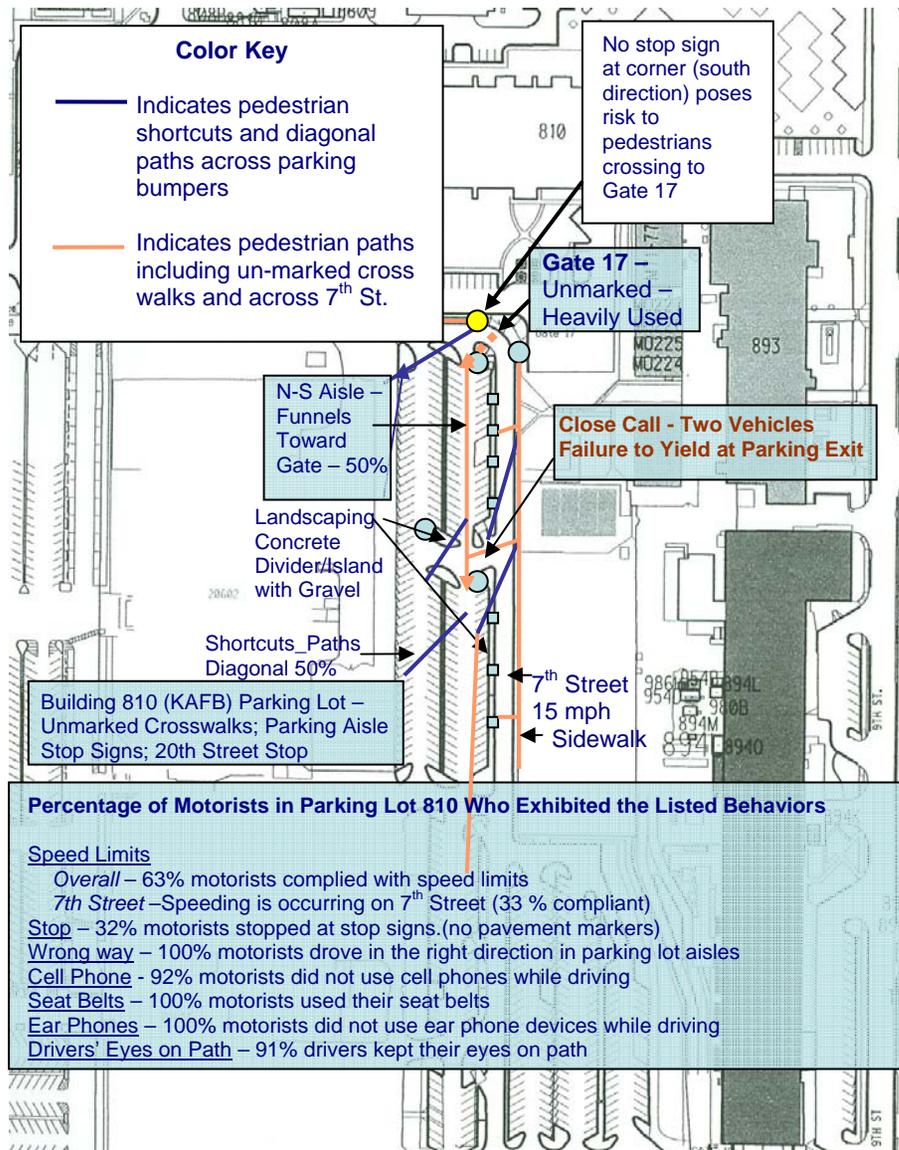
Another aligned unmarked crosswalk is a diagonal crossing point from the building 810 parking lot to Gate 17 (Appendix A, Diagram A4). Half the pedestrians observed took a shortcut across 7th Street to the sidewalk and didn't use the diagonal crossing. The other half of the pedestrians walked north along the north-south oriented parking aisles to the Gate 17 unmarked crossing. Pedestrian compliance measured 69% at this unmarked crossing, compared with 44 % crossing unmarked crossings across 7th Street (Appendix C, Table C3).

- The building 810 parking lot, which is a KAFB-maintained parking lot, has stop signs located at the ends of parking aisles. Like the other parking lots with longer aisle lengths, motorists routinely failed to stop at these stop signs. Combined with observations at the stop sign on 7th Street at Gate 17, the compliance rate was low (32% compliance).

Diagram A4: The Building 810 KAFB parking lot is small with parking aisles oriented in the direction of Gate 17.

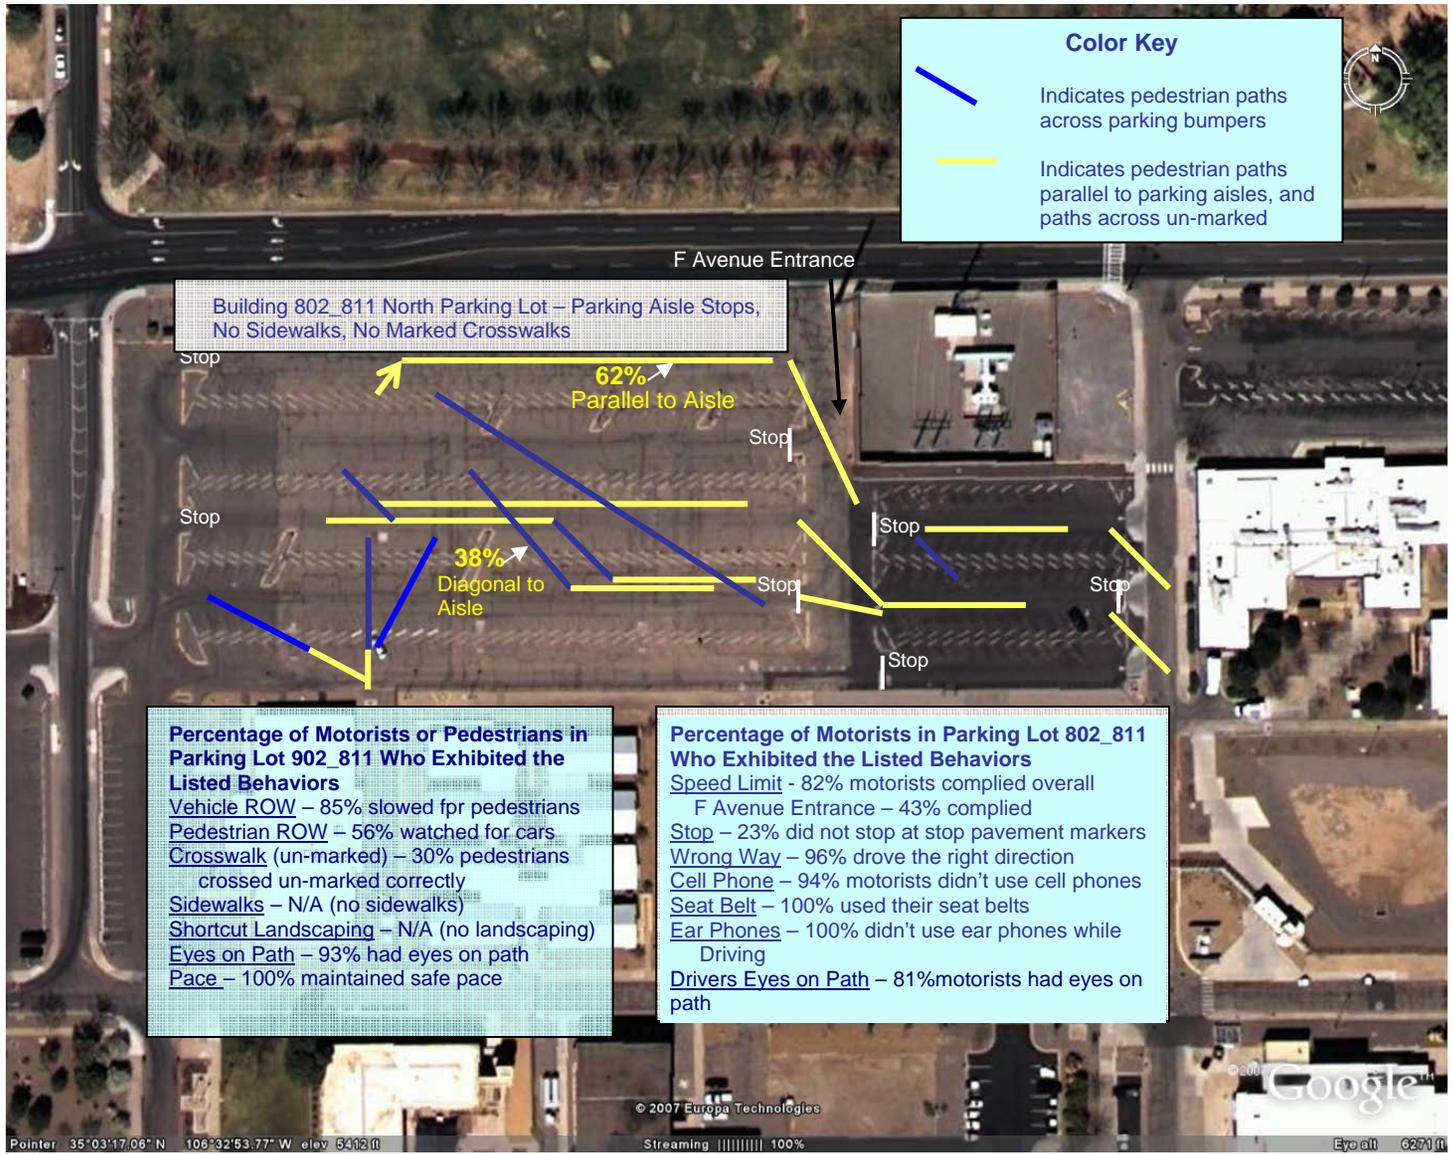
Diagram A5: The Building 802/811 parking lot, like the building 823/825 parking lot, includes no pedestrian walkways and no marked crosswalks. Pedestrians are more prone to walk across parking bumpers than newer parking lots with intralot walkways and sidewalks.

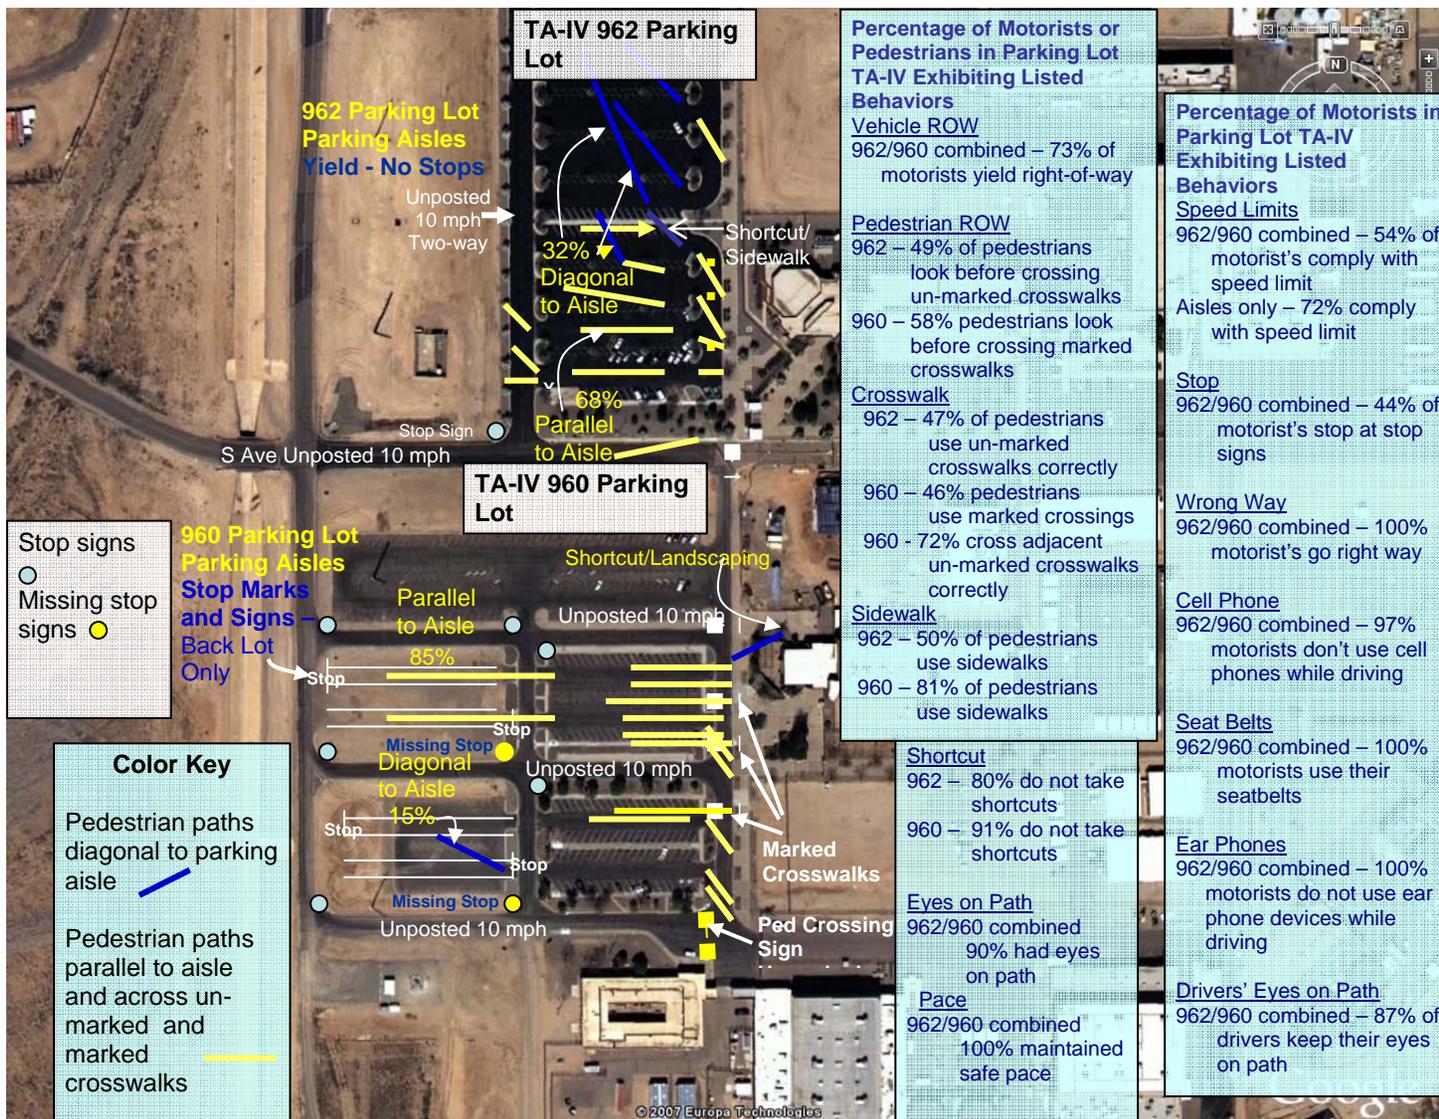
The presence of a marked crosswalk does not guarantee its use. Many pedestrians were observed walking diagonally, across the street, toward marked crosswalks. Pedestrians using the building 960 parking lot (Tech Area IV) did not use several aligned marked crosswalks, shown in parking lot diagram A7, Appendix A (46%). However, because of the alignment, over 70% of the pedestrians crossed adjacent unmarked crosswalks correctly. This is high compared to 47% in the unmarked crosswalk in the parking lot at building 962 (Appendix A, Diagram A7).

Diagram A7: The Building 962 and 960 parking lots are newer parking lot incorporating pedestrian friendly features. Aisle orientation affects differences between parking lot pedestrian paths taken between parking lots and destinations.
