SAND2011-1539

## **Report on Accelerated Corrosion Studies of Electrical Components**

S. Jill Glass, Curtis D. Mowry, and N. Robert Sorensen

Sandia National Laboratories (SNL) conducted accelerated atmospheric corrosion testing for the U.S. Consumer Product Safety Commission (CPSC) to help further the understanding of the development of corrosion products on conductor materials in household electrical components exposed to environmental conditions representative of homes constructed with problem drywall. The conditions of the accelerated testing were chosen to produce corrosion product growth that would be consistent with long-term exposure to environments containing humidity and parts per billion (ppb) levels of hydrogen sulfide ( $H_2S$ ) that are thought to have been the source of corrosion in electrical components from affected homes. This report documents the test set-up, monitoring of electrical performance of powered electrical components during the exposure, and the materials characterization conducted on wires, screws, and contact plates from selected electrical components. No degradation in electrical performance (measured via voltage drop) was measured during the cour

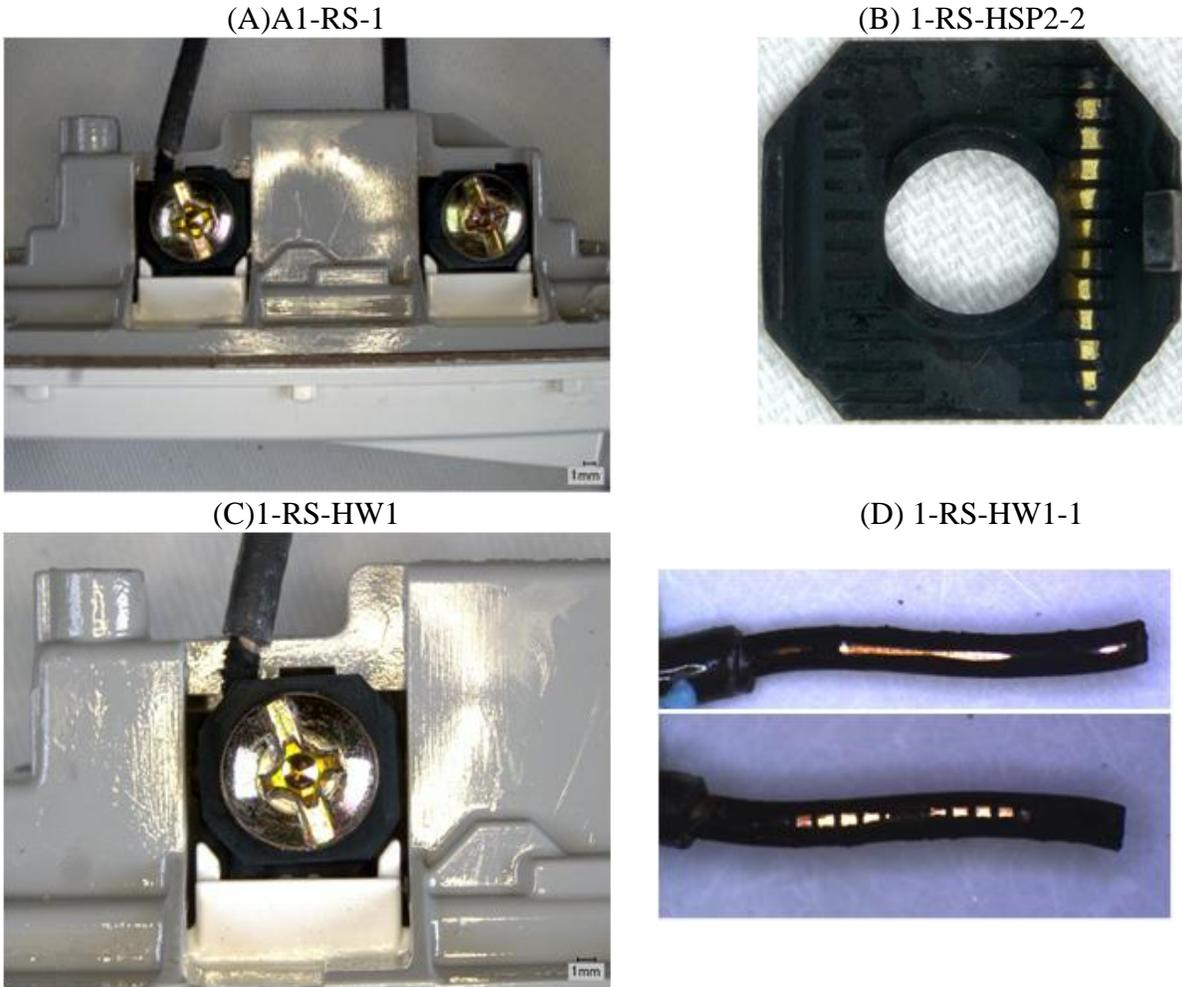
Figure 11 shows macro images for the rocker switch. The image in (A) shows one set of electrical connections to the switch. The image in (B) is of the contact plate under one of the screws. The image in (C) shows a close-up of one of the connections, and (D) shows both sides of the hot wire that was connected to the switch. The black color of the metal parts is the result of the sulfidation process. The contact plate is tarnished completely. Importantly, a row of shiny contact points is visible where the wire contacted the plate. There is a corresponding set of similar features on the wire, where the wire was in intimate contact with the screw. Note that bare metal is visible, indicating that the interface was shielded from the active species in the gas. The screws exhibit less attack. The wire shows considerable corrosion, with “furry” growth observed next to the insulation. Additionally, there is a band of bare metal adjacent to the insulation that appears to have suffered less attack. That is likely the result of slight movement of the wire, exposing fresh surface that had been protected previously by the insulation. This does point out the fact that the insulation shields the underlying metal from exposure to the gas. However, it is also important to note that this accelerated test is designed for boldly exposed metals. It is not designed to accelerate transport of aggressive species through the insulation. Thus, it does not represent 40 years relative to sulfide diffusion and cannot be used to assess the ability of the insulation to protect the wire over a 40-year life.

Figure 11. Optical images from sample 1-RS (rocker switch). The contact plate is shown in B, and one of the hot wires is shown in D (both sides of the same wire are shown). Note the presence of extensive corrosion product on the copper hot wire and contact plate.

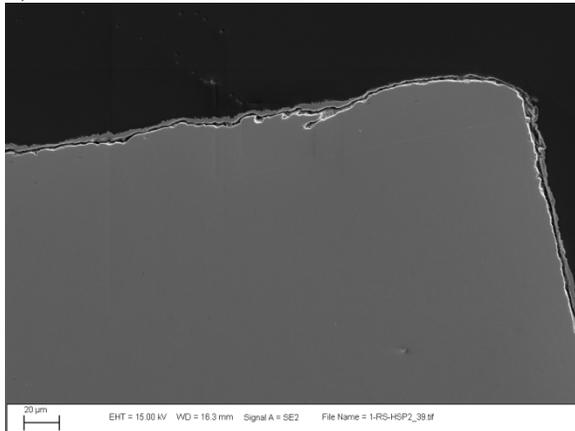
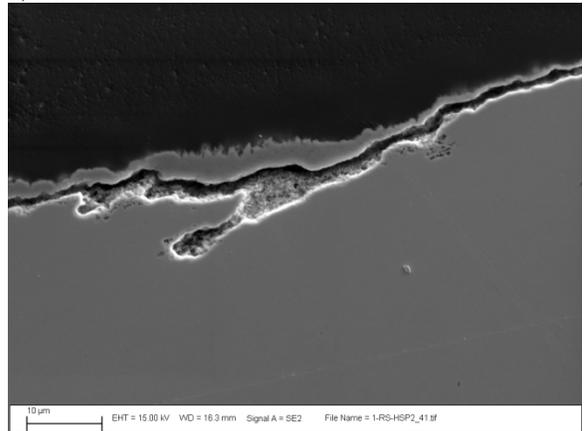
Figure 12. SEM cross section of the hot screw plate (HSP2) from the rocker switch in Circuit No. 1.

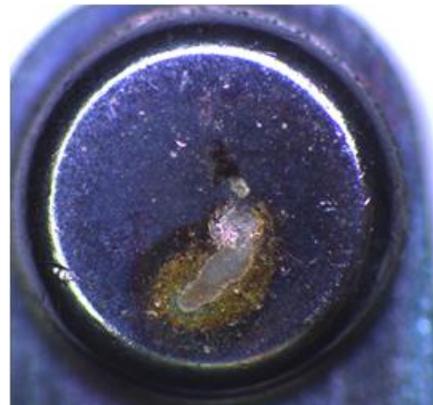
Figure 17. Photos of inside of GFCI receptacle from Circuit 1.

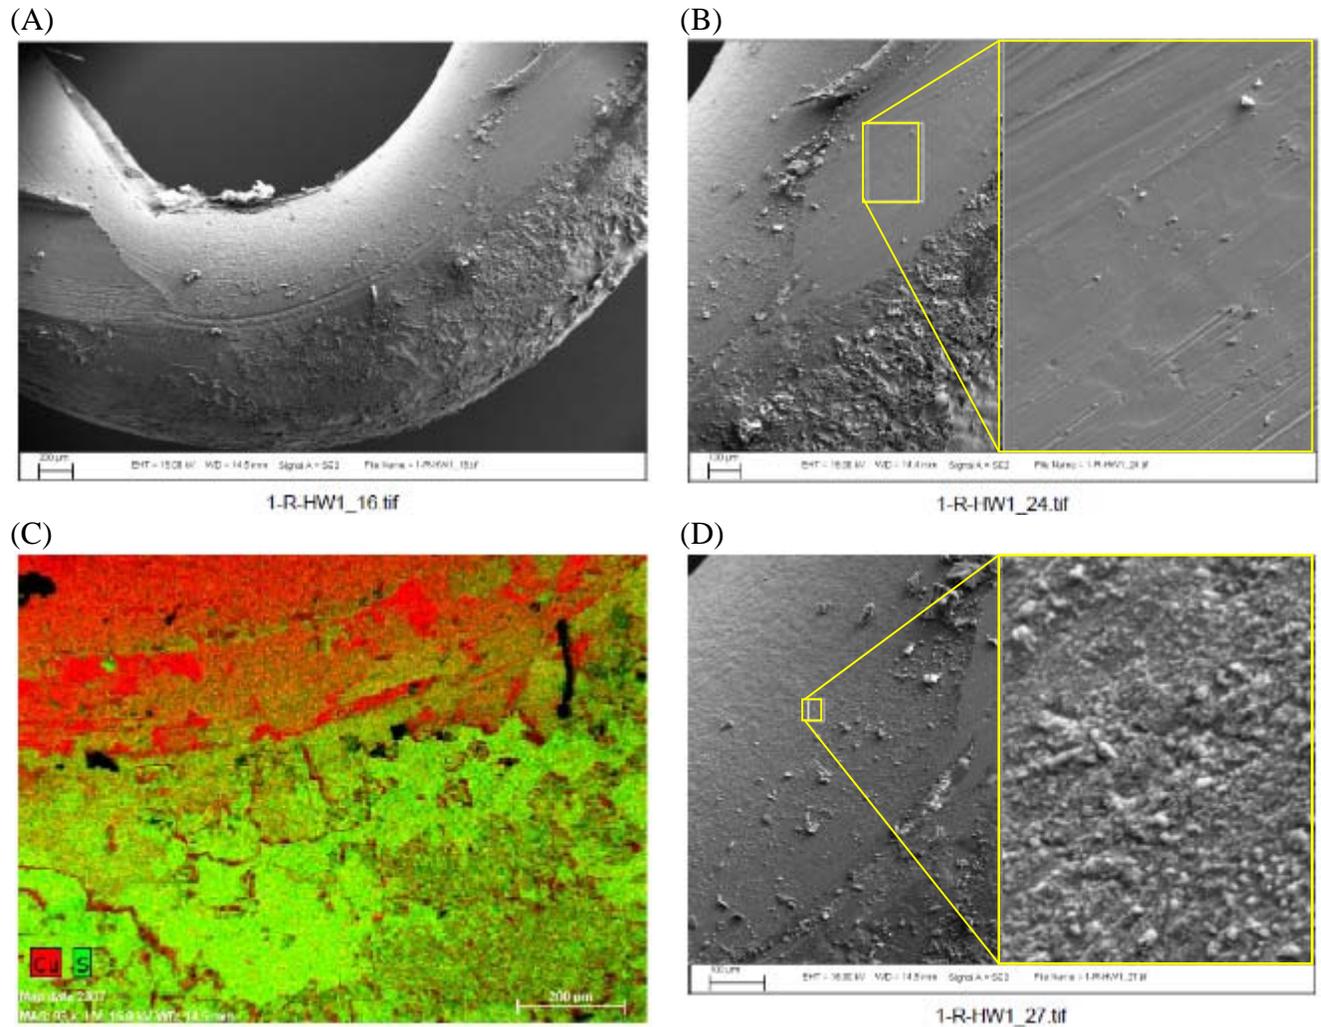
SEM analyses of the hot wire are shown in Figure 21. The location of these analyses is the bend in the wire. Note that the corrosion is significantly more extensive on the outside of the bend. The elemental maps clearly show the difference in corrosion product thickness, clearly a result of shielding the inner portion of the bend from the corrosive gasses.

Figure 21. SEM image (A) of hot wire 1-R-HW1; (B) SEM image of screw contact surface with zoomed area (top right); (C) EDS elemental map showing copper (red) and sulfur (green) distribution; and (D) SEM image ~300 μm from contact (all with 100 μm measurement bars).

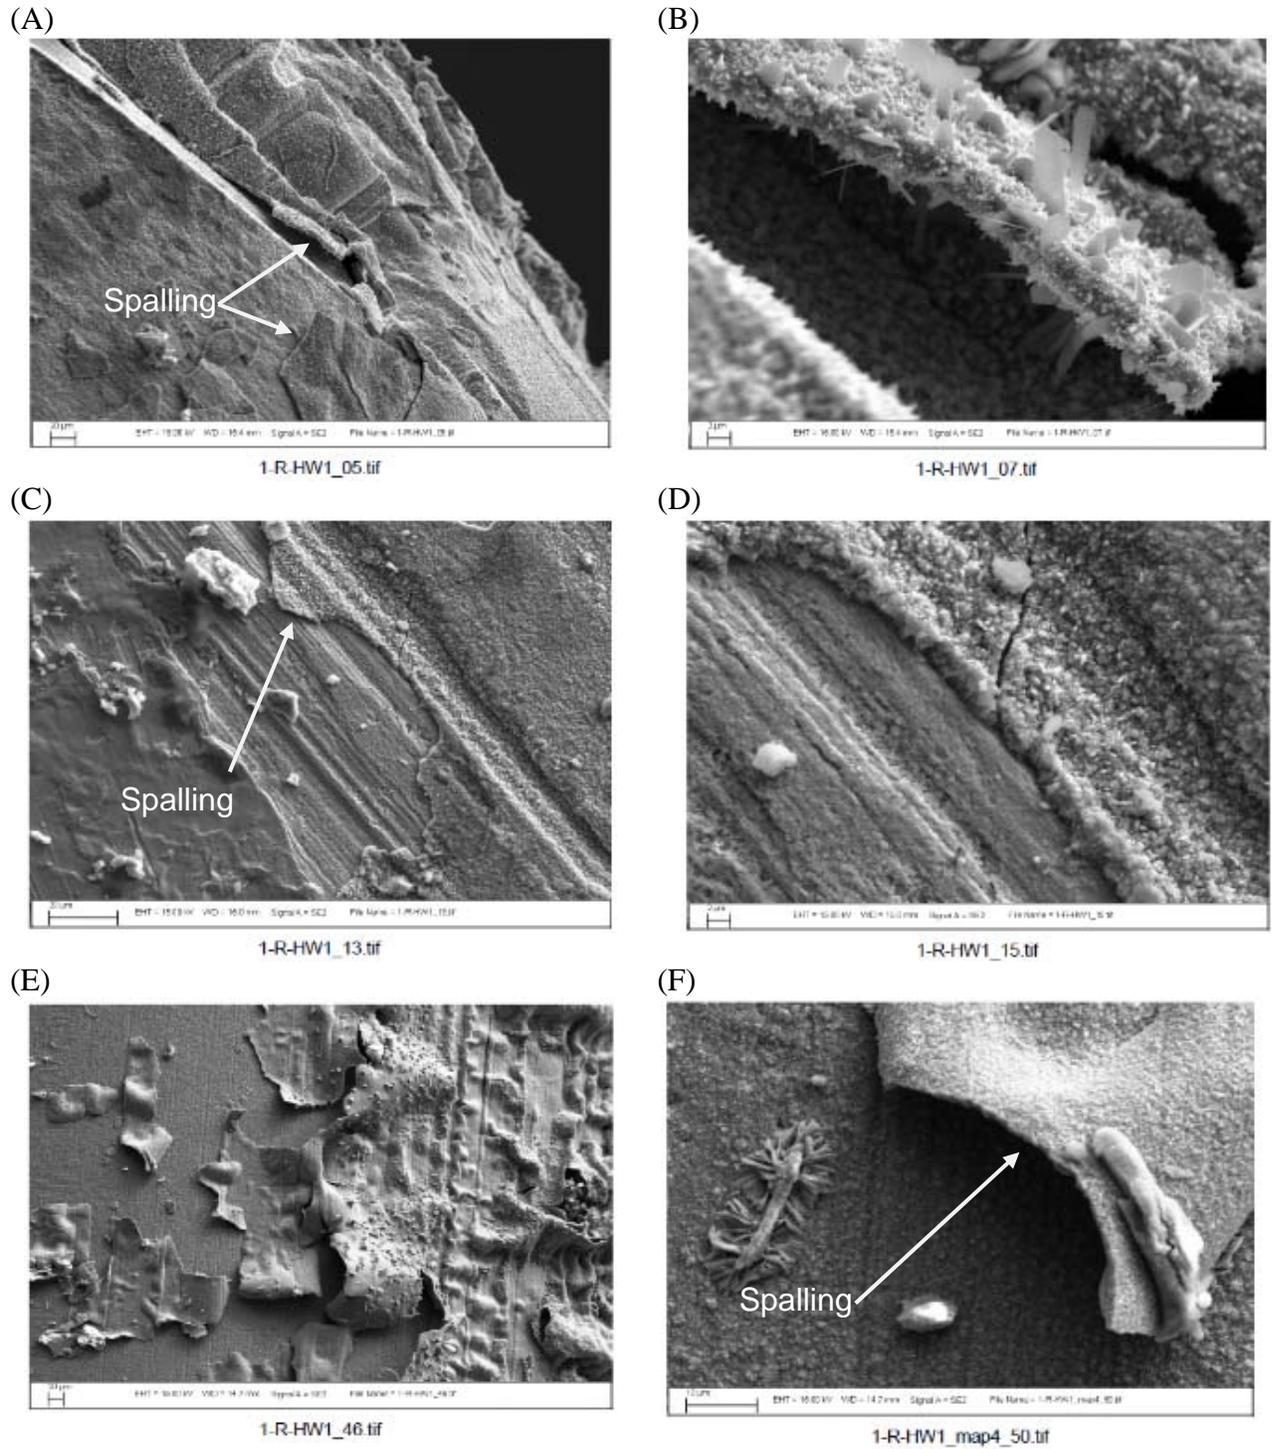
Figure 22 presents SEM images from various locations on the hot wire. Several corrosion product morphologies can be seen. In addition, there is evidence of spalling of the film. Once the film ruptures, it reforms below the previous layer.

Figure 22. SEM images showing the different morphologies of corrosion products on the hot wire from the receptacle in Circuit 1.

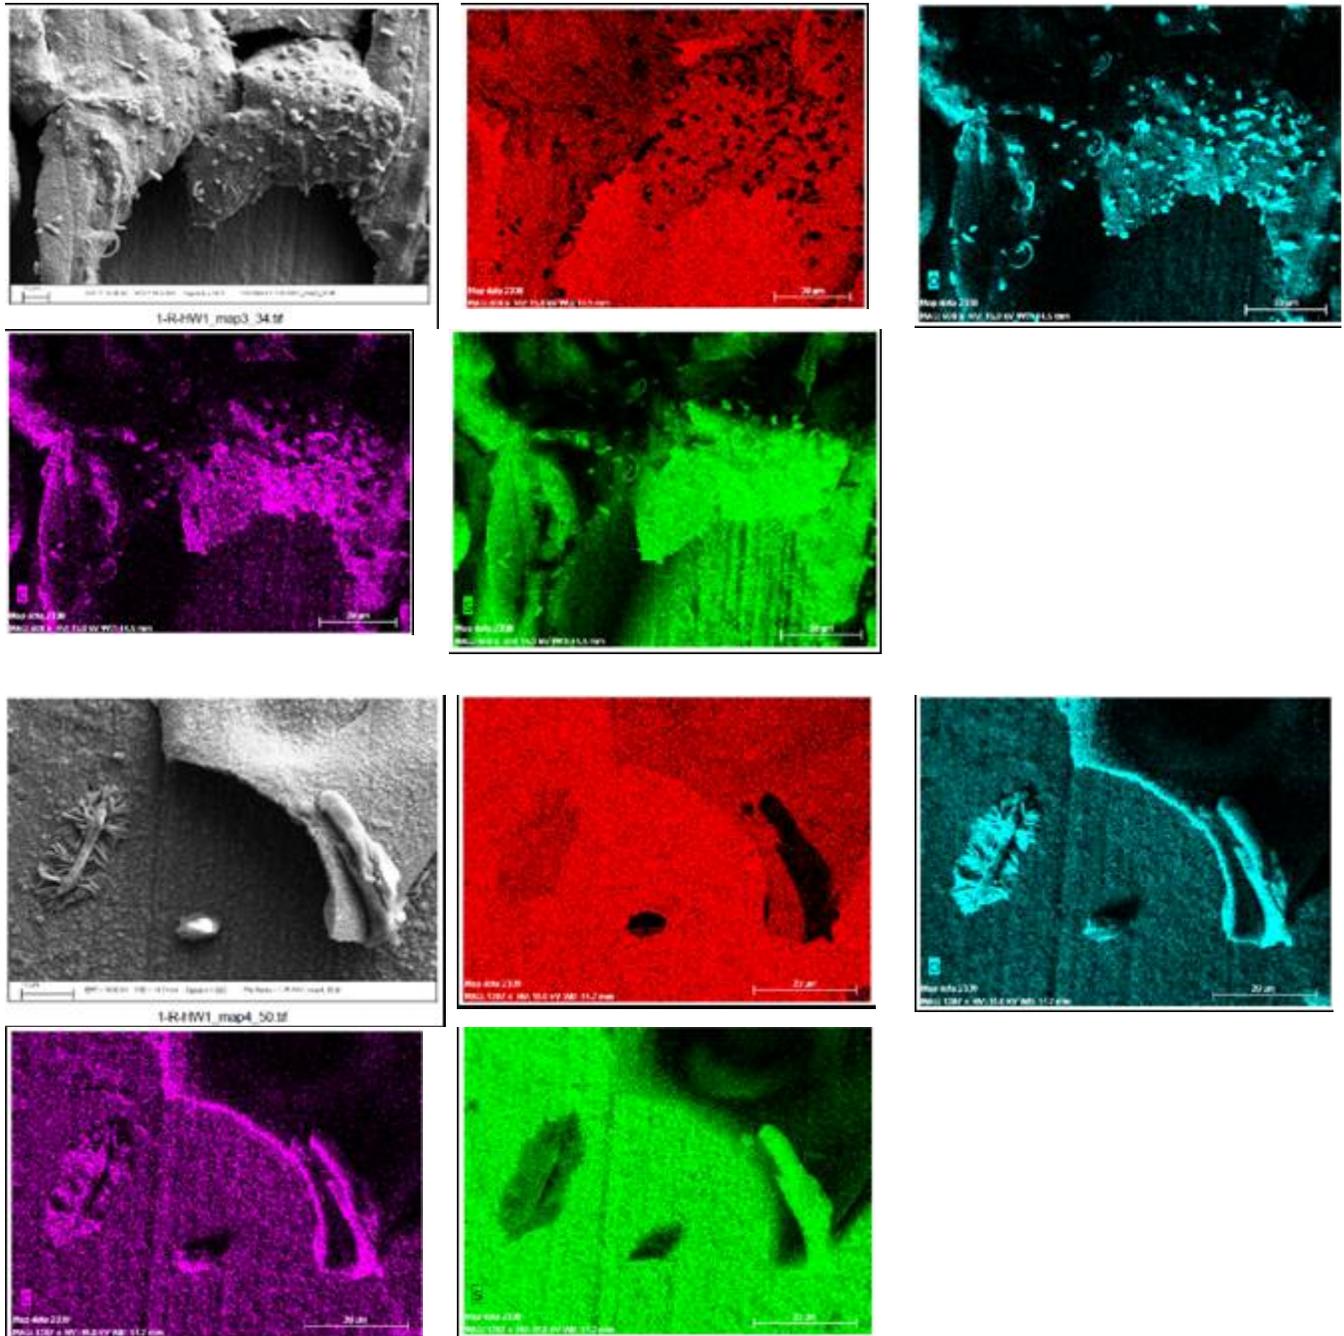
In addition to differences in film morphology across the surface, there is also evidence of differences in film composition. An example is shown in Figure 23. Clearly, certain features are oxygen rich, while others are sulfur-rich. The oxygen-rich features are on the outer surface of the film, and are likely due to oxidation of the surface of the copper sulfide.

Figure 23. SEM images and elemental maps for two areas on wire 1-R-HW-1, showing copper (red), oxygen (blue), carbon (purple), and sulfur (green) distributions.

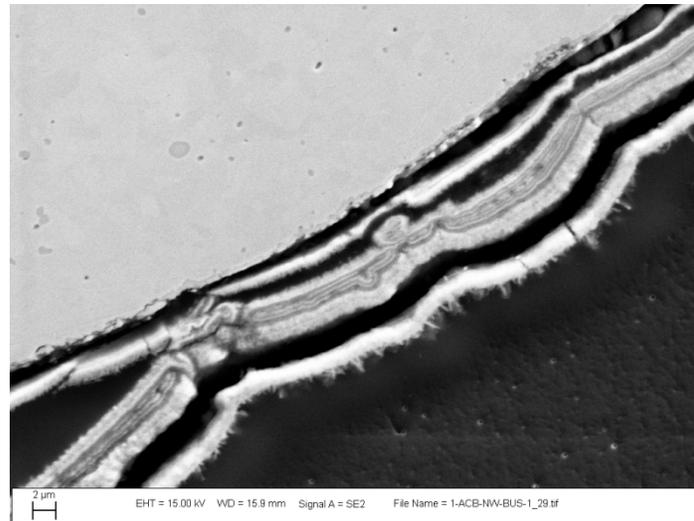
Figure 25 presents SEM images of the cross section of the neutral wire. A multilayered structure is observed. There is little or no adhesion between some of the layers, suggesting that spalling and/or delamination of the individual layers occurred during the corrosion process.

Figure 25. SEM image of the cross section of the neutral wire from the arc-fault circuit breaker from Circuit 1.

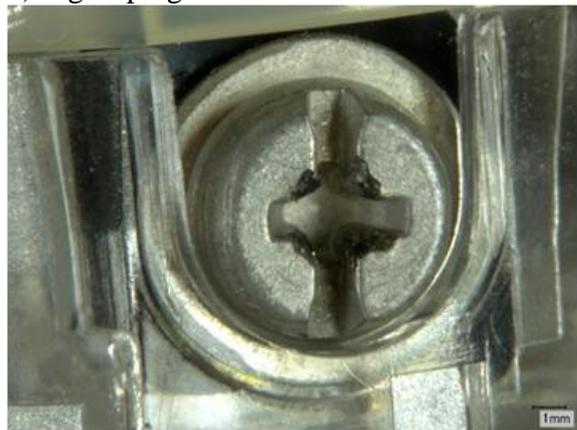
Figure 30. Optical images of the plug used to connect the standard receptacle to the GFCI receptacle in Circuit 1. The prongs and screws are blackened relative to those on a new, as-received, unexposed plug.

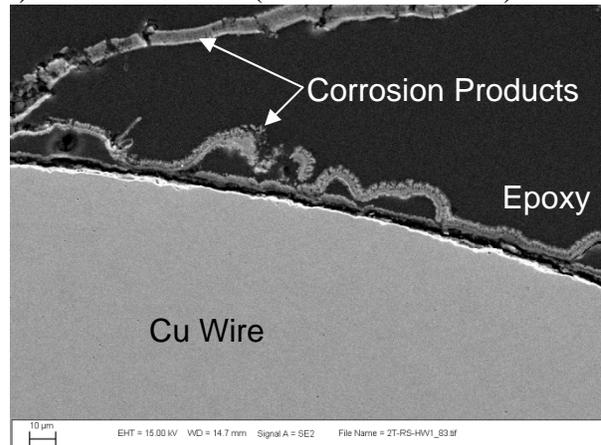
Figure 36. SEM images of the cross section of the rocker switch hot wire from Circuit 2. The image on the left shows a low magnification image of the wire, with a high magnification image showing details of the corrosion product layer presented in the figure on the right.

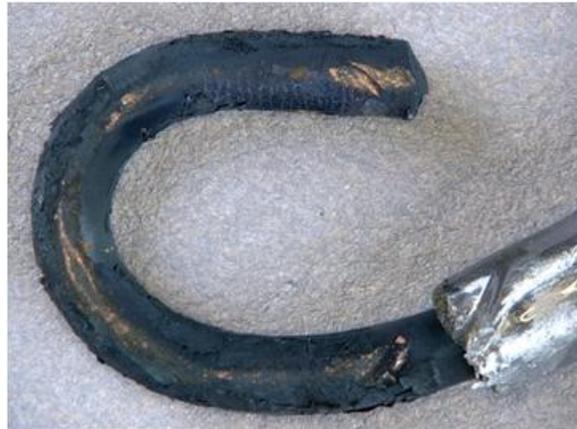
Figure 43. Optical images of the toggle switch in Circuit 3. The figure on the left shows the inside of the switch. Note the extensive corrosion product on some of the components. The image on the right is of the hot wire connected to the toggle switch (screw side).

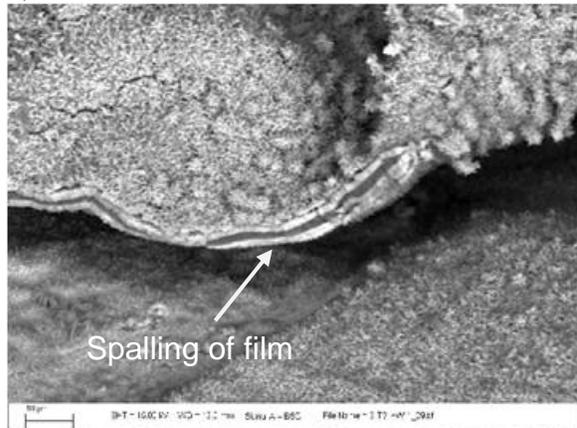
Figure 44. SEM images of the hot wire from the toggle switch in Circuit 3. Note the spalling of the corrosion product film. The contact areas can be seen in the upper two images (bright areas) where the contact shielded the surface from the corrosive gasses.

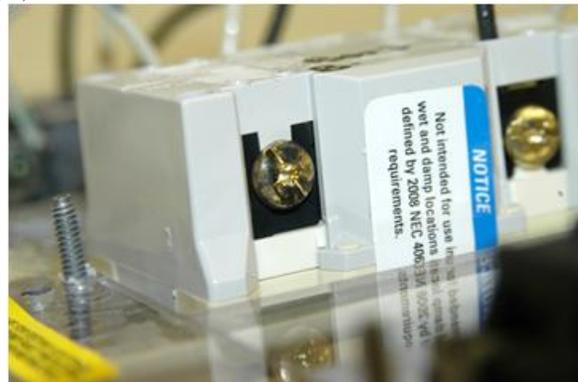
Figure 52. Optical images of the GFCI receptacle. Note the darkening of the normally shiny contact pads and slight corrosion (discoloration) of the screws.

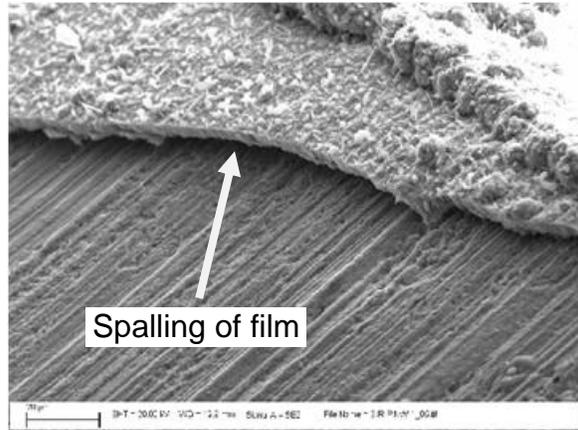
Figure 54. SEM images of the surface of the neutral wire from the receptacle in Circuit 3. The connection was a push-in connection. (B) shows the contact point, which is brighter due to the presence of Cu without S. The end of the wire is shown in the lower images at two magnifications. Note the spalling of the corrosion product film. It is believed that the spalling occurred during the test, but is it possible that it occurred after exposure and prior to analysis.

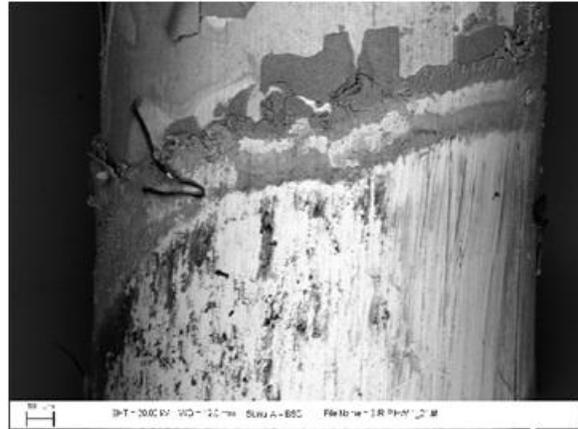
Figure 59. SEM images of the hot wire from the receptacle in Circuit 3. The connection was a push-in connection. The contact point is shown in the image on the left. The image on the right shows a region of a hot wire that was covered by insulation on the bottom.
