SAND2012-5170
Unlimited Release
Printed June 2012

Investigation of the Hydrogen Release Incident at the AC Transit Emeryville Facility

This report summarizes the investigation of the release of approximately 300kg of hydrogen at the AC Transit Facility in Emeryville, CA. The hydrogen release was avoidable in both the root cause and contributing factors. The report highlights the need for communication in all phases of project planning and implementation. Apart from the failed valve, the hydrogen system functioned as designed, venting the hydrogen gas a safe distance above surrounding structures and keeping the subsequent fire away from personnel and equipment. The Emeryville Fire Department responded appropriately given the information provided to the Incident Commander. No injuries or fatalities resulted from the incident.

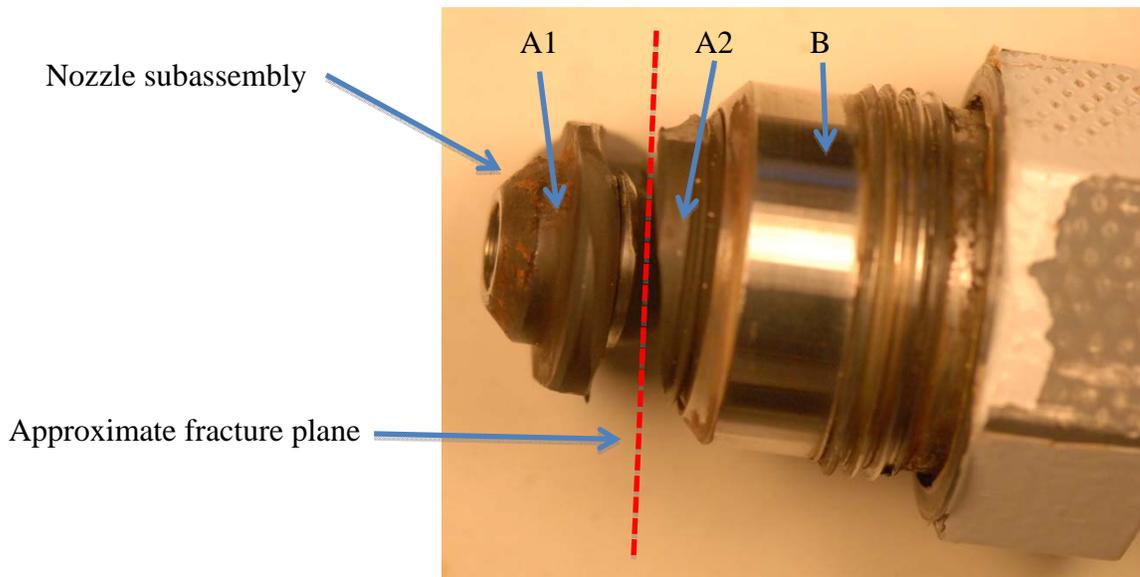
The pressure relief valve was removed from the system and taken to a local valve repair shop. Upon disassembly of the failed pressure relief valve, it was determined that the nozzle subassembly had failed as shown in Figure A1. After this preliminary examination, the pressure relief valve components were sealed in plastic bags and transferred to Linde Corporation's Richmond CA facility for storage.

Figure A1. Failure of nozzle subassembly (A); nozzle subassembly is threaded into the inlet base (B).

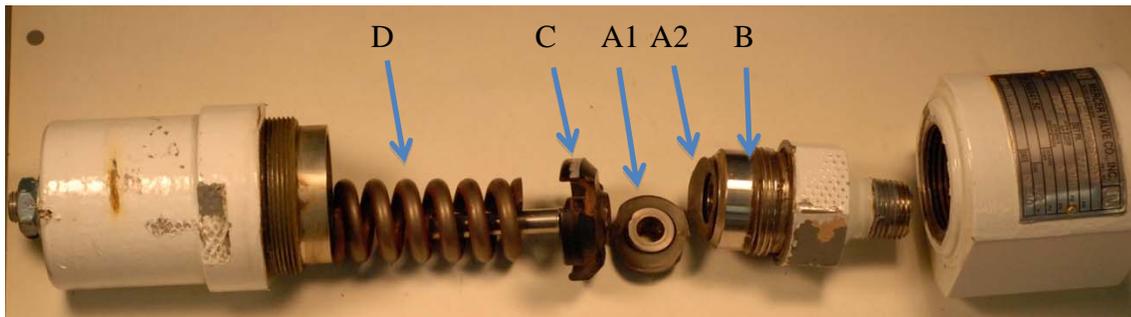
Figure A2 shows the internal components of the pressure relief valve: the two broken pieces of the nozzle subassembly (marked A1 and A2), the inlet base (marked B), the disk subassembly (marked C), and the set spring (marked D). The representative from Mercer Valve at the May 29th meeting identified the materials of construction of these pieces: the nozzle (A1 and A2) is 440C martensitic stainless steel; the inlet base (B) is 316 austenitic stainless steel; the disk subassembly (C) consists of a nose piece from 440C martensitic stainless steel, centering guide of 6061 aluminum, and shaft; and the set spring (D) is 17-7PH semi-austenitic stainless steel.

Figure A2. pressure relief valve components: failed nozzle subassembly (A1 and A2); inlet base (B); disk subassembly (C); set spring (D).

Details of the construction and function of the nozzle subassembly (the failed part) were not discussed at the May 29th meeting. The nozzle subassembly (A1 and A2) consists of several components. The nozzle housing or body is the piece that failed and is designed from type 440C

- 1) Replace pressure relief valves with devices specifically designed for hydrogen service
 - a) A pressure relief valve component material exists in the manufacturer's catalog that replaces type 440-C with type 316 stainless steel. Type 316 austenitic stainless steel is used extensively in gaseous hydrogen systems.

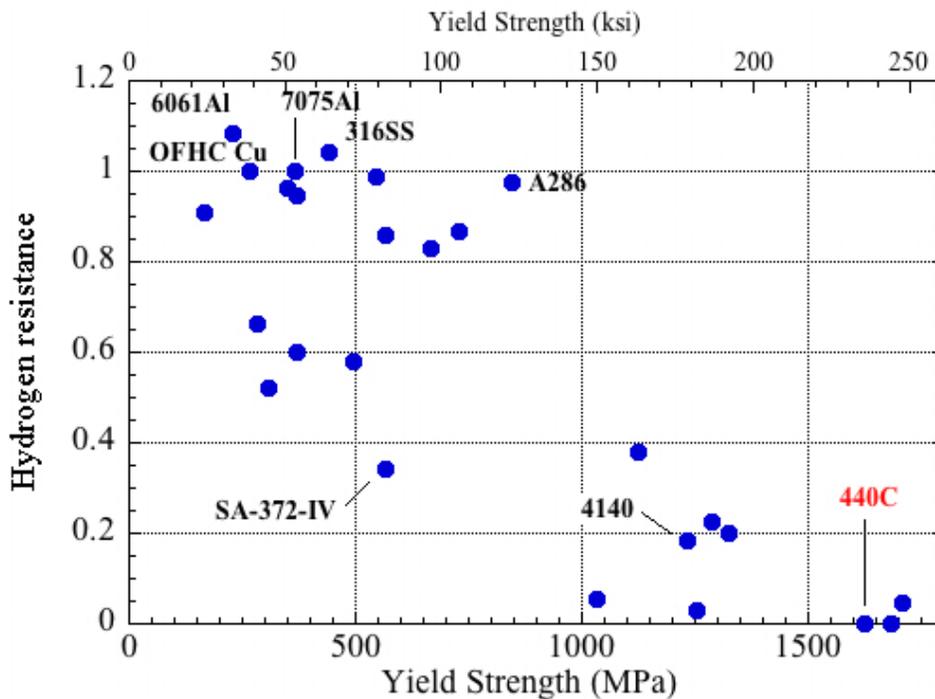
Many of the general trends of gaseous hydrogen embrittlement are embodied in Figure A3. This plot shows hydrogen resistance as a function of strength for a wide range of structural metals; a value of one indicates no measurable effect of gaseous hydrogen, while a value of zero indicates severe effects of hydrogen and implies brittle fracture. The alloys with high resistance to hydrogen embrittlement include relatively low-strength alloys such as austenitic stainless steels, aluminum, and copper. Materials with low resistance to hydrogen embrittlement include alloys in high-strength conditions.

Figure A3. Hydrogen susceptibility as a function of yield strength for a range of structural alloys. The susceptibility is the ratio of reduction of area in a tensile test measured in gaseous hydrogen at pressure of 69 MPa relative to measurement in helium at the same pressure. All data from Reference [1].

- Type 440C martensitic stainless steel is a poor choice of structural material for hydrogen service. Comparison with literature data (Figure A3) demonstrates that generally metals with yield strength >1000 MPa are severely embrittled by exposure to gaseous hydrogen, the yields strength of type 440C is significantly greater.
- Fractography suggests environmental-assisted fracture.
- Possible contributing factors:
 - The hardness of the failed nozzle was substantially higher than the hardness of the functioning nozzle. The discrepancy in measured hardness suggests that the failed nozzle was not properly heat treated, since the hardness of the failed nozzle is substantially greater than another nozzle from the same installation.
 - External damage was observed on the failed nozzle, but not on the functioning nozzle.

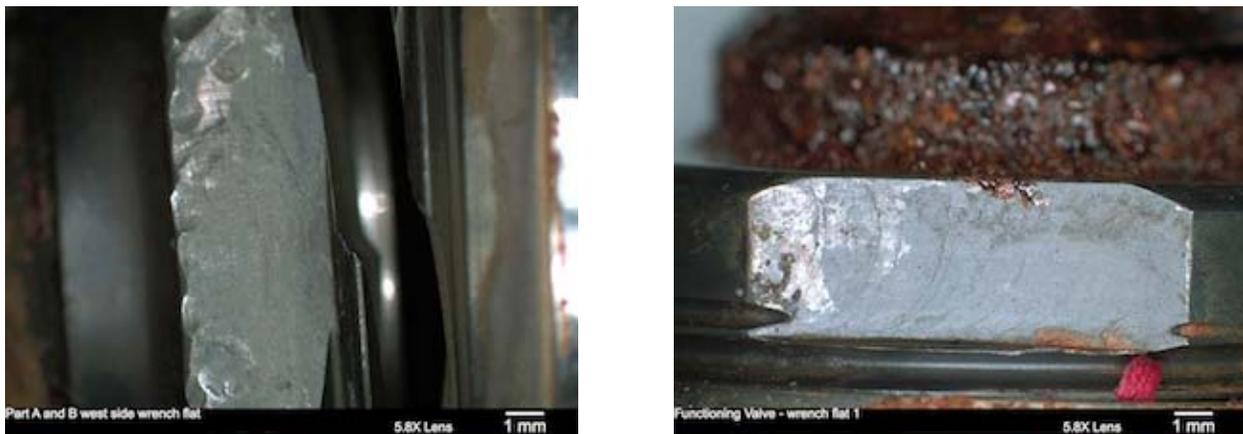
Visual inspection shows that the nozzle failed across its largest diameter, in the vicinity of the wrench flats on the nozzle (which are used for inserting the nozzle subassembly into the base inlet). The basic dimensions of the part appear consistent with the functioning part. After sectioning part B1, the thread roots of sections A2-1 and A2-2 were carefully examined with a stereomicroscope. Evidence of secondary cracking at the thread root and machining “corners” could not be found. Inspection of the wrench flats, however, showed evidence of external damage (Figure A4a), presumably due to assembly. The polished cross sections suggest that the macroscopic crack can be associated with the internal corner in the nozzle as shown in Figure A5.

Similar inspection of the nozzle from the functioning pressure relief valve was also performed. There was no evidence of damage on this part, including undamaged wrench flats (Figure A4b).

Figure A4. Wrench flats on the (a) failed nozzle and (b) the functioning nozzle. Significant external damage is apparent the failed nozzle, while no damage is observed on functioning nozzle.

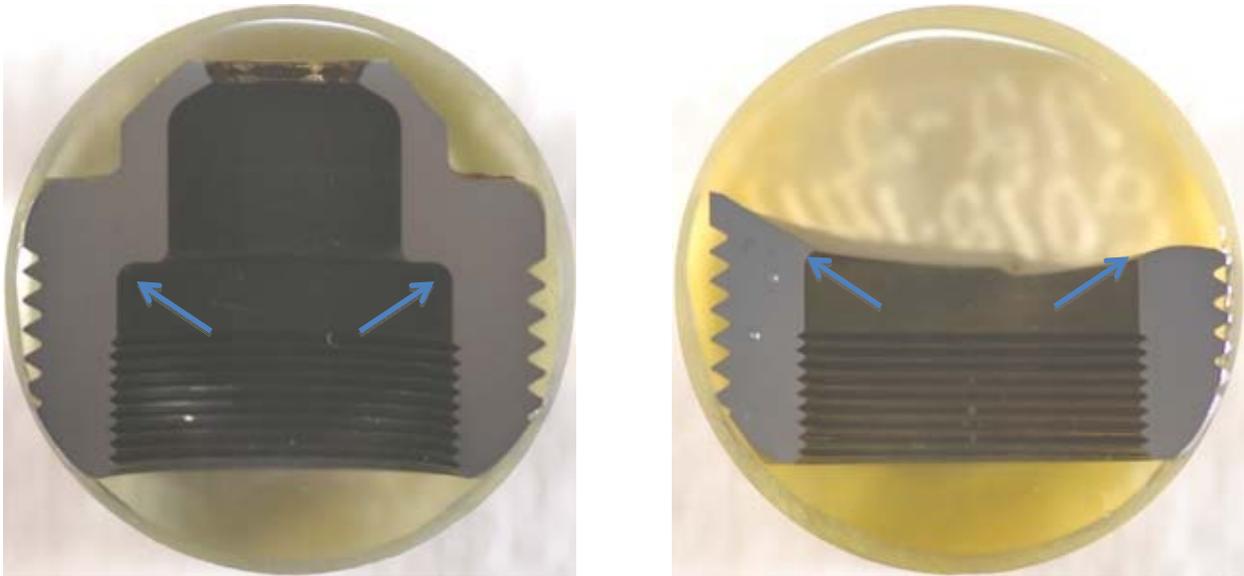
Figure A5. Polished cross sections of (a) functioning nozzle and (b) failed nozzle. The arrows indicate the internal corner associated with failure of the nozzle.

Rockwell Hardness Scale C (HRC) represents the common macrohardness scale used to specify the required hardness of high-strength steel, such as type 440C (typically specified as a range of about ± 2 HRC). The HRC, however, could not be measured on the polished sections due to the size and configuration of the part. Approximate conversions from HV to HRC using ASTM E140 Table 1 give approximately 55 and 49 for the failed and functioning nozzle respectively.

The yield strength of the material can be estimated from HV, where the yield strength is 1/3 of the hardness (using the proper unit conversions). While such correlations cannot be relied upon for accurate yield strength determination, such estimates provide information about the strength level of the material. The yield strength of the failed nozzle is estimated to be near 1960 MPa (280 ksi), while the yield strength of the functioning nozzle is estimated as 1640 MPa (240 ksi).

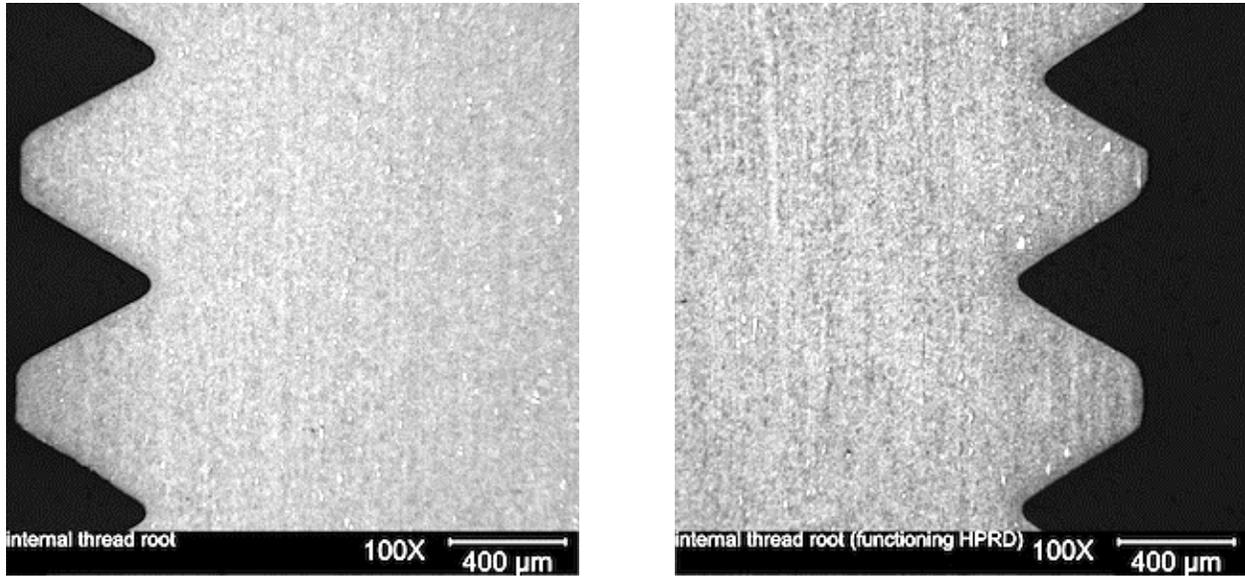
The metallographic sections were examined prior to etching to allow examination of the profile of the nozzle and inspection of the thread roots at high magnification. Evidence of secondary cracking at the notch root was not found (Figure A6), consistent with the visual inspection. There appears to be some decarburization on the surface of the part, this is likely a normal consequence

Figure A6. Light microscopy images of internal thread root of (a) the failed nozzle and (b) the functioning nozzle. Cracking at the root of threads (and other machined features) was not observed.

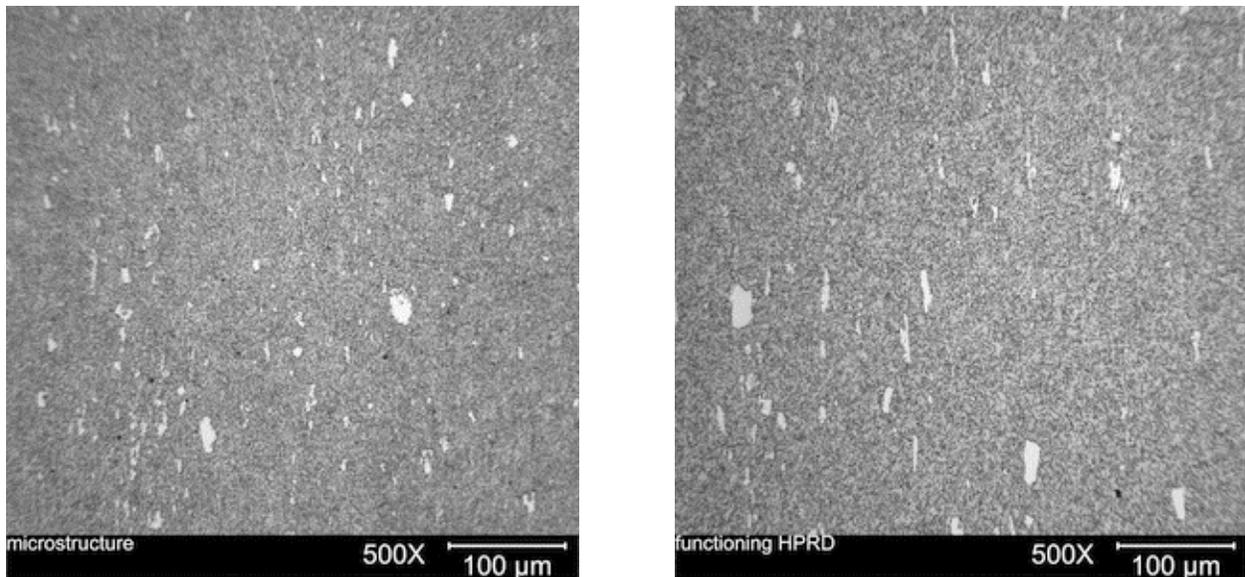
of the quench and tempering process. In short, the microstructure of the two nozzle pieces are similar as shown in Figure A7, consisting primarily of very fine structure that cannot be resolved with optical light microscopy. This type of microstructure is expected for a quench and tempered martensitic steel.

Figure A7. Microstructure of (a) the failed nozzle and (b) the functioning nozzle. This microstructure is consistent with that of a quench and tempered martensitic steel.

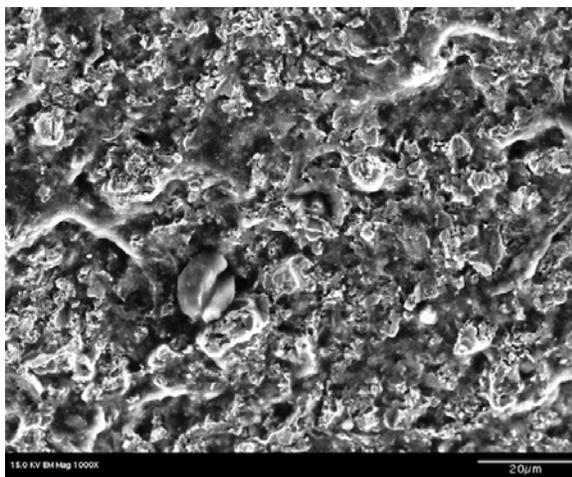
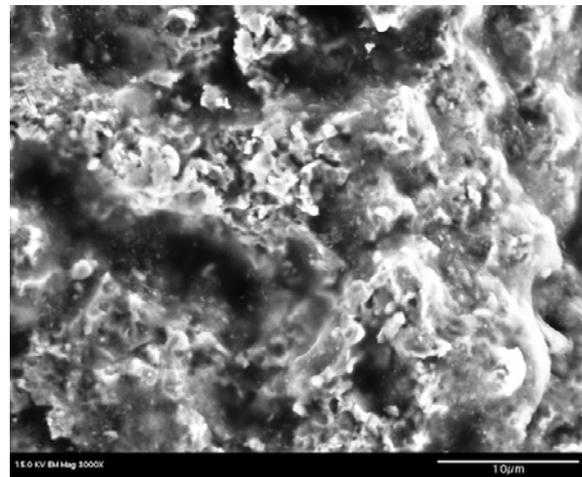
The parts in the as-received condition were extremely dirty. The lack of cleanliness obscured fracture surface of the as-received part labeled A1 and little could be determined from this examination (Figure A8). After sectioning to produce B1, the mating fracture surface (A2) was cleaned ultrasonically for a short duration prior to observation; this removed contamination from the cutting fluid during sectioning, as well as contamination from general handling. The cleaning operation was minimized to prevent damage to the fracture surface. While examination of this surface revealed characteristics of the true fracture surface, many portions of the surface remained obscured by dirt and debris. Further cleaning was not attempted.

Figure A8. Fracture surface of A1 showing dirt and debris on the surface.

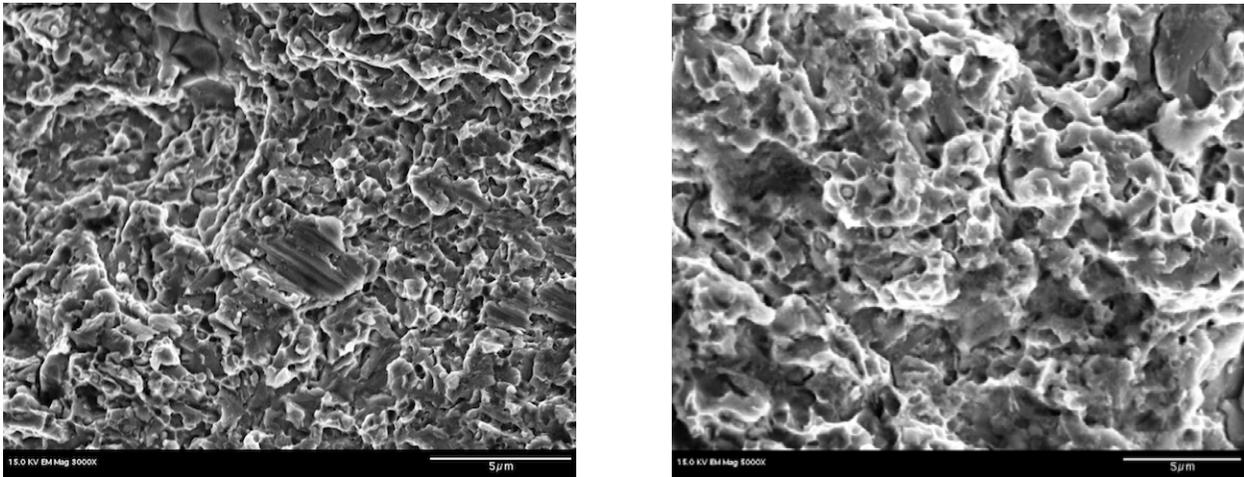
Examination of A2 did reveal a fracture surface with very fine structure, representative of the very fine microstructure. Classic brittle fracture was not observed, likely due to the fine microstructure. High-resolution images (Figure A9) suggest fine facets at submicron length scales. While the analysis is not definitive in this regard, these structures appear to be associated with boundary separation, a fracture feature often observed as a consequence of environmental-assisted cracking.

Figure A9. Fracture surface of A2 after light cleaning. These two images from distinct areas of the fracture surface show flat fracture features representative of low ductility.
