# SANDIA REPORT

SAND2013-3197

## Blade Reliability Collaborative: Collection of Defect, Damage and Repair Data

Thomas D. Ashwill, Alistair Ogilvie, and Joshua Paquette

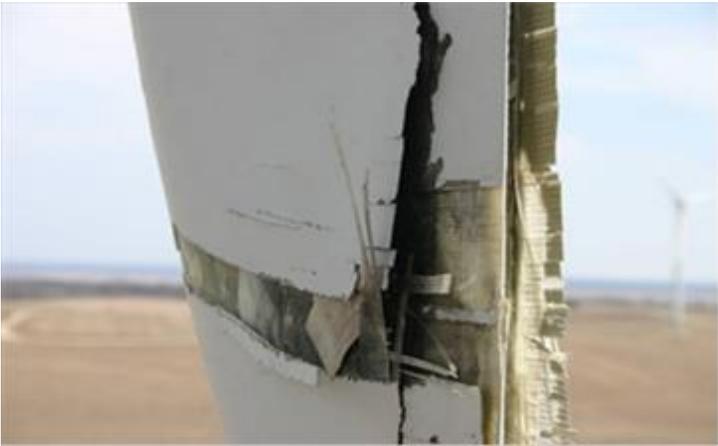
Figure 1: Severely Damaged Blade: Trailing Edge Separation (Courtesy of Knight & Carver)

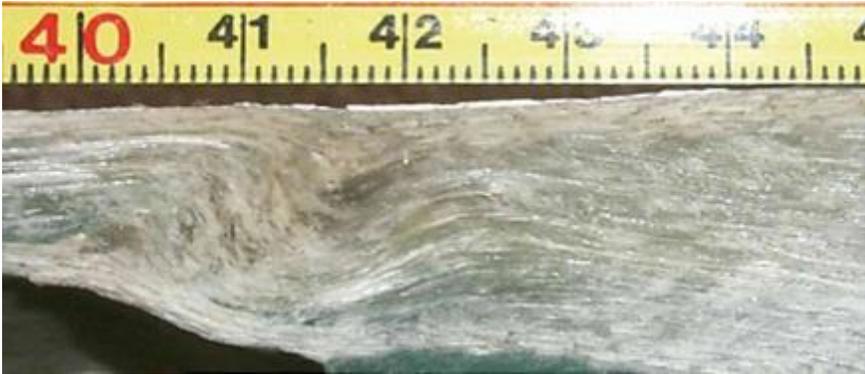
Figure 2: Extreme Fabric Waviness

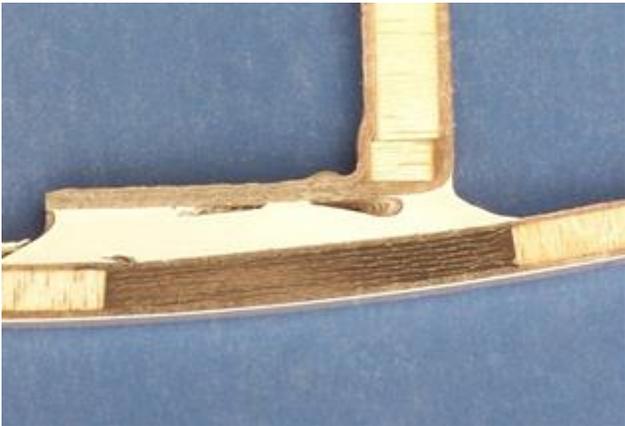
Figure 3: Poor Bonding

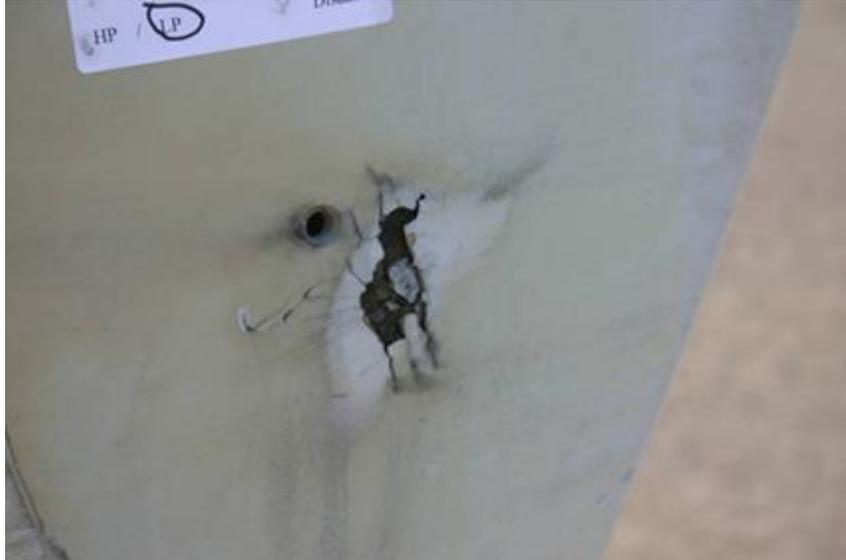
**Figure 4: Lightning Damage**

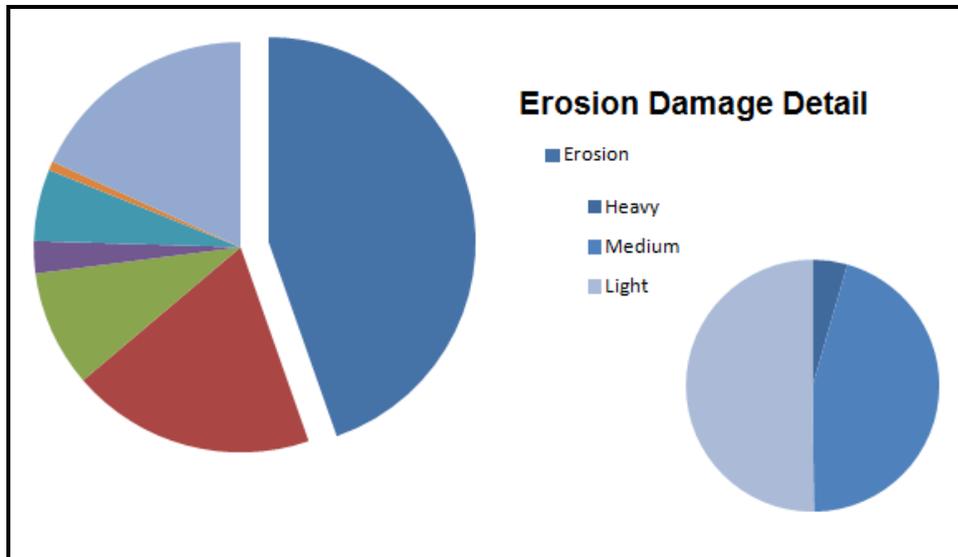
Almost every data source experienced erosion to some extent. This varied from small areas of “pitting” through to larger areas where the exterior coating was worn away and exposing damaged laminates (Figure 9)

Figure 9: Erosion Damage Detail

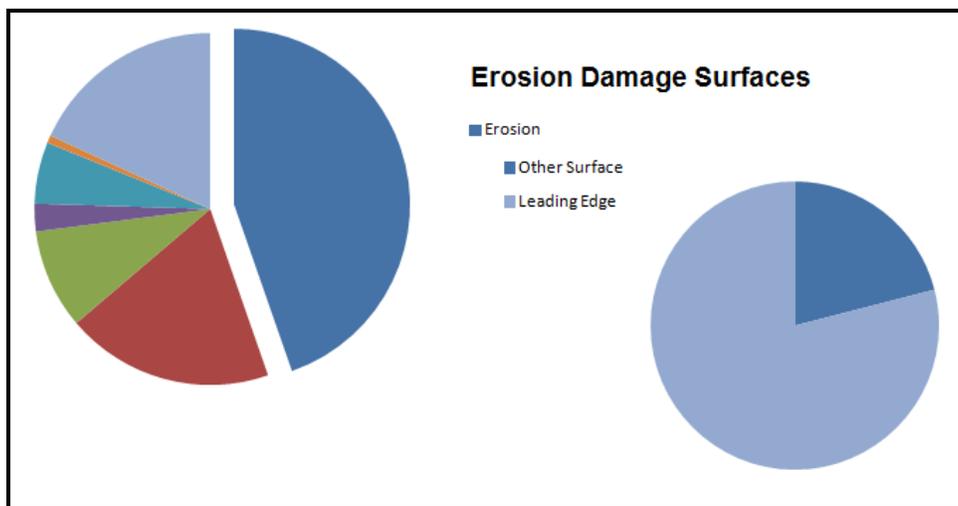
A substantial portion of the erosion seen occurred on the leading edge of the blades (Figure 10)

Figure 10: Erosion Damage Surfaces
