# SANDIA REPORT

SAND2015-2850  
Unlimited Release  
Printed April, 2015

## An Experimental Study of Shear-Dominated Failure in the 2013 Sandia Fracture Challenge Specimen

Edmundo Corona, Lisa A. Deibler, Benjamin Reedlunn, Mathew D. Ingraham and  
Shelley Williams

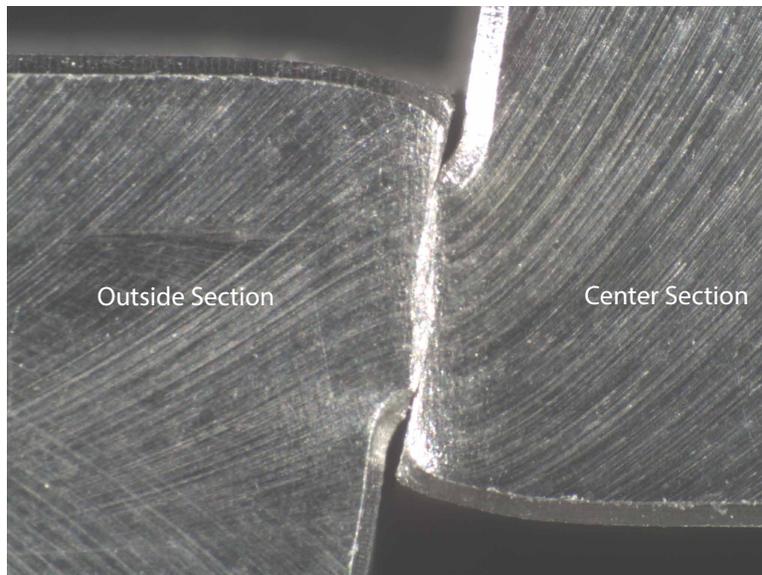
Figure 4: Close-up photograph showing one of the regions where failure occurred in experiment S6. The figure also defines the center and outside regions of the specimen.

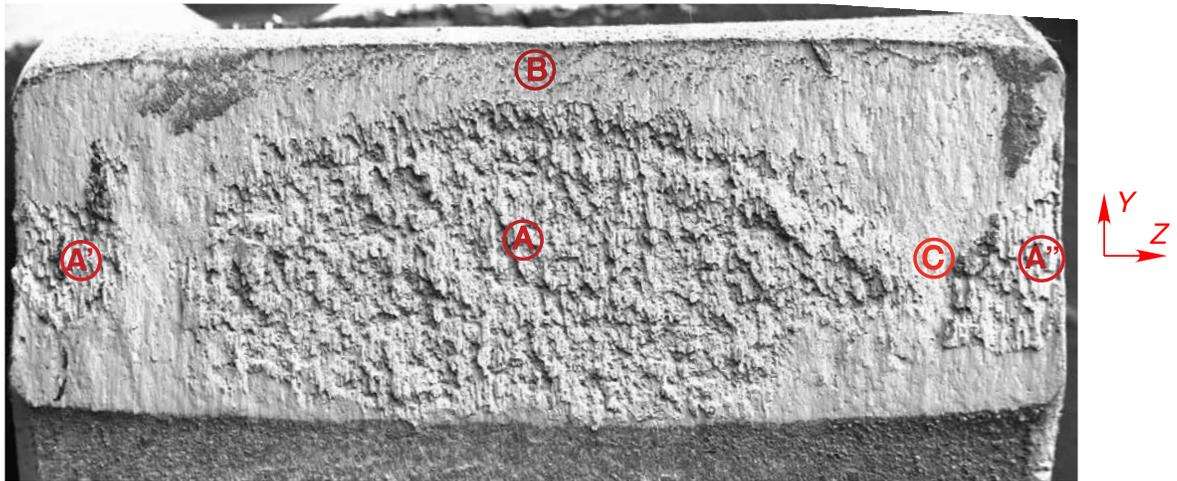
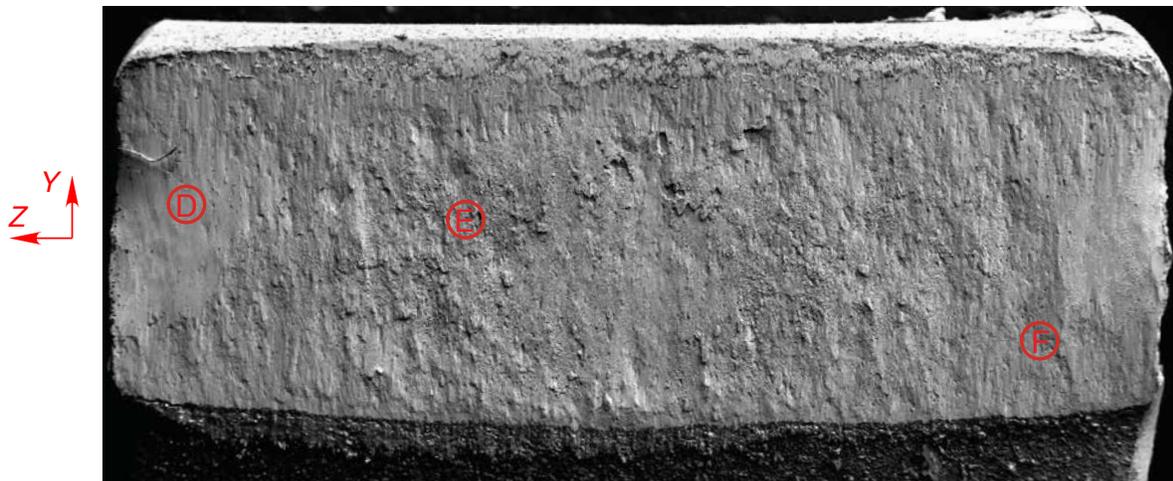
Figure 13 shows the regions marked in Fig. 12 at higher magnification. Looking first at Fig. 12 (a), magnification of the surface with rough texture at A shows a sub-structure with many equiaxed dimples in each of the flake-like formations that give this region a rough texture. Equiaxed dimples such as these are indicative of tensile failure [10]. The regions labeled A' and A'' also show similar fracture features. The region at B, which extends across the top of the sample fracture surface, shows a relatively smooth, or “smeared” surface with no evidence of dimples. It is possible that this surface was smeared by the fracturing process or perhaps by rubbing after it fractured. In contrast, the also smooth-looking surface at C exhibits evidence of dimples that have a preferential orientation. Inspection of the mating fracture surface confirmed dimples pointing the opposite direction, suggesting a shear type of failure. Looking next at Fig. 12 (b), D corresponds to the same ( $Y$ ,  $Z$ ) coordinates as the rough surface A'' in Fig. 12 (a), except it is on the right side of the outer section. The smooth surface at D shows a texture with dimples that are also elongated, thus suggesting shear dominated fracturing. Within the middle section of the specimen, at E, a rougher texture with some flake-like features and a reasonably equiaxed dimpled substructure can be observed. This seems similar to region A in Fig. 12 (a), but with smaller flake-like formations. Region F displays very similar features as region C. Finally, the region that corresponds to the same ( $Y$ ,  $Z$ ) coordinates as location B in Fig. 12 (a) shows essentially the same smeared texture. In summary, although the general appearance of the two surfaces in Fig. 12 is different, they have the following in common:

- The smeared region along the top of the fracture surface.
- The rougher sections with equiaxed dimples in the center area of the fracture surfaces.

Figure 12: Typical fracture surfaces seen in the tests. The surfaces shown are for specimen S8. (a) Right side, outside section and (b) left side, outside section. Note that these are not mating surfaces.

- The section around the center and away from the vertical edges that contains elongated dimples suggesting shear failure.
- The sections near the vertical edges that have similar overall shapes. Here, however, in one case the fracture surface is rough, while in the other it is rather smooth with elongated dimples.

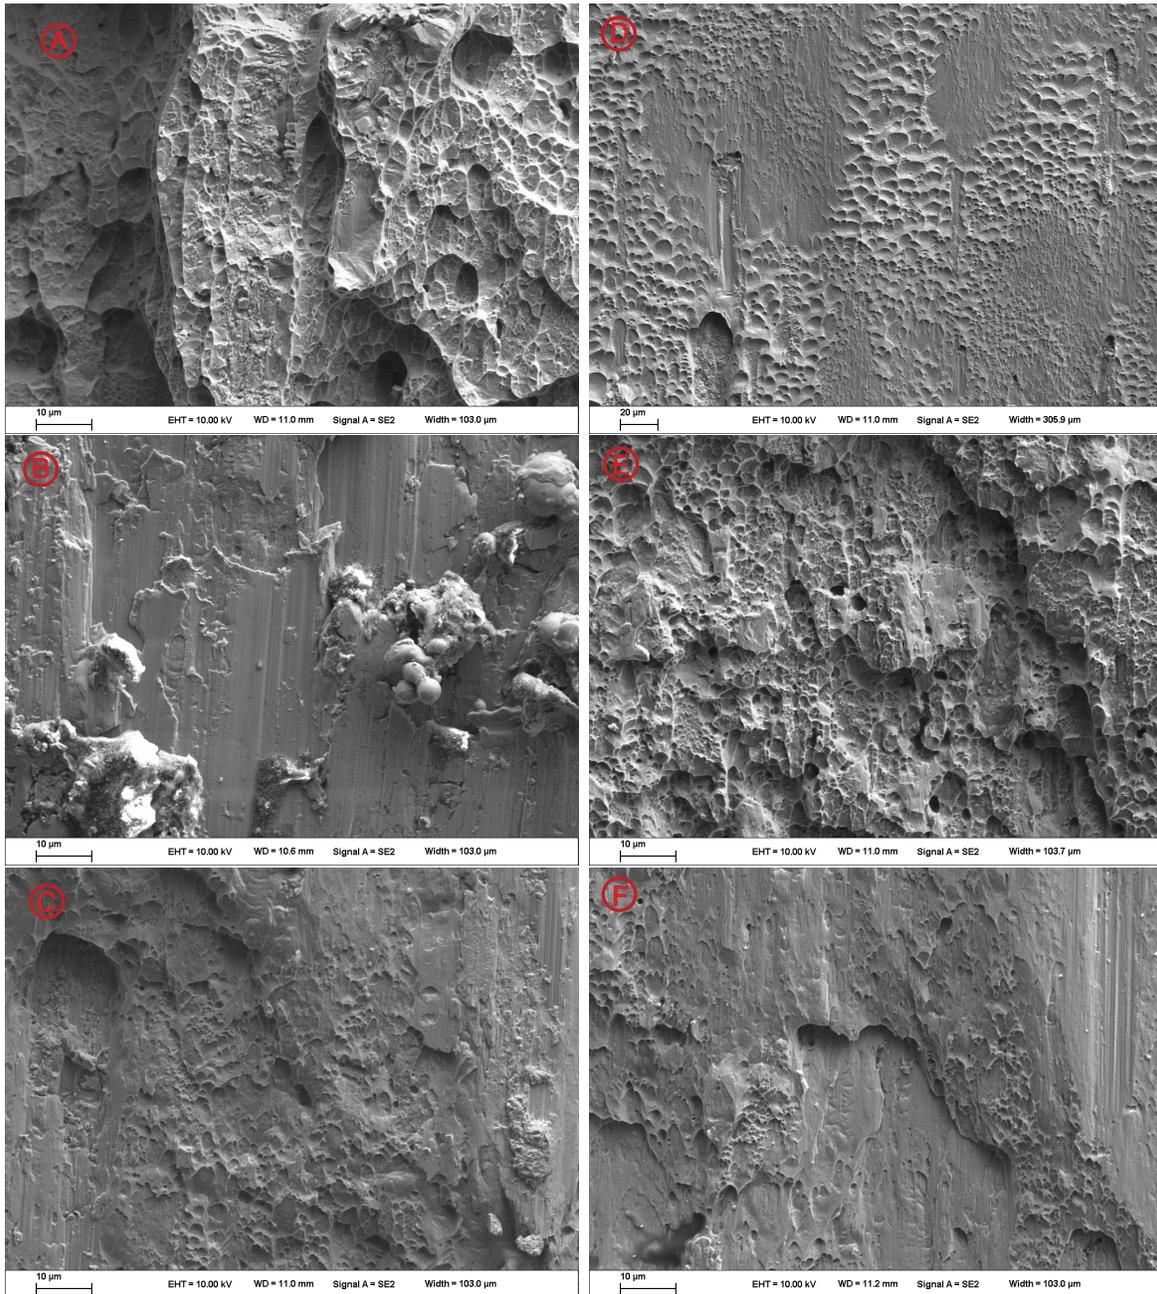
Figure 13: Photographs of regions marked in Fig. 12.

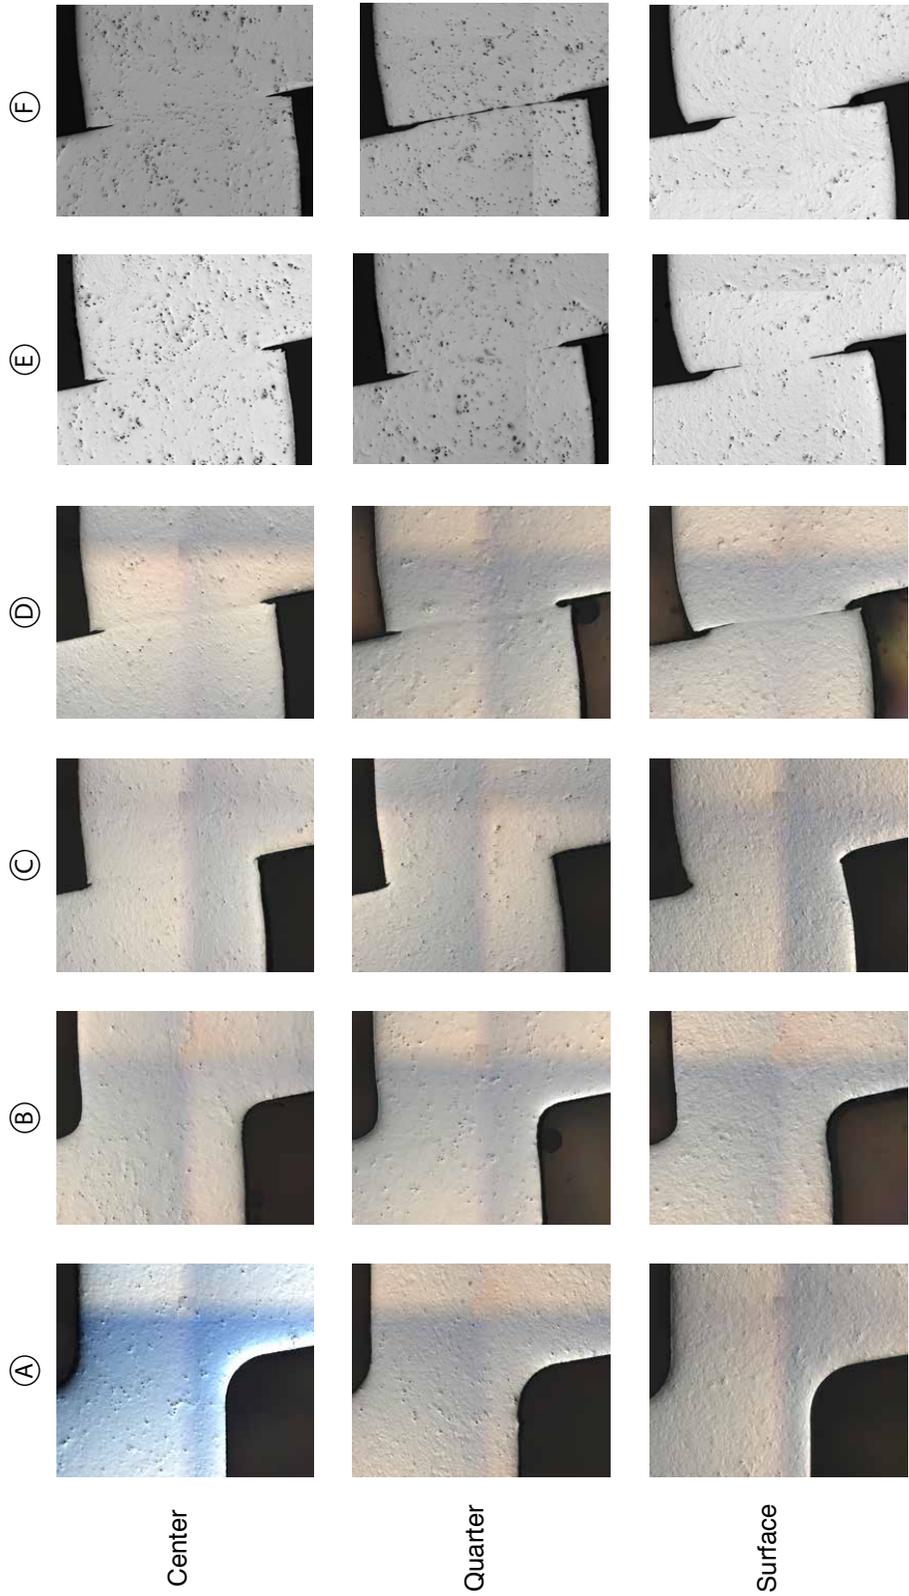
Figure 23: Montage showing micrographs of the right side taken for each steel specimen that was unloaded. The micrographs show the 'Center', 'Quarter' and 'Surface' planes defined in Fig. 22. The letters in the balloons correspond to the positions marked in Fig. 15.

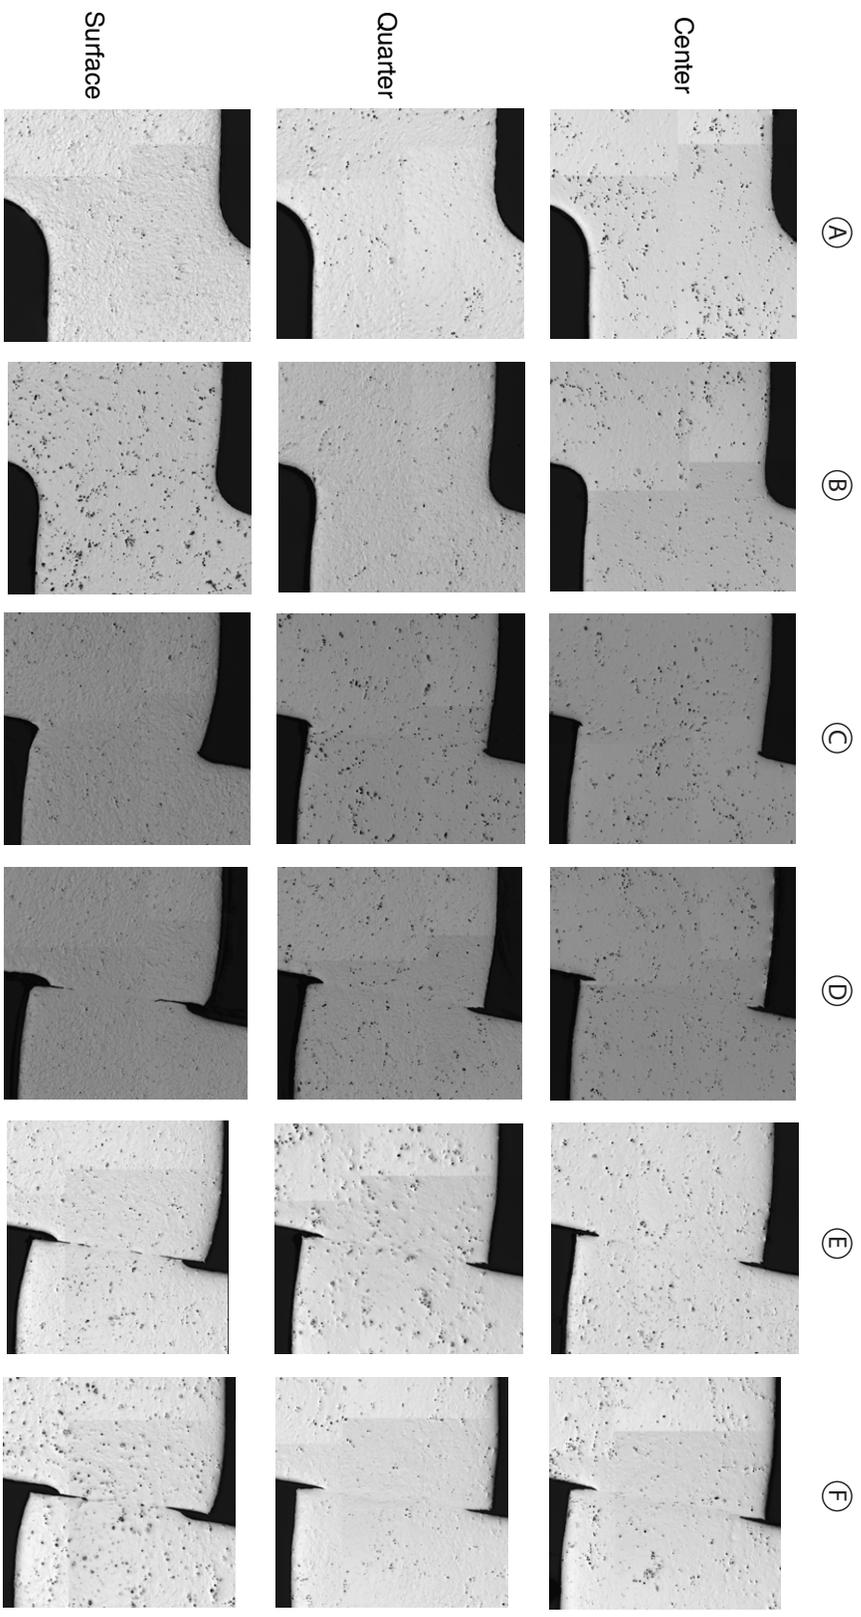
Figure 24: Montage showing micrographs of the left side taken for each steel specimen that was unloaded. The micrographs show the 'Center', 'Quarter', and 'Surface' planes defined in Fig. 22. The letters in the balloons correspond to the positions marked in Fig. 15.

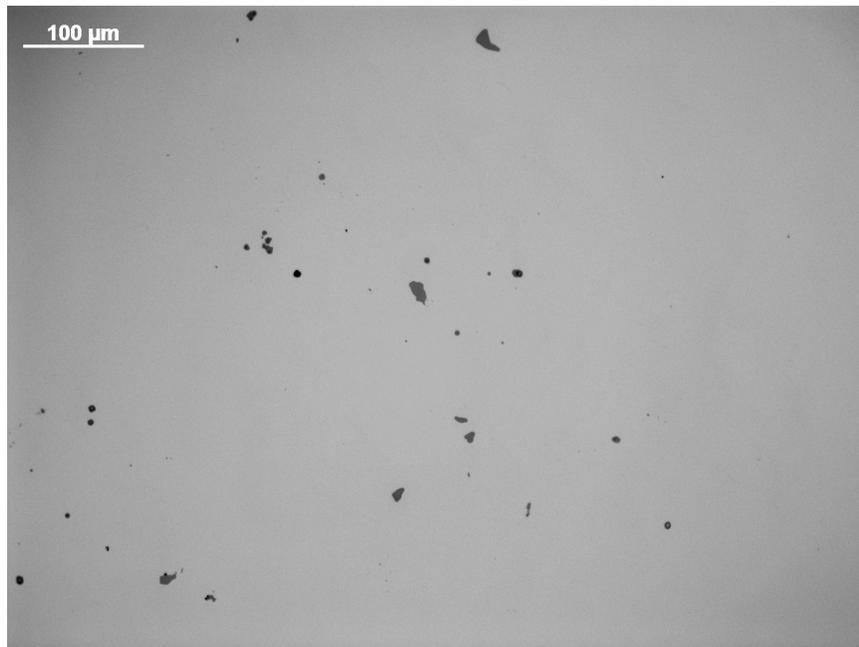
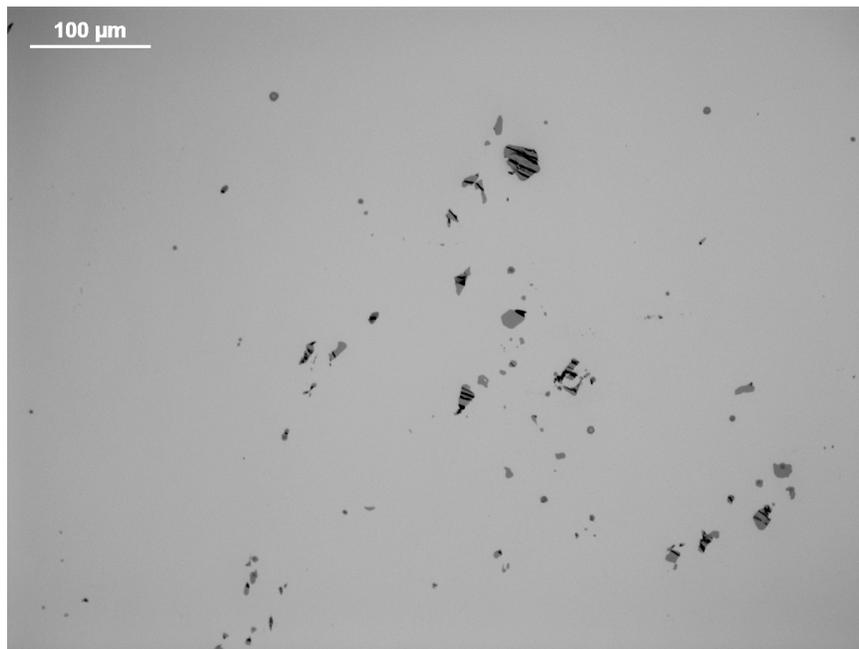
Figure 27: Micrographs from test S3 at a depth of one-half thickness. (a) Away from the zone of high deformation, showing intact carbide inclusions and (b) within the zone of high deformation, showing cracked carbide particles.

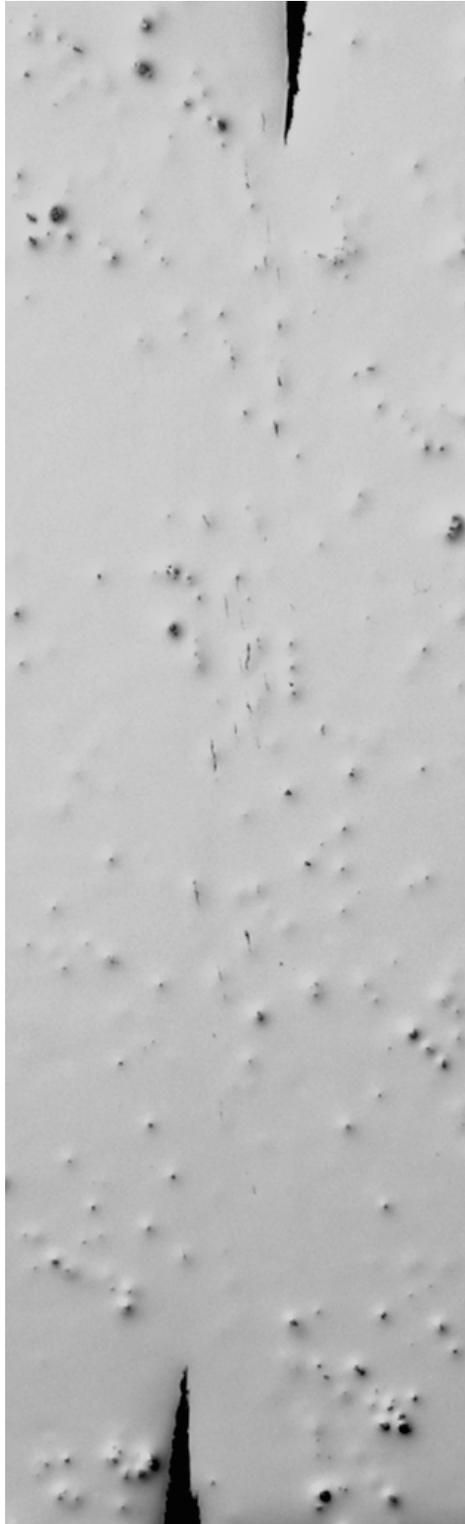
Figure 28: Section at a one-half thickness depth of specimens S6 prior to etching and showing the presence of small cracks near the center.

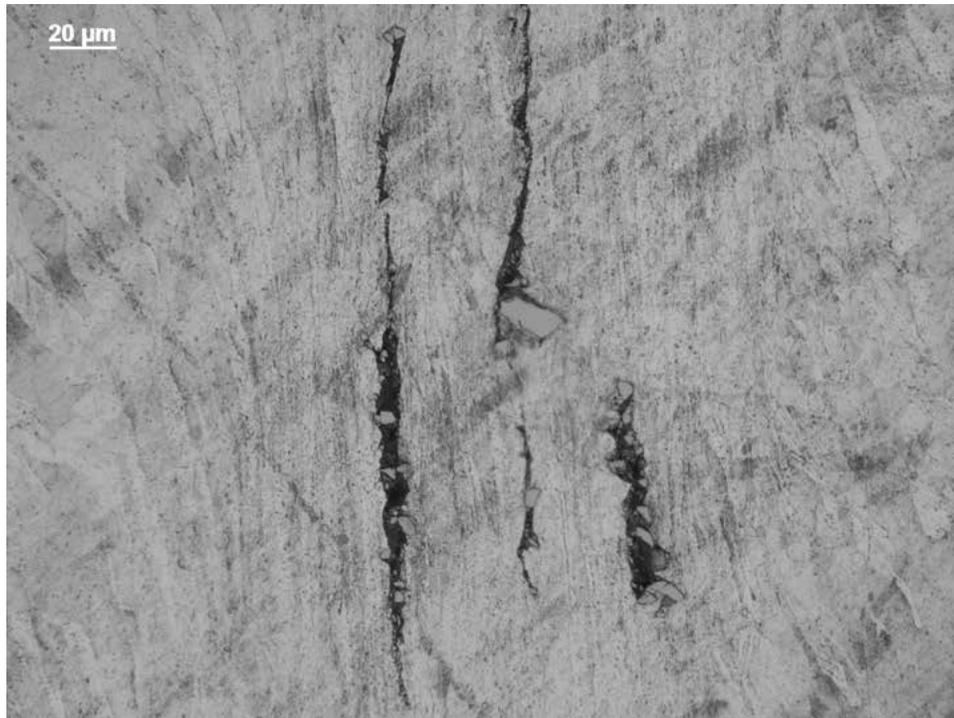
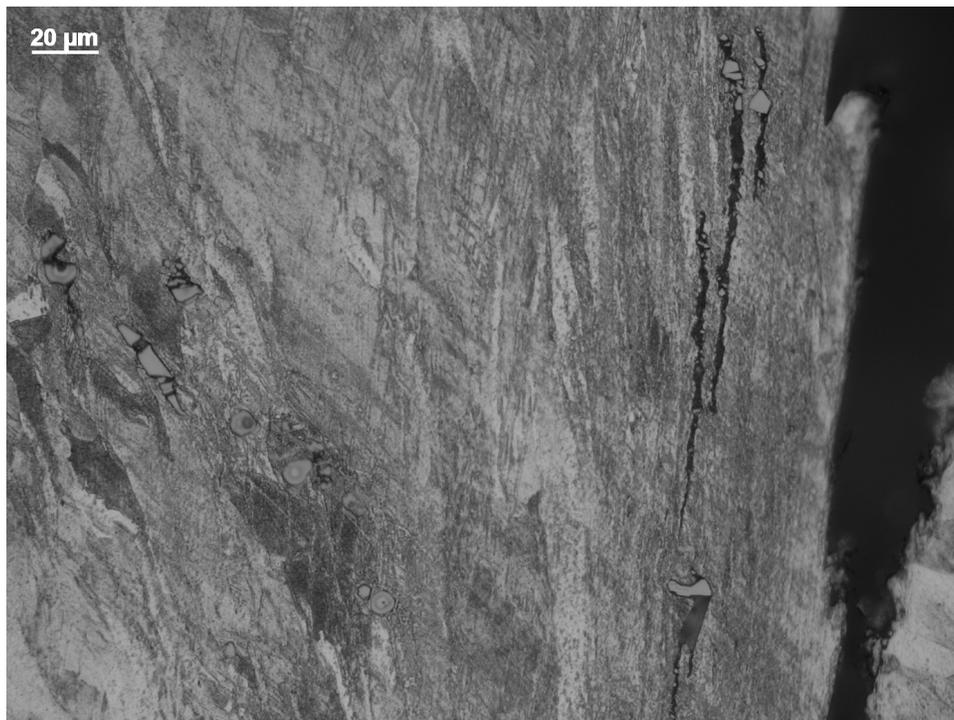
Figure 29: Detail from test S5 showing cracks initiated at carbide particles at a depth of one-quarter of the thickness. (a) Away from indentation features and (b) next to the indentation features.

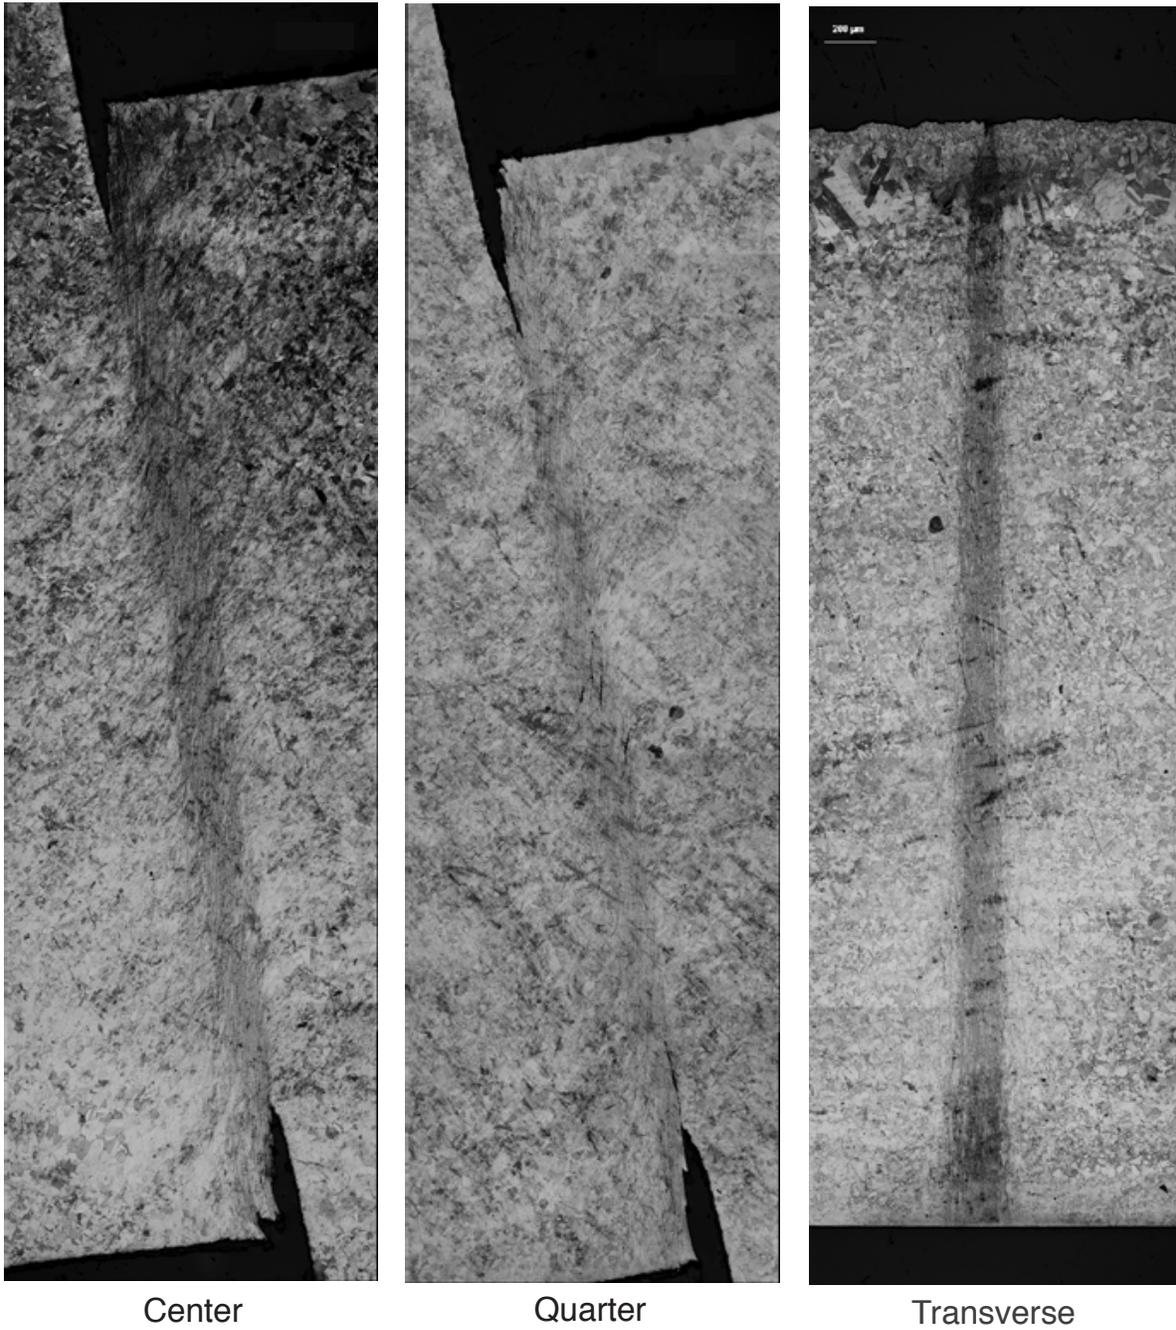
Figure 30: Magnified images of the failure zone for specimen S5 after etching. The figure also shows the image of the transverse cut.

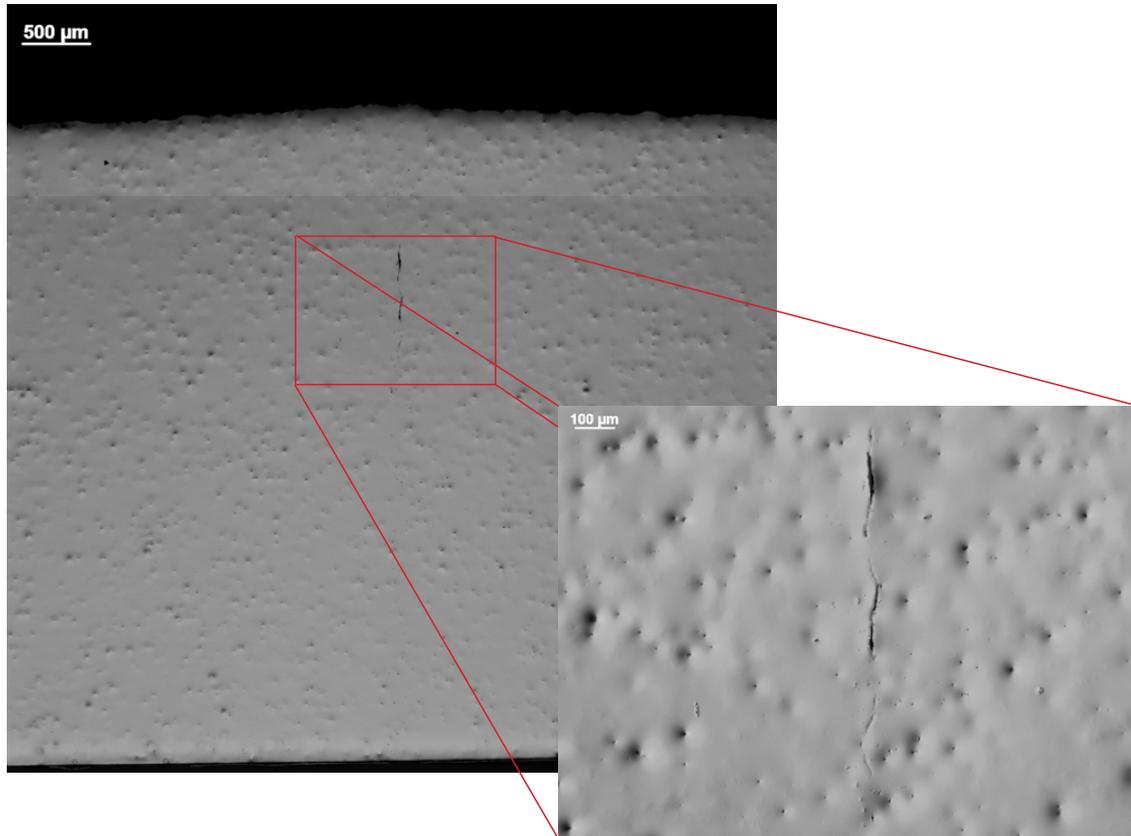
Finally, Fig. 31 shows the transverse, polished region of specimen S6. The width of this section is one half of the specimen thickness. It clearly shows the cracks that developed in the specimen at a depth around  $1/8$  of the thickness from the surface of the specimen. Not enough evidence exists to determine if these cracks actually represent sharp cracks that have bridged a significant length of the high deformation region or if they are just local features that appeared at the center of the specimen. They could be due to either, since both have been observed previously.

Figure 31: Detail of the transverse cut as shown in Fig. 22 showing that cracks have reached the mid-plane at locations between  $1/8$  and  $1/4$  of the thickness from the surface in specimen S6.

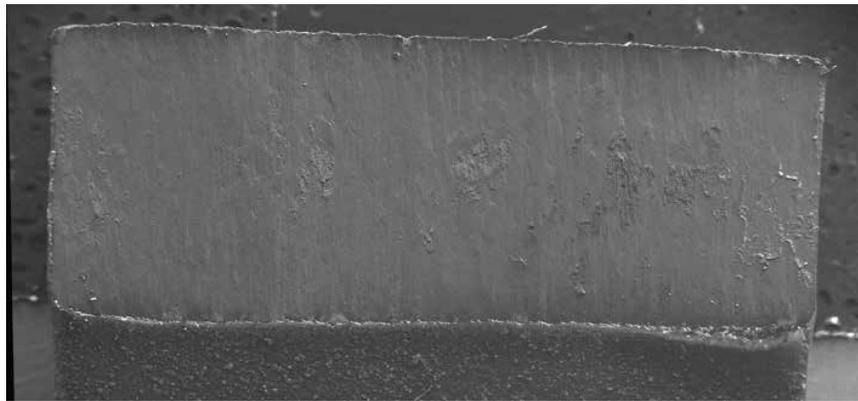
The aluminum specimens exhibited much simpler fracture surfaces, as in the example shown in Fig. 32, than corresponding images of the steel specimens in Fig. 12. Figure 32 shows a relatively smooth and uniform fracture surface with a few locations of some roughness. An interesting, and possibly significant, difference between the steel and aluminum specimens was that while the steel specimens broke apart at failure, thus exposing the fracture surfaces on both left and right sides, the aluminum specimens remained in one piece after failure. In other words, at failure the load dropped to zero, and cracks could clearly be seen on the surface, but the center part did not break away from the rest of the specimen. After sectioning the lower part of the specimen, it was possible to expose the fracture surfaces, but a little finger pressure was required to separate the center section from the outside section. Visual comparison between the fracture surfaces on the outside left and right sections showed few differences, unlike in the steel specimens.

Figure 32: Fracture surface from aluminum specimen A7.

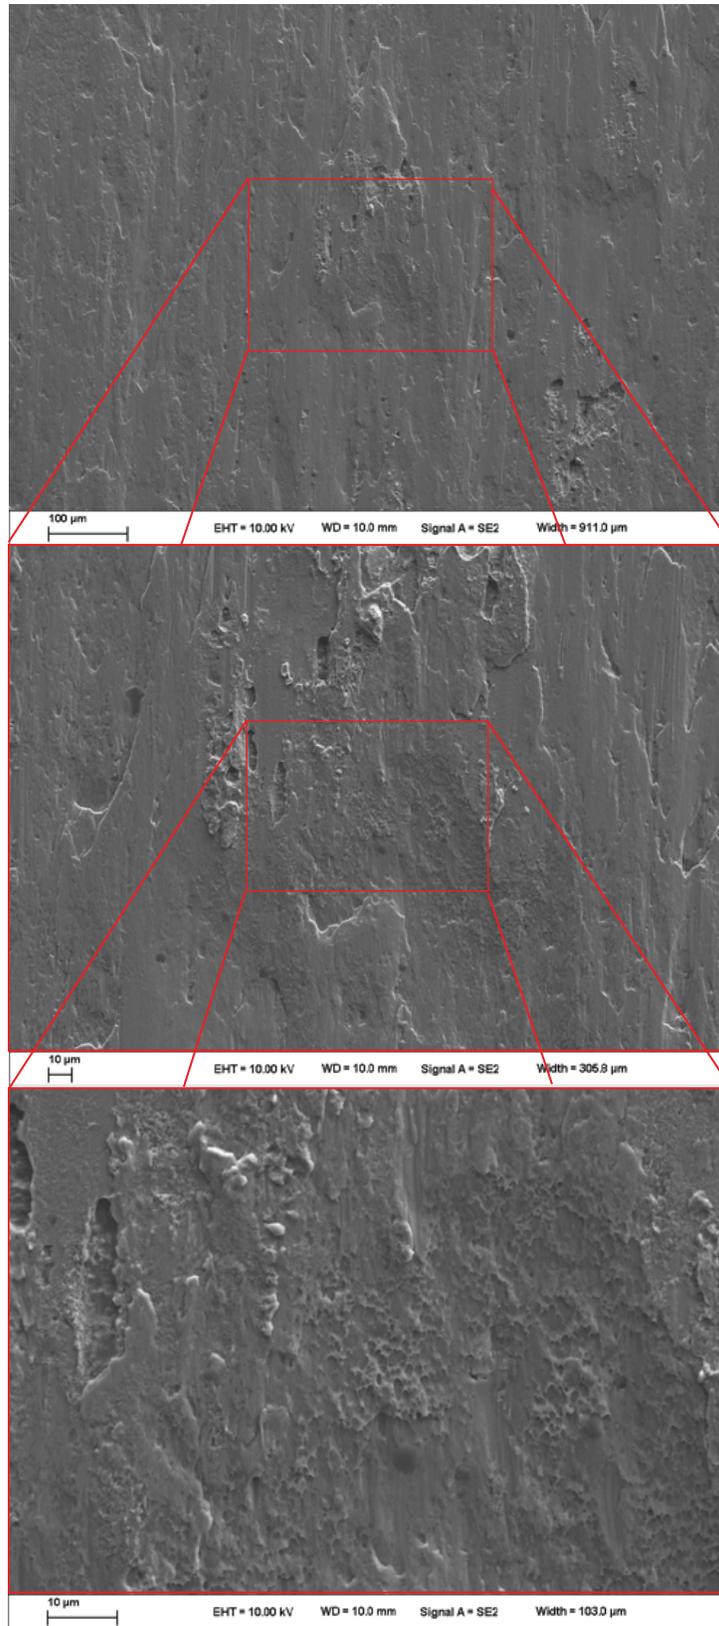
Not enough information is available in the SEM images to make statements as to how failure initiated and progressed in these specimens. It is also possible, and perhaps likely, that rubbing between the surfaces at failure erased the initial relief of the fracture surfaces.

Figure 33: Higher magnification images of the fracture surface of aluminum specimen A7.

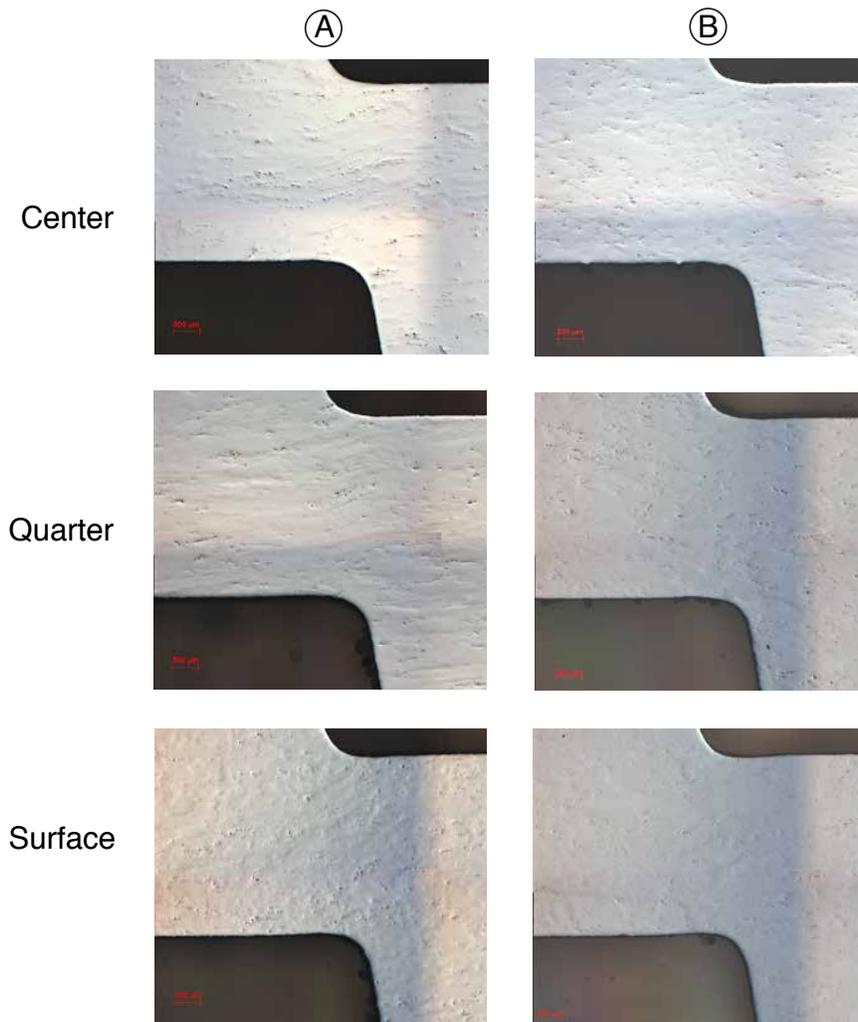
Figure 38: Montage showing micrographs taken for the two most deformed aluminum specimens that were unloaded. The micrographs show images of the three planes defined in Fig. 22. The letters in the balloons correspond to the points marked in Fig. 35 (b).
