## Causal Analysis For Occurrence Report

### OR NA—SS-SNL-2000-2015-0005, Unexpected Type of Failure of Thermal Battery

OR NA--SS-SNL-2000-2015-0005, Unexpected Type of Failure of Thermal Battery Event Pictures

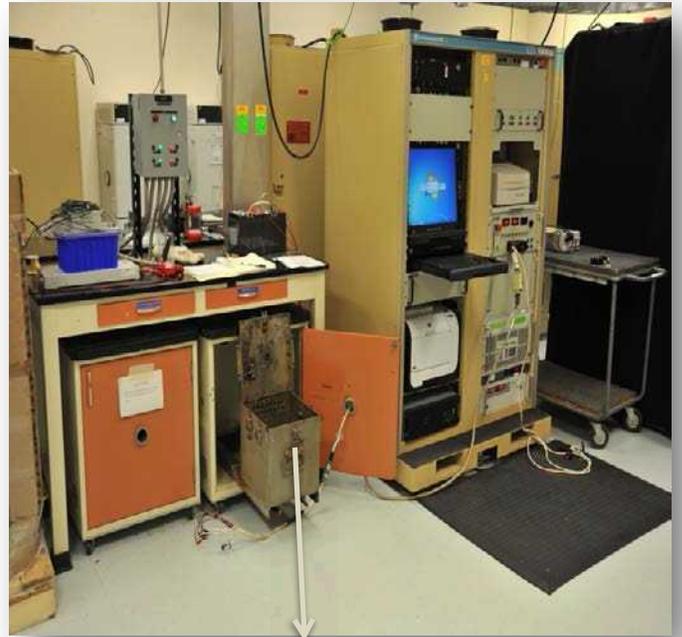
Battery Removed from Testing Box

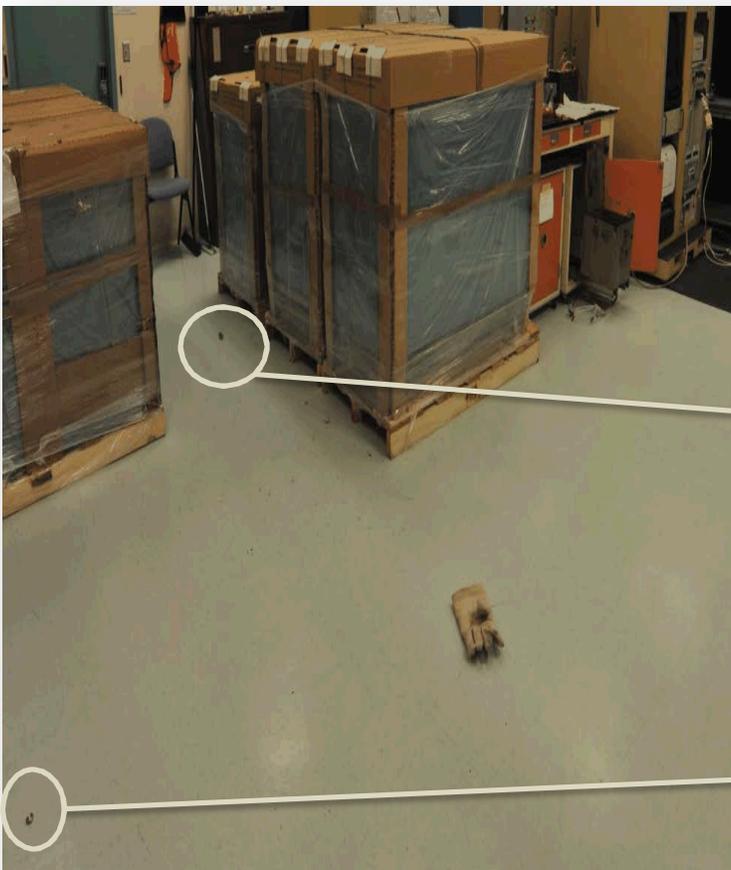
Dispersion of Parts

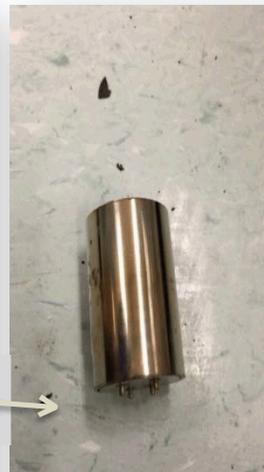
Battery Canister  
(approximately the size of a  
commercial size C Battery)
