CENTER 2500 LESSONS LEARNED

Title/Subject: Unexpected Type of Failure of Thermal Battery Resulting in a Near Miss to a Serious Injury

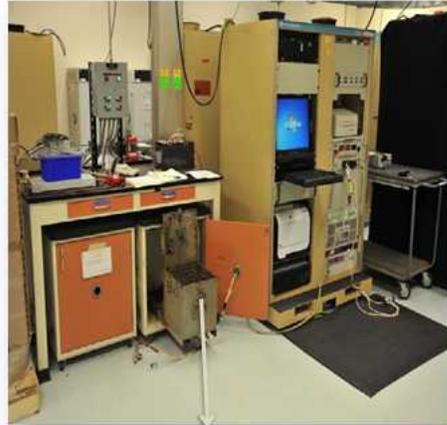
Battery Removed from Testing Box

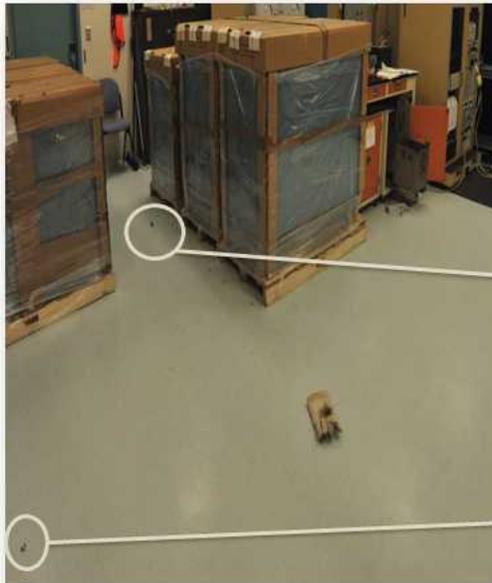
Dispersion of Parts

Battery Canister
(Approximately the size of a commercial size C Battery)

Thermal Glove

Battery Base Plate

The battery’s engineering team engaged with other Material and Metallurgy SMEs to evaluate the failure modes of the battery. It was determined during post-incident analysis that the closure weld failed during battery pressurization. The reason for this situation was that the effective weld penetration was less than 0.003 inch at some locations, significantly less than the 0.010 inch target. The origin for weld failure occurred at a location where the weld penetration was on the order of 0.002 inch. The characteristics that led to this situation are a low degree of pulse overlap (50% and less), poor seam tracking, and inadequate welding parameters due to insufficient communication from requester to technologist performing the operation.
