# Examination Results of the Three Mile Island Radiation Detector HP-R-212

SAND 83-1930  
Unlimited Distribution

ABSTRACT

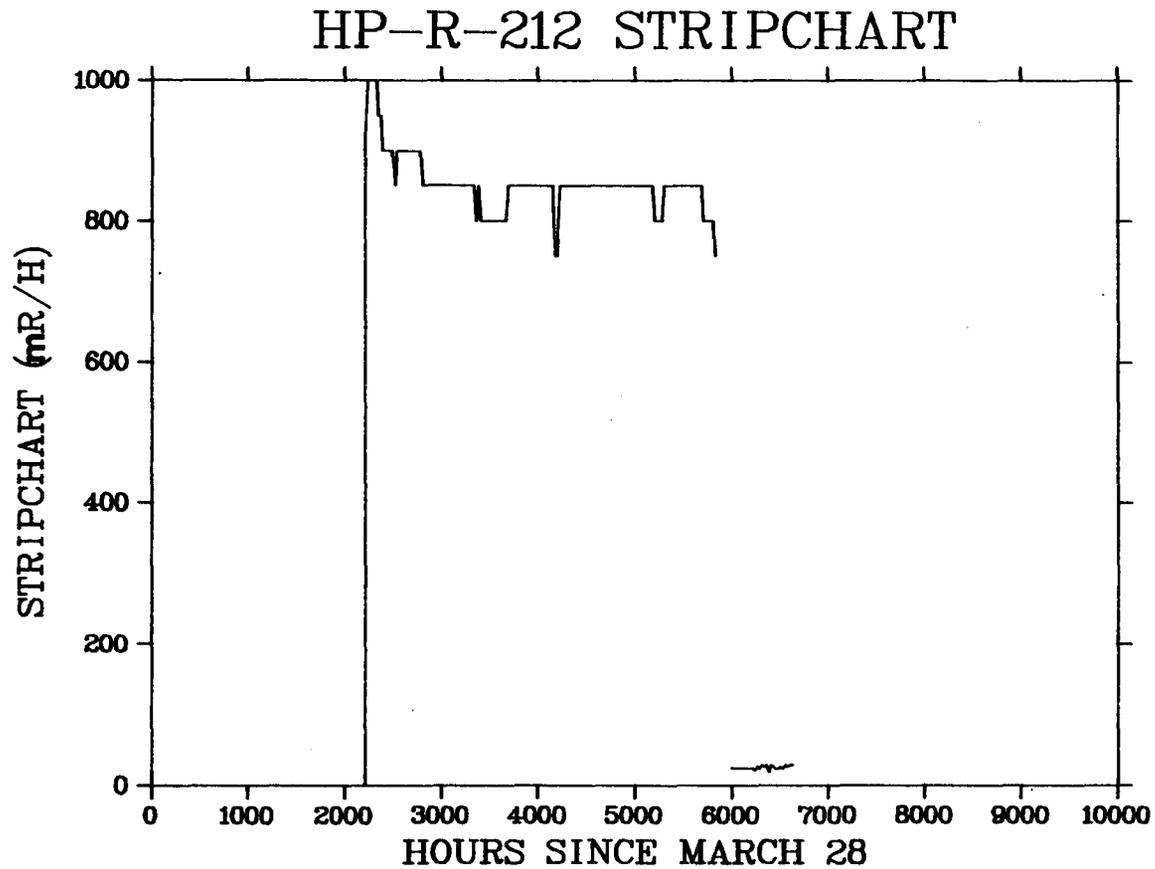
FIGURE 1. HP-R-212 STRIPCHART. This record shows that the detector was turned on June 28, 1979, 2208 hours after the March 28, 1979 incident. The output level started at 1 R/hr and decayed to about 700 mR/hr, 154 days later. At this time the GM tube failed and the reading dropped to 20 mR/hr.

1. The stripchart recording of HP-R-212 indicates that the detector was functional when it was turned on and worked for five months. At that time the output of the detector dropped from the nearly 1 R/hr reading to 20 mR/hr (Figure 1). Examination of the detector showed the failure to be a GM tube that had apparently used up the quench gas and was in continuous discharge. This design of detector is not capable of driving 366 meters (1200 feet) of cable at a frequency of 40 KHz. Therefore, when the GM tube went into continuous discharge, the output did not go to a reading of 10 R/hr as it should have, but read 20 mR/hr. If this detector is expected to work into "long" cable lengths and give the proper output readings at the ratemeter for this type of failure, I recommend that the output drive circuit in the detector and the input circuit for the ratemeter log pump circuit be redesigned.

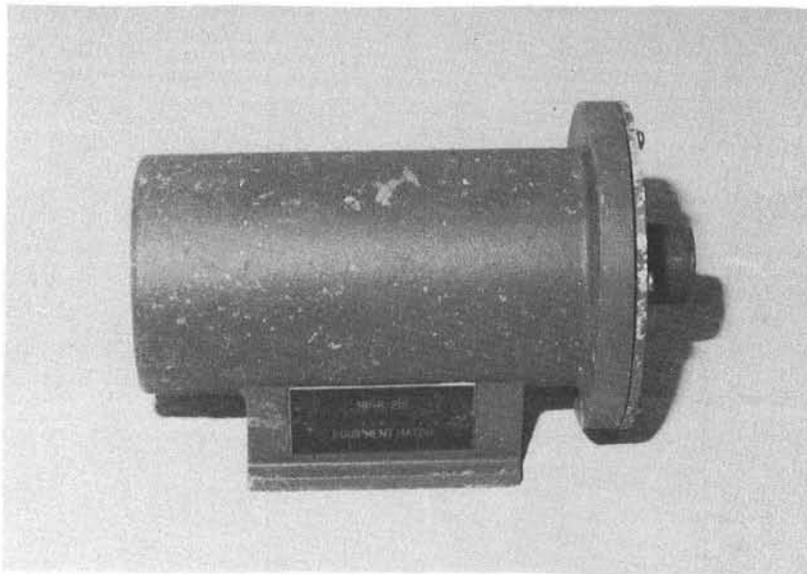
FIGURE 3. HP-R-212 DETECTOR, SIDE VIEW

The detector outside case showed the same pitting and corrosion around the connector as was seen in HP-R-211 and HP-R-213 (Figure 3 through Figure 6); however, this could be expected when the environment it was exposed to is considered. The O-Ring seal did a fair job of sealing the canister (Figure 7). Swipes taken on the inside of the canister indicate that only a small amount of radioactive materials had leaked in to contaminate the printed wiring assembly. A microscopic examination of the printed wiring assembly showed it to be free of foreign material except for some solder flux around most of the solder joints (Figure 8 and Figure 9), apparently residual from the manufacturing operation.

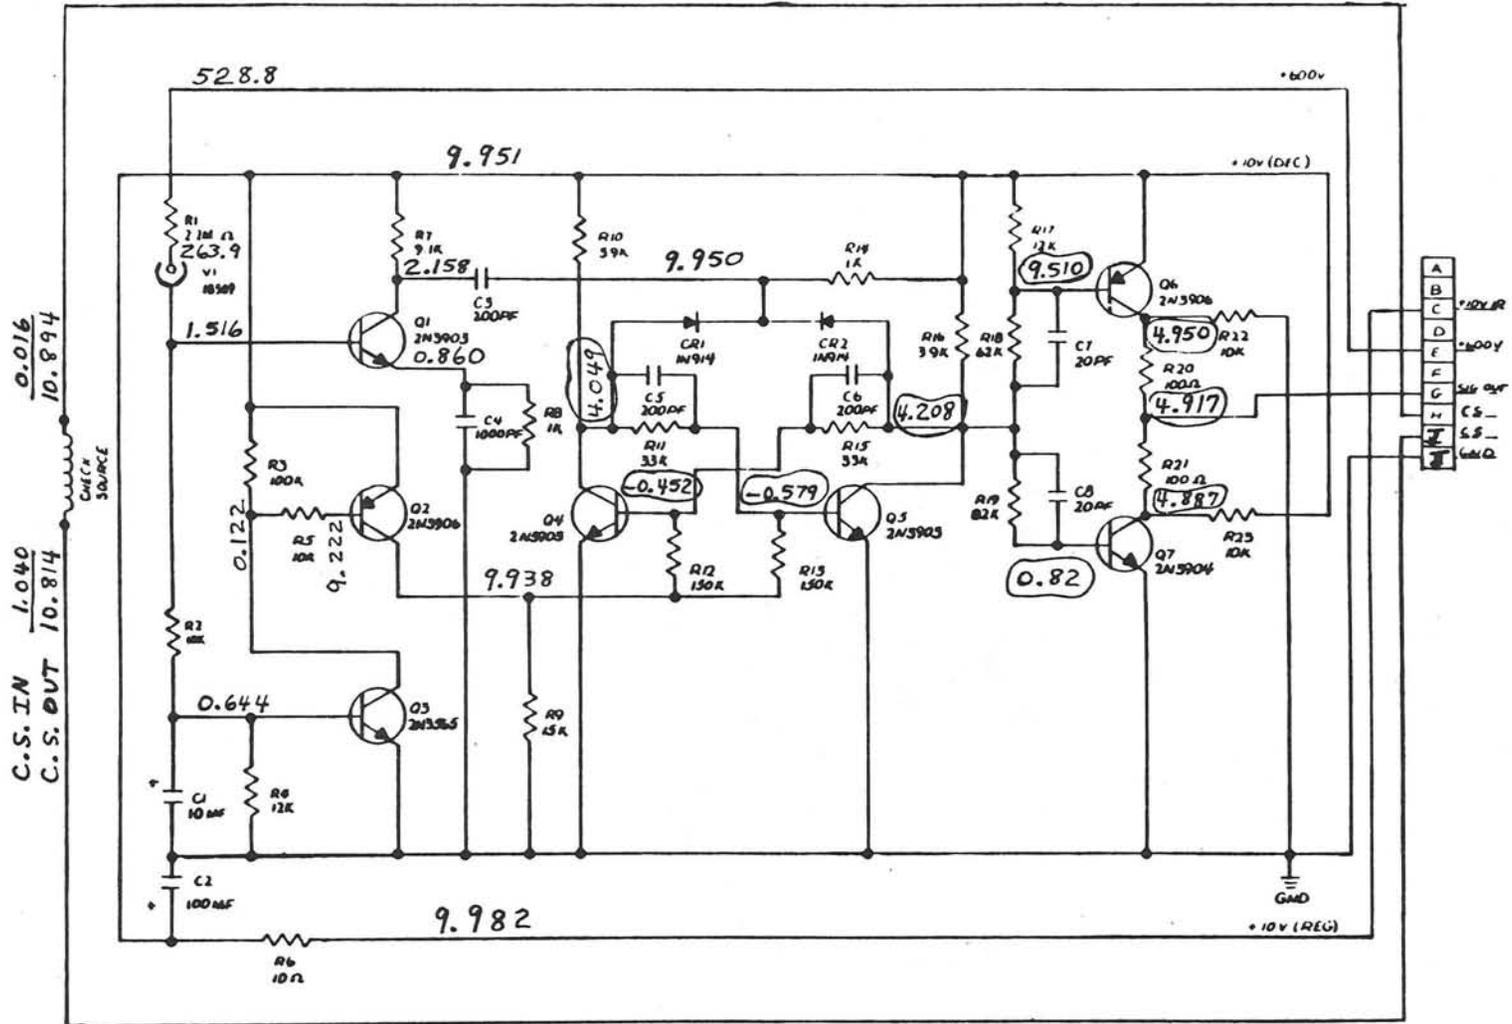
FIGURE 10. CIRCUITRY OF GAMMA DETECTOR 857-2, HP-R-212, PRE-REPAIR

These measurements were all made through the detector connector without opening the detector. The detector was eventually opened, and node voltages were measured. These DC node voltages are shown on a schematic of the detector in Figure 10. Since the detector's output was switching, some of the voltages are the average of the signal at the measured nodes. These voltages are circled. The GM tube was found to be in continuous discharge. The faulty GM tube was removed and replaced with a good GM tube. The DC node voltages were then recorded with the new GM tube and are shown in Figure 11. The detector was then exposed to  $^{60}\text{Co}$  at the Sandia Vertical Range Facility. The detector output reading versus input  $^{60}\text{Co}$  source level is shown in Figure 12. The detector operates properly over its normal 0.1 mR/hr to 10 R/hr range. The error in radiation measurement is caused by not calibrating this detector (GM tube) with the ratemeter. The anti-jam circuit was activated at an input level of 32 R/hr.

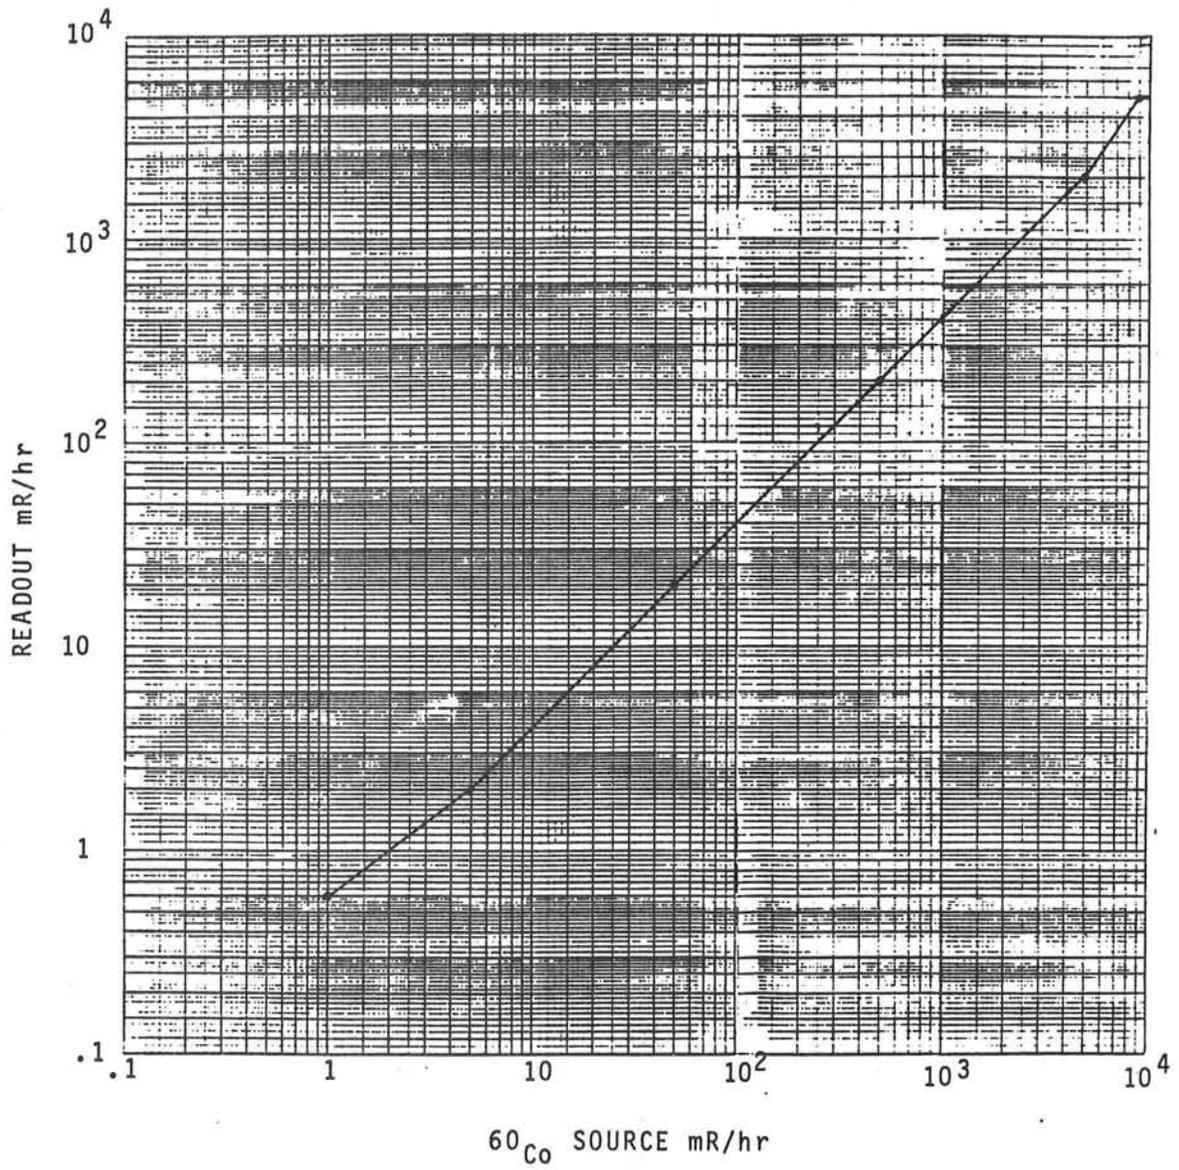
FIGURE 12. REPAIRED HP-R-212 DETECTOR RESPONSE WITH A REPLACED GM TUBE

2. A new GM tube from our test detector was placed in the HP-R-212 detector circuit. The detector then functioned normally when exposed to gamma radiation up to 20 R/hr.
3. We estimate the total gamma radiation dose accumulated by this detector to be approximately  $4.5 \times 10^5$  rads.

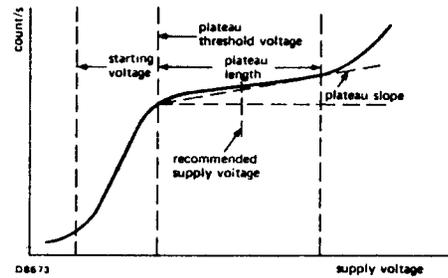
Fig.1

- 3.1 **Starting voltage**  
This is the lowest voltage applied to a G.M. tube at which pulses of 1 V amplitude appear across the tube. See fig.1.
- 3.2 **Plateau**  
This is the section of the counting rate versus voltage characteristic (with constant irradiation), over which the counting rate is substantially independent of the applied voltage. Unless otherwise stated, the plateau is measured at a counting rate of approximately 100 count/s.

- 3.3 **Plateau threshold voltage**  
This is the lowest voltage applied which corresponds to the start of the plateau for the stated sensitivity of the measuring circuit. See fig.1.

- 3.4 **Plateau length**  
This is the range of applied voltage over which the plateau extends. See fig.1.
- 3.5 **Plateau slope**  
This is the change in counting rate over the plateau length, expressed in % per volt. See fig.1.

- 3.6 **Recommended supply voltage**  
This is the supply voltage at which the G.M. tube should preferably be used. This voltage is normally chosen to be in the middle of the plateau. See fig.1.

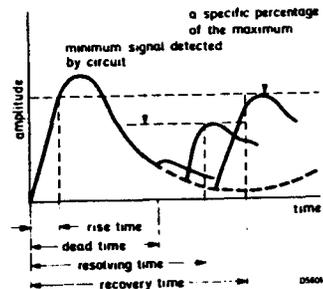
Fig.4

This is the time interval, after the initiation of a discharge resulting in a normal pulse, during which the G.M. tube is insensitive to further ionizing events. See fig.4.

This is the minimum time interval between the initiation of a normal size pulse and the initiation of the next pulse of normal size. See fig.4.

These represent the dead time (see 3.8 and fig.4) as a function of the supply voltage, measured with pulsed X-radiation in the recommended circuit, unless otherwise stated. The curves shown are typical. The maximum value is stated under OPERATING CHARACTERISTICS. Note that a higher anode resistor results in a higher dead time.

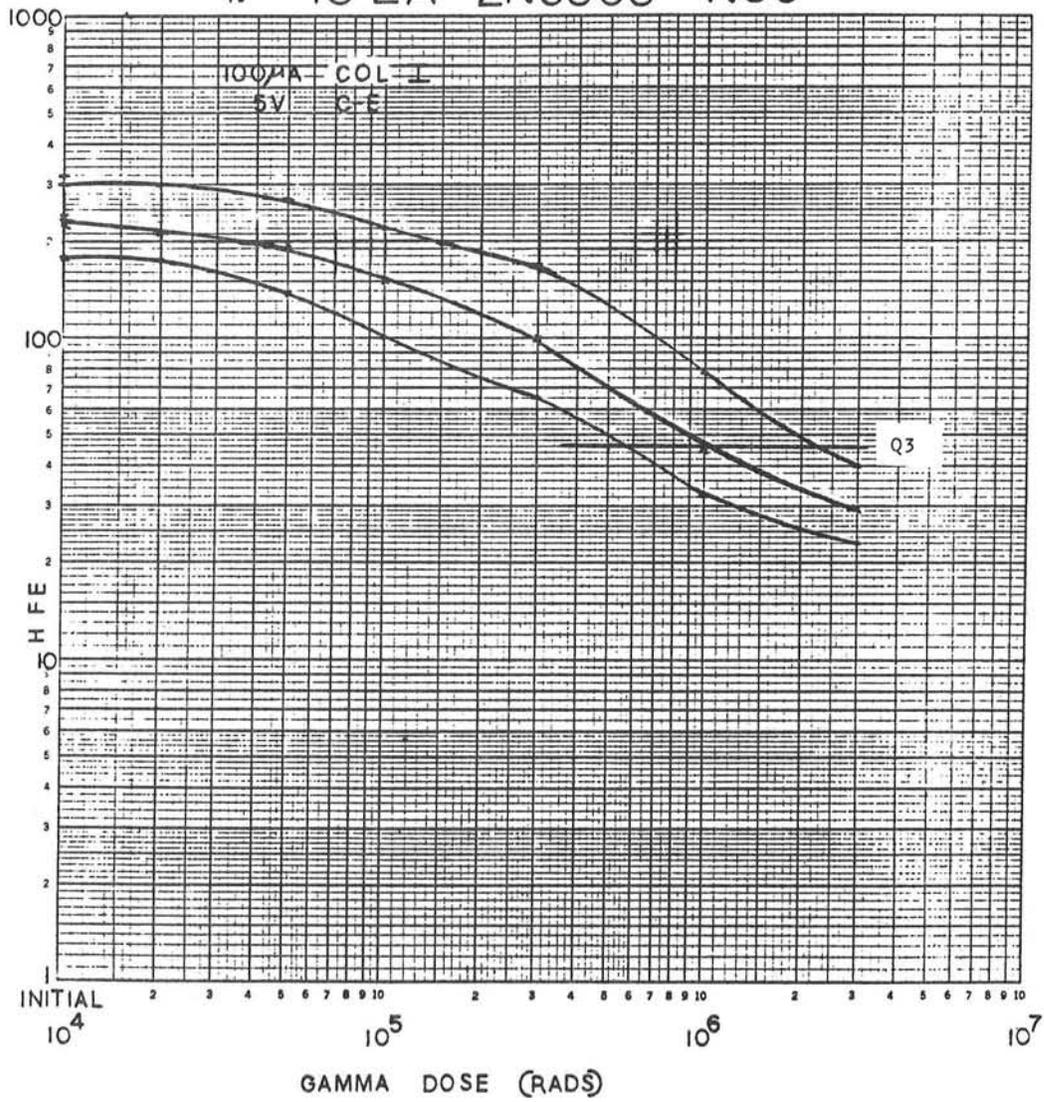
# I. 10 EA 2N3565 NSC

Transistor current gain, HFE, degradation is plotted in the curves given here versus cumulative gamma radiation dose. Eighty-seven devices from four manufacturers were passively exposed to a  $^{60}\text{Co}$  source in progressive steps, and the characteristics were measured after each step. Transistor HFE's are plotted for collector currents of 100 microamperes. The three curves shown for each device type represent HFE characteristics from the minimum device, the maximum device and the average of all the devices of that manufacturer. Also shown are the intersections of these curves with the HFE values measured for the devices removed from HP-R-212. The number of devices of each type as well as the manufacturer is listed on each graph.

The transistor curves shown in Appendix B are the curves generated for the same transistor types used in HP-R-211.<sup>1</sup> The HFE values recorded in Table 3 are drawn on the curves shown in Appendix B. The total dose for each of the transistor types is summarized in Table 4. The annealing and biasing factors are also accounted for in Table 4.<sup>1</sup>
