SANDIA REPORT

SAND91-0244 • TTC-1058 • UC-722

Structural Testing of the Los Alamos National Laboratory Heat Source/Radioisotopic Thermoelectric Generator Shipping Container

D. R. Bronowski, M. M. Madsen

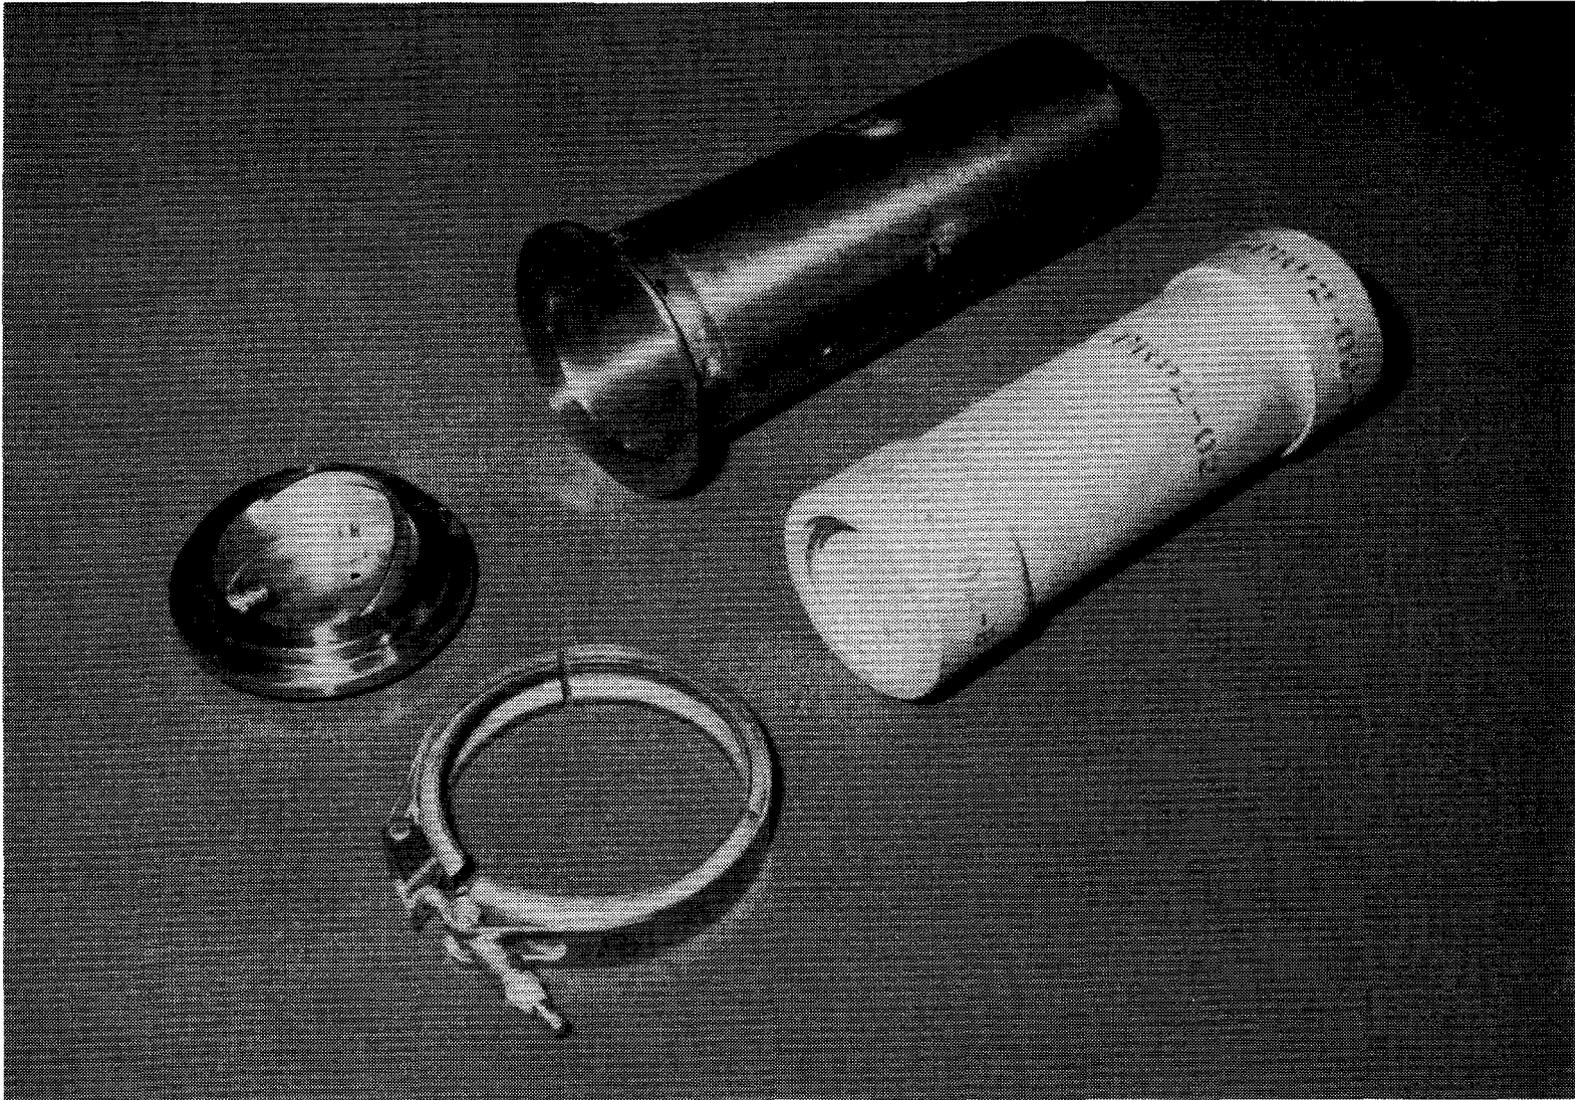
Figure 2-2. Inner Container Components

Inner container components are shown in Figure 2-2. The inner container body (Figure 2-3) is a flow-turned stainless steel payload container 12 inches long and 4 inches in diameter. A machined stainless steel lid incorporates a double O-ring seal, which provides the required level of leak containment and provides a test cavity for leak-testing. Closure of the inner container is made by a bolted V-clamp produced commercially by Aeroquip® Corporation. The RTG configuration payload (Figure 2-4) with two mock-up RTGs was used for all tests since it provided the highest weight content.

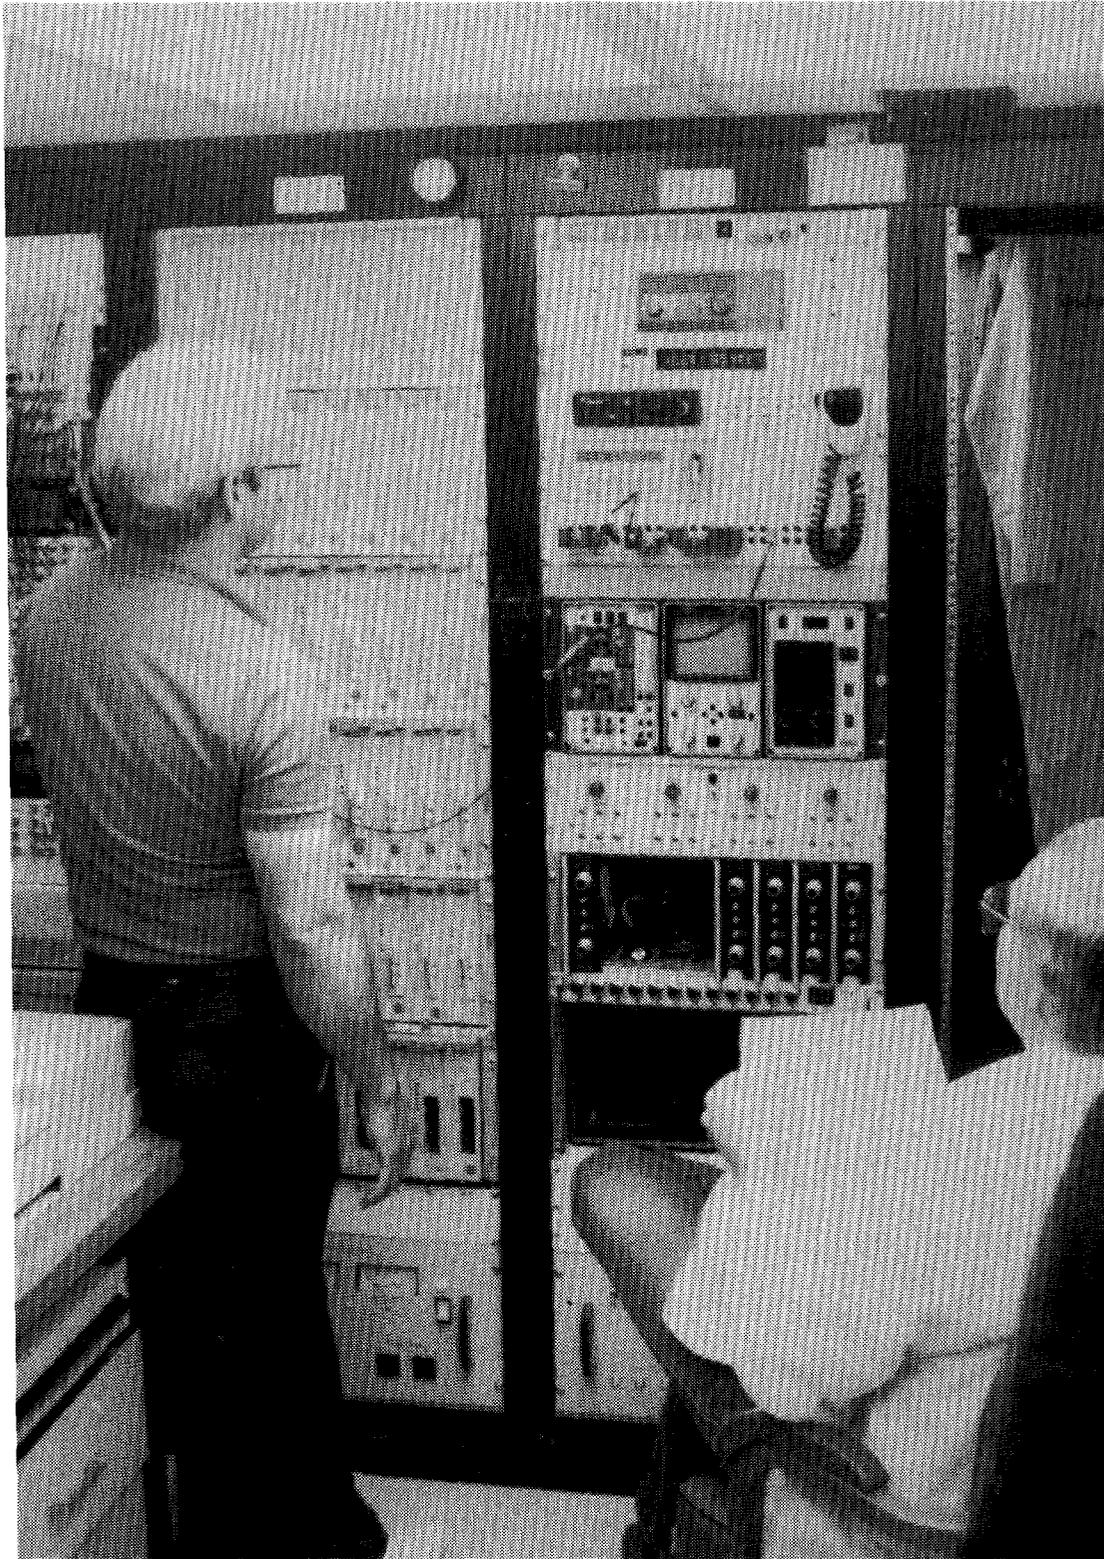
Figure 5-12. Data Acquisition System

Output from the transducers was converted into electrical signals and recorded on the data acquisition system shown in Figure 5-12. This system includes signal conditioners, which supply input voltages, and bridge balance and calibration capabilities. The signals then passed through amplifiers and were recorded on high-speed digital recorders. Data were also simultaneously recorded on analog tape machines as a backup.

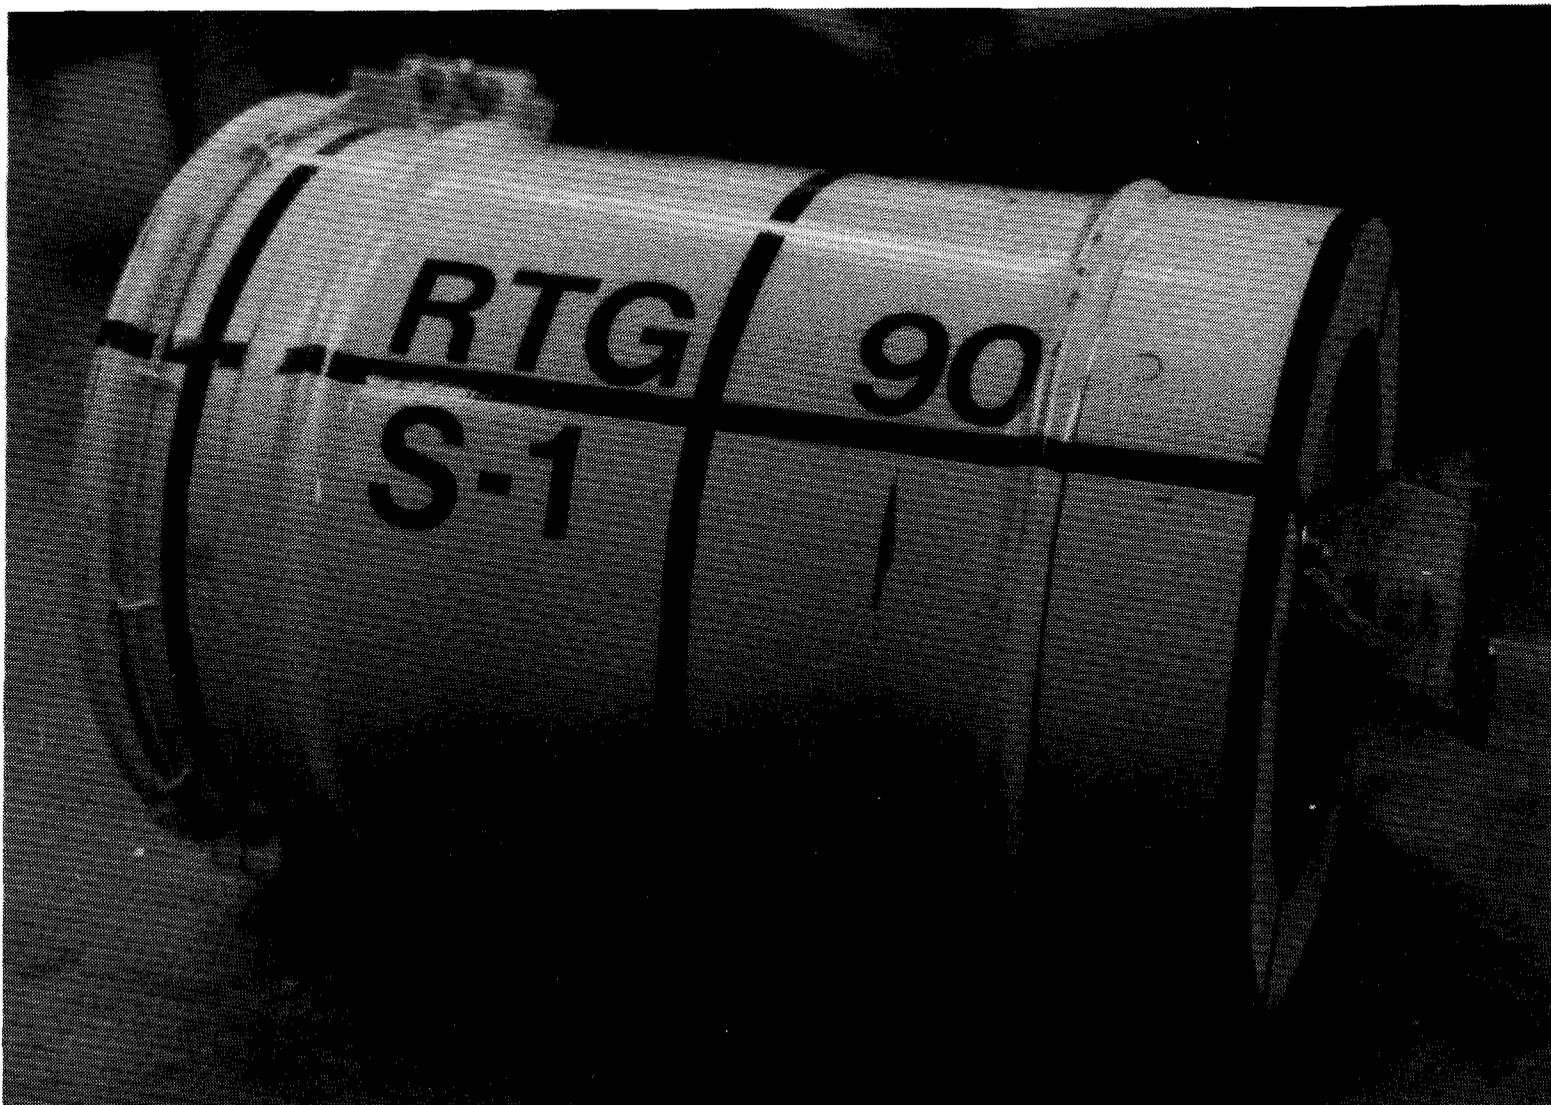
Figure 6-1. Test Unit with Weight Attached

Test unit weight was measured at 83 pounds. Because the unit was buoyant, a weight was attached to the bottom of the package to keep it submerged in the chamber (Figure 6-1).

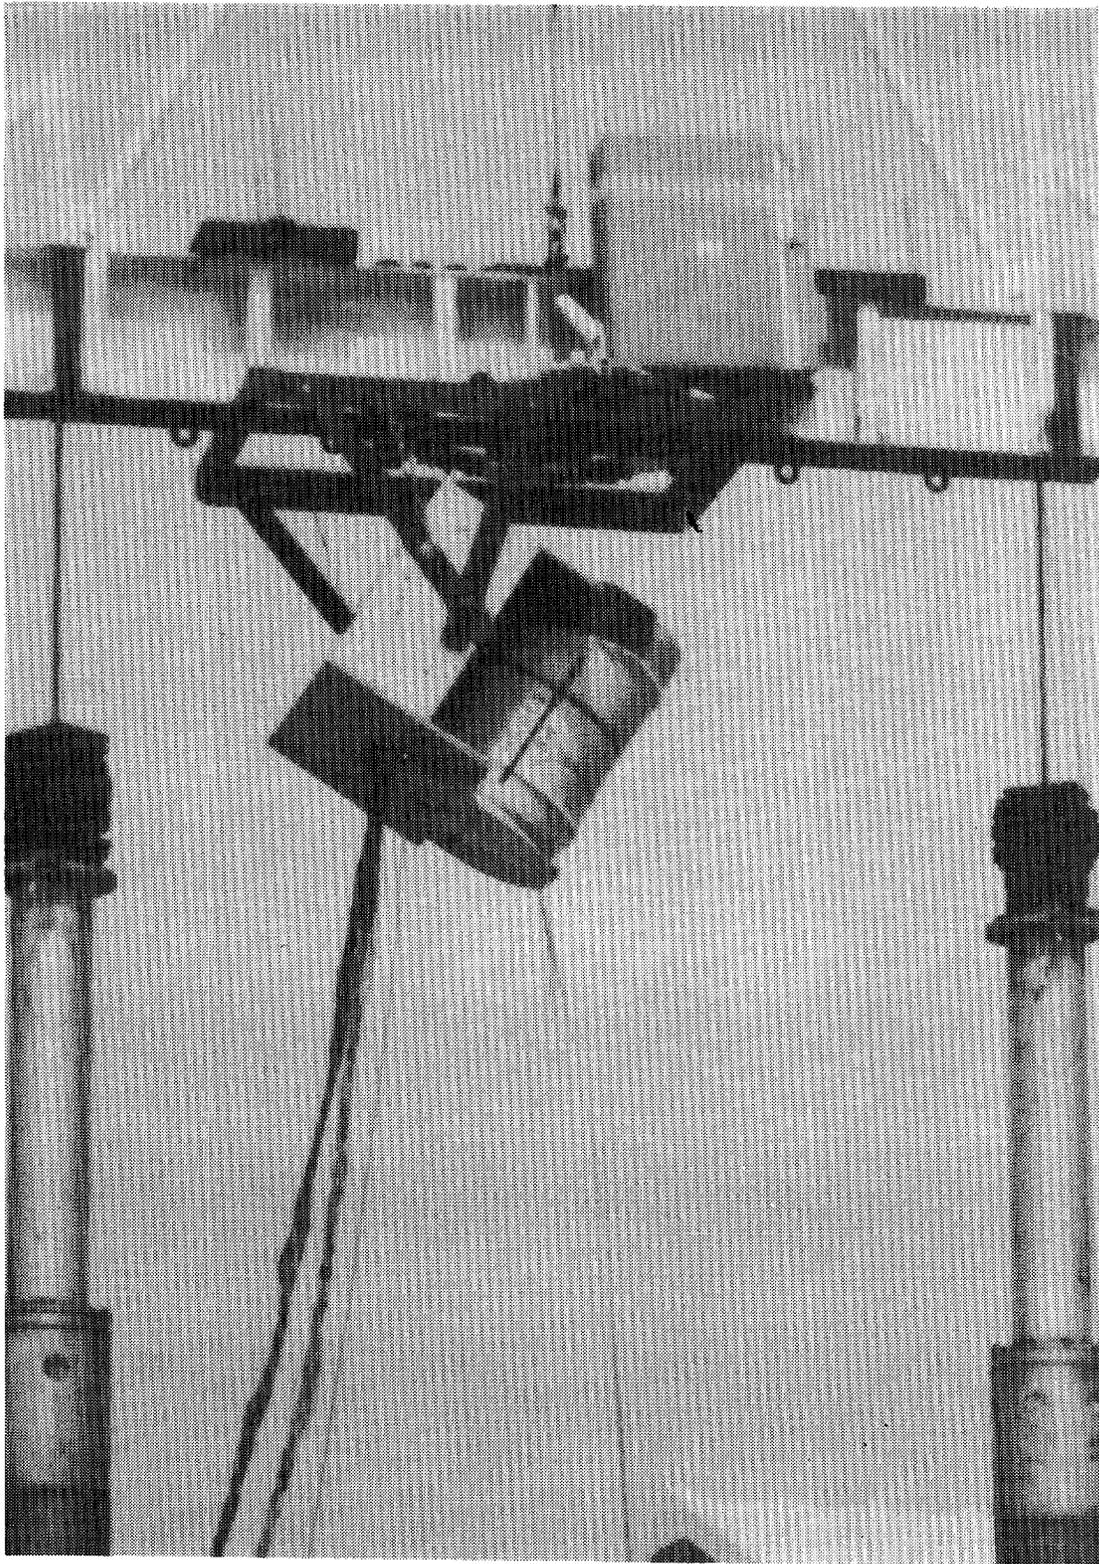
Figure 8-2. Test Unit in Cradle

This test was performed following the HS/RTG CG Over Corner Drop Test Procedure.⁵ The test unit was installed in the cradle at an angle of 57° with the 180° side facing down, aligning the center of gravity of the unit over the lid locking ring nearest the bolt lug (Figure 8-2). Figure 8-3 shows the cradle and sliding beam assembly, raised to the final drop height of 32 feet, 4-3/4 inches. The midpoint of the instrumentation wiring was tied to a forklift mast approximately 15 feet above the ground to remove some of the cable weight from the test unit and to reduce the chance of the cables being impacted by the unit during the test.

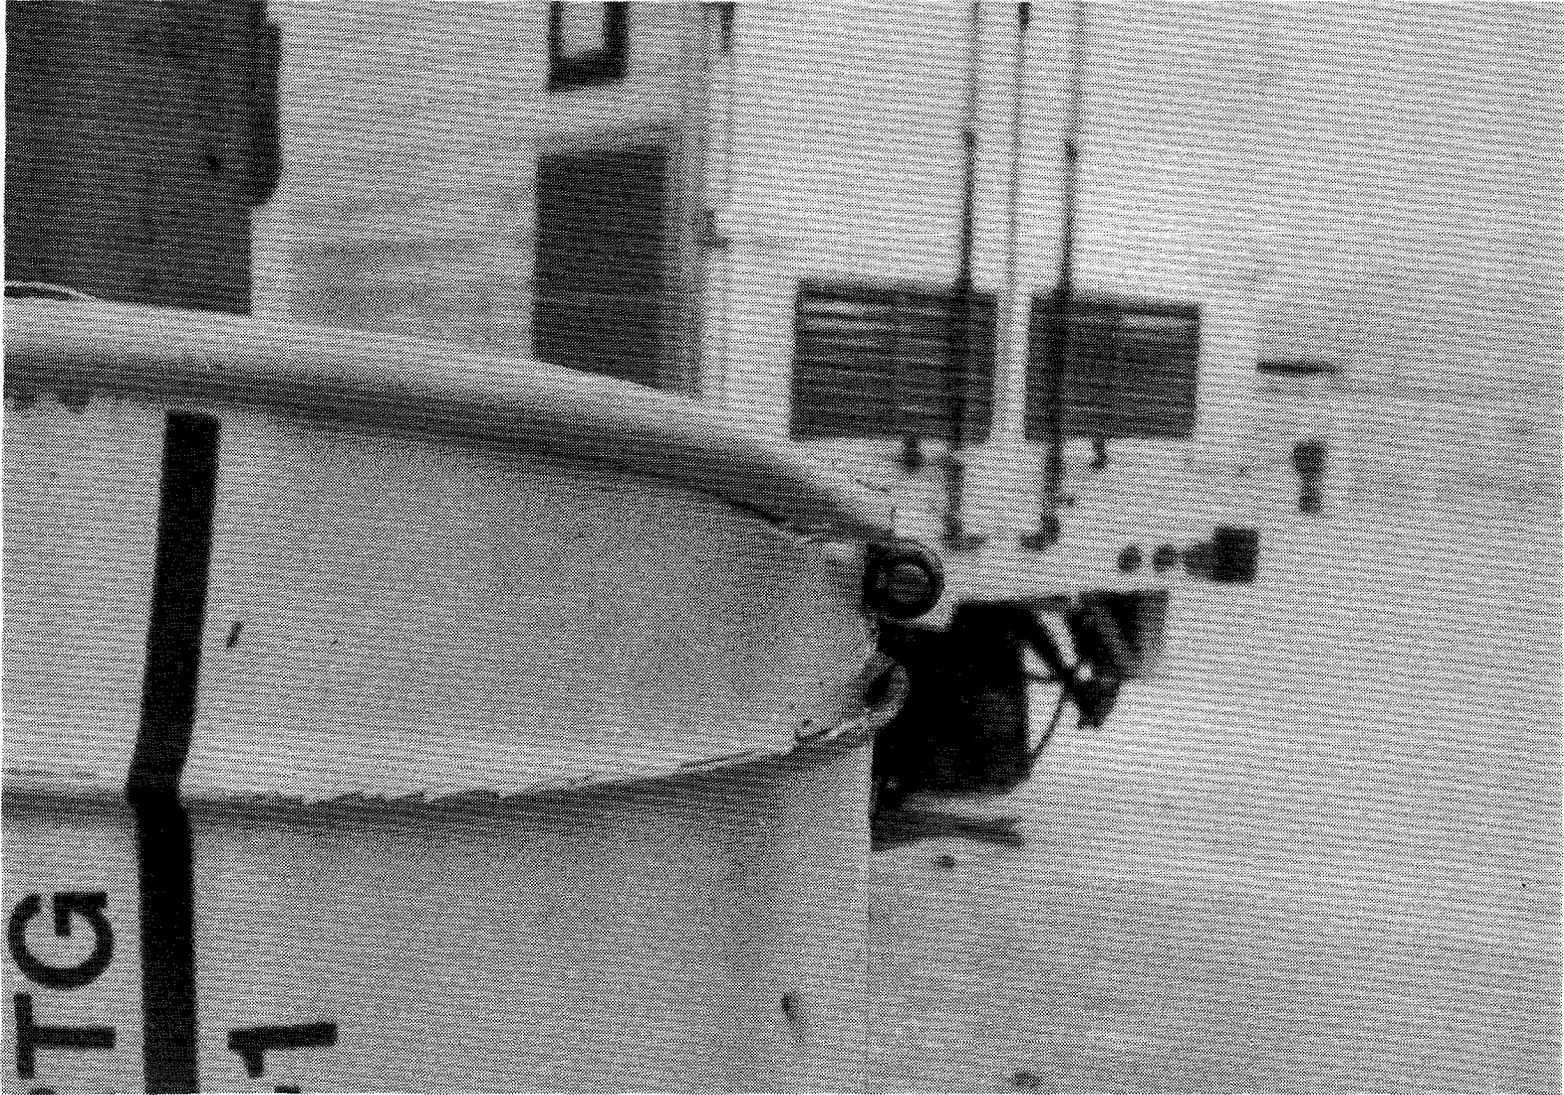
Figure 8-5. Outer Drum Deformations

Damage to the outer drum is shown in Figures 8-5 and 8-6. The deformed area is limited to the impact area extending to the upper (closest) rolled ring of the drum body, with a footprint approximately 11 inches wide. Maximum crush of the drum is estimated to be 2.5 inches at the clamp ring.

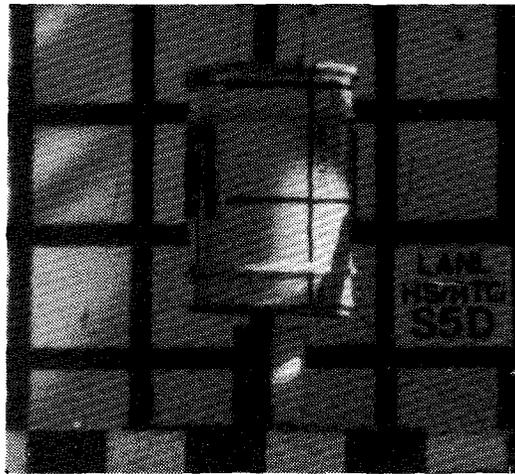
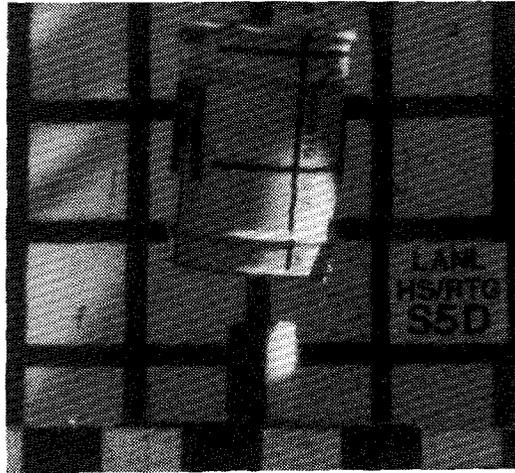
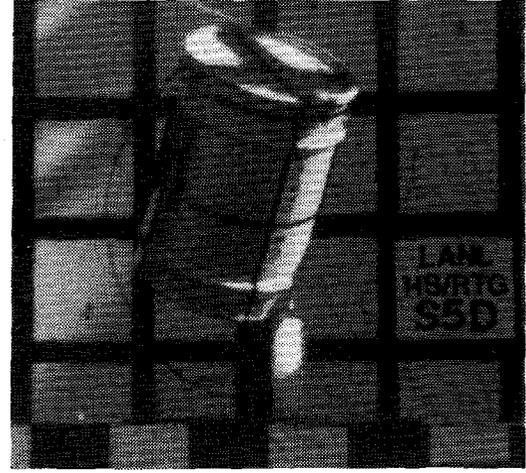
Figure 11-12. Test Sequence--Test D

The test sequence is shown in Figure 11-12. The test unit impacted the spike approximately 1 inch off center, rebounded 5 to 6 inches, and struck the spike a second time before falling to the target. The unit rolled off the raised target and came to rest on the ground.
