SANDIA REPORT

SAND97-8012 • UC-706

Quality Improvement Program for the B83 Bomb Hand Truck

This report describes the problems, issues, and history of the H1347 bomb hand truck for the B83 bomb after the bomb was put into stockpile in the mid-1980s. Major issues that were reported in Unsatisfactory Reports (URs) were cracking problems on stacking fixture welds, cracked welds on the caster bracket receptacles on the cradle, cracked caster mounting brackets, casters unlocking from the swivel lock position, and caster tires rubbing and binding on the stacking frame. Resolution of these and other problems is described.

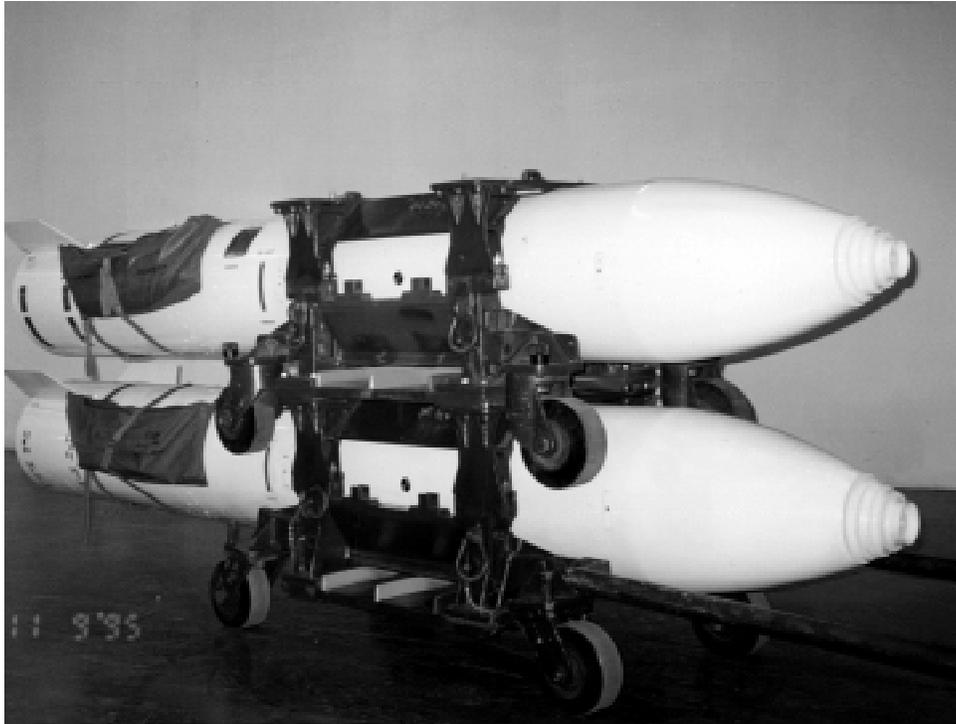
Figure 2. Two-high stack of B83 bombs in H1347 bomb hand truck.

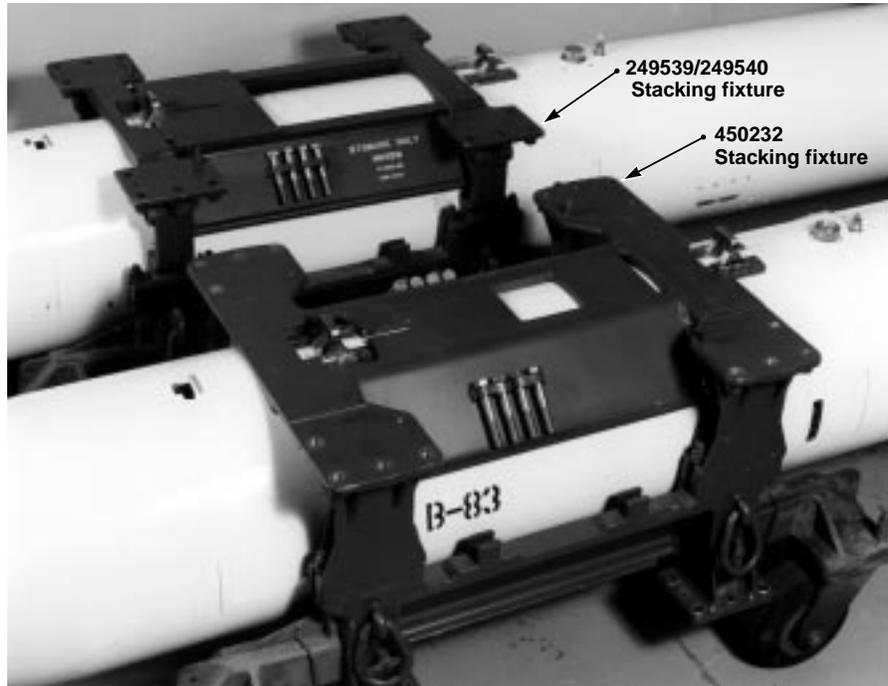
Figure 3. B83 bombs in H695B (upper) and H1347 (lower) bomb hand truck.

The configuration of stacking fixture assembly defines the bomb hand truck as H1347 (Figure 7), H695B (Figure 3, upper), or H1347A (Figure 4). The same cradle assembly is used on all three bomb hand trucks. Table 1 is a breakdown of the product definition for the various versions of the three bomb hand trucks.

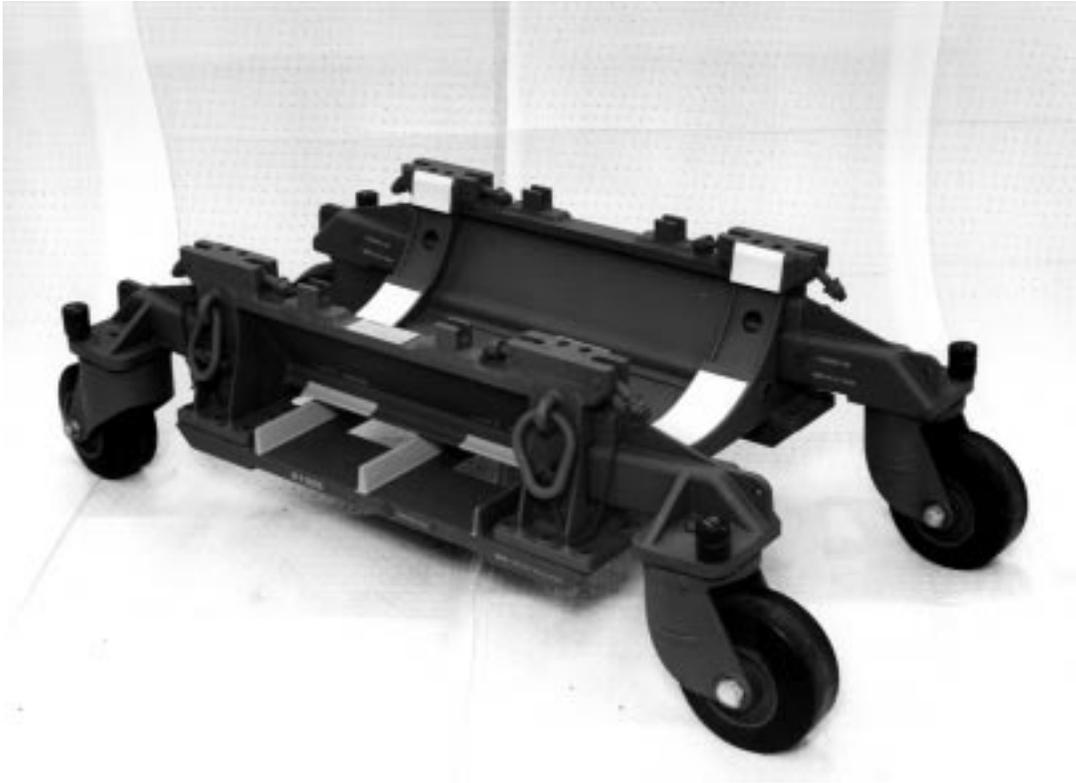
Figure 8. Cradle assembly used for H1347, H695B, and H1347A bomb hand trucks.

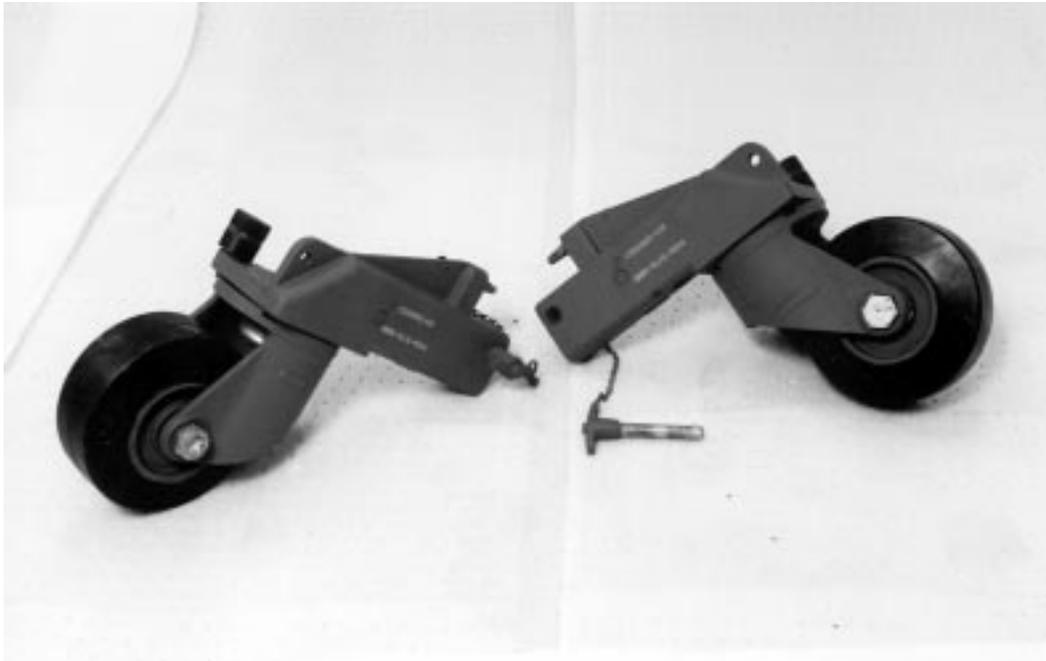
Figure 10. Barrel-type caster assemblies.

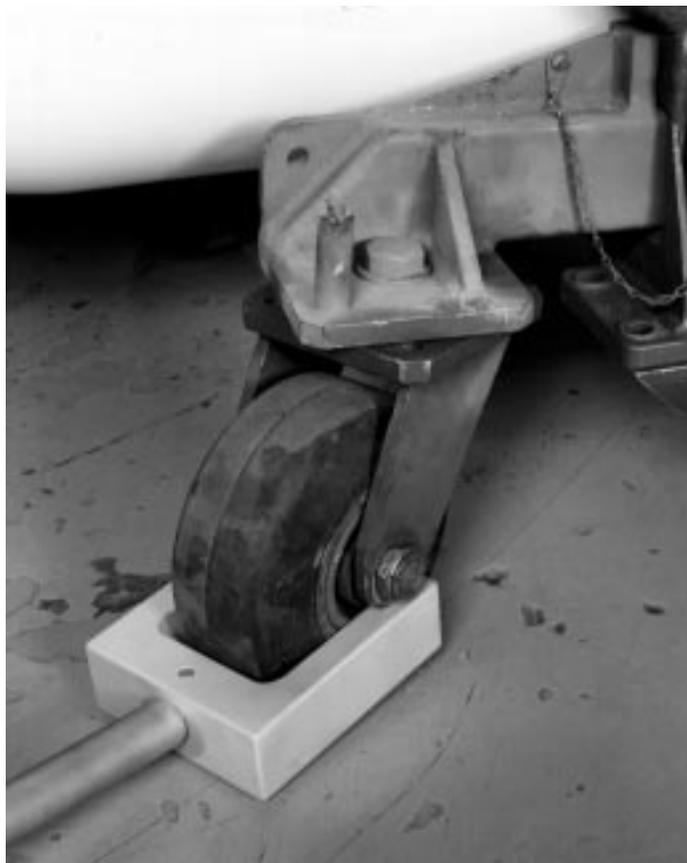
Figure 11. H1640 Casting tool engaging wheel hub on flat-sided caster assembly.

A new casting tool, the H1640, replaced the H631 and H1216 for the B83. The new tool will not gouge the frame (yoke) on the barrel casters.

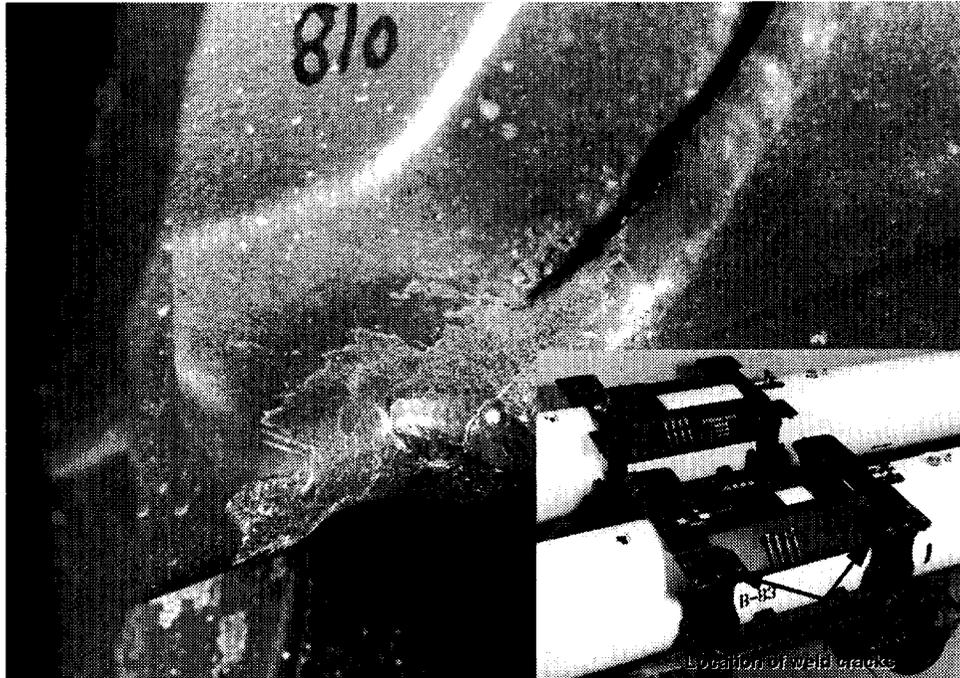
- a) Stacking fixture weld cracks on the H1347-associated stacking fixture (Figure 12).
- b) Concern with meeting the 10-g load requirement with a tail-forward loading configuration in the Safe Secure Trailer (SST).

Figure 12. Weld cracks on H1347-associated stacking fixture.

The first major indication of weld quality problems on the stacking fixture was reported by the Air Force via UR Code No. 053HG0692 dated June 22, 1992 where 20 of 38 units inspected were reported as cracked. The cracks are in the outboard regions of the 45° plates where the center section is welded to the end castings (Figure 12). An on-site inspection by an evaluation team consisting of Sandia, AlliedSignal/FM&T, and DOE/AL/WQD personnel was completed on July 21, 1992. Two H1347s with the cracked stacking fixtures were sent to AlliedSignal/FM&T for evaluation. The cracks were characterized as crater cracks with some propagating to form longitudinal cracks up to 1.1 inches in length. There was lack of fill of the weld crater at the time of manufacture and the cracks formed upon solidification of the weld metal. Some stacking fixtures had cracks in three of the four welds. The welding specification does not allow crater cracks, cracks in the weld bead, or in the parent material. Product with these defects do not meet the design requirements and should not have been accepted for WR use.

An asset-wide inspection program for the H1347-associated stacking fixture, including both Air Force and DOE inventories, showed 106 out of 529 units inspected to be cracked (20%). These inspections identified cracks that were visible through the paint.

- a) Changes to the TP manuals were made to allow cracks (any length) in the welds for the H1347-associated stacking fixture after load testing resolved there were no safety concerns. However, product shipped from DOE to the Air Force covered by Reprocessing Specification RS214073 limits the length of any individual crack to 2 inches and the accumulative length of all cracks to less than 8 inches, total.

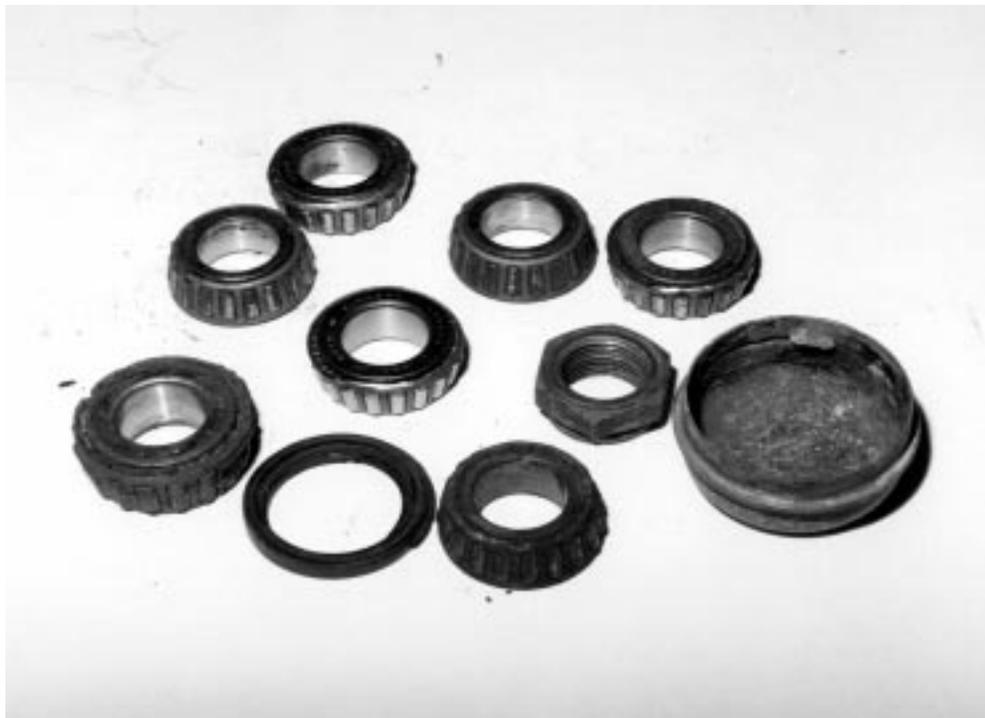
- e) Casters unlocking from the swivel lock position during transportation.
- f) Poor condition of bearings (corrosion, no lubrication), seals, nuts, and dust caps in caster assemblies (Figure 15).

Figure 15. Condition of bearings, seals, nuts, and dust caps in caster assembly.

caster binding against the stacking frame. Also, all casters were disassembled, damaged bearings and seals were replaced, and the bearings were relubricated. The casters used were 156982-00/01 and 156983-00/01 referred to as barrel casters (many that still contained the cam lock). An alternate version of casters (153790-00 and 153791-00), referred to as flat-sided casters, were not used in this production.
