SANDIA REPORT

SAND2004-1057
Unlimited Release
Printed May 2004

Analytical Investigation of $\text{AlCl}_3/\text{SO}_2\text{Cl}_2$ Catholyte Materials for Secondary Fuze Reserve Batteries

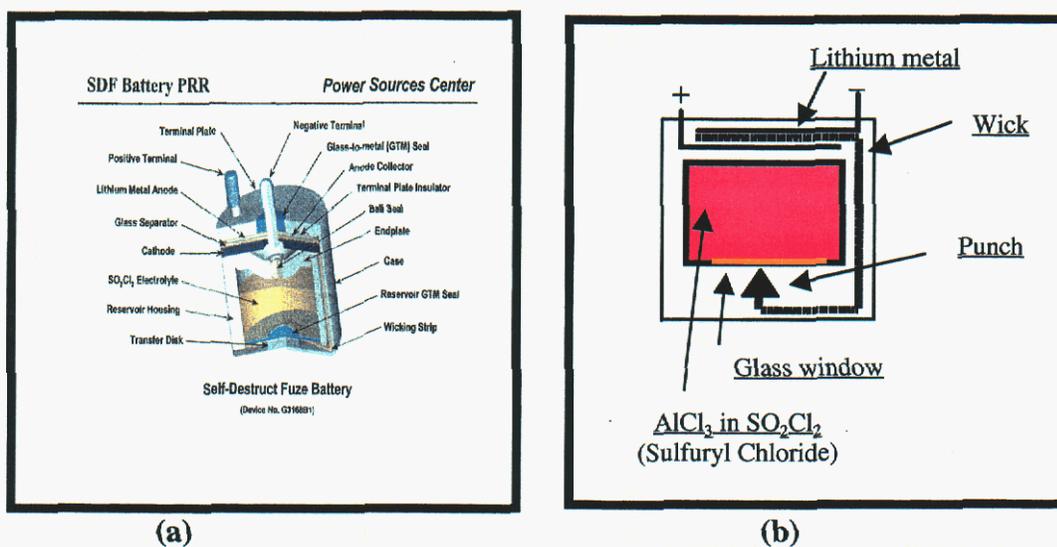
Figure 2. Schematic designs of the (a) KDI design and (b) simplistic diagram of component.

A battery is used to power a timer-drive that is used as the secondary fuze which consists for this system of a reserve lithium/aluminum chloride sulfuryl chloride ($\text{AlCl}_3/\text{SO}_2\text{Cl}_2$) catholyte, shown in Figure 2a . A catholyte is a material that acts as both cathode and electrolyte. As can be observed in Figure 2b, the battery in this setup is activated by breaking a glass plate at the bottom of the sealed ampule containing the $\text{AlCl}_3/\text{SO}_2\text{Cl}_2$ catholyte. Once released, the liquid is wicked into the active electrode area.

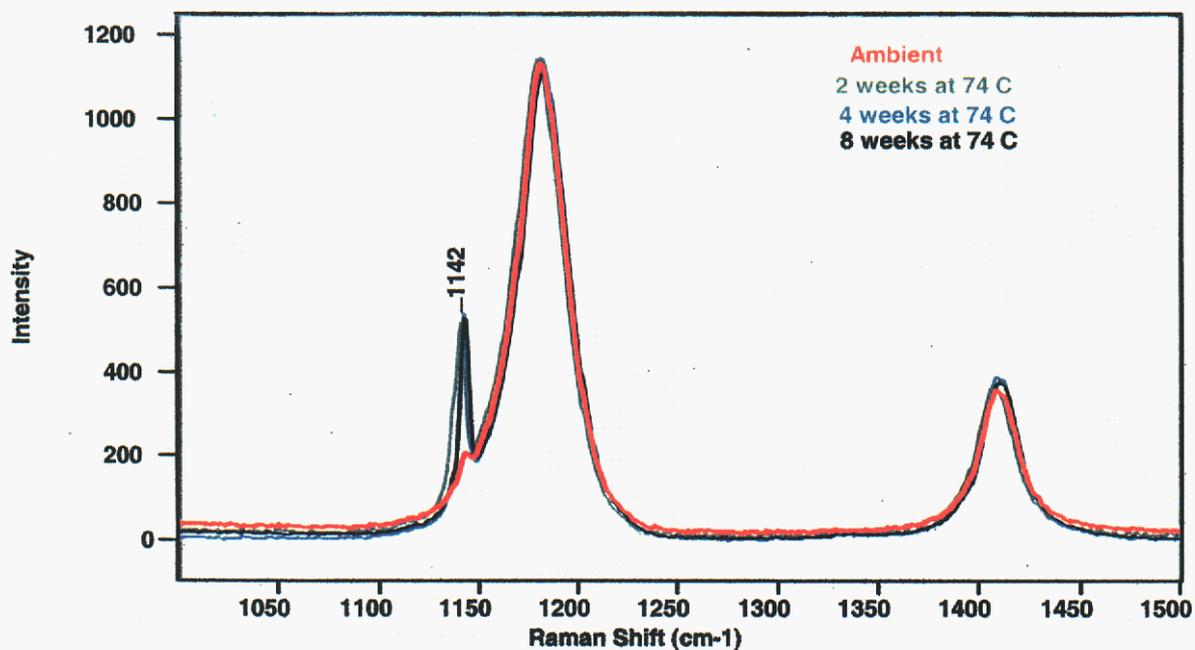
Figure 3. Raman spectrum of SO_2Cl_2 monitored over time

ingrowth of a peak at 1142 cm^{-1} was noted which is consistent with SO_2 gas. The Raman spectra are shown in Figure 3. Also observed at 500 to 550 cm^{-1} , but not shown here, were bands associated with $\text{Cl}_2(\text{g})$ that grew in a manner consistent with the amount of $\text{SO}_2(\text{g})$. This implies that SO_2Cl_2 decomposes as shown in eq 2.

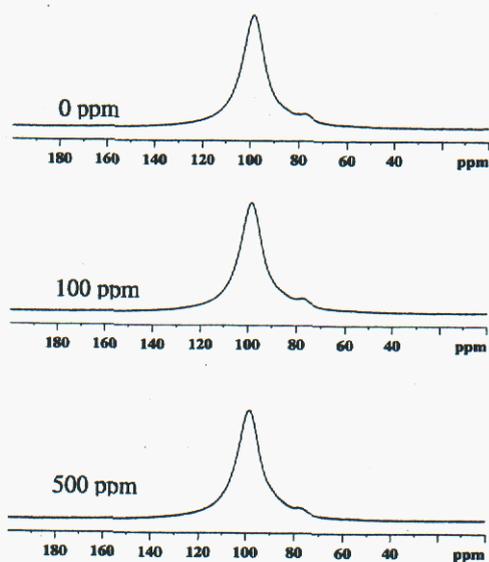
Figure 4. ^{27}Al NMR of AlCl_3 with various aliquots of water added.

addition of water at various concentrations (up to 500 ppm). Therefore water was removed as a potential part of any reactivity observed in this system.

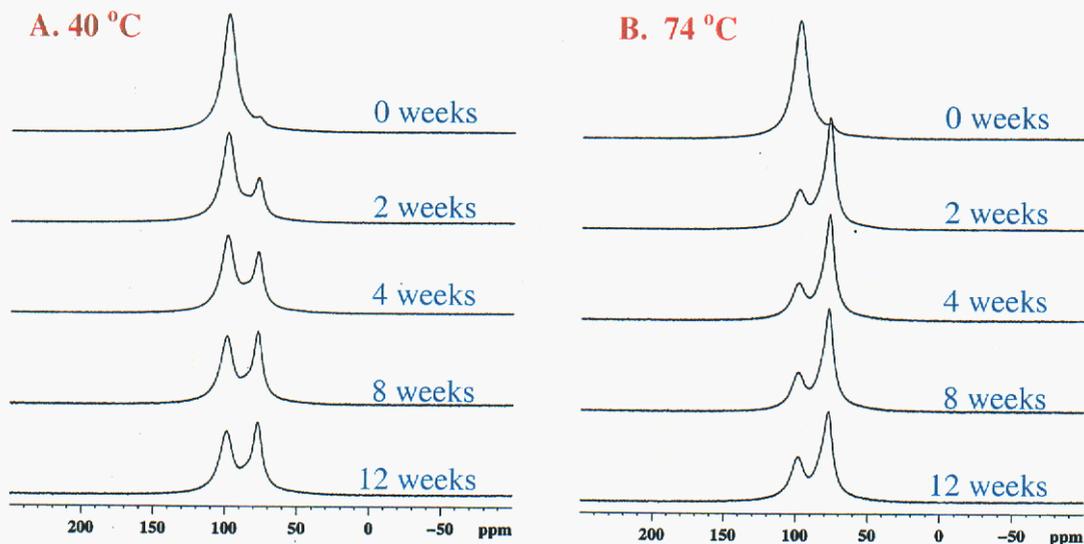
Figure 5. Solution ^{27}Al NMR data for aging of catholyte at (a) $40\text{ }^\circ\text{C}$ and (b) $74\text{ }^\circ\text{C}$.

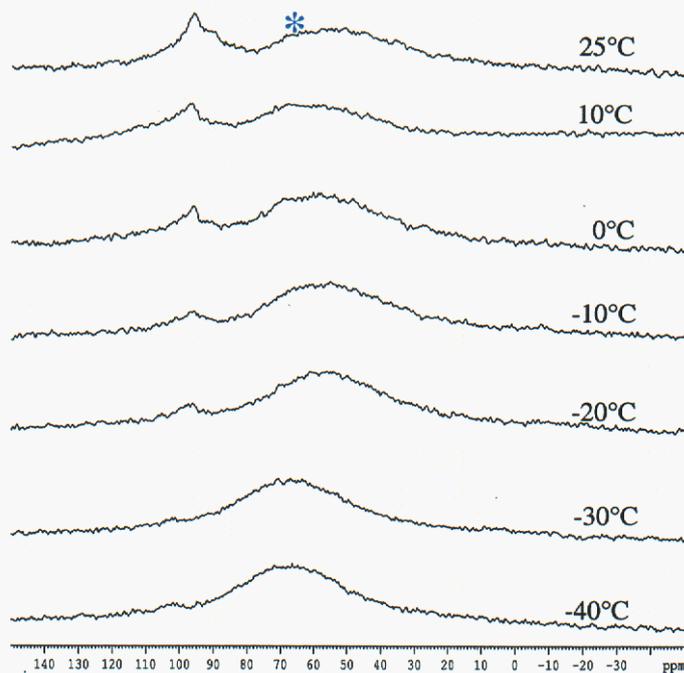
Figure 8. ^{27}Al NMR spectrum of slowly warmed catholyte solution (* probe background)

slowly warmed to room temperature (shown in Figure 8). For the frozen samples, the ^{27}Al NMR lines are extremely broad and could not be observed. A broad background signal originating from the probe, tubes and glass inserts is observed at $\delta \sim +68$ ppm. With heating only a single resonance is observed at $\delta = +101$ ppm, which is identical to what was recorded for AlCl_3 in toluene- d_8 . Therefore, this resonance was assigned to AlCl_3 . At higher temperatures an additional resonance grows in at $\delta \sim +92$ ppm, consistent with the AlCl_3 dinuclear complex.

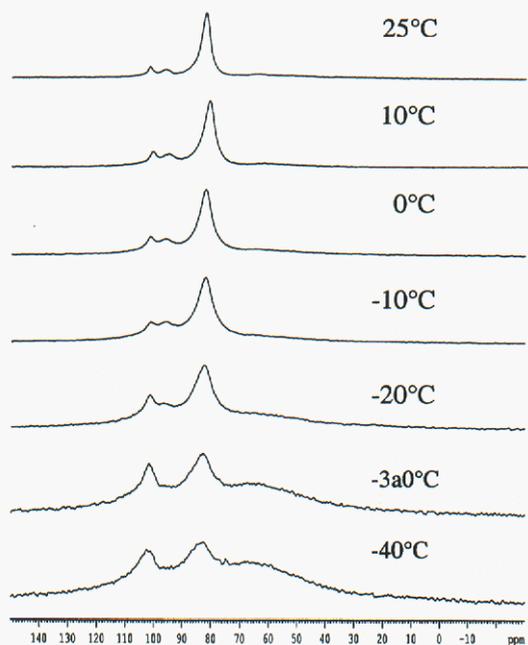
Figure 11. Variable temperature ^{27}Al NMR spectrum of a fresh $\text{AlCl}_3 + \text{SO}_2$ gas in toluene- d_8 .

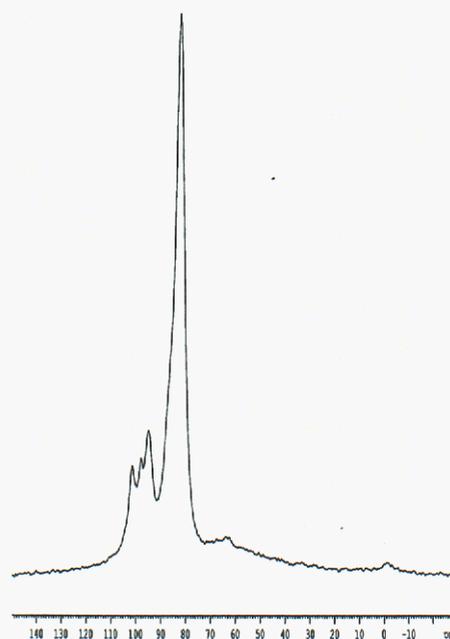
Figure 12. ^{27}Al NMR spectrum of aged $\text{AlCl}_3 + \text{SO}_2$ gas in toluene- d_8 solution

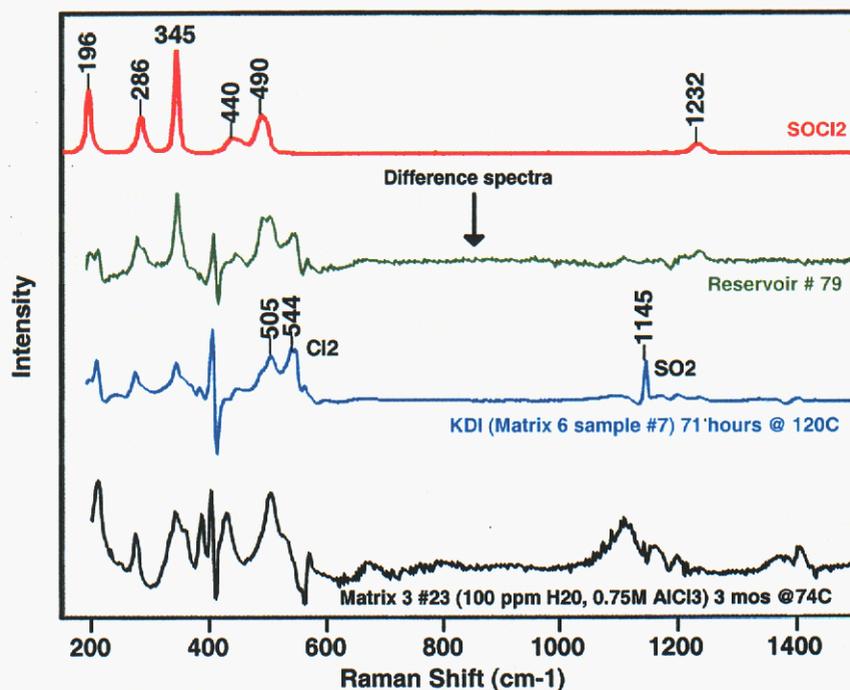
Figure 13. Raman spectra of (a) SOCl_2 , and difference spectra of (b) reservoir #79 (gelled), (c) KDI sample, and (d) sample prepared from commercial reagents.

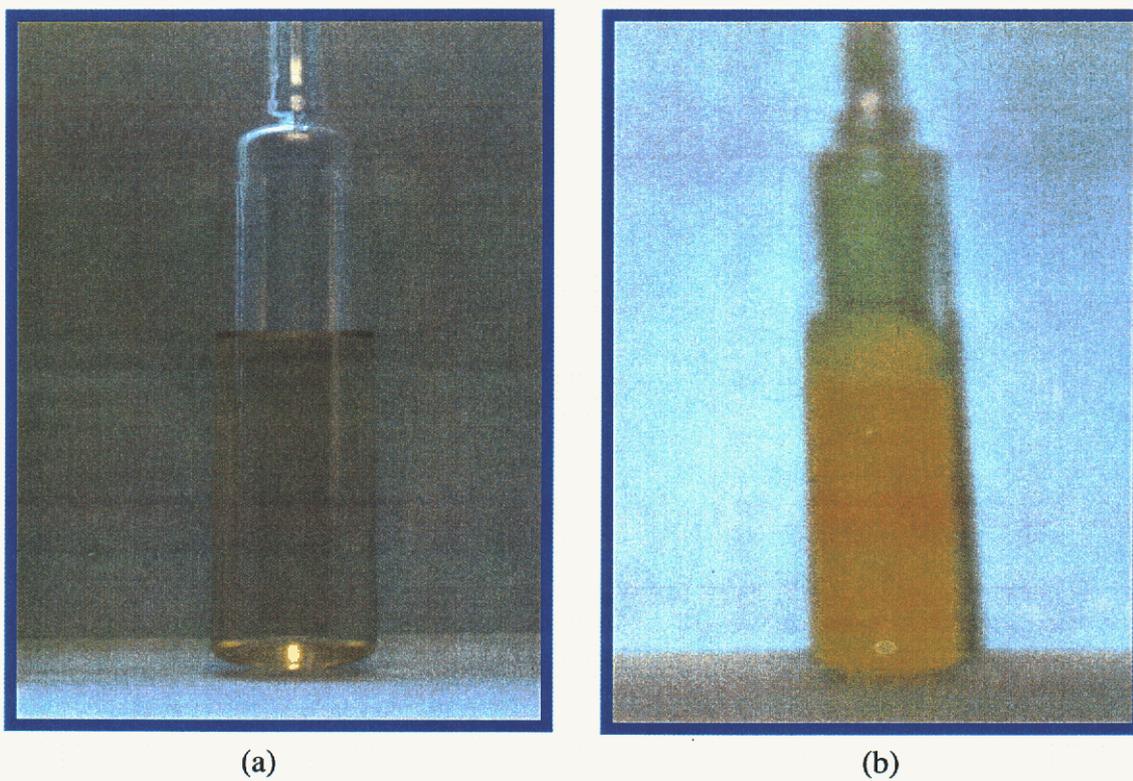
Figure 16. Pictures of catholyte at 120°C at (a) 0 h. and (b) 168 h.

5c. Precipitate. Investigation of the precipitate has also been undertaken. Shown in Figure 16 are the visual changes that occur upon high temperature treatment. The samples proved to be under a great deal of pressure, and in fact the reaction mixture was

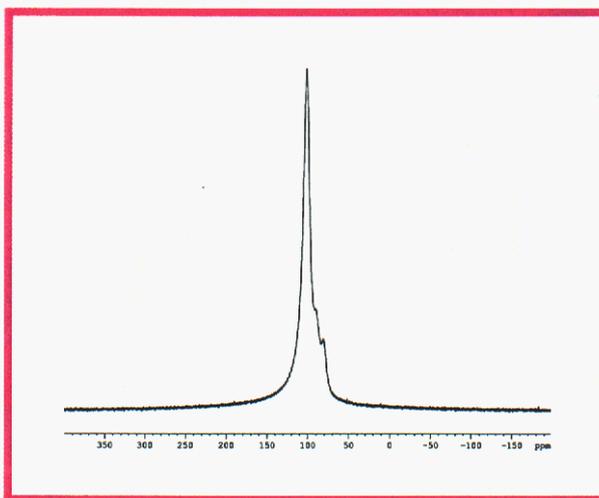
Figure 19. ^{27}Al NMR spectrum of mother liquor of sealed sample of precipitated catholyte.

Investigation of the mother liquor lends some insight into the behavior of this precipitate (Figure 18) and eq 6. For the 24 h mother liquor, NMR data collected at different times during the thaw reveal that there is no change in the speciation observed. Further, the mother-liquor solutions look very similar to the freshly prepared $\text{AlCl}_3/\text{SOCl}_2$ solutions previously discussed. However, when compared to the 168 h sample, AlCl_3 dominates the spectrum (Figure 19).

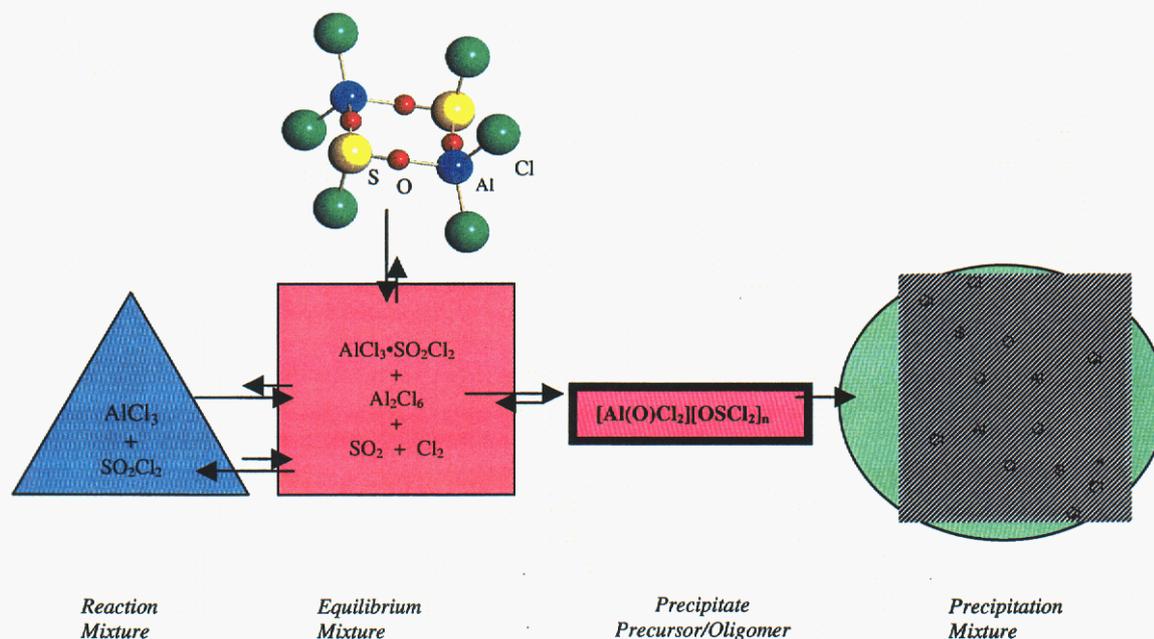
Figure 20. Schematic representation of various equilibria determined in this study.

Further, the precipitate or gel that forms from this solution over time was found by Raman spectroscopic studies to possess a component that is consistent with SOCl_2 . This implies that **1** may be transformed to a polymeric species with Al-O-Al bonds coordinated by SOCl_2 . In order to form a precipitate, it is necessary to have larger oligomers. The precipitate was further characterized by solid state ^{27}Al MAS NMR data to possess predominantly octahedral (O_h) Al metal center. This implies $\{[\text{Al}(\text{O})\text{Cl}_2][\text{OSCl}_2]\}_n$ must undergo some internal rearrangements prior to precipitation. In summary, Figure 20 shows a representation of the chemical pathway elucidated from this investigation.

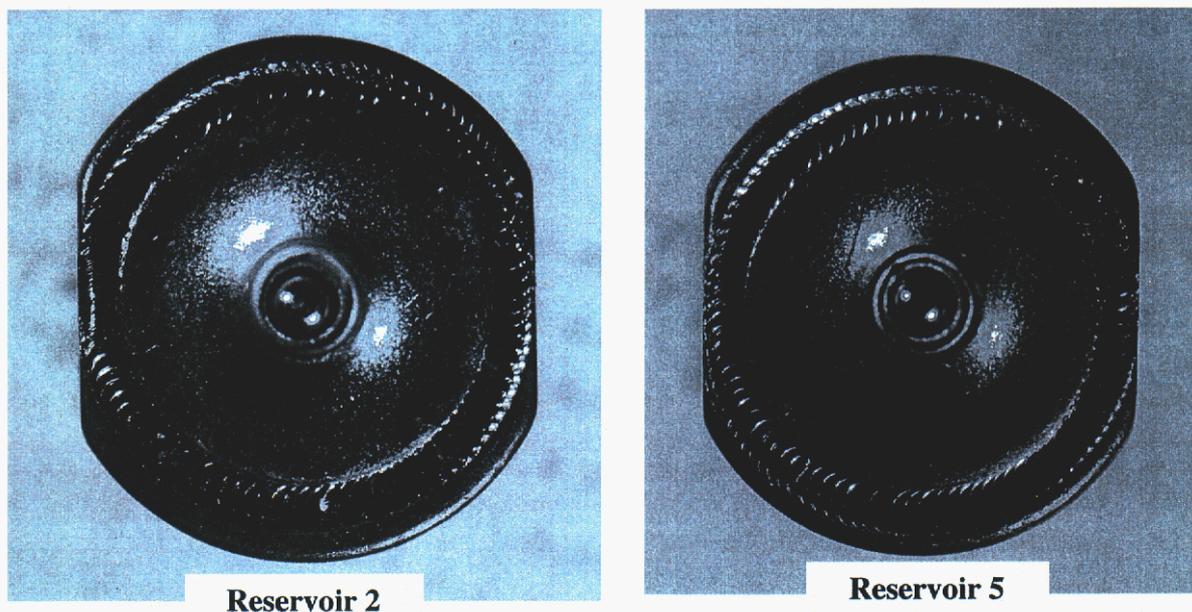
Figure 21. Photomicrographs of two different reservoirs showing typical laser weld.

After removal of the catholyte, microscopic examination of all of the welds on each reservoir was completed, and Figure 21 shows photomicrographs of the typical closure welds observed. As can be seen, the weld beads are uniform in width, and there did not appear to be excessive concavity in the bead. However, the solidification lines resulting from the pulsed laser source did show somewhat excessive pulse-to-pulse overlap. These observations were the same in every case, demonstrating high reproducibility.

As seen in the photomicrographs of Figure 21, the welds themselves are circular in nature, and the outer circumference of the reservoir displays two flats diametrically opposed to one another along the perimeter. Since it is conceivable that the nature of the weld is different in these areas, two reservoirs were cross-sectioned through the flats and two reservoirs were cross-sectioned at 90-degrees to the flats. Figure 22 shows cross-sectional photomicrographs of these four reservoirs. As seen, these welds were found to

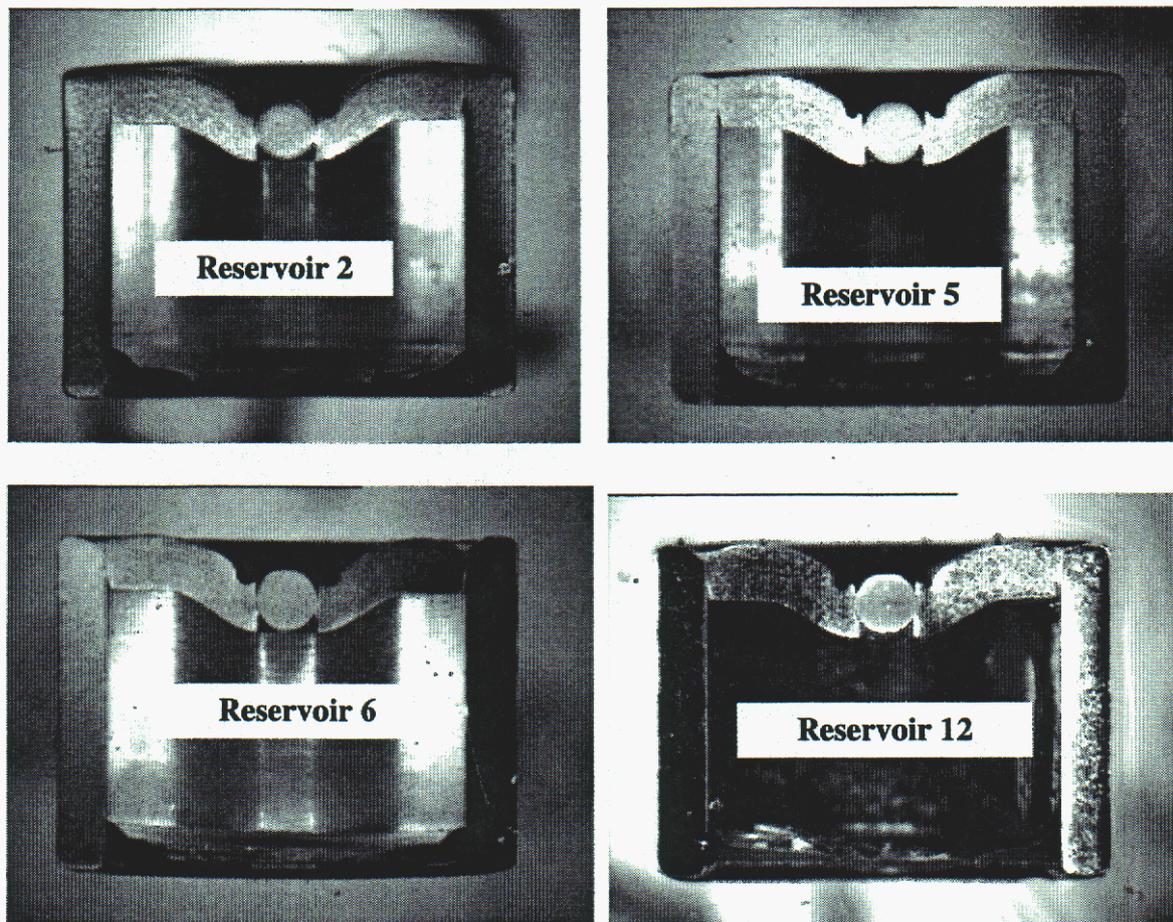
Figure 22. Cross sectional photomicrographs of the weld taken parallel and normal to the flat.

be essentially identical in every case, consequently the remaining 16 reservoirs were cross-sectioned through the welds at 90-degrees to the flats.

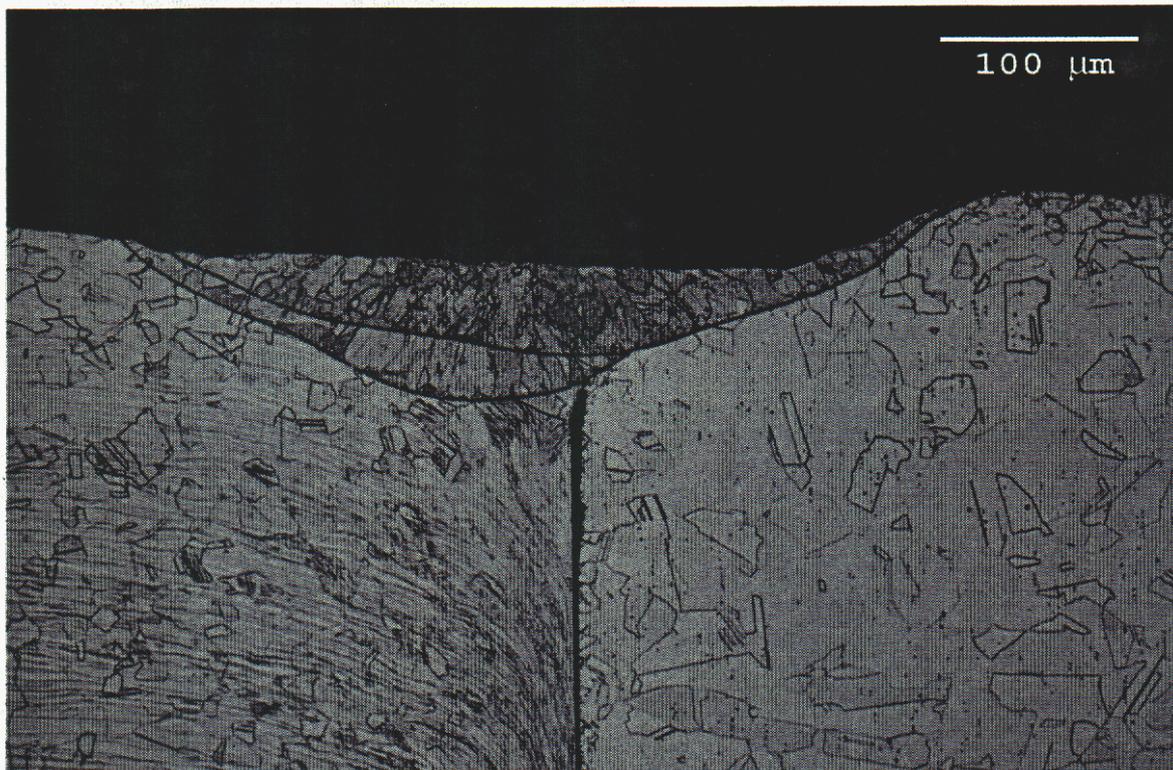
Figure 24 . Side 2 of Reservoir 2 Laser Weld Width = .018"; Max. Depth - .0036"; Eff. Depth - .003"; Fusion Lines - 3. The weld is a slight amount of a root void that reduced the leak path.

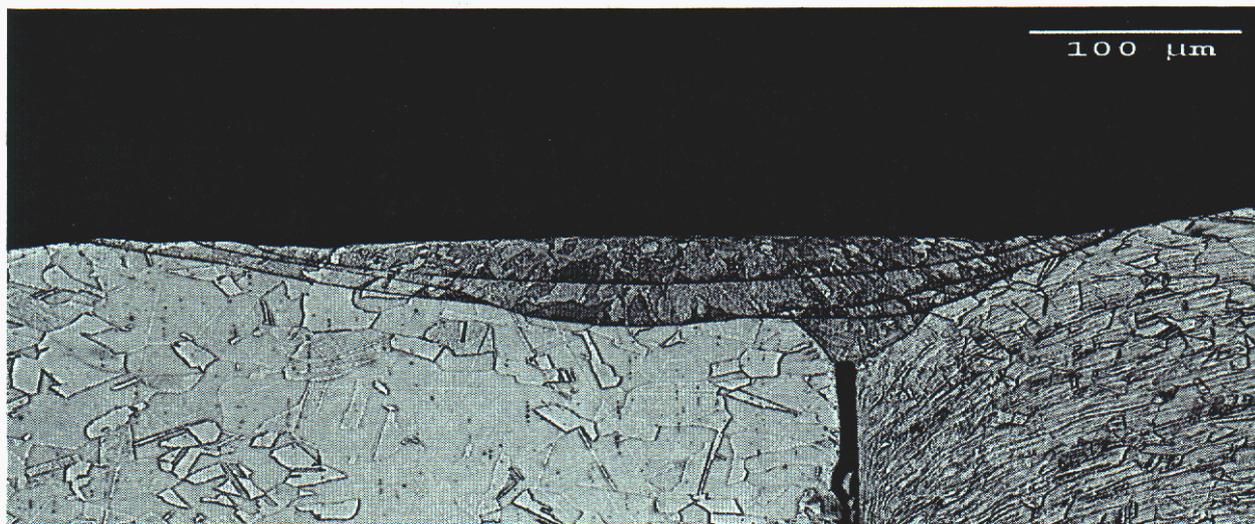
Figure 25. Side 1 of Reservoir 5 Laser Weld Width = .020"; Max. Depth - .0044"; Eff. Depth - .0044"; Fusion Lines - 4. The weld is slightly off-center of the weld joint.

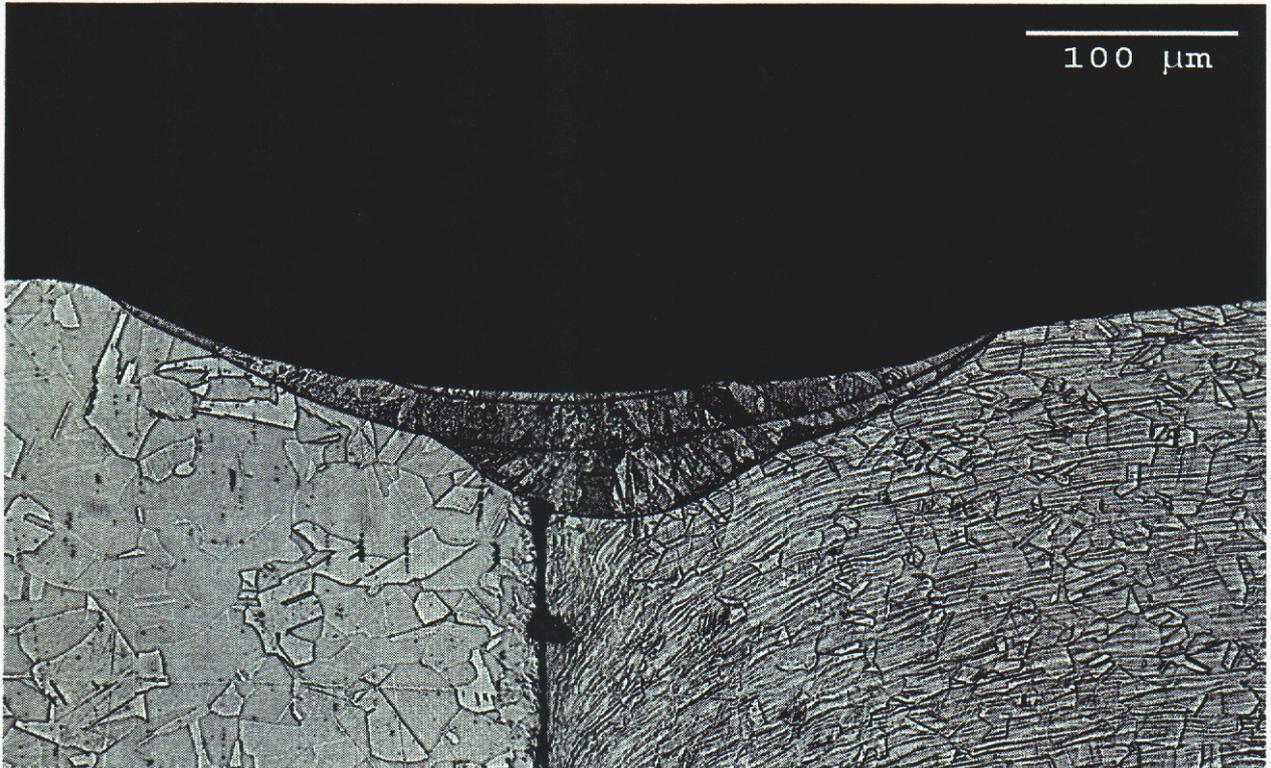
Figure 27. Side 1 of Reservoir 6 Laser Weld Width = .018"; Max. Depth - .0030"; Eff. Depth - .0025"; Fusion Lines - 3. The weld is slightly off-center of the weld joint.

The welding parameters (power, pulse length & rate, travel speed, etc.) used to make the welds also appears to be of high quality. The parameters used are producing a very consistent conductive (low depth to width ratio) weld. As shown in Table 1, the average width of the welds is .0186" with a standard deviation (STD) of .0012"; the average maximum penetration depth is .0043" with an STD of .001"; and the effective depth (leak path) average is .0037" with an STD of .0009". However, there is margin in the parameters to reduce the heat input by lowering the welding pulse rate or increasing the welding speed. The photomicrographs, Figures 23 and 27 for example, show 3 - 5

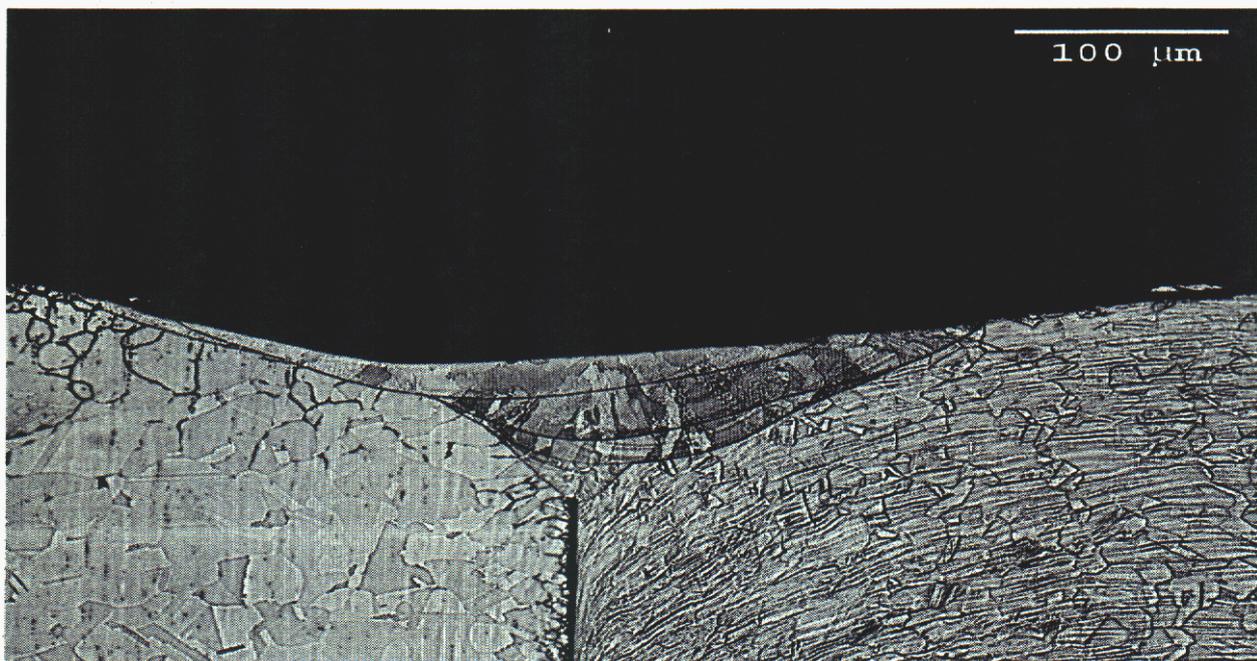
Figure 31 . Side 1 of Reservoir 14 Laser Weld Width = .018"; Max. Depth - .0038"; Eff. Depth - .0038"; Fusion Lines - 4. Areas of sensitization can be seen on the top & side of the case.

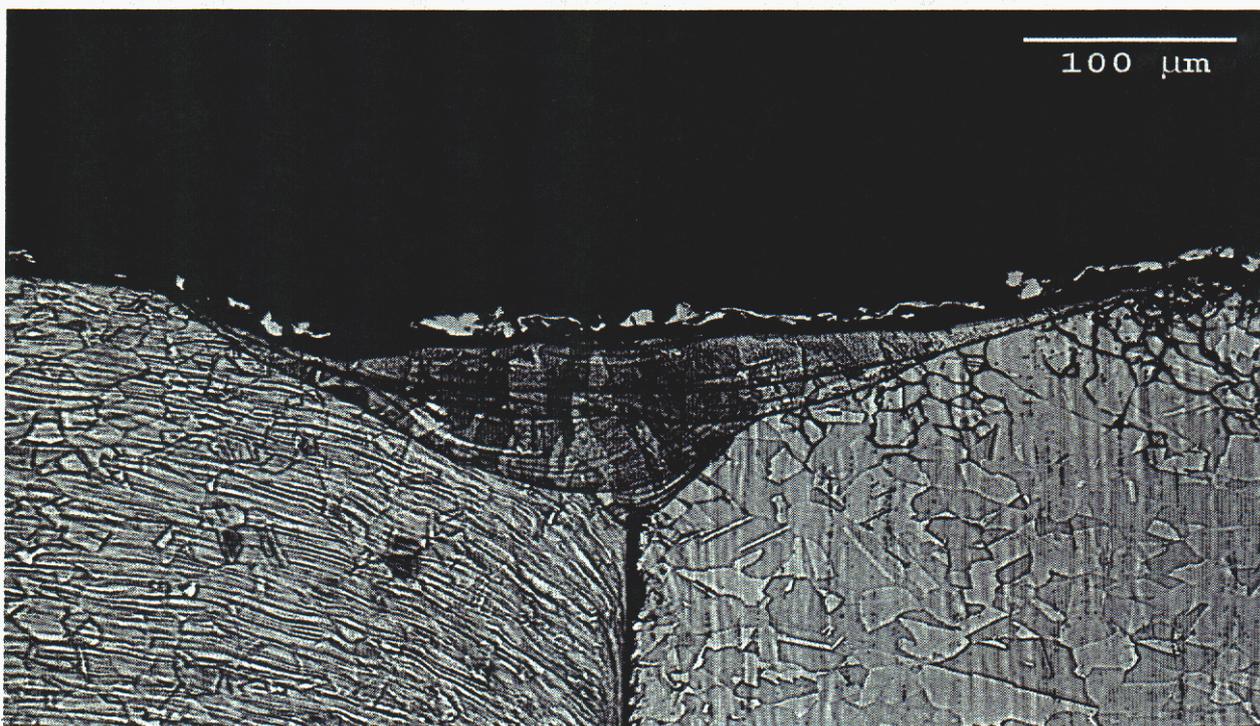
Figure 32. Side 2 of Reservoir 14 Laser Weld Width = .017"; Max. Depth - .0041"; Eff. Depth - .0036"; Fusion Lines - 5. Areas of sensitization can be seen on the top & side of the case.

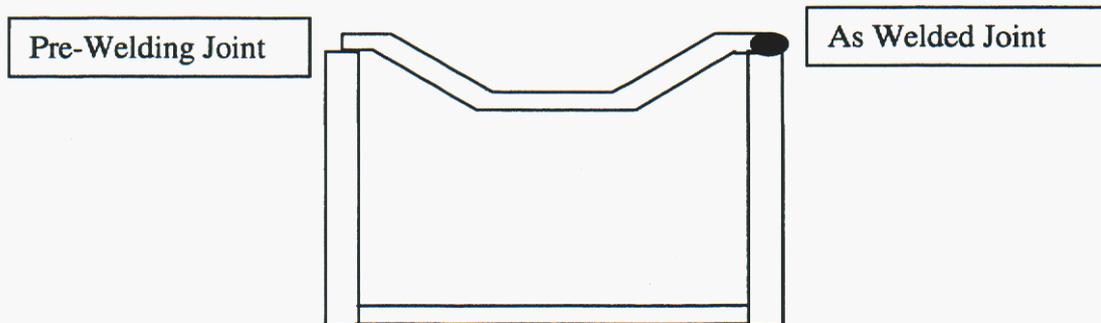
Figure 33. Proposed Endplate to Case Weld

Based on these results, it is recommended that the end plate geometry and weld be changed. If the present weld strength, based on .003" - .005" penetration, is sufficient for unit performance, the end plate thickness can be reduced to .005" instead of the .020" thickness. By reducing the thickness to .005" the plug can be stamped such that it can form a cap rather than a plug. The cap outer diameter should be slightly smaller in diameter than the case as shown in Figure 33. The seal weld can then be made around the edge of the cap producing a meltdown type fillet weld which is easy and results in a low-stress joint, eliminate the 'coalescence' problem when there is a gap in the 'butt' weld (plug/case), and reduce the effect of catholyte in the root of the joint. There should not be any catholyte present as the weld is being made to the outer portion of the end of the case rather than the inner portion where the catholyte is present. This option provides the opportunity of being able to increase the amount of catholyte in the reservoir by ~15% when the end plate thickness is reduced. The increase can be seen in the calculations shown with Figure 33 which may be beneficial to battery performance.

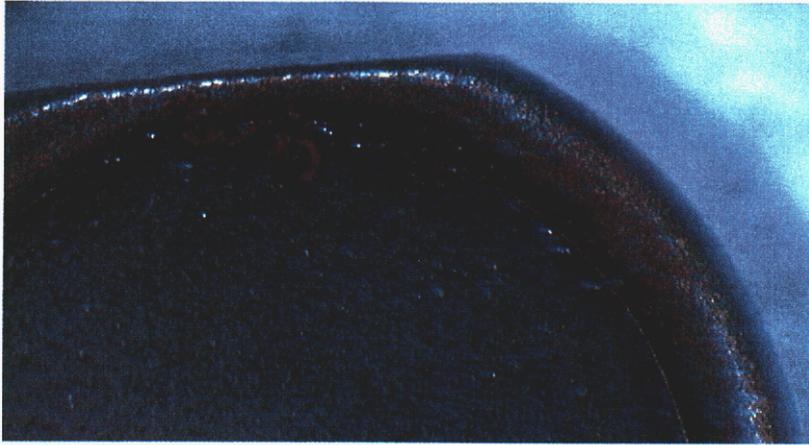
Figure 1. Photomicrograph of brown deposit at the glass-to-metal seal of Reservoir 94.

Ten reservoirs containing “aged/gelled” electrolyte were received from ARL, thereby satisfying Items 2a and 3 of the February 2002 Action Item List. We have completed an incoming visual/microscopic inspection of these reservoirs, and have identified both brown (iron oxide perhaps) and white crystalline materials on the external surface of many of these reservoirs. While the brown material was found at both the ball seal end of the reservoir as well as on the glass-to-metal seal end, the white material was found predominately on the ball seal end of the reservoirs. Examples of the deposits observed are shown in Figures 1-5 below, and Table 1 summarizes the visual observations made on all of the reservoirs.

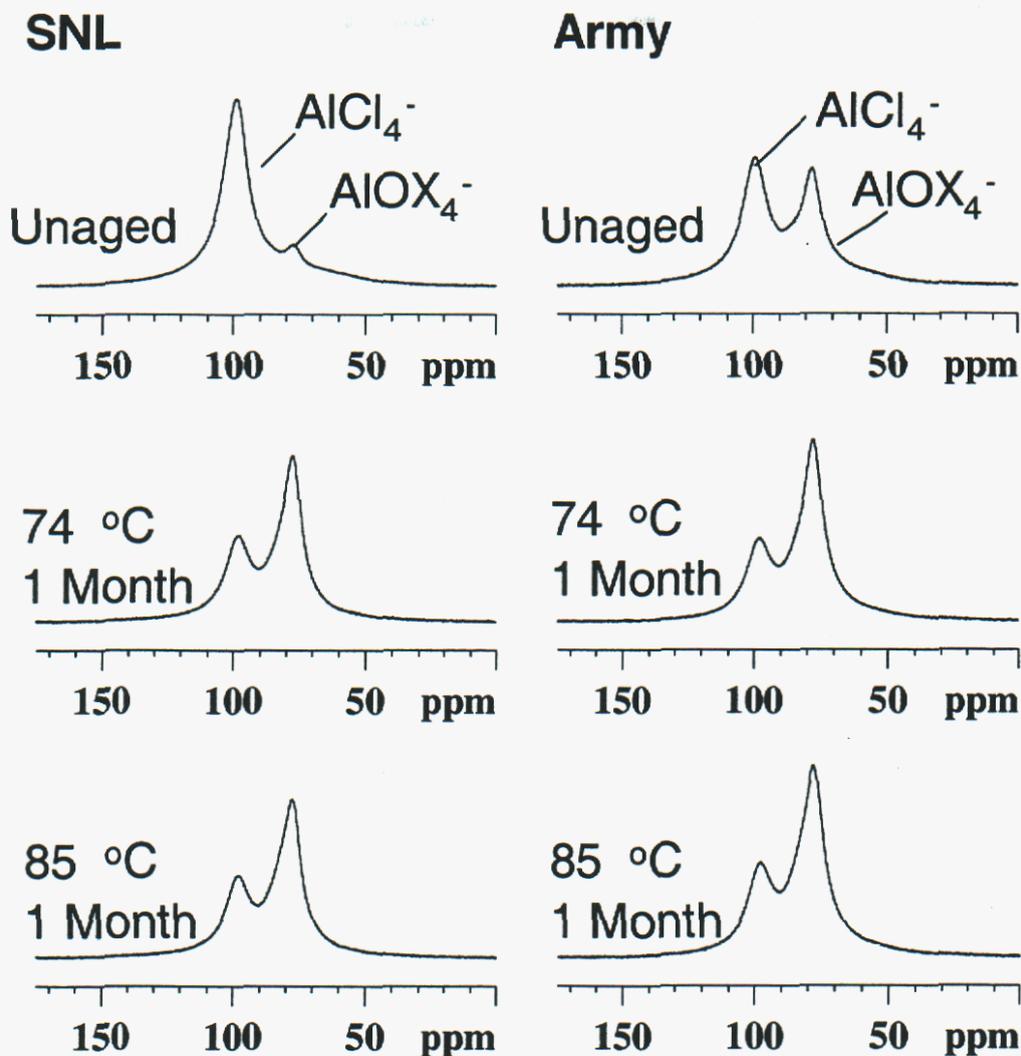
Figure 1. Effects of Thermal Aging on Al Coordination

As seen, these data provide at least two useful pieces of information. First, they support the earlier identification of formation of the Al complex with SO_2Cl_2 . Second, regardless of the initial starting composition or the aging conditions employed, the NMR spectra for all of the samples are essentially the same after aging at one month. The implication of this later observation is that the initial sampling time interval employed for characterization of the matrix samples should be less than one month.

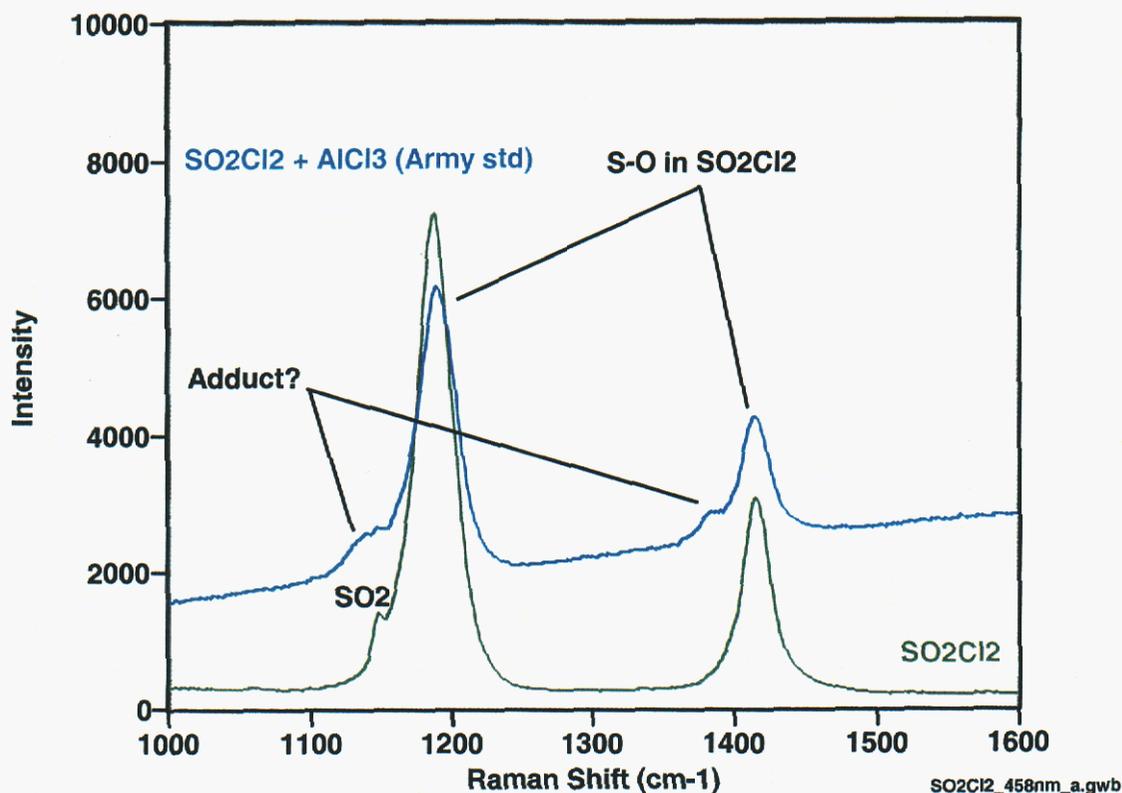
Figure 2. S-O stretch region of Raman spectra of unaged sulfuryl chloride solutions

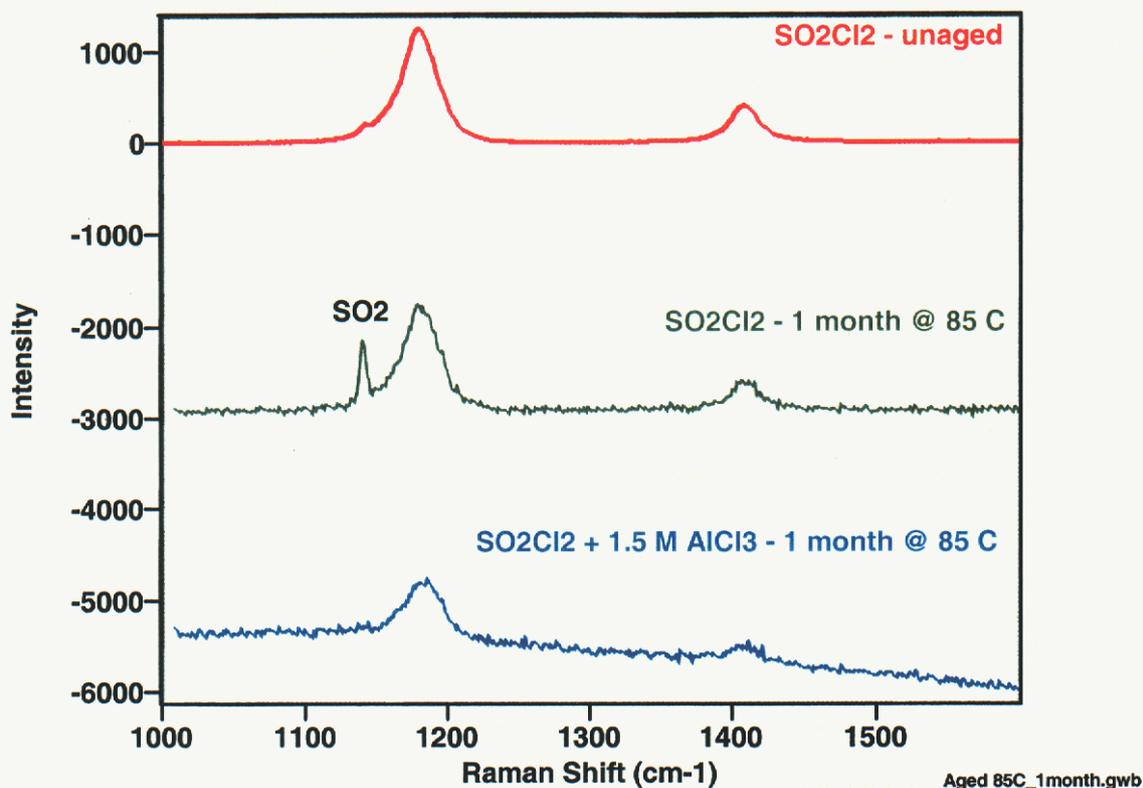
Figure 3. S-O stretch region of Raman spectra of unaged and aged suluryl chloride solutions

Increased turbidity has been noted in some of the aged solutions, and this is apparently due to formation of a precipitate. If enough of this precipitate accumulates after further aging, we should be able to obtain a Raman spectrum of this material with the hope of identifying its composition and structure.

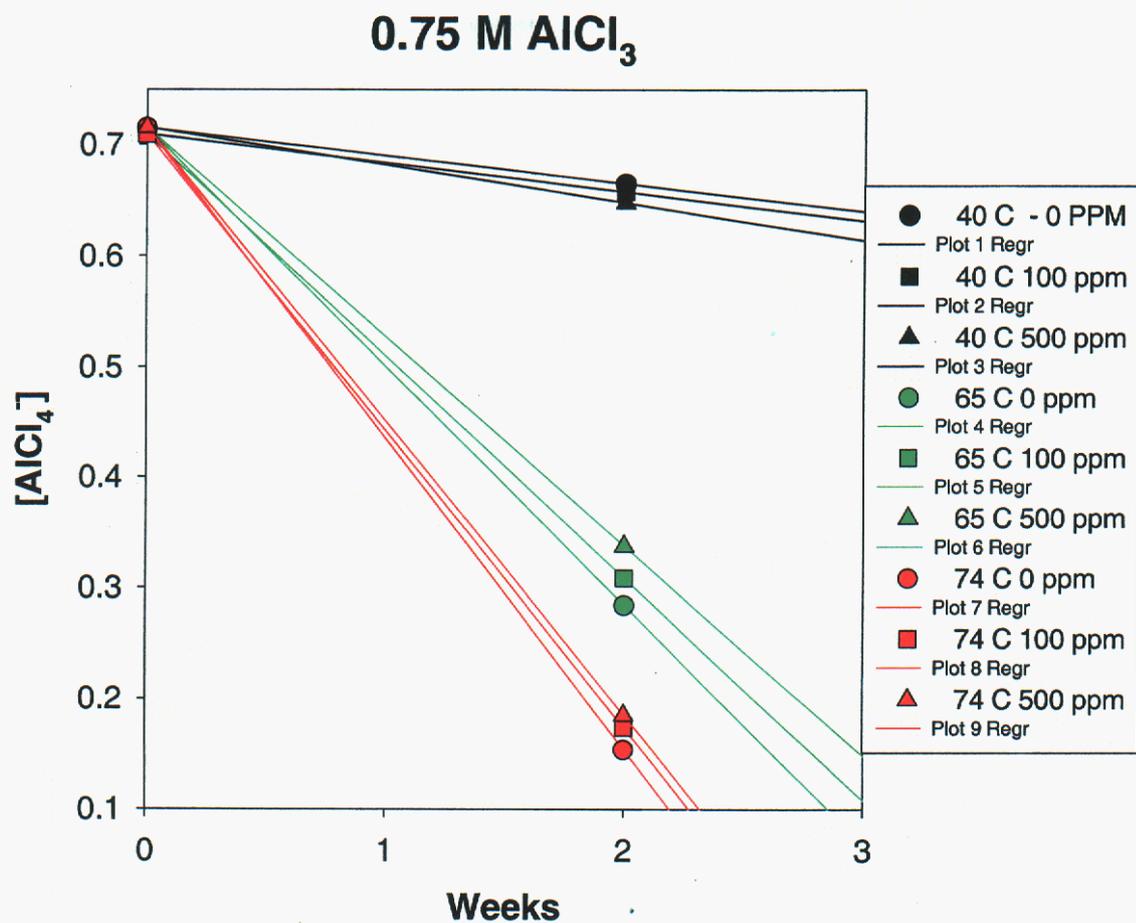
Figure 4. AlCl_3^- species as a function of aging conditions

After withdrawal the samples were analyzed by solution ²⁷Al NMR. (Characterization by Raman of these samples has not yet been completed.) At least two different Al species are observed in the solutions containing AlCl₃. The relative concentrations of these species were determined and tabulated as a function of nominal H₂O content and aging temperature. Figures 4 and 5 show the decrease in the “unaged” AlCl₃ species as a function of aging conditions.

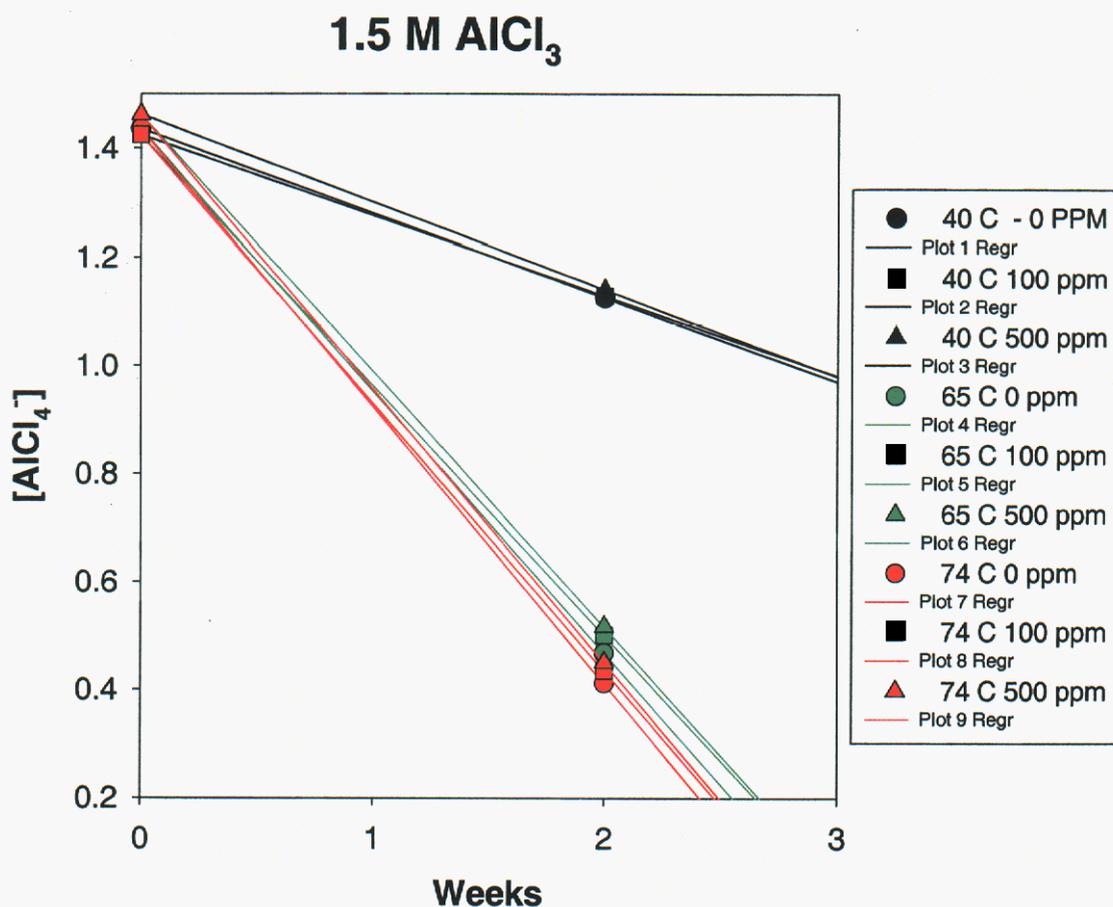
Figure 5. AlCl_3^- species as a function of aging conditions

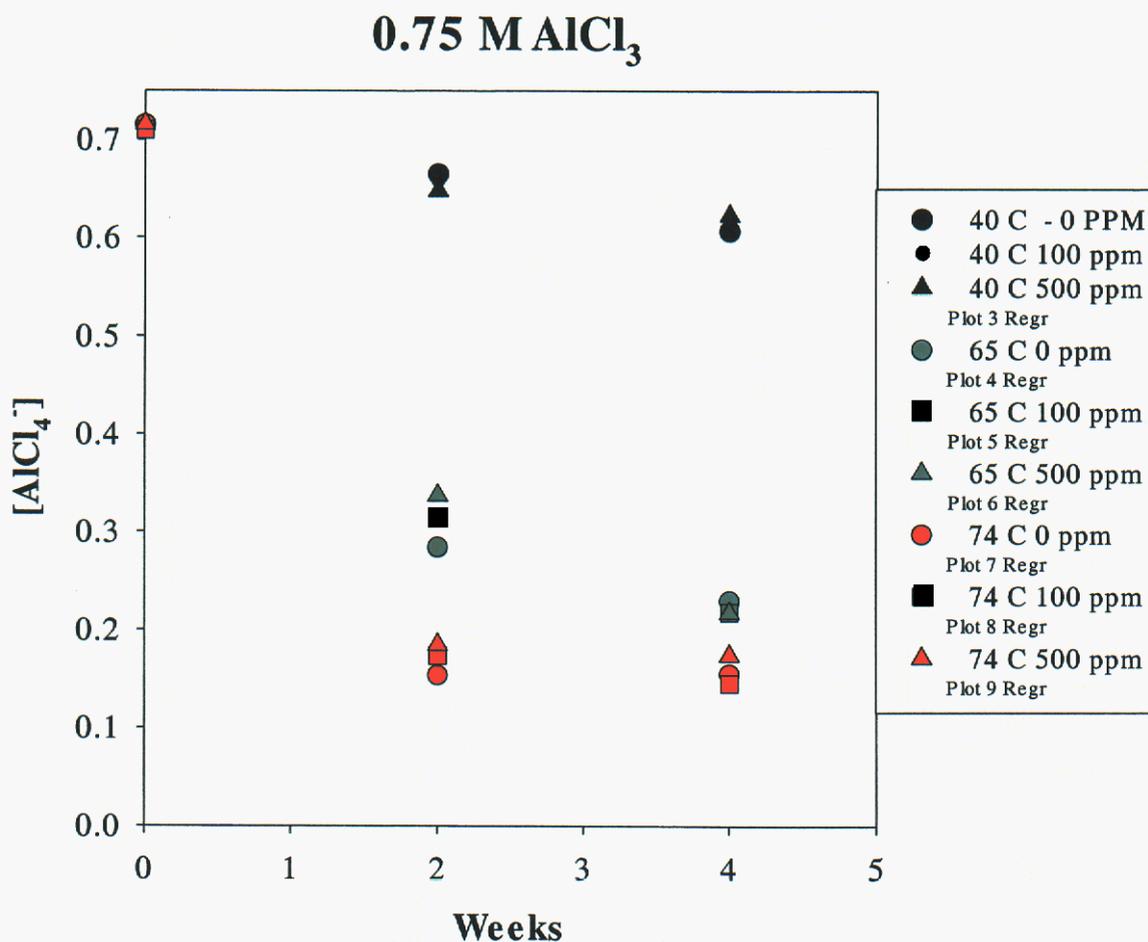
Figure 1. AlCl_4^- species in M as a function of aging conditions for initial 0.75 M AlCl_3 concentration

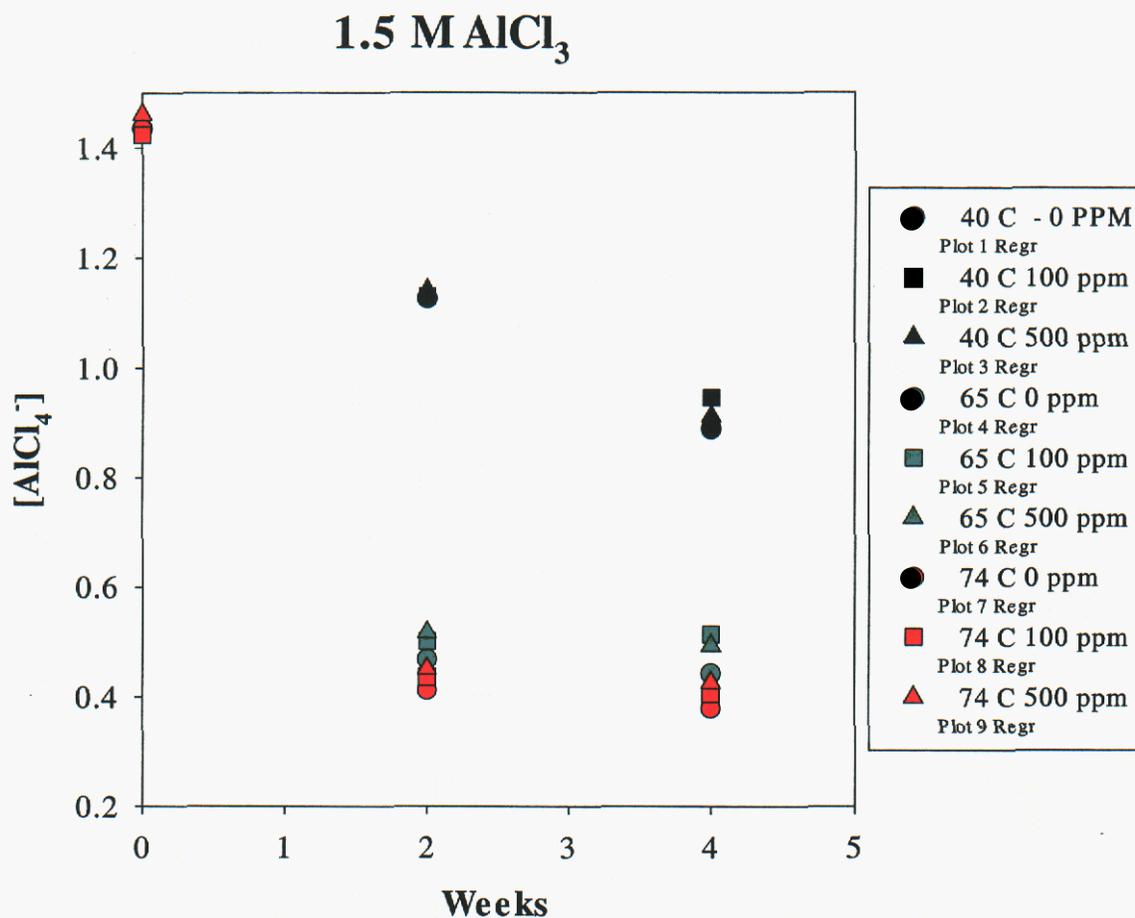
Figure 2. AlCl_4^- species in M as a function of aging conditions for initial 1.5 M AlCl_3 concentration
