SANDIA REPORT

SAND2004-1057
Unlimited Release
Printed May 2004

Analytical Investigation of $\text{AlCl}_3/\text{SO}_2\text{Cl}_2$ Catholyte Materials for Secondary Fuze Reserve Batteries

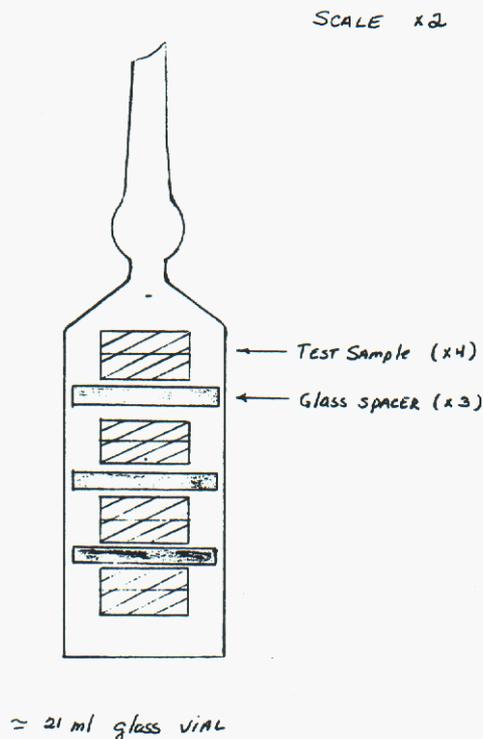
Figure 9. Schematic diagram of the vial and sample configuration to be used in the moisture-induced corrosion sensitivity studies

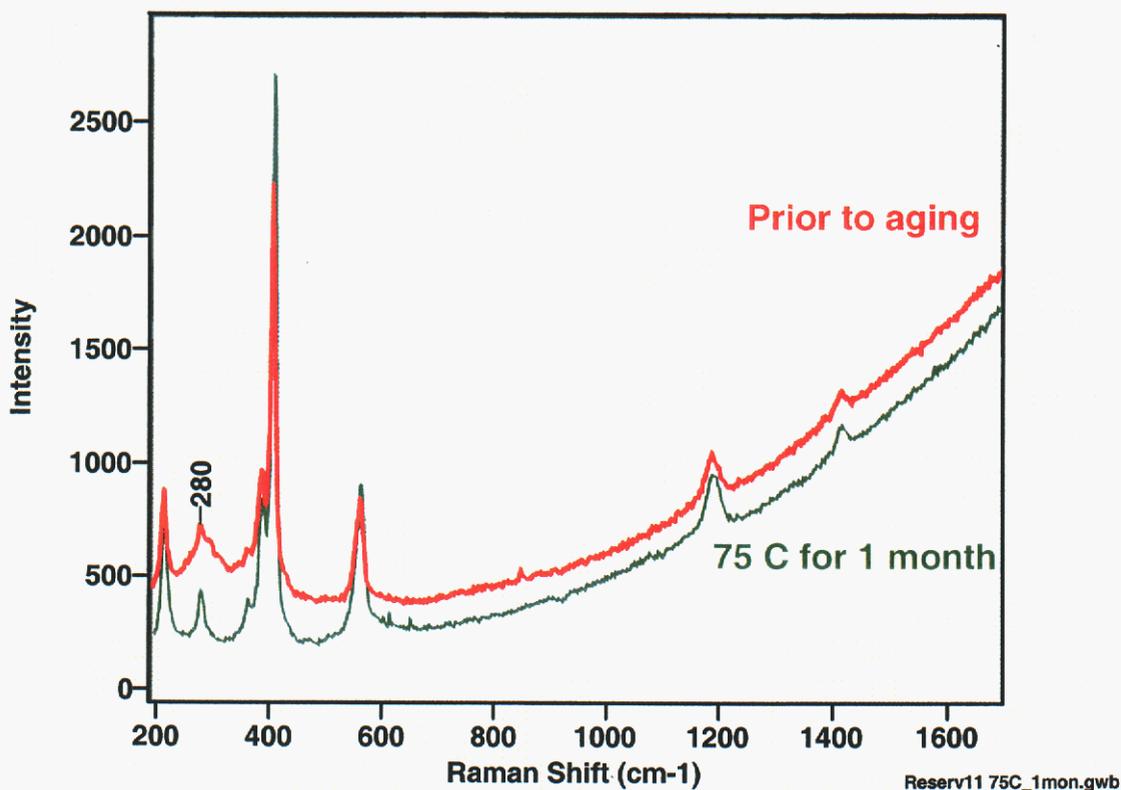
Figure 1. Raman spectra of reservoir #11 – prior to aging and aged at 75 C

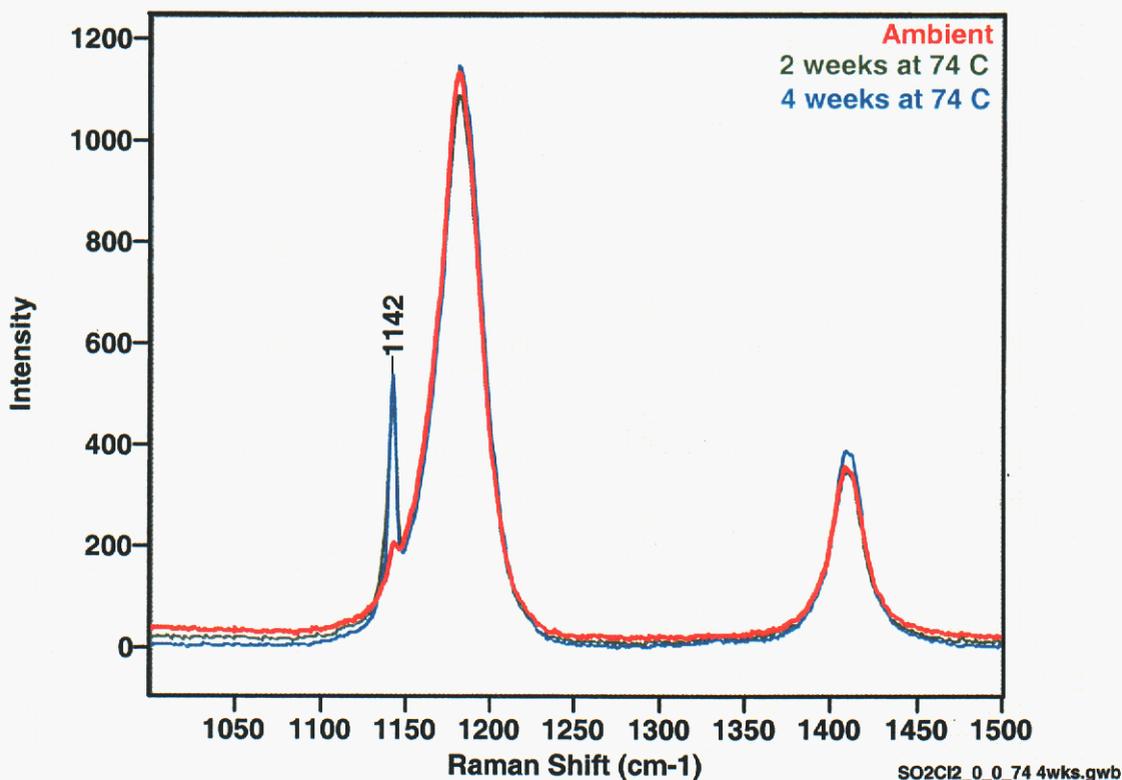
Figure 2. Raman spectra of SO₂Cl₂ (0 ppm H₂O, 0 M AlCl₃, Spl# 19), aged at ambient and 74°C, for up to four weeks.

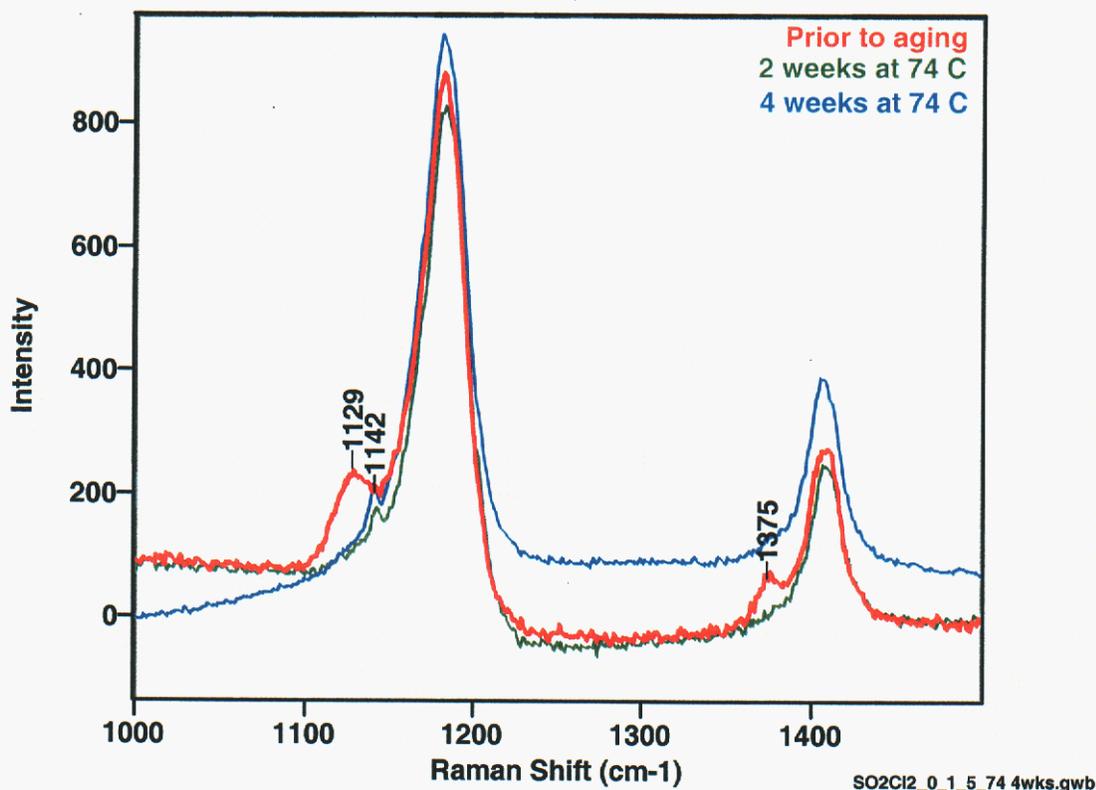
Figure 3. Raman spectra of SO_2Cl_2 (0 ppm H_2O , 1.5M AlCl_3 , Spl# 21), with up to four weeks aging at 74°C

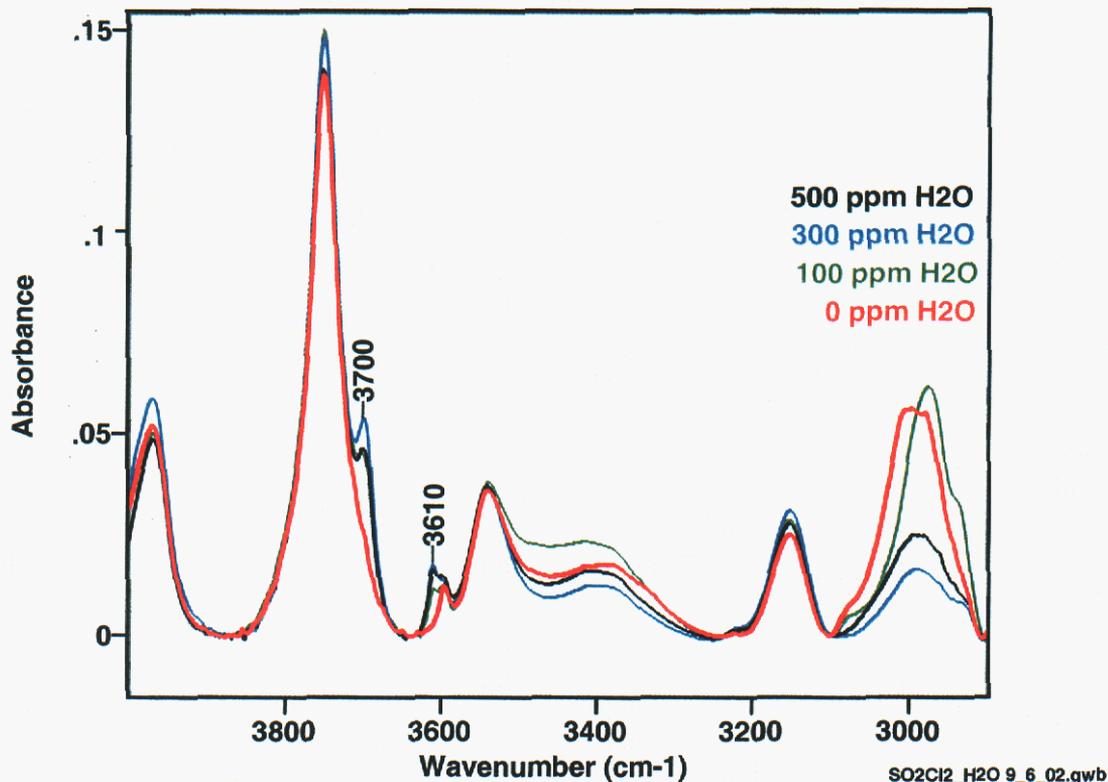
Figure 4. IR spectra of sulfuryl chloride with 0 - 500 ppm of added H₂O in 10 mm silica cells

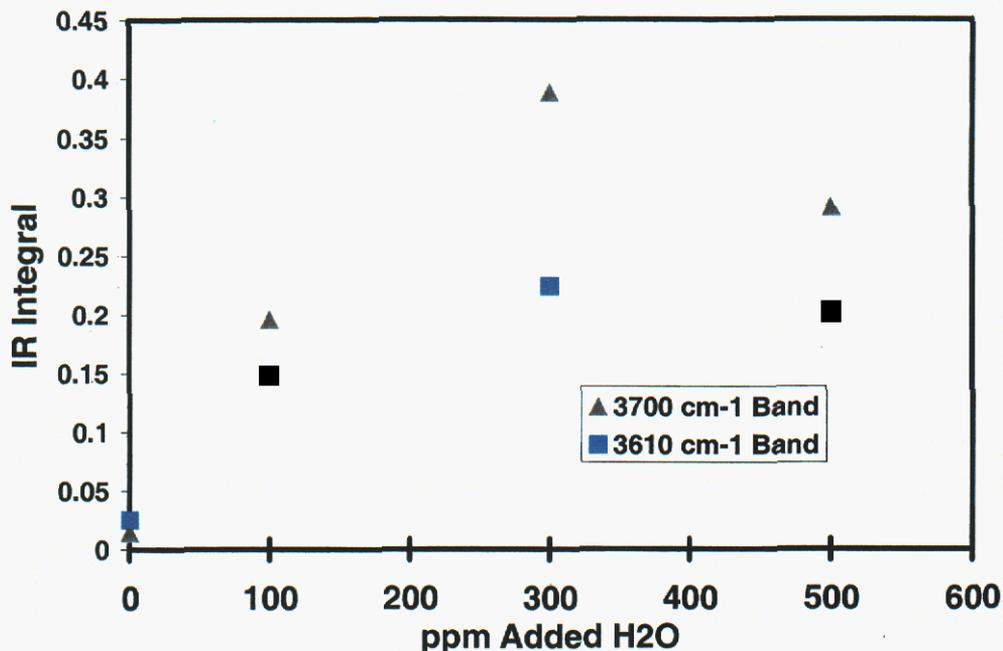
Figure 5. Integrated IR intensities of hydroxyl bands due to added water versus concentration of water added to sulfuryl chloride

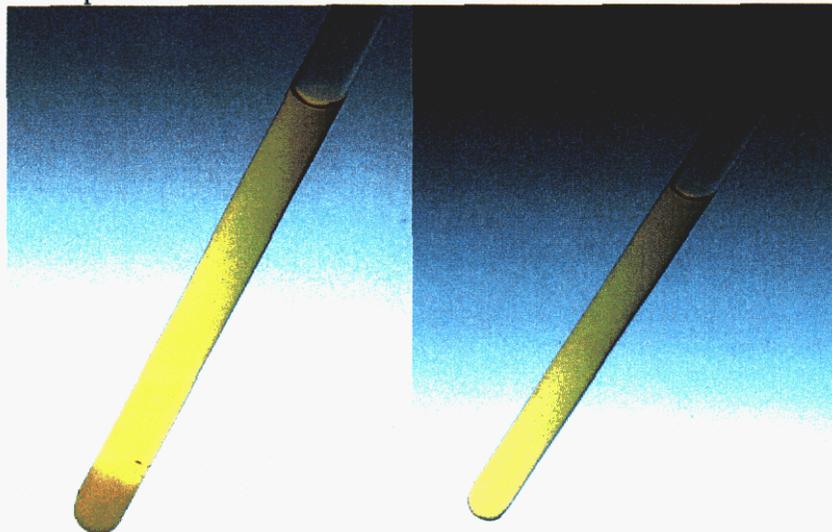
Figure 2. Photograph of a single sample before mixing, showing the presence of the deposit (on the left), and after mixing (on the right).

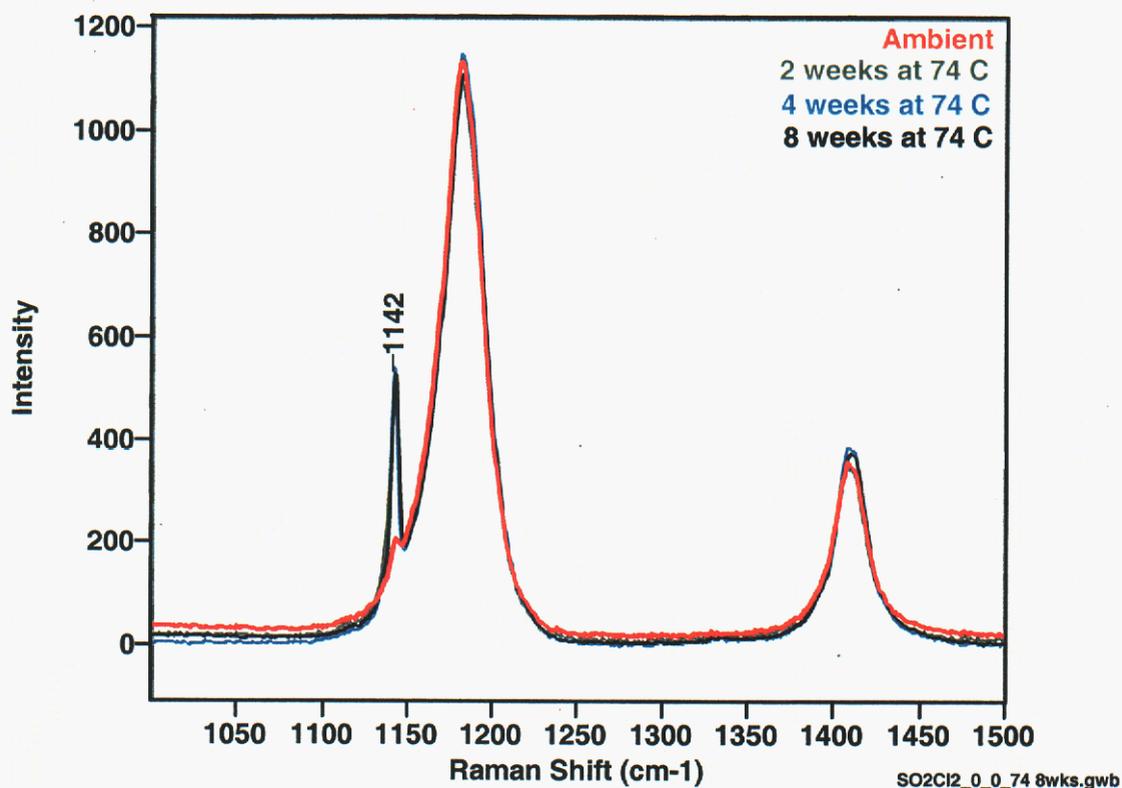
Figure 3. Raman spectra of SO₂Cl₂ (0 ppm H₂O, 0 M AlCl₃), aged at ambient and 74°C, for up to eight weeks.

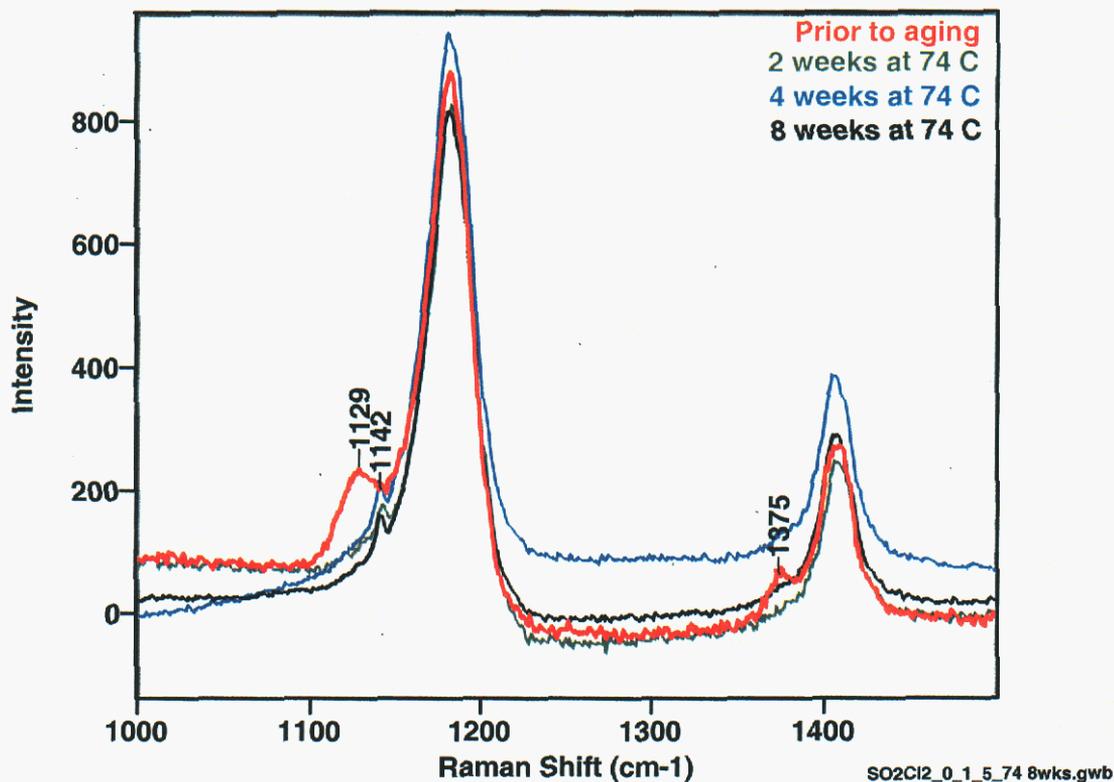
Figure 4. Raman spectra of SO_2Cl_2 (0 ppm H_2O , 1.5M AlCl_3), with up to eight weeks aging at 74°C

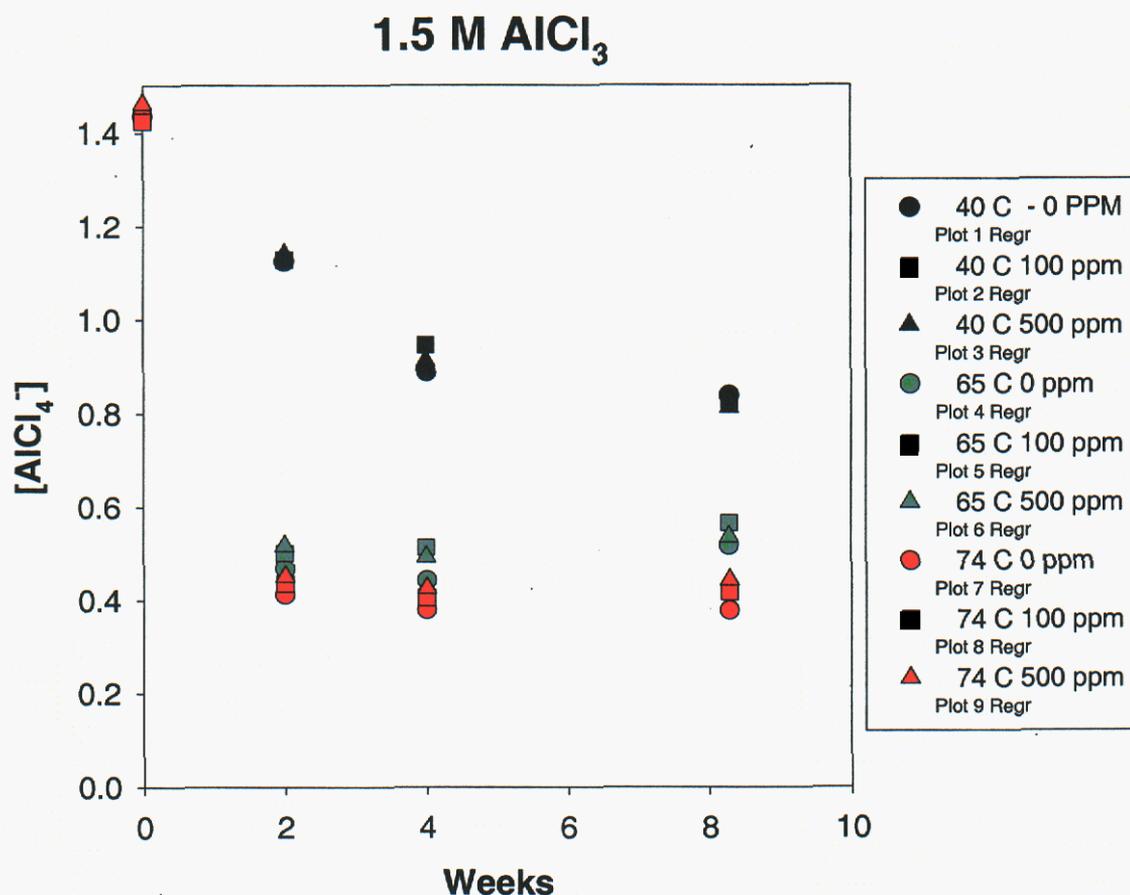
Figure 5. AlCl_4^- concentration as a function of time, temperature, and water concentration for 1.5 M AlCl_3 (initial concentration) samples.

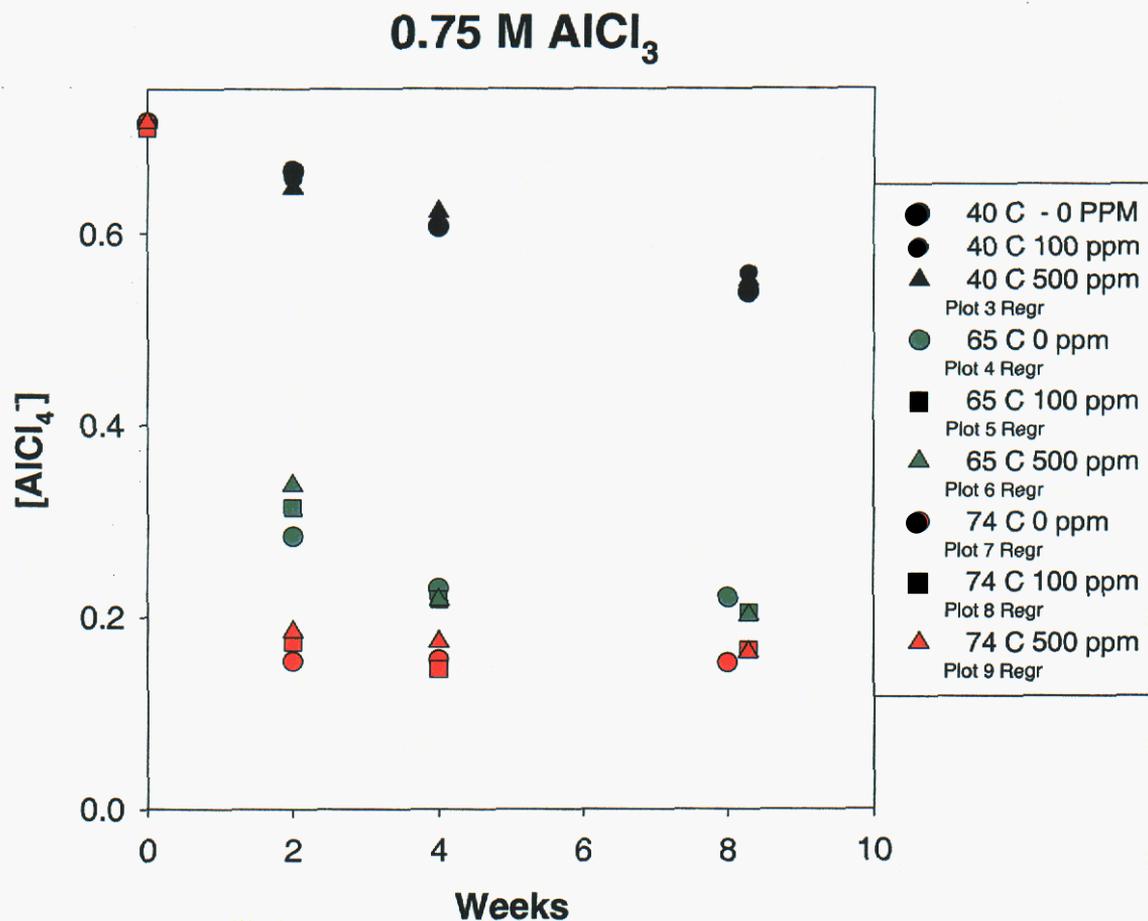
Figure 6. AlCl_4^- concentration as a function of time, temperature, and water concentration for 0.75 M AlCl_3 (initial concentration) samples.

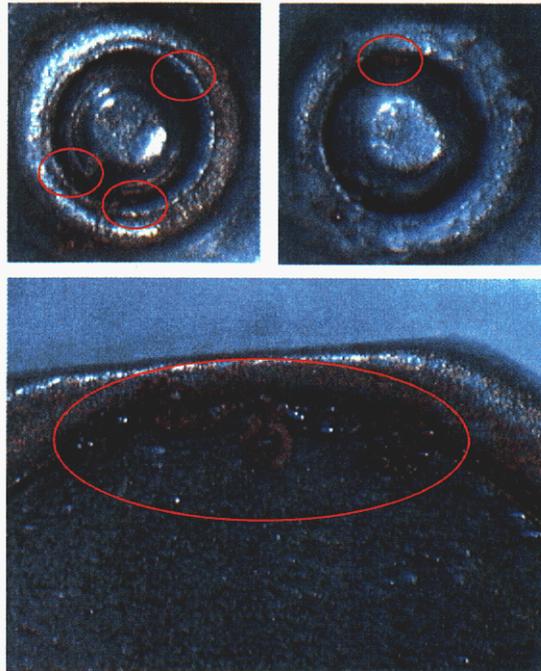
Figure 7. Photomicrographs of reservoir numbers 73 (top left), 81 (top right), and 94 (bottom) showing brown deposits.

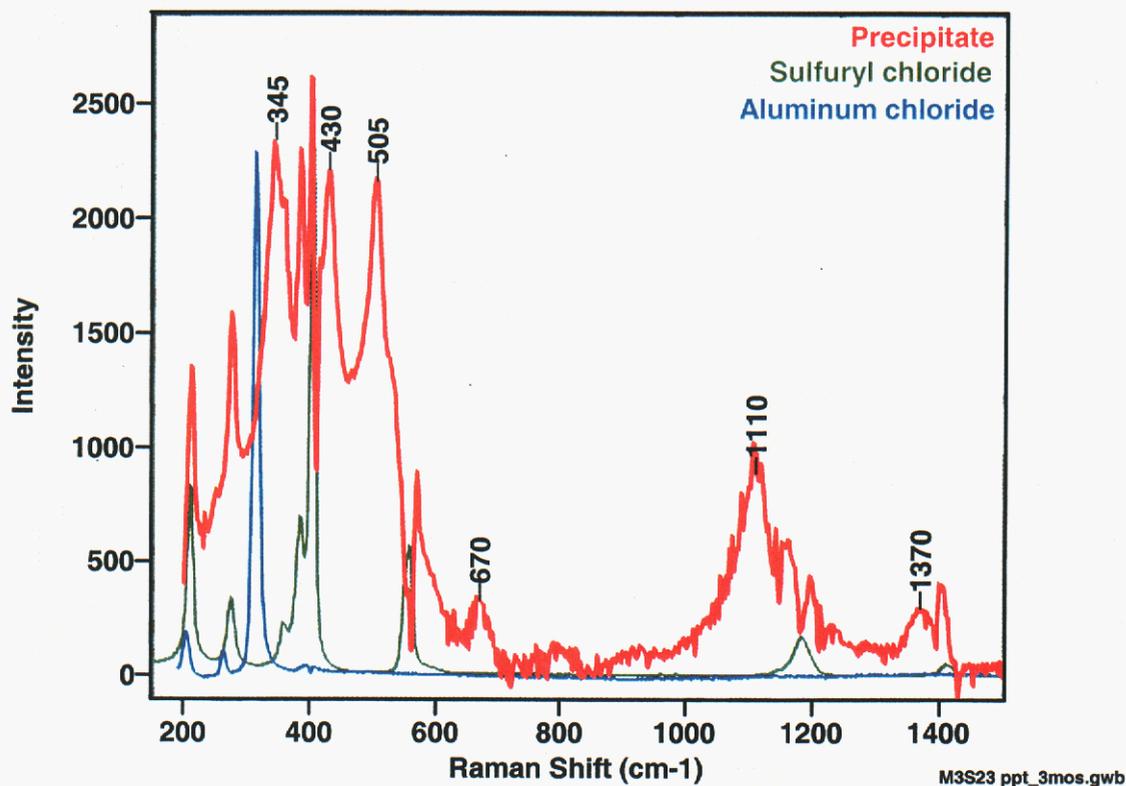
Figure 1. Raman spectrum (after removal of solution bands) of the solid in sample #23 after three months of aging at 74C.

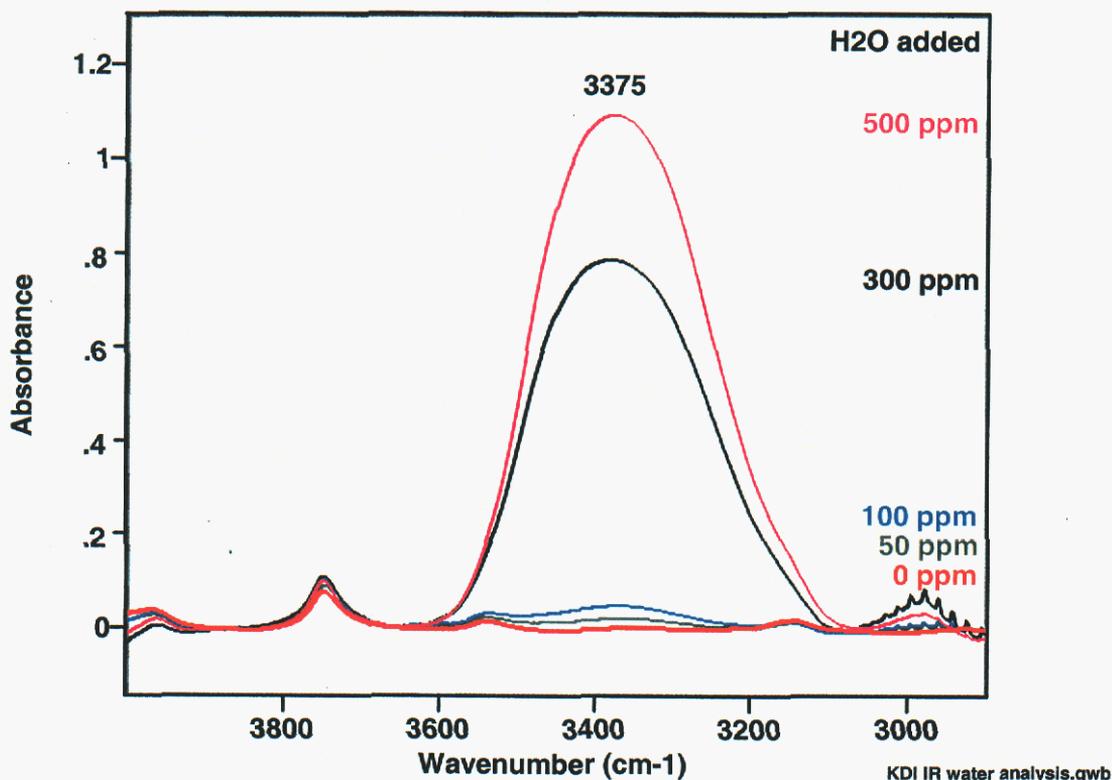
Figure 2. IR spectra of KDI electrolyte plus 0 - 500 ppm H₂O in 10 mm silica cells

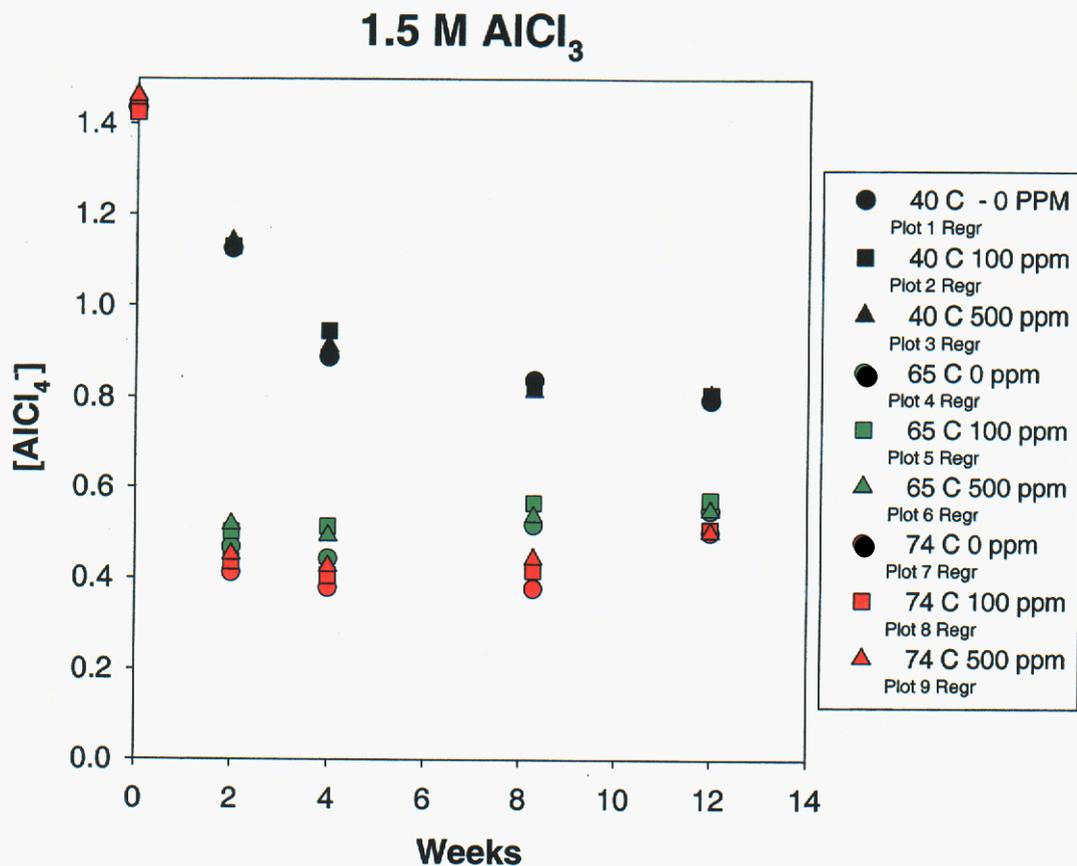
Figure 3. Concentration of AlCl_4^- as a Function of Aging Time with Initial Concentration of 1.5M AlCl_3

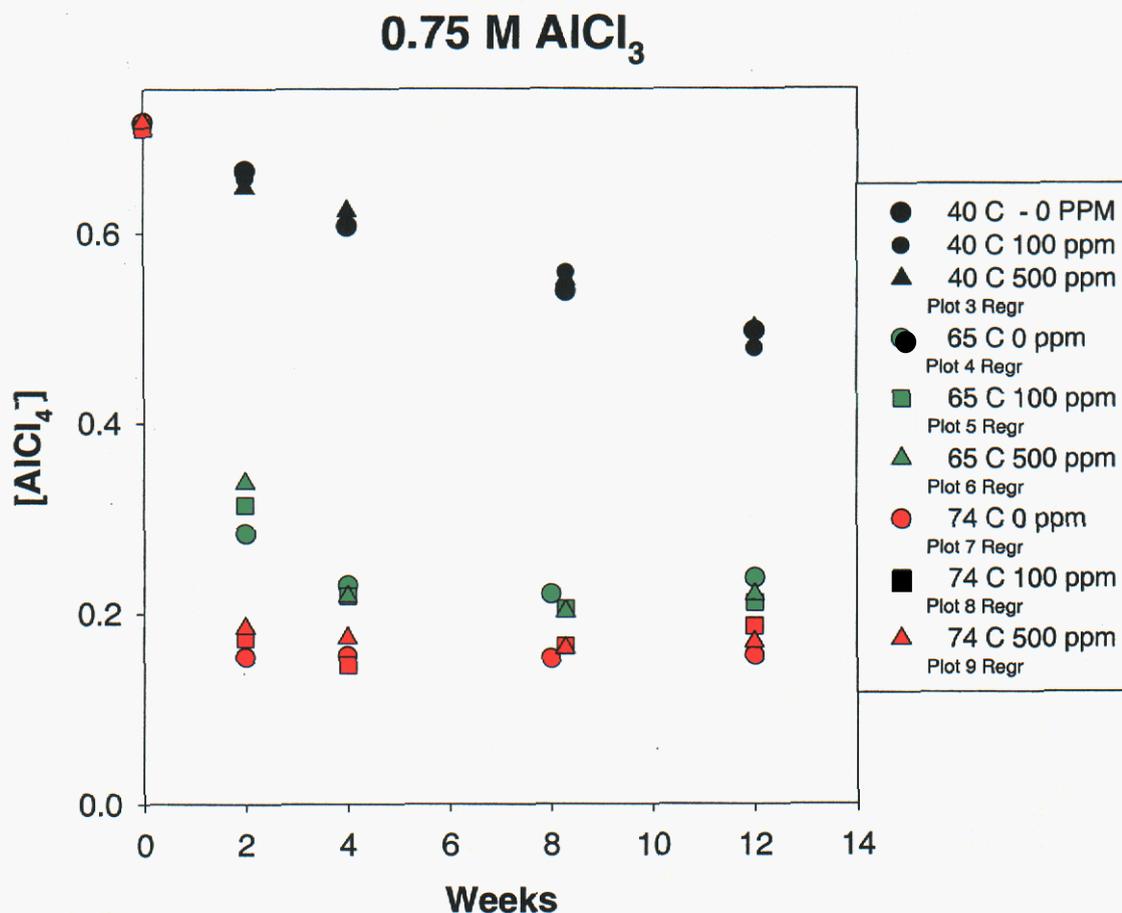
Figure 4. Concentration of AlCl_4^- as a Function of Aging Time with an Initial Concentration of 0.75M AlCl_3

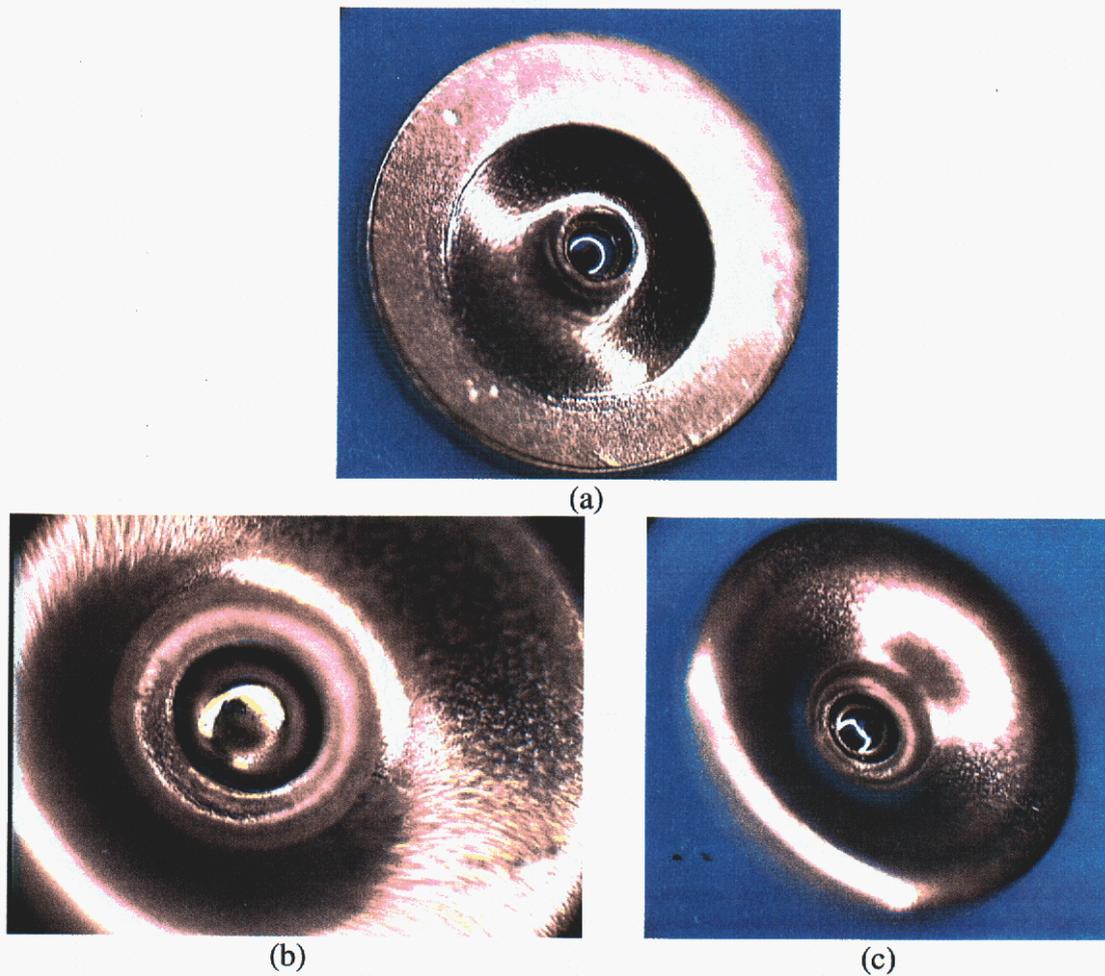
Figure 5. Photographs of as-received endplates (a) bottom, (b) top showing ball, and (c) top.

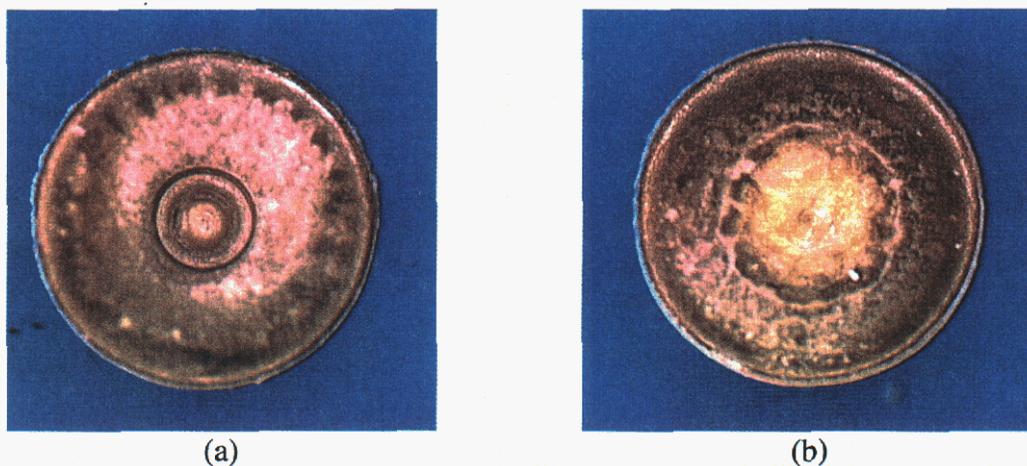
Figure 7. Photographs of endplates after electrolyte contamination and drying in dry room for 15 minutes - (a) horizontal dip, (b) 0.01 ml drop.

A few photographs of the endplates taken during the setup of this matrix are shown in Figures 5-7: as-received endplates (Figure 5), endplates after being dipped, exposed to dryroom/lab for 15 minutes and cleaned (Figure 6), and endplates after being dipped or contaminated with a drop, and dried in dryroom – no cleaning (Figure 7). As shown by comparing Figures 5 and 6, but better seen in the microscope itself, no corrosion was observed by inundating the endplates either horizontally or vertically in electrolyte, letting them dry in the dryroom environment for 15 minutes, and then letting them sit in a more humid lab environment for another 15 minutes prior to cleaning. Finally, the photographs in Figure 8 demonstrate the relatively substantial amount of salt coverage that is left following solvent evaporation on the endplates and how its distribution is affected by the contamination method (dipping or drop). Overall based on what we observed during this initial phase, we feel that the matrix we have implemented will provide ARDEC with the information they need.

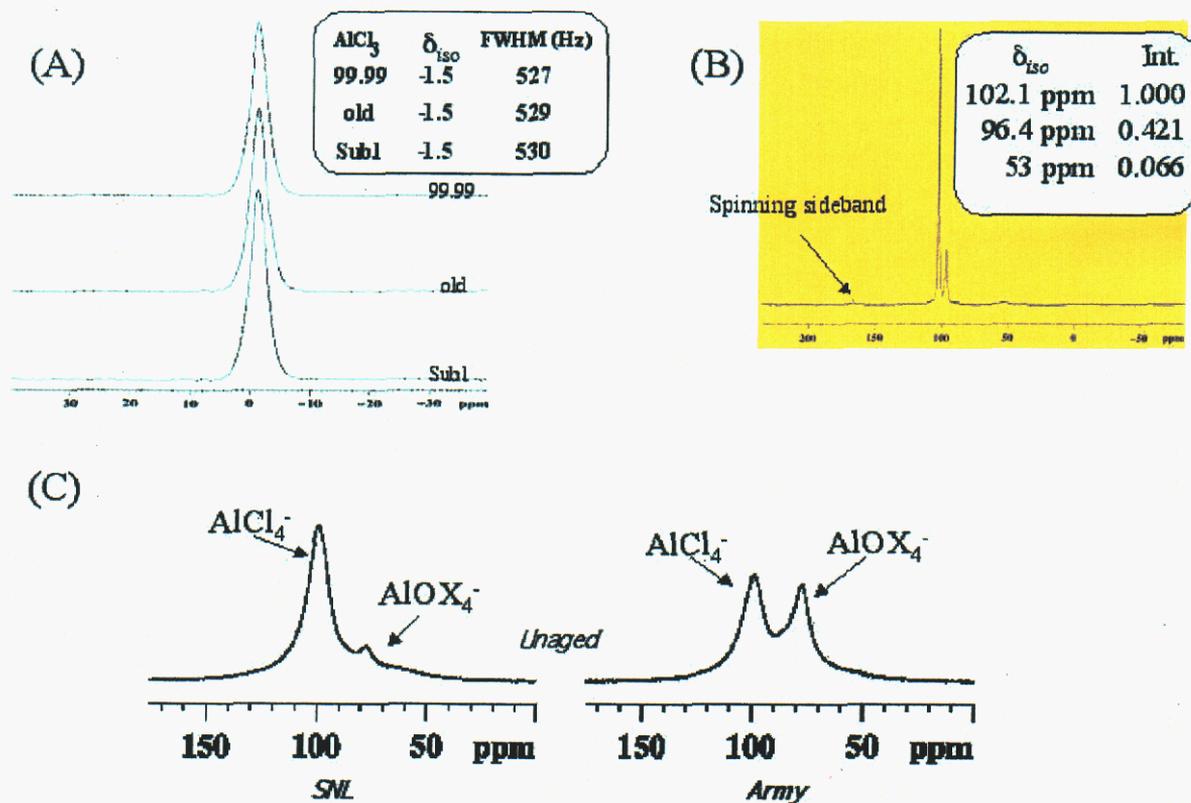
Figure 9. NMR Spectra of Solid Material after washing (a), unwashed (b) and NMR of Unaged Solution(c).

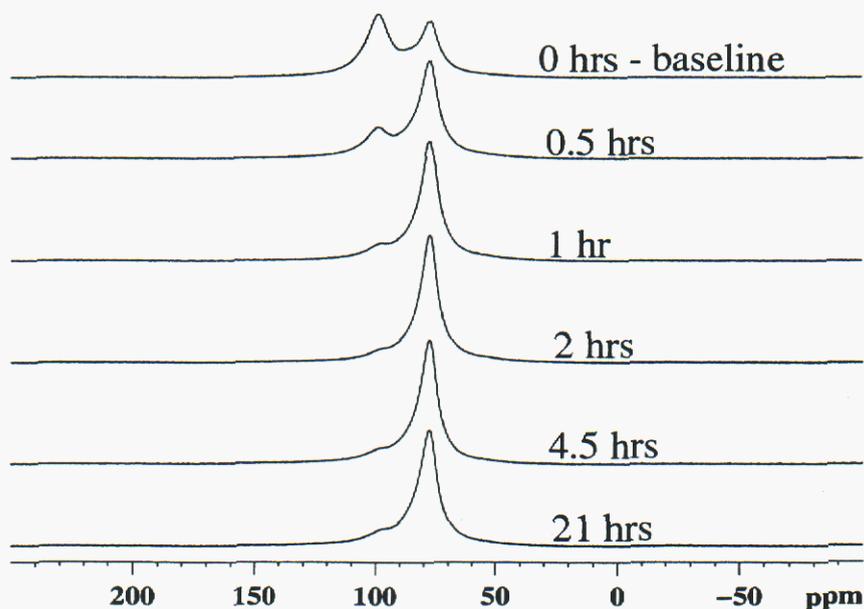
Figure 1.4.1. Comparison of NMR spectra of samples heated in oven at 120C for the time intervals shown.

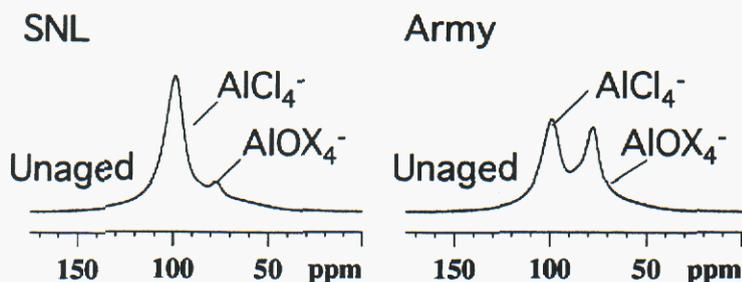
Figure 1.4.2. Comparison of NMR spectra of freshly prepared electrolyte and KDI supplied electrolyte first reported in July 2002.

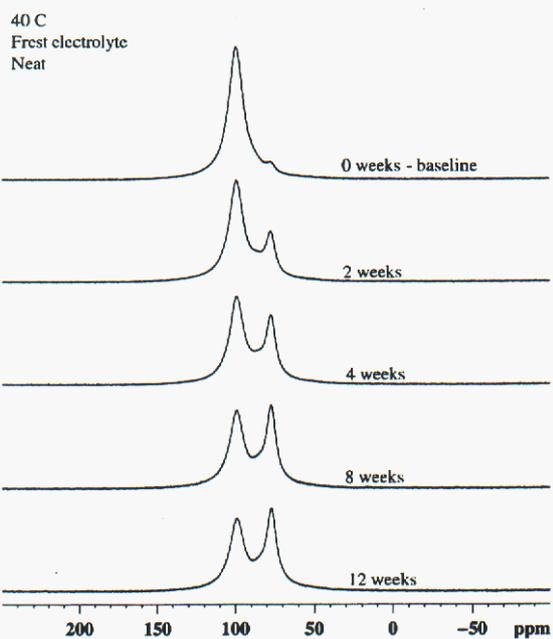
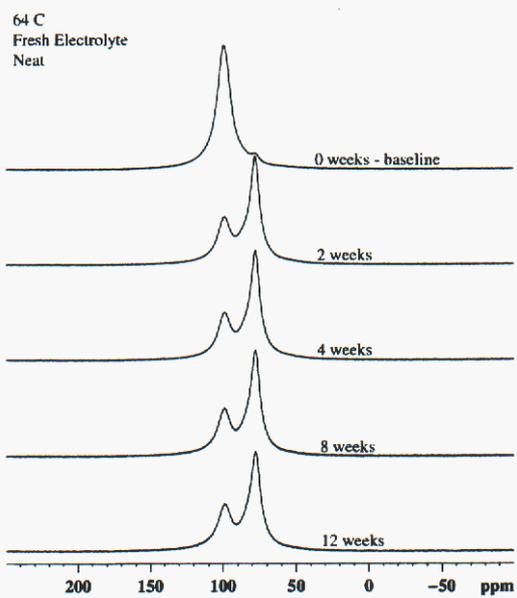
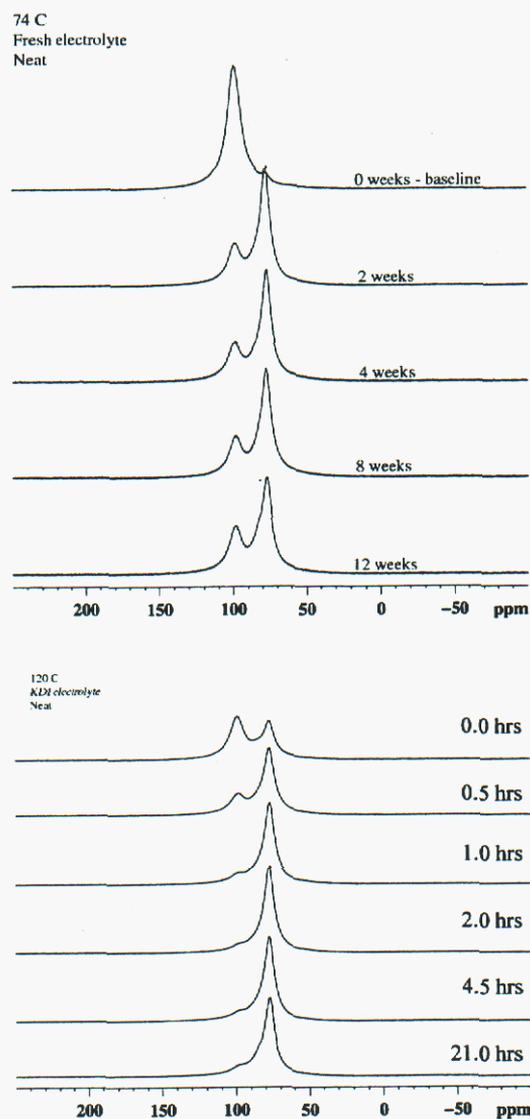
Figure 1.4.3. Comparison of NMR spectra for four different samples obtained at various time intervals during the aging process. In the case of the 40, 64, and 74 °C samples, these are freshly prepared electrolyte. In the case of the 120 °C samples, these are actually six separate samples of recently received KDI electrolyte. (Excess water was NOT added in any case.)

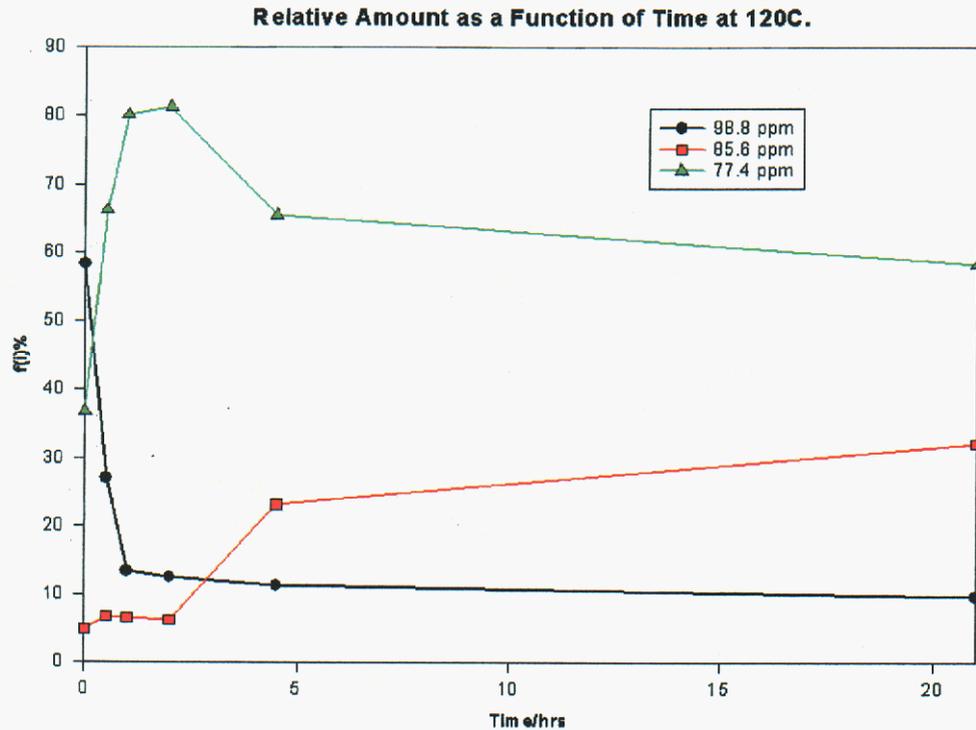
Figure 1.4.4. Plot of percent fraction as a function of time for the three different aluminum species found during the aging process.

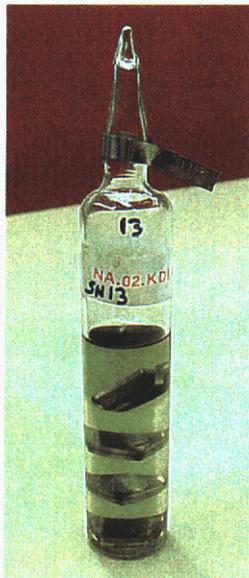
Figure 2.1. Photographs of sealed glass vials containing KDI electrolyte and various metal couples: (a) 304L SS welded to 440C SS, 316L SS, Ni, and WC, respectively from bottom to top, and (b) 304L SS welded to 304L SS alone. In the multi-sample configuration shown in (a), the individual metal sandwiches are separated with a glass spacer ring. For both of these specific tests, the electrolyte was contaminated with 100 ppm of water, the aging temperature is ambient, and the test duration had reached approximately one month.

The metal couples were formed by spot welding (in the case of the 304L-304L, 304L-316L, 304L-Ni, 304L-440C combinations) or banding together (in the case of the 304L-WC combination) 1-cm² coupons. This approach allowed formation of a tight crevice and galvanic couple. Photographs of two of the 18 vials now on test are shown in Figure 2.1. The electrolyte in all of the aging studies containing coupons other than just 304L (i.e. vials 10 -18) quickly discolored relative to the starting KDI material. The darkening began immediately after sealing of the vials and the level of the greenish discoloration appears to correlate primarily with aging temperature and not moisture content. Based on related work with the thionyl-chloride system, a probable cause for this observation is that a small amount of nickel was solubilized. Because the electrolyte in vials 1- 9 (which contain only 304L stainless steel) became only slightly darker, the source of the nickel was probably the nickel coupon itself and not the stainless steel.

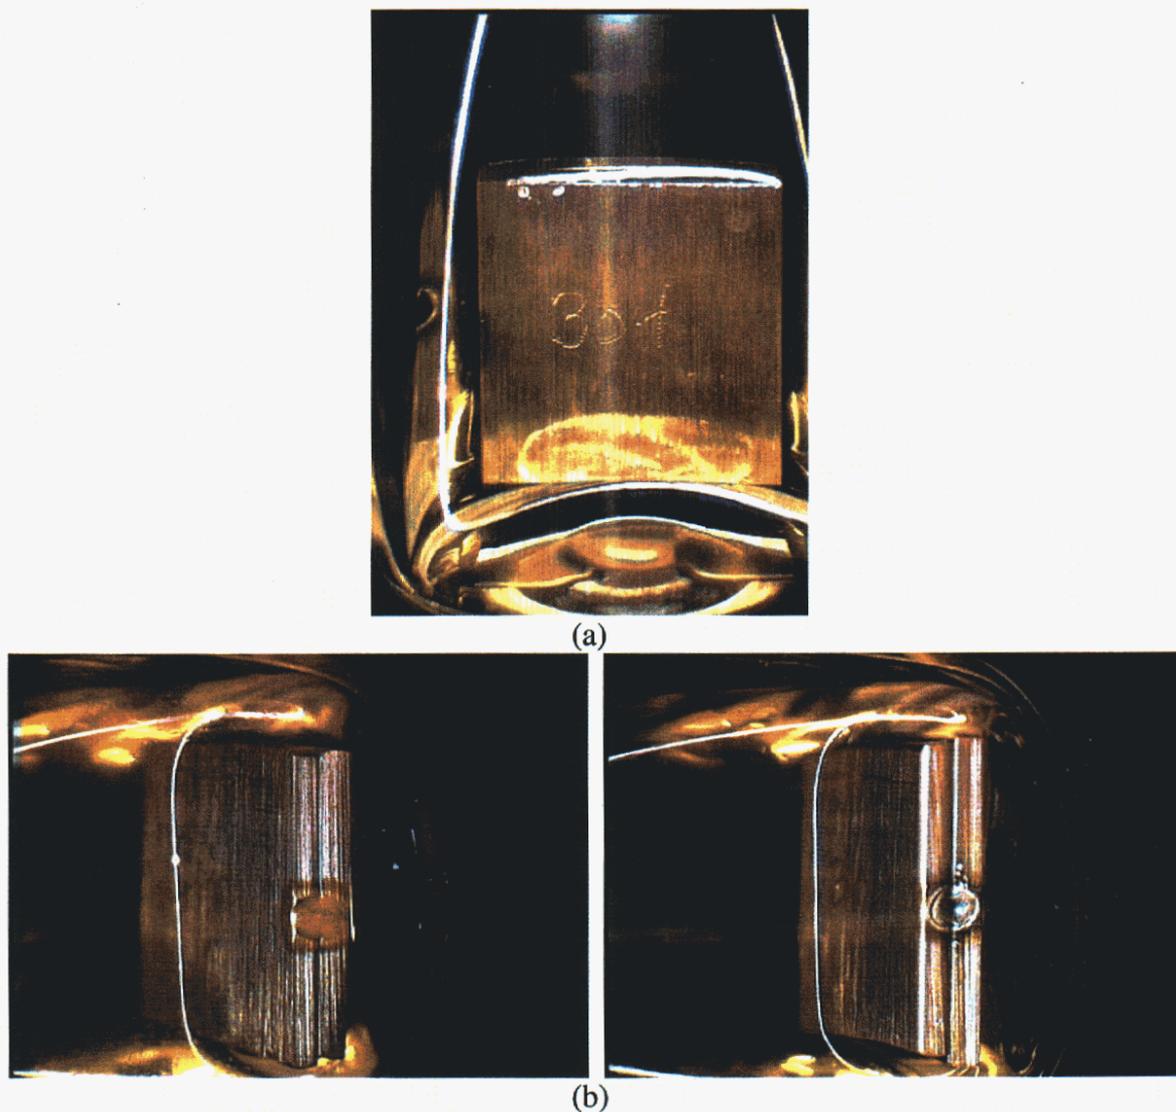
Figure 2.2. Photographs of features of 304L-304L couples that were aged in KDI electrolyte with 100 ppm H_2O for 4 weeks at 25°C : (a) a coupon face showing that no visible signs of corrosion, and (b) the slight rusty like corrosion that occurred around or on the welds on the edge of two separate couples. Also, the two edges of the samples that were cut with a band saw also experienced some general rusting. This edge corrosion probably occurred because of the presence of iron particles that were deposited during the sawing operation.

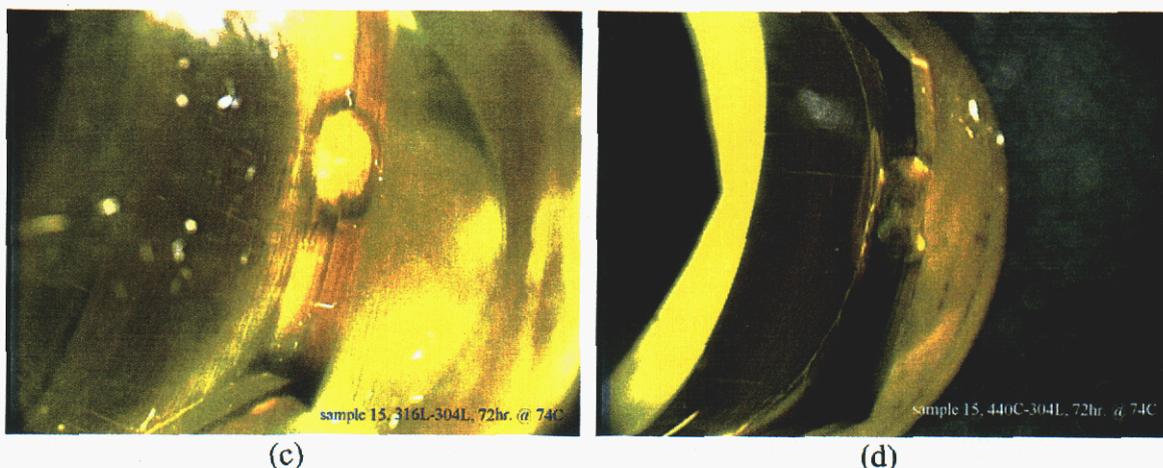
Figure 2.3. Photographs of the base 304L – ball metal coupons after aging in the KDI electrolyte with 100 ppm H₂O for only 3 days at 74°C: (a) nickel, (b) tungsten carbide, (c) 316L, and (d) 440C. Some evidence of corrosion exists on the tungsten carbide (staining on the visible face of the right hand WC coupon) and the 440C sample (significant darkening of the entire surface – left coupon).

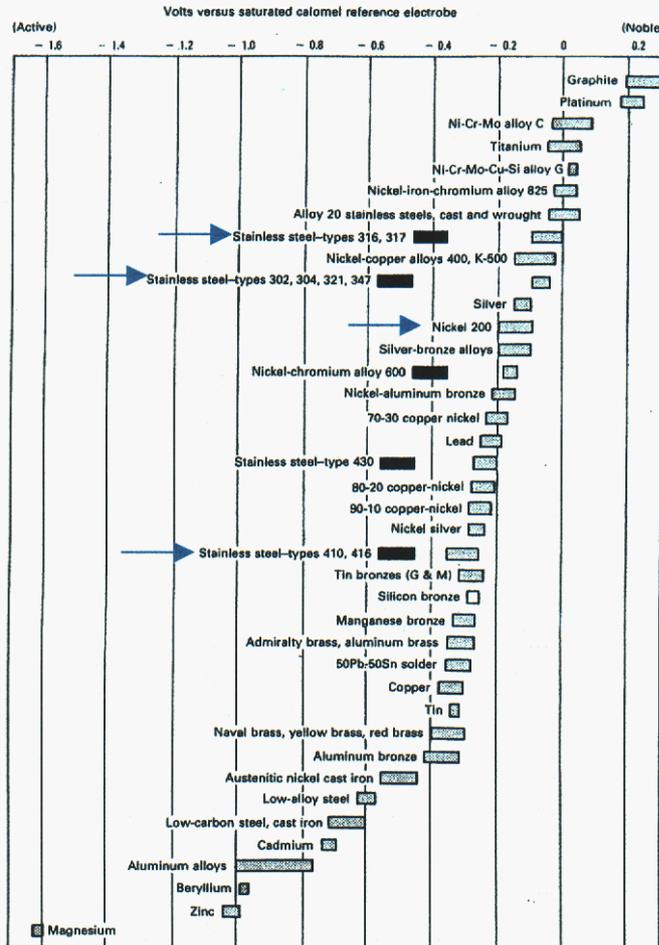
Figure 2.4. Galvanic series for various metals in seawater. Darker boxes indicate the range of observed potentials when the subject metal is in an electrochemically active state. The arrows point to the two primary stainless steels of interest. Note: this figure was copied from ASM Metals Handbook, Volume 13, p. 235.
