SANDIA REPORT

SAND2004-1057
Unlimited Release
Printed May 2004

Analytical Investigation of $\text{AlCl}_3/\text{SO}_2\text{Cl}_2$ Catholyte Materials for Secondary Fuze Reserve Batteries

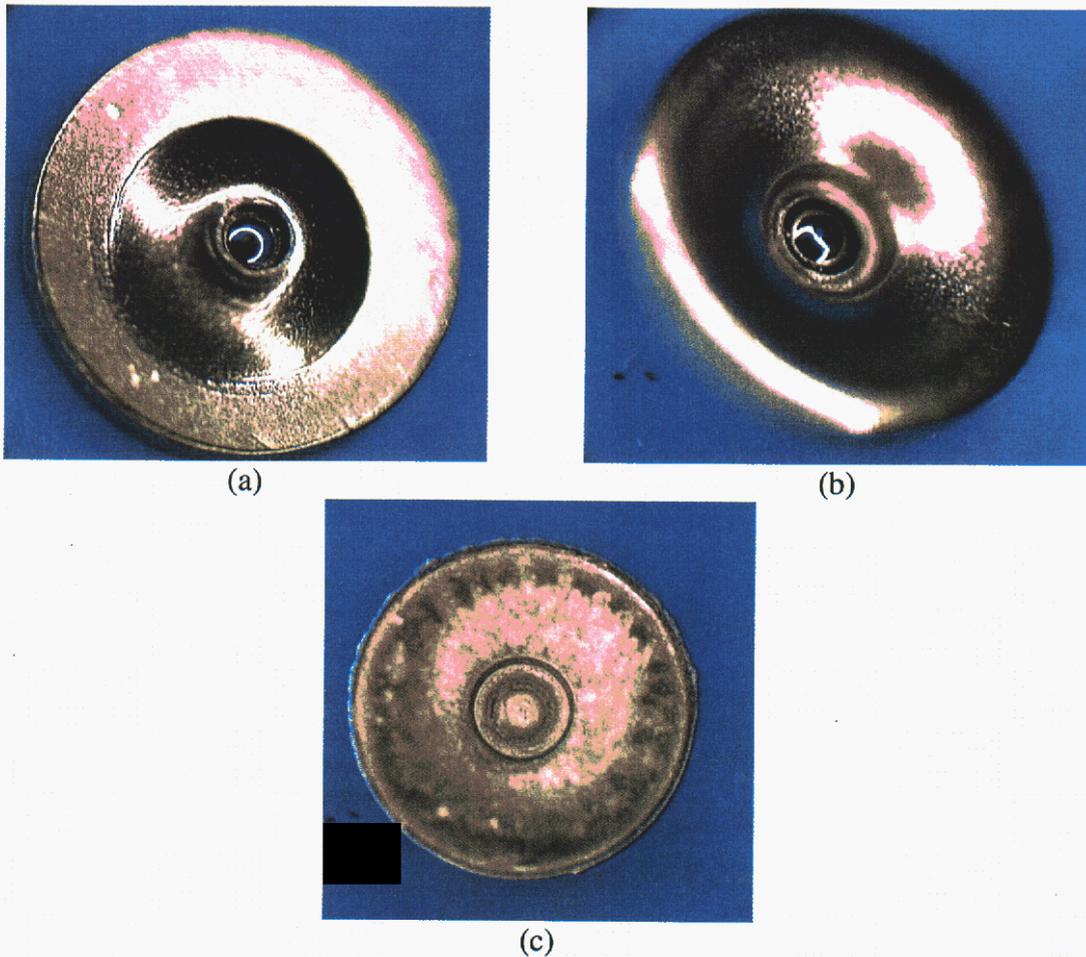
Figure 2.5. Photographs of as-received endplates (a) bottom, (b) top. A photographs of an endplate after electrolyte contamination and drying in dry room for 15 minutes is shown in (c). For reference, photographs of endplates after dipping in electrolyte, drying in dry room for 15 minutes, storage in lab for 15 minutes, and cleaning appear similar to those shown in (a) and (b).

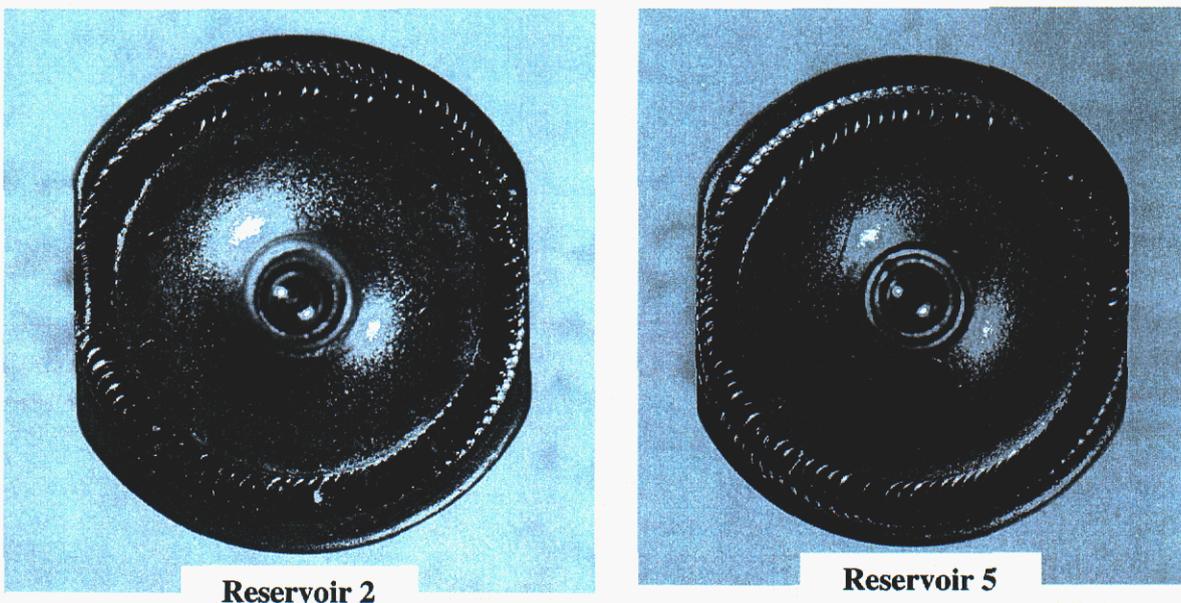
Figure 3.1. Photomicrographs of two different reservoirs showing typical laser weld.

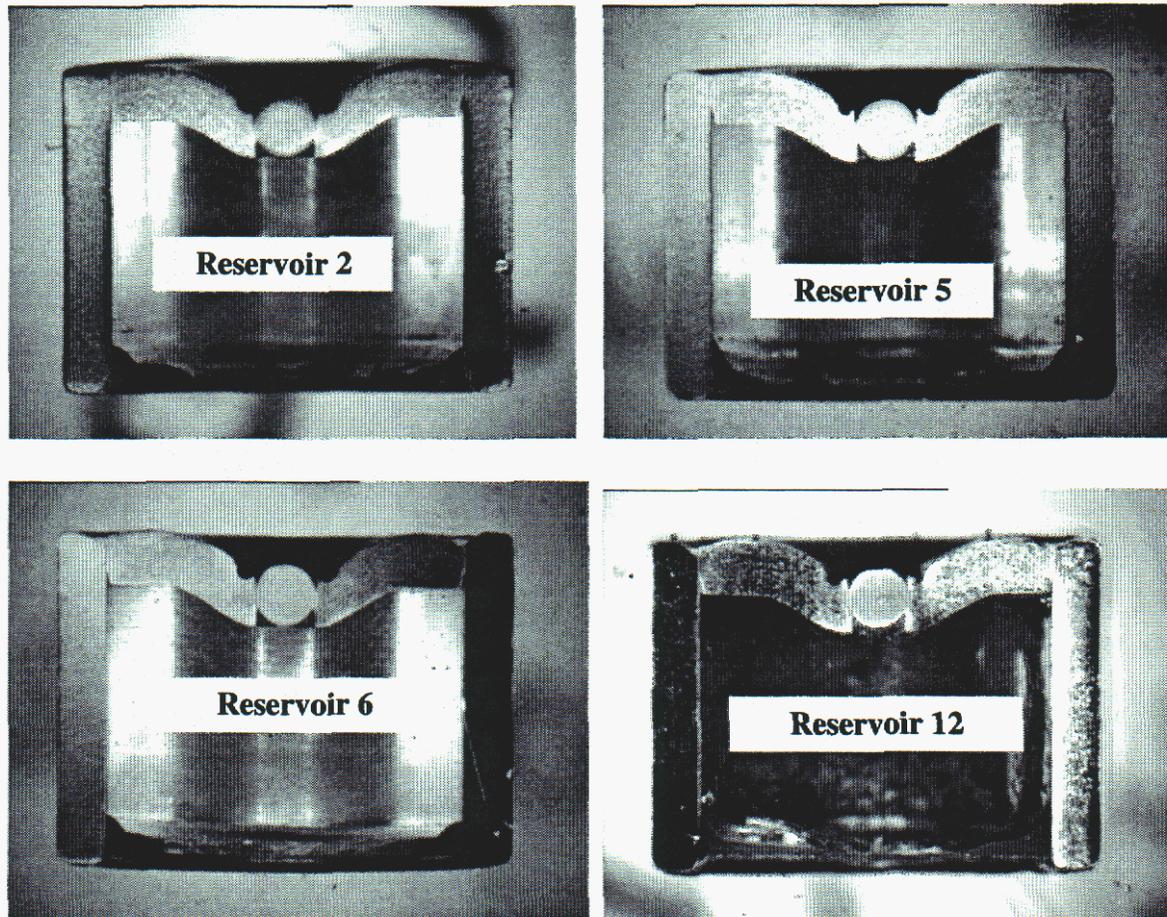
Figure 3.2. Cross sectional photomicrographs of the weld taken parallel and normal to the flat.

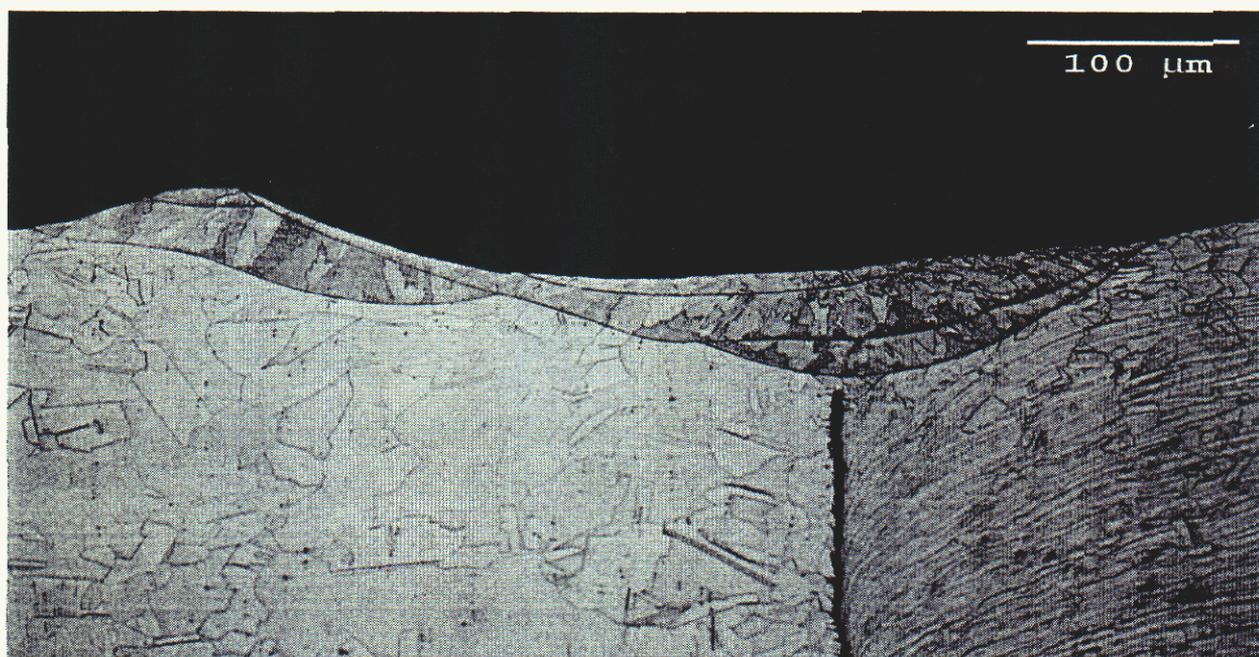
Figure 3.3 – Side 1 of Reservoir 2 Laser Weld Width = .017"; Max. Depth - .0041"; Eff. Depth - .0036"; Fusion Lines – 6.

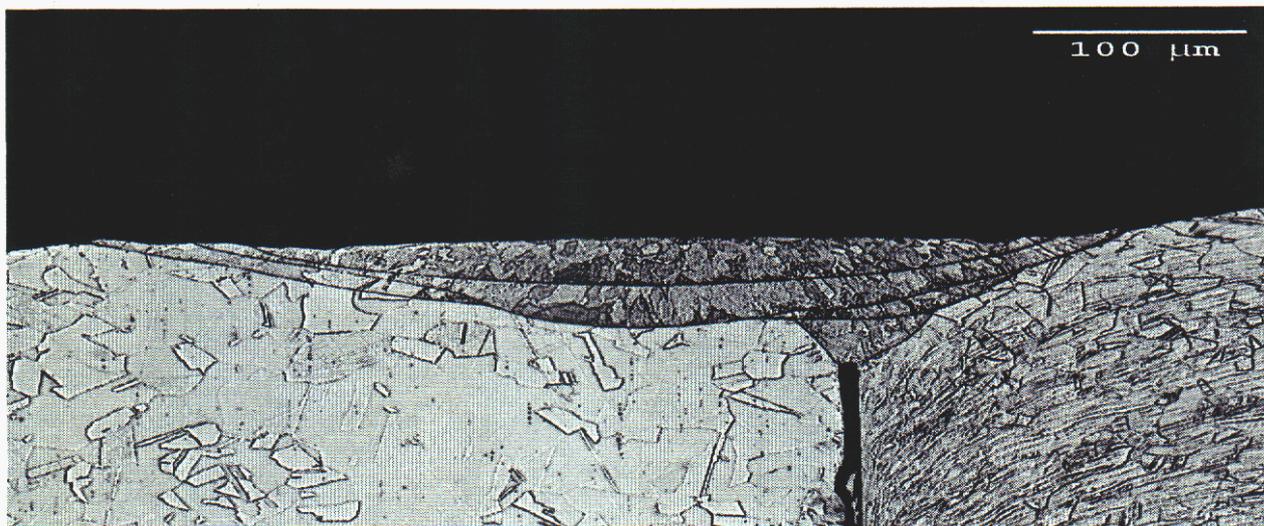
Figure 3.5 – Side 1 of Reservoir 5 Laser Weld Width = .020"; Max. Depth - .0044"; Eff. Depth - .0044"; Fusion Lines – 4. The weld is slightly off-center of the weld joint.

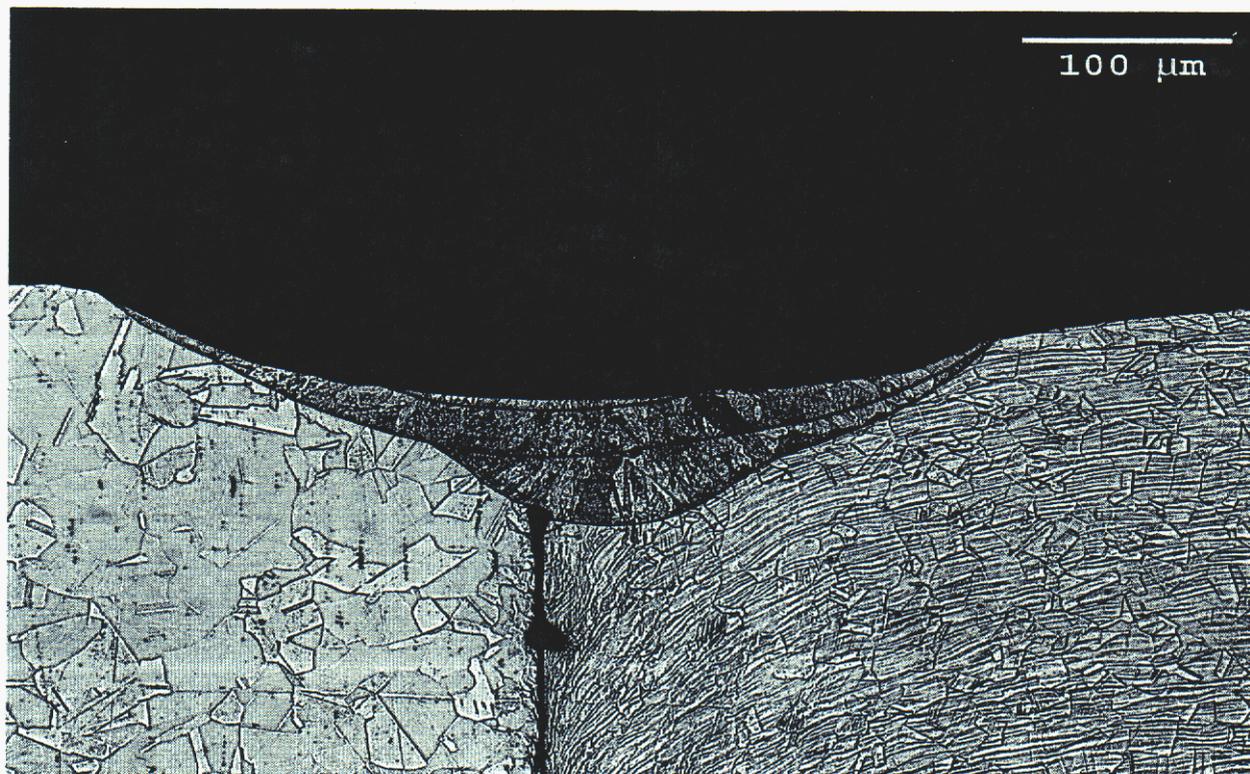
Figure 3.7 – Side 1 of Reservoir 6 Laser Weld Width = .018"; Max. Depth - .0030"; Eff. Depth - .0025"; Fusion Lines – 3. The weld is slightly off-center of the weld joint.

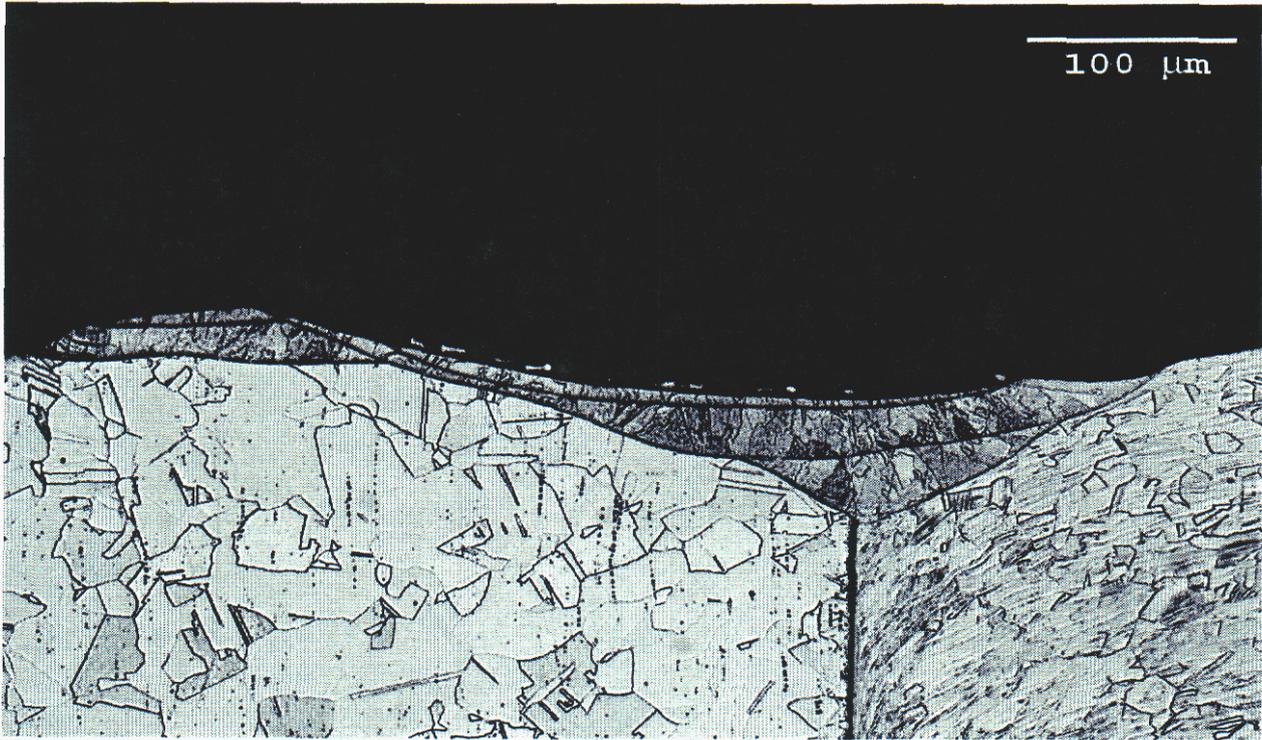
Figure 3.9 – Side 1 of Reservoir 12 Laser Weld Width = .021"; Max. Depth - .0030"; Eff. Depth - .0030"; Fusion Lines – 3 – 5. The number of fusion lines reflects a power ramp down area.

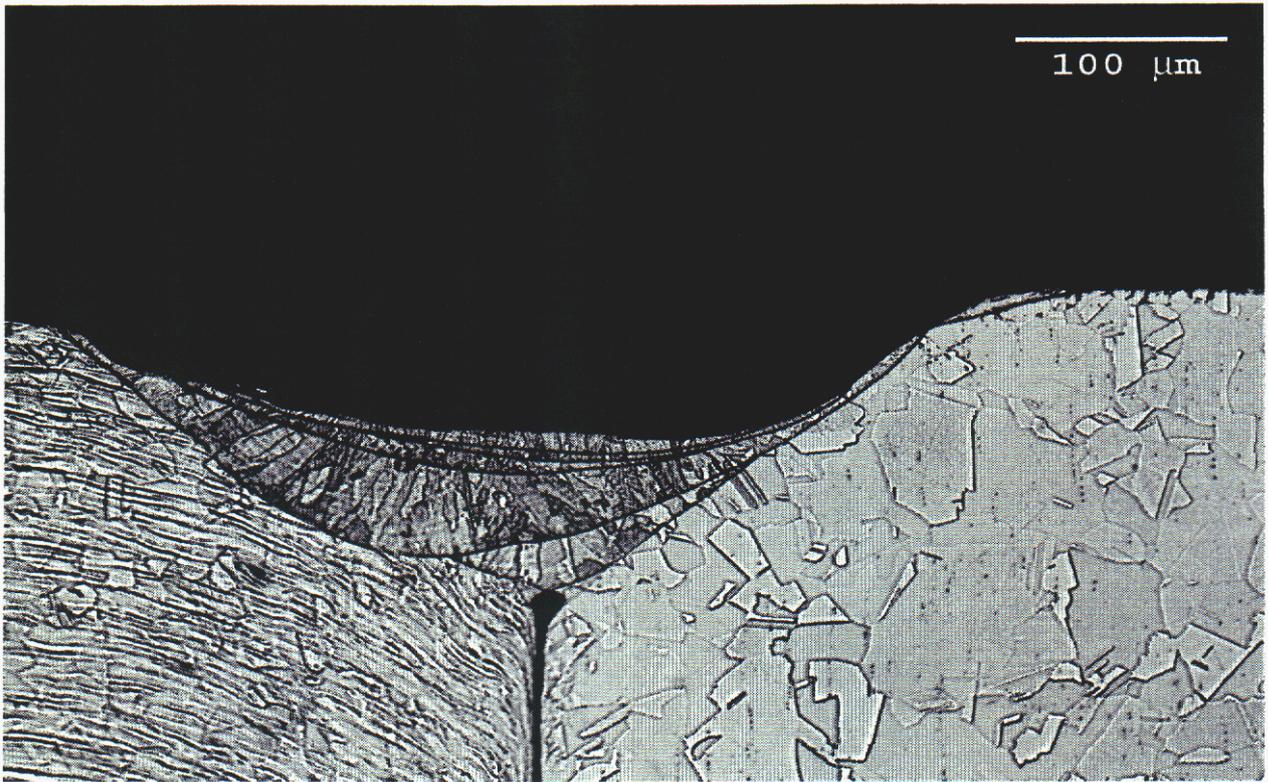
Figure 3.10 – Side 2 of Reservoir 12 Laser Weld Width = .019"; Max. Depth - .0044"; Eff. Depth - .0036"; Fusion Lines – 6. The number of fusion lines reflects a power ramp down area. Some root void/porosity can also be seen in this cross-section.
