SANDIA REPORT

SAND2004-4852

The Evaluation of Several Corrosion Mitigation Strategies for Oil Coolers Used by the Strategic Petroleum Reserve

David G. Enos, Bruce L. Levin, and Thomas E. Hinkebein

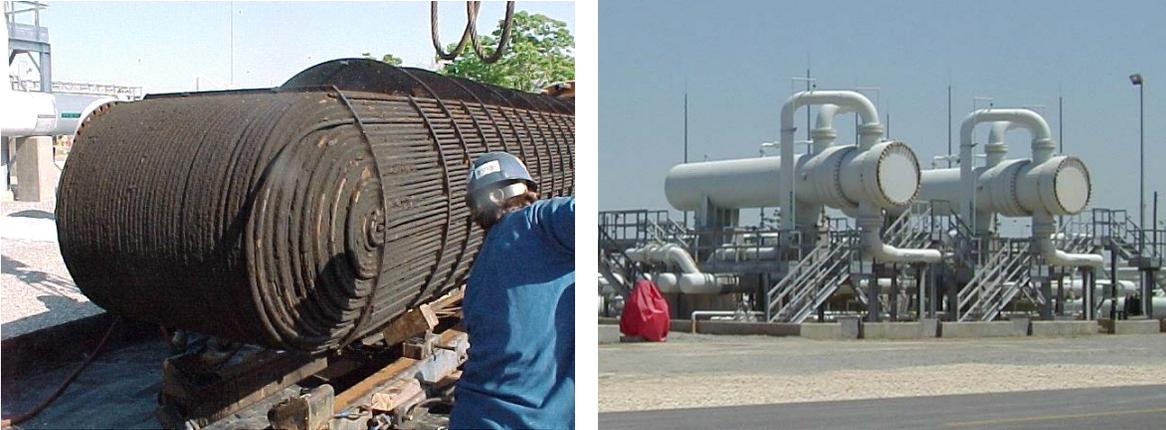
Figure 1: Oil Coolers located at the various SPR sites.

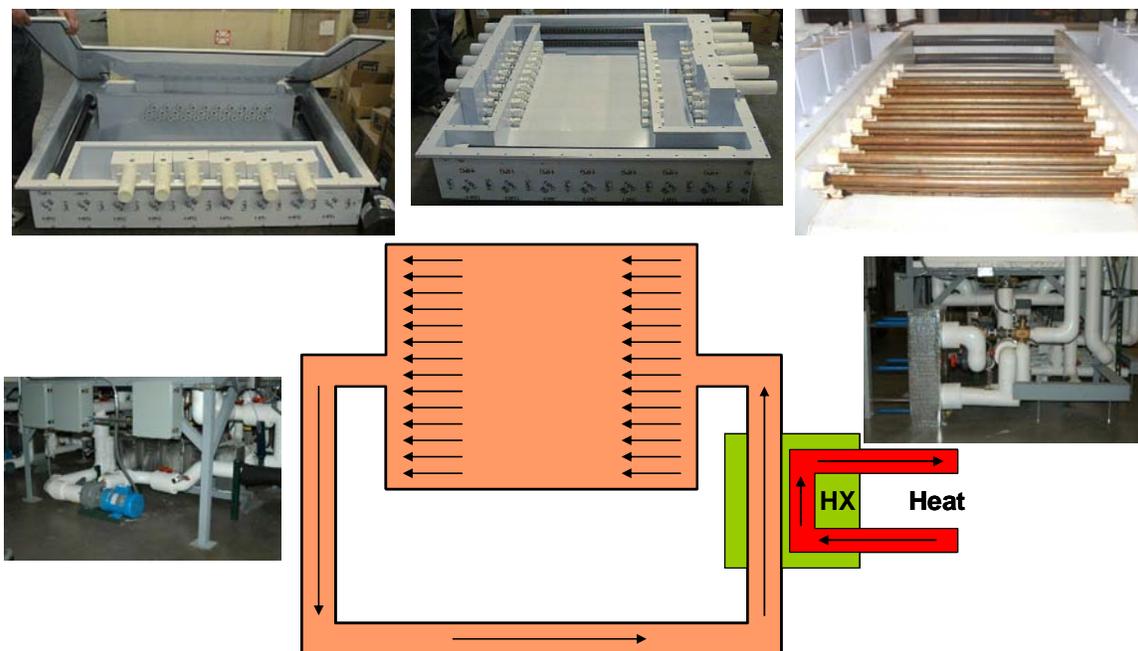
Figure 3: Schematic of a single shell side loop used to simulate the oil (in terms of temperature)

As mentioned previously, the oil coolers at each of the SPR sites are once through systems – in other words, the water which passes through the heat exchangers only passes through once – it is not a loop. This creates a challenge for a laboratory scale system, as in order to operate in the same manner, a prohibitively large quantity of water would need to be kept on hand. As an example, at a flow rate of 6gpm, the system would require 8640 gallons per tube segment per day – corresponding to 777600 gallons per tube for the total 90 day operating time of the system – clearly this was not feasible. As such, a closed loop, recirculating system was designed and constructed. In this system, the initial solution chemistry was identical to that present within an actual heat exchanger (i.e., source water taken from the SPR site). As time progressed, the solution chemistry was periodically monitored and adjustments made to maintain this similarity (e.g., chemical additions, filtering corrosion product particulates, etc.).

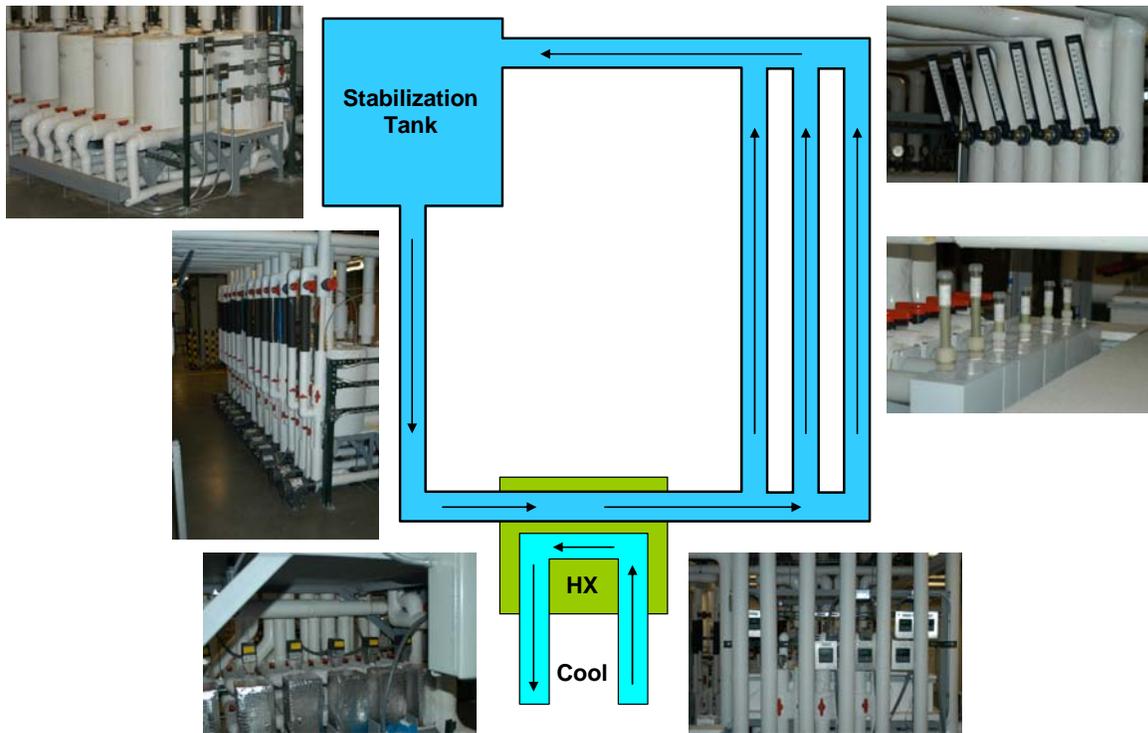
Figure 4: Schematic of a single tube side loop containing the water chemistry relevant to each SPR site

The tube side loops (Figure 4) contained the SPR source water chemistry (from the West Hackberry or Bryan Mound site). Each tube side loop consisted of a stabilization tank, a pump, a heat exchanger, and a manifold which contained the metal tubing being evaluated by each loop. The stabilization tank was used to maintain a large volume of solution, and was where all solution sampling and augmentation took place. In addition, a gas dispersion tube was present in each tank, and air was continuously bubbled through the tank to ensure that the oxygen concentration was not depleted over time. Water was pumped from the stabilization tank, through a heat exchanger to set the desired tube side temperature. The heat exchanger utilized processed chilled water from the building along with a three way valve and associated PID controller. Once brought to temperature, the water was pumped through a manifold containing tubes of the desired metallurgy, then returned to the stabilization tank. Each manifold contained, in addition to the tube segments being evaluated, a corrosion sensor and ports for thermocouples. The water temperature and flow rate were monitored and maintained throughout the test. Each tube side loop contained approximately 32 gallons of solution which was either used as is, or with the addition of the previously described inhibitor and anti-foulant chemistry.

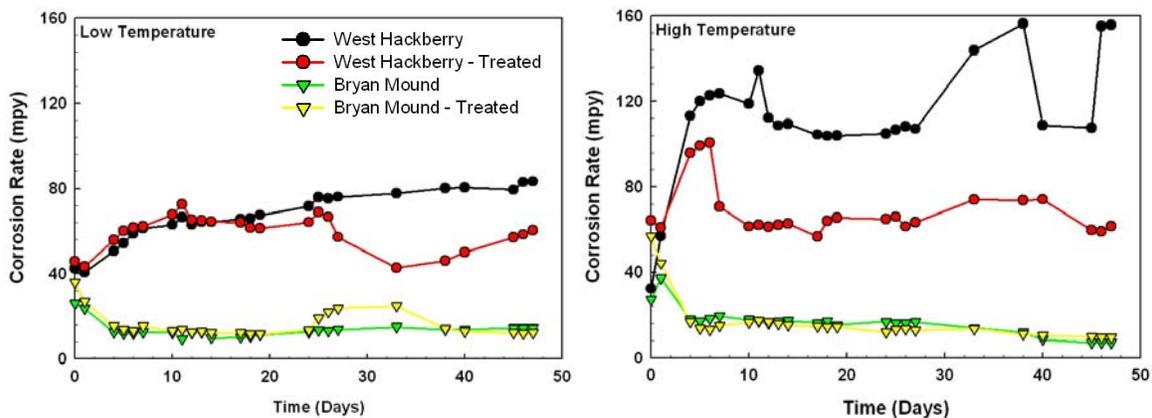
Figure 5: Corrosion sensor data for carbon steel in each solution chemistry.

manufacturer) for the superferritic stainless steel. The results are presented in Figure 5.

As can be seen in the figure, in the case of the low temperature loops, the corrosion rate for all of the carbon steel samples (independent of the presence of inhibitor) initiated at 30mpy, and then gradually changed with time. For West Hackberry, the corrosion rate gradually increased, stabilizing at a rate of 80 mpy for untreated water, and 50 to 60 mpy for the treated water. The samples in Bryan mound water decreased to approximately 15 mpy (both inhibited and uninhibited). The corrosion rate of the SeaCure material was effectively zero in both Bryan Mound and West Hackberry water.

In the high temperature loops, the samples exposed to West Hackberry had an initial corrosion rate of 30 mpy, then gradually increased to 150 mpy in the raw water and 60 mpy in the treated water. The Bryan mound samples behaved similarly to the low temperature case, with the corrosion rate again stabilizing at approximately 15 mpy (both with and without the presence of the inhibitor). Once again, the corrosion rate of the SeaCure material was effectively zero in both Bryan Mound and West Hackberry water.

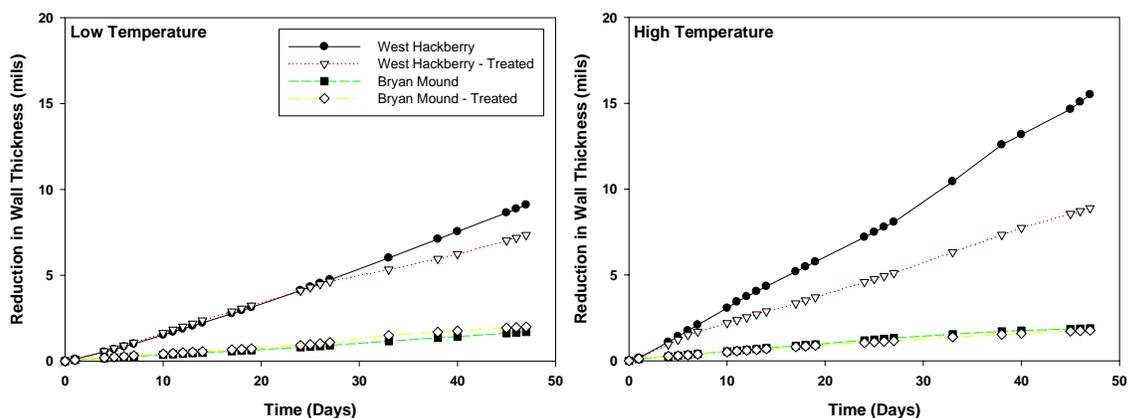
Figure 6: Average depth of corrosion as a function of time (calculated from corrosion sensor data)

Of primary concern in the operation of the heat exchangers is the remaining wall thickness in each tube section. While the corrosion rate data does not in and of itself provide this information, the average reduction in wall thickness as a function of time can be estimated based upon those results. In Figure 6, the average depth of corrosion as a function of time is presented. In each case, the depth was calculated assuming that the corrosion rate was constant and equal to the previous measurement for the time periods between measurements. Considering the nature of the corrosion rates as presented above, this is a reasonable assumption to make, and the resulting calculation should thus be reasonably accurate. As can be seen in the figure, the average depth of corrosion increases linearly with time. If the data for each flow loop is extrapolated to 180 days (the time of a single drawdown procedure), the following average corrosion depths and percent metal losses (based on calculated original and post measured

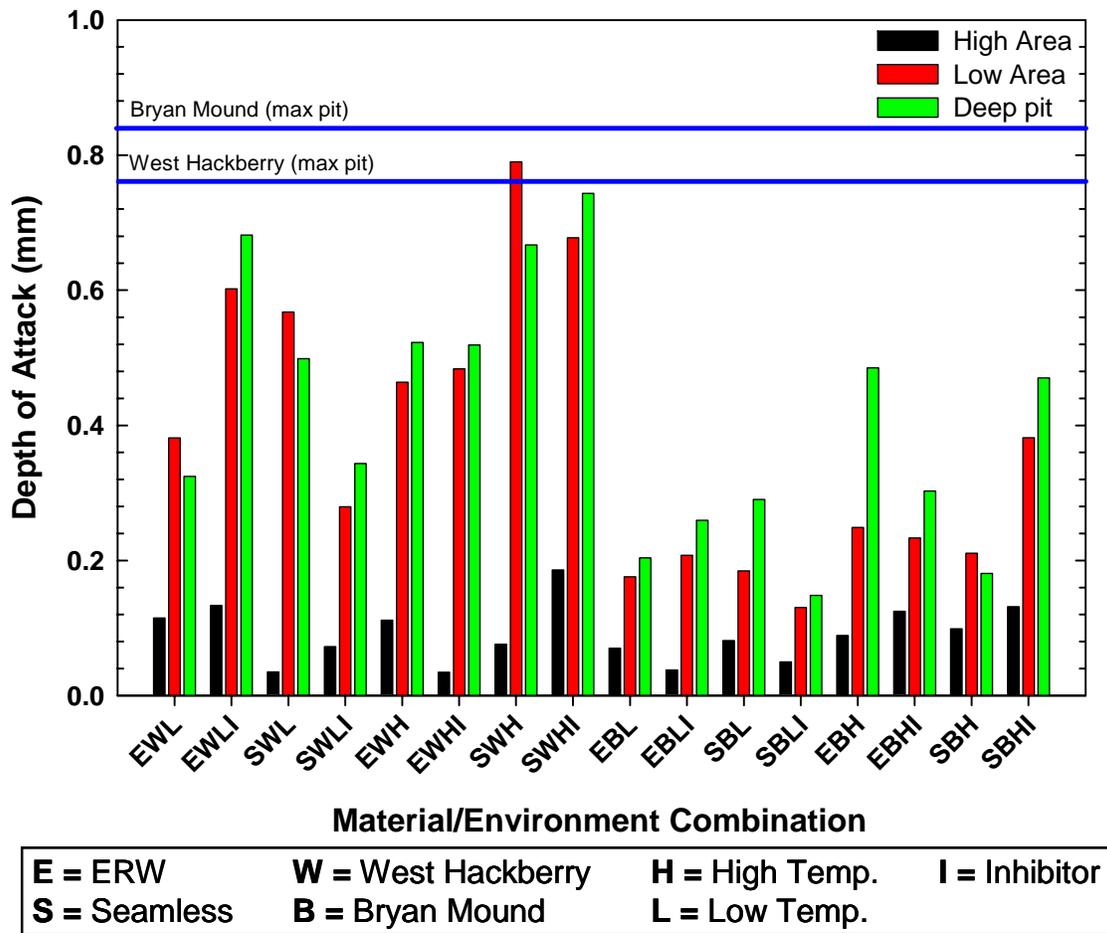
Figure 7: Depth of attack as a function of environmental conditions (60 day data)

As with the observations made of the corrosion sensors, *it should again be stressed that the attack was nonuniform in nature – as such, measures of the average reduction in cross section or overall weight-loss may be a poor representation of the true depth/severity of corrosion.* To further illustrate this effect, the depth of localized attack was measured using a digital micrometer equipped with pin anvils. Figure 7 illustrates the results obtained after 60 days of operation. As was seen in the pictures referenced above, the corrosion which occurred at a given point along the tube can be grouped into three general categories – high areas (minimal

attack), low areas (significant, general attack) and pits (significant, local attack). Also indicated on the figure is the maximum depth of attack allowed in order to ensure that the system will be able to contain the operating pressures for the Bryan Mound and West Hackberry sites. As can be seen, there are situations after only 60 days of operation where the depth of attack is sufficient to potentially result in failure of a tube section. Figure 8 shows the maximum pit depth at 60 days (same information as previous figure) as well as the 90 day data. At this point (corresponding to half of a full drawdown cycle) there are numerous material combinations

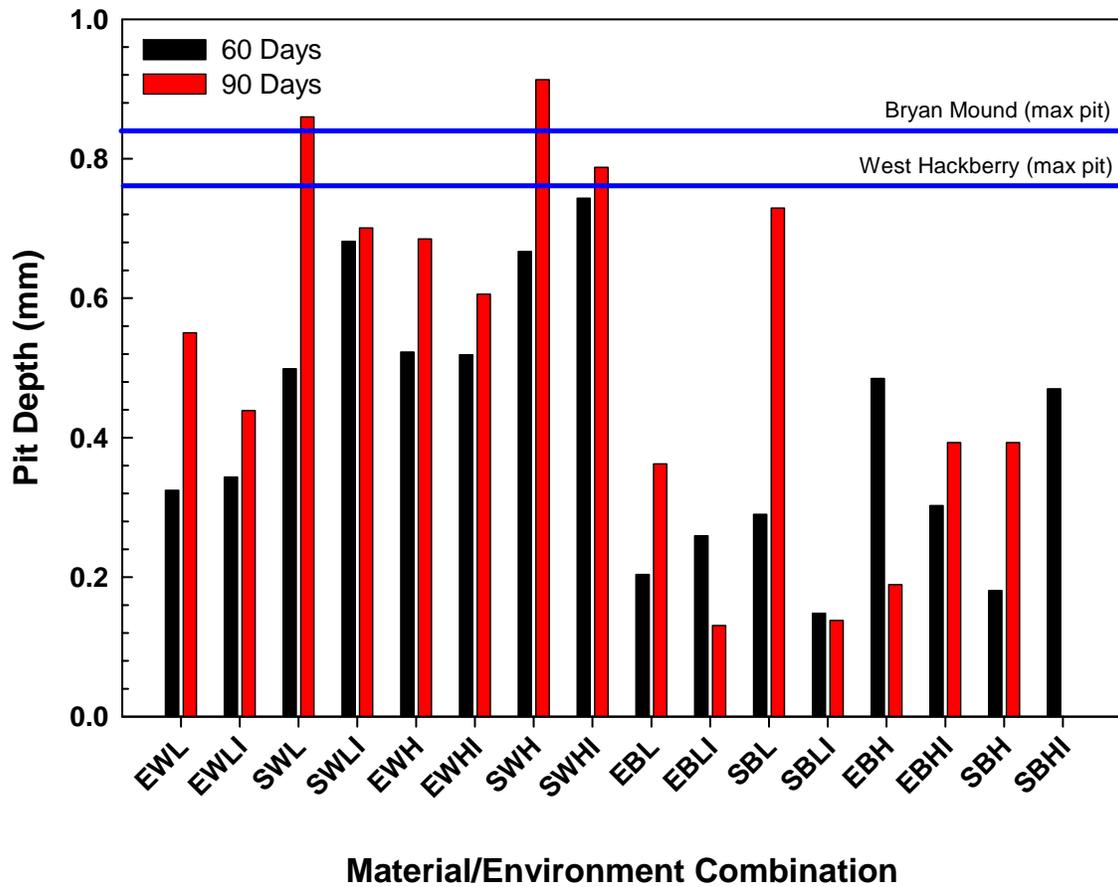
E = ERW	W = West Hackberry	H = High Temp.	I = Inhibitor
S = Seamless	B = Bryan Mound	L = Low Temp.

Figure 8: Depth of deep pits as a function of environment for 60 and 90 days of exposure.

which are at high risk for failure – both with and without the presence of the inhibitor.

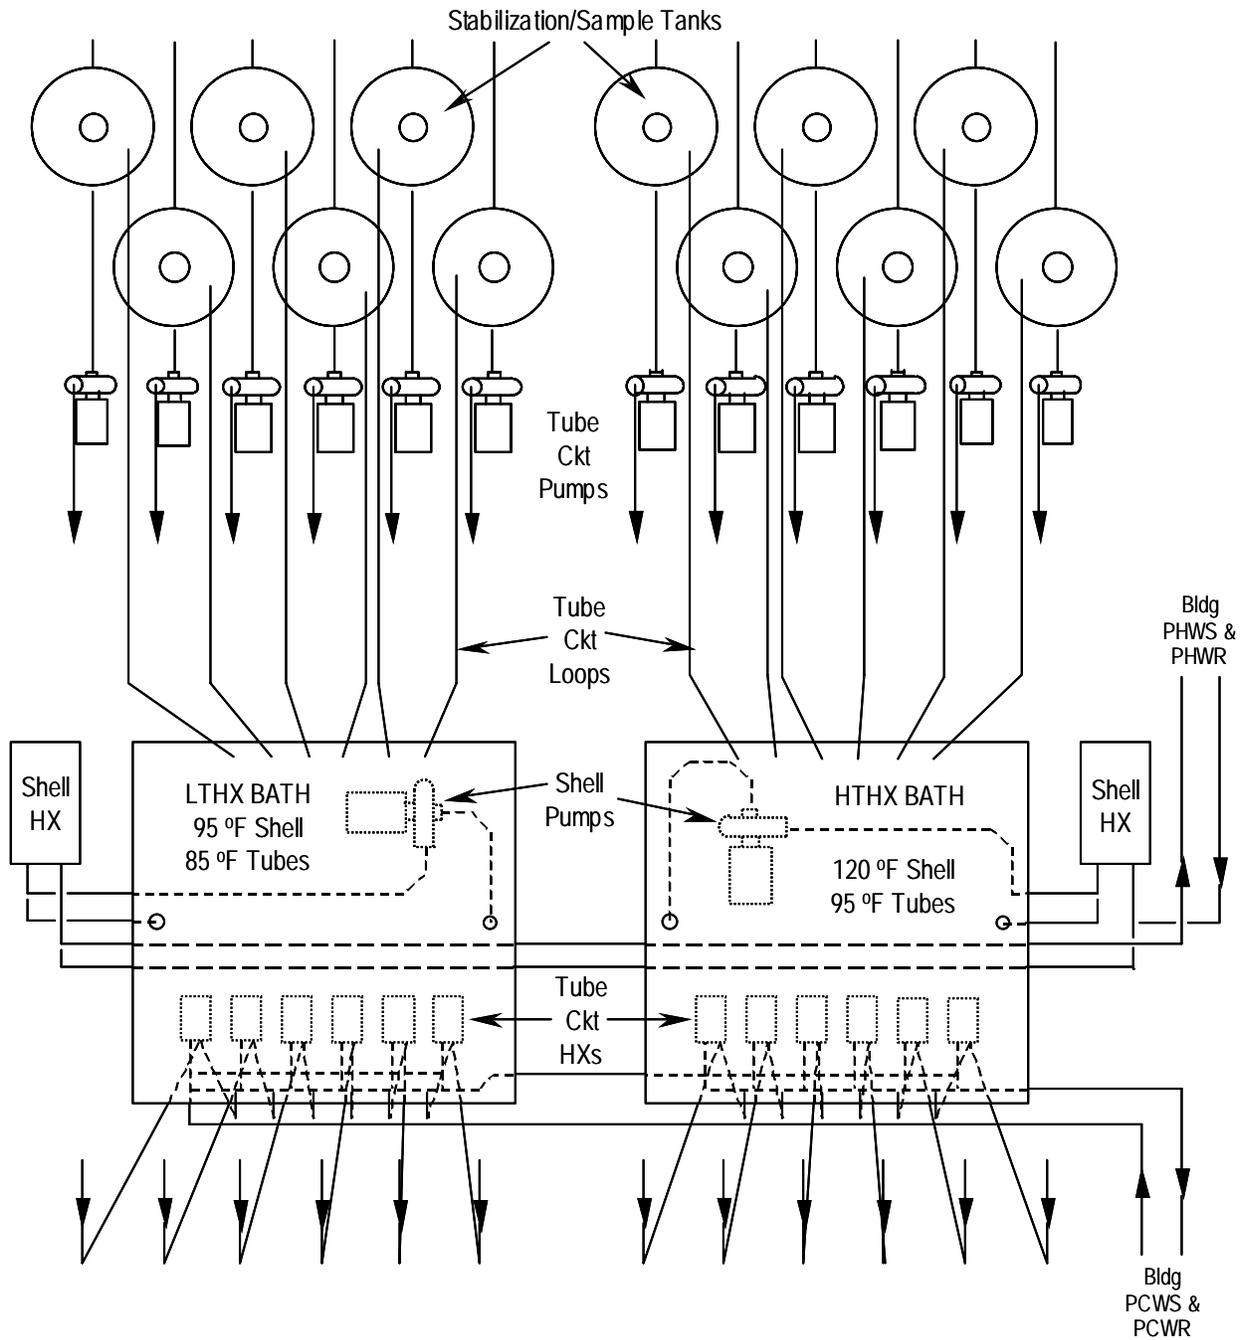
HEAT EXCHANGER TUBE CORROSION/FOULING EXPERIMENT LAYOUT PLAN – BUILDING 701 BASEMENT

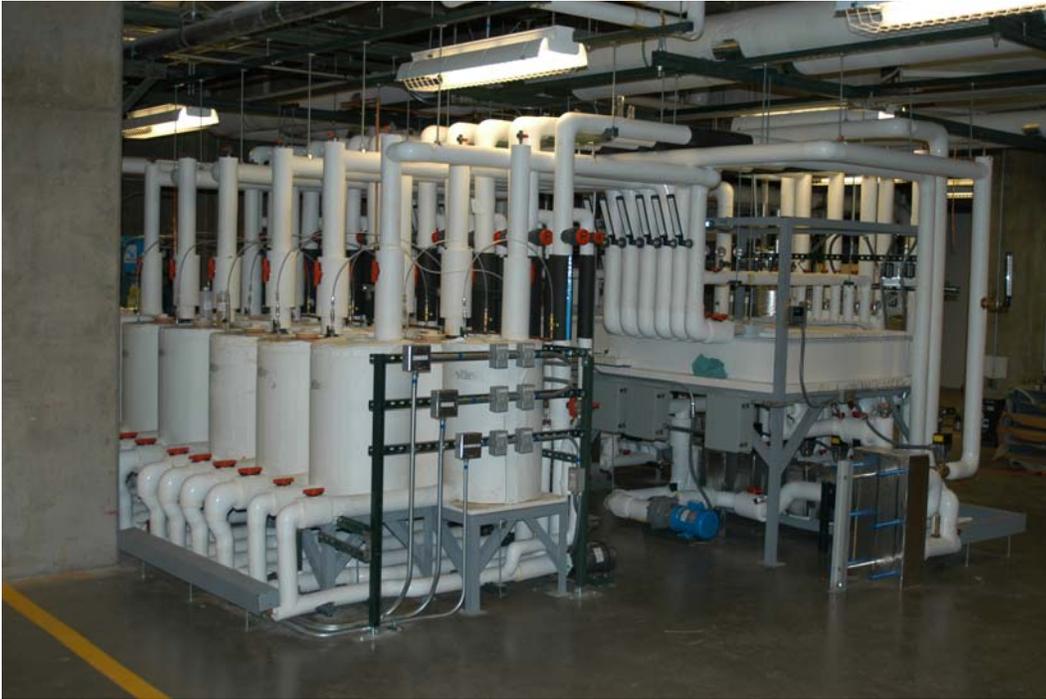
Overall System view from northwest corner. The stabilization tanks can be seen on the left of the picture, and the low temperature flow loops on the right.

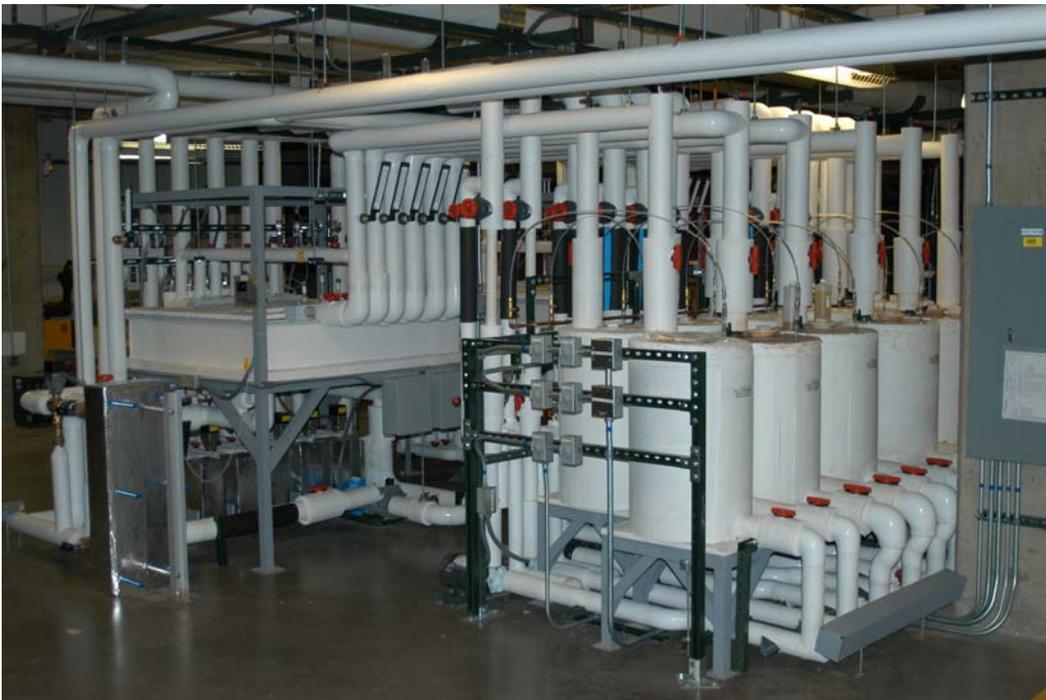
Overall system view from the northeast corner. The high temperature loops can be seen on the left side of the picture, the stabilization tanks and the power panel on the right side.

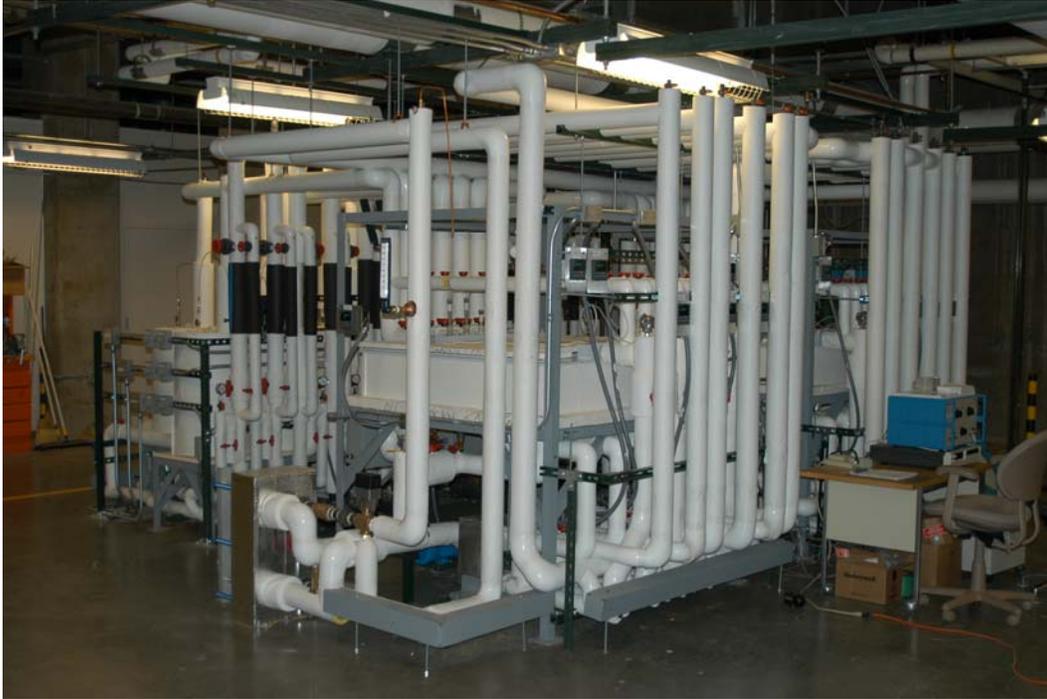
Overall system view from southwest corner. The stabilization tanks can just be seen on the left side of the picture. The high and low temperature flow loops can be seen on the right side of the picture, along with the equipment utilized to monitor the shell side temperature for each loop as a function of time.

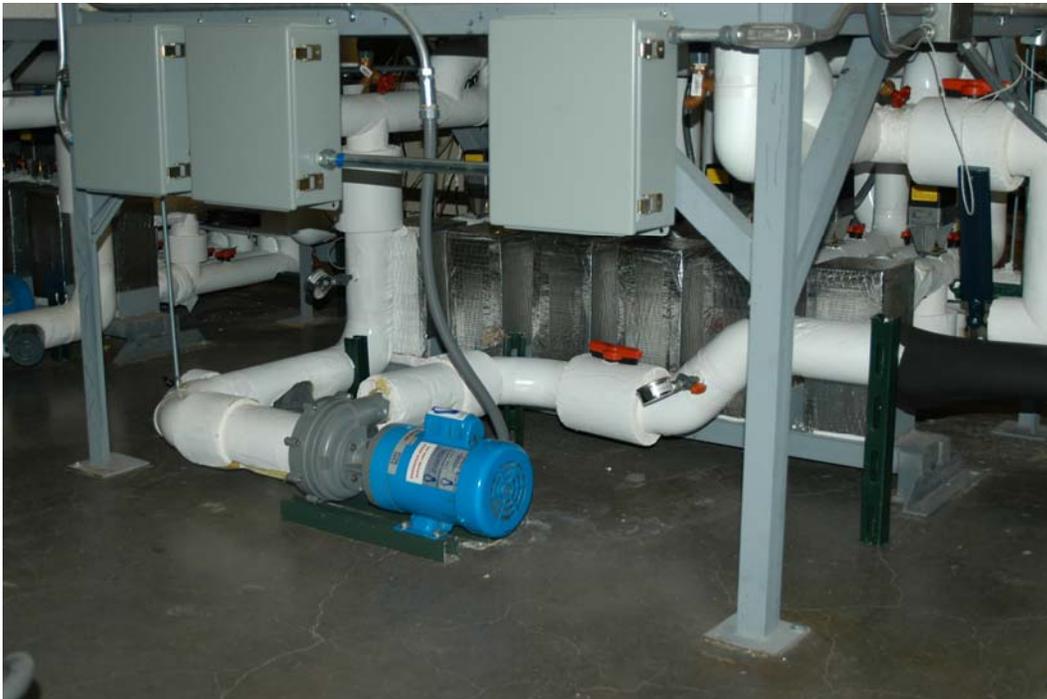
Pump used to control solution flow for the shell side loop – one such pump was used for both the hot side and cold side heat exchangers. The fuse boxes used to protect the equipment in the flow loops are visible at the top of the picture.

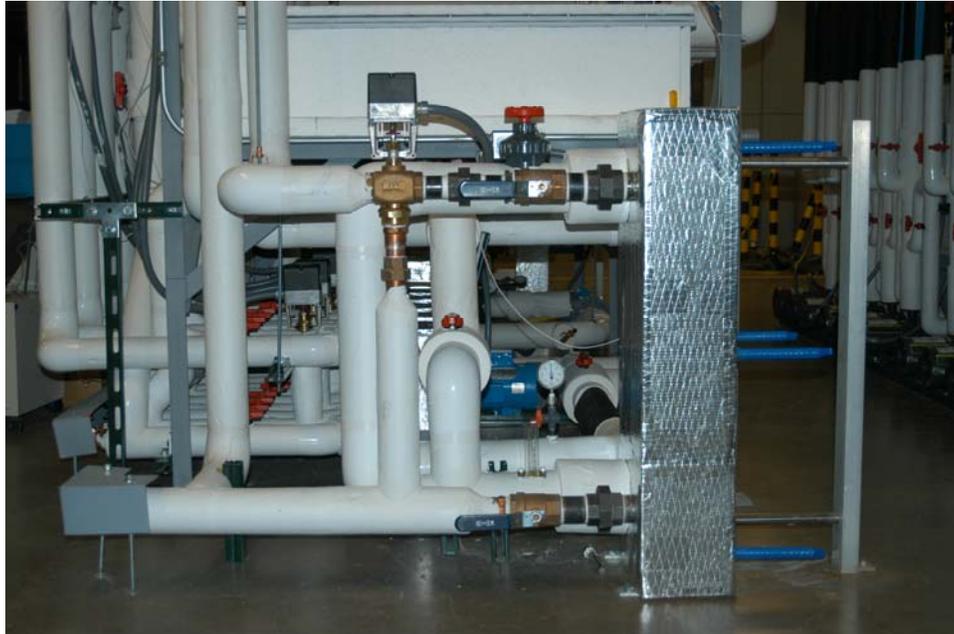
Heat exchanger and three-way valve used to control the shell side temperature on the hot side flow loop system. A similar heat exchanger was present on the low temperature shell side flow loop as well. The heat exchangers utilized processed hot water from the building utilities to heat the water in the flow loop

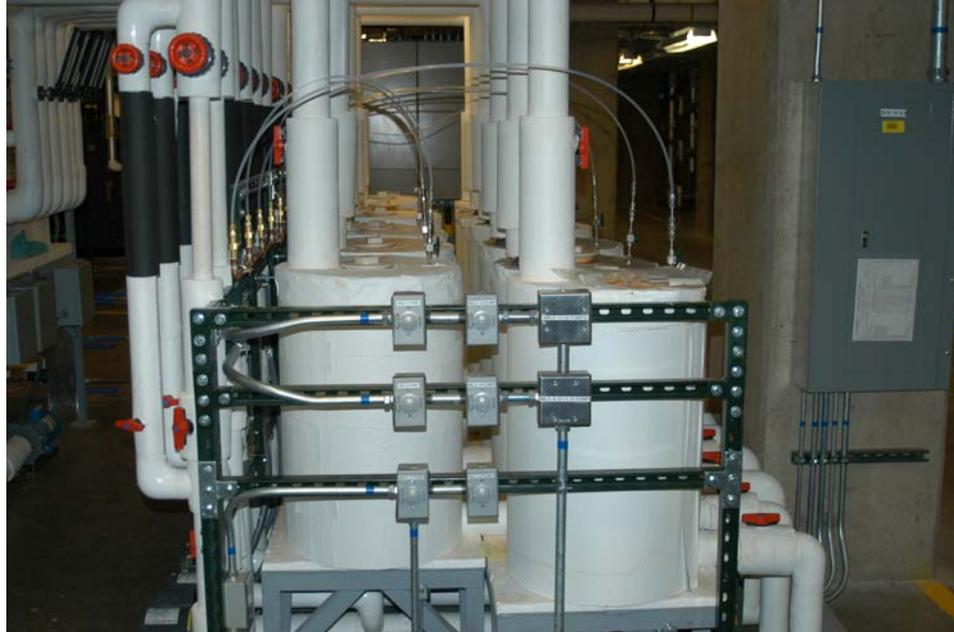
Overall view of the stabilization tanks. The water return for each loop was on the top of each stabilization tank, and the outlet on the bottom (right side of picture). Air lines were run through the top of each tank to a dispersion tube located inside on the bottom of each tank to ensure that the water remained aerated. Also shown are the power switches used to control the pumps for six of the tube side loops.

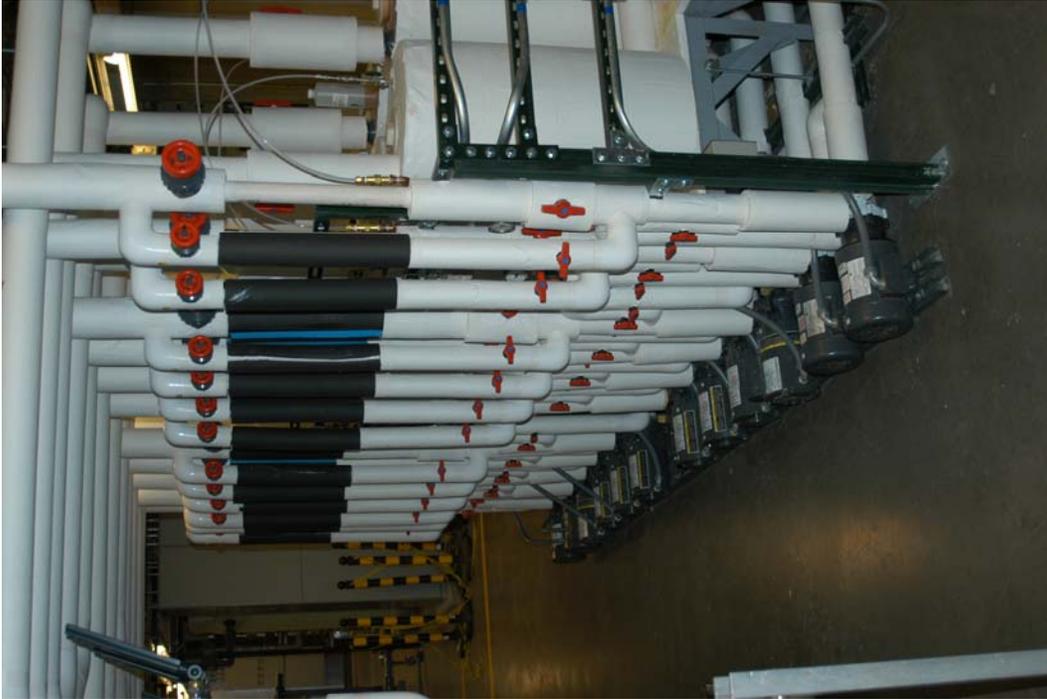
View from the center of the system, showing the pumps and valves used to control the flow rate of solution in the 12 tube side loops.

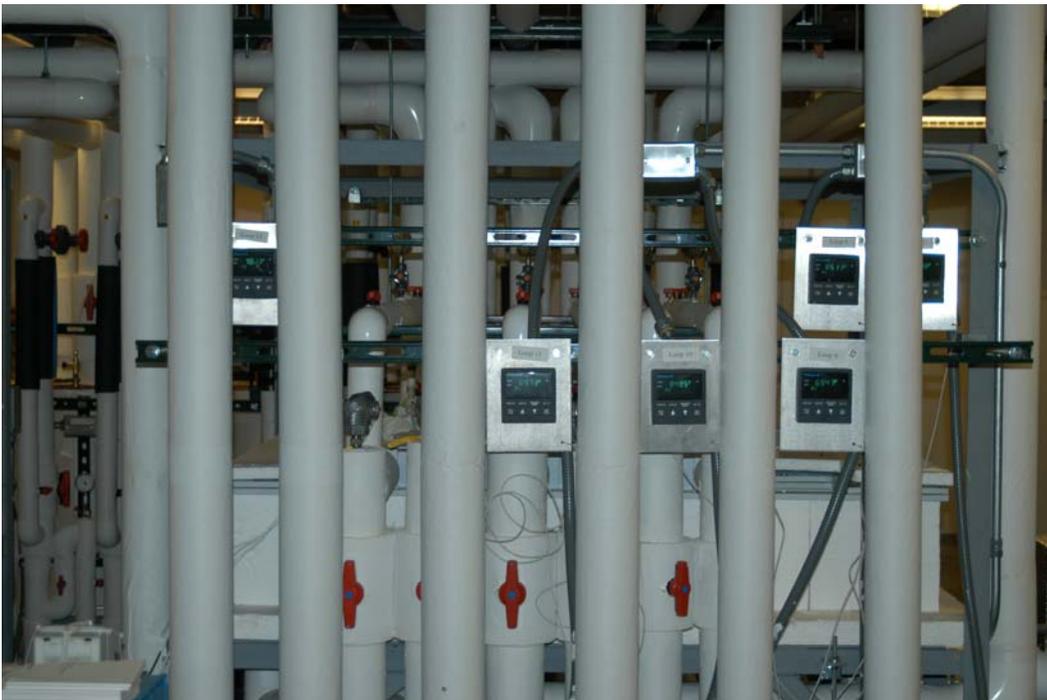
PID controllers and associated temperature sensors, shown here for the high temperature tube side flow loops, were used to monitor and control (via heat exchangers utilizing processed chilled water) the temperature in each loop.

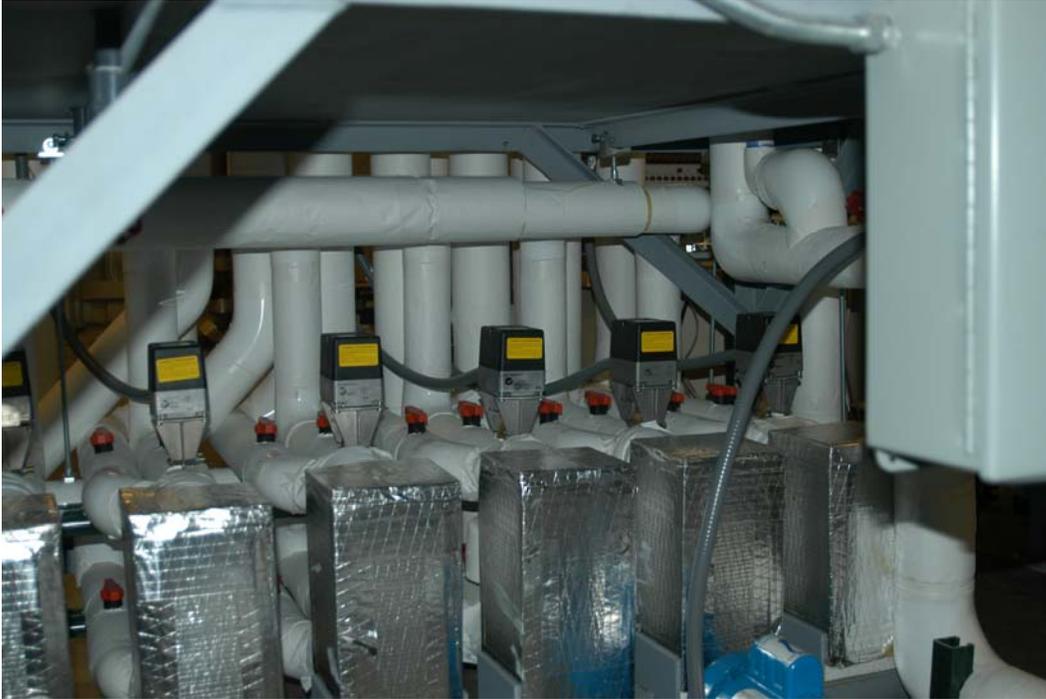
Heat exchangers used to control the temperature in each tube side loop. Each loop had its own exchanger, which utilized processed chilled water from the building (whose flow rate was controlled via a three way valve) to control the temperature for each loop.

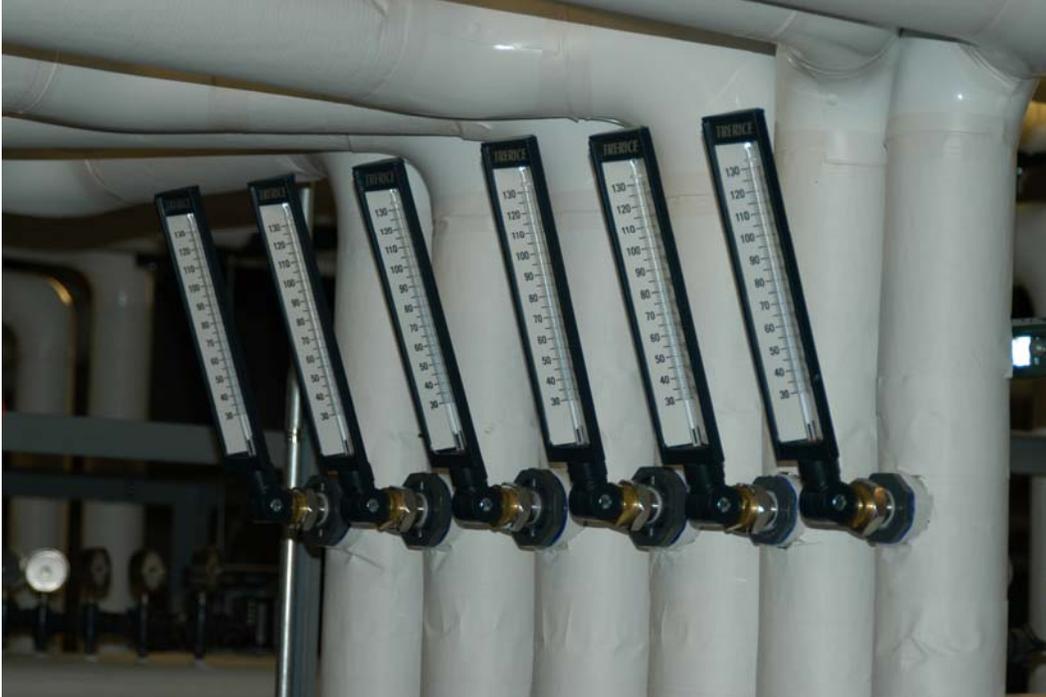
In addition to the PID controller, the water temperature was monitored (checked) for each of the tube side loops using thermometers and thermal wells which extended into the flow stream.

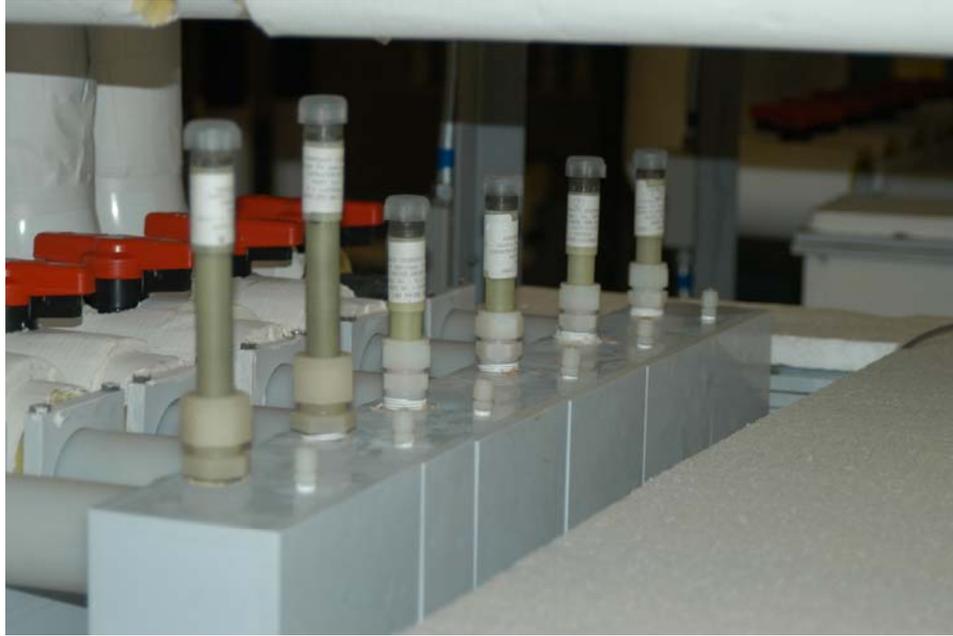
Each material/environment combination (corresponding to each of the twelve tube side loops) contained a CorrPro corrosion sensor which was utilized to monitor the corrosion rate of each material as a function of time.

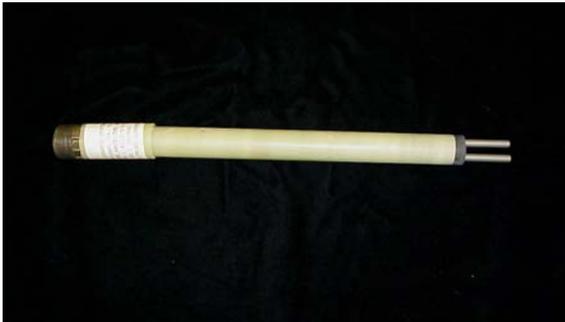
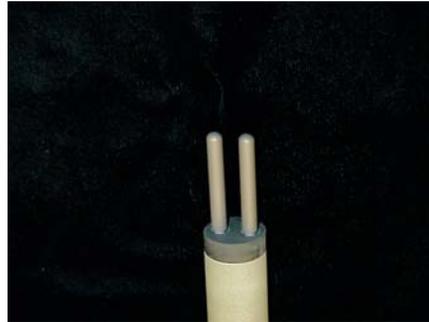
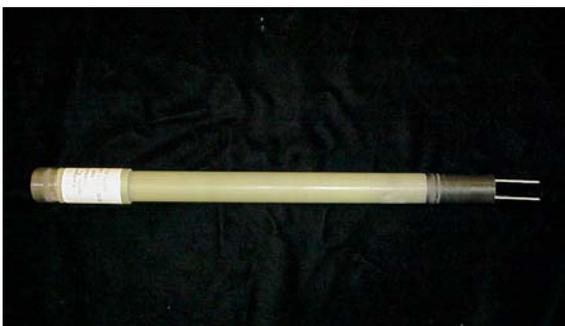
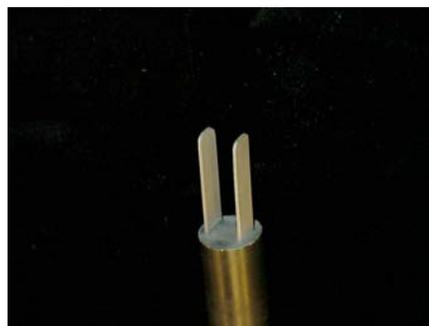
CorrPro corrosion sensors used to monitor the corrosion rate as a function of time. The sensor on the top utilized carbon steel rods, while the sensor on the bottom utilized SeaCure stainless steel taken from an actual tube segment. In both cases, the active portion of the sensor is of a known size and geometry, such that the corrosion rate can be calculated from a linear polarization measurement.

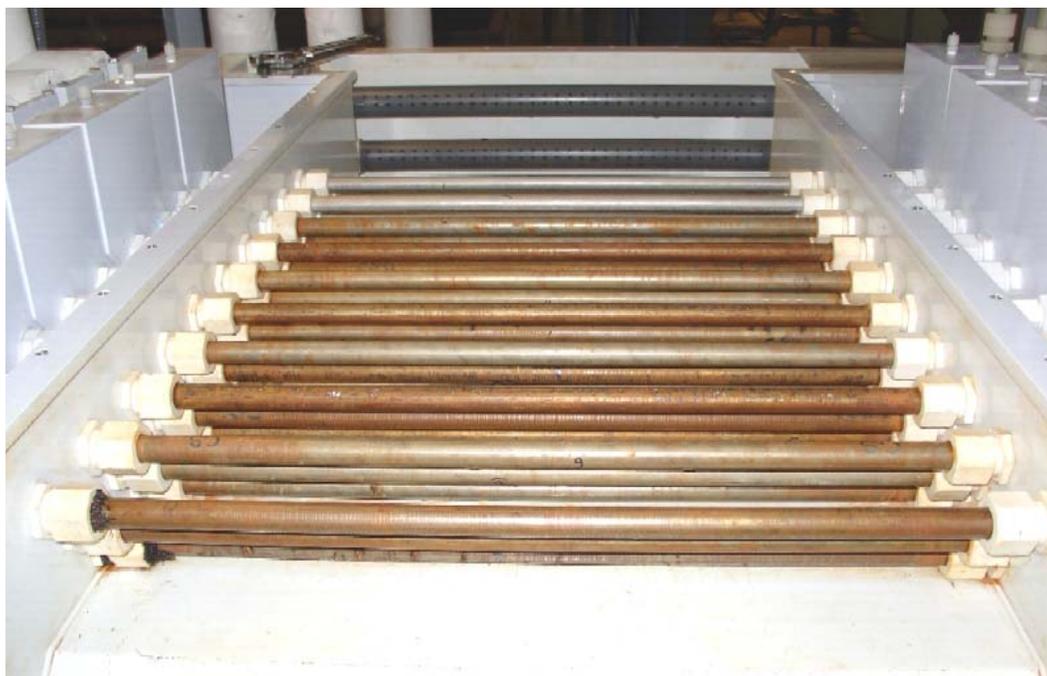
The tube segments which were located within each of the two shell side flow loops. Samples are shown here after the first 60 days of the test (at which point the top layer of tubes were removed and analyzed)

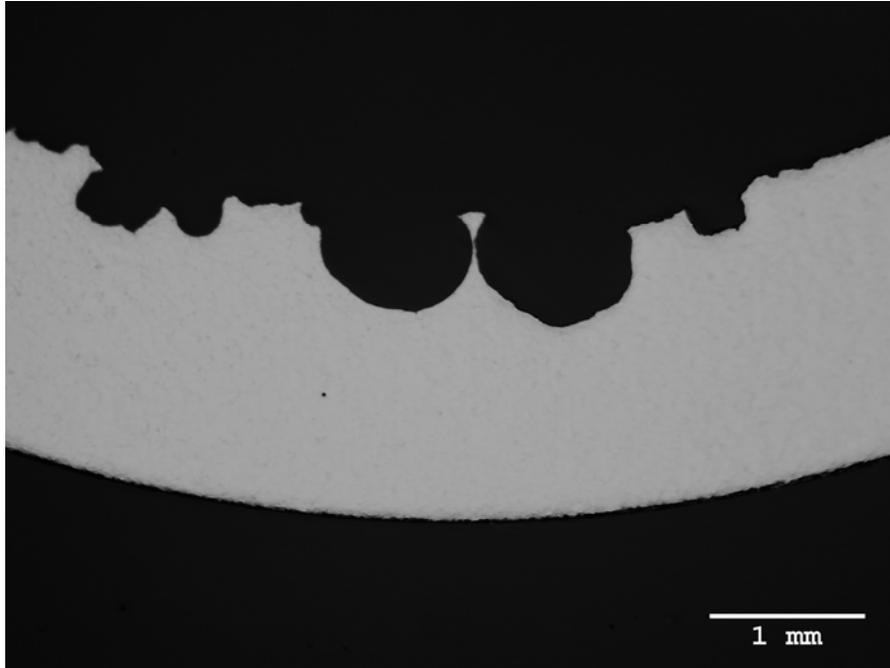
West Hackberry, Low Temperature, Untreated

Seamless, Illustrating depth of attack

As can be seen in the figures, the depth of attack in the deepest pits (captured in the appendix) approaches 40% of the remaining wall thickness. In the case of the seamless (i.e., unwelded) tubing, the attack is in the form of a uniform, hemispherical-type pitting. However, in the case of the ERW tubing, this attack is more knife-line like in nature, along the entire length of the weld region. Based upon the results observed at 60 days, it is not unreasonable to expect perforation to occur before the 180 days of a complete drawdown in the case of the West Hackberry water. The Bryan Mound solutions (not pictured here) exhibited a lesser degree of attack, and at this point it appears less likely that perforation would be a risk over the course of a drawdown.

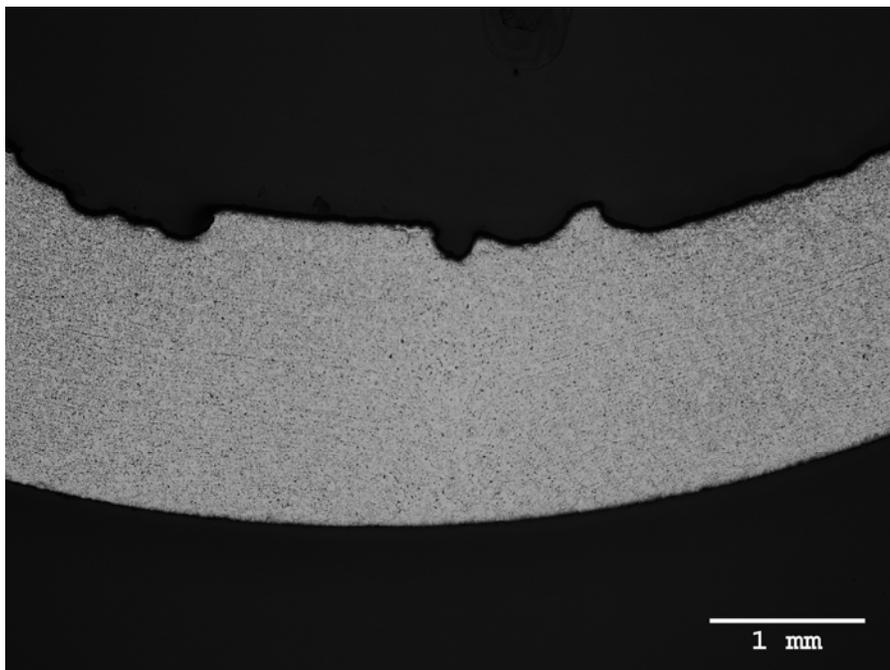
ERW, illustrating selective attack at weld line

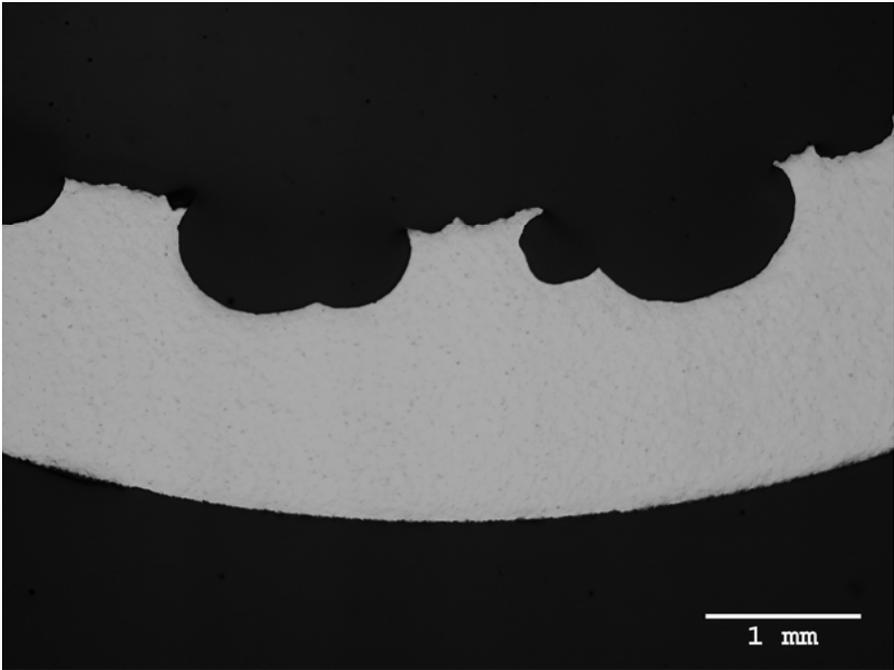
West Hackberry, High Temperature, Untreated

Seamless, Illustrating depth of attack

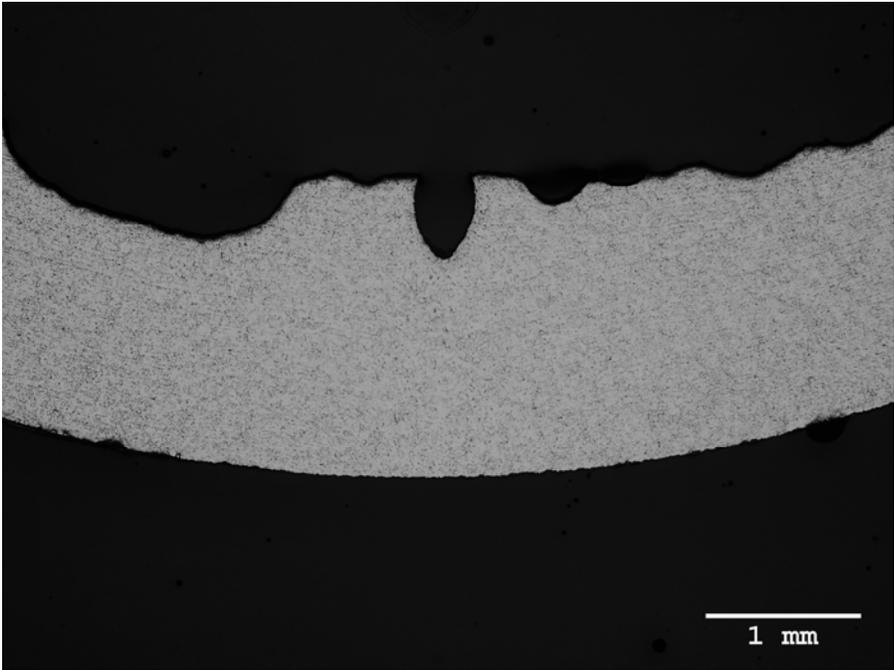
ERW, illustrating selective attack at weld line

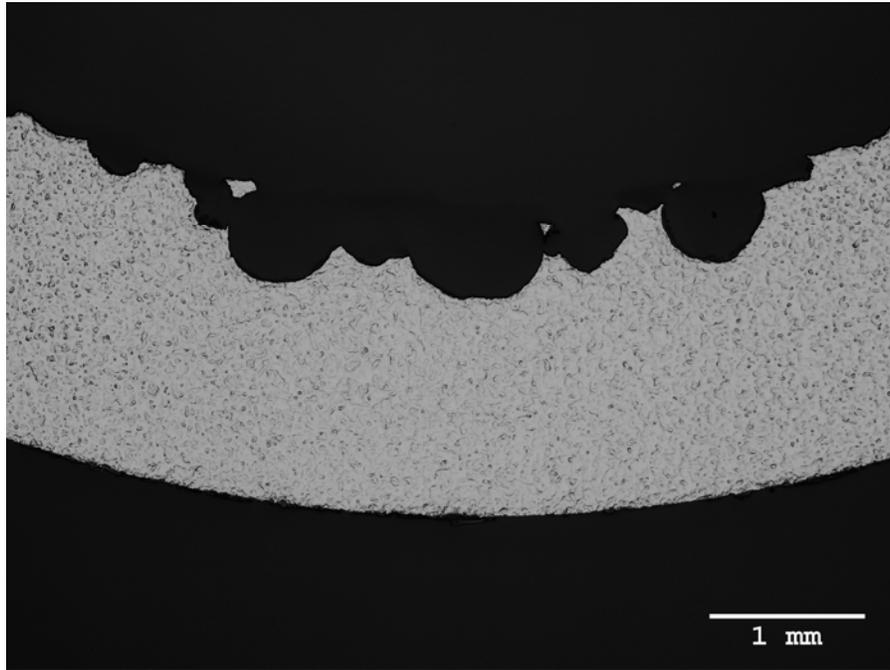
West Hackberry, High Temperature, Treated

Seamless, Illustrating depth of attack

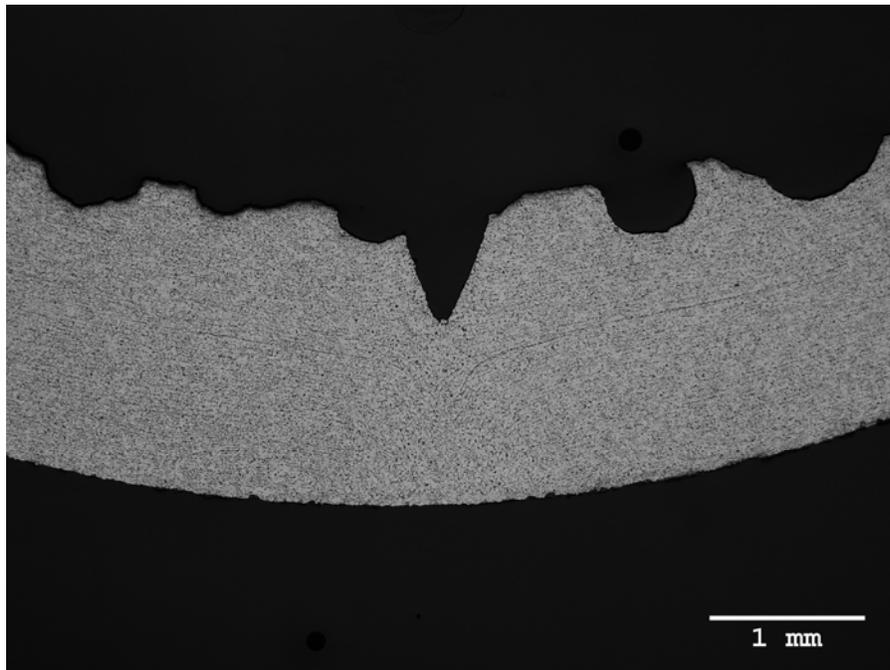
ERW, illustrating selective attack at weld line
