SANDIA REPORT

SAND2004-4852

The Evaluation of Several Corrosion Mitigation Strategies for Oil Coolers Used by the Strategic Petroleum Reserve

David G. Enos, Bruce L. Levin, and Thomas E. Hinkebein

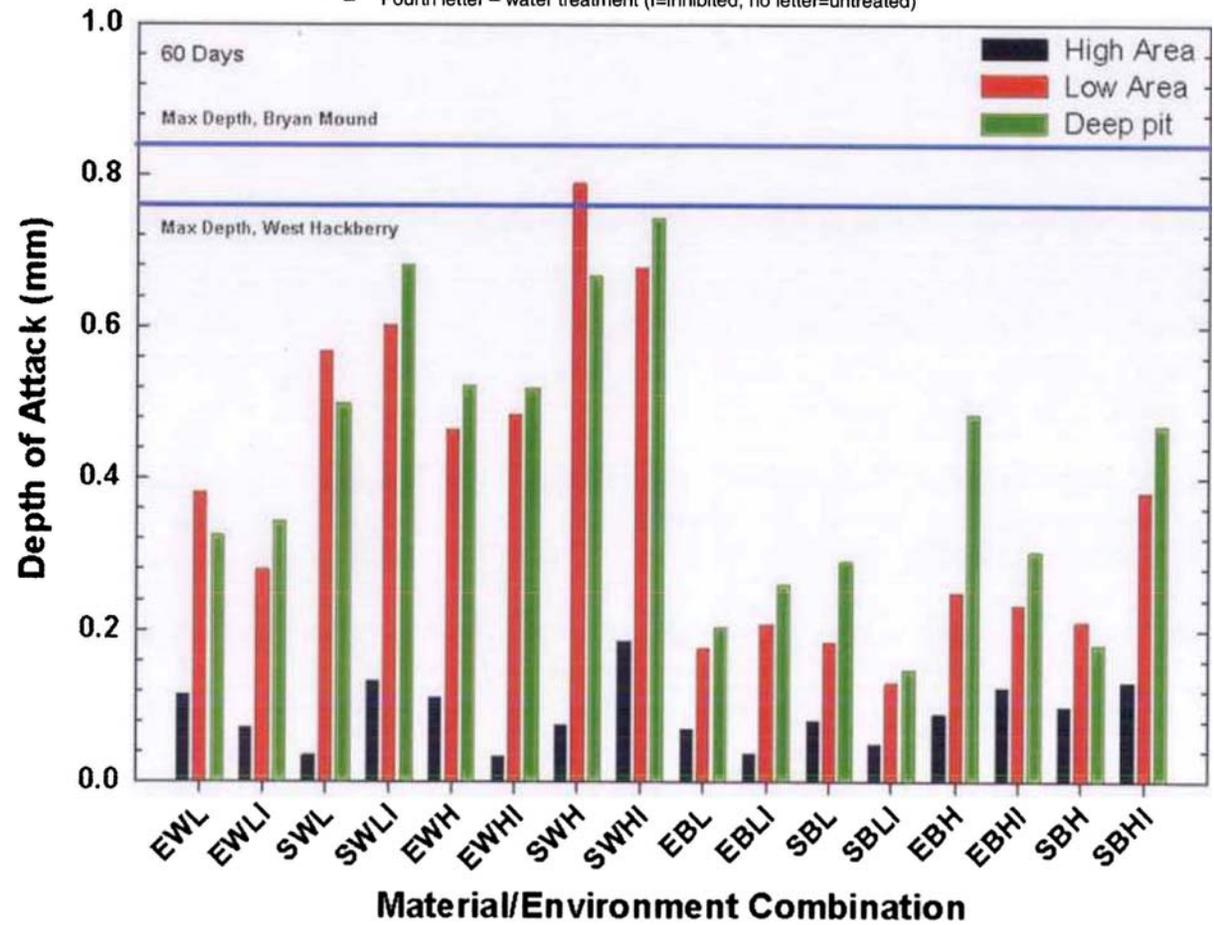
Figure 1
Nomenclature:
 - First letter – tube type (E=ERW, S=Seamless)
 - Second Letter – water source (W=West Hackberry, B=Bryan Mound)
 - Third letter – loop temperature (L=low temperature, H=high temperature)
 - Fourth letter – water treatment (I=inhibited, no letter=untreated)

Our earlier assessment of the Sandia test results, briefed in December 2003, was that the BM exchangers would probably be more affected by fouling than by corrosion for a full six month drawdown. Since that time, Sandia has completed their metallurgical examination of the test samples and they have found that pits 0.020 inches deep (approximately 60% of allowable wall losses) were produced within 60-days, despite inhibitor treatment. In fact pitting was more severe with treated than untreated water. One explanation offered by Sandia is that with untreated water general corrosion dominates and pitting is less severe. When the water is treated and general corrosion suppressed, pitting dominates and is far more severe. Sandia's analysis is summarized by Sandia in the following chart.
