SANDIA REPORT

SAND2005-7644

Infiltration in Unsaturated Layered Fluvial Deposits at Rio Bravo: Photo Essay and Data Summary

An infiltration and dye transport experiment was conducted to visualize flow and transport processes in a heterogeneous, layered, sandy-gravelly fluvial deposit adjacent to Rio Bravo Boulevard in Albuquerque, NM. Water containing red dye followed by blue-green dye was ponded in a small horizontal zone (~0.5 m x 0.5 m) above a vertical outcrop (~4 m x 2.5 m). The red dye lagged behind the wetting front due to slight adsorption thus allowing both the wetting front and dye fronts to be observed in time at the outcrop face. After infiltration, vertical slices were excavated to the midpoint of the infiltrometer exposing the wetting front and dye distribution in a quasi three-dimensional manner. At small-scale, wetting front advancement was influenced by the multitude of local capillary barriers within the deposit. However at the scale of the experiment, the wetting front appeared smooth with significant lateral spreading ~ twice that in the vertical, indicating a strong anisotropy due to the pronounced horizontal layering. The dye fronts exhibited appreciably mo

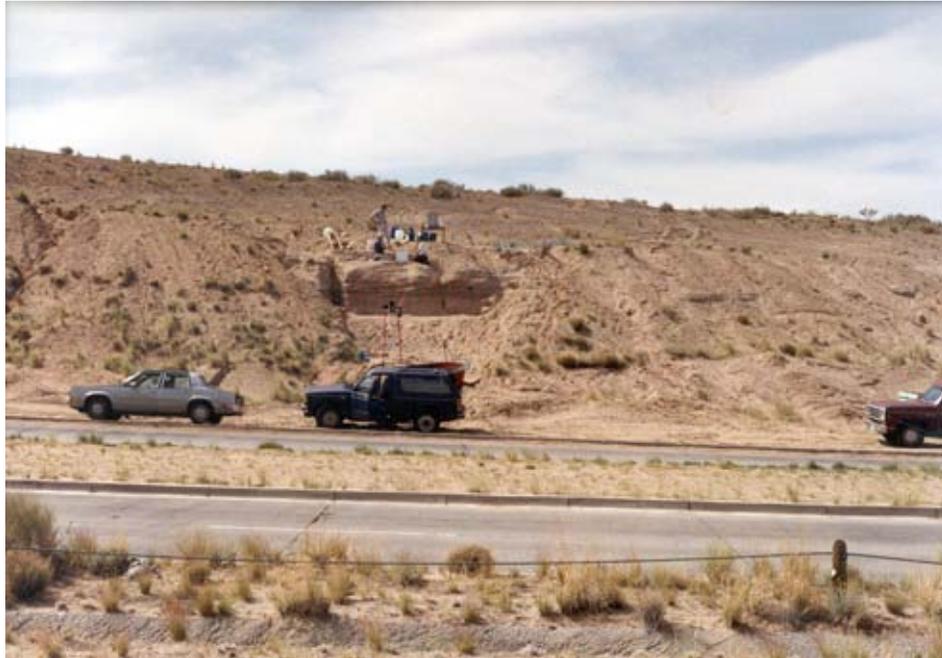
Figure 2.2: View of the Rio Bravo Infiltration Site from the north across Rio Bravo Boulevard. Exposed in the outcrop is a sandy-gravelly fluvial deposit within the upper Santa Fe Group; an extensive basin fill deposit within the Rio Grand Rift. Albuquerque International Airport is due east of the Rio Bravo Site. In this photo, much of the experimental apparatus is in place. The outcrop is approximately 2 meters high and consists of ancestral Rio Grande bedded sand and gravel deposits. Bob Glass is seen kneeling to the left of the infiltrometer where he is negotiating working conditions with the graduate students. Notice the camera mounted on the orange ladder behind the blue truck and the garbage can used as a supply tank for the infiltrometer. Notice also the Bob Glass Bomb, the grey Oldsmobile to the left of the blue truck. This vehicle is a remnant of Bob's graduate school days that he had a hard time giving up...until the car gave it up.

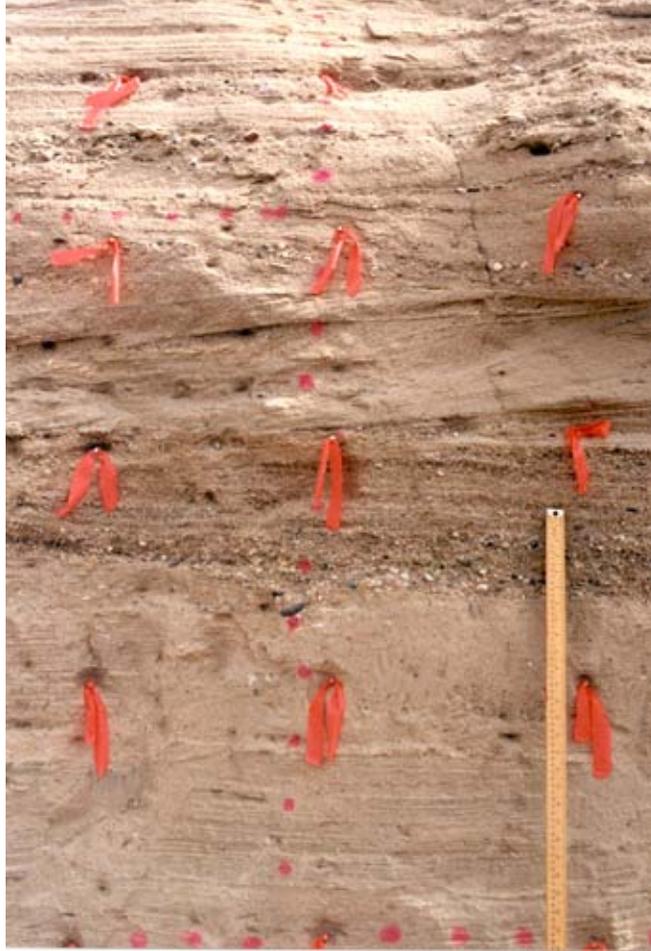
Figure 2.5: Close-up view of the Rio Bravo infiltration site outcrop. The heterogeneous nature of the upper two thirds of the outcrop is highlighted by differential erosion exhibited in this view. Loose debris was removed from the lower third of the outcrop to expose undisturbed sediments. A yardstick provides scale.

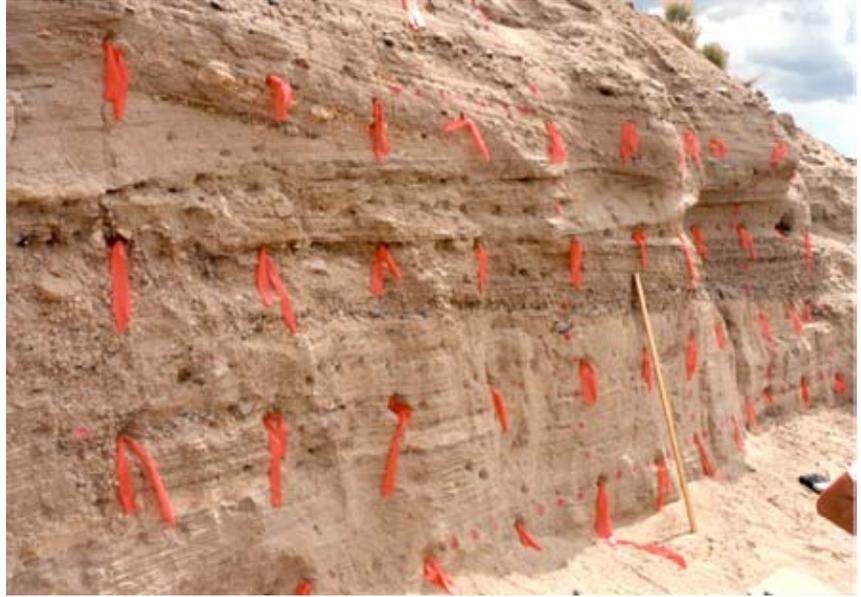
Figure 2.6: Left (top) and right (bottom) oblique views of the outcrop showing the complex nature of the deposit.

Natural sedimentary sequences can be quite complex with layers that are highly variable in thickness and lateral extent. Often, macroscopic layers, or ‘units’ are identified through sedimentological mapping with differences between the units reflecting changes in the local depositional environment, origin of the sediments, stream dynamics, or subsequent superposition of pedogenic processes. A close inspection of individual macroscopic units within the stratigraphic sequence at the Rio Bravo site reveals each unit to be composed of a hierarchy of many sub-unit layers. At small-scale, the bedding is composed of alternating fine-coarse layers obviously truncated by local erosion and re-deposition of sediments resulting in the superimposition of a variety of longer length scales that increase the variability within the macro-unit.

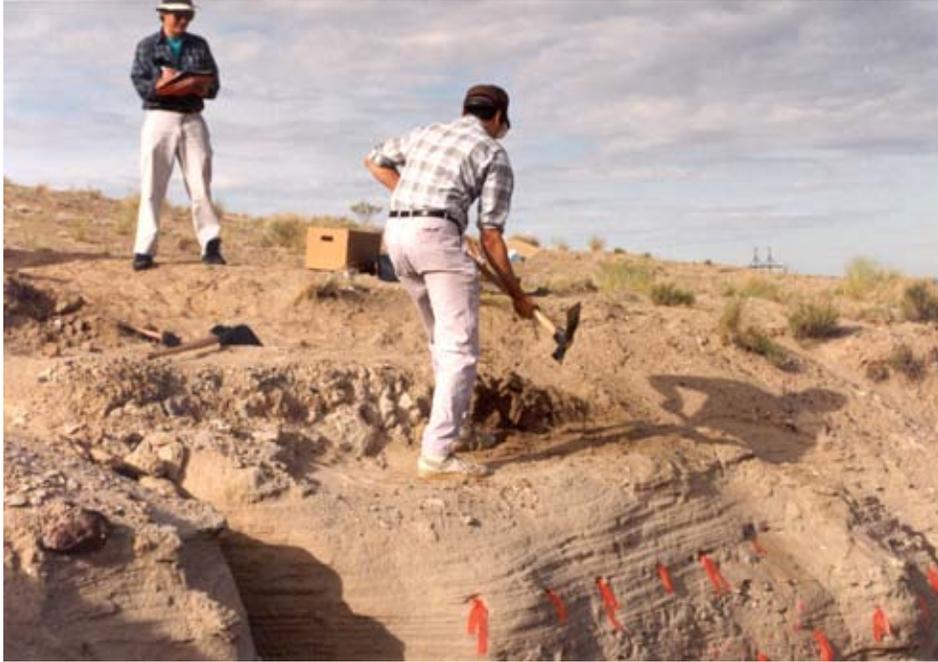
Figure 2.7: Preparation of the infiltration surface. Karl Martin is creating a horizontal and flat infiltration surface on top of Unit 1. This unit is a calcium carbonate cemented sandstone and the most indurated bed in the outcrop. Note Bob Glass taking precise notes on Karl's pickaxe-operating technique which led to estimates of formation hardness calculated from Karl's apparent effort versus depth of penetration of the pick ax. The hardness was then converted to parameters commonly used to describe the relationship between saturation and matric potential which then is used to obtain an expression for the unsaturated hydraulic conductivity that then is used to simulate unsaturated flow. This method has been found to be at least as accurate and meaningful as measuring the same parameters on disturbed sediments in the laboratory with hanging columns (data yet to be published by R.J. Glass and J.R. Brainard).

Most of the effort to prepare the site involved leveling an infiltration surface in the indurated upper most unit (Unit 5). Additional site preparation involved setting up the garbage can water supply system and installing the infiltrometer.

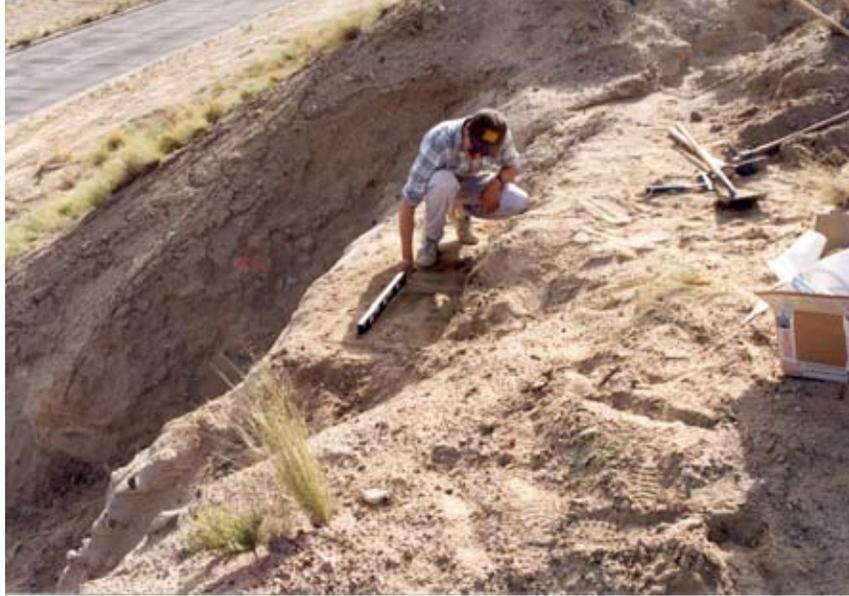
Figure 2.8: Checking for a level infiltration surface. Karl Martin carefully checks for a level infiltration surface.

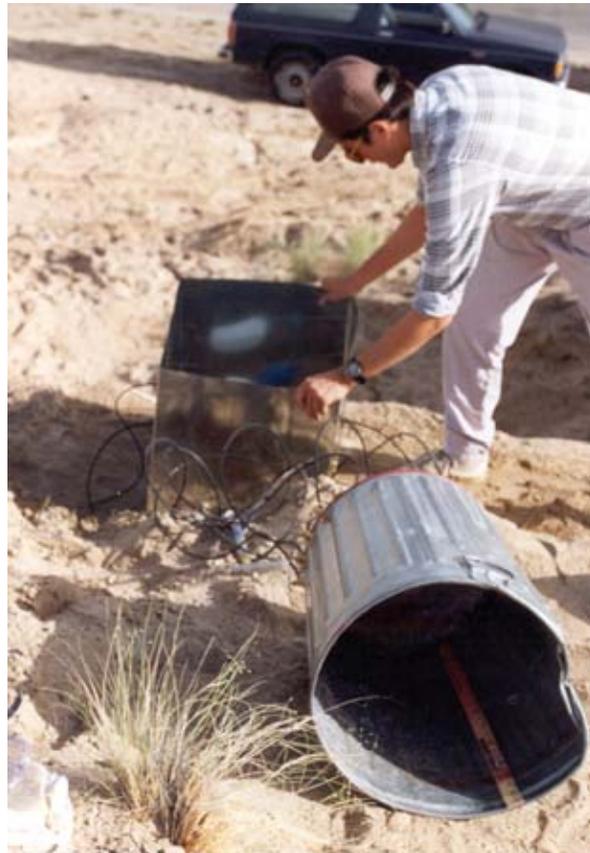
Figure 2.9: Infiltrometer installation. After the infiltration surface was leveled, a trench matching the bottom opening of the infiltrometer was excavated to a depth of 5 cm and backfilled with a 20% bentonite-sand mixture. Here, Karl Martin is pressing the infiltrometer into the backfilled trench to form a seal between the infiltrometer and the outcrop.

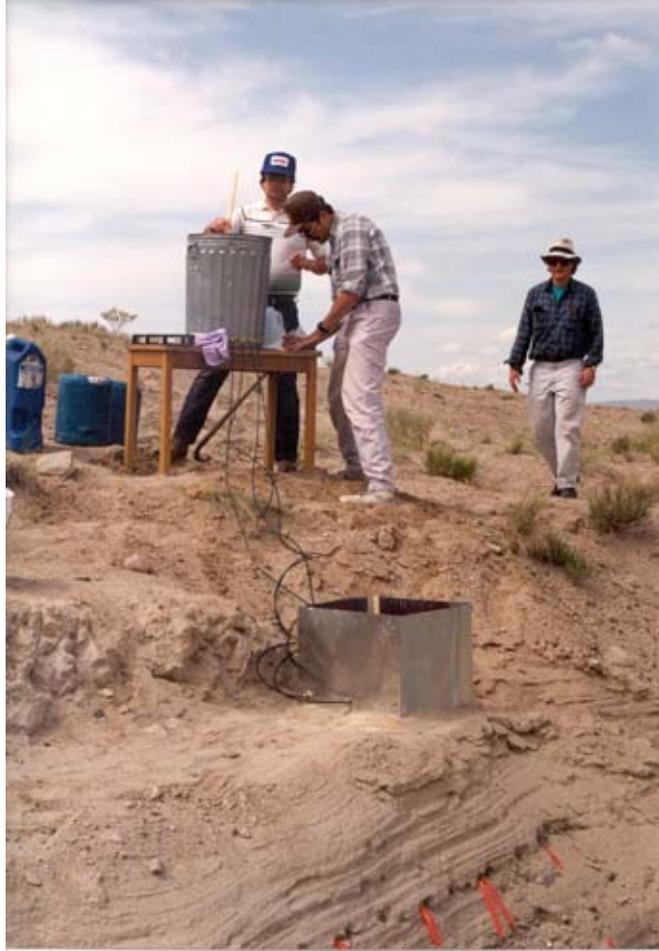
Figure 2.10: View of completed infiltrometer installation. The infiltration system consisted of a 30 gallon trash can used as a reservoir, 3/8 inch plastic water supply lines, and a 40 cm by 40 cm open-ended box formed with galvanized sheet metal, and evaporative cooler float valves to maintain a constant water level in the infiltrometer. Here, Drew Baird is making final measurements on the infiltration system while Karl Martin takes notes. Infiltration rates were obtained by converting manually measured water depths to volumetric flow through a trashcan-rating curve. Bob Glass, wary of Drew Baird with pointy objects in hand, observes from a safe distance and begins closing-in just in case Karl needs help defending himself.

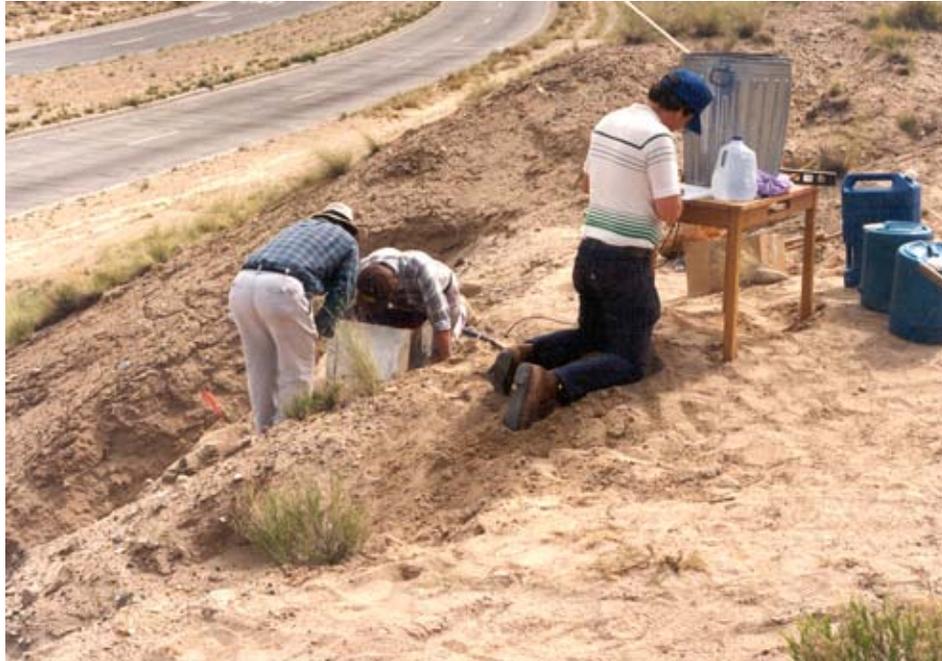
Figure 2.11: Final adjustments to the infiltrometer infiltration system. Bob Glass and Karl Martin make final adjustments to the float valves while Drew Baird continues to take notes.

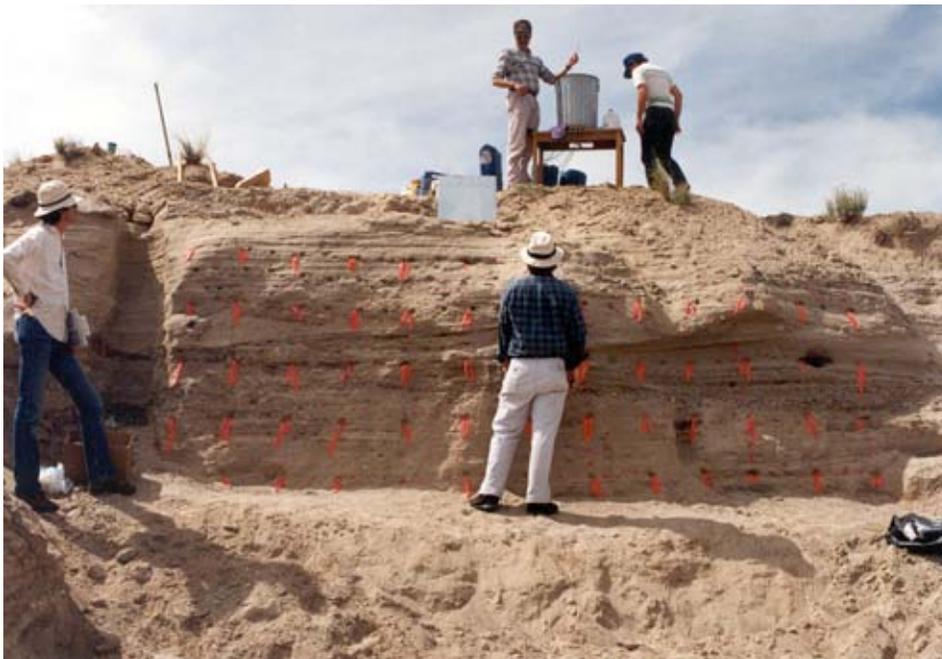
Figure 2.12: Inspection of infiltrometer. Bob Glass discusses the infiltrometer installation with Karl Martin while Jim Brainard looks on from the left trying his best to look important while Drew Baird heads for a drink...of water.

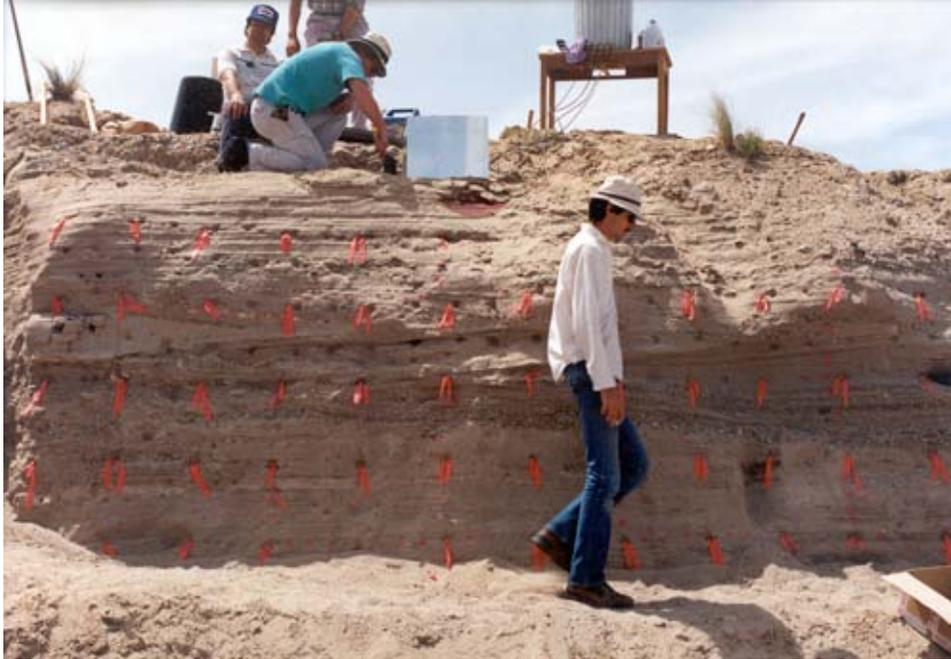
Figure 3.2: First Photo of developing bulb at 55 minutes. Within a few minutes of starting the infiltration, red dye appeared on the outcrop to the viewer's right side of the infiltrrometer. The apparent asymmetry of the bulb at this early infiltration time is attributed to the drop off of the outcrop on the viewer's right side of the infiltrrometer and not to formation heterogeneities. Drew Baird takes a well-deserved break from note writing while Bob Glass performs a little infiltrrometer-formation seal maintenance and Jim Brainard ambles from left to right.

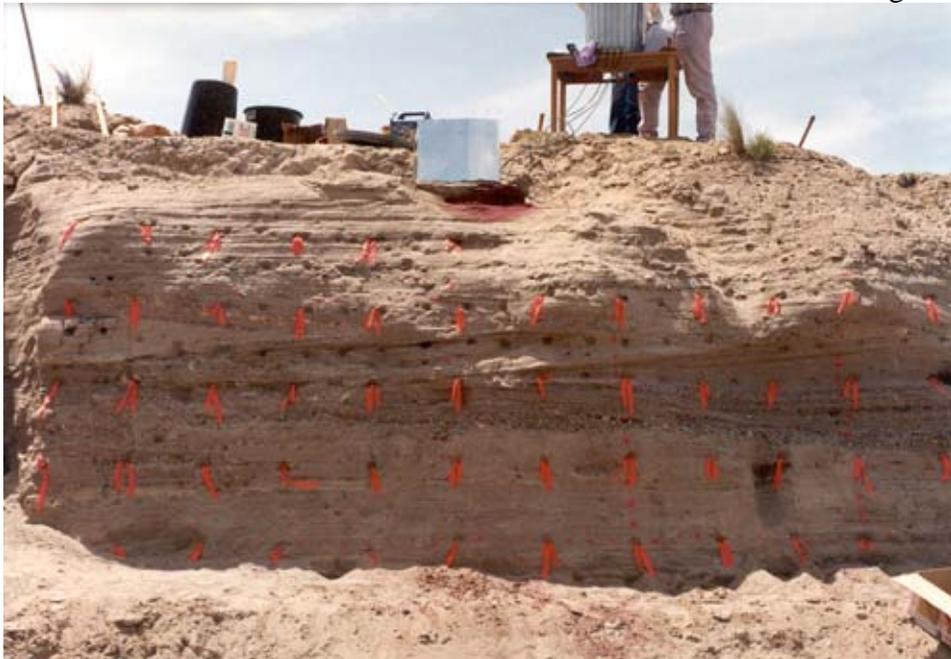
Figure 3.3: Developing bulb at 70 minutes. The bulb still appears to be asymmetric as it continues to expand down and out from the source.

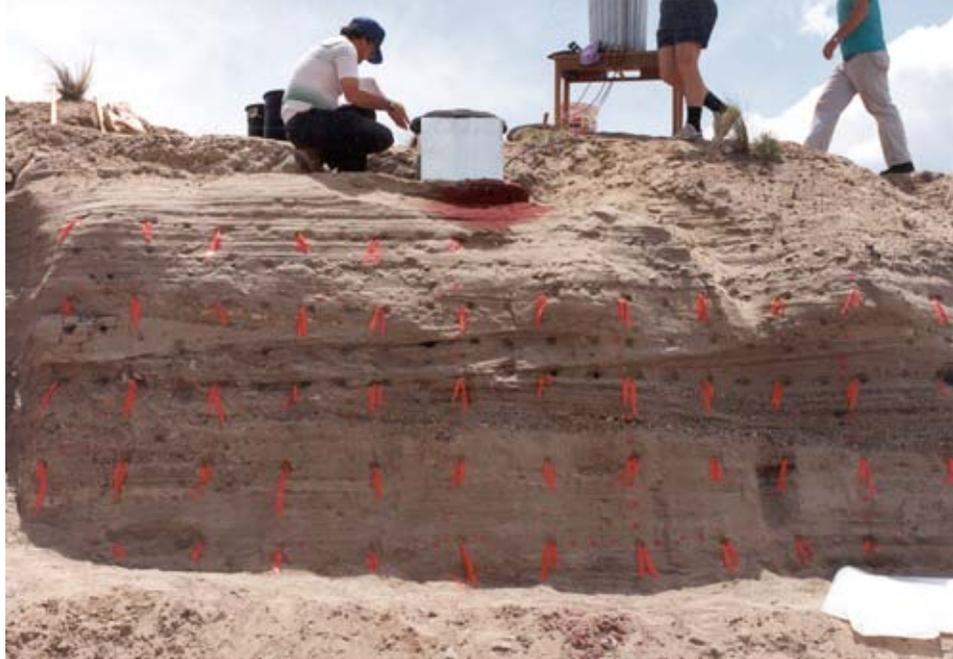
Figure 3.4: Developing bulb at 118 minutes. At this time the bulb appears to take on a more symmetrical shape while hints of dye absorption are becoming apparent as a clear water wetting front seems to be developing ahead of the dye plume. This is somewhat visible in the upper left part, and the lower most extent of the bulb. Notice the lid placed on the infiltrometer to minimize evaporation.

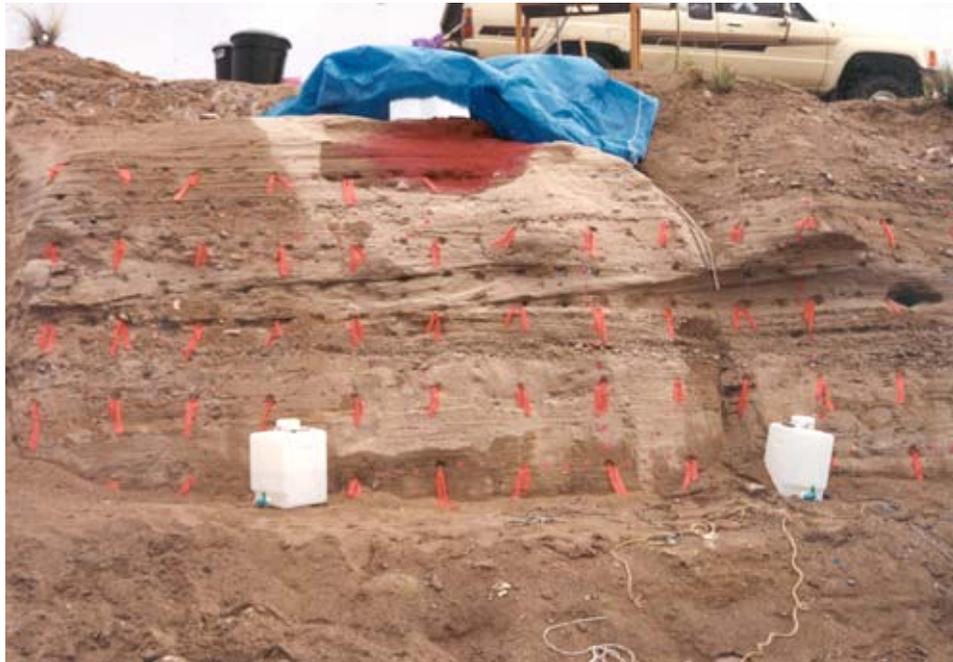
Figure 3.5: Developing bulb at 450 minutes. The outcrop was covered during the night to minimize impact from precipitation. At this time the bulb has expanded into an almost symmetric shape exhibiting considerable lateral spread and the wetting front has continued to move ahead of the dye front. Jim Brainard's then six year old Toyota is seen in the background. Now the Toyota is almost retired with nearly 300K miles on it...all on gas less than \$1.50/gallon. Ah, the good old days!

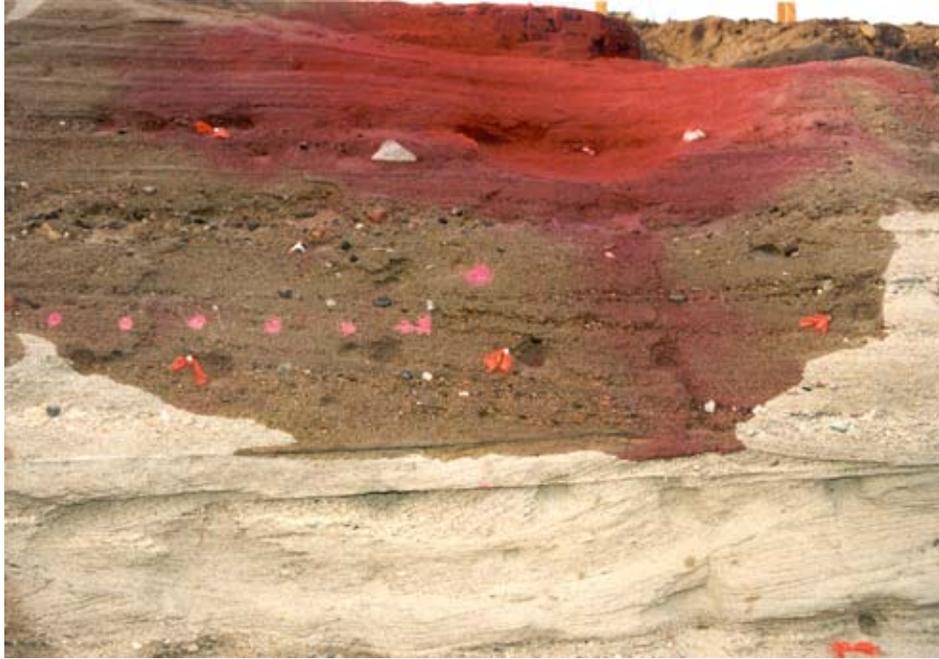
Figure 3.6: Developing bulb at 1260 minutes. Close up of the bulb showing the red dye streamer emanating from the red dye bulb and extending to the wetting front along a fracture. The shape of the wetting front is also being influenced by the contact separating Unit 4 from the underlying Unit 3. Steep dipping cross-beds facing left can be seen in the sandstone below the contact in contrast to the pebble-sandstone above where the beds are dipping gently to the right. The lateral spread of the wetting front can be attributed to one of two flow mechanisms: ponding on top of a less hydraulically conductive bed or ponding on a capillary barrier. In the resistive bed case, the water would pond to a point where the water pressures would become positive and the hydraulic head (pressure gradient) would be sufficient enough to force the water through the more resistive bed. In the latter case, coarse over fine layers can create capillary barriers that promote lateral spread at the wetting front and eventual breakthrough with increasing moisture content and an associated increase –less negative- in water pressure (water pressure increases as water collects above the barrier allowing water to eventually move into the larger openings in the underlying coarser deposit). Since water was not observed to pour out of the outcrop, it is likely that a capillary barrier exists exactly at the contact where a thin fine bed occurs just above the contact between the two units.

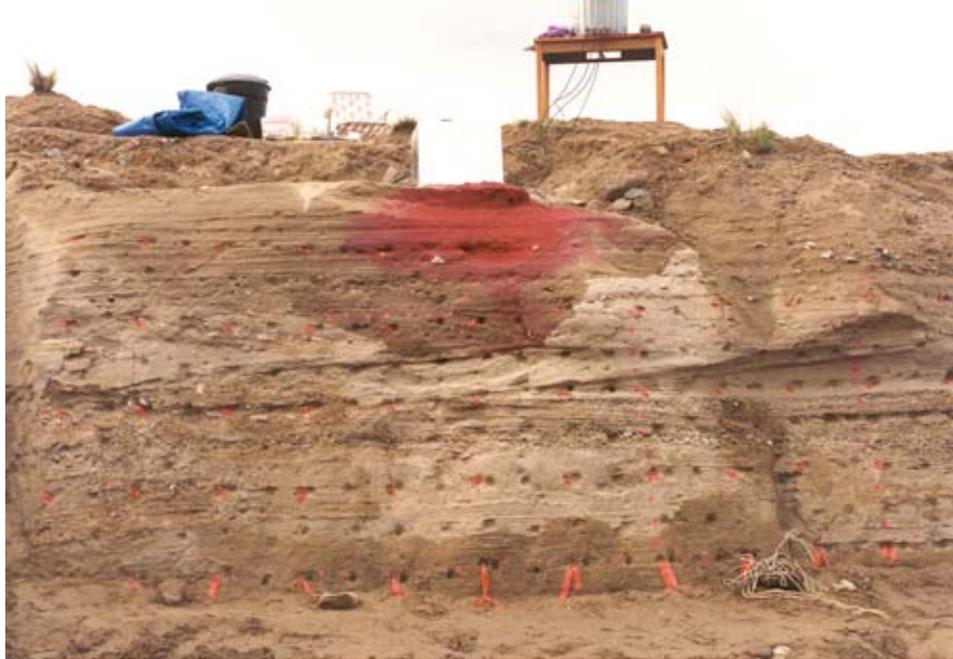
Figure 3.7: Developing bulb at 1336 minutes. The bulb has continued to expand laterally and downward and the wetting front continues to outpace the dye front. On the left side of the bulb, the wetting front is somewhat obliterated by the wet outcrop surface from the previous nights rain. The fracture continues to provide a fast pathway for the dye to the wetting front. The wetting front is now approaching a cut and fill contact within Unit 3, which may also be a capillary barrier. The blue-green dye tracer was started at 1200 minutes and is just slightly visible in this photograph as a darker red surface at the base of the infiltrometer.

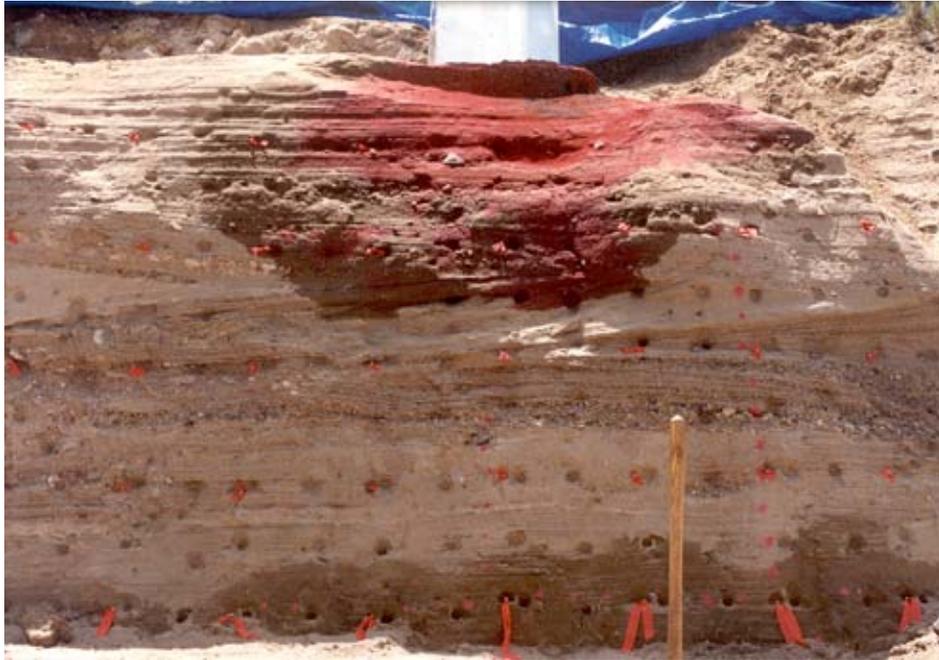
Figure 3.8: Developing bulb at 1675 minutes. In this vivid image, the wetting front is breaking through the suspected capillary barrier within Unit 3 and the apparent influences of the micro layering on the wetting front can be observed just below the barrier where flow appears to be occurring parallel to the cross-beds. The red dye plume is still lagging behind the wetting front and appears to be somewhat mottled in the bottom one-third of the bulb. The blue-green dye is now more apparent below the right side of the infiltrrometer.

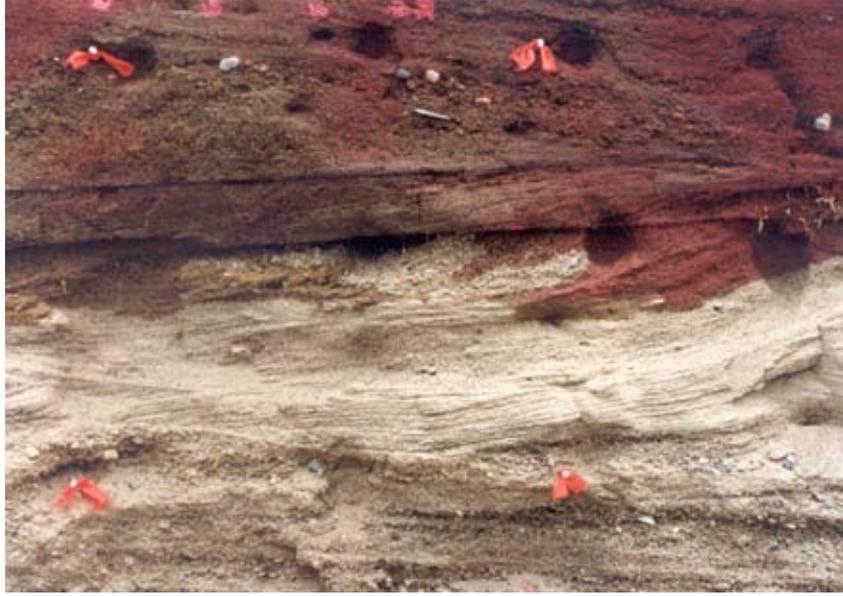
Figure 3.10: Close up of wetting front breakthrough at a suspected capillary barrier at 1740 minutes. In this photo, the effects of small-scale layering on the wetting front are visible. It appears that the wetting front has moved through the suspected capillary barrier and then progressed preferentially laterally through finer grained beds.

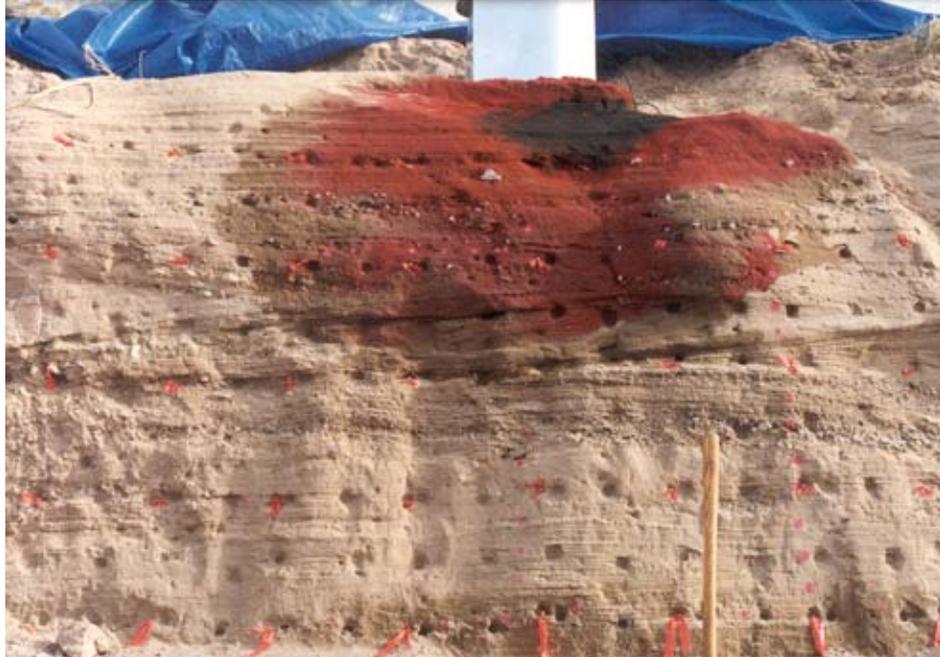
Figure 3.12: Developing bulb at 1905 minutes. The wetting front has passed a second capillary barrier and the apparent lag between the wetting front and red dye front seems to be diminished somewhat when compared to previous photographs. The mottling of the red dye bulb seems to be diminished compared to the previous photograph. The blue-green dye bulb is clearly evident in this photograph.

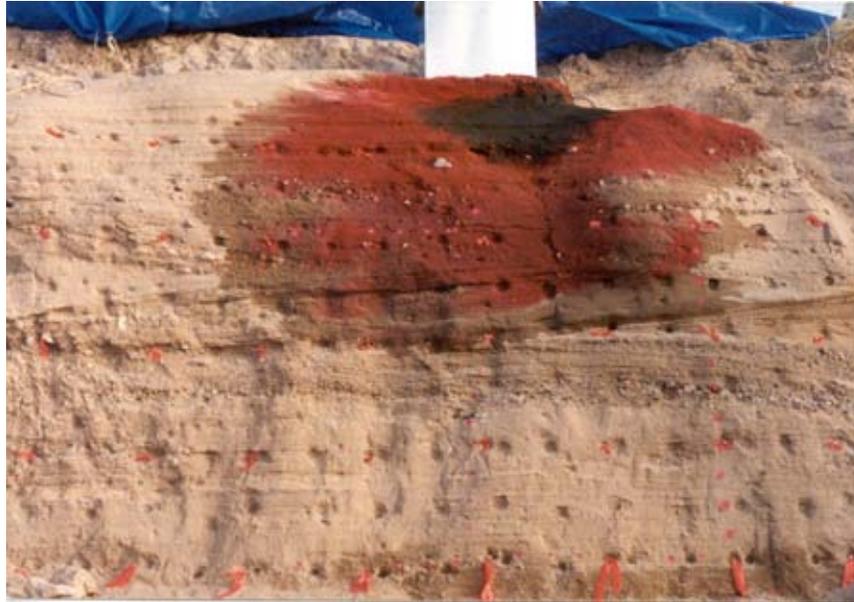
Figure 3.13: Developing bulb at 1960 minutes. Some small changes within the bulb can be observed when compared to the last photograph. In particular, the red bulb continues to lose its mottled appearance.

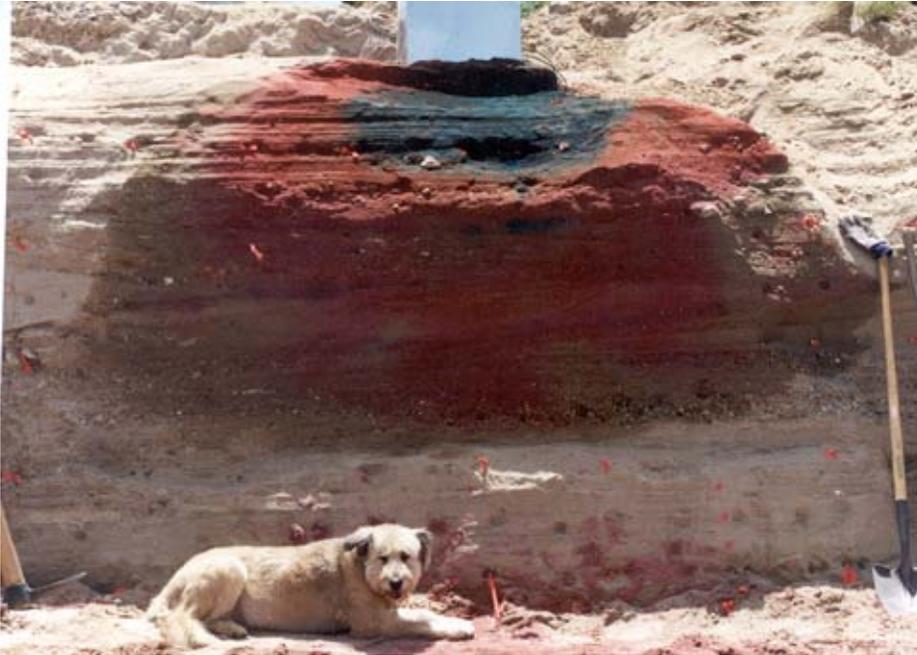
Figure 4.1: First slice-70 cm from the center of the infiltrrometer. The separation between the wetting front and the red dye front is pronounced and the three streamers in the red/clear water interface are large. Preferential horizontal spread of the wetting front along a select few layers can be seen on each side of the bulb as well as horizontal spread in the three large vertical red dye streamers. Notice the relatively smooth wetting front relative to the red dye/clear water front. A passerby provided the dog for scale.

The next series of figures are photos and digital schematics of each face following excavation of slices from the outcrop face following the infiltration event. The excavated faces are exposed at 10-cm and greater intervals starting at the face and ending at the center of the infiltrrometer. Notice in each of the photos the red and blue-green streamers radiating from the center of the plume.

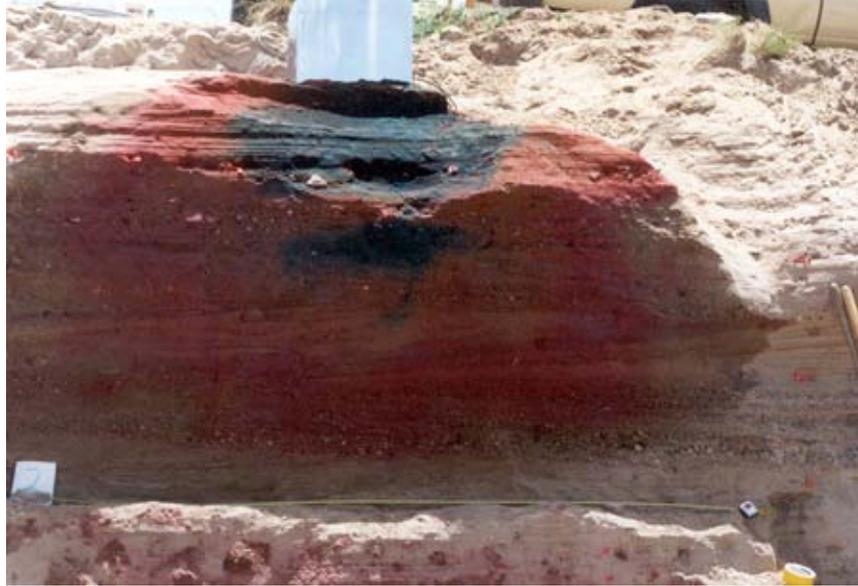
Figure 4.2: Second slice-60 cm from the center of the infiltrometer. The photograph shows the first hint of streamer in the red/blue-green dye interface at the base of the blue-green dye bulb on the right hand side. This streamer is associated with the fracture seen in the photographs recording bulb development during infiltration. The red dye/clear water interface appears evenly distributed along the base of the red dye plume as compared to the previous photograph.

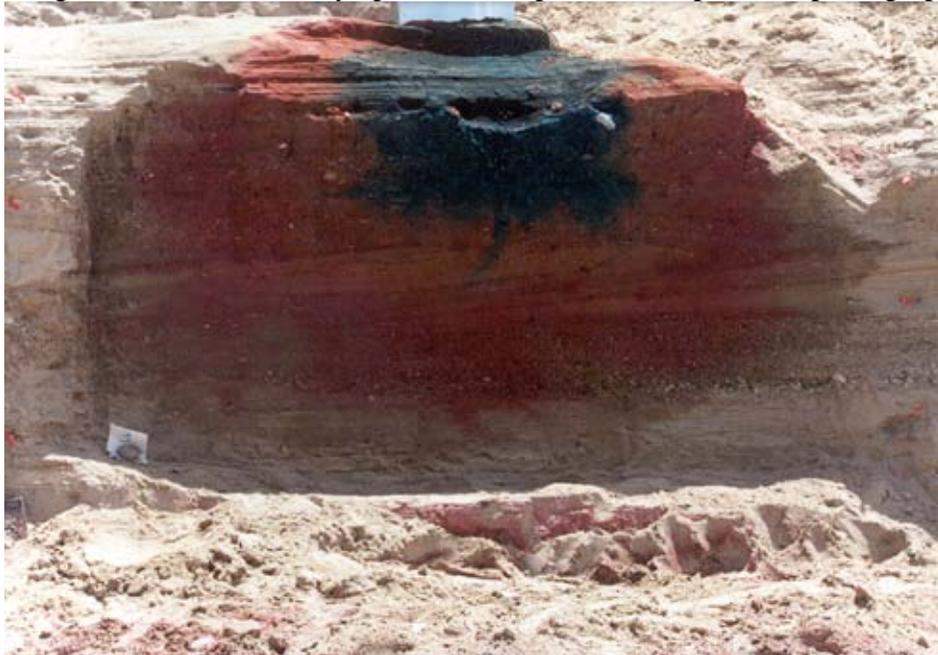
Figure 4.3: Third slice-50 cm from the center of the infiltrometer. In this photograph other dye streamers in the red/blue-green dye interface are approaching the length of the fracture streamer. The Red dye/clear water interface appears to contain some vertical streamers at the base of this interface and horizontal spread is observed in both the wetting front and the red dye plume along the sides.

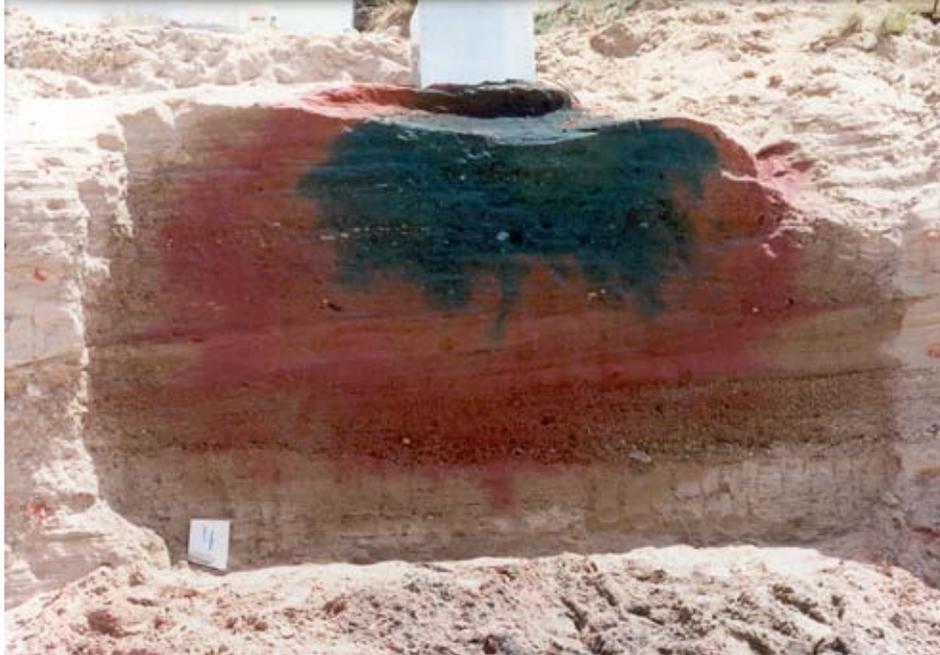
Figure 4.4: Fourth slice-43 cm from the center of the infiltrometer. The non-fracture streamers become even more pronounced as the slices approach the infiltrometer. Localized horizontal spreading into a certain beds continues along the sides of the bulb in both the wetting front and the red dye plume. Vertical red dye streamers at the base of the red dye plume continue to be present.

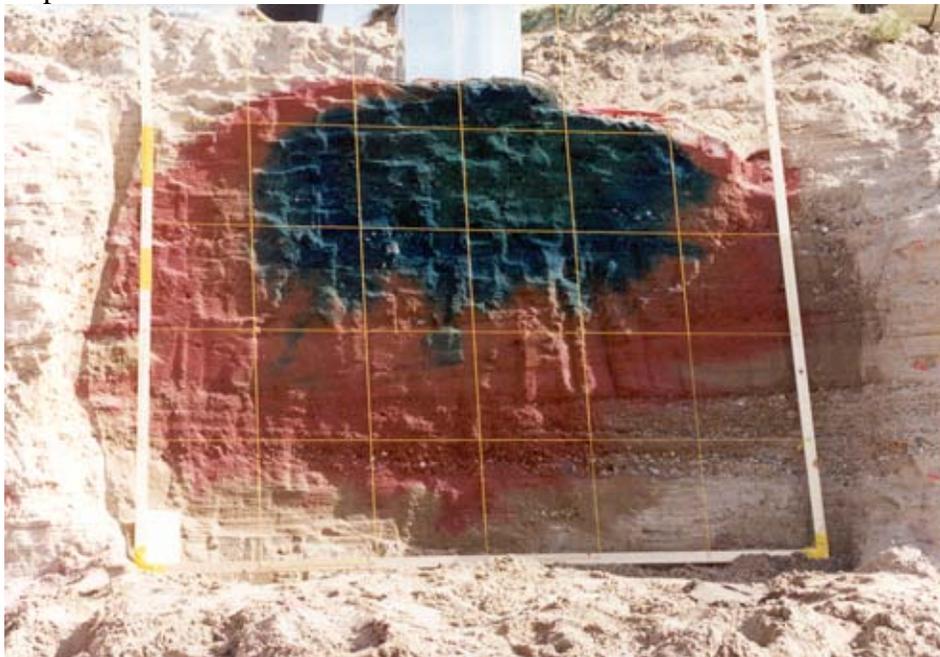
Figure 4.5: Fifth slice-37 cm from the center of the infiltrometer. Once again the dye streamer dominates the red/blue-green dye interface as most of the other streamers in this interface become less pronounced. Notice that some of the blue-green dye has traveled horizontally in a bed just left of the fracture streamer. Vertical streamers in the red dye are also observed. The 40 cm square grid is in place for mapping purposes.

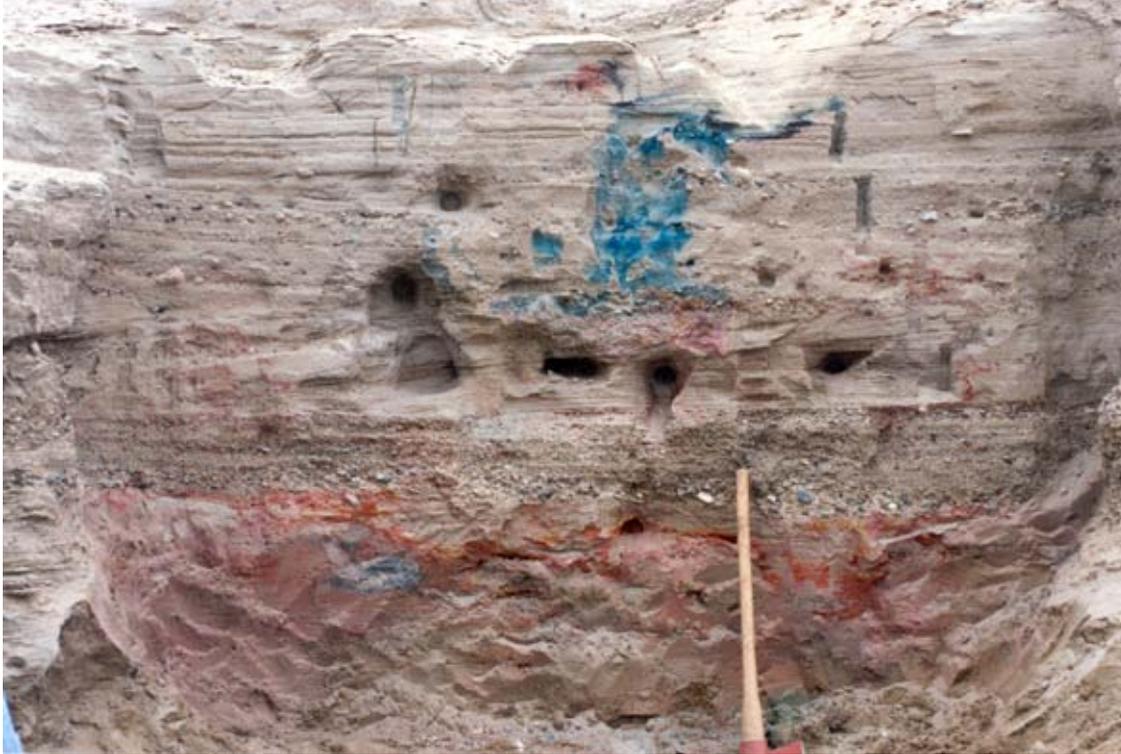
Figure 5.3: Partially excavated outcrop of Figure 5.2 one year after initial excavation. The blue in the center of the photograph is the remnant blue-green dye bulb while the red dye bulb appears significantly more faded. The original shape of either bulb cannot be discerned.

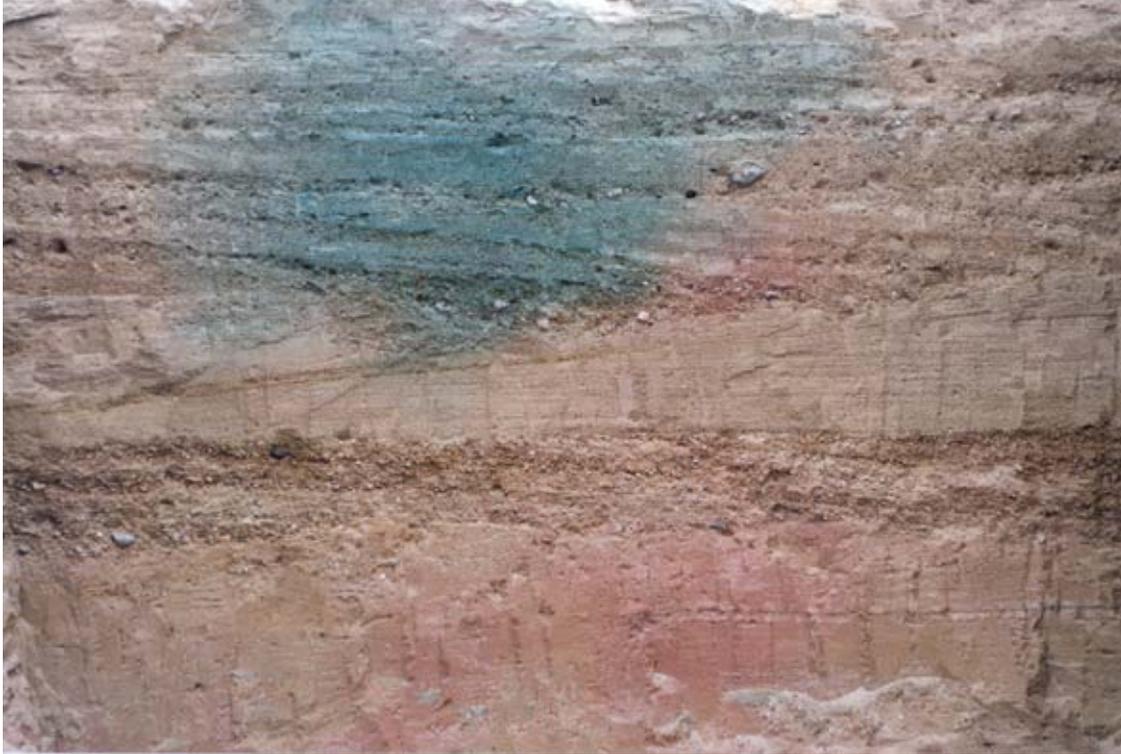
Figure 5.4: Fully excavated outcrop of figure 5.3. The blue-green bulb can be discerned easily while the red dye plume is significantly more faded. The original shape of the blue dye plume is almost identifiable, but the outer boundaries of the red dye plume are indistinct.
