# **SANDIA REPORT**

SAND2006 -7573

## **Development of a Novel Technique to Assess the Vulnerability of Micro-Mechanical System Components to Environmentally Assisted Cracking**

David G. Enos and Steven H. Goods

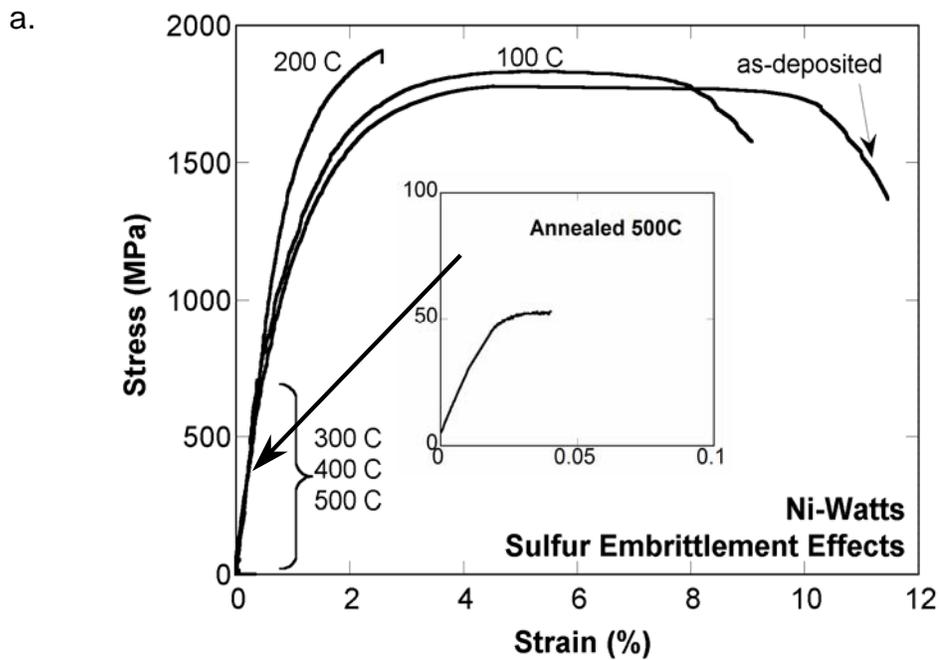
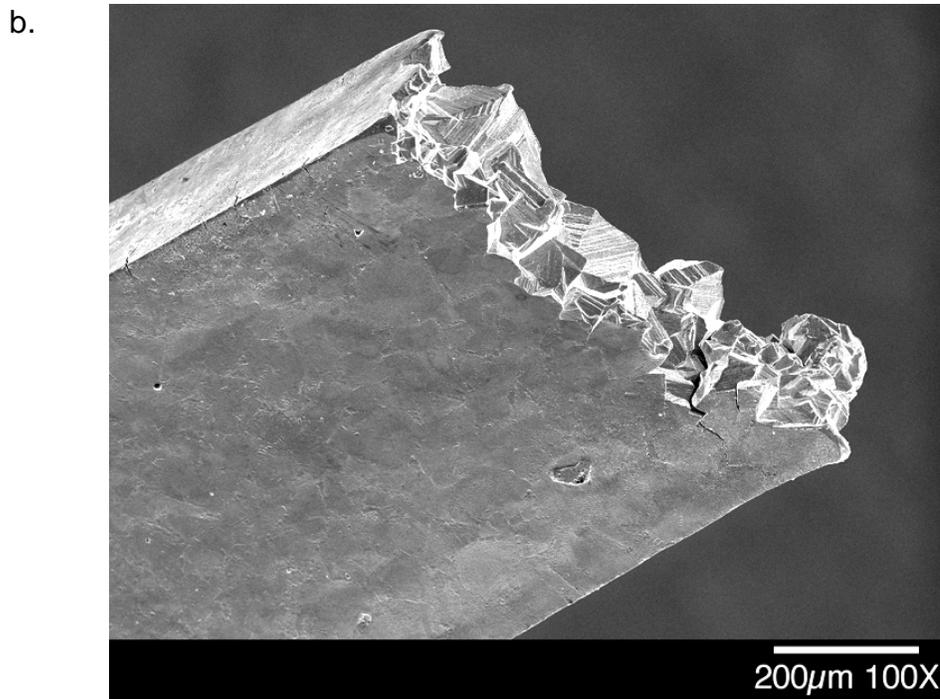
**Figure 4.3:** (a) Stress strain curves typical of Watts nickel prior to and following annealing at several temperatures. Note the large reduction in ultimate tensile strength and ductility illustrated in the inset graph. (b) Fracture surface of an annealed sample, illustrating the intergranular nature of the fracture.

As-plated Watts nickel is characterized as a high strength electrodeposit with good ductility. Figure 4.3a shows a family of tensile curves for the material. In the as-plated condition the deposit exhibits a yield strength of approximately 1200 MPa, a UTS of 1800 MPa and greater than 10% strain to failure. Annealing induces a profound loss in ductility the onset of which is evident at temperatures as low as 100°C. With increasing temperature, the residual ductility continues to decrease, until at 300°C the ductility is nil (Figure 4.4). At this and higher temperatures, specimens fail during their initial elastic loading with virtual no permanent plastic deformation. This is illustrated more clearly in the inset in Figure 4.3 that shows the tensile curve for a specimen annealed at 500°C. The actual measured plastic strain is only approximately 0.02%. Fracture in these embrittled specimens is entirely intergranular. And an example of this is shown in Figure 4.3b.

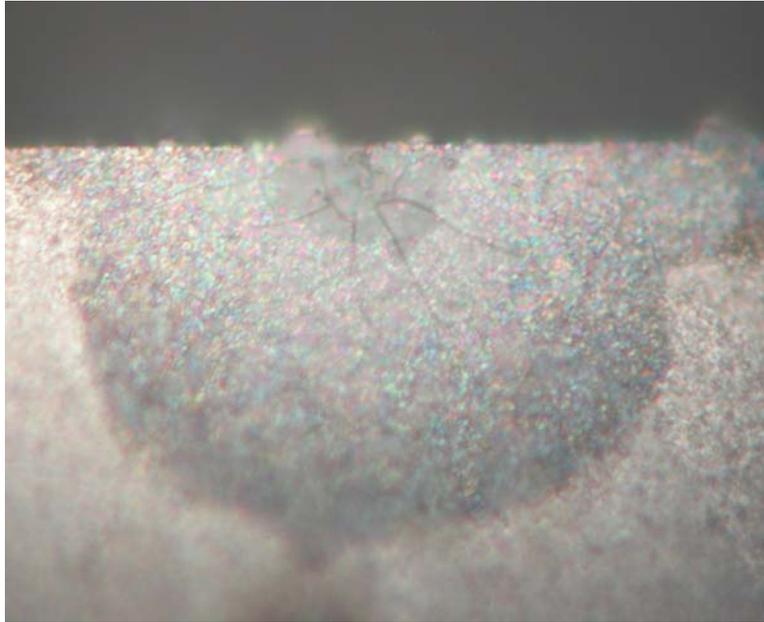
**Figure 4.6:** Typical image of the leading edge of a fracture surface. Shown here is a large pit and associated corrosion product for a sample exposed to 85% RH, 50 ppb Cl<sub>2</sub>, at a temperature of 30°C. A number of such pits were observed on all failed samples, always at the leading edge of the fracture surface, as shown here.

Fracture was intergranular in nature, and there was no visible transition from a stress corrosion crack to tensile overload on the fracture surface. Similarly, the load and crosshead displacement vs. time plots always transitioned rapidly (typically on the order of seconds) from fully loaded to failed – no evidence of slow crack propagation was observed. Based upon the mechanical properties of the aged material, specifically the near complete lack of ductility, the fact that failure was largely nucleation controlled was to be expected. (i.e., due to the low ductility, and hence low fracture toughness, crack blunting would be minimal, and as such, a crack, once initiated, would advance through the sample) Looking at the leading edge of the fracture surfaces, there were one or more large pit sites (Figure 4.6) for all samples. These large pits would be potent stress concentrators, and were likely the site of crack initiation.

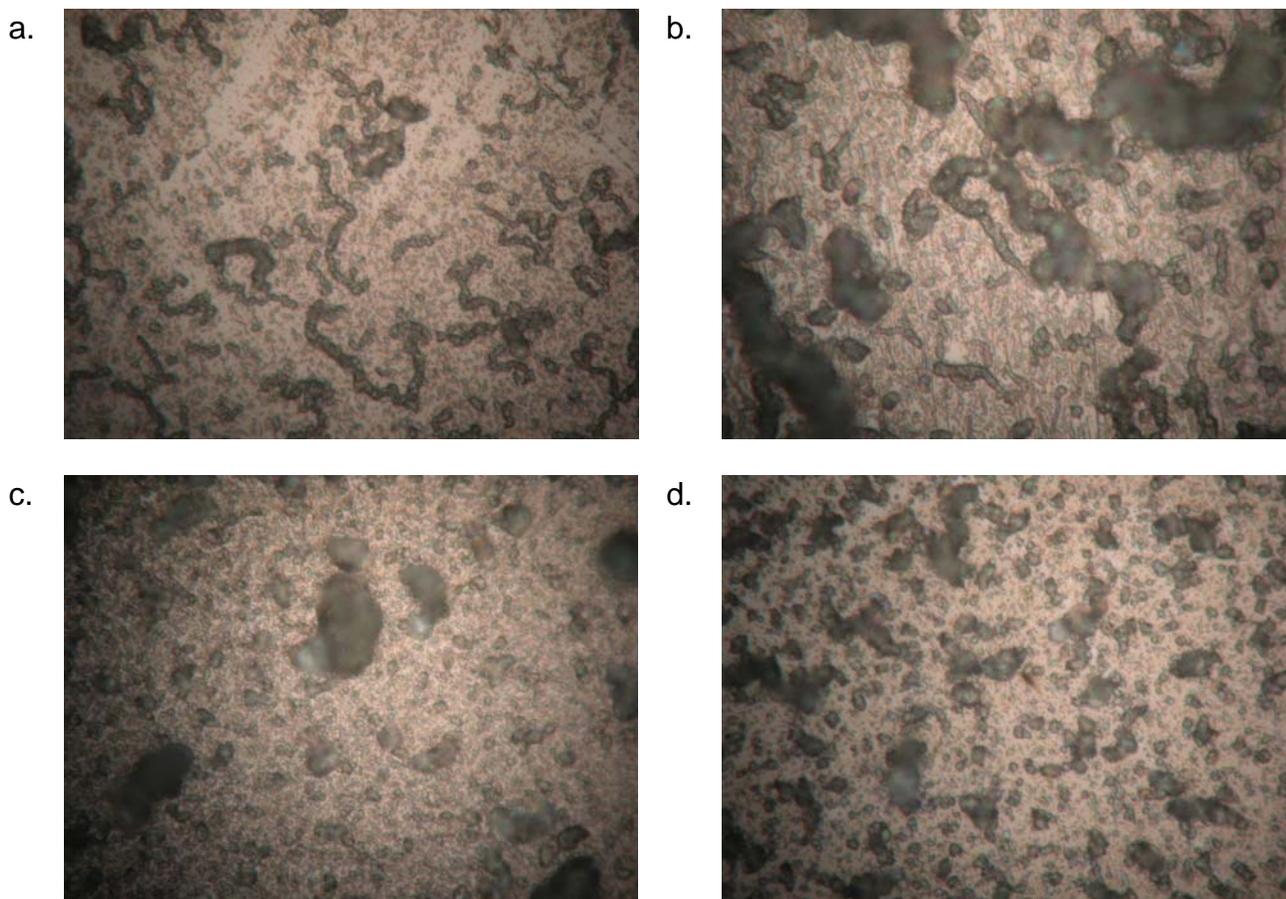
**Figure 4.7:** Optical microscopy (1000x) of surface morphology following exposure to 50ppb  $\text{Cl}_2$ , 30°C, at 50%RH (a), 60%RH (b), 65% RH (c), and 85% RH (d). As the relative humidity increased, the number density of pit sites increased, then at 60% RH a population of large pits began to form. The number and depth of these pits also increased as the relative humidity increased.

Figure 4.7 illustrates the surface morphology of the samples following exposure to each environment. As the relative humidity was increased, the number density of pit sites also increased. In addition, at a RH of 60%, a population of larger, deep pits begins to form. As the RH continued to increase, these larger pits increase in aspect ratio (i.e., they start to become smaller in diameter, but extend deeper into the material.). At 85% RH, the large pits have become much higher in density, and very high in aspect ratio. While clearly much work is still needed to more thoroughly evaluate the crack initiation process, looking at the mechanical testing data available to date, a reasonable conclusion would be that these larger, high-aspect ratio pits act as stress raisers which then result in crack initiation. As the relative humidity increases, the acuity of these pits, which act as secondary notches in a way, increases, which may explain the reduction in time to failure with increasing RH. The lack of crack initiation at an RH of 50% and below is consistent with this in that no large, high aspect ratio pits were observed on the metal surface following as much as a month of exposure.

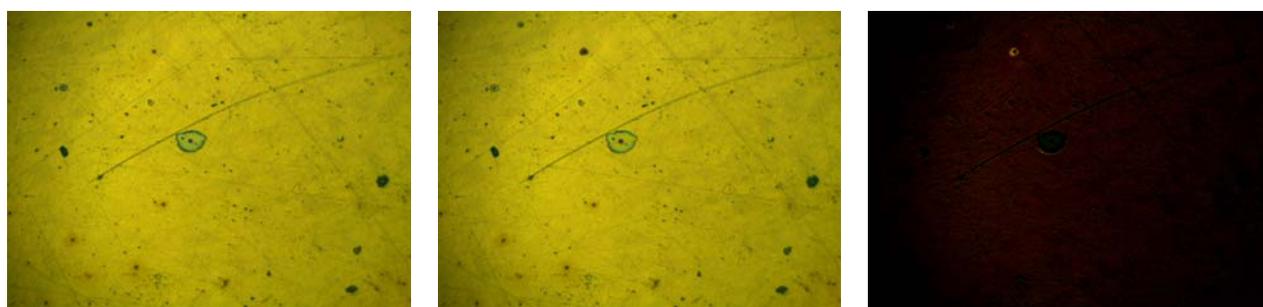
**Figure 4.8:** The first two images represent views of the same region on a gold plated copper surface undergoing sulfidation. The third image illustrates how image subtraction allows the regions which have changed (in this case due to the formation of copper sulfide corrosion product) to be clearly observed.

alternative approach was pursued in FY06. Development began on a technique based upon differential imaging microscopy which allows the researcher to deconvolute optically complex images (due to surface morphology, etc.), extracting only the degradation response (represented as changes in the image). This would allow complex sample geometries, as are present on MEMS devices, to be evaluated as the system functioned, without introducing potential defects/failure sources due to a sensor added to the device itself. Due to the large optical train which was required (camera, lenses, coaxial light source, etc.), the differential imaging system could not readily be adapted onto the mechanical test system. This isn't to say it couldn't be done, just that due to the time remaining on the project, it was not feasible. As such, an alternative material system was utilized for initial proof of concept testing. The atmospheric sulfidation of connector materials such as gold plated copper lend themselves to this technique, as the corrosion sites which are monitored for such materials are often difficult to observe due to the surface morphology of the plated copper. As mentioned above, an imaging system consisting of a camera, optical train, and mechanical translation stages was assembled. Proof of concept experiments demonstrated that this technique is capable of monitoring subtle changes in the surface, in this case the initiation of pore corrosion, previously unresolved experimentally. Figure 4.8 presents two images separated by approximately one day – individually, it is easy to miss the small differences in the second image due to corrosion product production at a single site on the surface. By using image subtraction, however, this site becomes readily visible. There are, however, a number of experimental difficulties which must still be overcome. These include image registration (as a shift of a single pixel can result in the observation of “differences” which aren't really there. A similar issue can occur with variations in lighting which may occur over time (though the use of a solid state lighting source does alleviate this to a degree). Future work will focus on addressing these discrepancies through a combination of mechanical and software based approaches.
