# **SANDIA REPORT**

SAND2007-0375

## **Experiments for calibration and validation of plasticity and failure material modeling: 304L stainless steel**

Experimental data for material plasticity and failure model calibration and validation were obtained from 304L stainless steel. Model calibration data were taken from smooth tension, notched tension, and compression tests. Model validation data were provided from experiments using thin-walled tube specimens subjected to path dependent combinations of internal pressure, extension, and torsion.

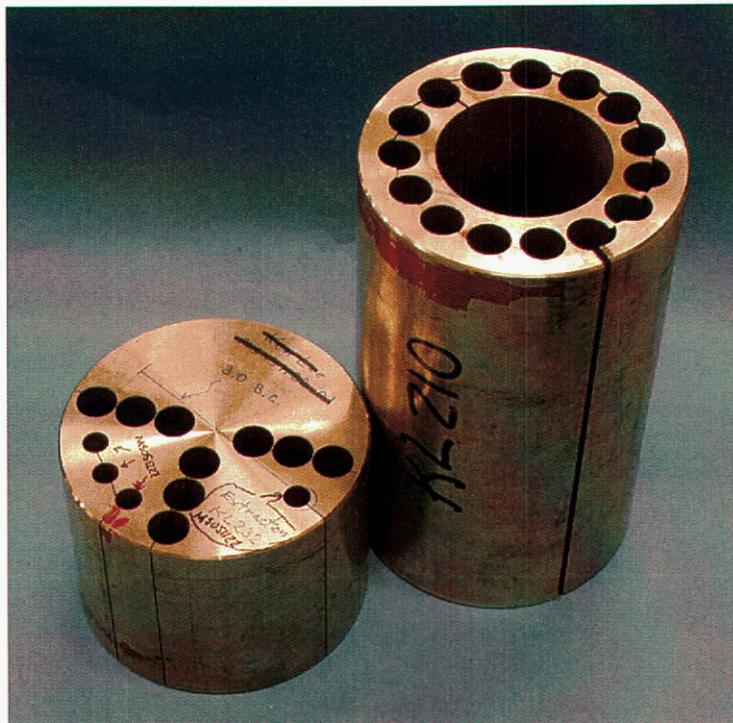
**Figure 1.** Examples of raw stock after specimen extraction. The large center extraction shown on the right was used in a different project.

Tensile specimens were extracted from .50 in, 1.10 in, and 1.60 in radius circles with respect to the center of the 4 in diameter rod, oriented with the tensile axis parallel to the extrusion direction. The nominal dimensions of tensile specimens used in this work are listed in Table 1. The notched tension specimen design has been used extensively for investigation of the damage parameters that are part of the BCJ and EMMI material models. All tension tests were conducted under actuator stroke control of .002 in/s, which resulted in a measured true strain rate of approximately .001 in/s in the smooth tension specimens. Compression specimens were extracted on 1.50 in radius circles with respect to the rod center. The specimens were .350 in diameter and .450 in long. The specimen ends were grooved, and the grooves were filled with molybdenum grease during testing. Compression tests were run under true strain rate control of .001/s. Examples of raw stock after specimen extraction are shown in Figure 1. Figure 2 shows examples of the calibration specimens.

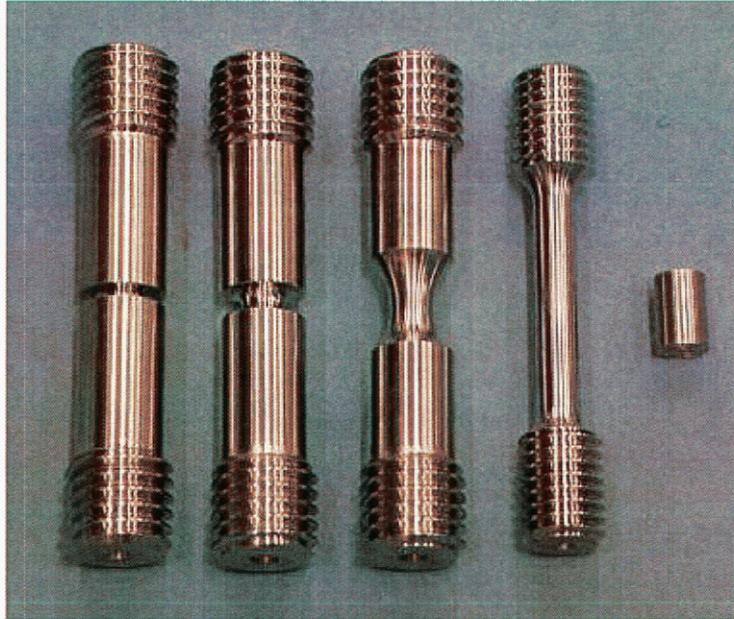
**Figure 2.** Calibration specimens. From left to right: notched tension (R1, R2, R4), smooth tension, and compression.

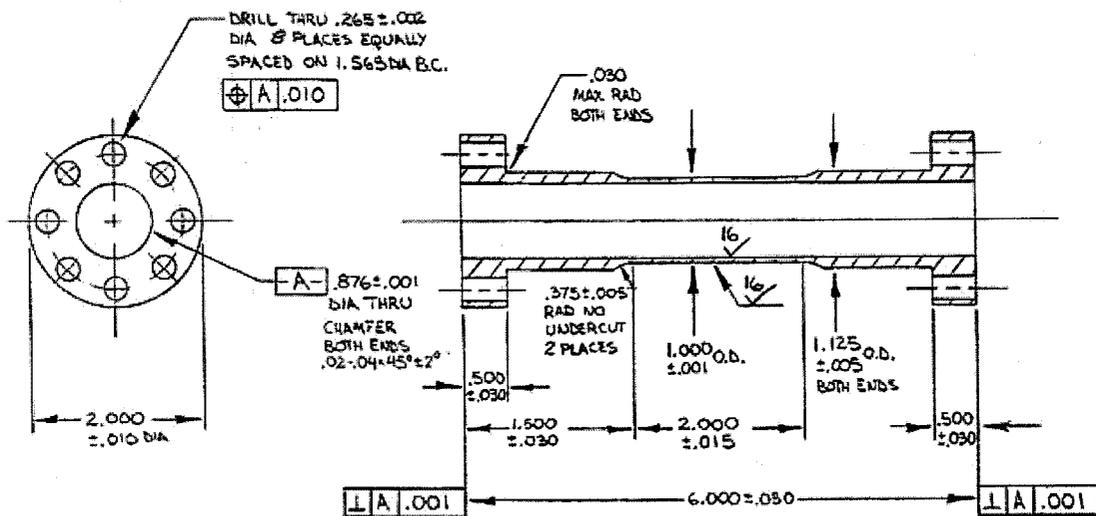
**Figure 3.** Validation specimen geometry.

The model validation specimen geometry is shown in Figure 3. The specimens were extracted with centers located 1.0 in from the rod center. Measurements of the as-machined specimen inner diameters (ID) showed an average of .8755 in with a standard deviation of .0005 in. Measurements of the as-machined specimen gage section outer diameters (OD) showed an average of .9995 in, with a standard deviation of .0005 in. Each of the servo-hydraulic actuators that controlled pressure, extension, and rotation were operated under closed loop control. Here, "stroke" is used to denote actuator axial displacement, and "rotation" to denote actuator rotational displacement. To simplify the model boundary conditions that would correspond to each experiment, test frame control signals were restricted to stroke, rotation, and pressure.

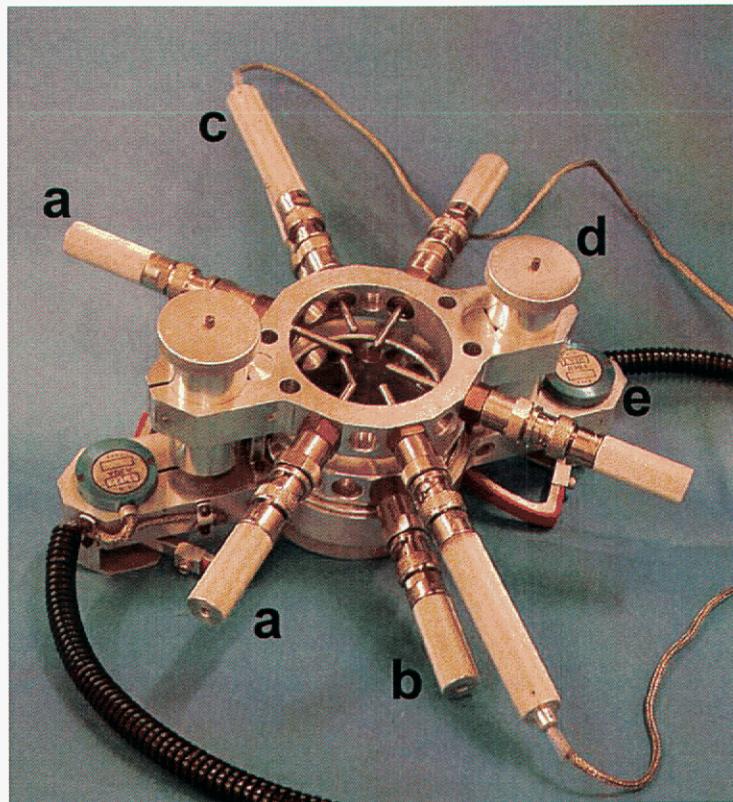
**Figure 4.** Axial, diametric, rotational displacement gage. The gage fits around the validation specimen. Two pairs of conical tip spring loaded contact pins (a) fix the top half of the gage to the specimen, while one pair (b) fixes the bottom half, with 1.0 in of vertical separation (gage length). Two similar opposing pins in the top half (c) contain LVDT's that measure diametric displacement. Axial displacement is obtained from two LVDT's (d) that measure the displacement between the upper and lower sets of contact pins. Rotational displacement is obtained from two RVDT's (e) that measure the angular difference between the upper and lower sets of contact pins. The signal from each pair of LVDT's and RVDT's is summed to provide an average displacement.

The complex loading validation tests were completed on a MTS load frame with 100 kip axial and 50 kip torsional capacity. Specimen internal pressure was provided by a MTS 286.50 pressure intensifier, which used a servo-hydraulic ram to pressurize and control water that was fed into the test specimen. Pressure was measured near the inlet port to the specimen, with a 10 ksi transducer and TestStar DC signal conditioner. The pressure control feedback signal was provided by a pressure sensor located on the water inlet line to the test fixture. Stroke and rotational control feedback signals were obtained from a LVDT and a RVDT that were integral to the load frame. Axial, diametric, and rotational displacements were measured on the specimen using the displacement gage assembly shown in Figure 4 [2]. The displacement gage employed LVDT's and RVDT's. The signals were processed with three TestStar AC conditioners. The axial displacement gage length of 1.0 in was determined by the distance between the locator pins in the assembly. Figure 8 shows the displacement gage mounted on a specimen.

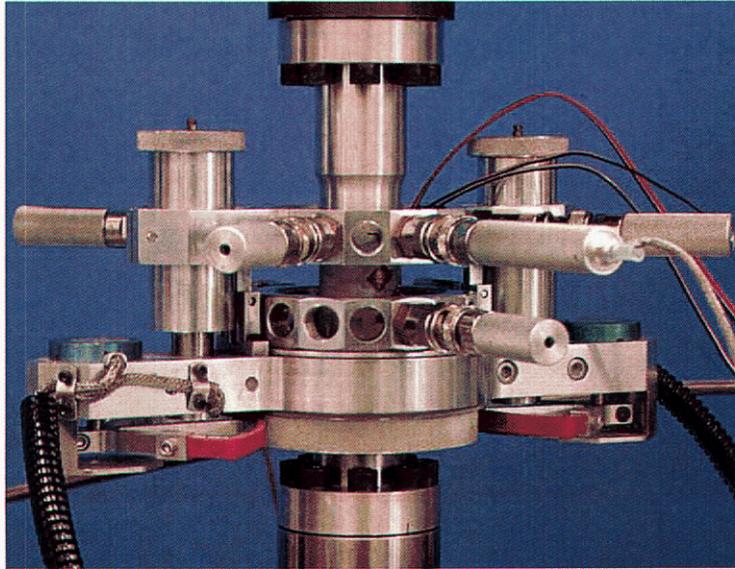
**Figure 5.** Validation specimen and displacement gage.

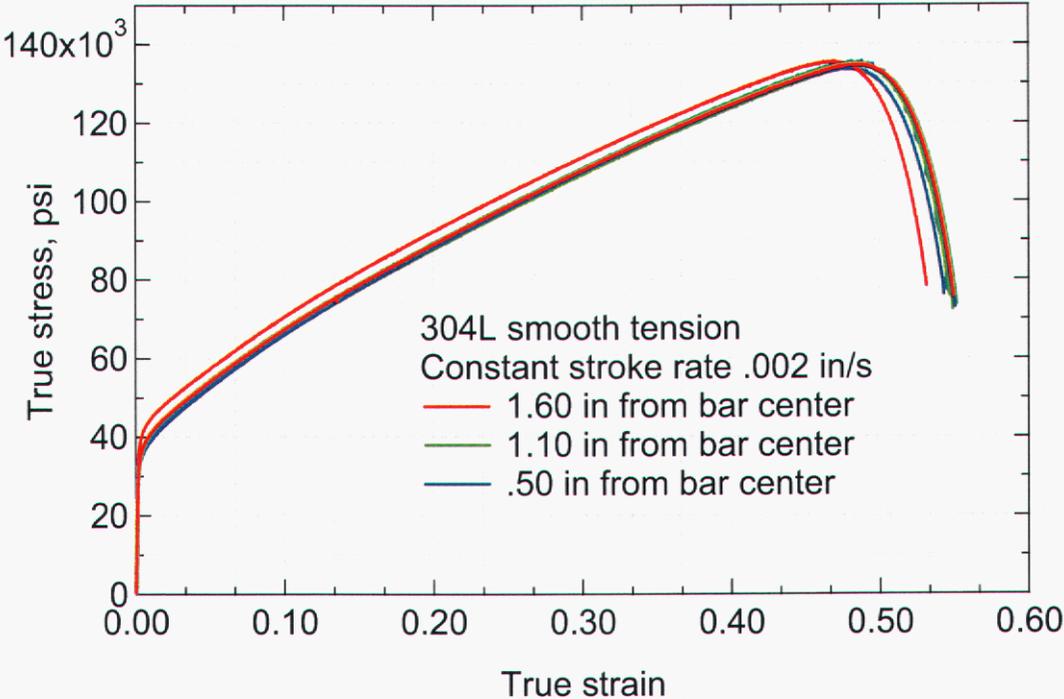
Figure 6. Smooth tension true stress vs. true strain curves. Nominal displacement rate was .002 in/s.

Smooth tension data is shown in Figure 6. No significant affect of radial position on tensile properties was observed. Figure 7 shows a plot of the measured true strain rate vs. time. Notched tension load-displacement data is shown in Figure 8. Compression stress-strain curves are shown in Figure 9. The compression specimens shown in Figure 10 demonstrate uniform deformation.

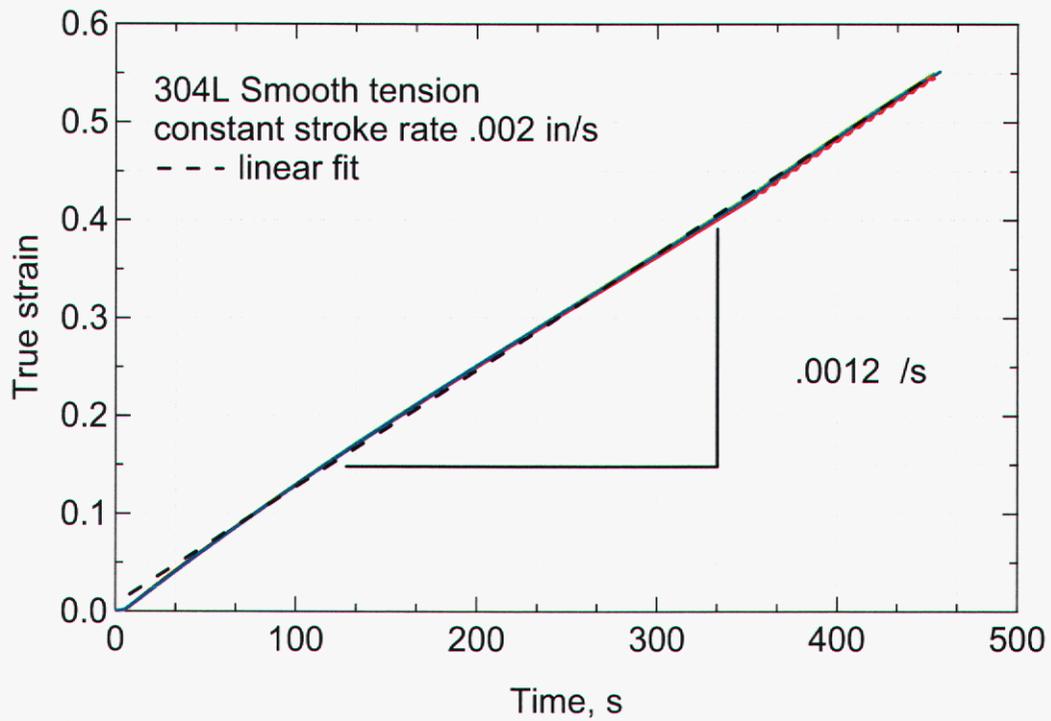
**Figure 7.** Measured true strain vs. time. The data is from the tests shown in Figure 6.

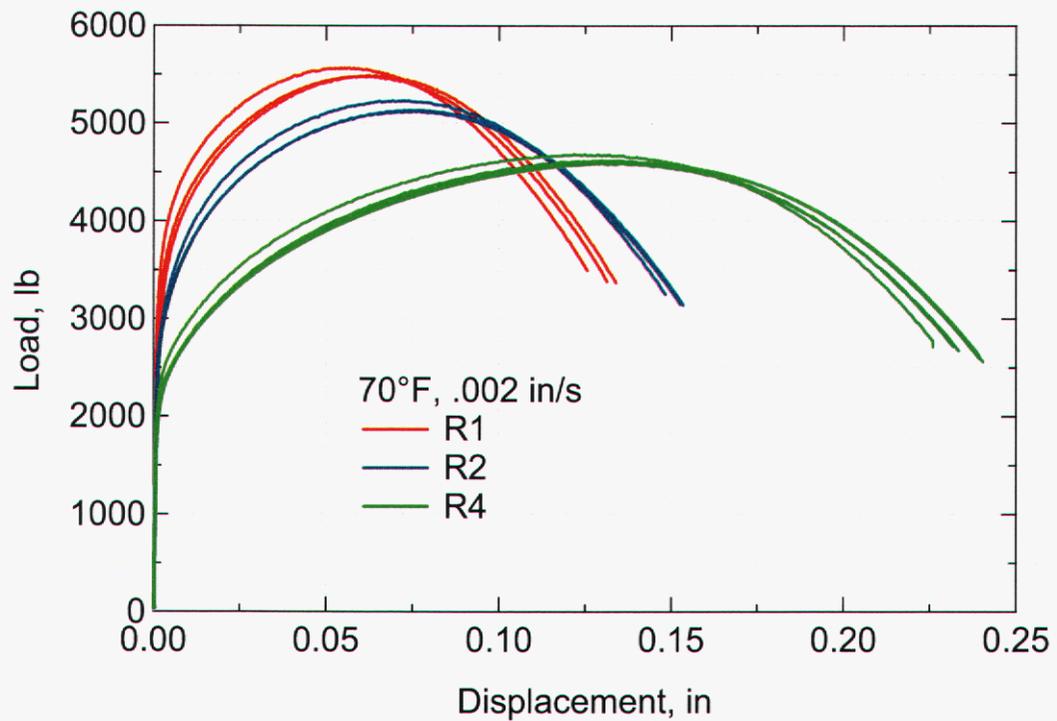
**Figure 8.** Notched tension load-displacement data.

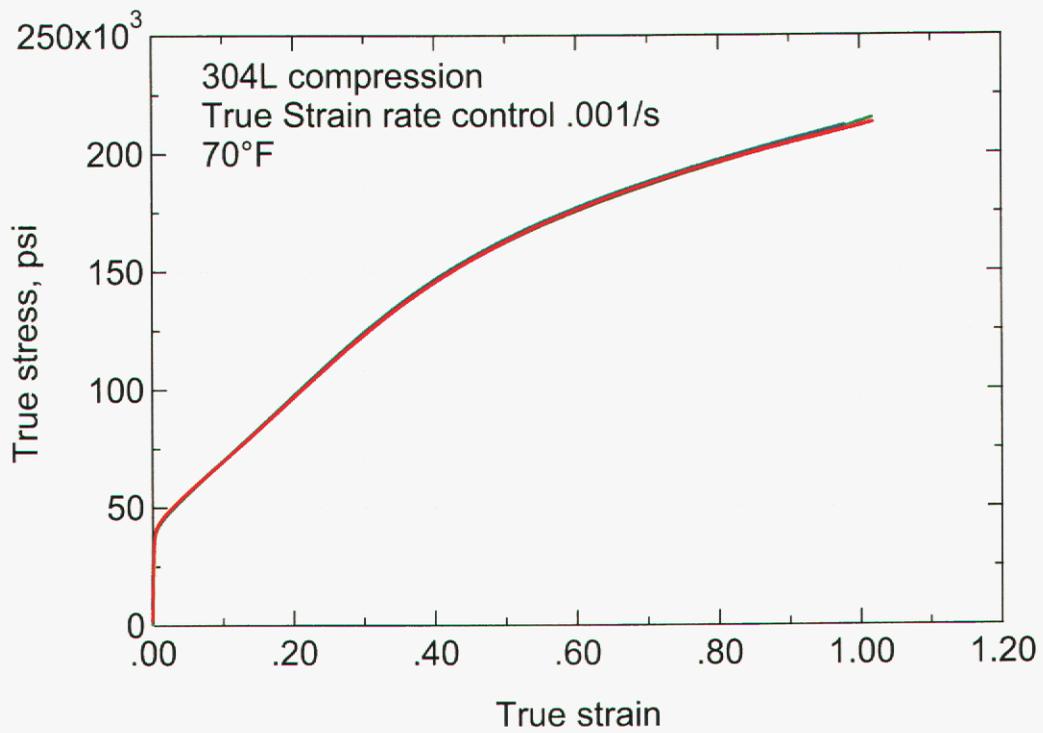
**Figure 9.** Compression data.

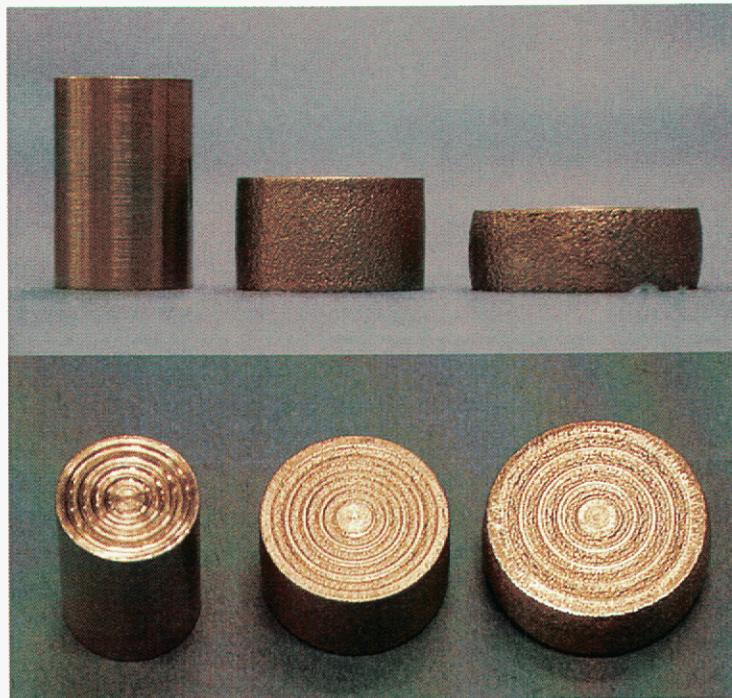
**Figure 10.** Compression specimens. The specimen on the left is as-machined. The specimen on the right was deformed to a true strain of 1.02.

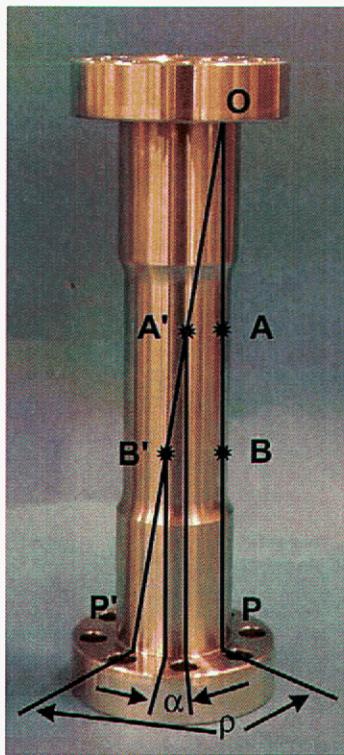
**Figure 11.** Schematic representation of the difference between rotation and angular displacement measurements. The line  $OP$  represents a line drawn on the specimen prior to straining in torsion. The line  $OP'$  approximates the line  $OP$  after straining. Before straining, the upper half of the displacement gage is pinned at  $A$  and the lower half is pinned at  $B$ . After straining,  $A$  is rotated to  $A'$ , and  $B$  is rotated to  $B'$ . The angle  $\alpha$  is the angle measured by the displacement gage. The angle  $\rho$  is the angle measured by the hydraulic actuator RVDT.

The validation test data is presented here as a function of time. Pressure is plotted with diametric displacement. Torque is plotted with rotation and angular displacement. Rotation is a measure of the hydraulic actuator angular position obtained from the load frame RVDT, and angular displacement was measured on the specimen using the displacement gage described previously. Load is plotted with stroke and axial displacement. Stroke is a measure of the hydraulic actuator axial position, and axial displacement was measured on the specimen using the displacement gage described previously. The differences between the rotation and angular displacement measurements, and between the stroke and axial displacement measurements, are mostly due to the dimensions of the displacement gage, although load frame compliance contributed a small part. The difference between rotation and angular displacement measurement is shown schematically in Figure 11.

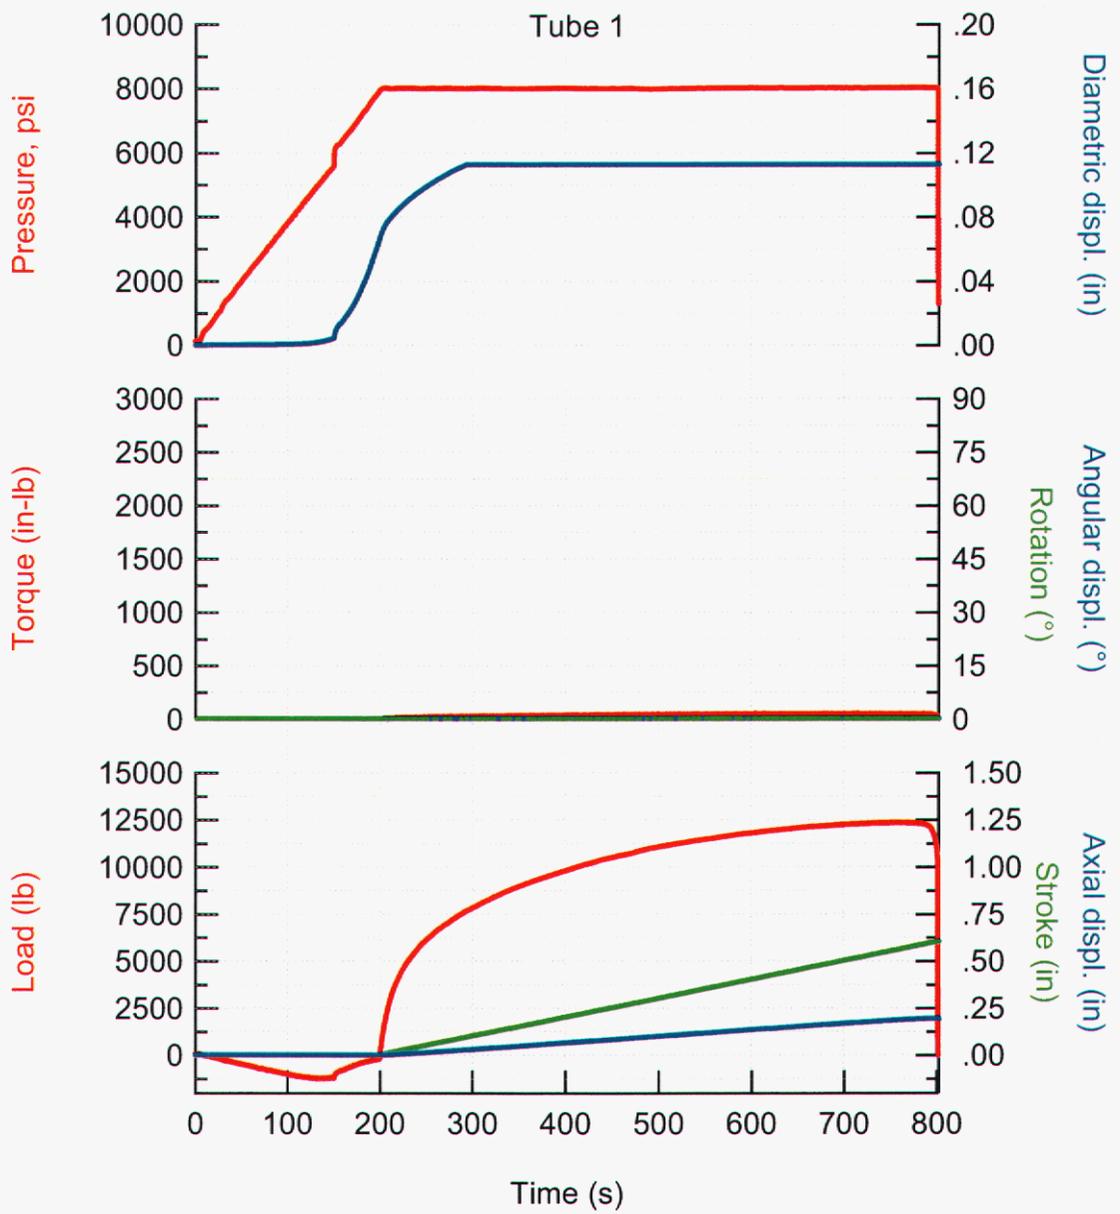
Figure 12. Load path 1 data.

Data for load path 1 are shown in Figure 12. The relaxation of axial load at about 125 s, coincided with the internal pressure required to cause yielding under hoop stresses. Similar relaxation of load or torque caused by yielding during a subsequent step is present throughout the validation test data. About two-thirds of the way through step 2, a pressure jump occurred. Smaller pressure jumps were recorded during other experiments, but the cause was not determined. During step 3, the diametric displacement gage went out of range. Similar issues with the diametric displacement measurements persisted throughout the experiments. Fortunately, the diametric changes are only one data set for comparison between model predictions and experimental results. Figure 13 shows the load path 1 specimen after testing.

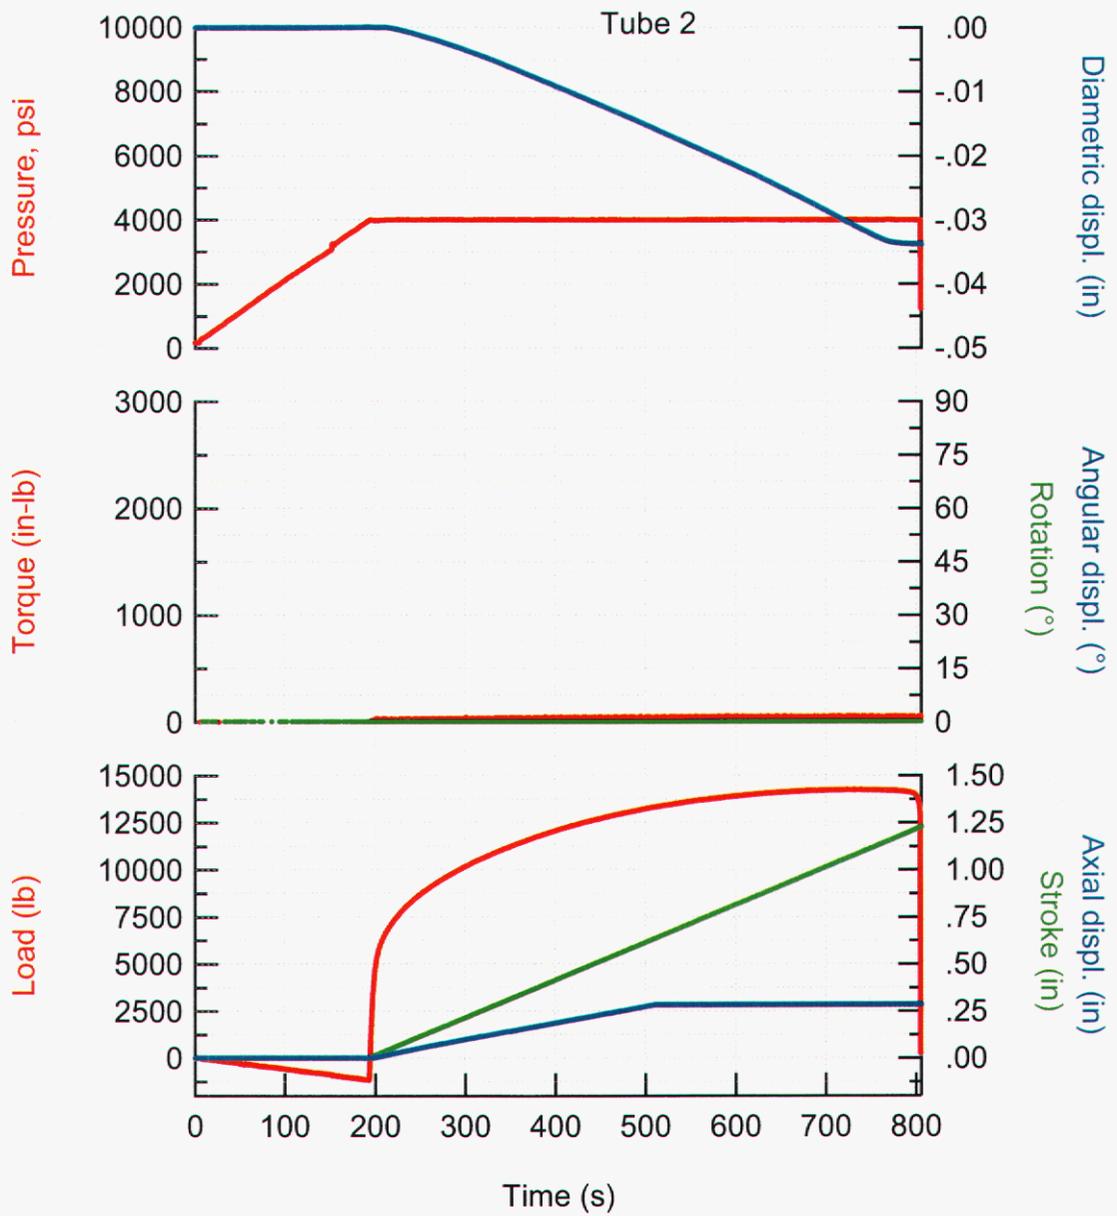
Figure 14. Load path 2 data.

Data for load path 2 are shown in Figure 14. Because the internal pressure was not sufficient to cause yielding, the axial load increased in compression until step 3, stroke to failure. The diametric displacement gage went out of range at the end of step 3. Figure 15 shows the load path 2 specimen (tube 2) after testing.

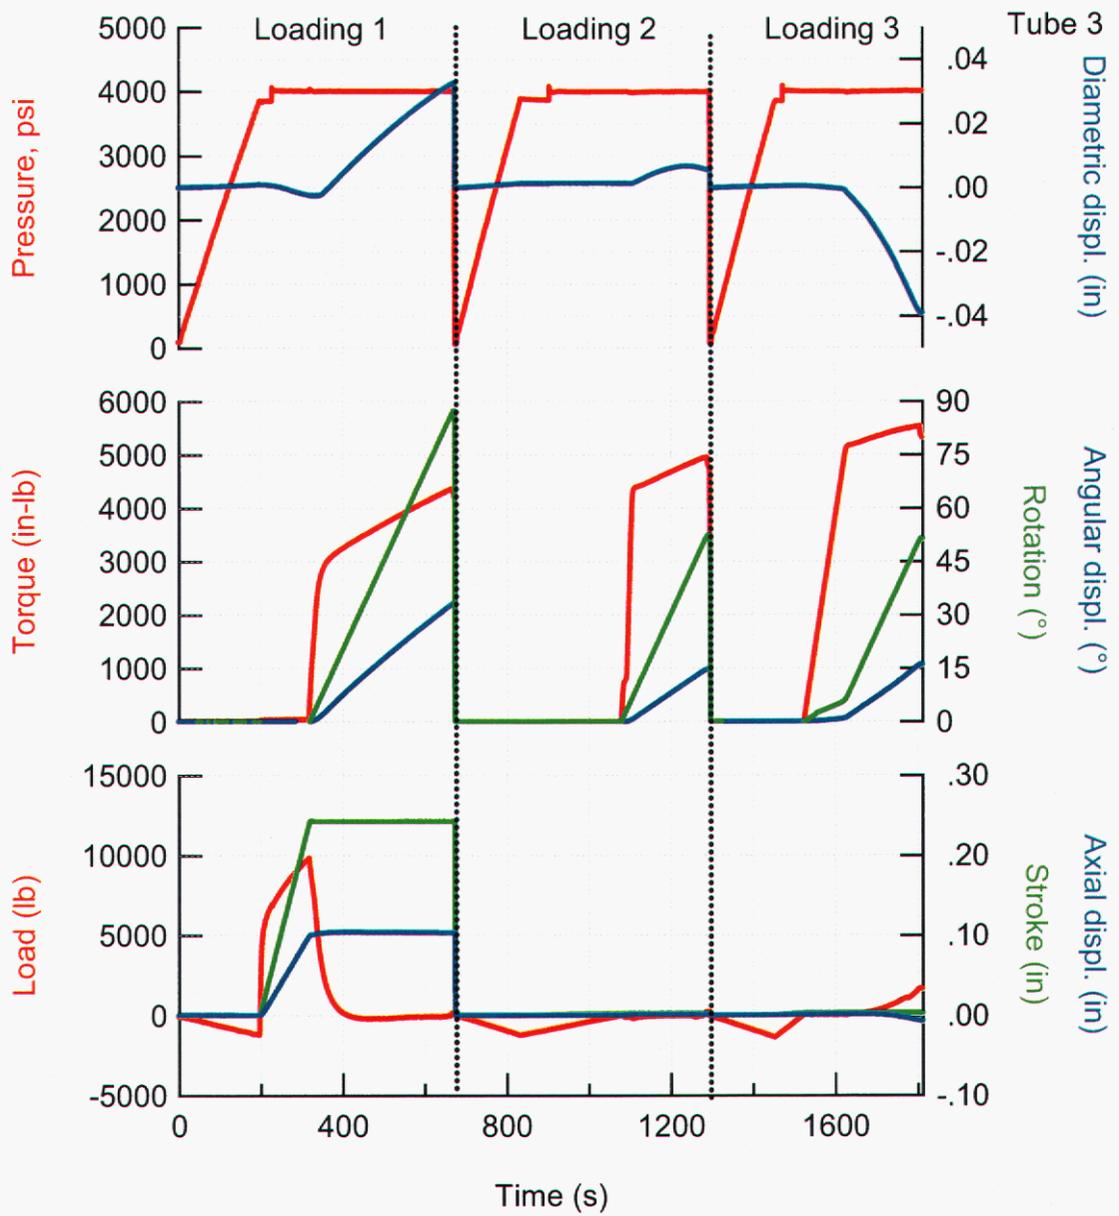
**Figure 16.** Load path 3 data.

Load paths 3 and 4 were intended to cause failure during rotation. However, because of the large ductility of 304L, the rotational actuator reached its maximum travel before the onset of failure. The specimens were removed from the test frame, the rotational actuator reset, and the experiment was continued. The unloading portion of the experiment was accomplished manually, and the data was not recorded. Prior to the second and third loadings, pressure was ramped to the level at the end of the first loading. Because the axial force had relaxed to zero by the end of the first loading, axial displacement was not included in the second and third loadings. During the pressure step of the second and third loadings, the axial load should have been controlled at 0 lb, then stroke control resumed for the third step. Fortunately, the axial load developed from internal pressure was small, and holding in axial stroke control may simplify the boundary conditions for modeling the second and third loadings. At the end of the third loading, the specimens showed significant buckling and the experiments were ended. Figure 16 shows the data from all three loadings for load path 3. The Figure 17 contains images of the specimen after testing. Figure 18 shows data for load path 4. Figure 19 contains images of the load path 4 specimen after testing.

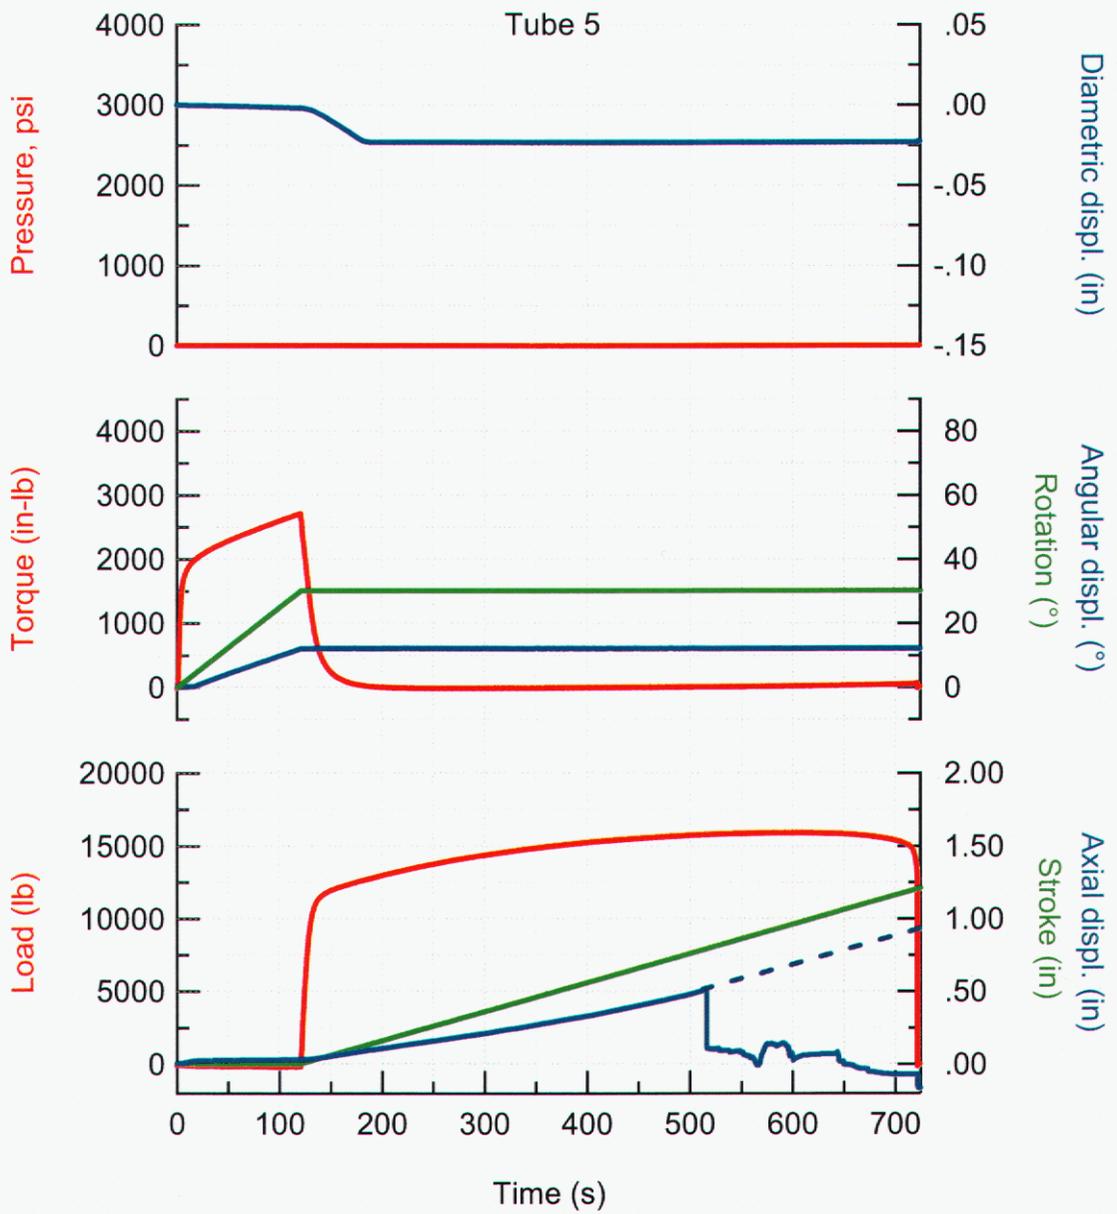
**Figure 20.** Load path 5 data.

Data for load path 5 is shown in Figure 20. The diametric displacement gage went out of range after step 3. Adjustments were made to the displacement gage rods to reduce the risk of the LVDT's going out of range during subsequent experiments. During step 3, the axial displacement gage slipped. The dotted blue line extending the axial displacement curve in Figure 20 was taken from the stroke data. Because the axial load was not changing much during that segment of the test, the changes in stroke and axial displacement would have been very close to the same value. The Load path 5 specimen after testing is shown in Figure 21.

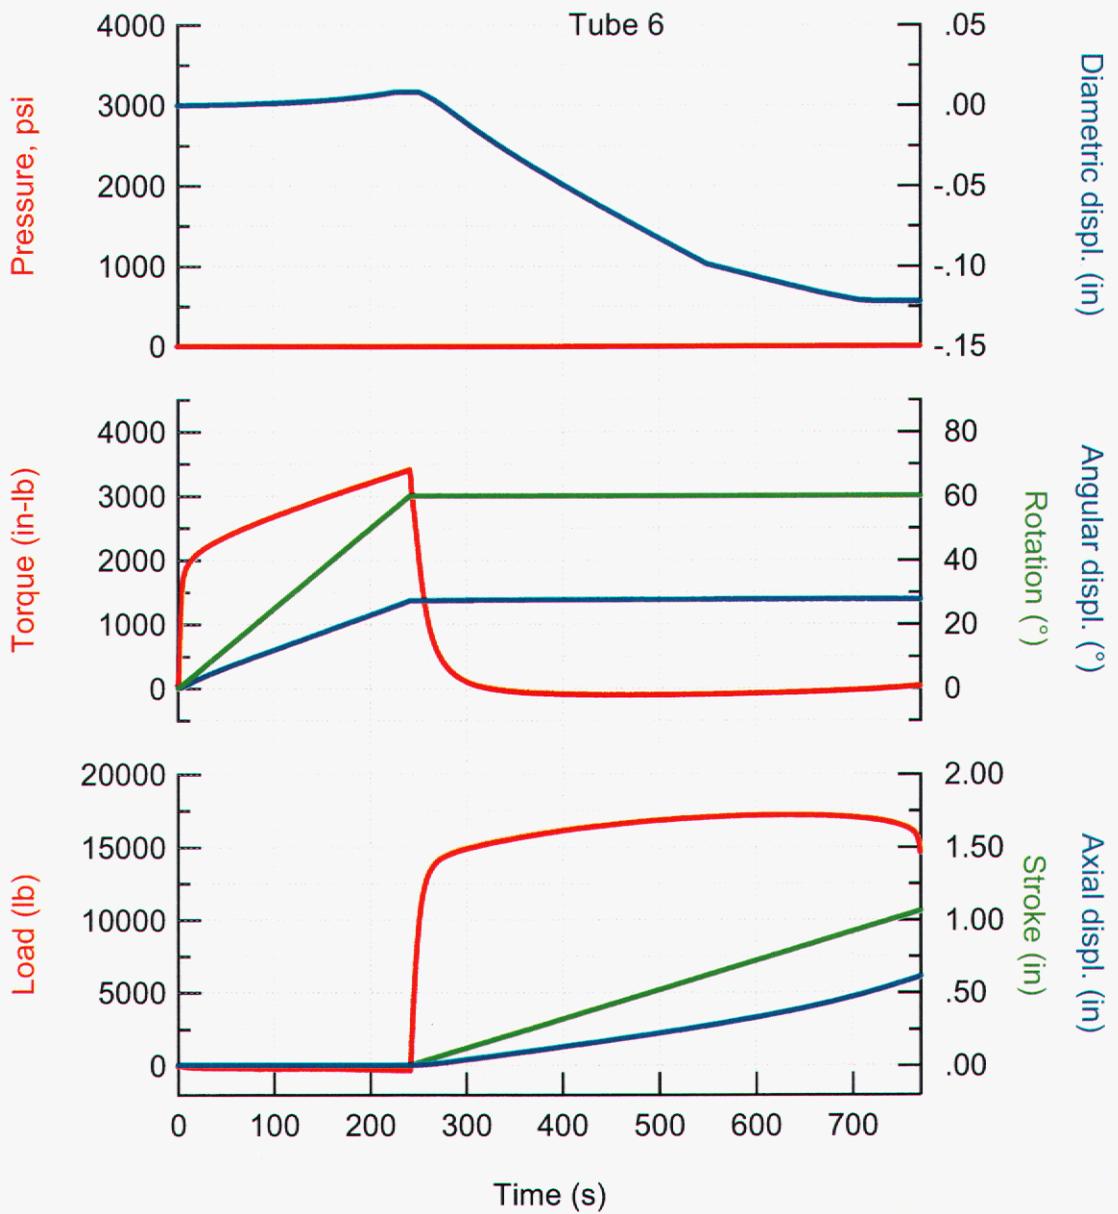
Figure 22. Load path 6 data.

Data for load path 6 is shown in Figure 22. In this case, some of the diametric expansion during rotation was out of range, but the majority of the contraction during the stroke step was recorded. Near the axial peak load, the diametric change slowed down, a result that was attributed to the location of the measurement. Since the diametric LVDT's were located above the location of final minimum diameter, the rate of diameter change during non-uniform deformation would slow down from the rate during uniform deformation. The deformed load path 6 specimen is shown in Figure 23. Data for load path 7 are shown in Figure 24 and images of the deformed specimen are shown in Figure 25. Comments regarding load path 7 data are the same as for load path 6.

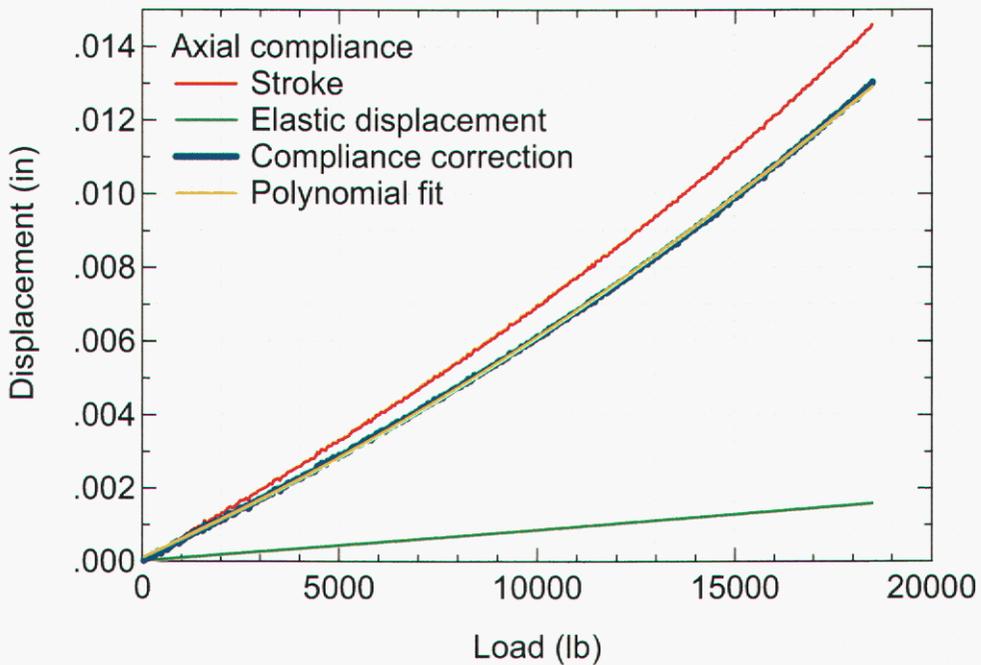
Machine compliance was measured for axial and torsional loading of the test frame using the solid steel specimen described in the section on experimental details. Figure 36 shows the axial compliance data and the calculated compliance correction curve, which is the displacement difference between the stroke measurement and the calculated elastic displacement of the solid steel link. A linear fit of the axial compliance correction curve had a slope of 6.92 in/lb. A second-order polynomial fit of the compliance correction curve with the form  $Y=K_0+K_1(\text{load})+K_2(\text{load})^2$ , had coefficients:  $K_0=8.886e-5$ ,  $K_1=4.972e-7$ , and  $K_2=1.053e-11$ .

**Figure 36.** Axial compliance data.

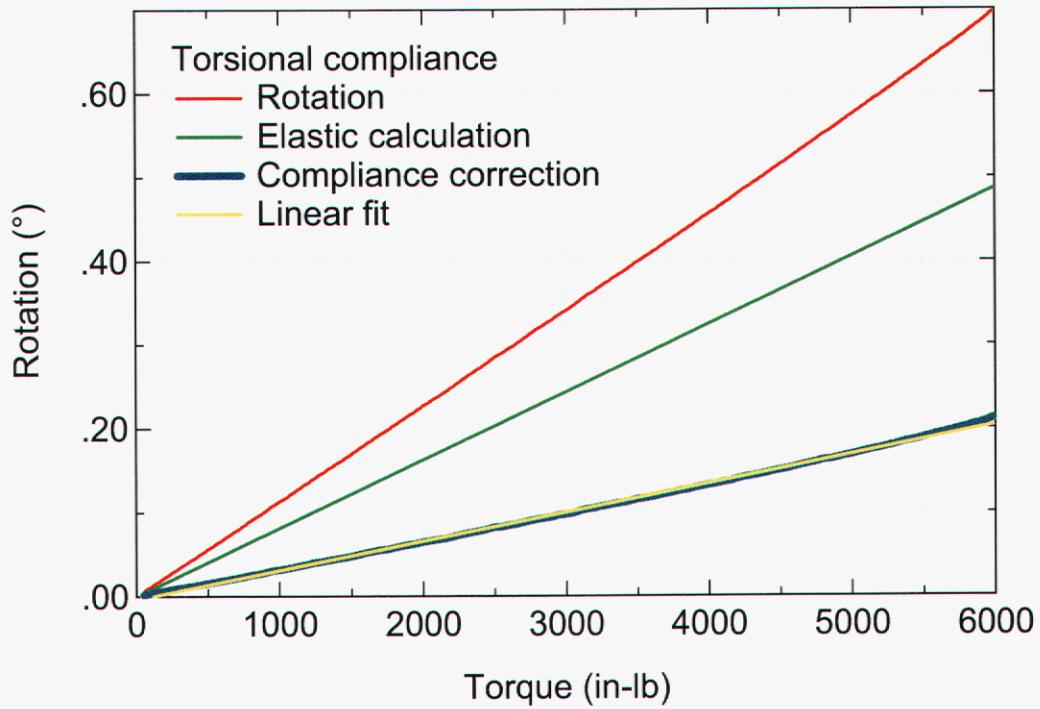
Torsional compliance data is shown in Figure 37. A linear estimate of the compliance correction curve had a slope of  $3.452 \times 10^{-5}$  degrees/in-lb. A second-order polynomial fit of the compliance correction curve, with the form  $Y=K_0+K_1(\text{torque})+K_2(\text{torque})^2$ , had coefficients:  $K_0=9.130 \times 10^{-4}$ ,  $K_1=2.967 \times 10^{-5}$ , and  $K_2=8.021 \times 10^{-10}$ .

Figure 37. Torsional compliance data.
