SAND2007-3526  
Unclassified Unlimited Release  
Printed September 2007

## **Antarctica X-Band MiniSAR Crevasse Detection Radar: Final Report**

Grant J. Sander  
Douglas L. Bickel

This document includes discussion of the hardware development, system capabilities, and results from data collections in Antarctica.

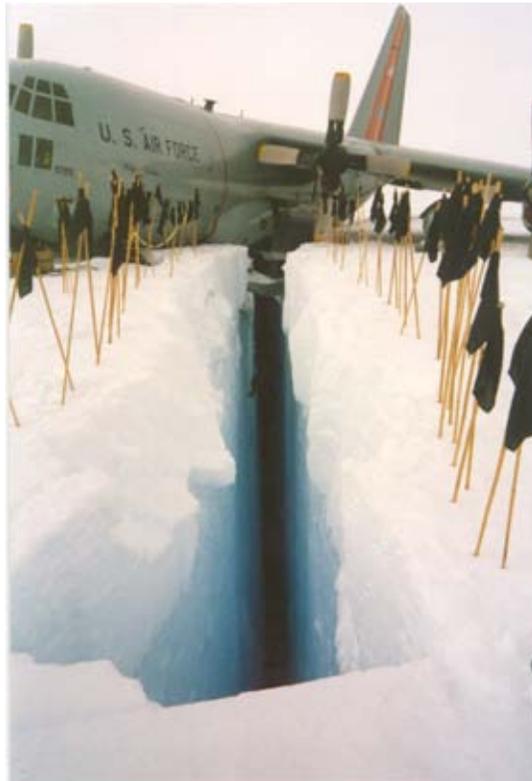
Figure 1: Photo of LC-130 in a Crevasse

The desire for crevasse detection in potential landing sites has been known for some time. The U. S. Antarctic program is supported extensively by the LC-130 aircraft fleet. “These heavy-lift, long-range aircraft, with their deep-field landing capability (i.e., landing in areas without prepared skiways) have been instrumental in allowing research to be carried out virtually anywhere on the continent [1].” However, as shown in Figure 1, these aircraft are vulnerable to undetected crevasses which are covered over with a snowbridge. These crevasses are very difficult to detect visually, even in the best of circumstances. Recovery of an aircraft in these deep-field environments is expensive, time-consuming, and potentially dangerous. Therefore, the desire to detect the crevasses a priori and avoid such events is obvious.

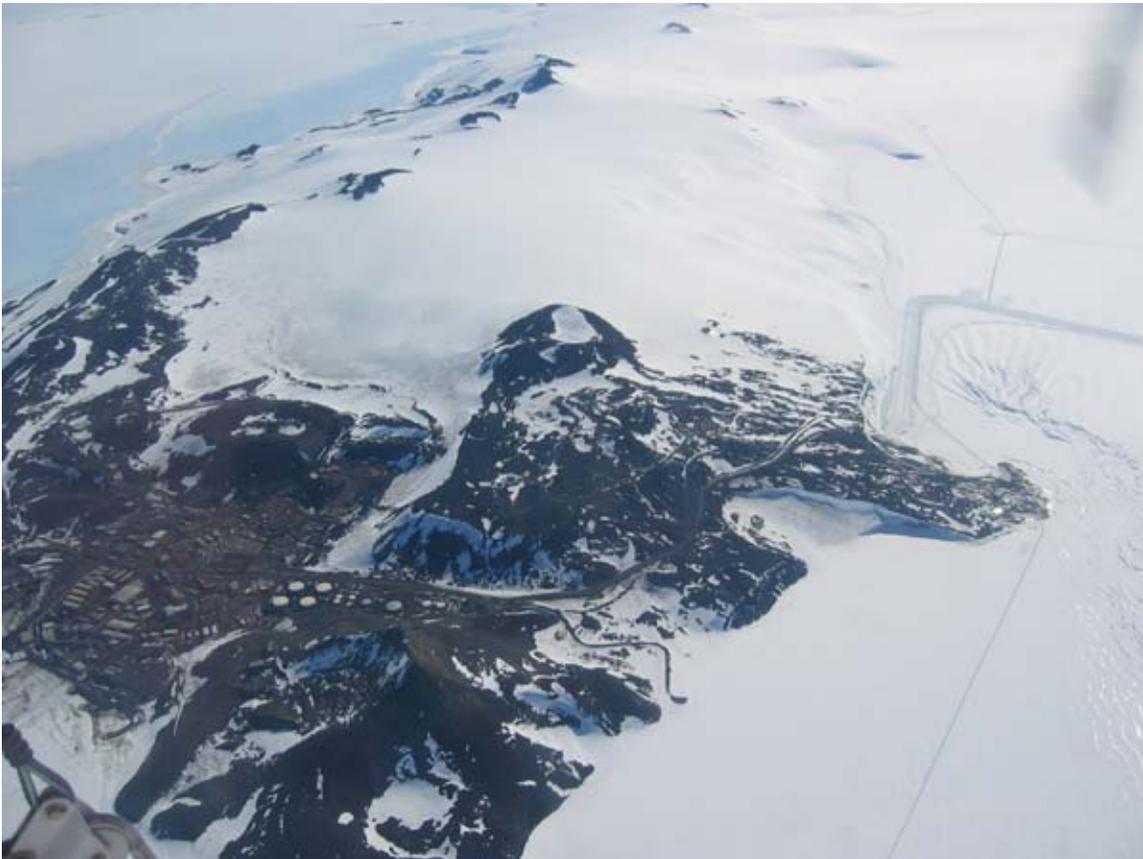
Figure 2: Photo of Area Imaged Dec 5, 2006

Dec 5, 2006: Initial flight to check out the radar and perform RFI testing at McMurdo Station and Pegasus air field. Figure 2 shows a photograph of the general area imaged for the first flight. Figure 3 shows an approximate layout of the objects found within the Pegasus wreck site, also imaged during this flight. Figure 4 shows a photo of part of the Pegasus wreck site imaged.

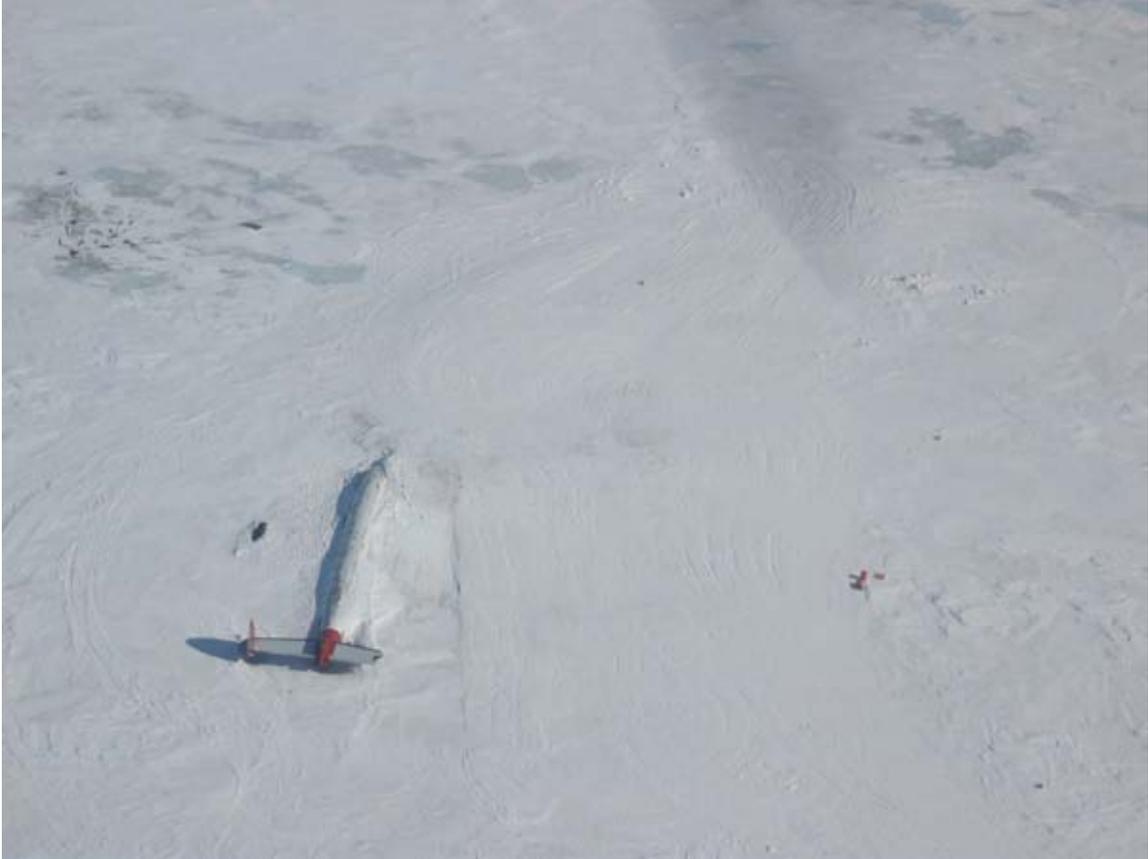
Figure 4: Photo of Pegasus Wreck Area Imaged Dec. 5, 2006

Another lower priority task was to look for objects at the Pegasus site (refer to Figure 3 and Figure 4). The detection of these objects were a function of viewing geometry. Certain orientations of the radar with respect to the objects were better for object detection. Also, at lower grazing angles, the objects were easier to detect because the surface clutter, i.e., the snow and ice, had a smaller backscatter coefficient at these geometries. Figure 28 shows an example X-band image from the Pegasus wreck site at 8 inch resolution and 15° grazing angle.

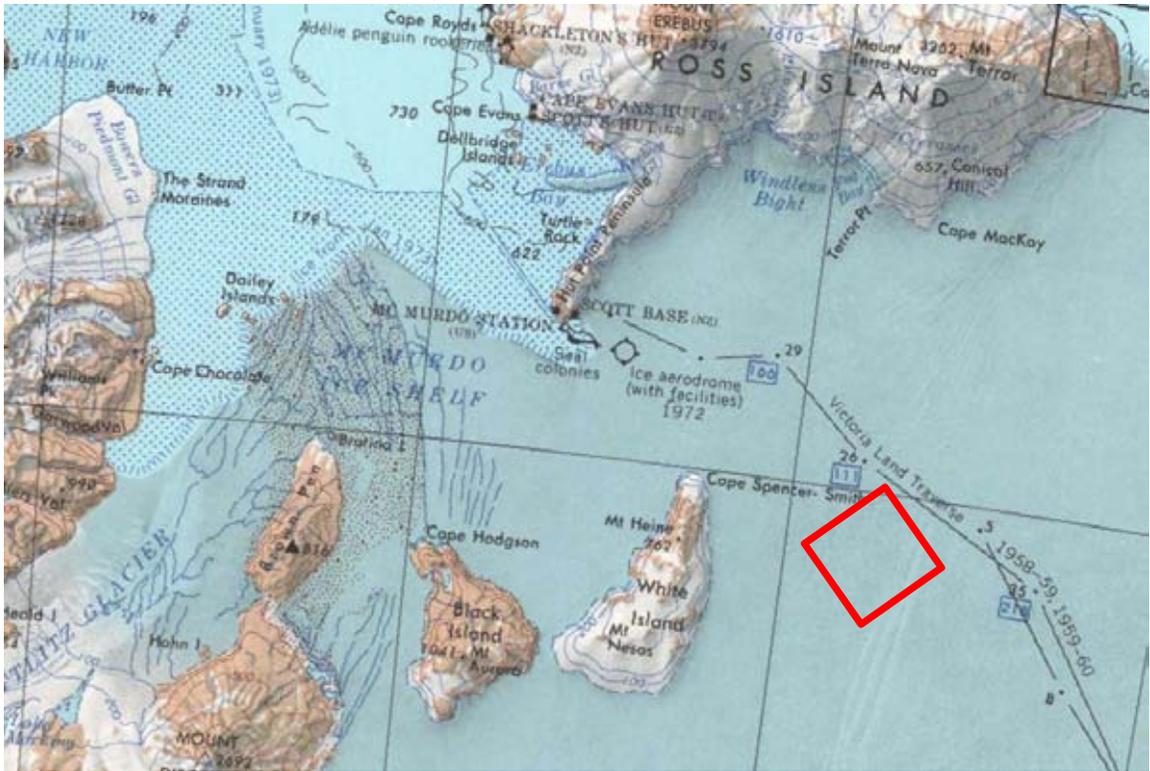
Figure 5: Approximate Location of 5 nmi by 5 nmi Area Imaged during South Pole Traverse Collect on Dec. 6, 2006

Dec 6, 2006 (morning): Data collected at 1-foot resolution over a 5 nmi by 5 nmi area at the South Pole Traverse (centered at Latitude S 78° 02' 43.87", Longitude E 168° 29' 04.56"). This area was in the Shear Zone and contained the South Pole Traverse route. The area near the traverse route had been mapped with ground penetrating radar and marked for crevasses between late 2002 and early 2003 [3]. Figure 5 shows the approximate area imaged by the MiniSAR radar on the morning of Dec. 6<sup>th</sup>. No photos are available for this area, but it was reported that from the aircraft the area looked like a flat white ice plain with no particular distinguishing features.

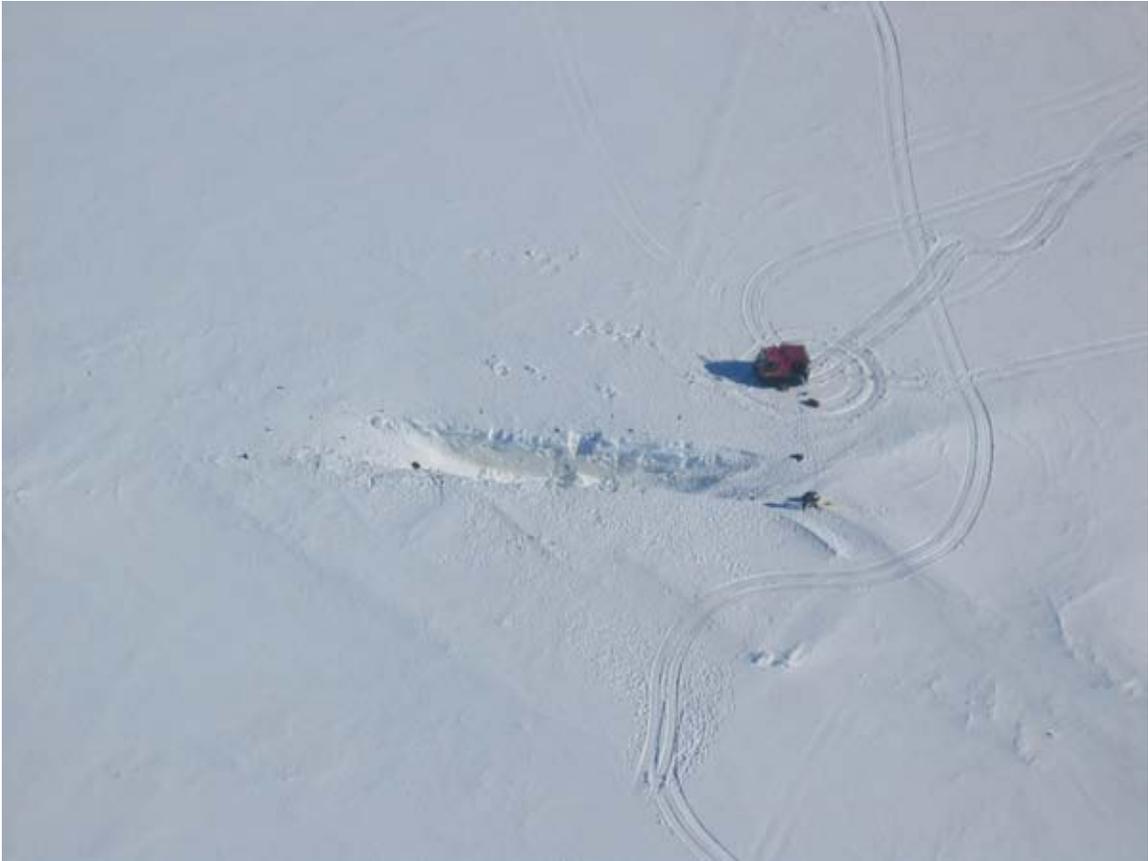
Figure 7: Photo of Simulated Crevasse Area Imaged Dec. 8, 2006

Dec 8, 2006: Data collected to investigate penetration of the ice at a simulated (manmade) crevasse used for mountaineer training (Latitude S 77° 49' 58.33", Longitude E 166° 51' 47.83"). Figure 7 shows a photo of the simulated crevasse area. In addition, we collected spotmap data of the McMurdo and Scott Base area, including the pressure ridge. Figure 8 shows the layout of radar reflectors buried in the wall of the simulated crevasse. Figure 9 and Figure 10 shows the photos of burying the reflectors in the simulated crevasse.

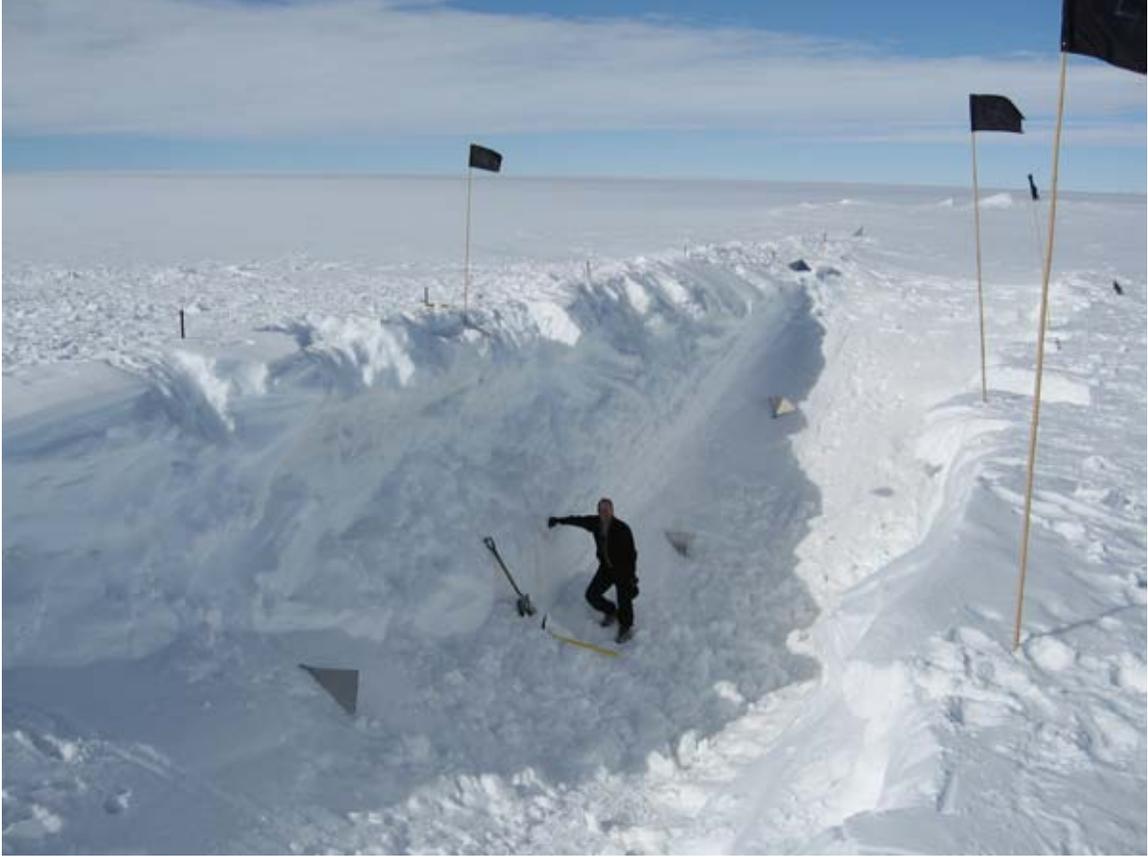
Figure 9: Photo of Rough Layout of Radar Reflectors at Simulated Crevasse (these reflectors were buried in the wall at the appropriate depths shown in Figure 8)

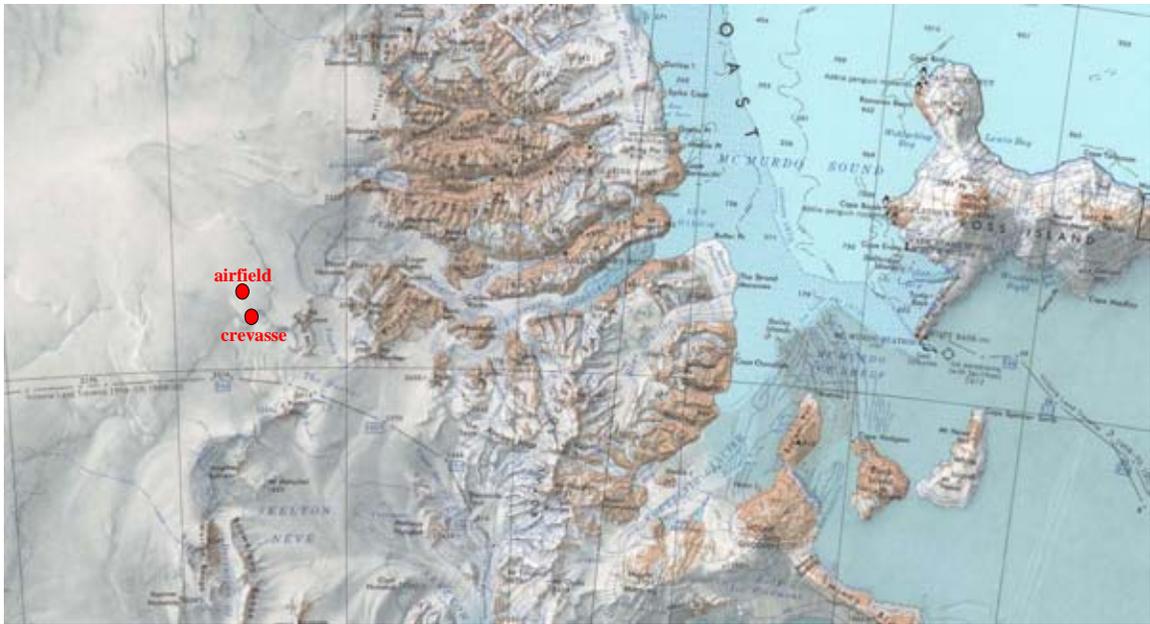
Figure 11: Approximate Location of Taylor Dome Collects on Dec. 11, 2006

Dec 11, 2006: Data collected in the Taylor Dome area. The region contained several crevasses in sloped terrain. The mountaineers provided coordinates and placed radar reflectors along one of these crevasses. One foot resolution radar data was collected over an approximately 1 nmi by 1 nmi region (centered at Latitude S 77° 52' 25.44", Longitude E 158° 50' 49.80"). Circle data was collected near the crevasse with the reflectors (centered at Latitude S 77° 52' 39.72", Longitude E 158° 49' 04.62"). As a secondary requirement, data were collected at the old drill site, and near the runway to look at object on, and possibly under, the ice. Figure 11 shows the approximate location of these data sets collected by the MiniSAR system on Dec. 11<sup>th</sup>. Figure 12 and Figure 13 show the crevasse site and runway, respectively, at Taylor Dome.

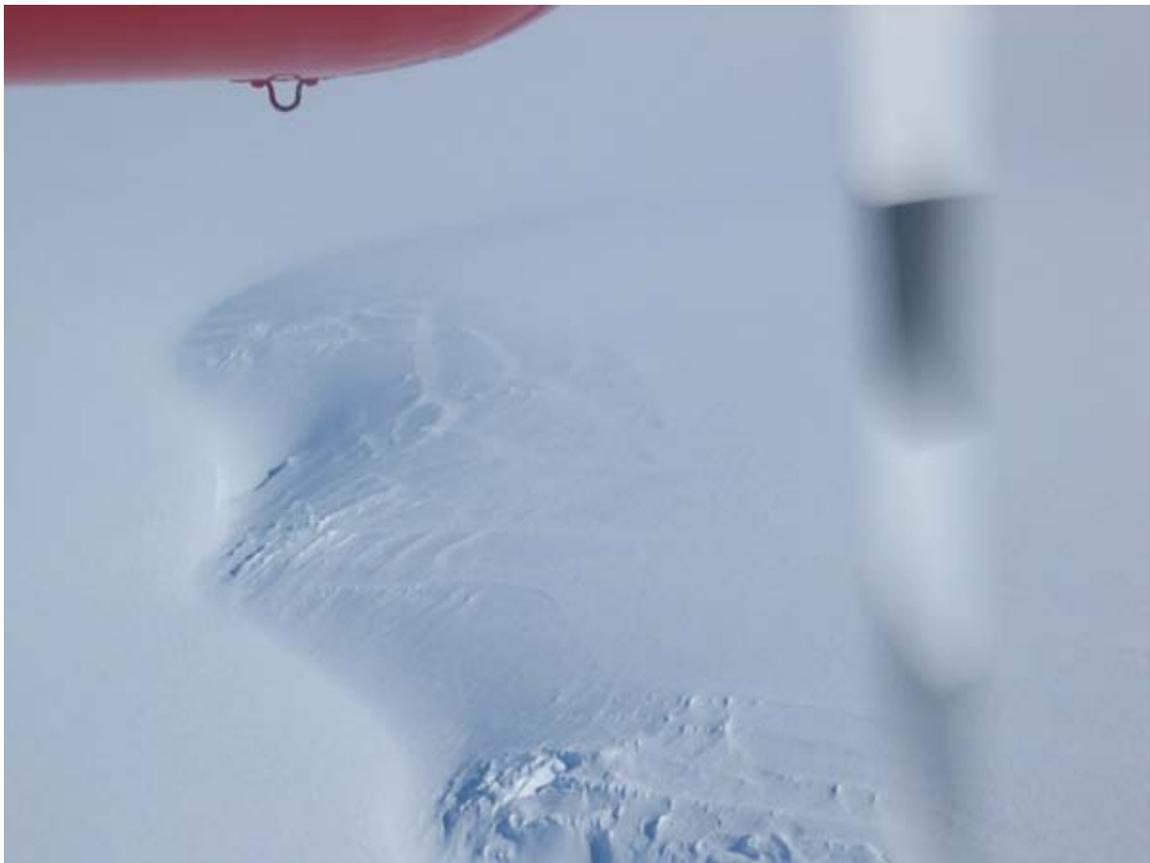
Figure 12: Photo of Crevasse Site Area at Taylor Dome on Dec. 11, 2006

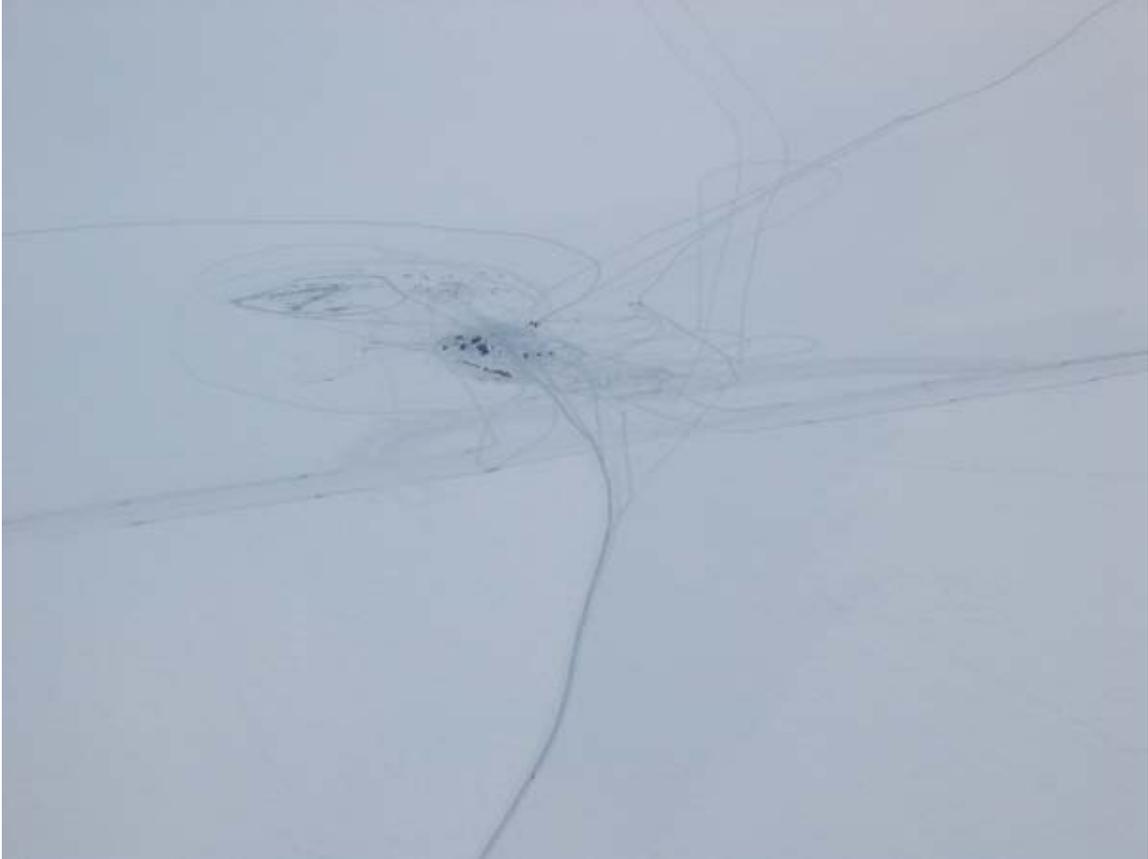
Figure 13: Photo of Runway Site Area at Taylor Dome on Dec. 11, 2006

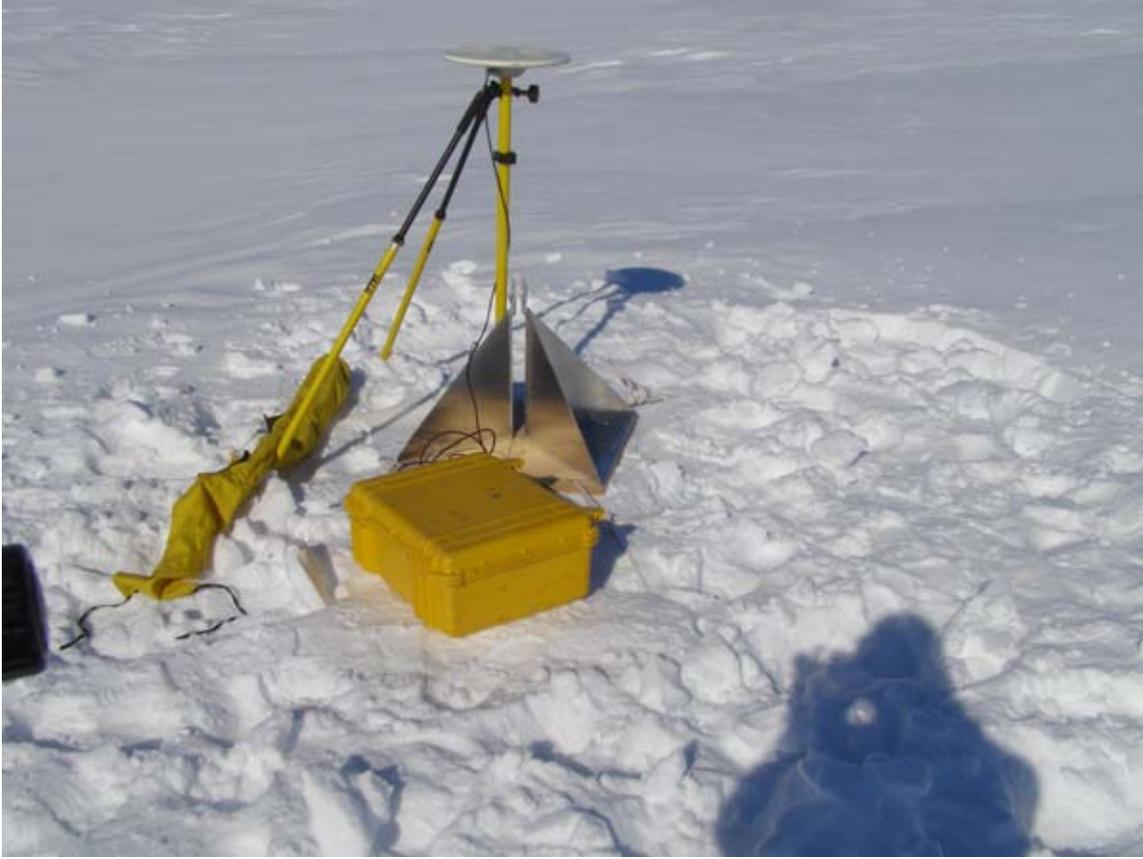
Figure 14: Photo of Radar Reflector Along with GPS Survey Equipment

Radar reflectors were placed along the edge of the crevasse in the Tres Hermanas and Taylor Dome crevasse scenes. These reflectors serve as markers in the radar data, to ensure we were actually detecting the crevasse with the radar. Since the reflector locations were surveyed with differential GPS (DGPS), they also permitted the evaluation of the radar image position accuracy. Figure 14 shows back to back radar reflectors mounted on a piece of plywood for insulation. The radar reflectors were intended to have a radar cross-section of approximately 21 dBsm, which allows radar backscatter calibration of the images.

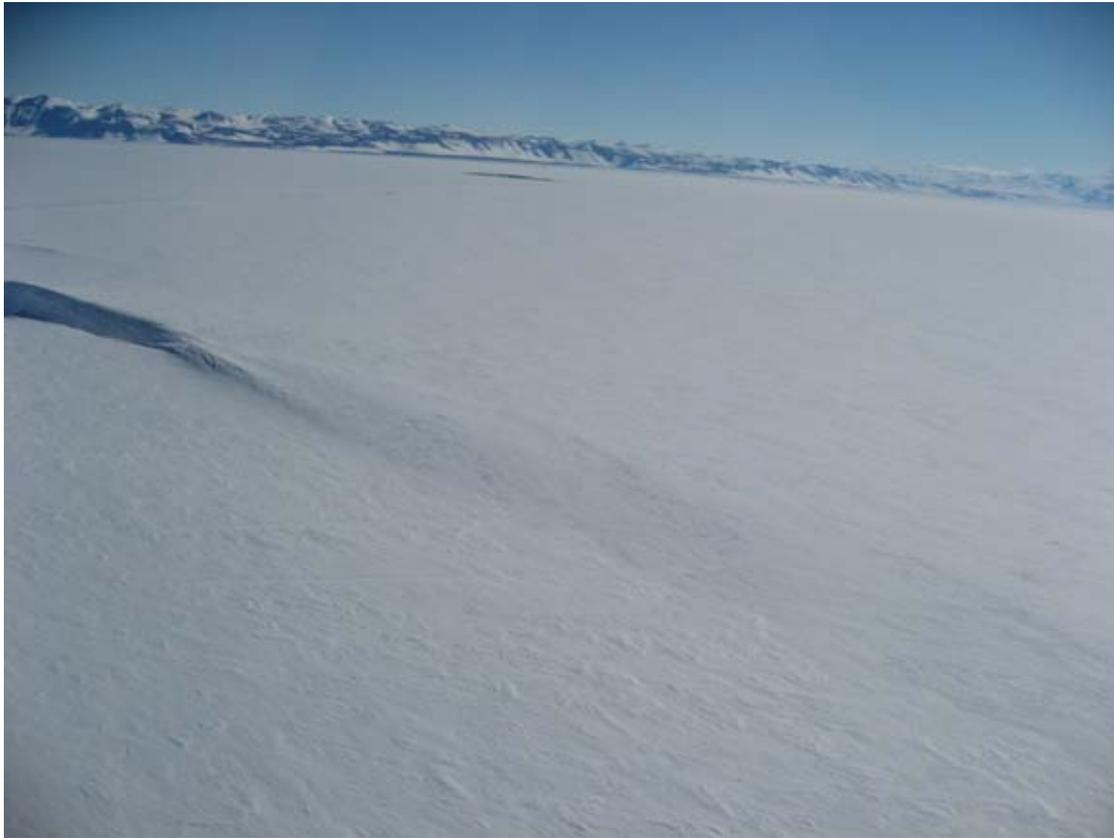
Figure 17: Close-up Photo of Tres Hermanas Crevasse Site (crevasses are faint horizontal lines at left-center in the photo)

A photo showing those crevasses is given in Figure 17 below. These crevasses were nicknamed Tres Hermanas, or the three sisters. The crevasses in this photo are actually visible, but they required the proper viewing geometry (e.g., proper orientation with respect to the crevasses and the sun angle, distance from the crevasses, etc.) to be visible. Even then, one can see from the photo, that they are difficult to detect.
