SAND2010-1181

## **Dynamic Load Test of Arquin-Designed CMU Wall**

The Arquin Corporation has developed a new method of constructing CMU (concrete masonry unit) walls. This new method uses polymer spacers connected to steel wires that serve as reinforcing as well as a means of accurately placing the spacers so that the concrete block can be dry stacked. The hollows of the concrete block are then filled with grout. As part of a New Mexico Small Business Assistance Program (NMSBA), Sandia National Laboratories conducted a series of tests that dynamically loaded wall segments to compare the performance of walls constructed using the Arquin method to a more traditional method of constructing CMU walls. A total of four walls were built, two with traditional methods and two with the Arquin method. Two of the walls, one traditional and one Arquin, had every third cell filled with grout. The remaining two walls, one traditional and one Arquin, had every cell filled with grout. The walls were dynamically loaded with explosive forces. No significant difference was noted between the performance of the walls constructed by the Arquin method when compared to the walls constructed by the tradi

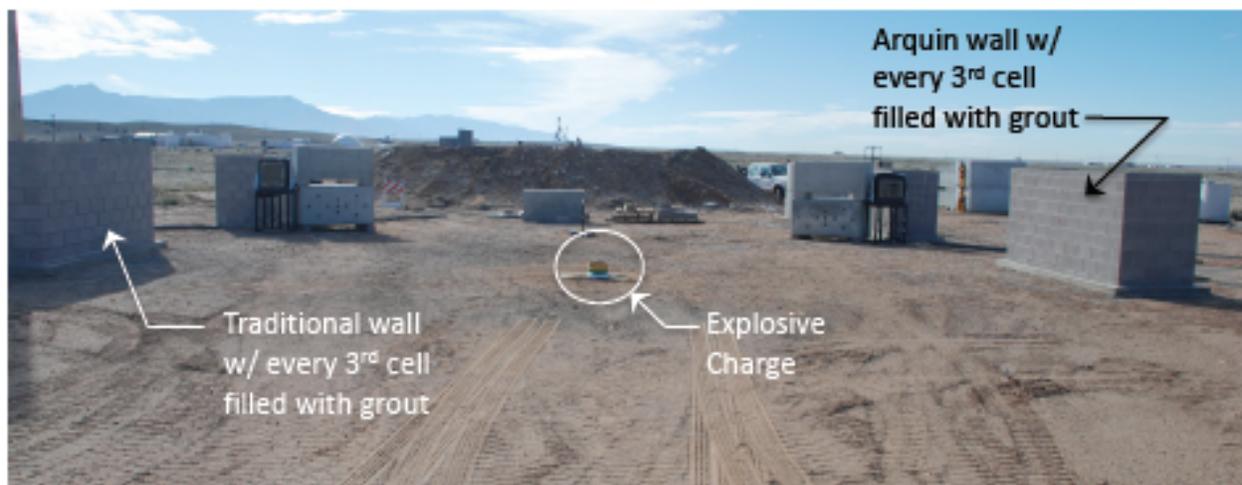
**Figure 4.** Completed walls just prior to initial test.

The grouting of the walls was also a permutation. In grout type one, one Arquin wall and one traditional wall had every third cell in the walls filled with grout. In grout type two, one Arquin wall and one traditional wall had every cell in the walls filled with grout. Figure 4 shows the completed walls ready for testing.

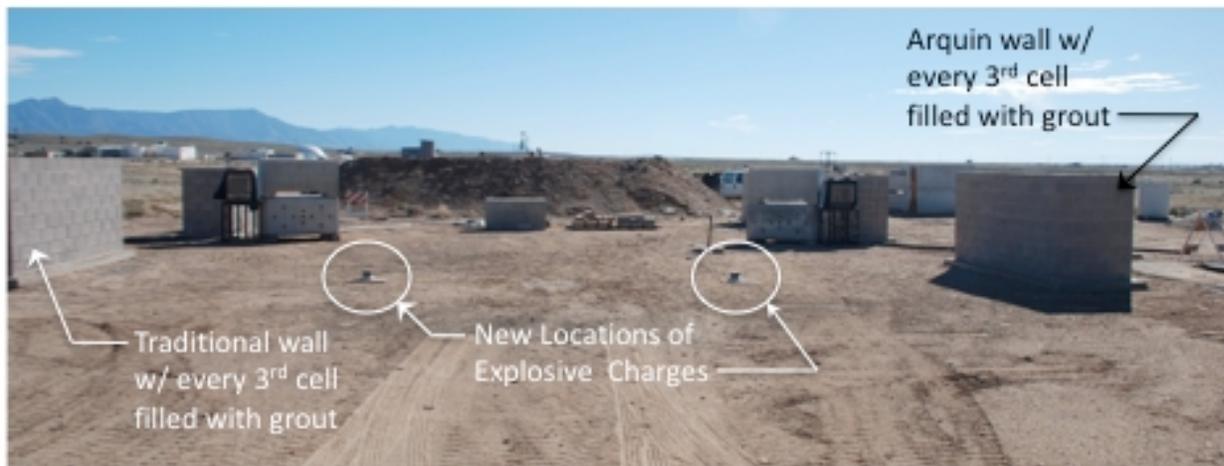
**Figure 12.** Photograph showing new location of explosive charges. In order to get higher pressures on the walls, the explosive charge was divided into two and moved closer to the walls. This enabled higher pressures to be achieved without exceeding the permitted charge weight.

The first three blasts were each a cylindrical charge equidistant from the walls. The explosive charge weight of the second blast was larger than the first blast and the third blast was at the maximum quantity of explosive that was allowed under the site permit that was requested. Due to reaching the maximum quantity allowed under the permit without breaking the walls, it was decided to split the charge into two cylindrical charges, place them closer to the walls, and detonate the explosives simultaneously. This would give a higher peak pressure but a slightly less uniform pressure wave with the center of the wall being impacted by the wave shortly before the ends of the wall. The total weight of the explosive used in the fourth blast was less than the weight of the charge in the third blast. The fifth blast was also two charges, with a charge placed closer to each of the walls being tested with both charges being detonated simultaneously. The total weight of the two charges used in the fifth test was equal to the maximum quantity allowed under the permit for the test. For the fifth blast, the distance from the charge closest to the traditional wall was 13.5 feet and the distance from the charge closest to the Arquin wall was also 13.5 feet.

The sixth and seventh blasts were set off against the walls with all cells filled with grout. Since it was anticipated that these walls were stronger than the walls with every third cell filled, it was desired that the peak pressure would be higher than any of the first five blasts. Therefore, to obtain this higher pressure load, a charge was placed closer to the walls and detonated singly. The charge weight for the sixth blast was the same as the charge weight for the seventh blast. The distance from the sixth blast to the traditional wall was 13.5 feet. The distance from the seventh blast to the Arquin wall was also 13.5 feet.

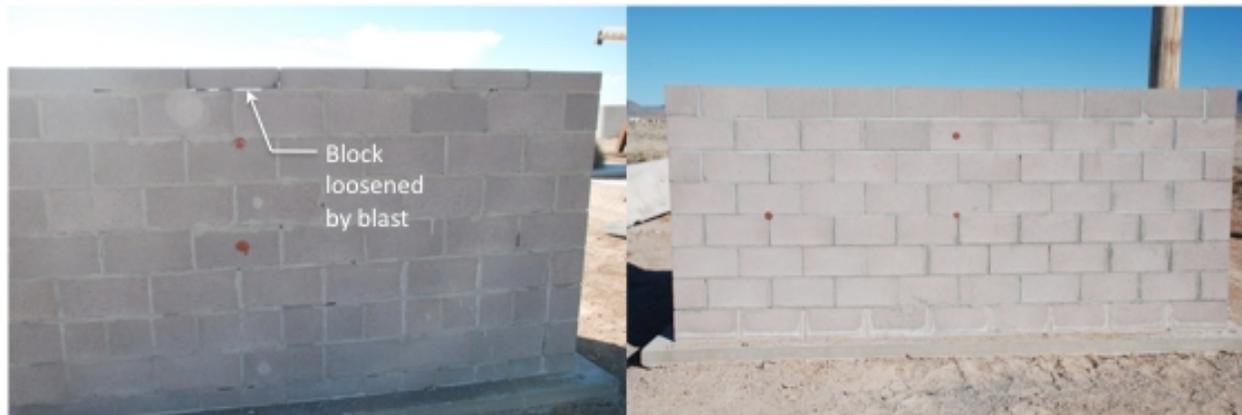
**Figure 13.** The image on the left is the Arquin wall with every third cell filled with grout. The image on the right is the traditional wall with every third cell filled with grout. Note the difference in the number of courses in the Arquin wall because the bottom and the top courses are half height blocks. The block in the Arquin wall that was loosened had neither cell filled with grout.

The initial blast resulted in no discernable damage on the walls. Figure 6 shows the pressure profile of the first blast, including the free-standing probe. For the second charge, the explosive quantity was roughly doubled. The second charge also resulted in no discernable damage. Figure 7 shows the pressure profile of the second blast. The explosive charge was again increased, this time to the maximum amount allowed at the test range without additional permitting requirements. This third blast also did little to no discernable damage to the walls except for a few small cracks in mortar in the Arquin walls. Figure 8 shows the pressure profile of the third blast. Due to reaching the maximum allowed quantity of explosive per the required permit, it was decided to divide the charge and move each of the smaller charges closer to the walls. Moving the charge closer to the walls resulted in a larger peak pressure, but a slightly less uniform pressure load to the walls. Figure 12 shows the new location of the charges with respect to the walls and Figure 9 shows the pressure profiles from the fourth blast. Once again, the damage to the walls was minimal, principally some cracking in the mortar. Slightly more damage was ascertained to have occurred in the Arquin wall, though all damage was limited to cracking in the mortar, with the exception of the half block that was located directly in the center of the wall on the top course. This one block was broken free from the adjoining blocks and

displaced several inches. However, this is probably an artifact of the design. Due to every third cell being filled with grout, some blocks in the walls had no grout in either cell. Since the Arquin wall had nine courses of block as a result of using a half height block as the first course, the top course was also a half height block. The center block of the top course of the Arquin wall had no grout in either cell. This made the block more susceptible to being broken free from the blast pressure, in contrast to the top center blocks in the traditional wall, which had grout in at least one cell of either block. The difference in block configuration and block damage can be seen in Figure 13. An additional measure of damage was the permanent horizontal displacement of the walls, at the center of the walls. In the first four blasts, no permanent displacement was measured from the vertical. The fifth blast had two cylindrical charges located 13.5 feet from either wall, with both charges larger than the charges used in the fourth blast and with a combined weight at the maximum allowed for the permit.

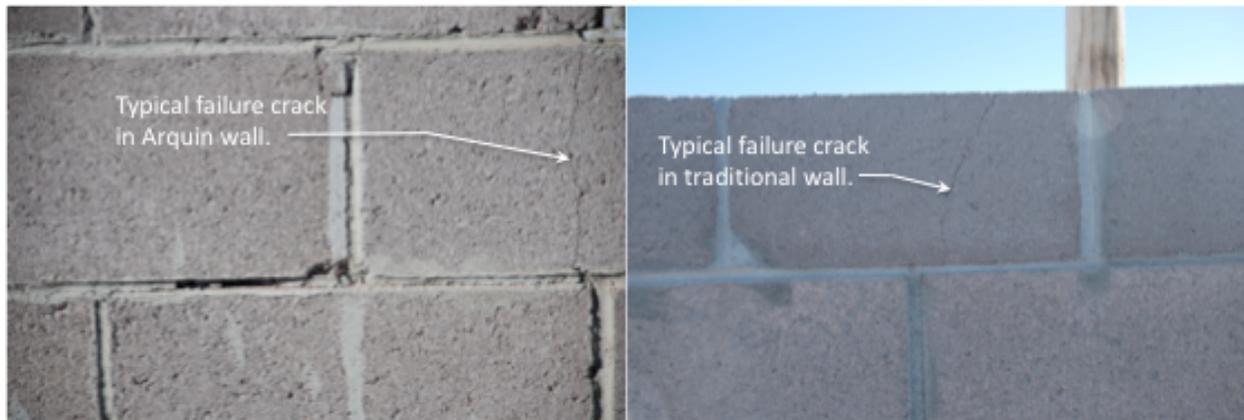
**Figure 14.** Images of typical through block cracks following the fifth blast. The image on the left is the Arquin wall and the image on the right is the traditional wall.

Figure 10 shows the pressure profile on the walls resulting from this blast. Damage on both walls was more extensive than evidenced in any previous blast with more and larger cracks in the mortar and some visible displacement of the block. Figure 14 shows images of the typical through block damage evidenced in both walls.
