# SANDIA REPORT

SAND2012-8110

## EFFECTS OF DEFECTS IN COMPOSITE WIND TURBINE BLADES: ROUND 1

Jared W. Nelson, Trey W. Riddle, and Douglas S. Cairns (Principal Investigator)  
Department of Mechanical & Industrial Engineering  
Montana State University, Bozeman, MT

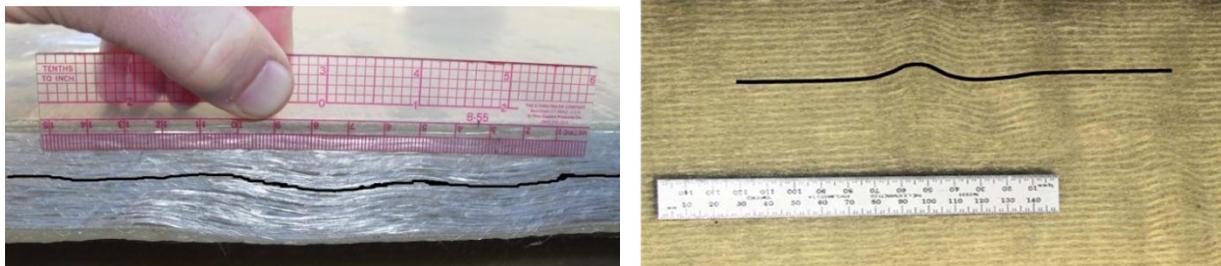
**Figure 1: Image of OP wave (left) and IP wave (right).**

into Image J, an open source image processing software package typically used in the medical imaging field. In this environment the photos were converted to 8-bit color, and then the wave features were manually traced with a black line (Figure 1).

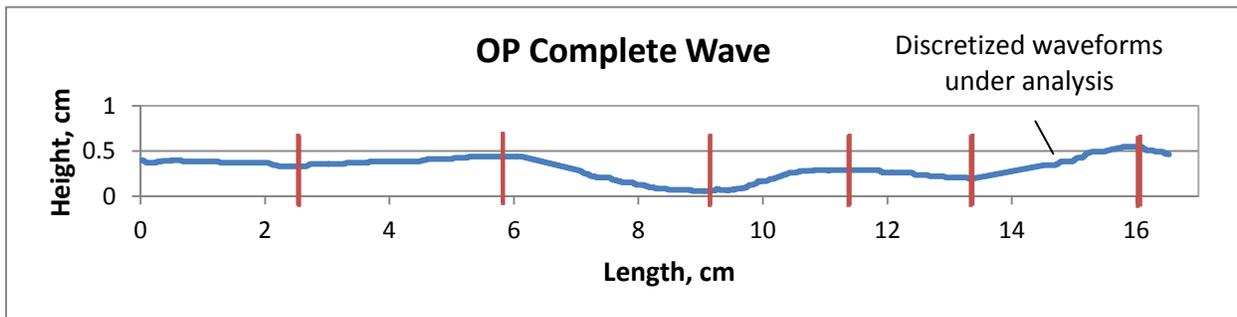
**Figure 2: Example OP Wave. Complete spatial data and discretization positions.**

The incorporation of the measurement device into the photo made it possible to develop a pixel based dimensioning system. This was the extent of the image processing necessary for the adhesive bondlines. Waveform flow images required more processing. Colors in an 8-bit space are represented with a number from 0 (black) to 255 (white), enabling the application of mathematical operations to remove unwanted colors. Manipulating the color depth of each pixel allowed for the removal of the background, leaving only the feature tracing line. This image was then exported as a binary bitmap. A separate processing script was written in Matlab to extract the spatial coordinate data. From this data, each complete wave form was discretized into separate individual waveforms. One example of a complete wave and the waveform discretization process is shown in Figure 2.

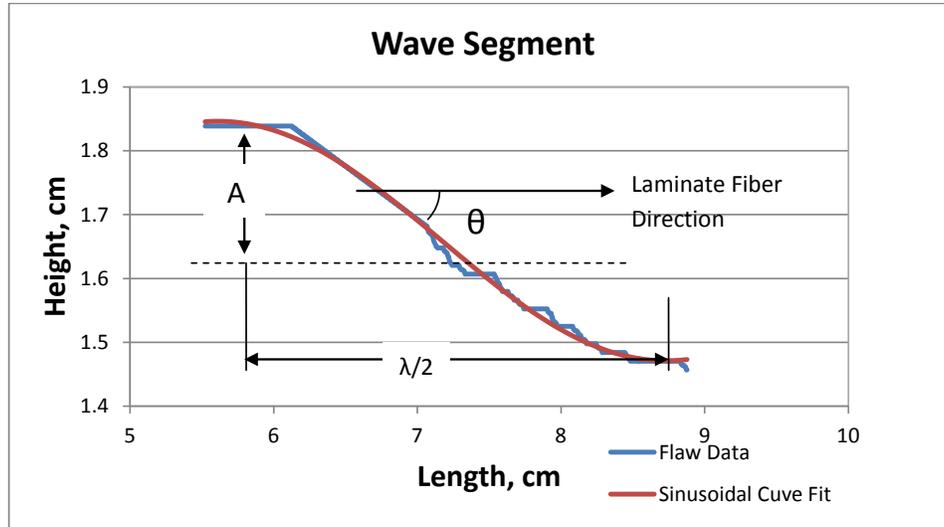
**Figure 3: Example of sine wave fit, where  $A$  is the wave amplitude,  $\lambda$  is the wavelength and  $\theta$  is the off-axis fiber angle.**

Each discretized wave form's geometry was then mathematically characterized. Cubic splines and sinusoidal curve fits were both evaluated for applicability. Both techniques yielded similar goodness-of-fit tendencies. The sinusoidal analysis proved to be faster and was therefore chosen for utilization on the bulk data analysis. Once a fit was performed each wave was characterized in terms of wavelength, amplitude and off-axis fiber angle Figure 3. While, some previous studies have used aspect ratio instead of fiber angle as metric for characterization, such quantification may be slightly more challenging in the field. Aspect ratio requires knowing both the amplitude and wavelength whereas the fiber angle can be measure directly.<sup>6,7</sup>

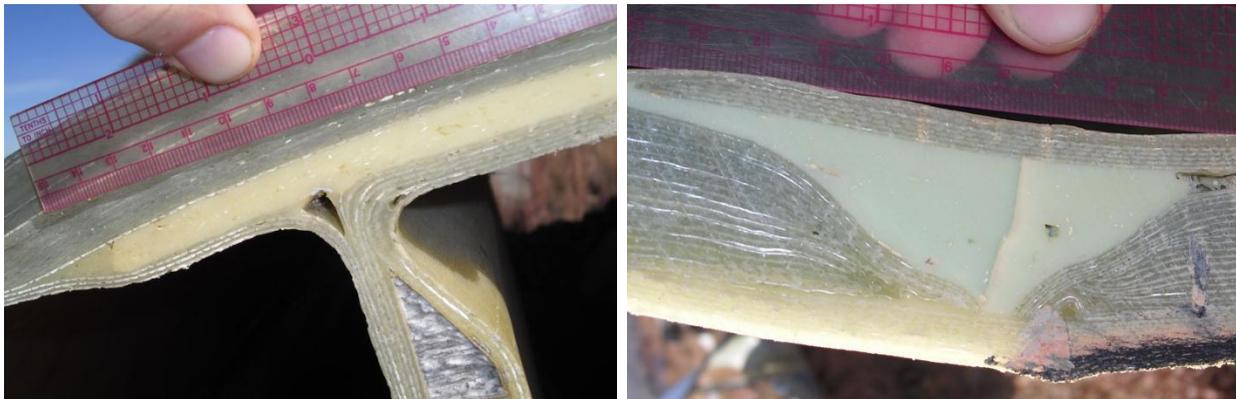
**Figure 4: Spar to shear web adhesive bondline (left) and adhesive mold-line (right).**

In both cases voids were found to be extremely prevalent, nearly ubiquitous. The general shape of voids tended to be elliptical. Moreover every image showed some porosity content as well. Bonding of the spar cap and shear web to the blade skin appeared fairly straight forward. Mold lines on the contrary exhibited a variety of negative manufacturing attributes. All mold line cases showed voids, some porosity, ply drops and in many cases extreme OP waves. Another artifact of the mold joining process was the use of laminate patches on either side of the joint for reinforcement.

After reviewing the same group of images for adhesive bondlines it has been inferred that there are two distinct cases where adhesives are used in wind turbine blades. For the purposes of this reporting, the two cases will be referred to as “Spar”, where adhesives are used to bond the spar cap or shear web to the skin of the blade and “Mold Line” where adhesives are used to bond the two molded halves of the blade skin together. Representative images of the two cases are shown below in Figure 4.

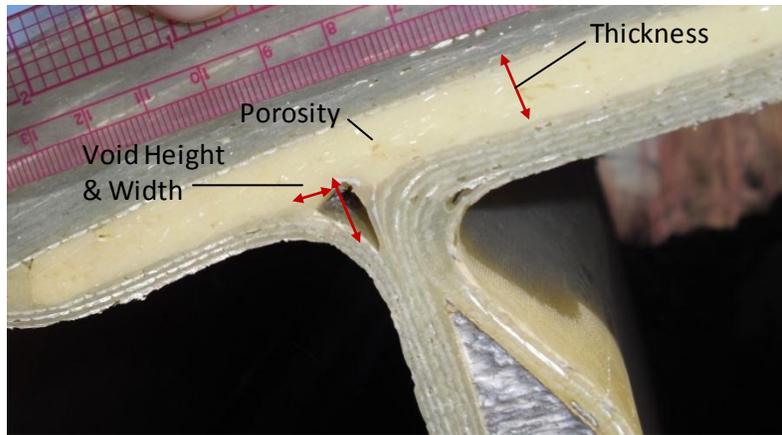
**Figure 5: Spar case characterizing geometry.**

In addition to identifying the function or type of adhesive application it is also necessary to define characterizing geometry such that an application can be quantitatively analyzed. Defining characteristics Figure 5 of the Spar case include; adhesive thickness, void dimensions and percent porosity.

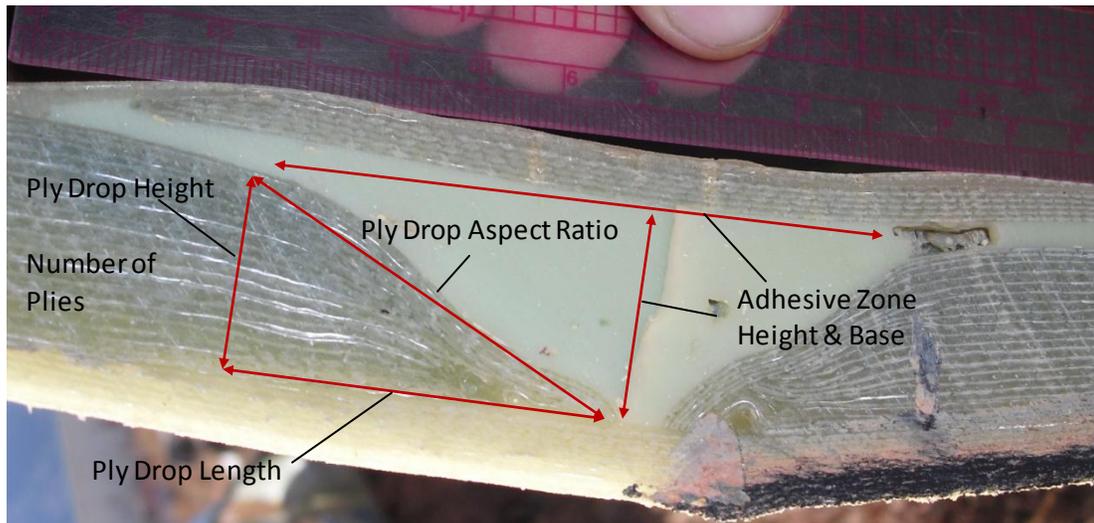
**Figure 6: Mold line characterizing geometry.**

Defining characteristics of the Mold Line Figure 6 case include; adhesive height & base, void dimensions (same as Spar), number of plies, ply drop height, ply drop length, ply drop aspect ratio. Based on the images collected, the porosity level proved difficult to obtain.

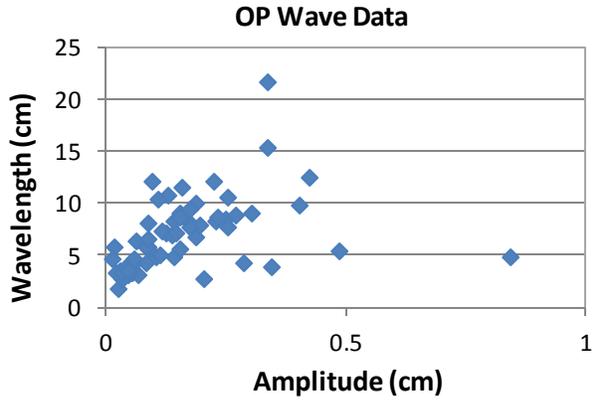
Figure 7: Collected OP wave data.

Characterization of the various wave flaws found in the field data yielded 63 OP and 48 IP independent, discrete waveforms. Values for amplitude and wavelength of each instance are shown in Figure 7 and Figure 8. Here it can be seen that there is significant variation within the data. However, the data are well grouped indicating some consistency in the manufacturing processes. Of interest for this work are the outliers and statistical anomalies. The results of calculated off-axis fiber angles for OP waves and IP waves are shown in Figure 9 and Figure 10. Specific attention should be paid to the outlying group of angles highlighted by the red circle in Figure 9. Of particular note is that these angles were collected from blade sections which failed at these out-of-plane flaw locations.

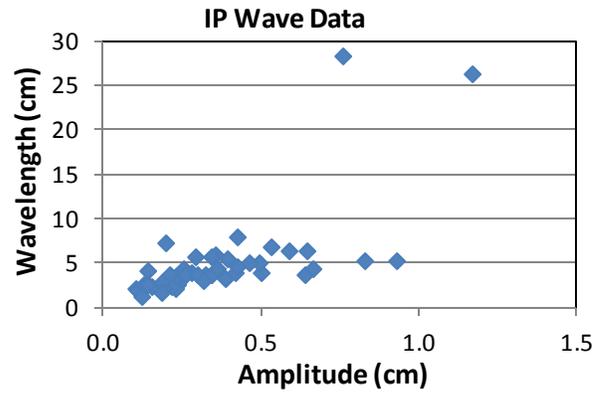
Figure 8: Collected IP wave data.

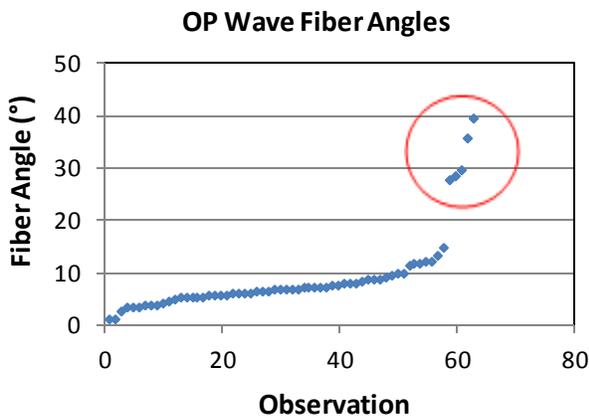
Figure 9: OP wave off-axis fiber angles.

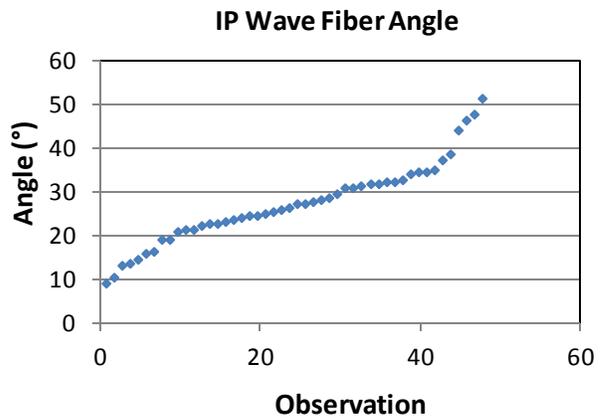
Figure 10: IP wave off-axis fiber angles.

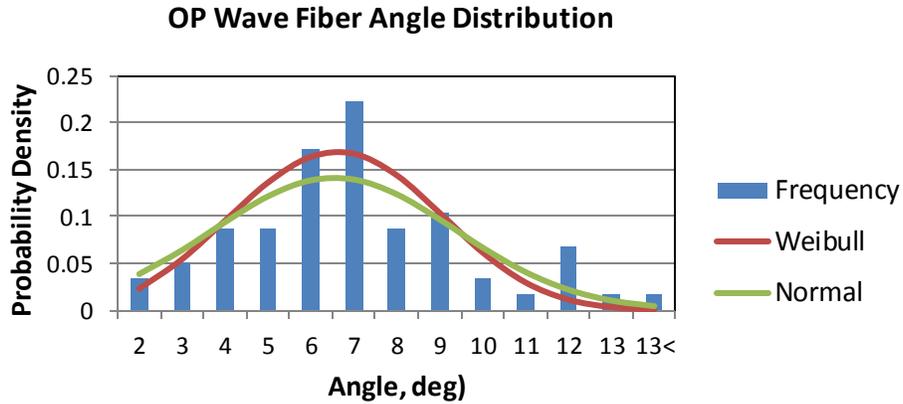
Figure 11: OP fiber angle distributions.

In order to develop frequency of occurrences distributions, fiber angle values were grouped together. For the case of OP waves, angles were binned in one degree increments. IP wave angles were grouped in four degree increments. Binning of OP wave fiber angle values shows a strong inclination towards common distributions such as the Weibull and Normal distributions. This can be seen in Figure 11 where the observed frequency of occurrence is displayed with the distribution curves. It is interesting to note the IP wave fiber angle data did not follow such trends (Figure 12). This is most likely the result of a lack of source data for the IP waves.

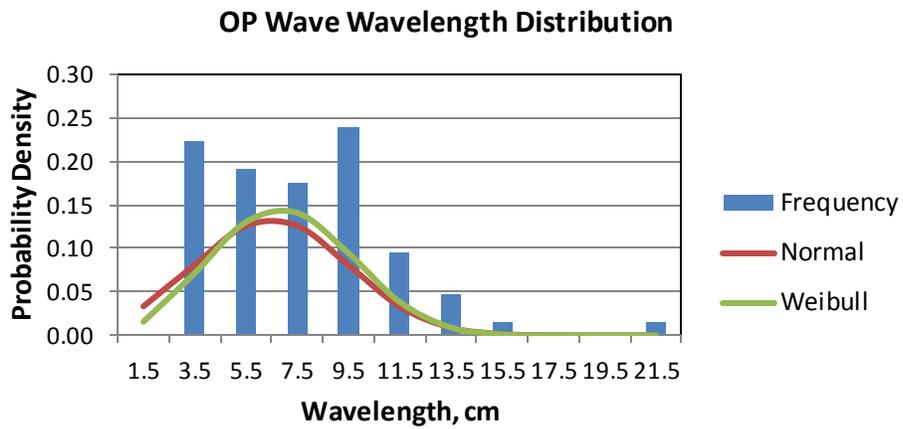
Figure 12: OP wavelength distributions.

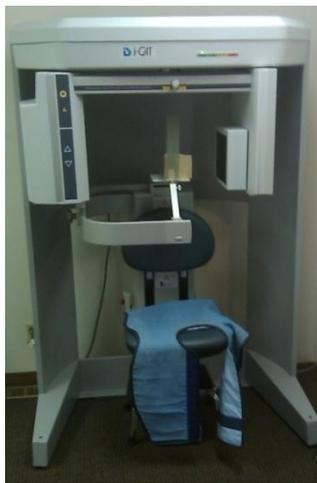
Figure 13: CT scanner.

Computed Tomography (CT) was found to provide the most amount of accurate information on flawed composites. Three dimensional renderings of specimen allow for precise measurement of the actual flaw geometry introduced into the coupons. A medical imaging CT scanner (Figure 13) was used successfully on randomly selected samples of the test specimen used in this investigation. It is of critical importance to have accurate measurements of the introduced flaws in developing analytical/empirical damage correlations.

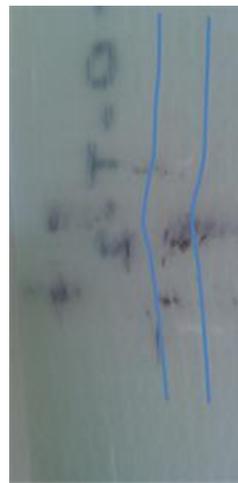
Figure 14: Coupon with IP wave highlighted.

Figure 14 shows an example of a coupon with a manufactured IP flaw. This wave can be measured on the surface but there is no guarantee that the subsurface layers contain a flaw with the same geometry. In this particular case, they did not. Figure 15 shows through thickness layer by layer radiographs which clearly indicate that there are two different wave forms within the four different laminate layers. The waves were easily measured with the software interface. The same process can be utilized to measure OP waves.

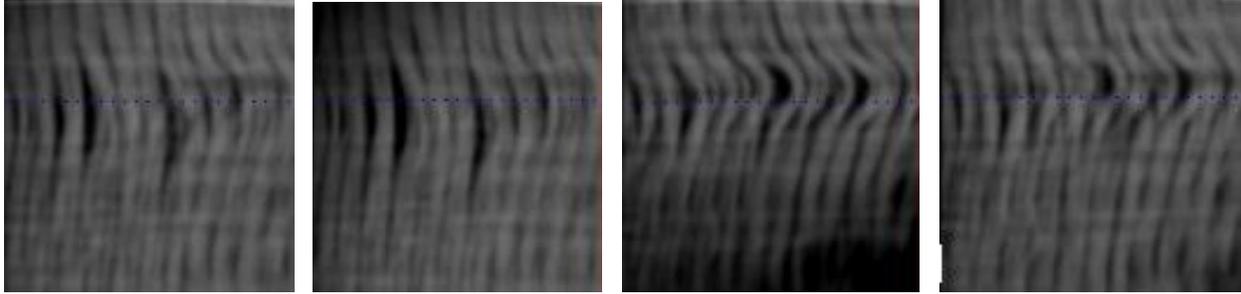
**Figure 15: IP wave layer-by-layer radiograph**

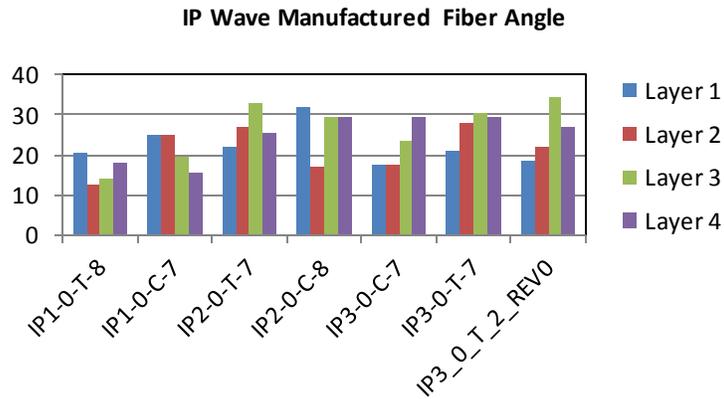
**Figure 16: Variations of fiber angle within and individual coupon**

The results from post processing of the non-tested coupons showed strong variations between the plies of each laminate. In order to rectify these discrepancies, a coupon is characterized by averaging the individual ply laminate values. When the characterized coupons are compared, strong variations exist between the coupons as well (Figure 16 and Figure 17). These results indicate that all test specimens should have their flaws characterized prior to testing for establishing benchmark effects of defects data.

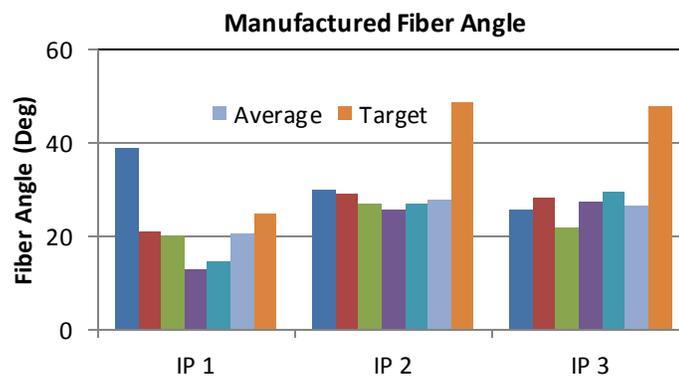
**Figure 17: Variation of fiber angle between coupons**

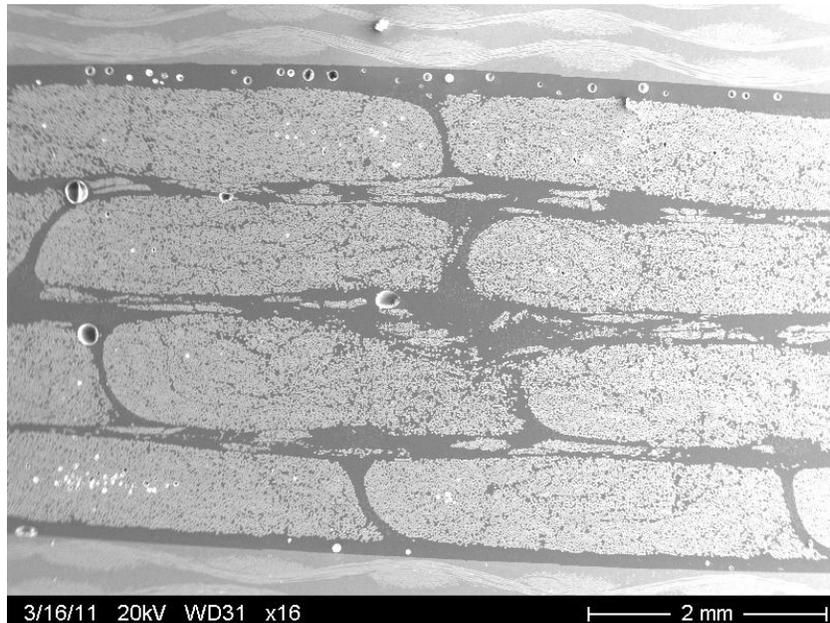
**Figure 18: SEM Image of a porosity test specimen.**

blades\*. Even at the laboratory scale, evaluation of porosity content is labor intensive and time consuming. The method employed by the MSUCG with the most success is microscopy. For this process specimen are cut into small pieces, mounted in acrylic resin and then polished. Depending on the size of the voids either an optical or Scanning Electron Microscope (SEM) is used to take digital images of the cut surface plane. Image processing techniques are then used to identify the location and size of gas inclusions. From this data a planar area fraction of porosity content is established. This value is then extrapolated to percent porosity by volume. An image taken by a scanning electron microscope on a specimen with induced porosity is shown in Figure 18.

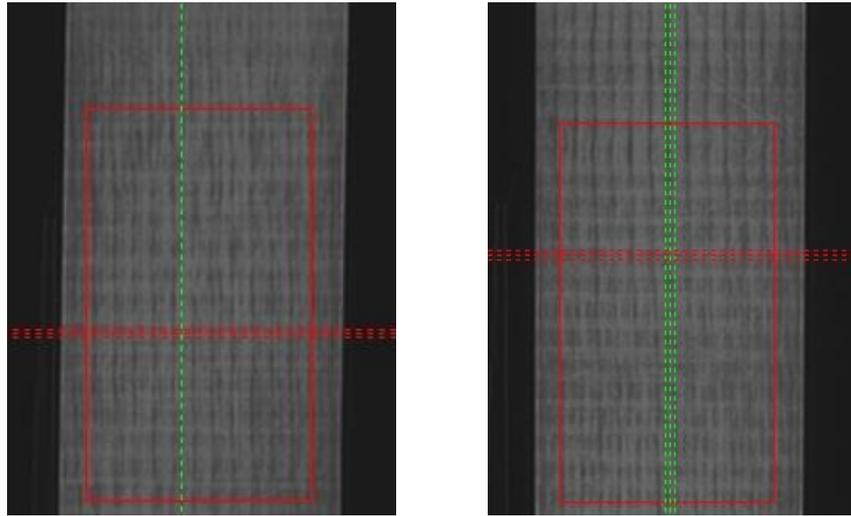
Figure 19: Radiographs of a porosity (left) and a control (right) specimen.

~1200HU. Initial results from microscopy estimate the porosity content for these test samples at ~1.8%. Further investigations need to be conducted to correlate the two results.

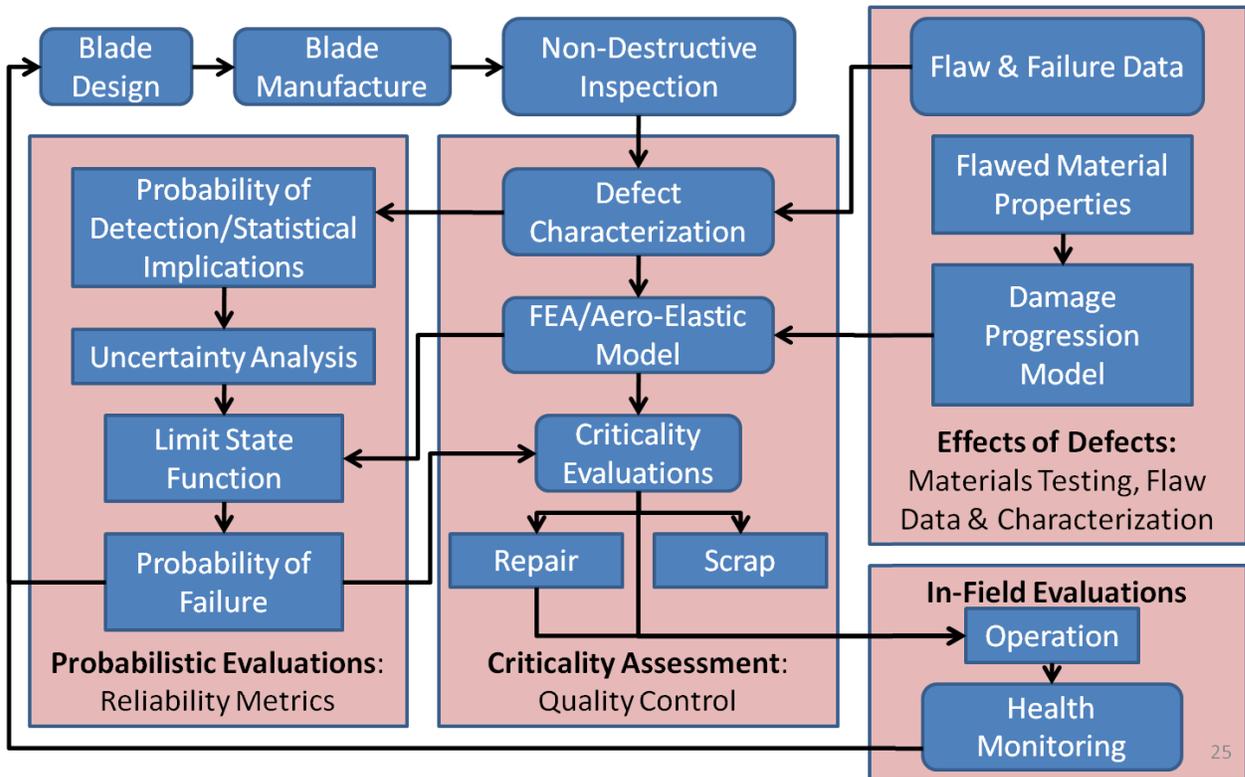
Figure 20: Framework for composite structure defect management and improved reliability

A framework for a defect risk management and composite structure reliability has been developed. A conceptual flow diagram of this protocol is shown in Figure 20. The protocol consists of four major areas:

- **Effects of Defects:** Flaw and failure data are collected in the field. Testing is performed on specimen with representative defects to generated mechanical properties of flawed laminates. A damage progression model is developed to assess the onset and evolution of damage.

- **Criticality Assessment:** Data from flawed, as-built structures are characterized to describe the defect. This information is fed to the probabilistic evaluation metric and a macro-structure aero-elastic model. Information is imported from the probabilistic model to the criticality analysis. Then the criticality of the defect can be evaluated and a decision is made to operate the structure as is, repair or scrap.

- **Probabilistic Evaluation:** With information on the as-built defect, statistics on flaw distributions and the probability of defect detection, an uncertainty analysis can be performed. From this analysis a limit state function which relates to the structure design criteria can be developed. Random variables are then applied and the probability of failure is discerned. This information is the delivered to the criticality analysis and design process.

- **In-Field Evaluation:** Once the structure has been placed in operation a health monitoring procedure should be implemented. Results from inspections as to the accuracy of the models previously described are then fed back into the design and evaluation procedures.

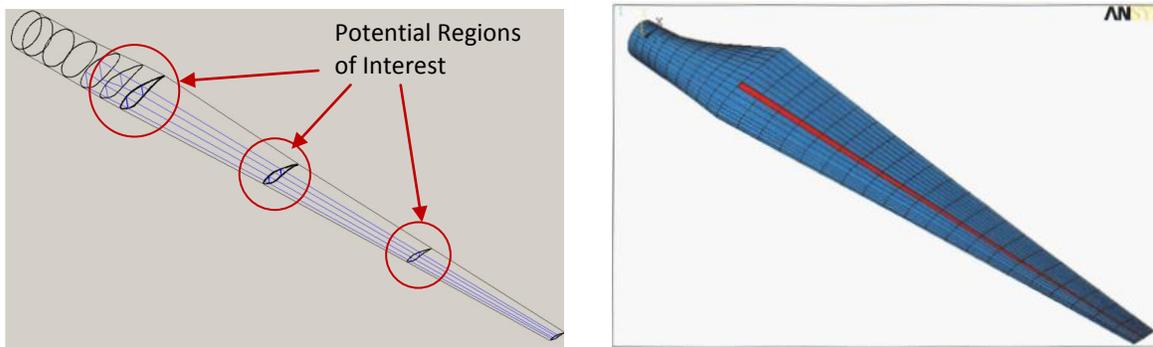
**Figure 21: Finite Element Analysis. Blade model building process in NuMAD (left) and a finalized meshed blade model in ANSYS (right)**

Data from experiments described in this paper are being analyzed to correlate the mechanical response of a flawed laminate to the individual geometric parameters. These results will then be used to build damage models which consider the constitutive response of a flawed composite material.<sup>5</sup> While these models will be largely micromechanical in nature, it is also necessary to consider macro and global effects. For this end, finite element analysis will be used. Analyses of interest include the response of a blade based on global flaw location, location of the flaw in the laminate schedule and the combined effects of multiple flaws. Results from numerical evaluations of specific as-built flawed structure instances will be included in the criticality assessment. One technique being developed presently to evaluate these effects has been to build a blade model in NuMAD (Numerical Manufacturing And Design), a preprocessor for ANSYS developed by SNL. The material properties of regions of interest can be modified to reflect the modified response of flaws from the test data. Examples of the NuMAD interface and a blade meshed in ANSYS are shown in Figure 21.

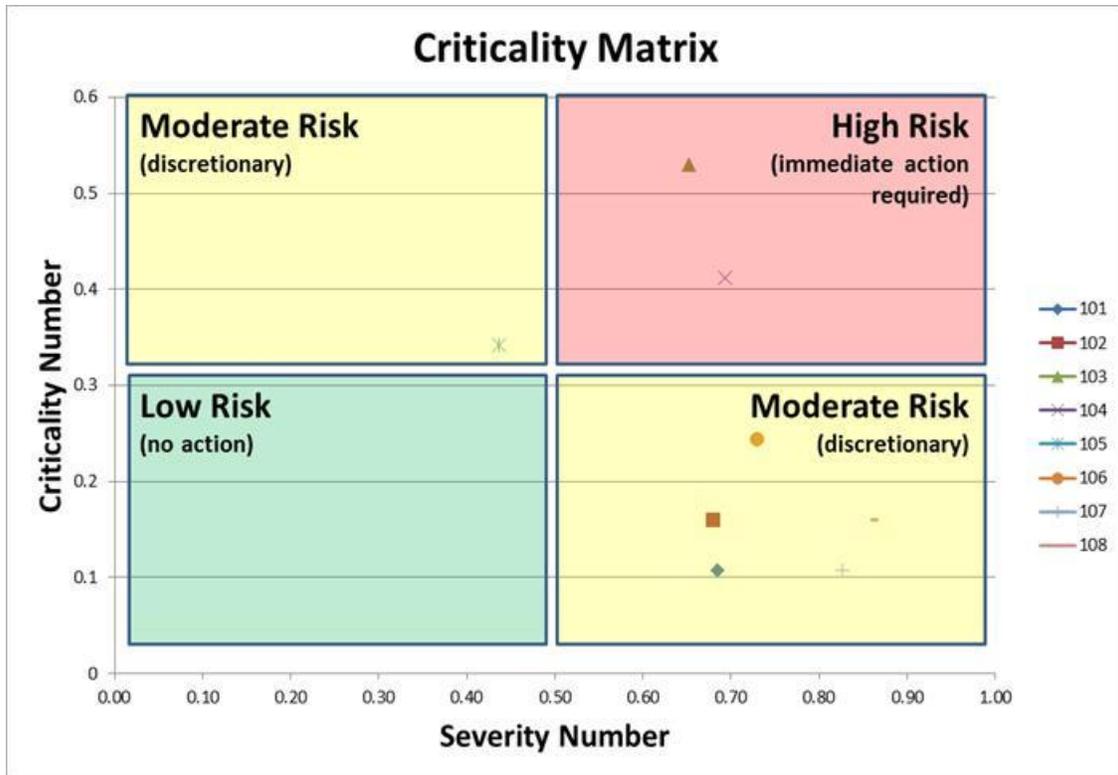
Figure 22: Graphical criticality matrix with defect examples.

An example of the current first revision criticality analysis has been performed on a random set of IP waveforms. Input parameter descriptions and mechanical strength correlations can be found in the Appendix. Figure 22 shows the results of this analysis. This is a good example of how criticality and severity are mapped and quadrants are established describing the risk of a specific flawed structure. At present the risk quadrants are place holders. Further analysis and input from manufactures will help define the quadrant space. However, this approach provides a framework for capturing and quantifying manufacturing flaw data from a variety of sources. A tool like this can be employed at the manufactures floor, enabling a quantitative quality control protocol that describes the risk of field failure for a flawed blade. The decision can then be made as to whether or not a blade should be deployed as is, repaired or possibly scrapped altogether. A similar evaluation can be performed on site at the wind farm by installation or maintenance personnel. These investigations may include damage due to transportation or service, as well as manufacturing flaws.

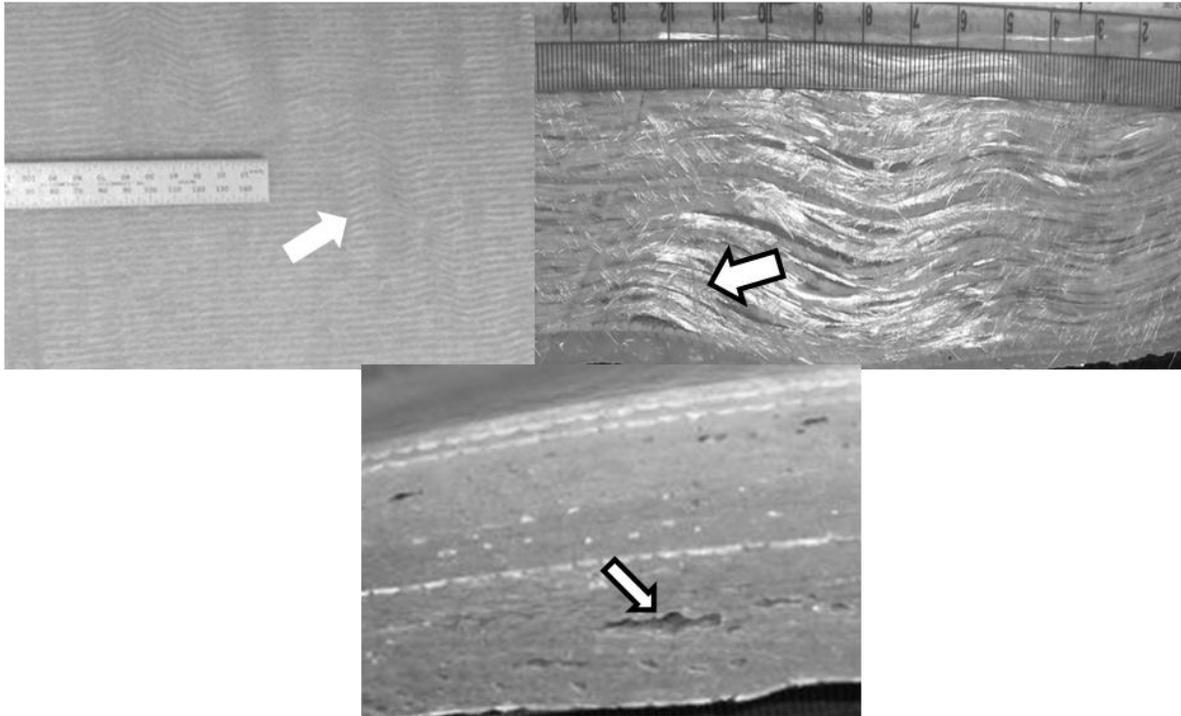
**Figure 23: IP waves seen on the surface (top-left), OP waves seen through the thickness (top-right), and Porosity/Voids seen within the laminate (bottom).**

Three composite material defect types (Figure 23) were investigated after being deemed critical to blade function and life cycle: IP and OP waviness, and porosity.<sup>20</sup> Extensive studies have reported on the testing of each of the defect types in relatively thin laminates utilizing varying advanced composite materials.<sup>22-34</sup> Much less research related to these and other structural details has been performed for wind turbine blade materials.<sup>33-37</sup> In addition, significant research has been performed modeling flawed composites utilizing different damage progression models.<sup>41-43</sup> It must be noted that much of this research has been performed for industries utilizing smaller scale manufacturing where expense is less critical. Most of this prior research offers a preliminary basis for this work, but it is known that acceptable defects often included in wind turbine blades far exceed what would be acceptable in other industries, such as aerospace. Thus, research specific to understand and model the criticality of defects common to blades is necessary.

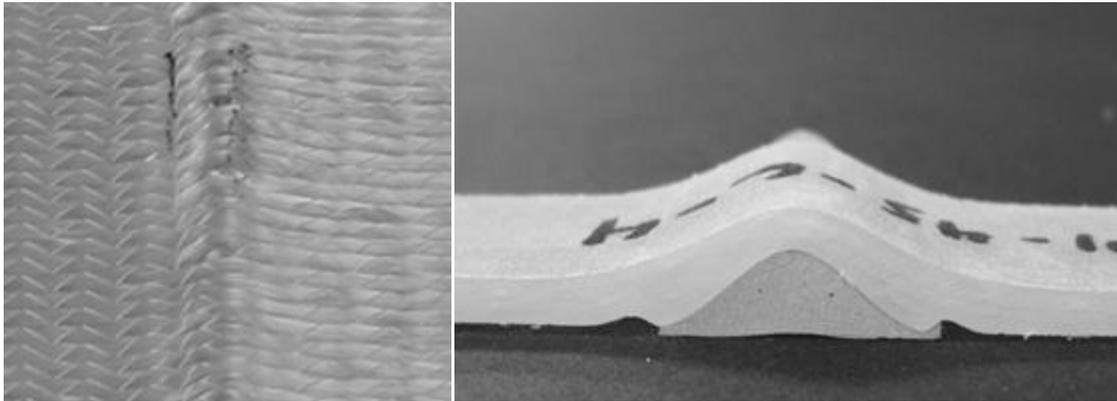
**Figure 24: IP waves imparted into a layer in a 0° laminate (left) and an OP wave form used to impart necessary wave into a 0° laminate (right).**

Test coupons were cut from the panels for use in tension and compression testing. Tensile coupons were cut to approximately 50 mm wide by 200 mm long and were tabbed resulting in a gage length of 100 mm. Compression coupons were cut to approximately 25 mm wide by 150 mm with an anticipated gage length of 25 or 38 mm where the wavelengths were greater than 25 mm.

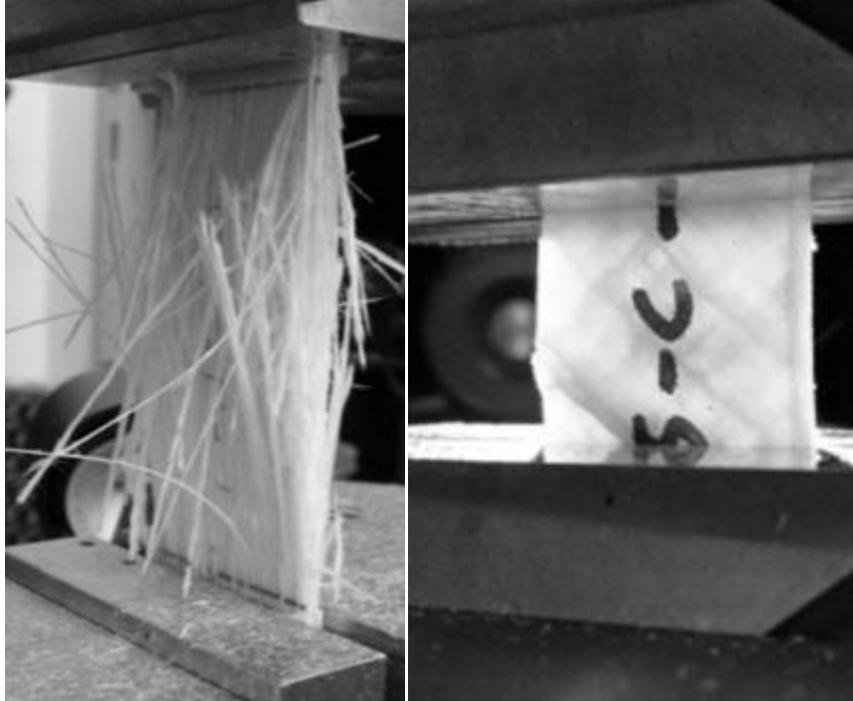
Figure 25: Representative 0° tensile (left) and ±45° compressive (right) samples being tested.

The control and porosity samples were symmetrical, while each of the wave samples were not. Test methodology was considered when determining lay-up and coupon dimensions. Coupons were constructed with representative of blade materials and construction processes though scale was reduced. Scaling was required to achieve compatibility with the Instron 8802, 250 kN testing machine and grip capacity (Figure 25). Static ramp tests on the specimens were conducted at a rate of 0.05 and 0.45 mm/s for tension and compression, respectively. A total of approximately 135 coupons were tested with 2-5 in each test group. A digital image correlation system was utilized to measure and analyze the strain field of each specimen type. These displacement data were compared to the displacements recorded from the Instron's LVDT and were utilized where discrepancies were identified. Results of all experiments will be available in the DOE/MSU Composite Material Database.<sup>37</sup>

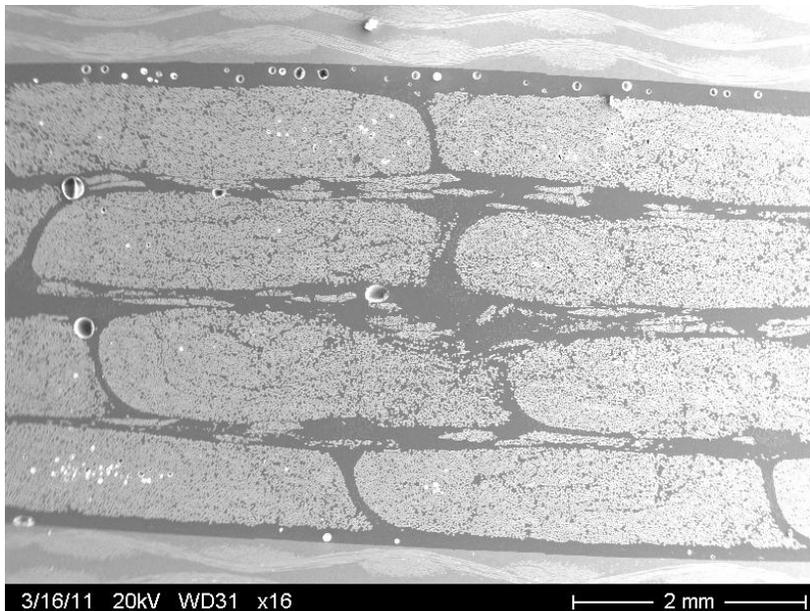
Figure 26: Scanning electron microscopy (SEM) image of porosity sample tested.

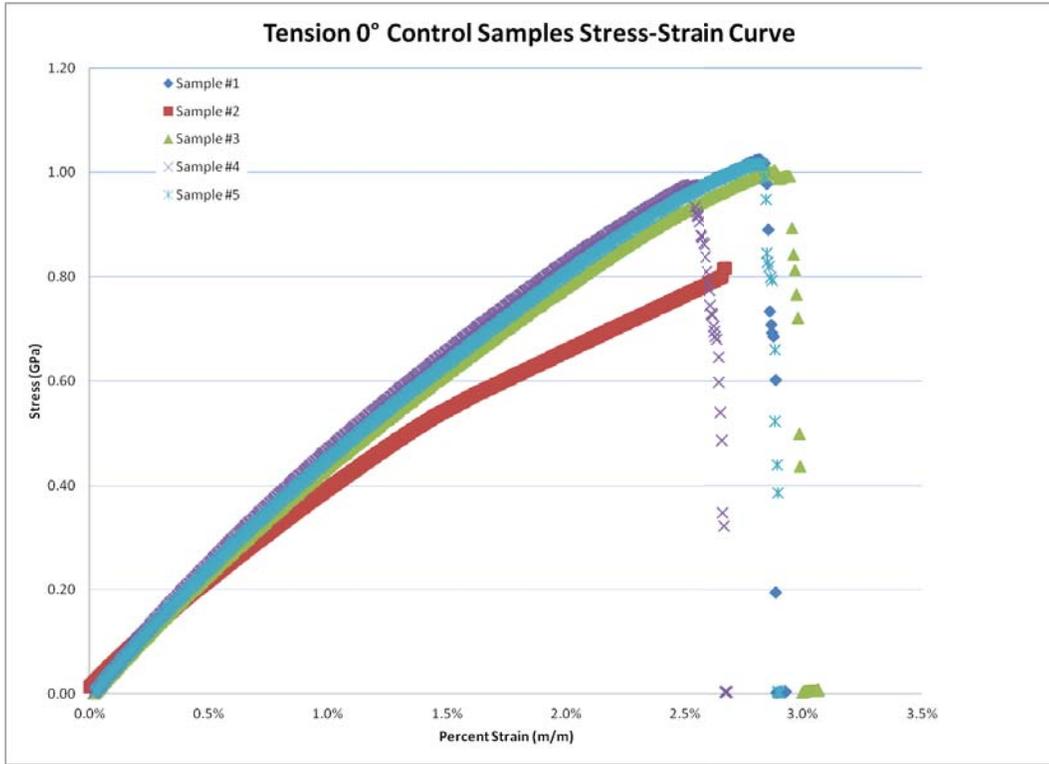
Figure 27: Stress-strain curve for 0° tensile control laminates.

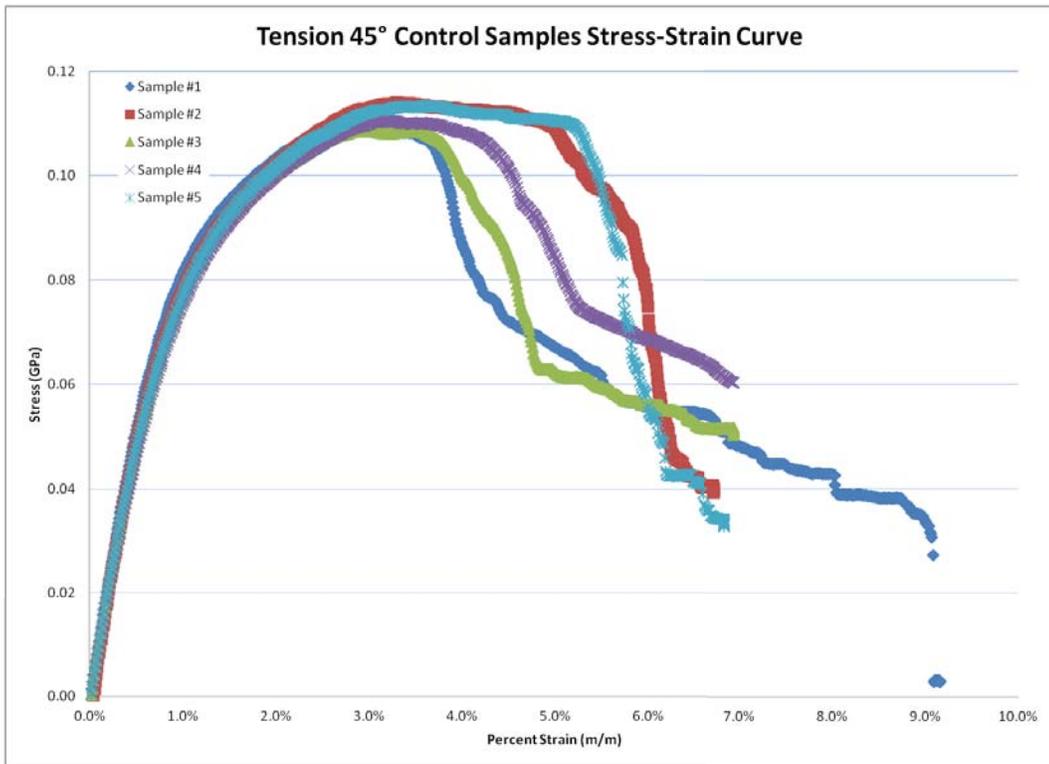
Figure 28: Stress-strain curve for ±45° tensile control laminates.

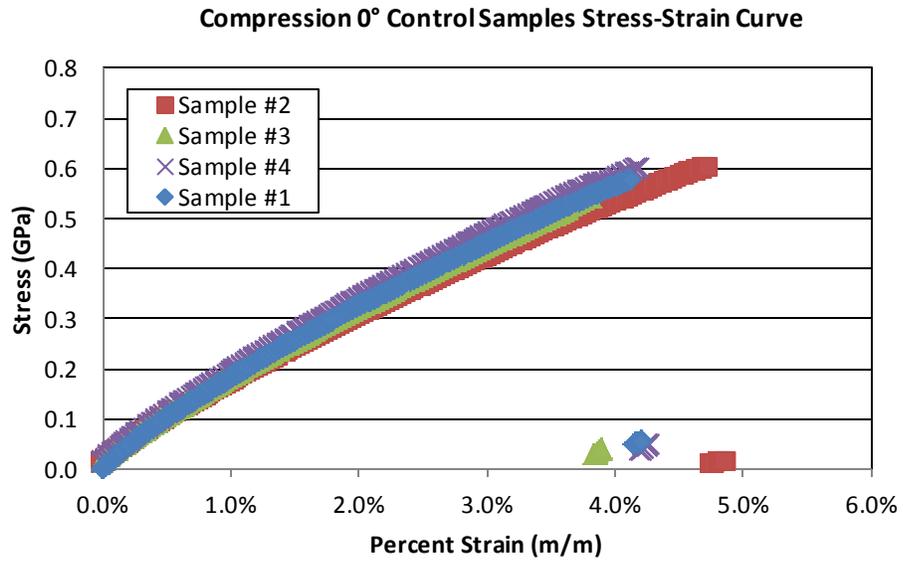
Figure 29: Stress-strain curve for 0° compressive control laminates.

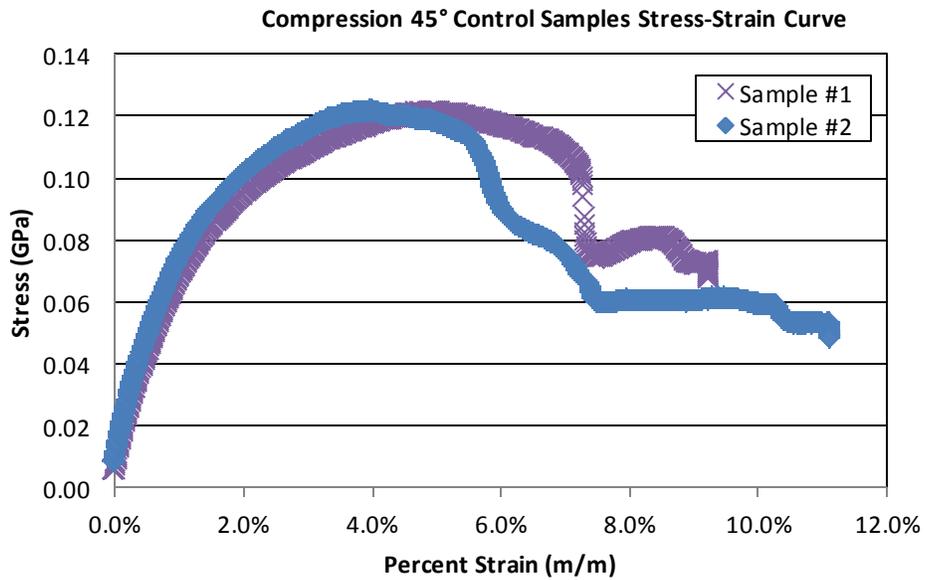
Figure 30: Stress-strain curve for 45° compressive control laminates.

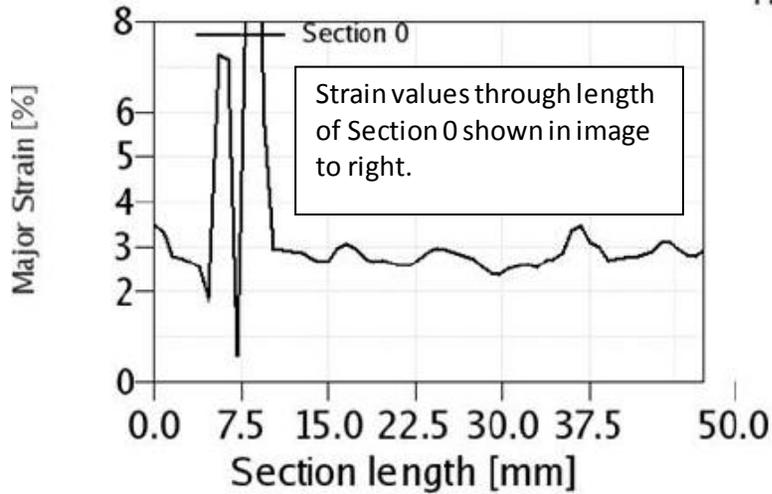
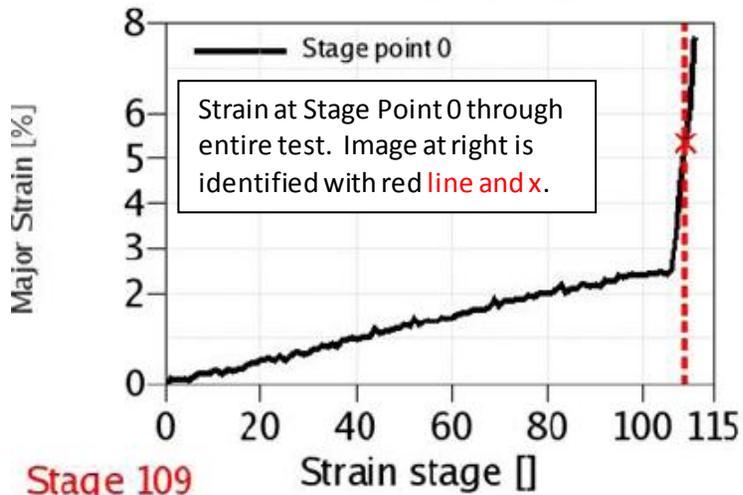
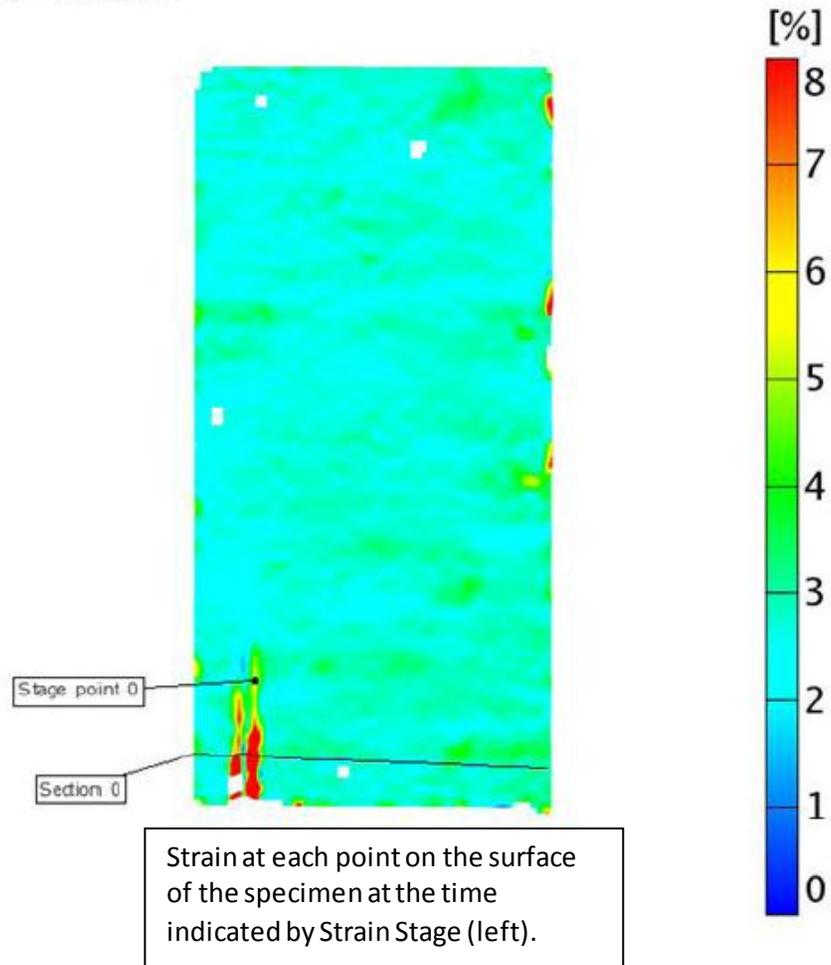
### 0° Control

Figure 31: Representative images near failure of 0° control laminate tested in tension from the digital image correlation system.

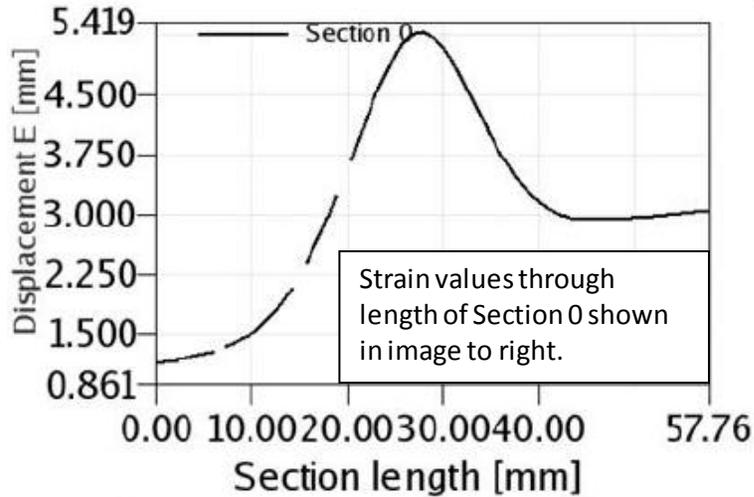
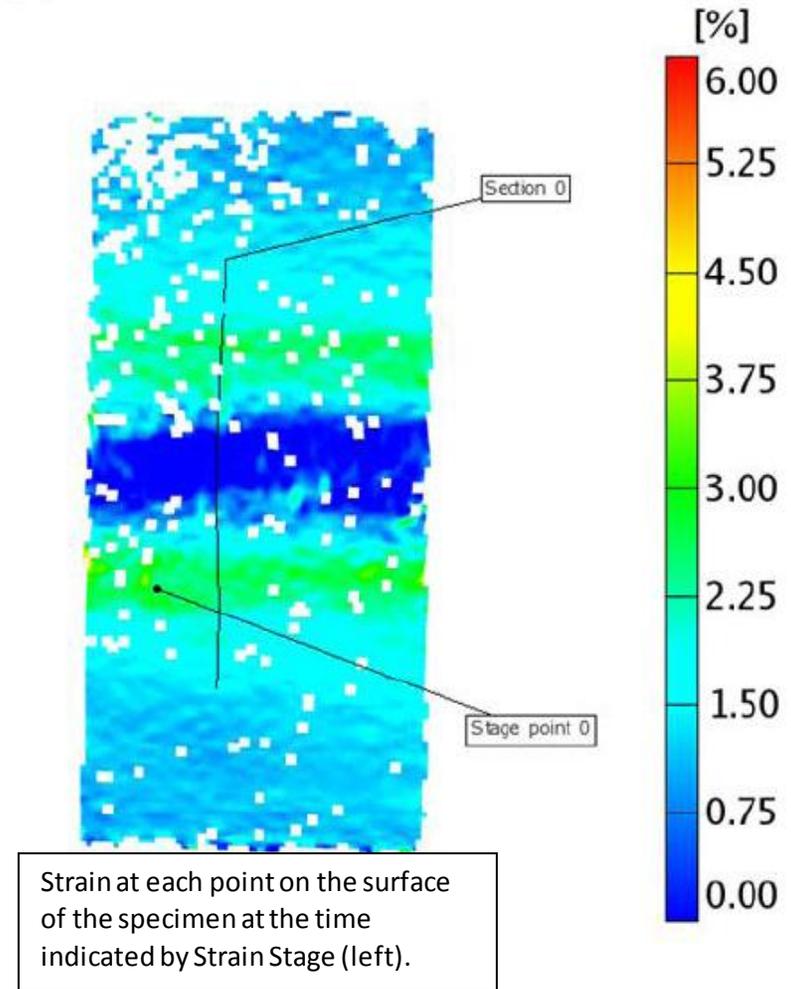
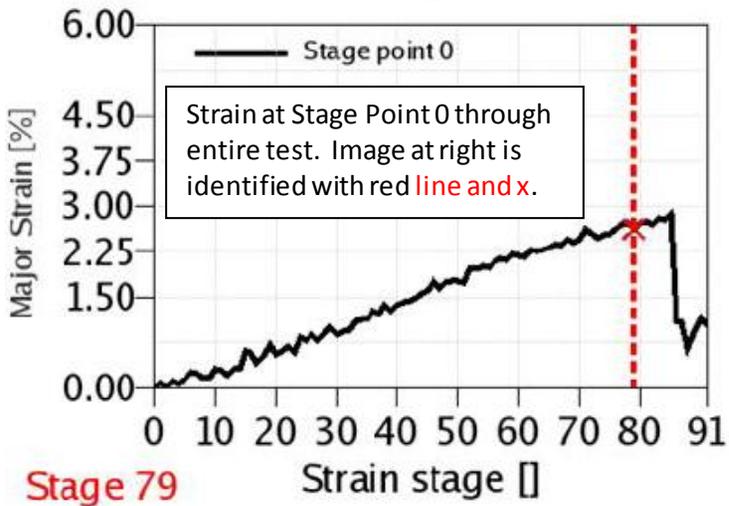
### 0° OP1 Wave

Figure 33: Representative images near failure of 0° OP1 wave laminate tested in tension from the digital image correlation system.
