# SANDIA REPORT

SAND2012-8110

## EFFECTS OF DEFECTS IN COMPOSITE WIND TURBINE BLADES: ROUND 1

Jared W. Nelson, Trey W. Riddle, and Douglas S. Cairns (Principal Investigator)  
Department of Mechanical & Industrial Engineering  
Montana State University, Bozeman, MT

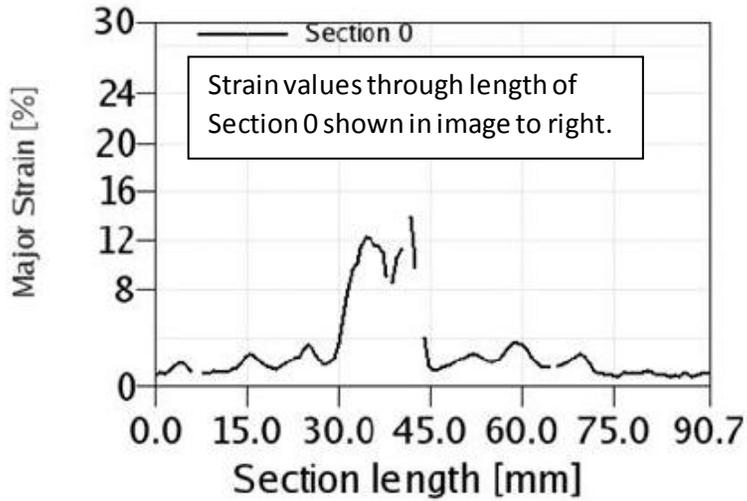
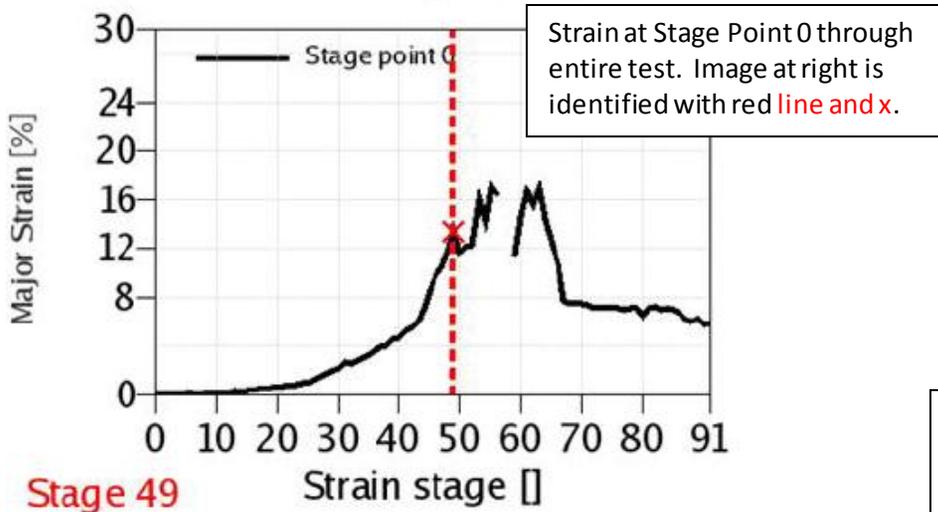
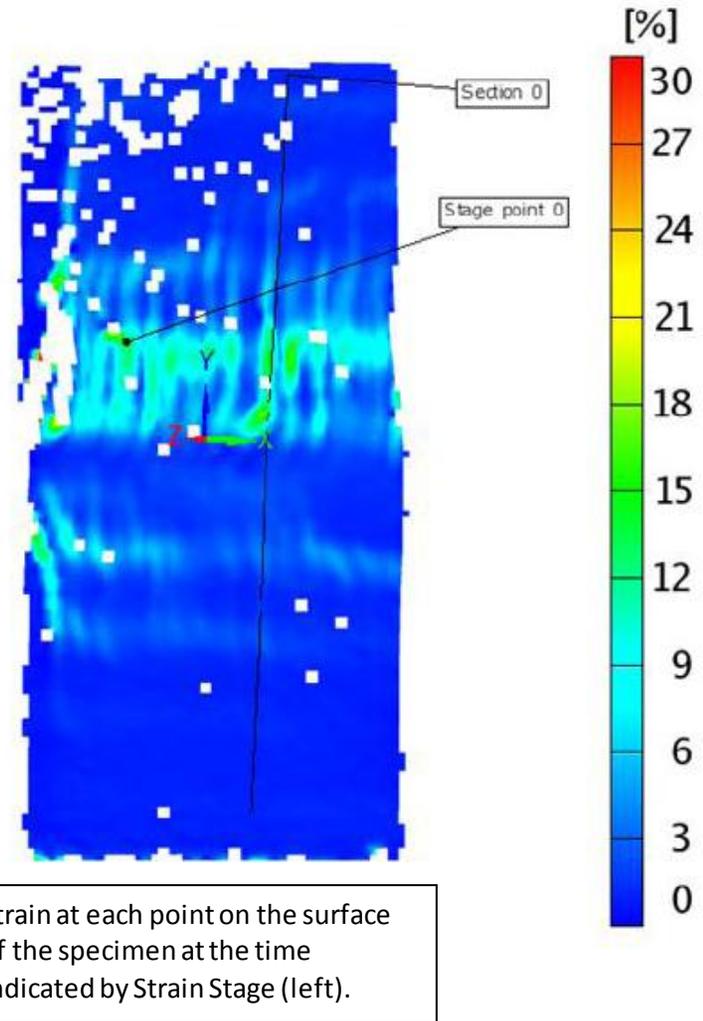
Figure 34: Representative images near failure of 0° IP1 wave laminate tested in tension from the digital image correlation system.

As these were the first modeling efforts of this research, several steps were taken to ensure proper details were being considered and check for convergence. First, damage was checked for and the damage progression for IP1 is shown in Figure 43 below. Note that stress accumulates rapidly in the peak of the wave and increases until fiber-matrix failure and then with each step the damaged area grows. This matches the damage progression noted visually (Figure 41) and with the DIC (Figure 34).

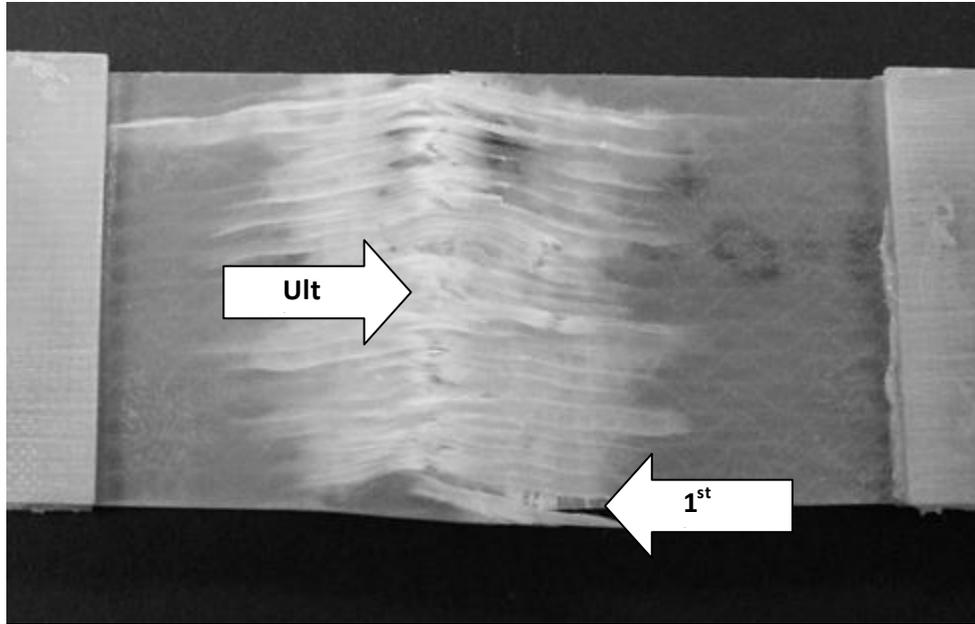
**Figure 35: Failed IP tensile specimen showing delamination and fiber failure.**

Test results for the IP wave groups are also noted in Table 6 and Table 7. Results from test observation and the digital image correlation suggest that each of the IP wave groups was noted to have similar damage progression. First failures were noted at low loading levels in areas where fibers were not continuous through the length of the sample. As strain levels increased, cracks initiated in the resin at the ends of the wave before delaminating and growing through the entire wave section resulting ultimately in fiber failure (Figure 35). These observations combined with the strains at failure indicate that damage accumulation was lower than the control group.

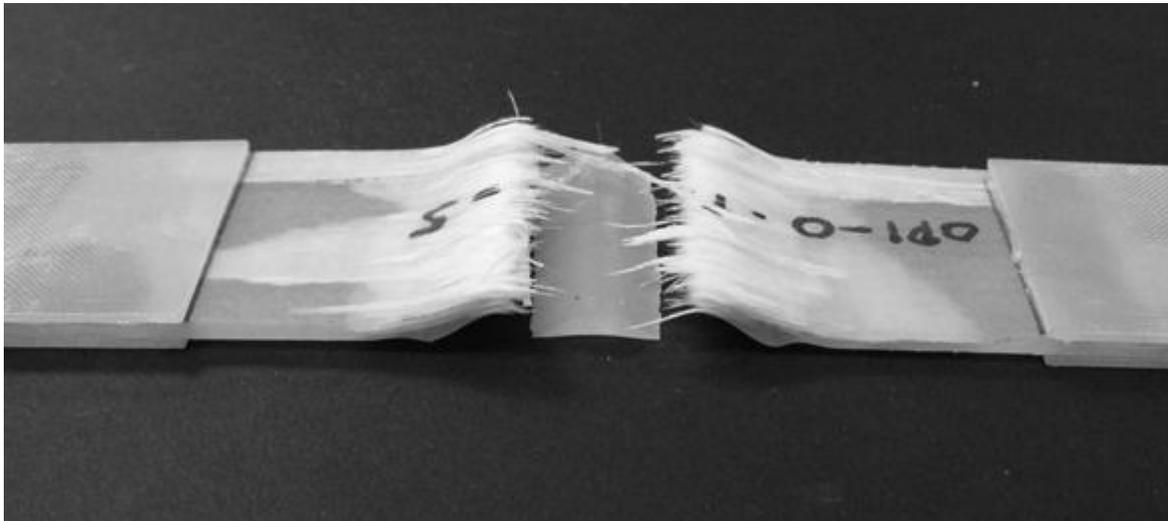
**Figure 36: Failed OP tensile specimen showing interlaminar delamination, fiber failure and delaminated resin wave form.**

Test results for the OP wave groups are also noted in Table 6 and Table 7. Results from test observation and the digital image correlation suggest that each of the OP wave groups was noted to have similar damage progression. Also similar to IP waves, as strain levels increased cracks initiated in the resin at the ends of the wave before delaminating. However, unlike the IP waves, after delamination the failure area for the OP wave specimens were concentrated at the peak area of the wave. This was due to the fibers being pulled straight and the center of bending being at the peak of the wave (Figure 36). It must be noted that the wave forms for all of the OP1 groups delaminated during testing. This resulted in an extreme decrease in the ultimate stress and modulus of elasticity results of the OP1 groups in both tension and compression. These results also suggest that partial delamination may have occurred in other groups.

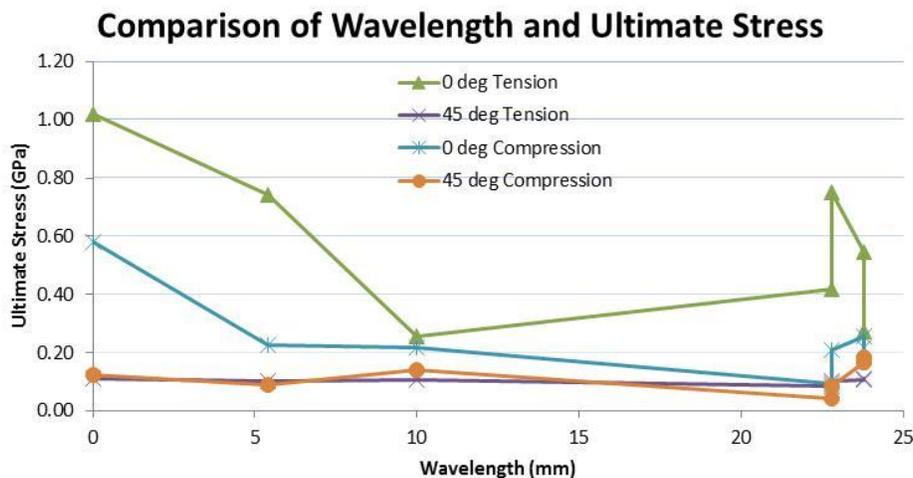
Figure 37: Comparison of wavelength and ultimate stress for each of the groups tested.

As might be expected from the results of the IP waves noted above, the ±45° groups with higher fiber angles increased in ultimate stress. It is very interesting to note that the ±45° tension groups had very little variation between any of the groups tested. This indicates that failure was the result of edge effects and the included defects did little to reduce ultimate stress. This is a further indicator that like the ±45° groups in compression, the ±45° groups in tension need no further analysis.

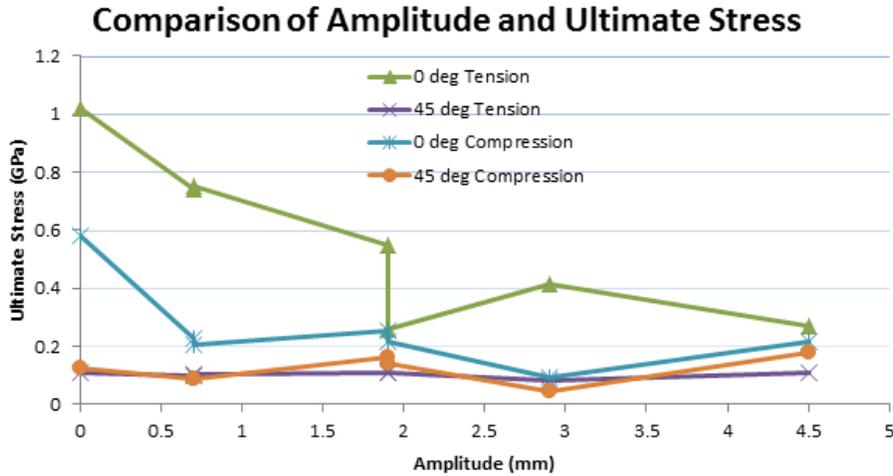
Figure 38: Comparison of amplitude and ultimate stress for each of the groups tested.

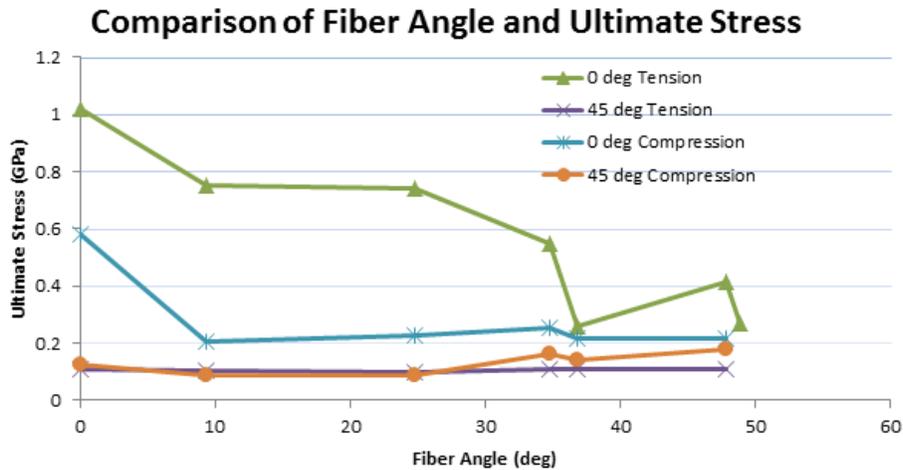
Figure 39: Comparison of fiber angle and ultimate stress for each of the groups tested.

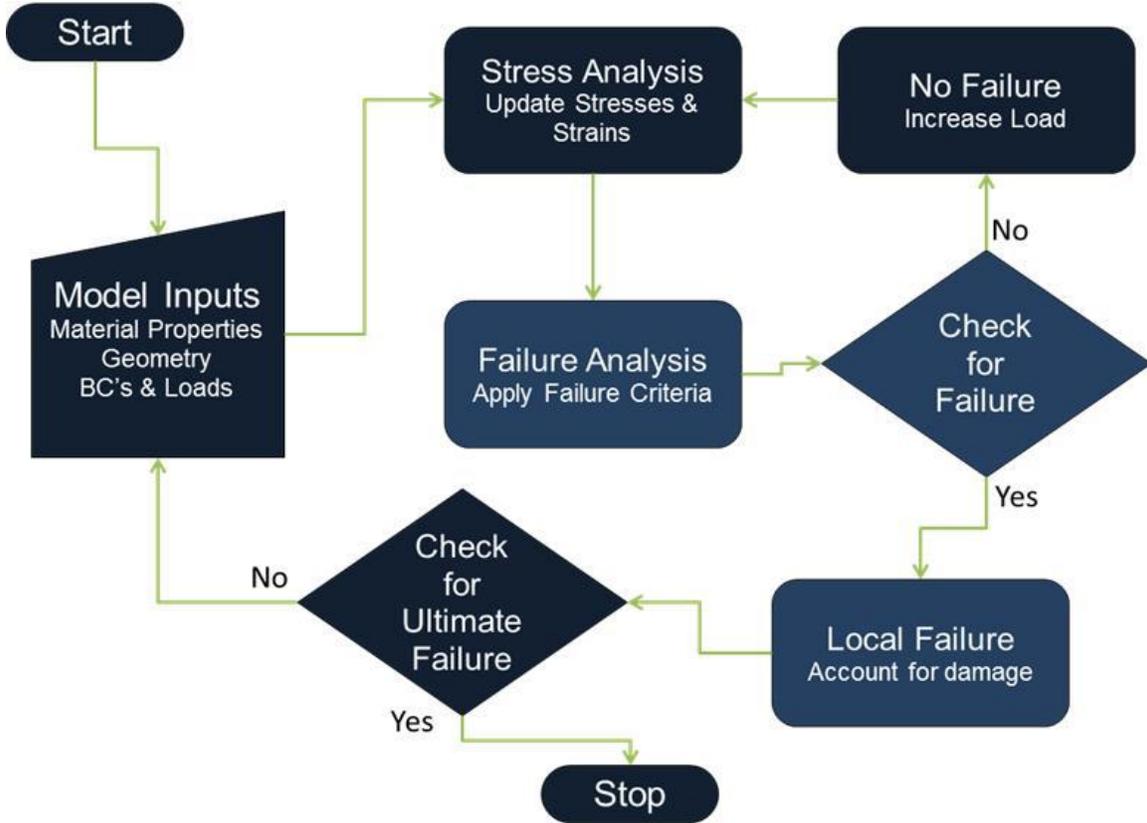
Figure 40: Decision tree for progressive damage modeling utilized in this round of modeling.

As noted, these results will be utilized for material properties and convergence points in building analytical models. Based on the research performed by Chang and Lessard, Abaqus has created a user subroutine to model damage progression for a circular hole within a composite laminate that achieves in good agreement.<sup>42,45</sup> Given that material properties degrade to zero upon reaching stress that induce a particular failure mode, this method is acceptable for comparison to this initial round of testing but is not applicable beyond this initial round. Efforts have been made to reach agreement utilizing this simplified modeling technique and will be traded for more robust methods in future rounds. This method modifies the nodal forces of an element of a composite material as damage accumulates and maps damage initiation and propagation when utilizing a micromechanics based failure criteria.<sup>43</sup>

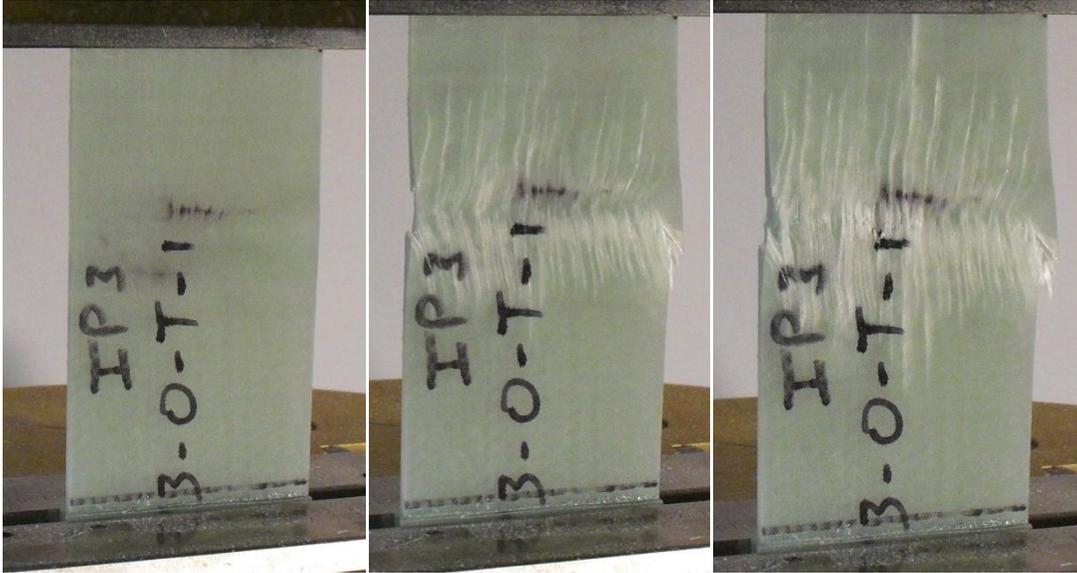
**Figure 41: Damage progression of IP Wave 1 with initial damage accumulating at the areas where fibers are not continuous through the length of the sample.**

In reviewing the test data, images and DIC data, it was apparent that initial damage occurred in each of the wave samples at low loading levels on the ends of the samples where fibers ended on the sample edge (Figure 41). Due to the wave pattern introduced, when the samples were cut fibers through the wave were cut resulting in discontinuous fibers along the sample length. Based on this observation, it was assumed that these portions of the laminate were not of interest when considering the goal of isolating defects in this initial round. Thus, the geometry shown in Figure 42 was utilized for all of the IP1 modeling efforts herein while similar models with differing geometries were utilized for the Control and IP1\_ACTUAL.

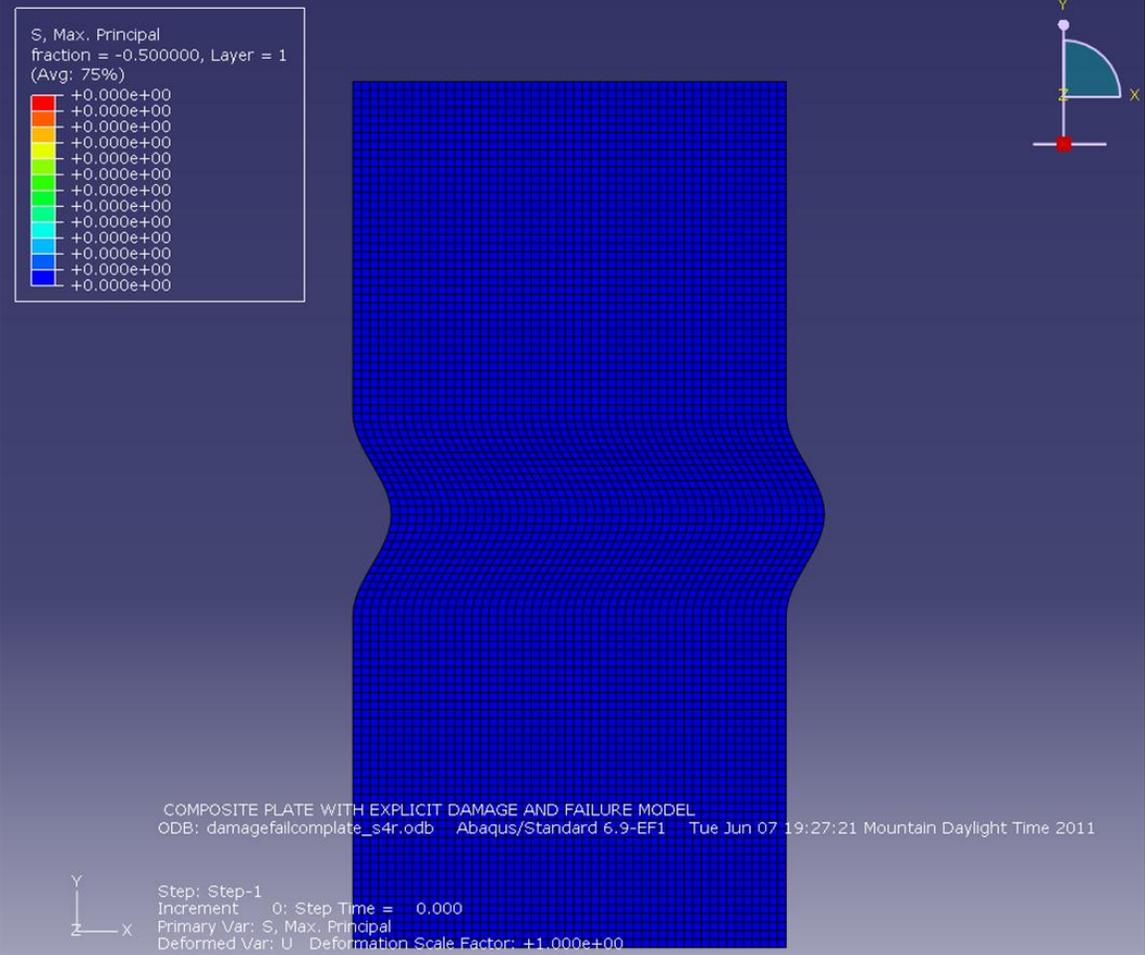
**Figure 42: Meshed IP Wave 1 as model in Abaqus.**

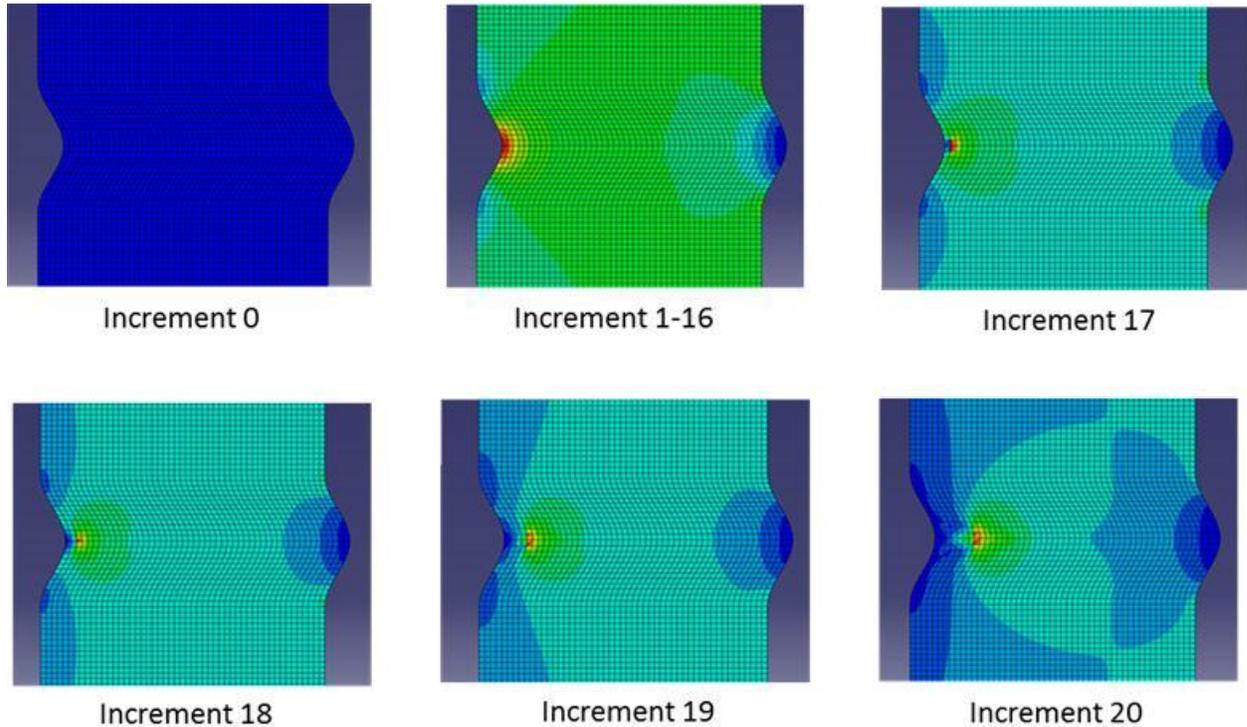
**Figure 43: Modeled damage progression through time in a laminate with IP1.**

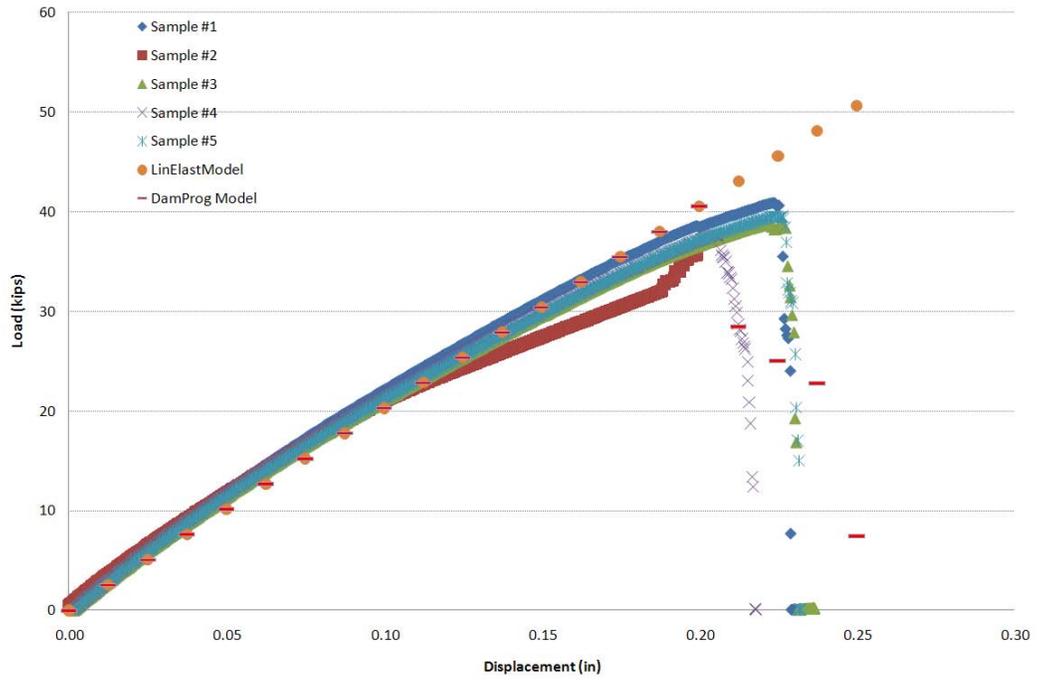
Figure 44: Comparison of 0° tension Control specimen results of load-displacement curves from physical testing and modeling.

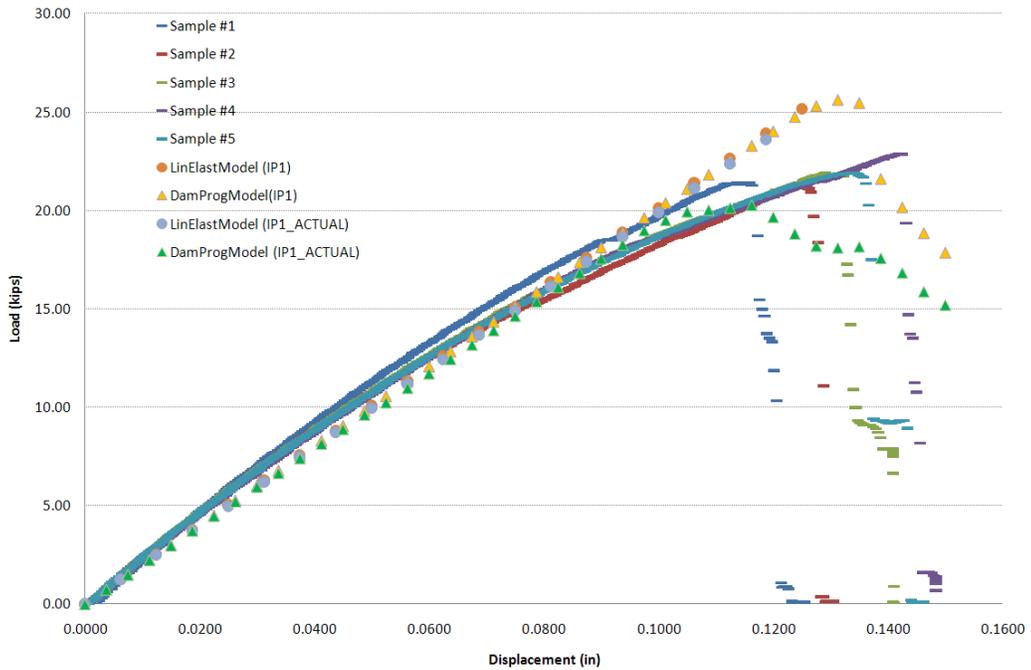
Figure 45: Comparison of 0° tension IP1 specimen results of load-displacement curves from physical testing and modeling.

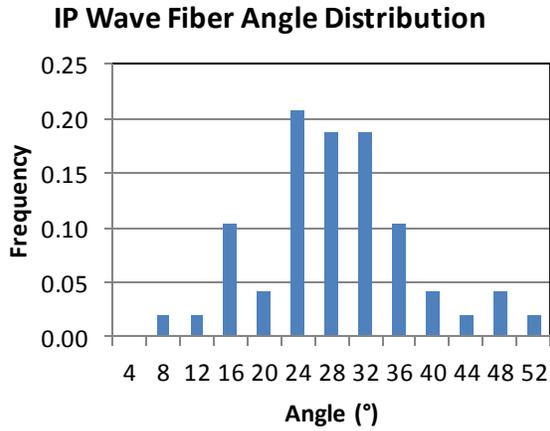
Figure 46: IP fiber angle distribution.

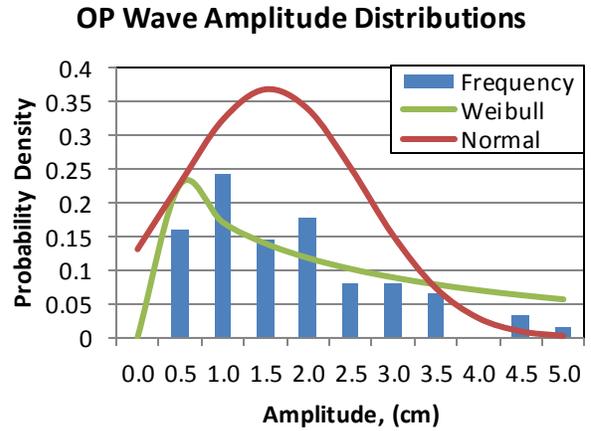
Figure 47: OP amplitude distributions.

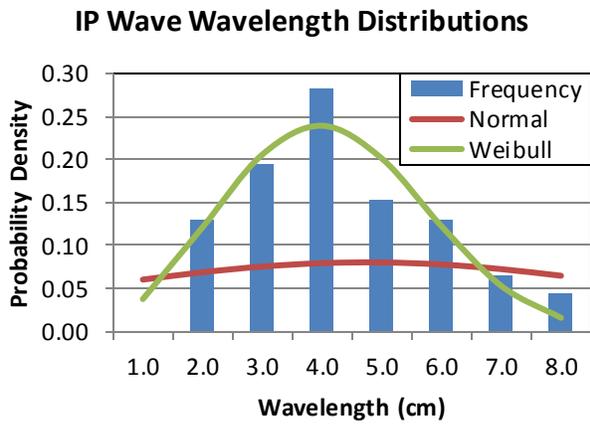
Figure 48: IP wave wavelength distributions.

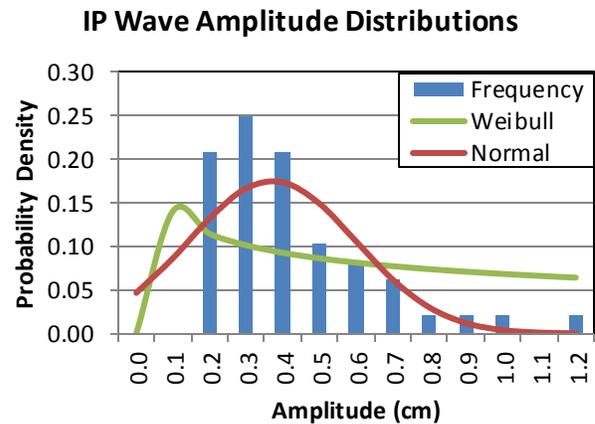
Figure 49: IP amplitude distributions.

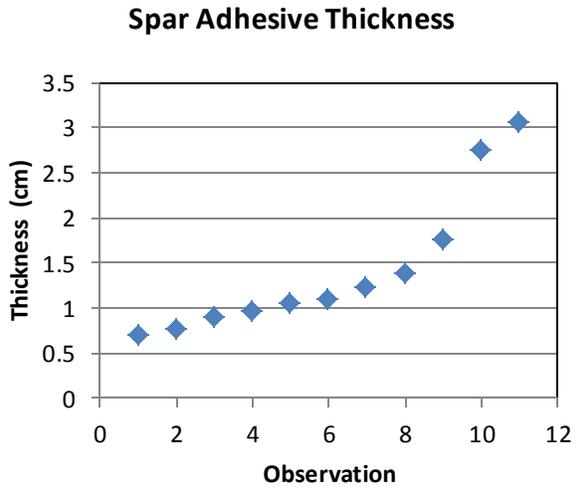
Figure 50: Adhesive bond thicknesses for spar/sheer web to blade skin.

A summary of the adhesive bond parameter data collected is shown in Table 2 and Table 3 below. Plots of the data can be found in the Appendix; Figure 50 through Figure 52.

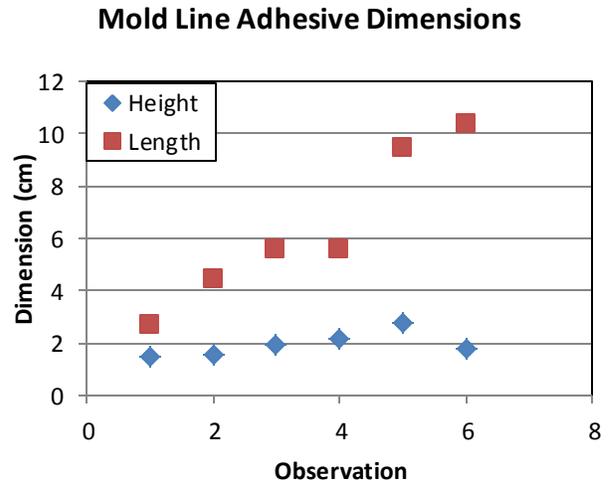
Figure 51: Adhesive layer dimensions for the mold line case.

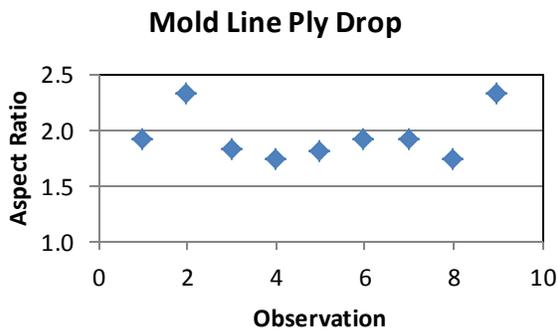
Figure 52: Adhesive layer dimensions for the mold line case.

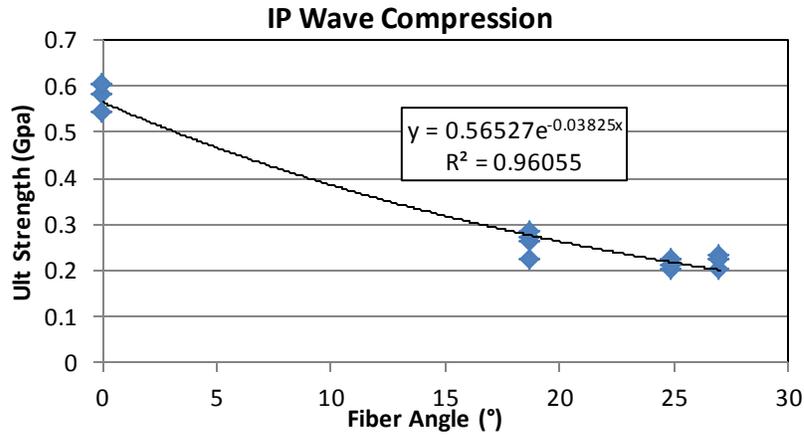
Figure 53: Example of mechanical response correlation between IP wave off-axis fiber angle and ultimate strength in compression

in the following two figures. These correlations are used in equation 3 to designate  $\sigma_f$ , the ultimate strength of a flawed laminate. Future analysis will incorporate more complex damage progression and/or residual strength models.

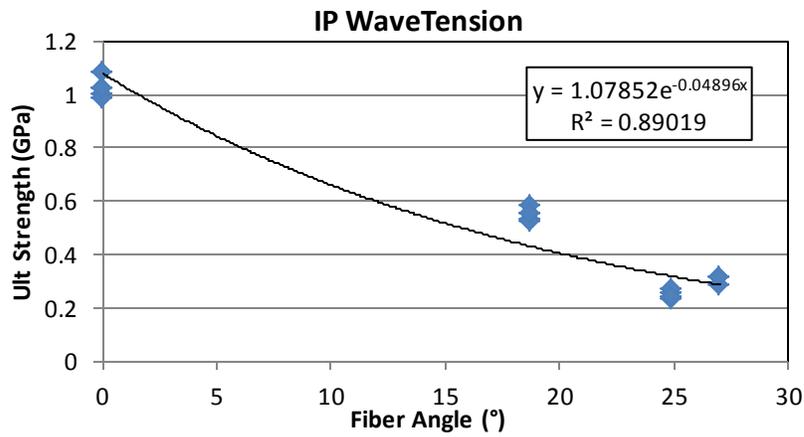
Figure 54: Example of mechanical response correlation between IP wave off axis fiber angle and ultimate strength in tension
