SANDIA NATIONAL LABORATORIES LAND USE PERMIT FOR OPERATIONS AT OLIKTOK ALASKA LONG RANGE RADAR STATION

The property subject to this Environmental Baseline Survey (EBS) is located at the Oliktok Long Range Radar Station (LRRS). The Oliktok LRRS is located at 70° 30' W latitude, 149° 53' W longitude. It is situated at Oliktok Point on the shore of the Beaufort Sea, east of the Colville River. The purpose of this EBS is to document the nature, magnitude, and extent of any environmental contamination of the property; identify potential environmental contamination liabilities associated with the property; develop sufficient information to assess the health and safety risks; and ensure adequate protection for human health and the environment related to a specific property

This Phase I Environmental Baseline Survey (EBS) provides the findings of a survey and assessment for a proposed land use permit by Sandia Corporation for operations at the United States Air Force Long Range Radar Station located at Oliktok, Alaska. The purpose of this document is to provide information regarding baseline environmental conditions of the proposed sites. This document was prepared in accordance with U.S

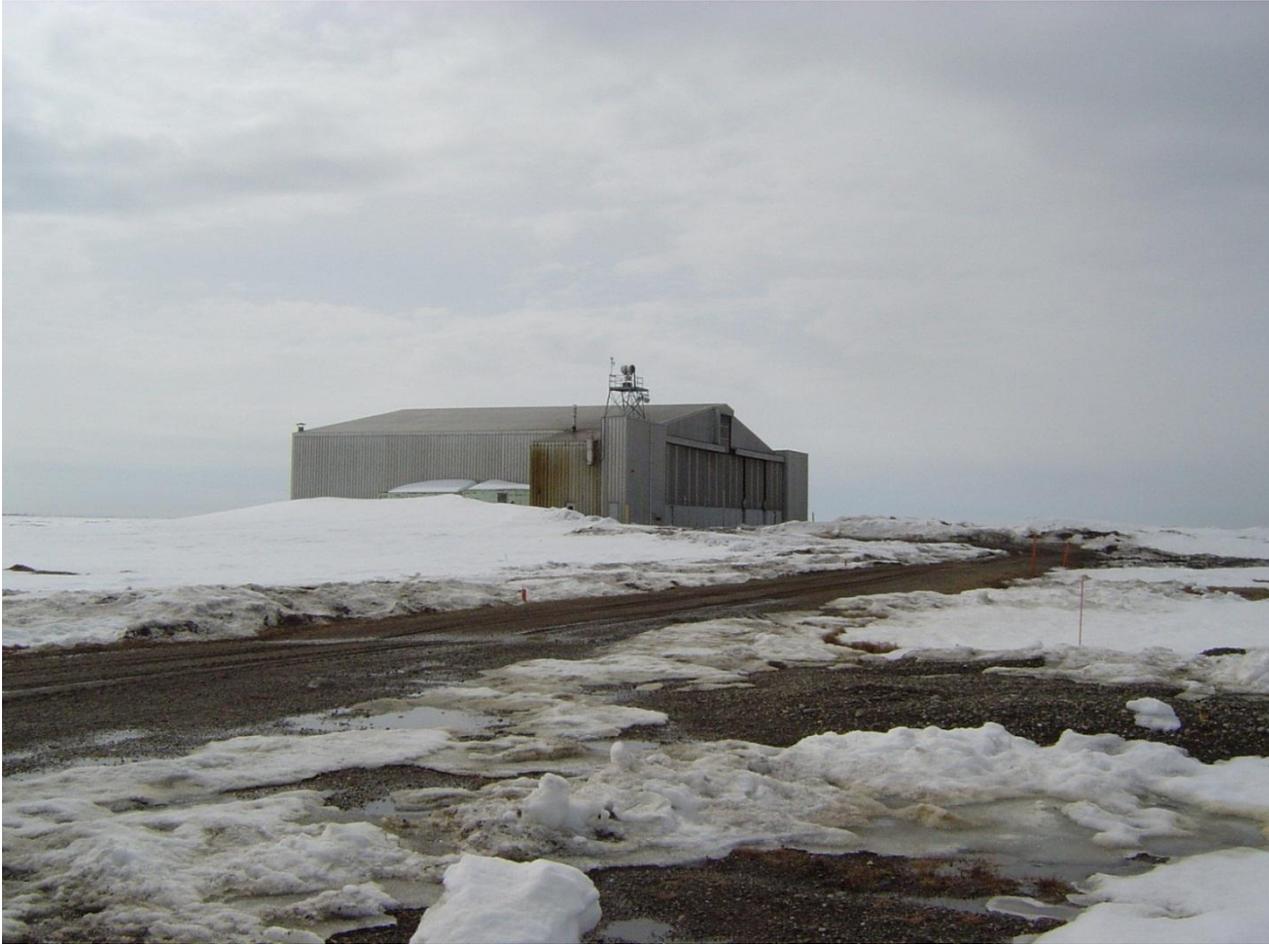
Existing Hangar at Oliktok LRRS

- Aircraft shelter- Constructed in 1957, this 17,400 sq. ft. structure with a dirt floor served as a hangar for aircraft. This structure has also been referenced as the "Air Freight Terminal" in historical documentation. It is considered deactivated and is currently utilized for storage of miscellaneous items by the USAF.
- Module Train 1- Constructed in 1957, this serves as the main facility for the site. The Module Train consists of electronics equipment areas, bedrooms, administration offices, mechanical rooms, sewage treatment plant, diesel engine generators and boiler, dining, kitchen, and recreation areas.

After visual site inspection and historical records review showing the date of construction, it is suspected that the Aircraft Hangar would contain ACM. If ACM is assumed or confirmed to be present, the friable ACM must be removed, if it is likely to release airborne fibers and cannot be reliably maintained, repaired, or isolated. All ACM identified as non-friable does not present a health hazard at this time as long as the ACM is not disturbed. It is not anticipated that any SNL activities would disturb areas of suspected ACM as SNL personnel would use the Aircraft Hangar for the purpose of a temporary work space sheltered from the outside elements.

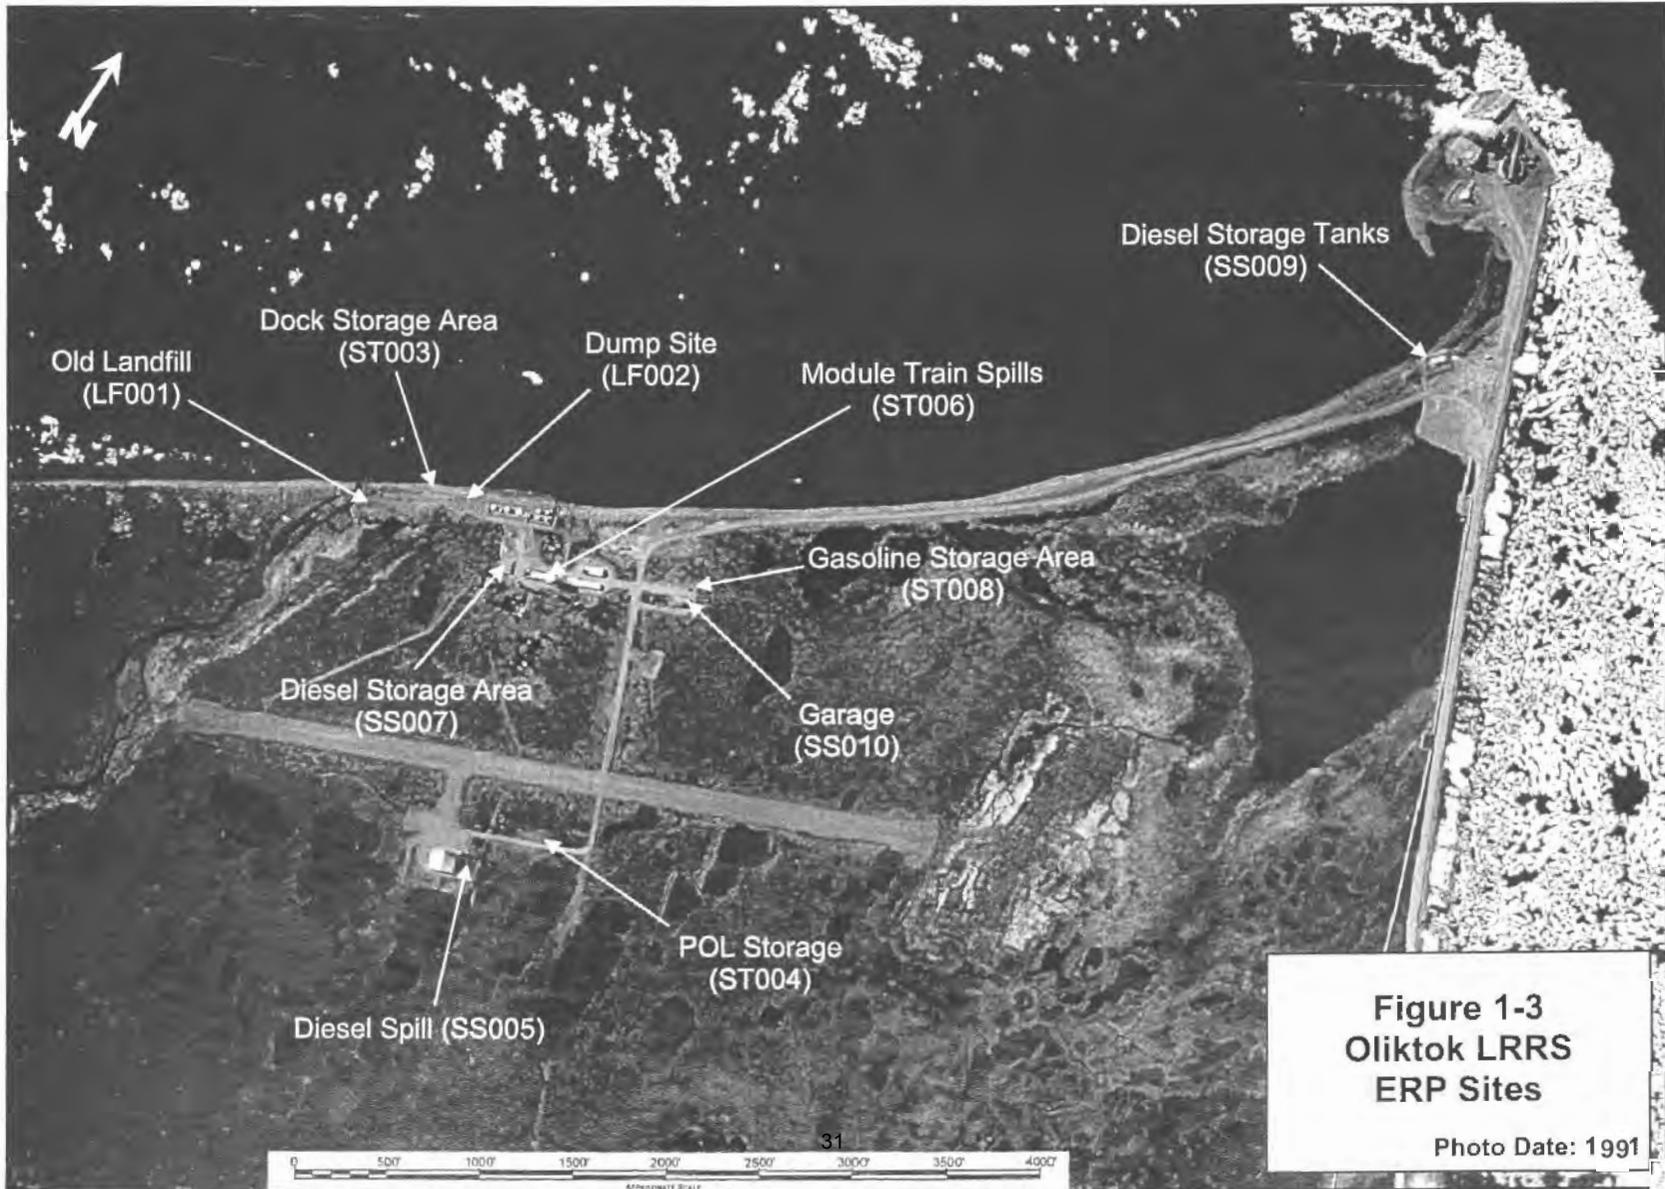
Figure 1-3
Oligtok LRRS
ERP Sites
 Photo Date: 1991

Review of the *Oliktok Long Range Radar Site Environmental Restoration Program (ERP) Sites* map indicated that 10 ERP Sites are located within the boundaries of the Oliktok LRRS. The following provides the current status of the ERP sites:

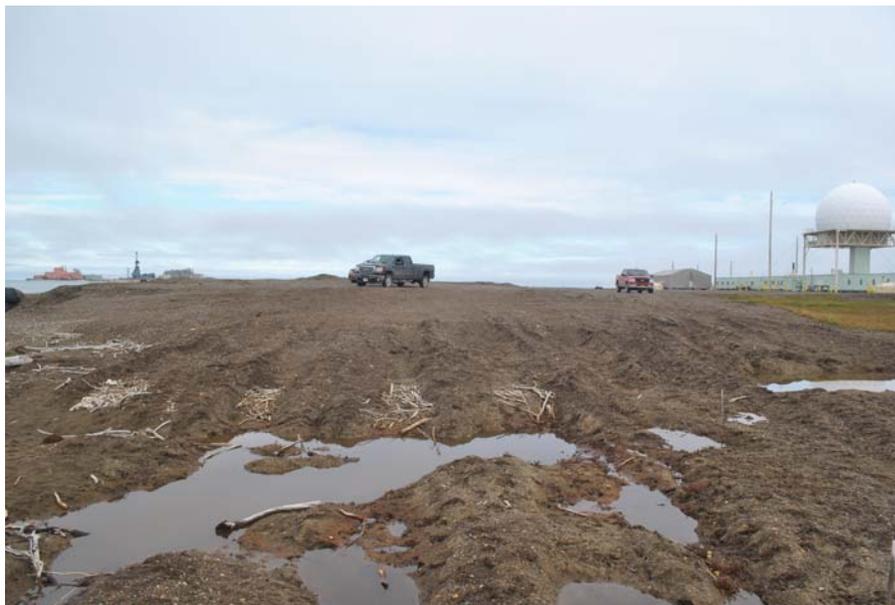
Photograph C-1. Site A, looking east toward LRRS main facility.

A Sandia Corporation Environmental Technical Professional conducted a visual and physical walk-through inspection of the land use permit site on August 21, 2012. No environmental concerns or issues were observed: no odors; pools of liquid; drums; hazardous substance and petroleum product containers; potential asbestos-containing material (ACM); polychlorinated biphenyl (PCB)-containing electrical equipment; drains and sumps; pits, ponds, and lagoons; stained soil or pavement; stressed vegetation; wastewater; or dead or diseased wildlife. No concerns relating to the health and safety of individuals or local flora or fauna, such as stains or leaks, were observed (See Appendix D for site photographs).
