Normal Conditions of Transport Truck Test of a Surrogate Fuel Assembly

Fuel Cycle Research & Development

SAND2014-20495

FCRD-UFD-2014-000066, Revision 0.1

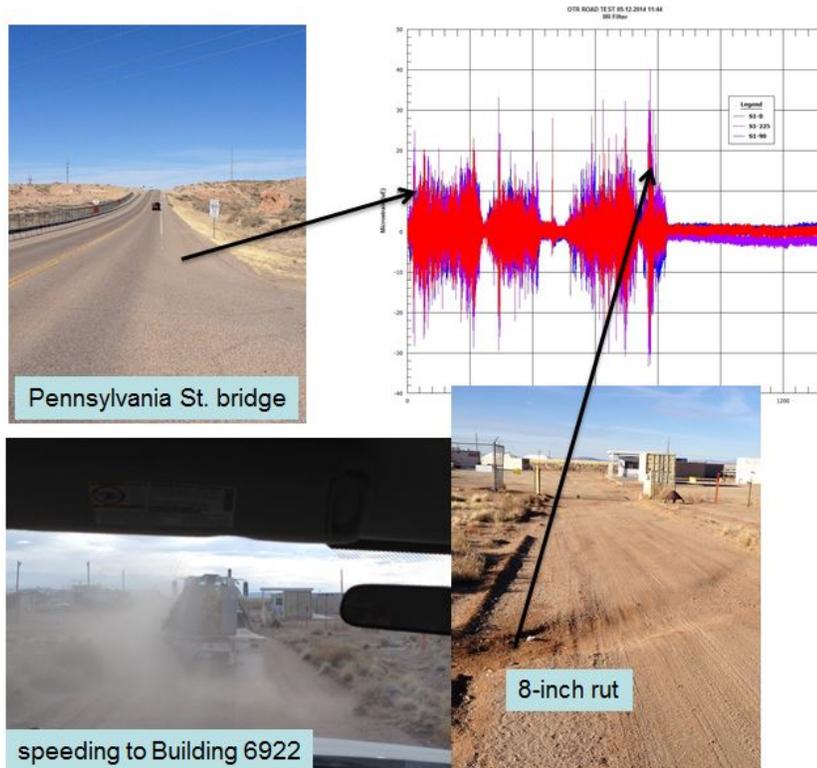
The strains measured on the instrumented Zircaloy-4 rod over a 40.2 mile route in the Albuquerque area over a variety of road conditions – rough dirt to Interstate highway (Figure S.1) – never exceeded 150 $\mu\text{in./in.}$ – a very low level of strain well below the elastic limit/yield strength of Zircaloy-4, Figure S.1. The strains measured in the truck test were slightly lower than those measured in the shaker tests.

Figure S.1 Rod strains were measured over a 40.2 truck route of varying conditions.

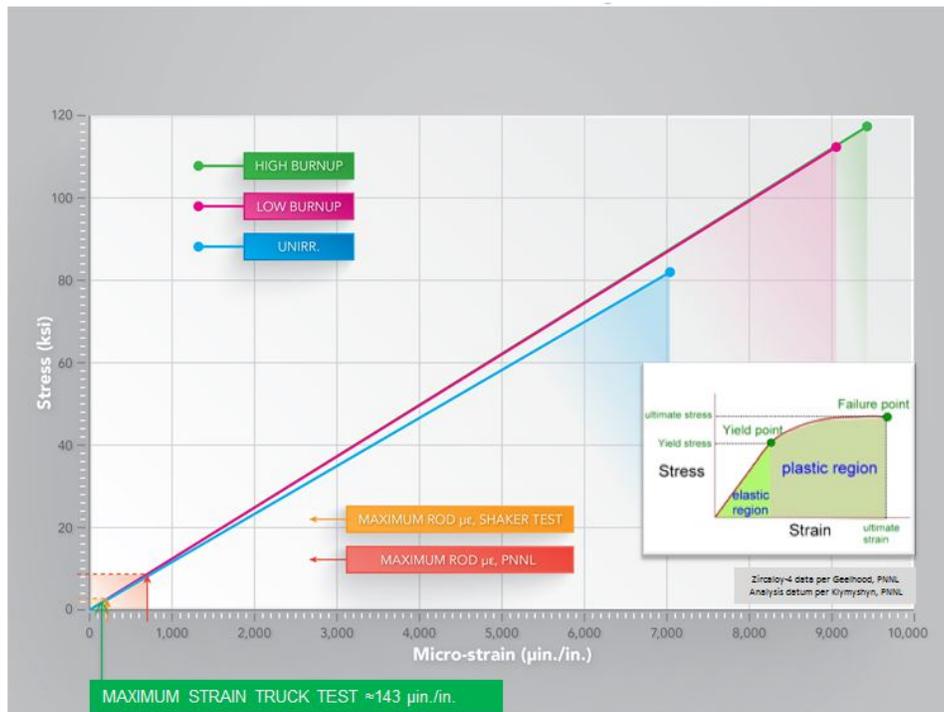
The stresses corresponding to the maximum experimentally measured strains in both the truck test and the previous shaker tests are approximately 2 - 3 ksi (13.8

- 20.6 MPa) as shown in Figure S.2, which is a plot of the elastic portion of the stress-strain curves for unirradiated Zircaloy-4 and low-burnup and high-burnup irradiated Zircaloy-4. The figure also shows the maximum strain result from finite element analyses performed at Pacific Northwest National Laboratory. The figure indicates how low the magnitude of the strains and corresponding stresses were on the rod relative to the elastic limit of unirradiated and irradiated Zircaloy-4. The applied stresses on the rod were low relative to the yield strength of the Zircaloy-4.

Figure S.2 Strains on Zircaloy-4 rod measured in truck and shaker tests relative to elastic limit / yield strength of Zircaloy-4 were very low.

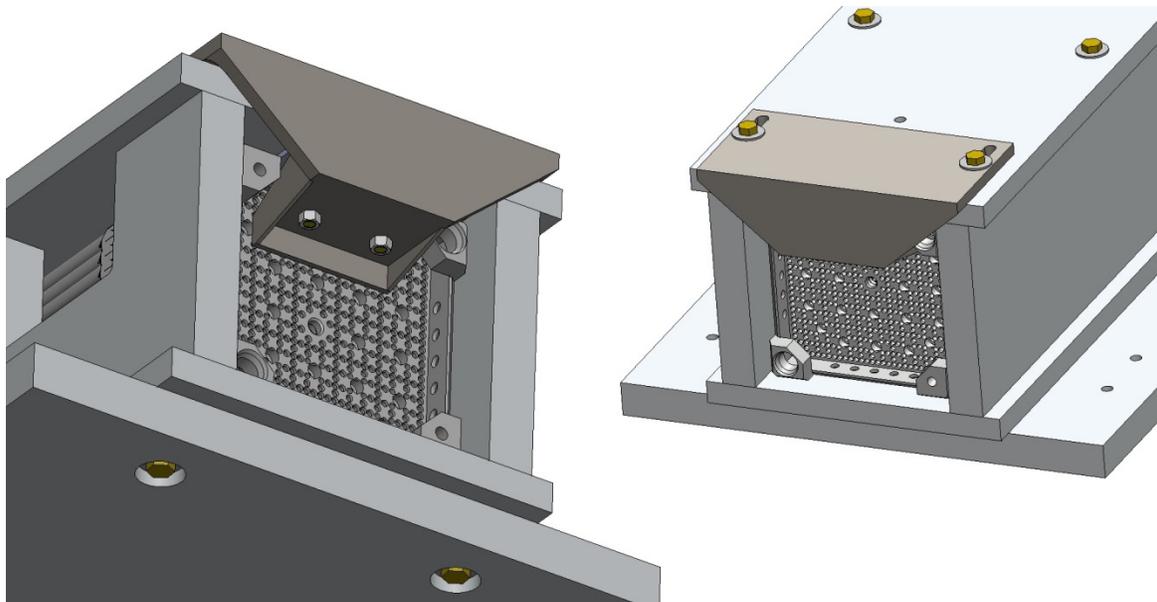
In order to ensure that the assembly would not slide forward nor backward out of the basket during the truck test, especially should a hard brake be required during transport, a set of brackets were placed at either end of the basket. These brackets had a lip that was configured below the top plate of the basket that would allow the assembly to slide only 1.25 inch, Figure 3.2.

Figure 3.2 Schematic of brackets used to limit possible longitudinal motion of assembly within basket.

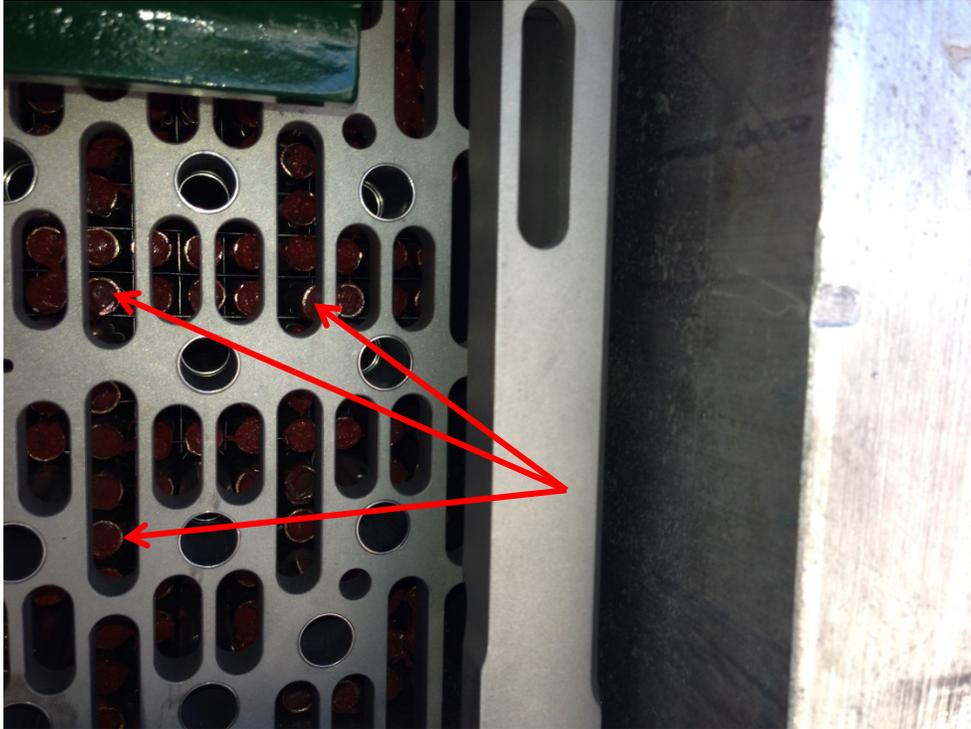
Prior to the truck test, a dab of silicone was placed on the edge of these brackets which would contact the assembly if it happened to slide beyond approximately 0.25 inch. Post-test examination revealed that the assembly had not contacted the silicone. It was noted, however, that some of the copper rods within the assembly moved longitudinally during the truck test. Visual examination suggested that the magnitude of this longitudinal motion was less than 0.25 inch (Figure 3.3).

Figure 3.3 The red arrows point to some of the copper rods that moved longitudinally within the assembly during the truck test.

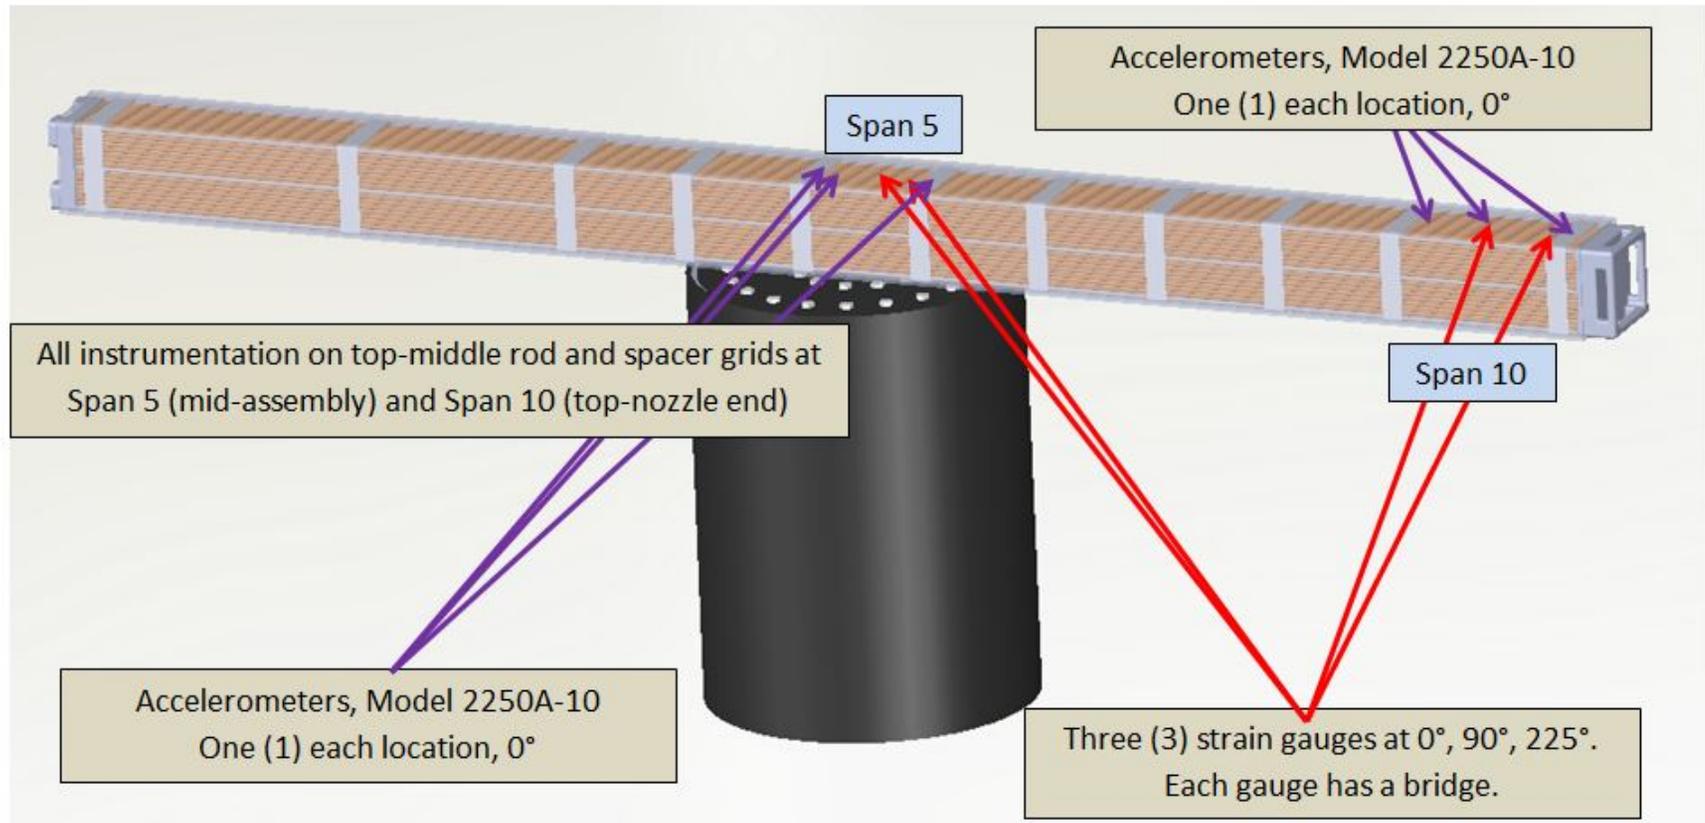
Strain gauges on top-middle Zircaloy-4 rod and accelerometers on top-middle Zircaloy-4 rod and Span 5 and Span 10 spacer grids for over-the-road truck test. Span 10 is the top nozzle end of the assembly.

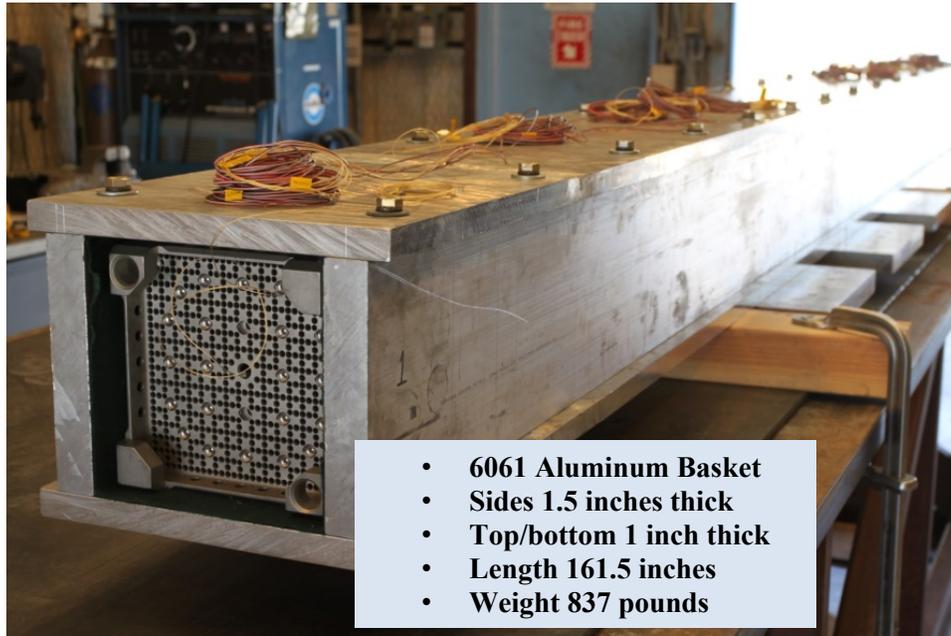
Figure 3.5 Basket / assembly test unit.

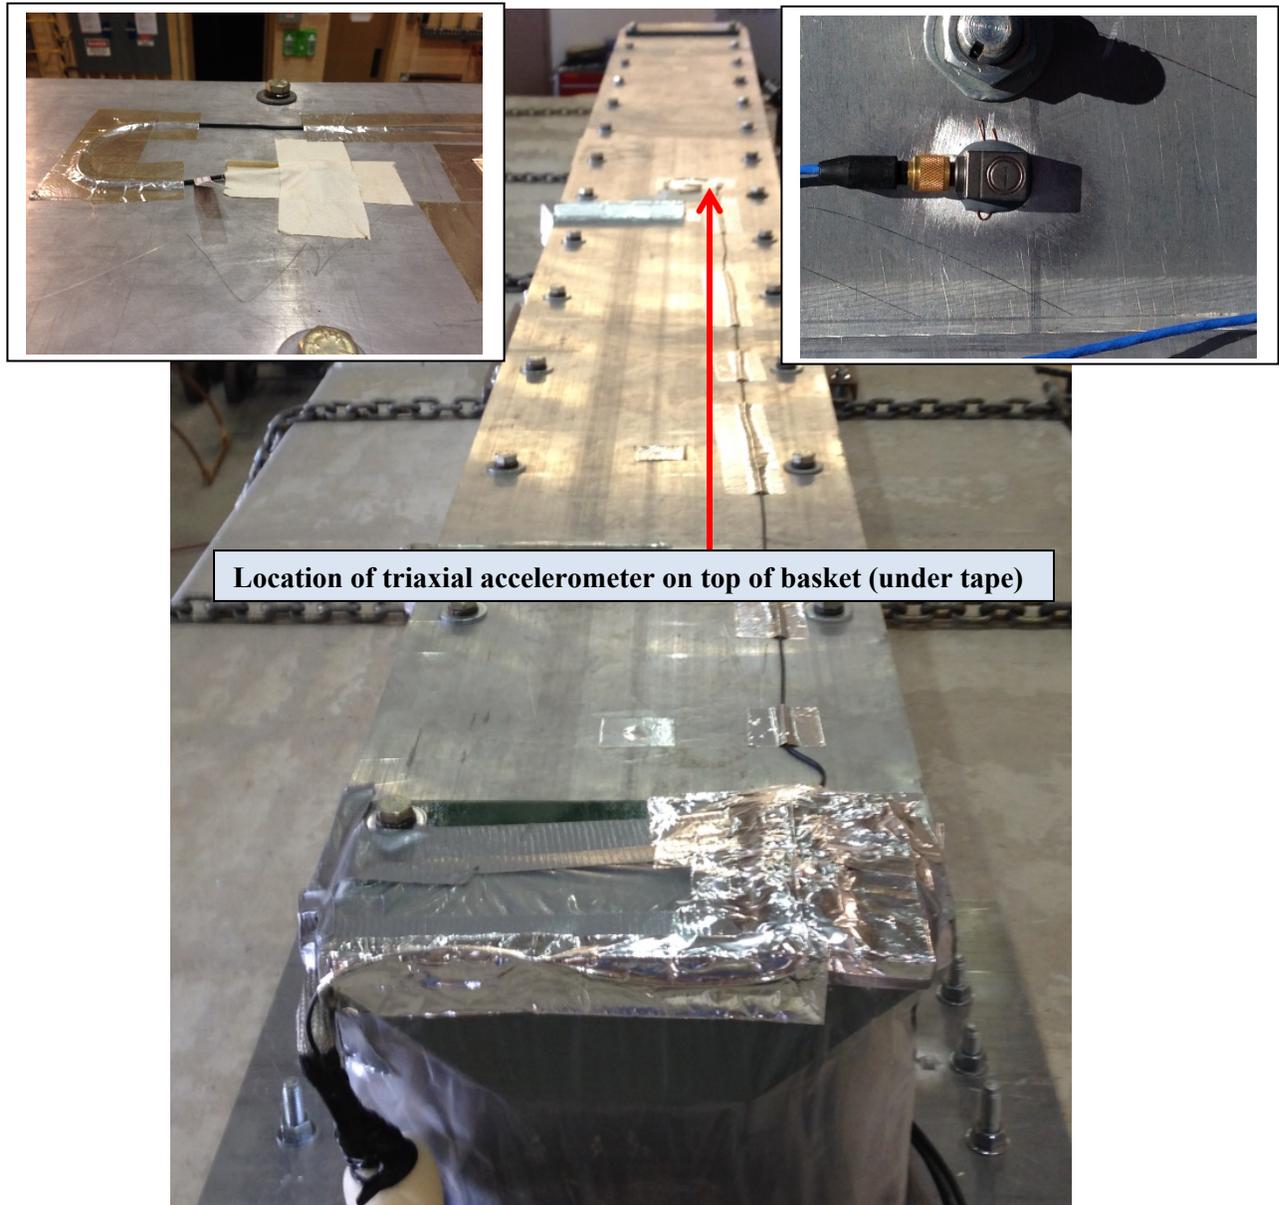
Figure 3.8 Location of triaxial accelerometer on top of basket.

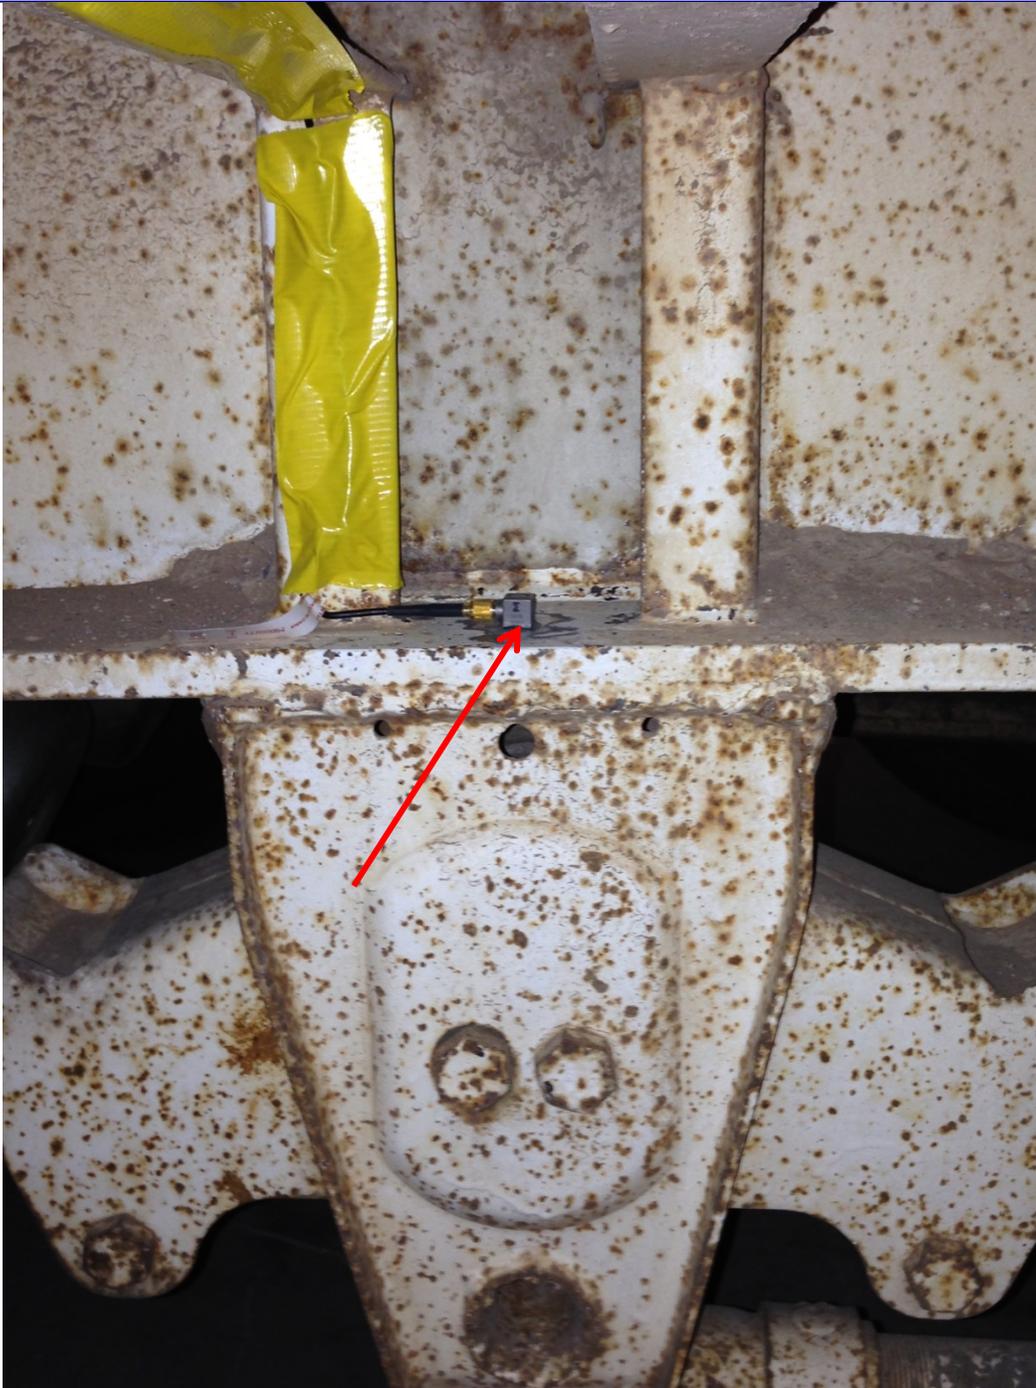
Figure 3.9 Triaxial accelerometer below trailer drop deck above rear axle (see Figures 3.11 and 3.13 and Table 3.1).

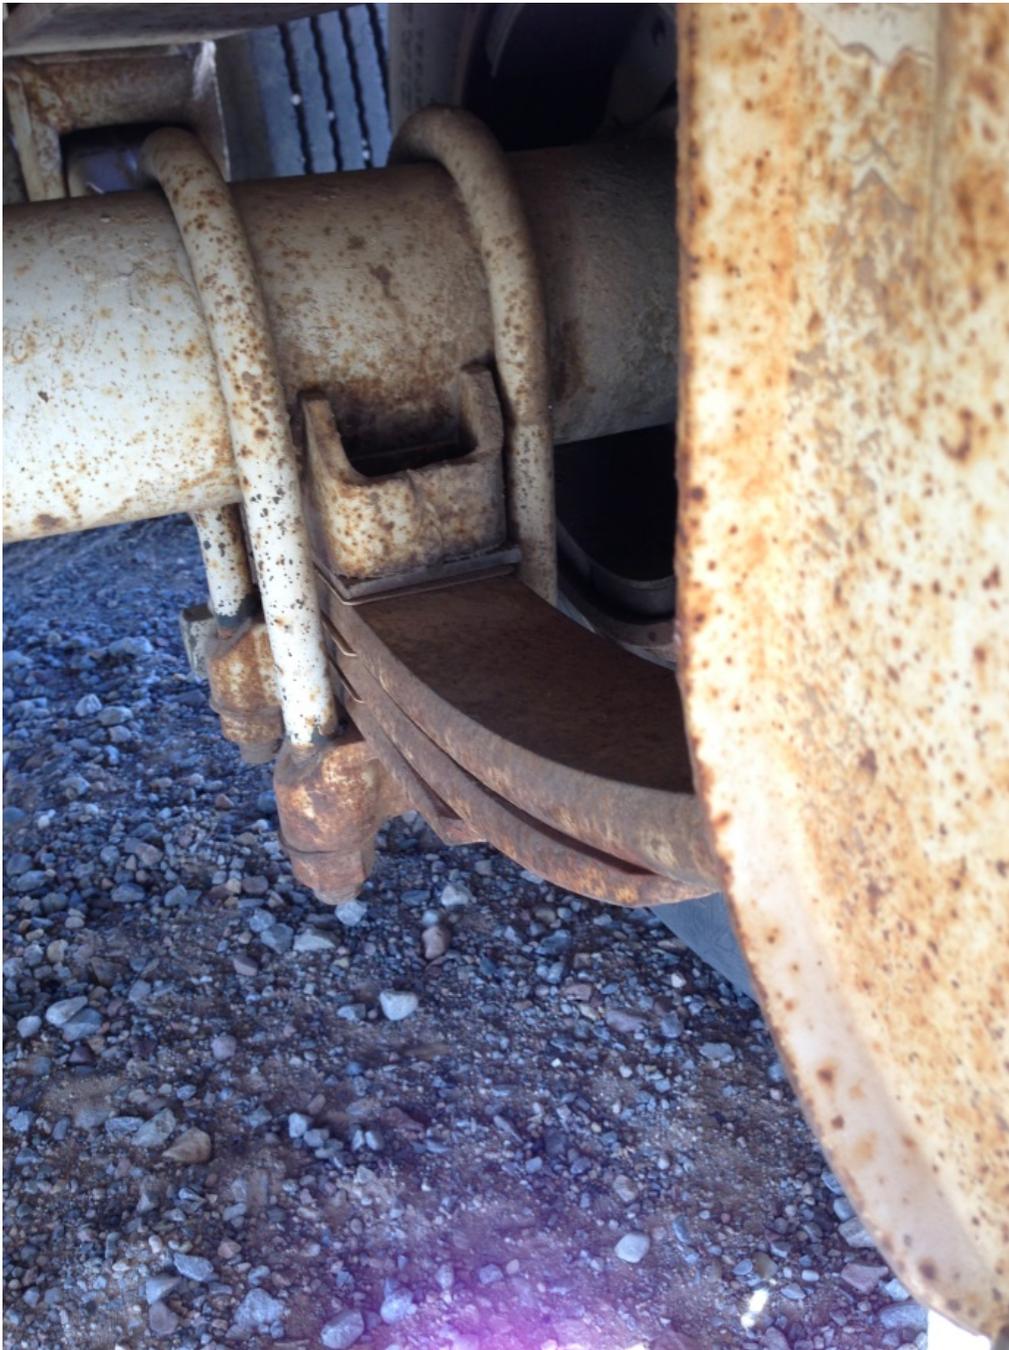
Figure 3.13 Trailer rear spring suspension.

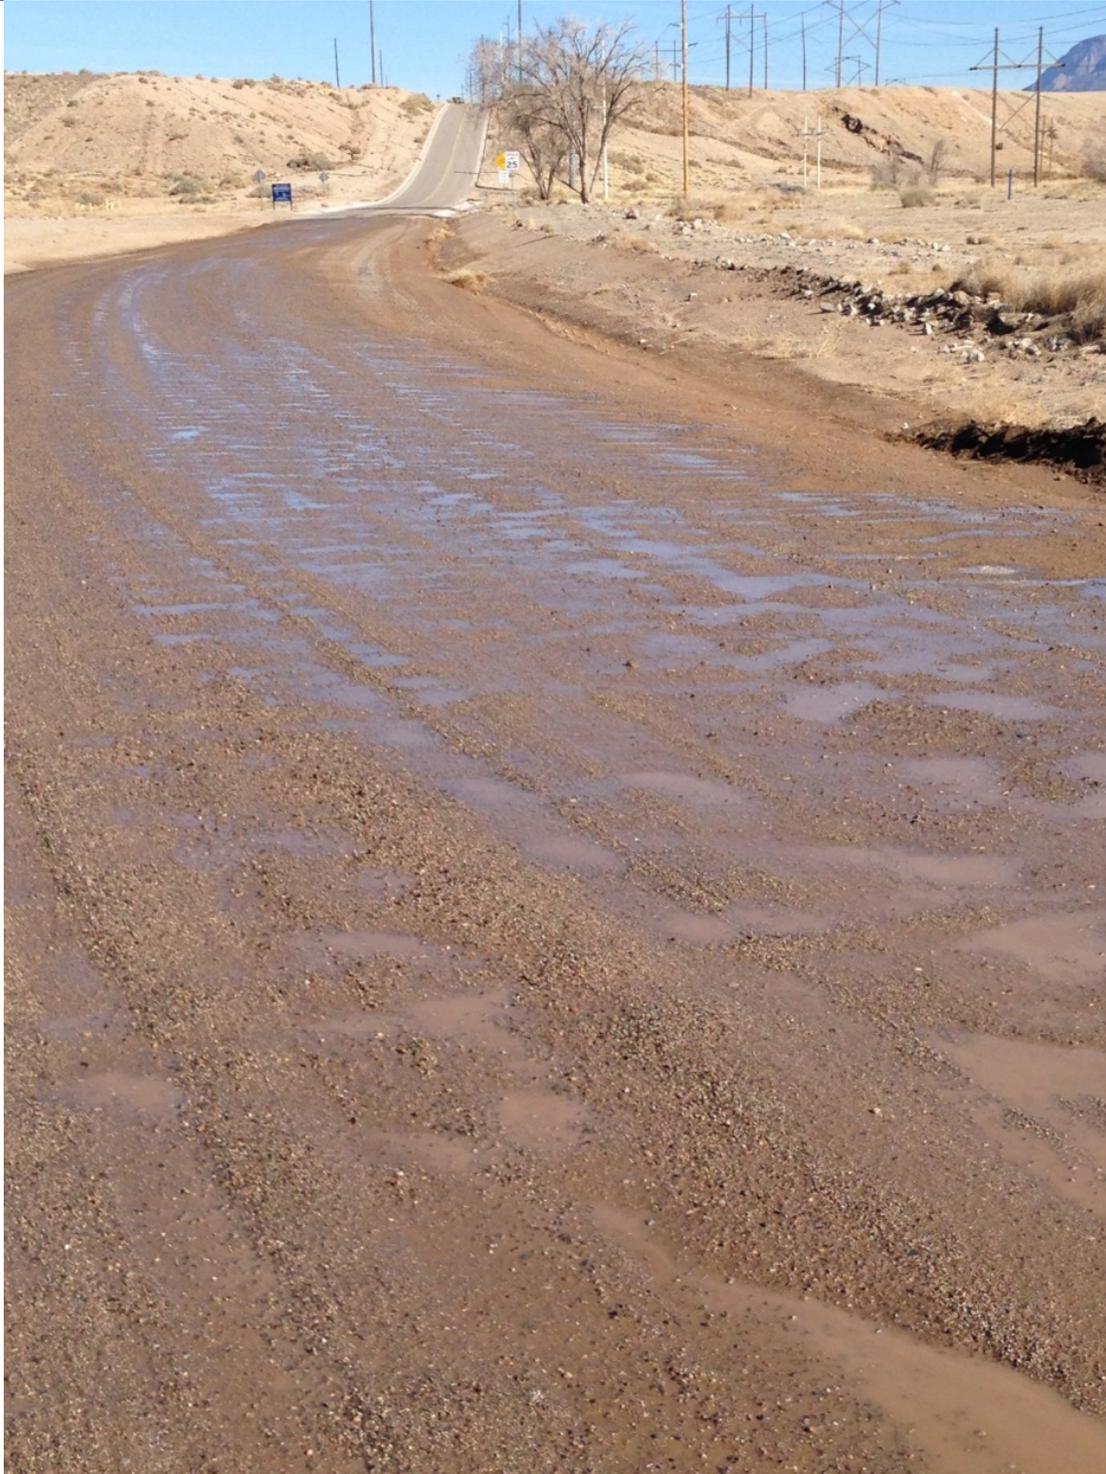
Figure 4.7 Poleline Road looking north, Segment 1. The paved surface near top is a brief section of this dirt road. The highest strains measured on the instrumented rod were on the dirt section just north of the paved section (Figure 4.8).

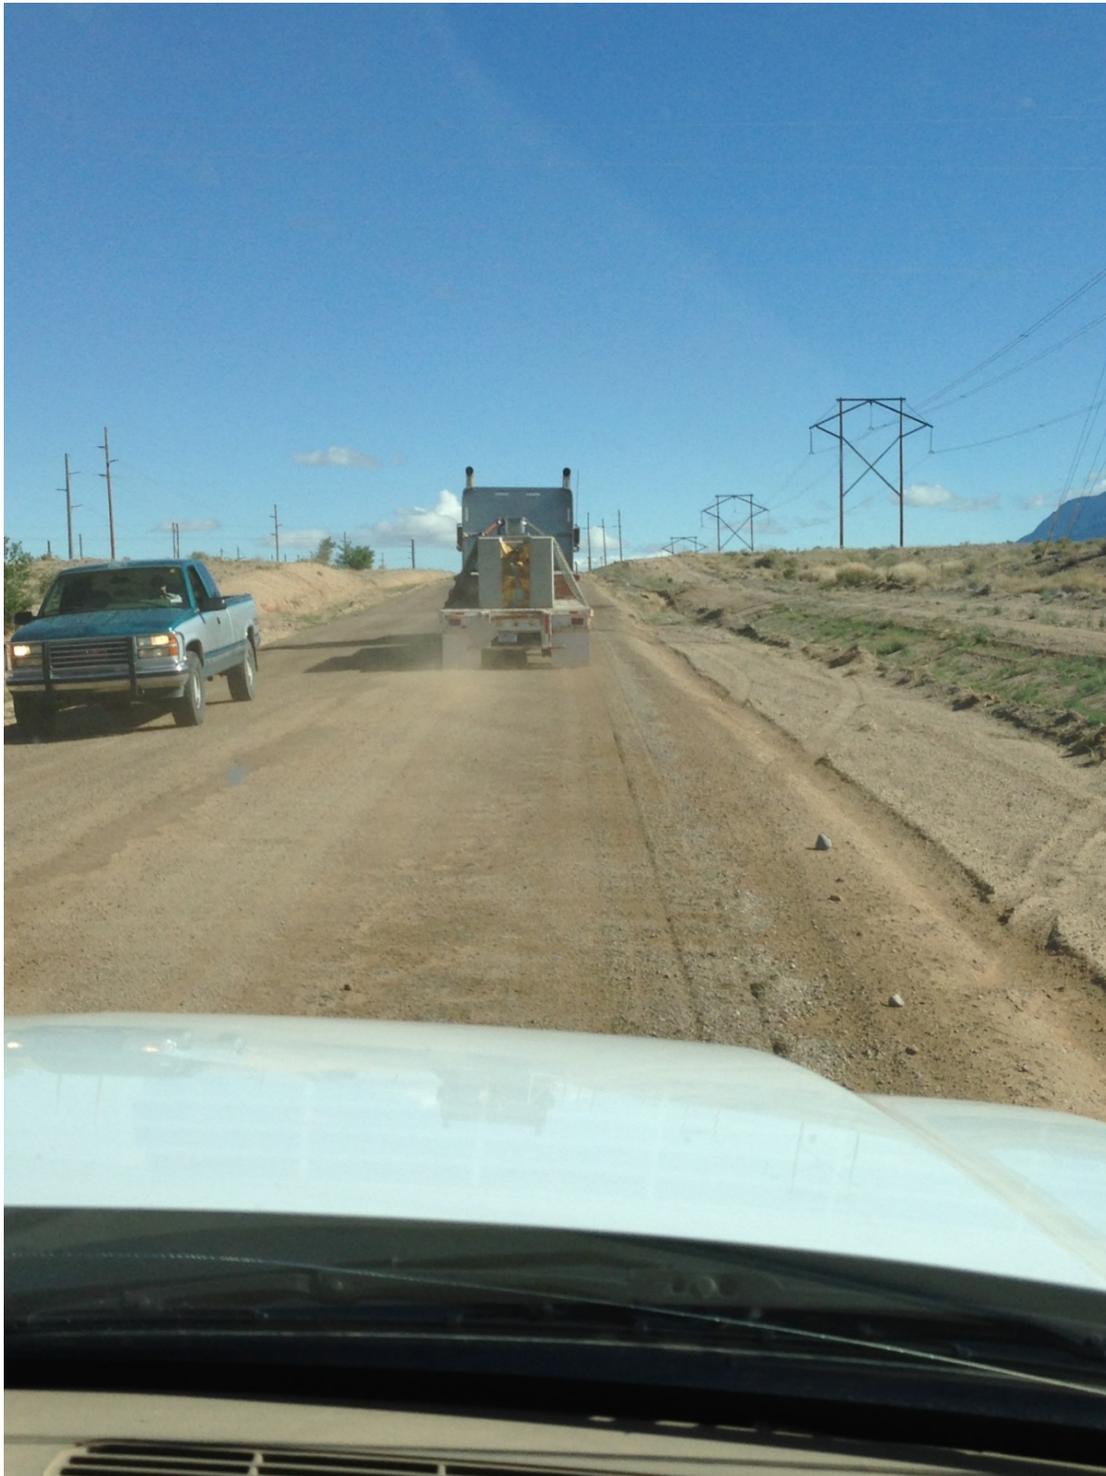
Figure 4.8 Poleline Road approaching Eubank Contractors' Gate, Segment 1. This potholed, dirt/gravel portion of the truck route resulted in the highest measured rod strains.

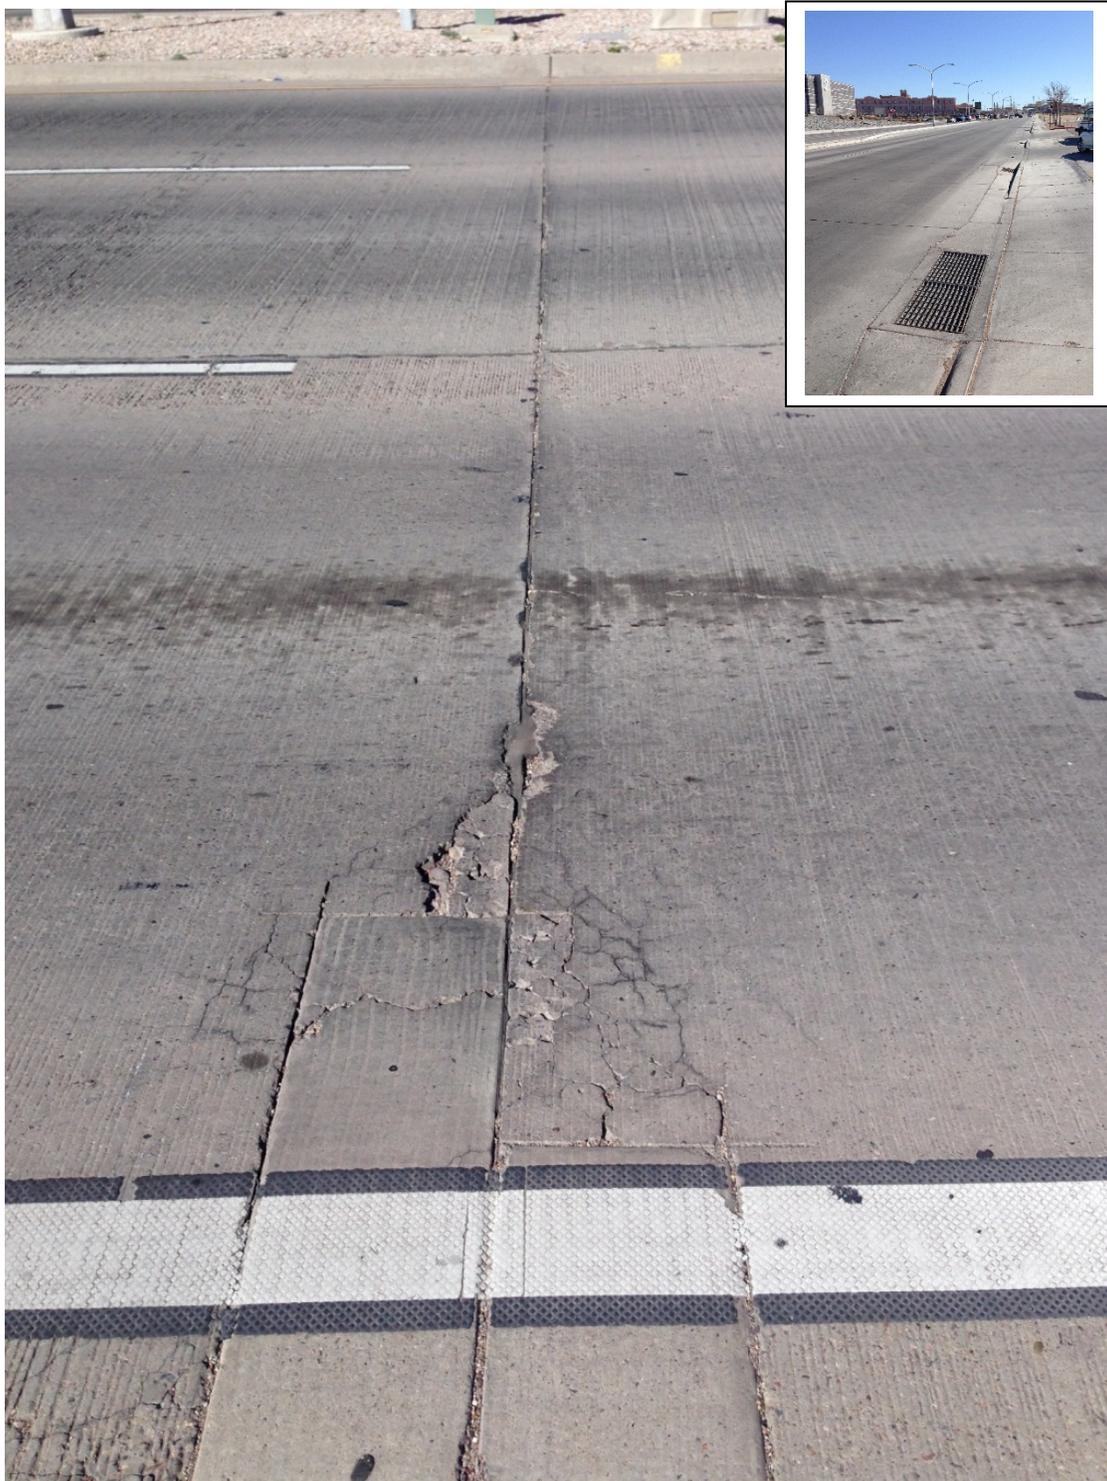
Figure 4.12 Gibson Blvd. (east) concrete plate road surface, Segment 4. Relatively high strains were measured on Gibson Blvd.

Figure 5.1 Correlation of measured strains on rod to road conditions. Top left is the strain versus time for the S1 strain gauges for truck route Segment 1, top right is the strain versus time for Segment 4 (y-axis is 80 $\mu\epsilon$ in both plots ; Figures 8.1 and 8.13). The bottom set of figures are for Segment 5 (y-axis is 50 $\mu\epsilon$; Figure 8.17). Refer to Tables 3.1 and 4.1. Gibson Blvd. has a series of concrete plates separated by gaps which apparently caused peaks in rod strain (Figure 4.12).

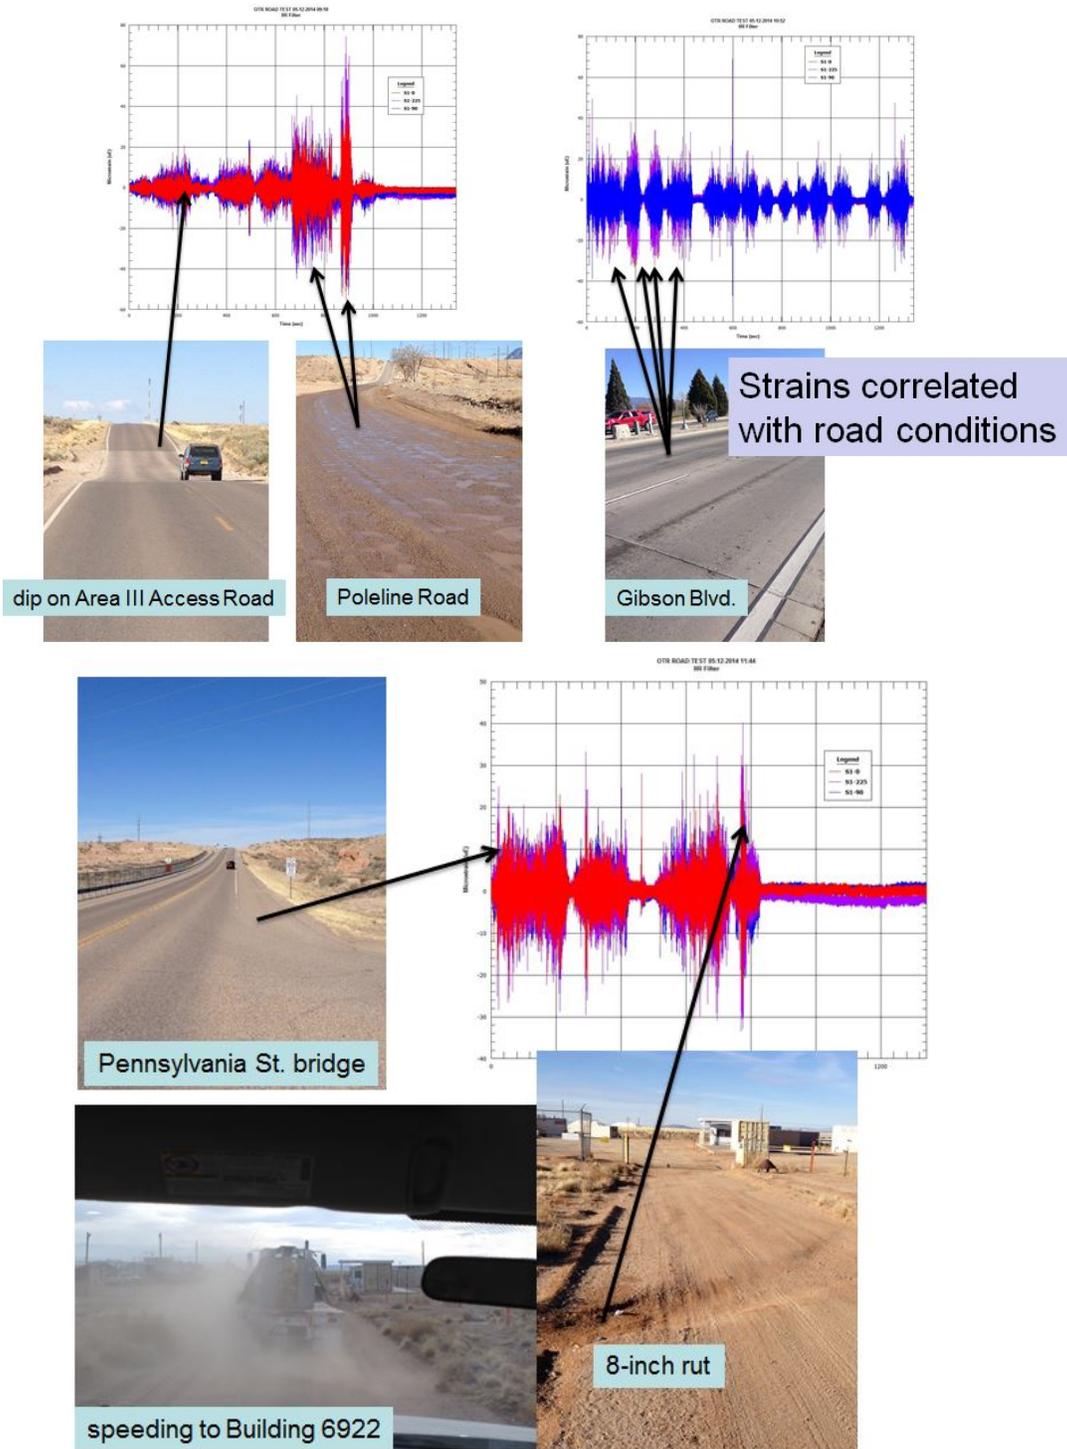
Figure 5.1 correlates strain time-histories with road conditions to illustrate how road surfaces produced displacement and strains on the rod.

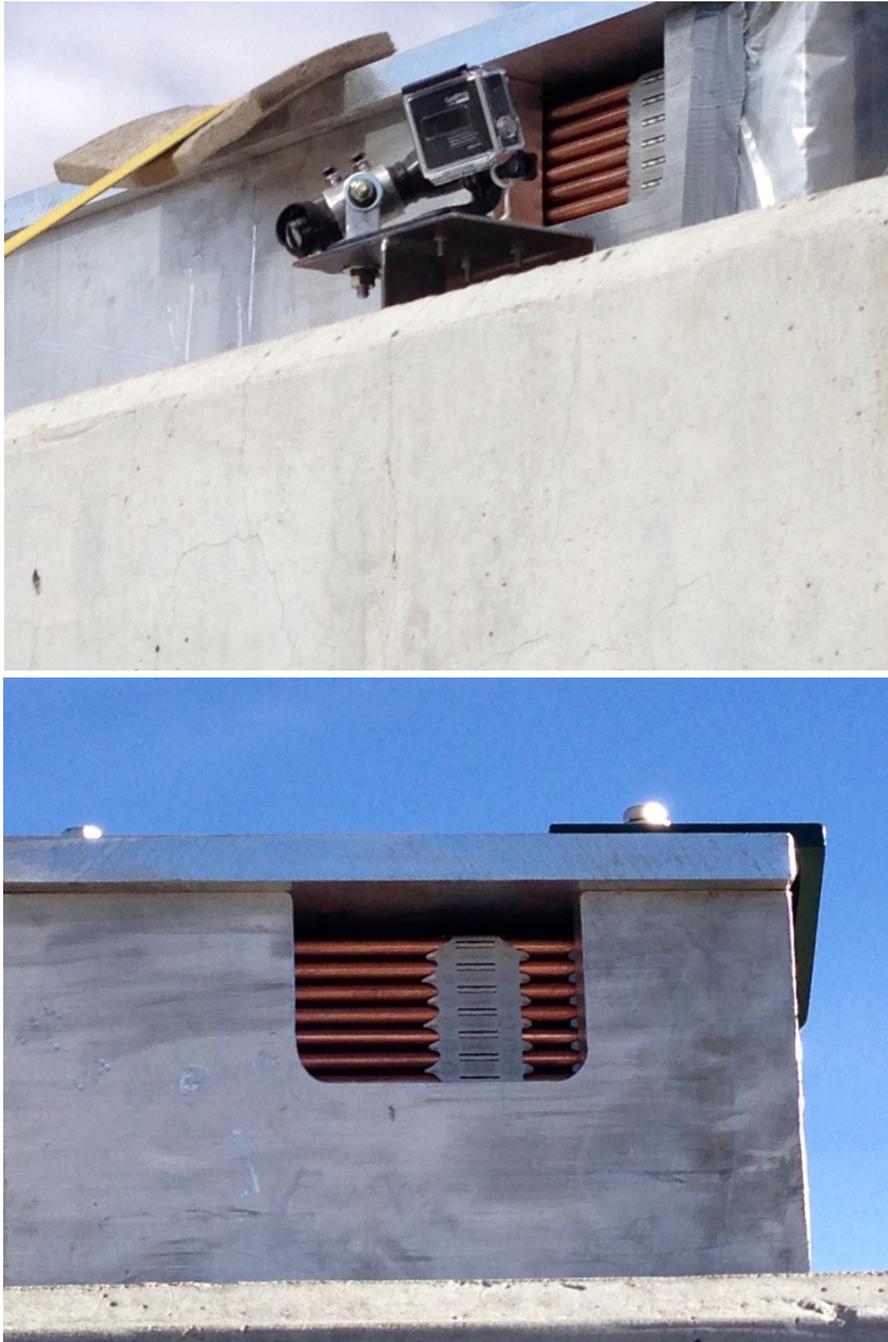
A GoPro® HERO3+ camera was attached to the basket (Figure 5.2). A video was taken while the tractor/trailer was driven along the Area III access road (rough asphalt) to Building 6922 (rough dirt). This was done to observe whether the assembly moved relative to the basket or if the rods moved relative to one another. The video was recorded at 240 frames/second. The video speed was subsequently reduced to 30 frames/second. In either version of the video, no motion of the assembly relative to the basket or of individual rods relative to one another was observed (Figure 5.3).

Figure 5.2 Basket cutout, bottom, showing side view of assembly for GoPro® video, top.

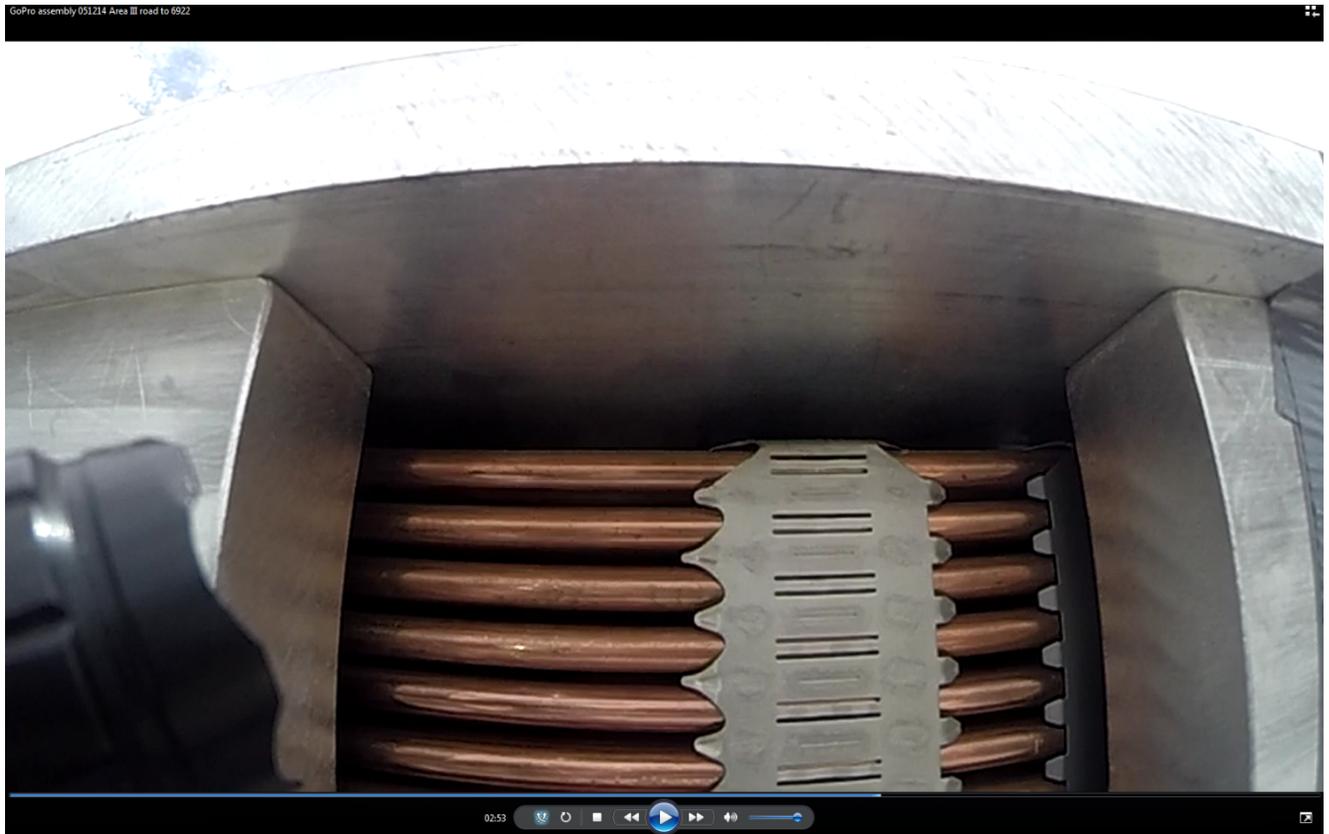
Figure 5.3 Screen capture of GoPro® .MP4 video file. There was no observed motion of the assembly relative to the inside of the top basket plate or the copper rods relative to one another or relative to the spacer grid in the 4 minute 23 second video (240 frames/second). There was occasionally motion observed between the top edge of the top basket plate relative to the clouds in the sky (note bluish-gray patch in top left corner of figure). The perceived curvature is an artifact of the wide angle view of the video.

A dab of silicone was placed on top of the assembly spacer grid shown in Figures 5.1 – 5.3 to within about 0.25 inch of the bottom of the top plate of the basket. Post-test examination of the silicone revealed that it had not come into contact with the top plate suggesting that the assembly had not “jumped” vertically during transport.

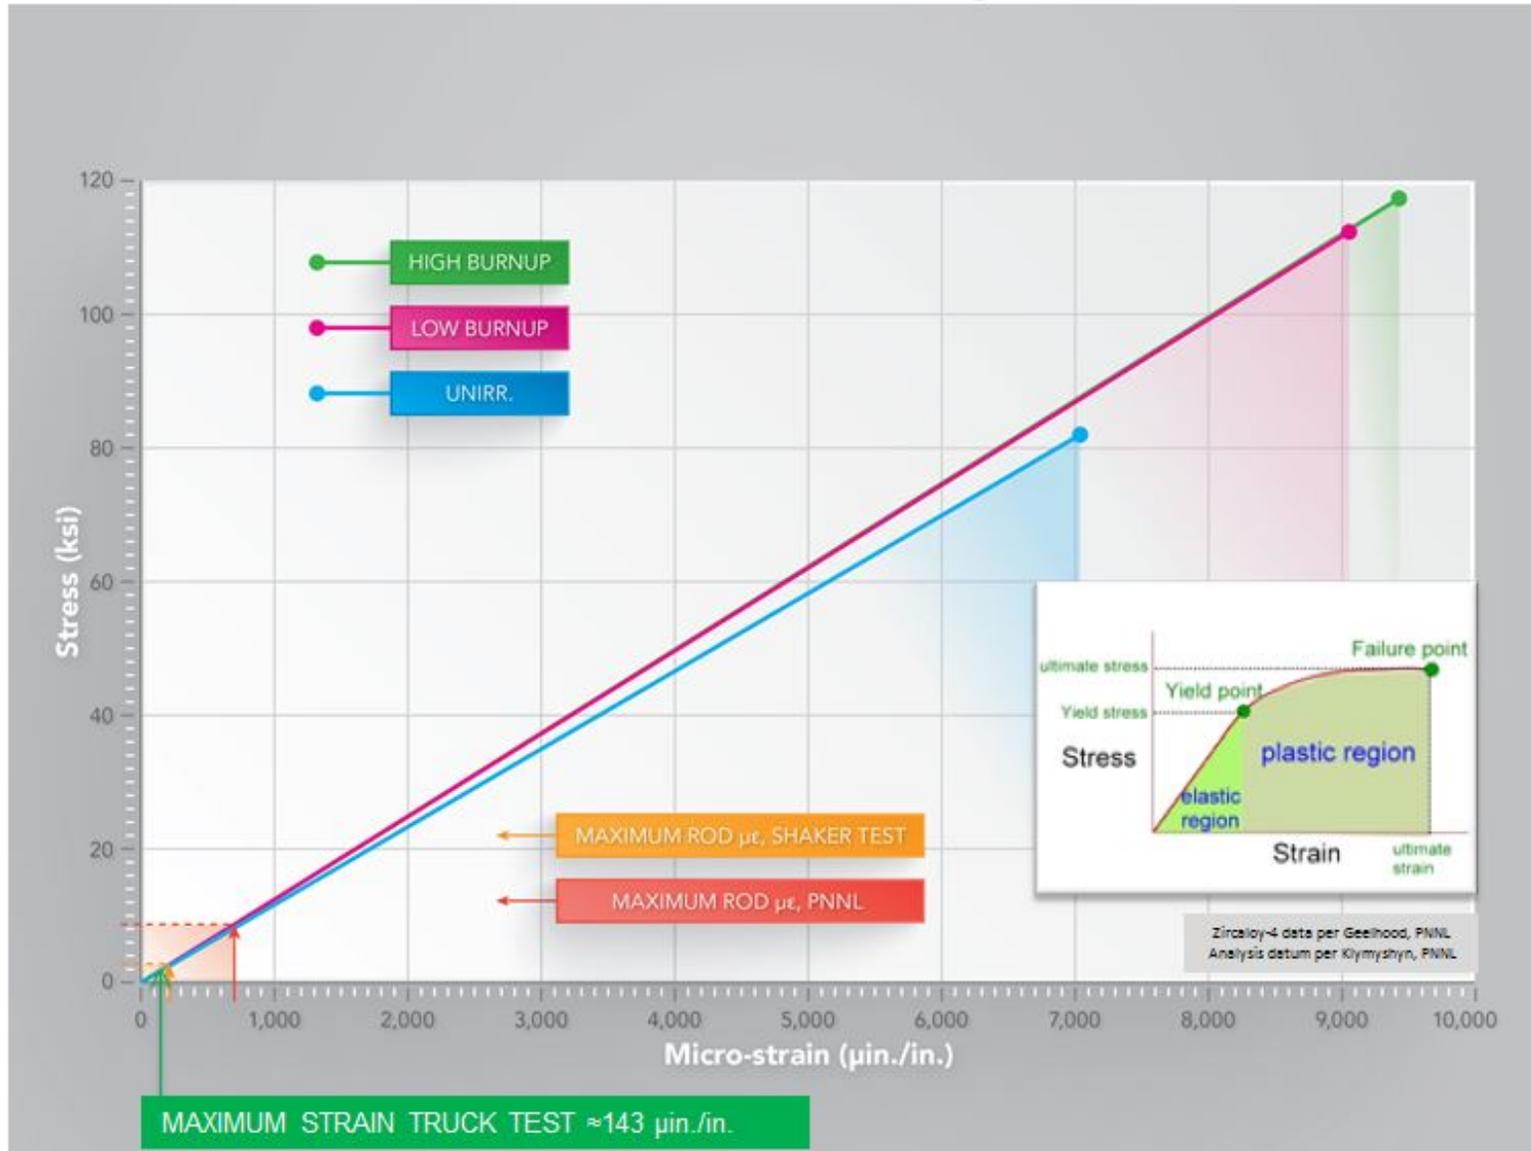
The stresses^k corresponding to the maximum experimentally measured strains in both the truck test and the previous shaker tests are approximately 2 - 3 ksi (13.8 - 20.6 MPa) as shown in Figure 5.4, which is a plot of the elastic portion of the stress-strain curves for unirradiated Zircaloy-4 and low-burnup and high-burnup irradiated Zircaloy-4. The figure also shows the maximum strain result from finite element analyses of the shaker tests performed at Pacific Northwest National Laboratory^l. The figure indicates how low the magnitude of the strains and corresponding stresses were on the Zircaloy-4 rods relative to the elastic limit of unirradiated and irradiated Zircaloy-4. The applied stresses on the rod were low relative to the yield strength of the Zircaloy-4.

Figure 5.4 Strains on rod measured in truck and shaker tests relative to elastic limit/yield strength of Zircaloy-4.

The strain data measured during the tests, for shock and vibration loadings, suggest that the axial strains on the rod—and the corresponding applied stresses—are very low in relation to the elastic limit of unirradiated Zircaloy-4 and the estimated elastic limits for low-burnup and high-burnup Zircaloy-4.^r This suggests that cladding will not fail during NCT via strain- or stress-based failure criteria (Figure 5.4).

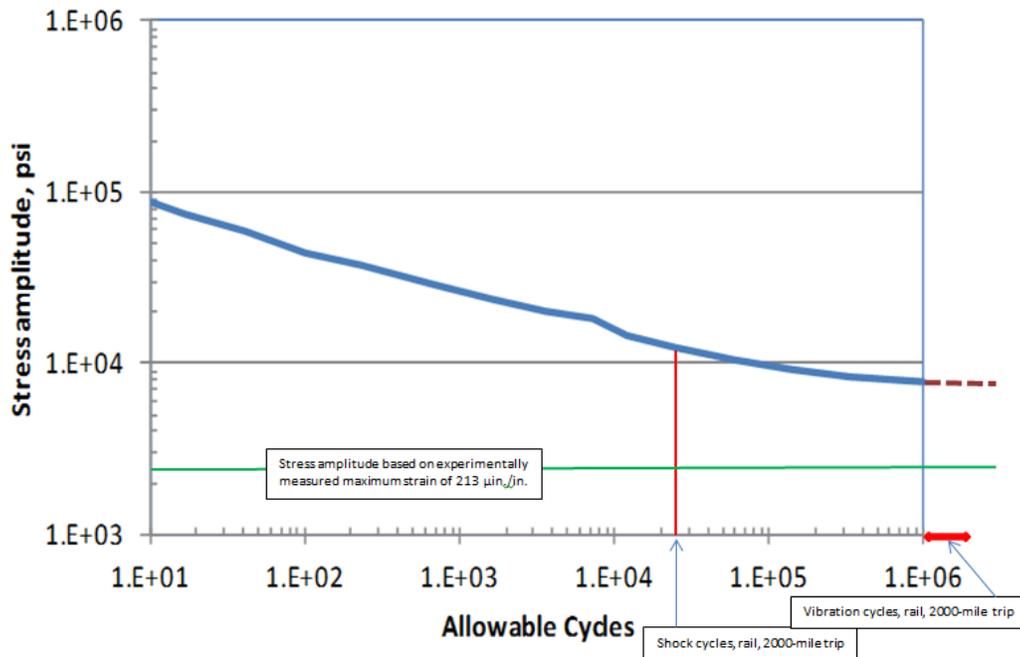
An estimate was made of the number of shocks a rail car may experience in a typical 2000-mile trip and the number of vibrations over the same distance. The number of shock cycles was estimated to be approximately 25000 and the number of vibration cycles was estimated to be approximately 1000000 to 2000000[†]. Based upon the fatigue curve in Geelhood and Beyer relative to the stress amplitude for cyclic loading based upon the maximum strain measured in the shaker tests, it appears that a fatigue crack would not initiate in Zircaloy-4 cladding, Figure 5.5.

Figure 5.5 Stress amplitude based upon maximum strain measured in shaker tests relative to irradiated Zircaloy-4 fatigue curve.
