Subject: ***Certification and Submittal of Solid Waste Management Unit (SWMU) Assessment Report for Building 9960 Surface Discharge, Sandia National Laboratories/New Mexico, April 2015, Environmental Protection Agency, Identification Number NM5890110518***

**SWMU ASSESSMENT REPORT FOR
BUILDING 9960 SURFACE DISCHARGE
APRIL 2015**

SANDIA NATIONAL LABORATORIES, NEW MEXICO

APRIL 2015

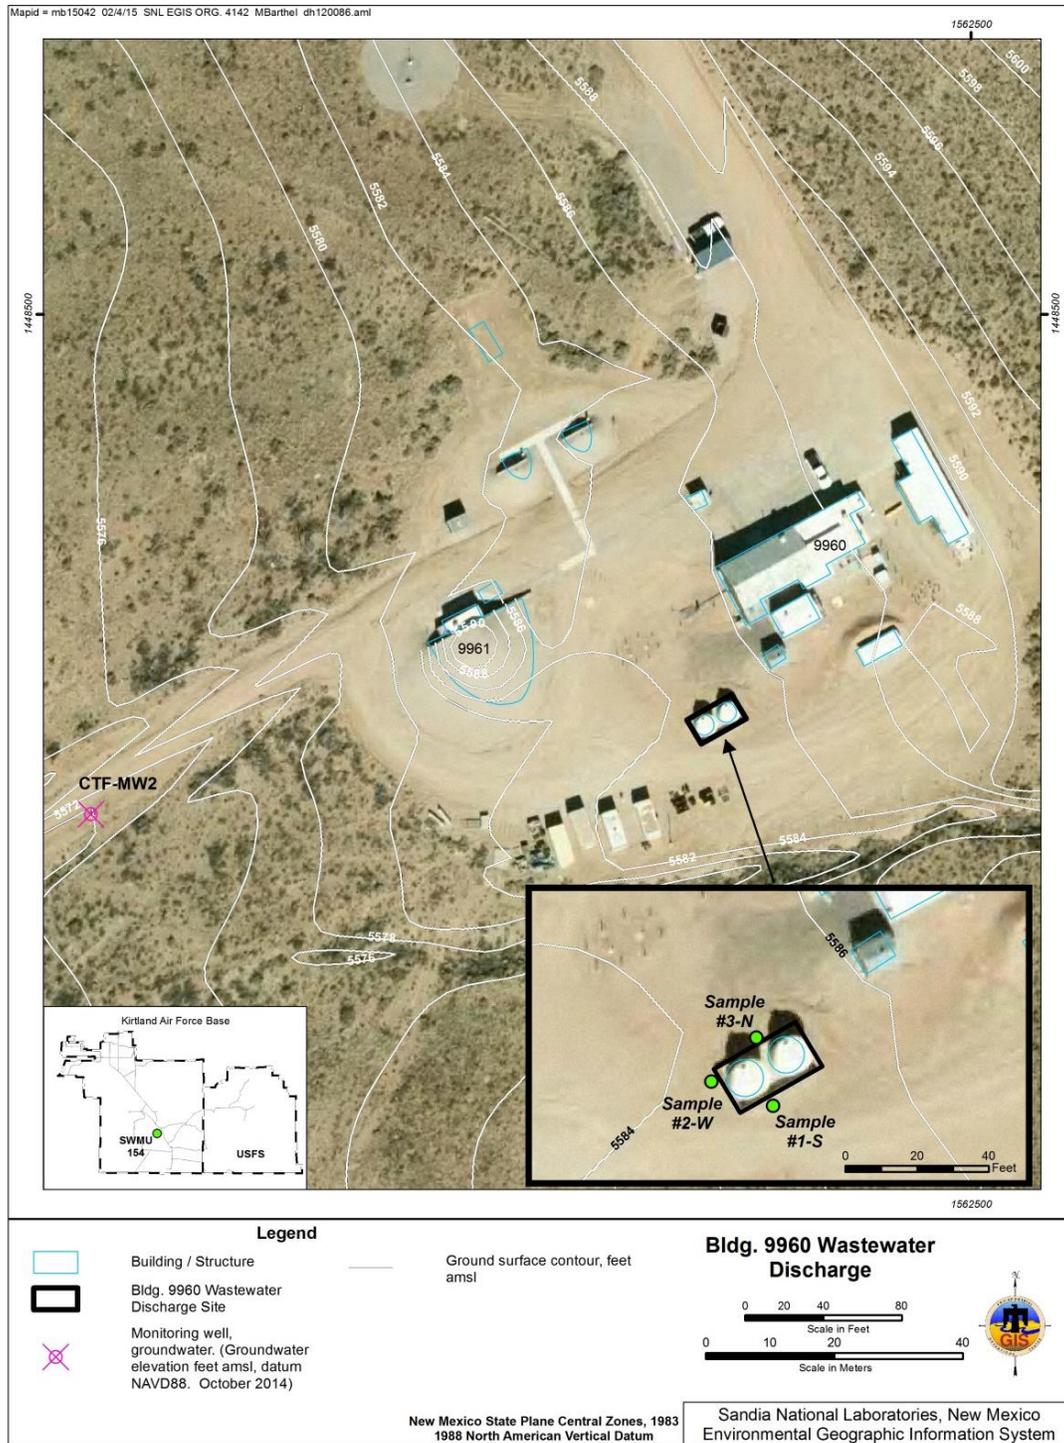
Figure 2-1
Building 9960 Site Location Map showing Soil Sample Locations

The Building 9960 wastewater storage tanks are located approximately 40 feet southwest of Building 9960 (Figure 2-1). Wastewater seeped from the secondary containment on the south, west, and north sides of the containment structure. Wastewater was not observed seeping from the east side of the secondary containment structure. Photos 1, 2, and 3 in Appendix A show the condition and extent of the spill on November 26, 2014, the day after the spill was reported by Building 9960 personnel. As shown in the photographs, the spill consisted of small, localized, surface areas adjacent to the containment structure perimeter. Wastewater was observed seeping through construction joints and small fractures in the concrete resulting in small discrete areas of damp soil. Free liquid was not observed. None of the spill areas extended more than 1 to 1.5 feet from the containment structure.

On December 10, 2014, Sandia ES&H personnel collected three discrete soil samples from the south, west, and north sides of the secondary containment structure at locations where damp soil was previously observed on November 26, 2014. The three samples are identified as #1-S, #2-W, and #3-N, respectively, and are shown in Figure 2-1. Biased-sample locations were selected to estimate worst case wastewater constituent concentrations in the soil. All sample locations were observed to be dry at the time of sample collection.

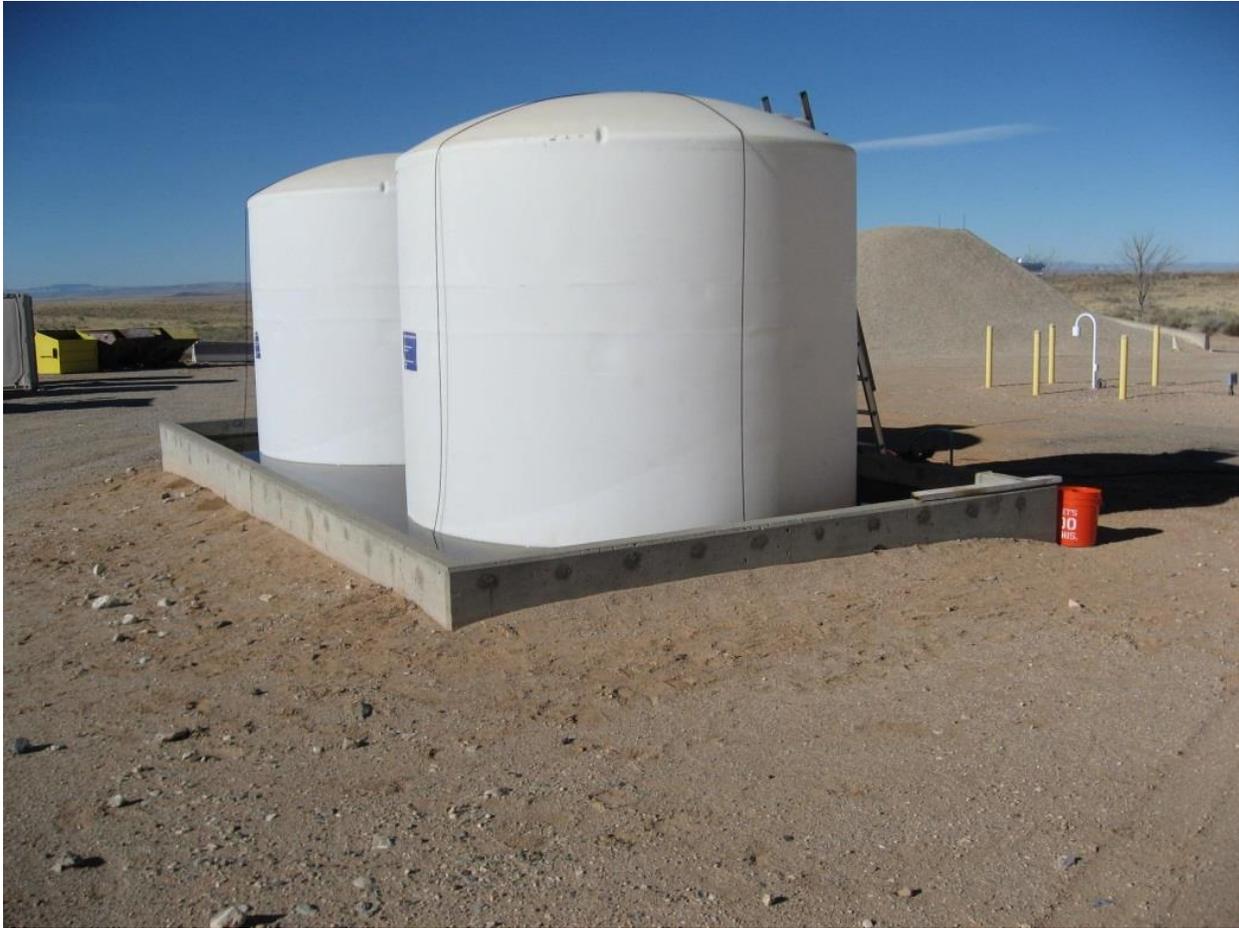
Photo 1

View to the west showing the east and south sides of the Building 9960 concrete secondary containment structure and holding tanks. Localized wastewater spill areas are visible near the southwest corner of the structure.

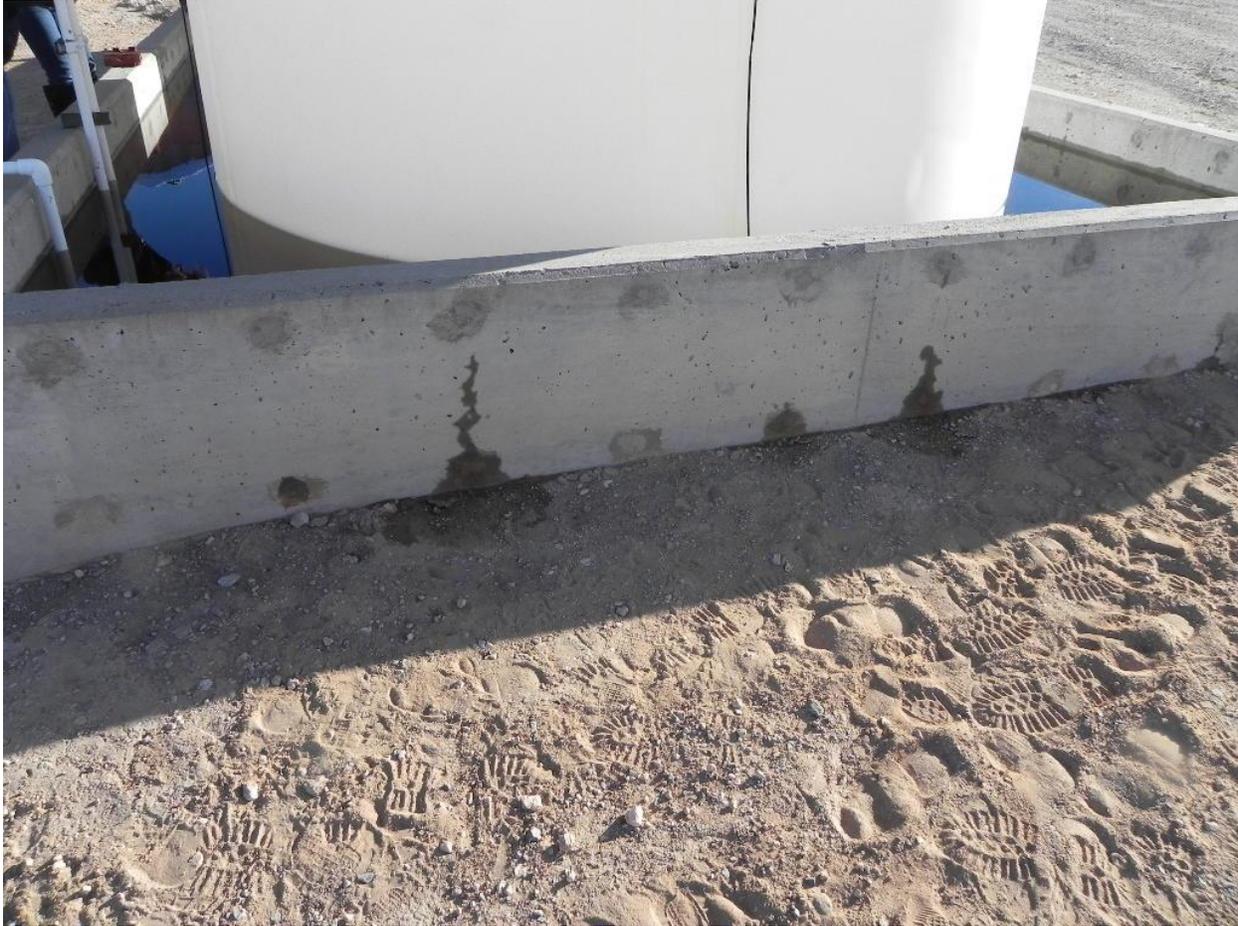
Photo 2

View of the west side of the Building 9960 concrete containment structure and holding tank. Localized wastewater spill areas are visible in the foreground.

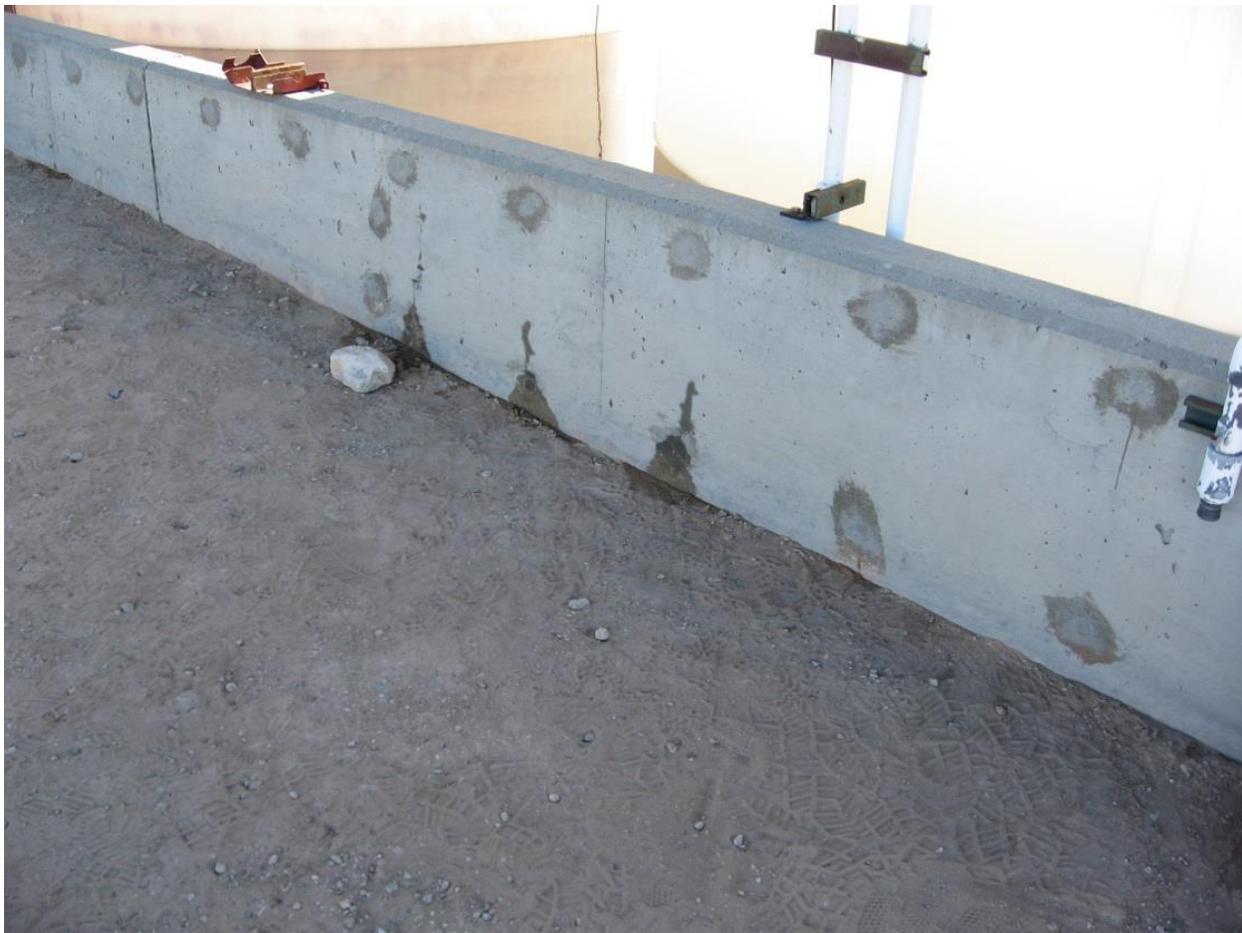
Photo 3

View of the north side of the concrete containment structure and holding tank.
