# SANDIA REPORT

SAND2015-2369

## Intermediate-scale Fire Performance of Composite Panels under Varying Loads

## Abstract

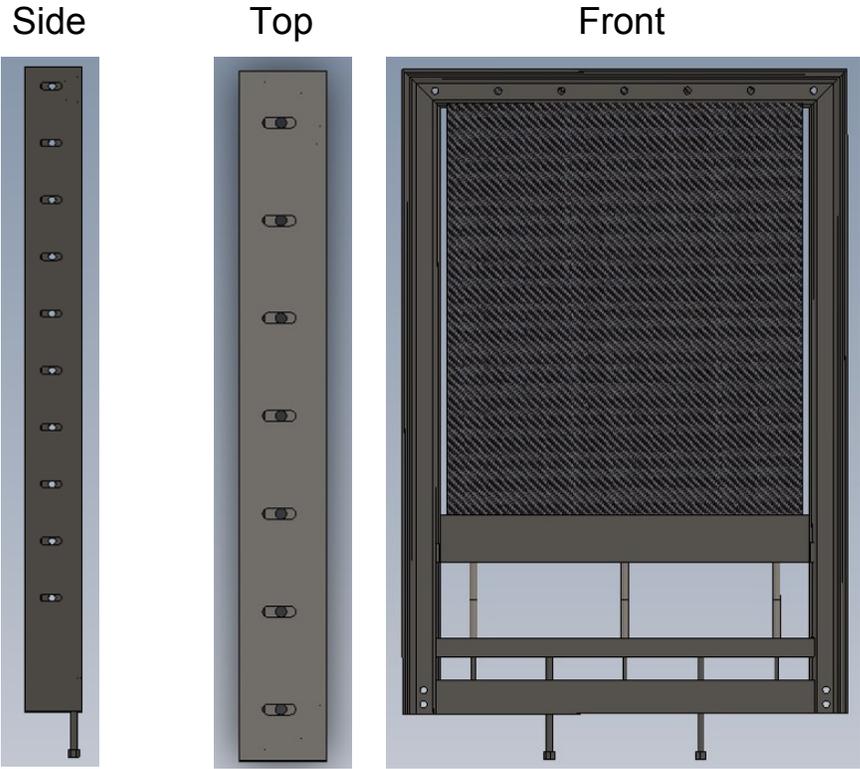
**Figure 4. Three views of the compression structural test rig.**

The first configuration used in testing was designed to put the panel in compression as it was subjected to the fire-like conditions. Drawings of this configuration are illustrated in Figure 4.

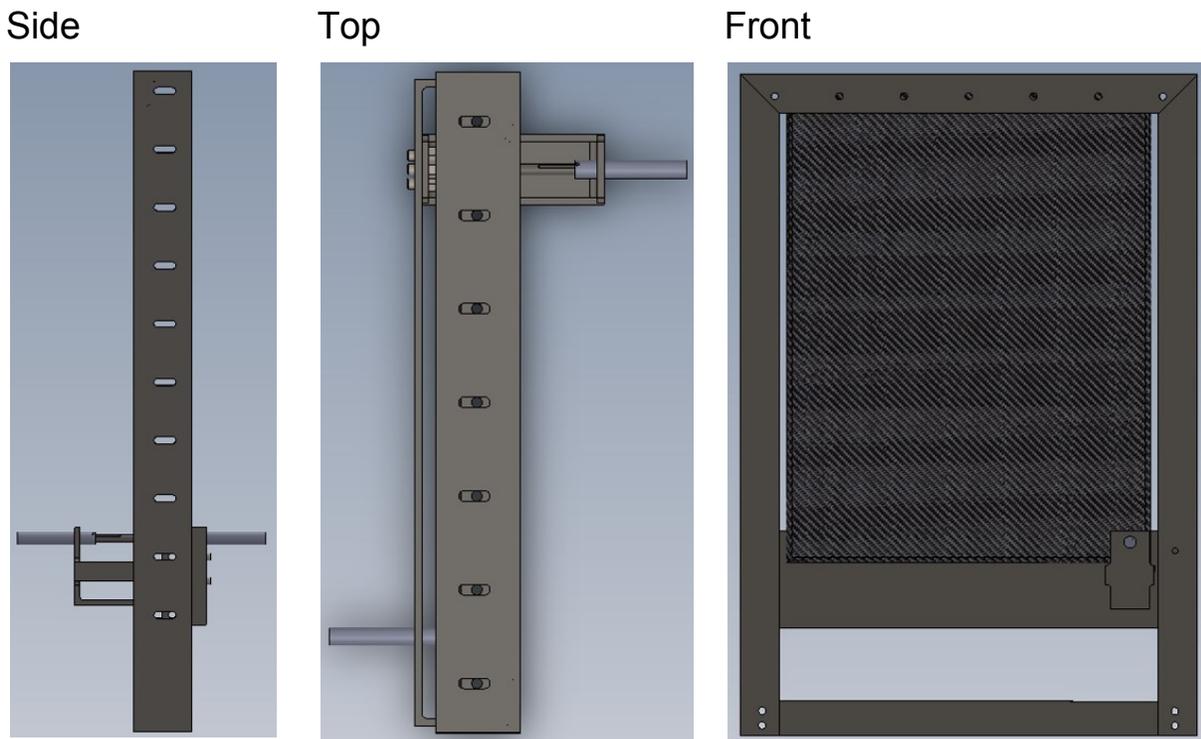
**Figure 6. Three views of the torsional structural test rig.**

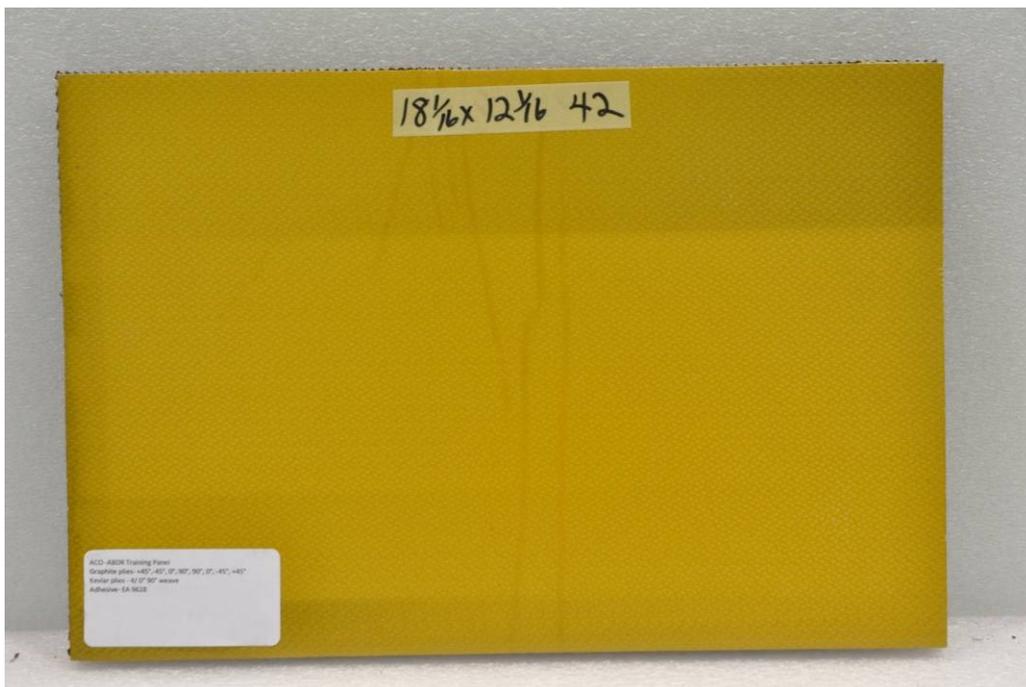
**Figure 7. A photograph of an ABDR panel, the Kevlar (back) side.**

Three principal materials are the subject of this testing. The **first** material is a sandwich board composed of unidirectional layers of Cytec 5208/T-300-12 with a +45, -45, 0, 90, 90, 0, -45 +45 lay-up (about 1.5 mm thick), a HRP-3/16 core (NOMEX, about 25 mm thick), and an 8-layer fabric Kevlar epoxy fabricated in a 0/90 x 4 lay-up (about 1 mm thick). The layers are adhered with HYSOL EA 9628 adhesive. The sandwich boards are termed Advanced Battle Damage Repair panels (henceforth abbreviated as ABDR panels or ABDR sandwich panels), and they are nominally 30.5 cm by 45.7 cm (12" x 18") in dimension. They were acquired from the US Air Force, and are understood to be used to train students on the repair of composite airframes. These weigh about 0.45 kg (1 lb) each. Figure 7 and Figure 8 show photographs of an example part. These materials were contributed to the study by the Hill AFB Advanced Composite office. The **second** material was obtained from Composite Tooling Corporation, and consisted of 16 layers of a unidirectional IM7G/8551-7A Hercules carbon fiber prepared with varying rotations. The exact lay-up is (0/90/-45/+45/-45/+45/90/0/0/90/+45/-45/+45/-45/90/0), with two of these being placed together to get the thickness to where they were tested. These are 3.2 mm thick, and 48.7 cm x 61.0 cm in dimension (1/8" thick, and 19 3/16" x 24"). These panels are henceforth called 19x24 thin panels. They weigh approximately 1.4 kg (3 lbs). These were cut from a single 1.22 x 2.44 m (4 x 8 foot) panel, and there

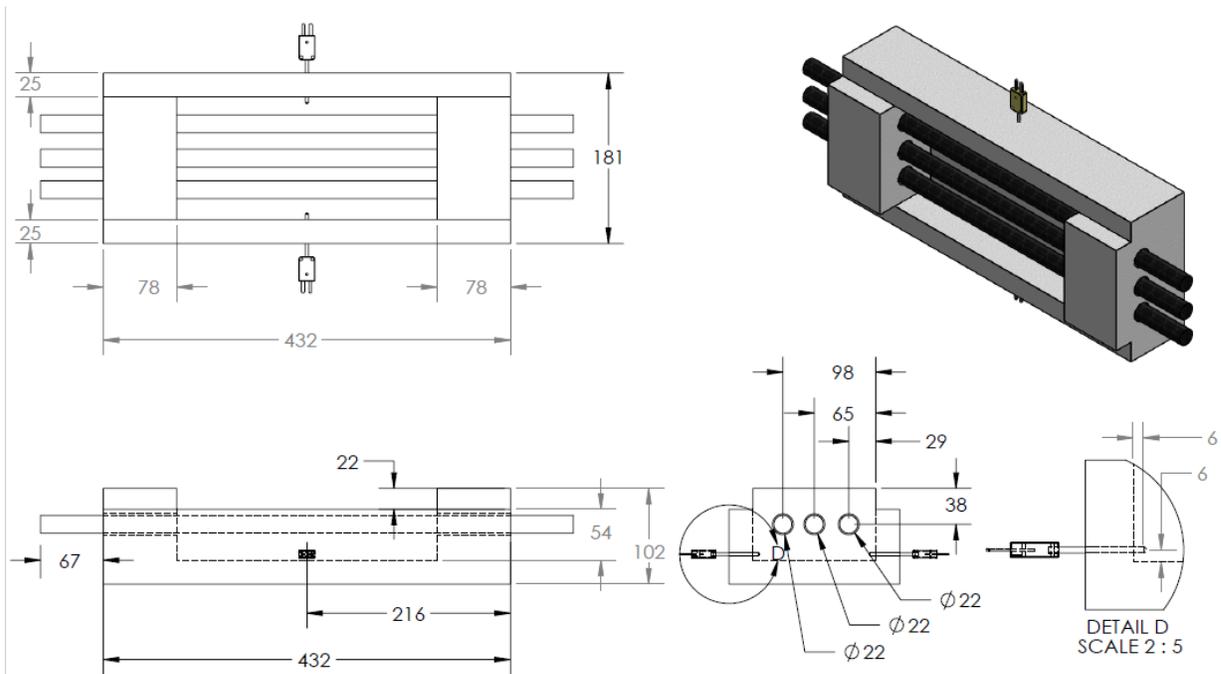
**Figure 10. Engineering drawings of the insulated box (units in mm).**

A drawing of the oven box assembly is found in Figure 10. It was constructed by screwing together various cuts of the insulation board with standard iron based board screws.

To understand the repeatability of each test, two thermocouples were placed at fixed locations within each oven as illustrated in Figure 10. These monitored the temperature of the oven, and provided the control room with a good indicator of repeatability and of abnormalities in tests. Both ovens and rods had a finite lifetime. A total of 8 oven boxes were constructed, and seven rods were used (three at a time). Test 38 is omitted because a rod exploded early in the test, rendering the data and panel less useful. The thermal environment was controlled by the electrical supply settings, which were actively measured and shown to be consistent from test to test to within two decimal places.

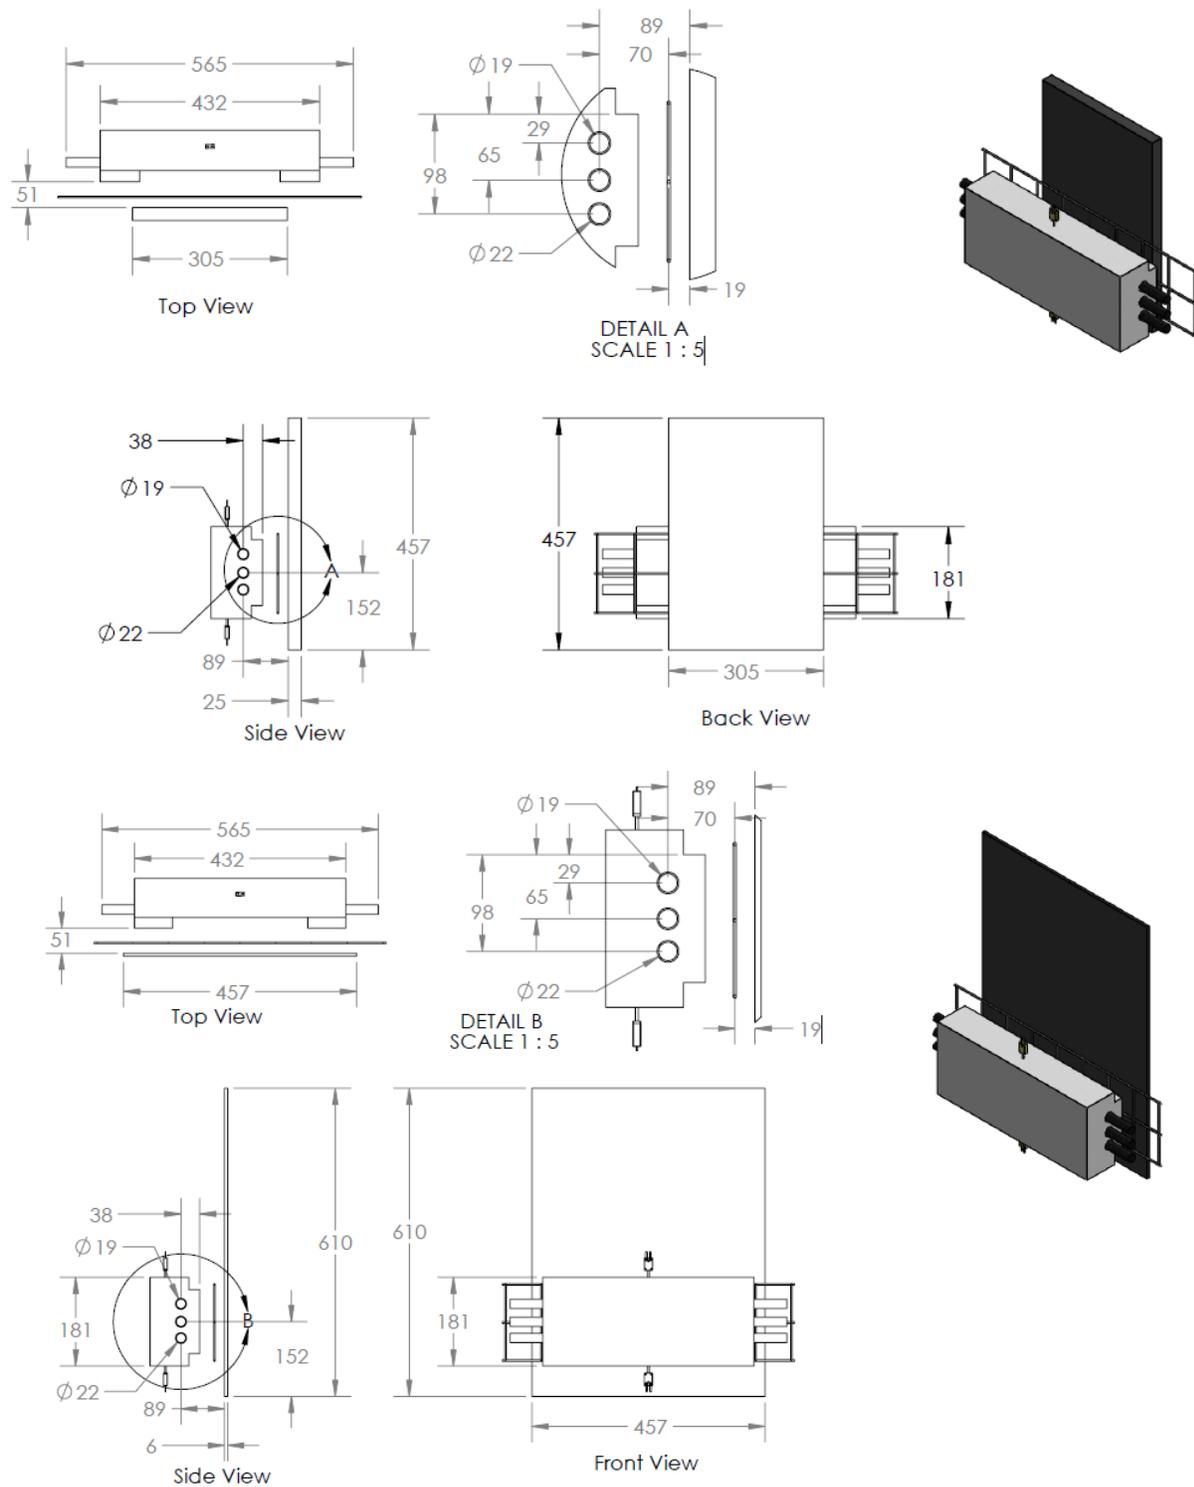
**Figure 11. Engineering drawings of the assembly for the ABDR (top) and 18x24 thick (bottom) panel tests (units in mm).**

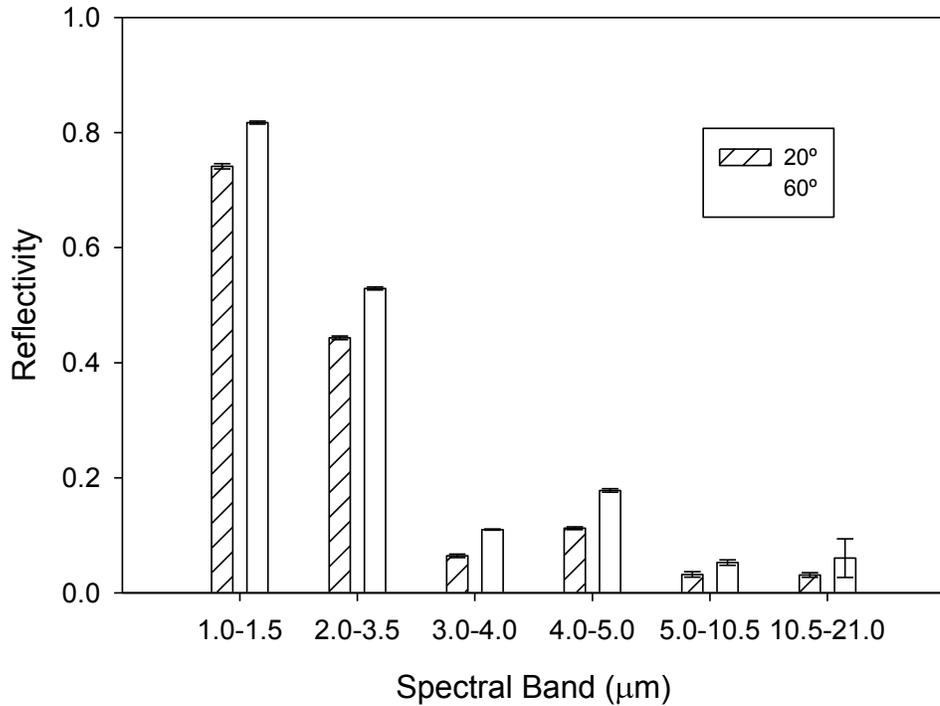
**Figure 12. Measured reflectivity of the oven insulation.**

Reflectivity of the oven insulation material was measured with the reflectometer (described later in this chapter). This helps characterize the spectral emissivity, suggesting low emissivity at visible and near IR ranges, but a very high emissivity in the deep IR. These data are found in Figure 12. Error bars are mostly quite small, and are a single standard deviation in magnitude from three measurements.

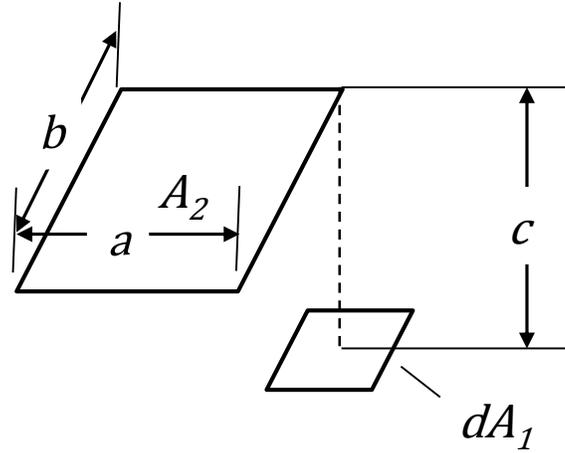
**Figure 14. View factor equations for calculating heat flux from rectangles to surfaces a fixed distance away.**

Relations were found for flux from three 1400°C rods to a surface at a distance from the rods. After gaining operational experience through check-out testing and examinations with the IR camera, the oven thermocouple temperatures were believed to be representative of the oven insulation temperature. The low-emissivity oven is thought to behave like a cavity, reflecting much of the incident radiation from the rods and re-radiating to appear close to a black-body at the thermocouple temperature. Emissivity was assumed to be 0.9 for the rods and for the oven. The oven was modeled using the Siegel and Howell (1992) Appendix C relations found reproduced in Figure 14.

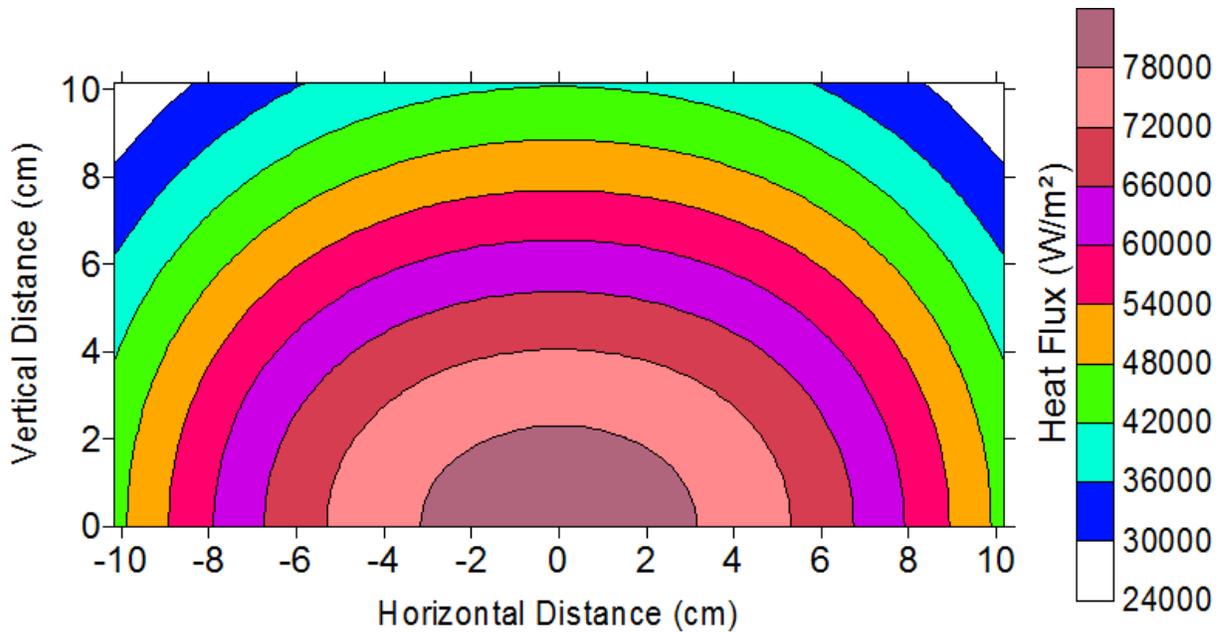
**Figure 15. Predicted radiative heat flux to the objective surface. Axis scales are distance in inches, contours are radiative flux in  $W/m^2$ .**

Geometric math is used to construct the view factors for calculating incident flux to a panel a given distance away. The model was then sampled at many locations over an area, and the plot found in Figure 15 was obtained. The key quantitative finding in this endeavor is that the peak fluxes to the panel will be above 50 kW/m<sup>2</sup>, which should be sufficient to assure char and fiber oxidation reactions occur once flaming subsides. Having made assumptions about emissivities and temperatures, the quantitative values are not thought to be particularly accurate. However, the qualitative relationships are thought to be reasonably representative. Thus, the model predictions are taken as good indicators of the peak flux location, and the relative drop-off in flux moving away from the peak region.

This model ignores the flux contributions of hot objects other than the core oven around the panel. It also ignores the full width of the oven, only modeling ~20 cm (8 inches) width. It is not expected to be fully accurate, and should give a low-end estimate of the actual flux. It is presented because it gives an estimate of the flux for a complex system that was helpful to the design team to understand the test conditions. The important finding from this was that the imposed radiative flux would be at least  $50 \text{ kW}/m^2$ , helping to assure fiber and char combustion once flaming had subsided.

These data are also significantly higher in magnitude than those plotted in Figure 15. Those predictions did not take into account the full extent of the oven or convection. It is therefore not surprising that modeled values are lower than measured values. The magnitude of the difference, however, is somewhat surprising. We consequently expect that the shape of the actual thermal environment contours look more like what is plotted in Figure 15, but the general magnitude to be closer to that found in Figure 19. Vertical scale is also inconsistent between the two figures. The oven was shifted up from the original zero point to resolve data below the horizontal plane of symmetry for the oven.

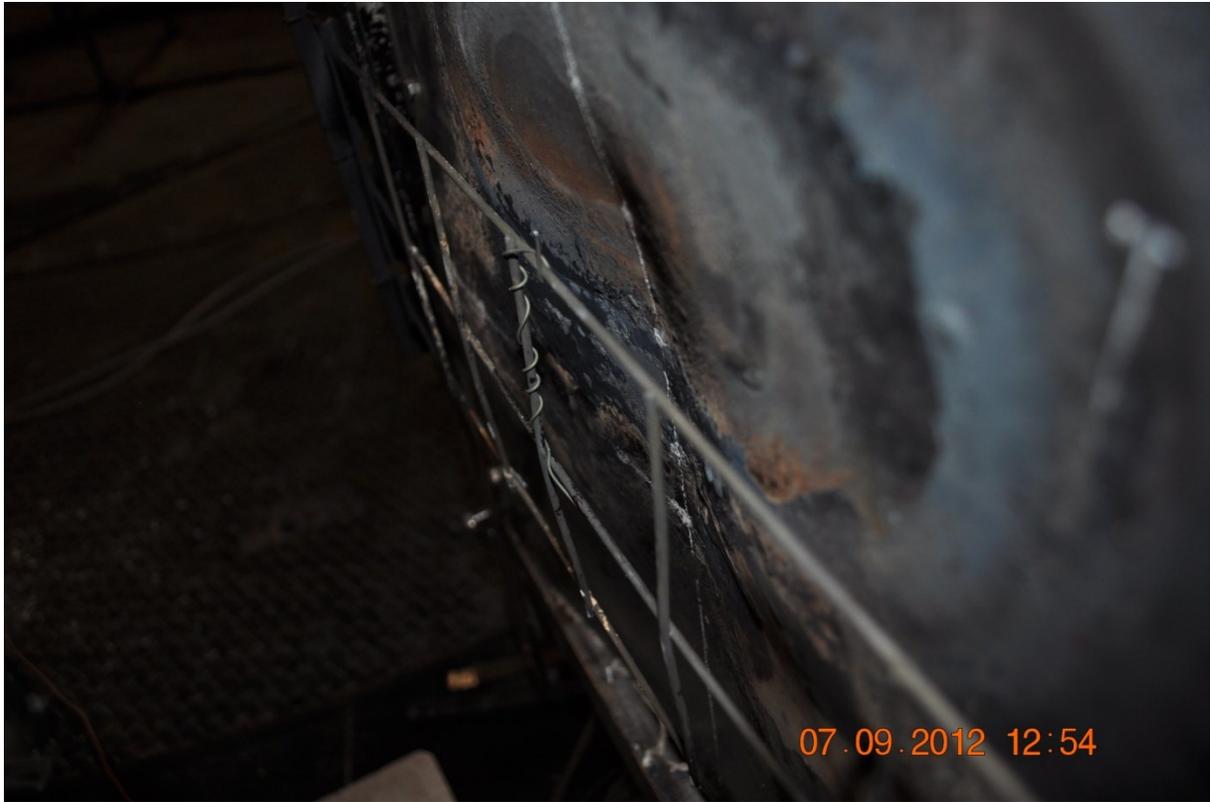
**Figure 17. A photograph of the plate showing the significant distortions and wear of the panel.**

Because the plate was used extensively in pre-test characterization of the heat source and it took several iterations to select the source, the plate was well used by the time characterization was performed with the oven box. The paint was removed in areas, and the plate had warped significantly in areas, as suggested by the photograph in Figure 17.

A consequence of the wear on the plate is that the data are not considered particularly accurate after interpretation. It would have been much better to take these data on a new plate. Even with a new plate, some distortion and variability exists using this method to probe the environment created by the oven.

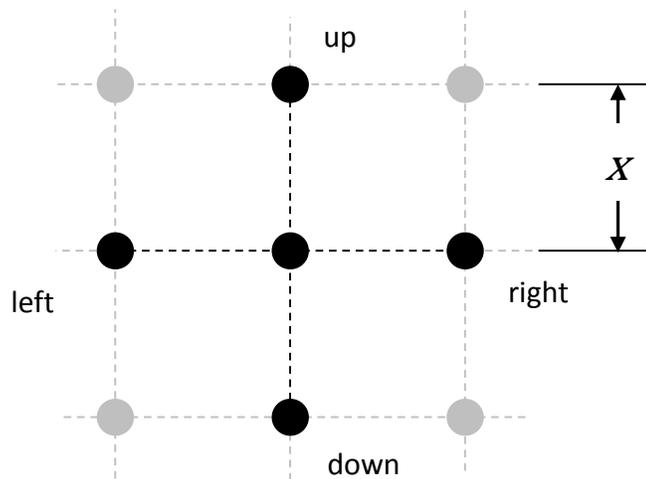
**Figure 18. An illustration of the finite difference convention for the conduction portion of the total heat flux calculation.**

Here,  $C_P$  is the specific heat,  $\tau$  the thickness, and  $\rho$  the density of the panel. The change in temperature with time is extracted at the reporting interval of the test data, over one second. Density was assumed constant at  $7854 \text{ kg/m}^3$ , and the specific heat constant at  $685 \text{ J/kg-K}$ . These were taken from tables found in heat transfer textbooks, with the specific heat taken at an intermediate average temperature ( $\sim 800 \text{ K}$ ) in the hot region. Thermal conductivity is required for the conduction term ( $k$ ), and is taken at the same temperature to be  $40 \text{ W/m-K}$  (Incropera and Dewitt, 1990). A finite difference assumption is made for the conduction. Each thermocouple had a neighbor, which was considered a finite difference point. A discretization approximation is made according to Figure 18, such that conductive flux may be calculated:

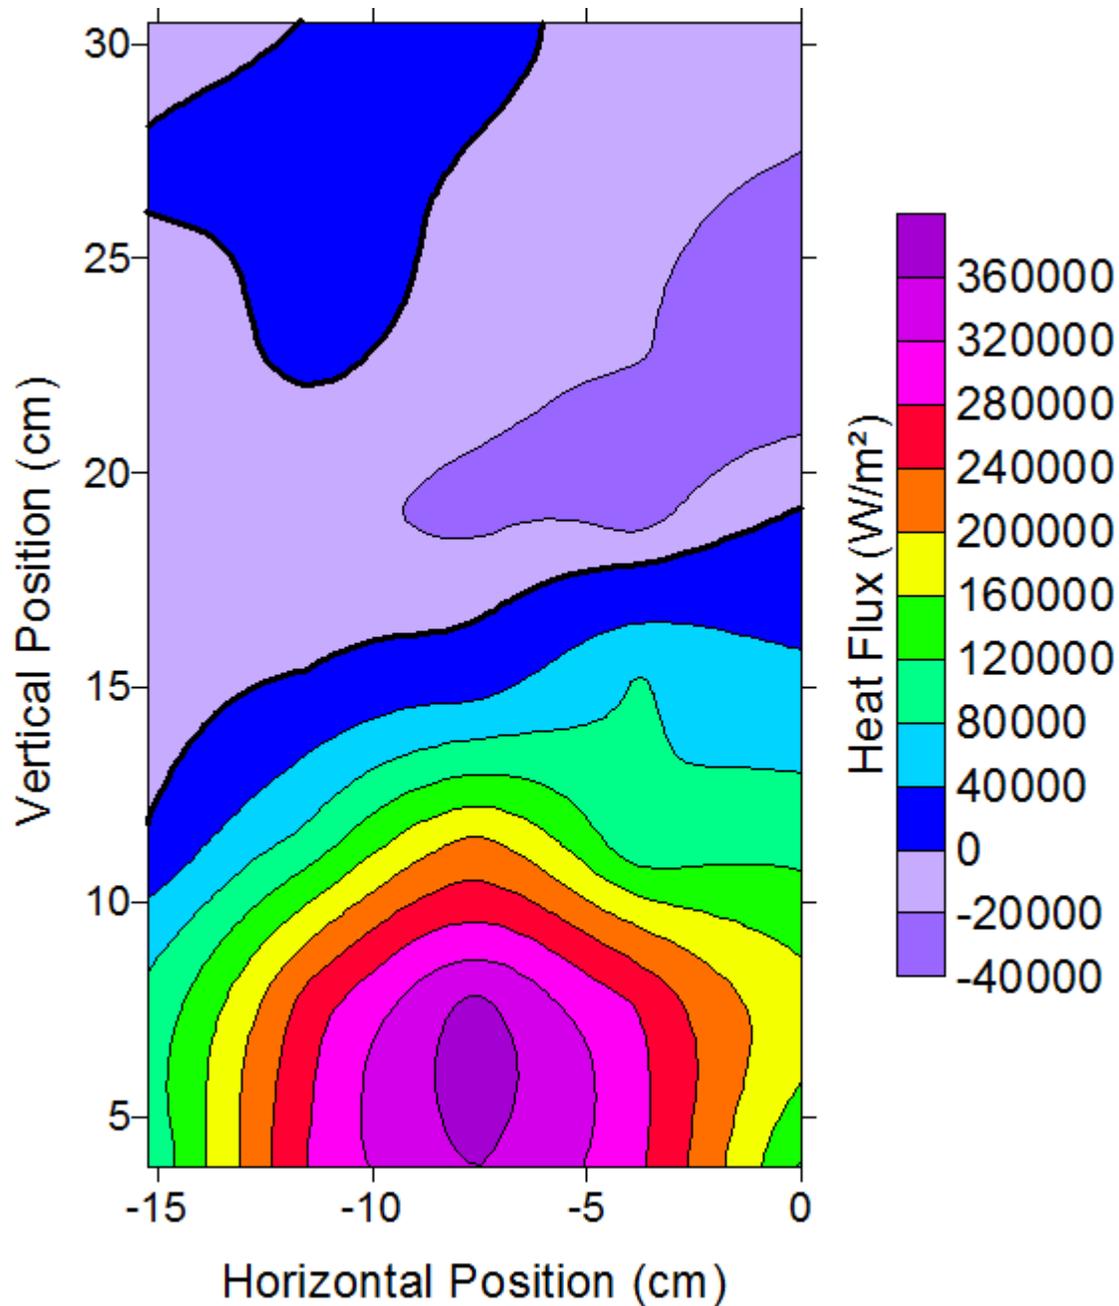
**Figure 19. Quantitative results from analysis of the plate thermocouple data.**

Figure 19 shows measured total flux from the assessment of the panel thermocouple readings. The zero horizontal point is the panel symmetry plane. The total flux was averaged over the main duration of the test. More details are found in the appendix. A surprising feature to this plot is that the peak flux is not located along the centerline. It is rather found about 7 cm in. This is believed to be an artifact of two previously identified issues, namely that the panel was bowed in at the centerline, and that the surface coating had worn off towards the center of the panel. Peak fluxes are also surprisingly high, which may be compensatory for the incorrect emissivity employed in the model to reduce the data. These data might be interpreted to mean that the center of the oven was colder than the edges, however the IR cameras frequently imaged the heated portion of the rods as well as the conduction through the panel, and the IR data do not support this interpretation.

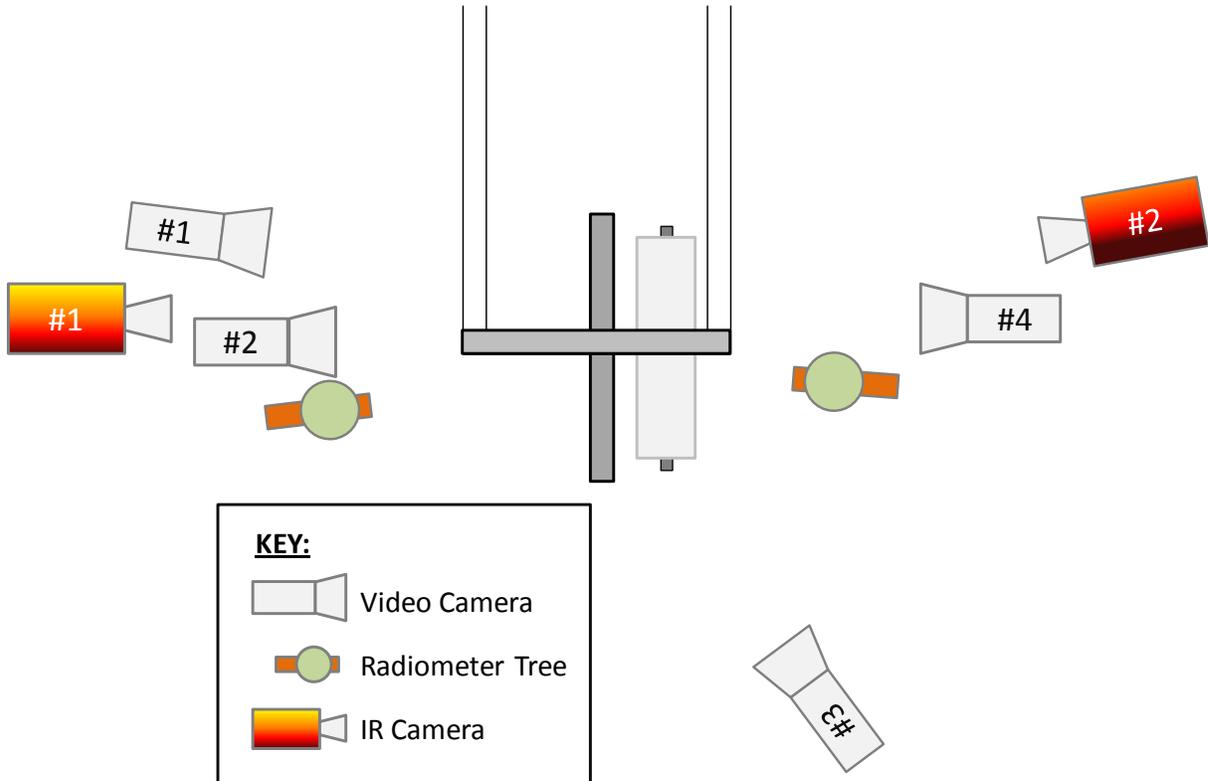
**Figure 20. A general layout of the camera and radiometer instrumentation.**

Because mass loss was key to the dataset, the test was designed such that no wires were hanging from the panel. Consequently, there are no thermocouple measurements on or around the target. Much of the rest of the instrumentation is designed to provide good environment data.

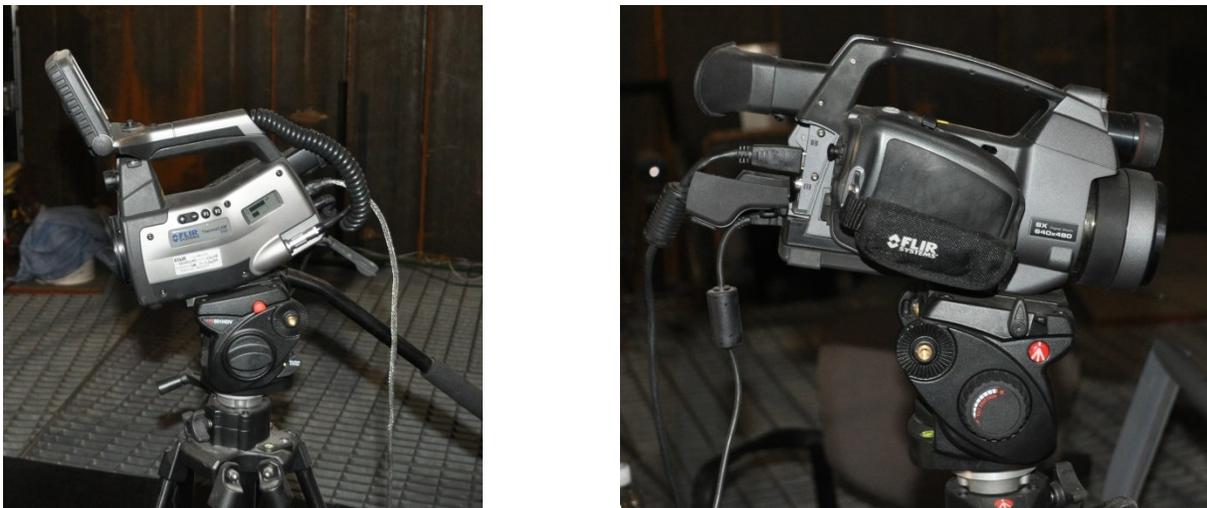
**Figure 21. Images of the IR cameras.**

Two FLIR cameras were pointed at the front and back faces of the panel during the test. A ThermaCAM® model S60 was located 178 cm distance from the back-side of the test. It recorded 640 x 480 images examining a spectral range of 7.5 to 13  $\mu\text{m}$ . A FLIR SC660 camera was situated 170 cm from the front side of the test, and recorded images with similar specifications. Images of the two instruments are found in Figure 21.

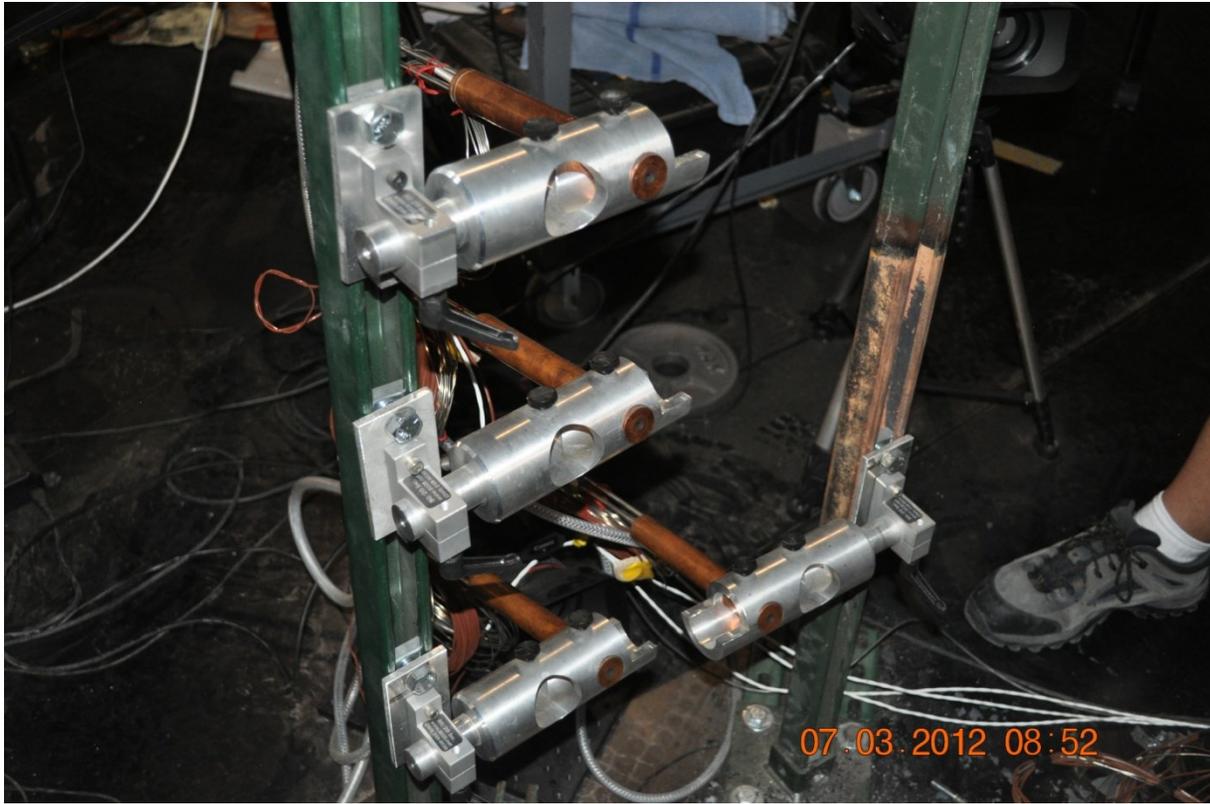
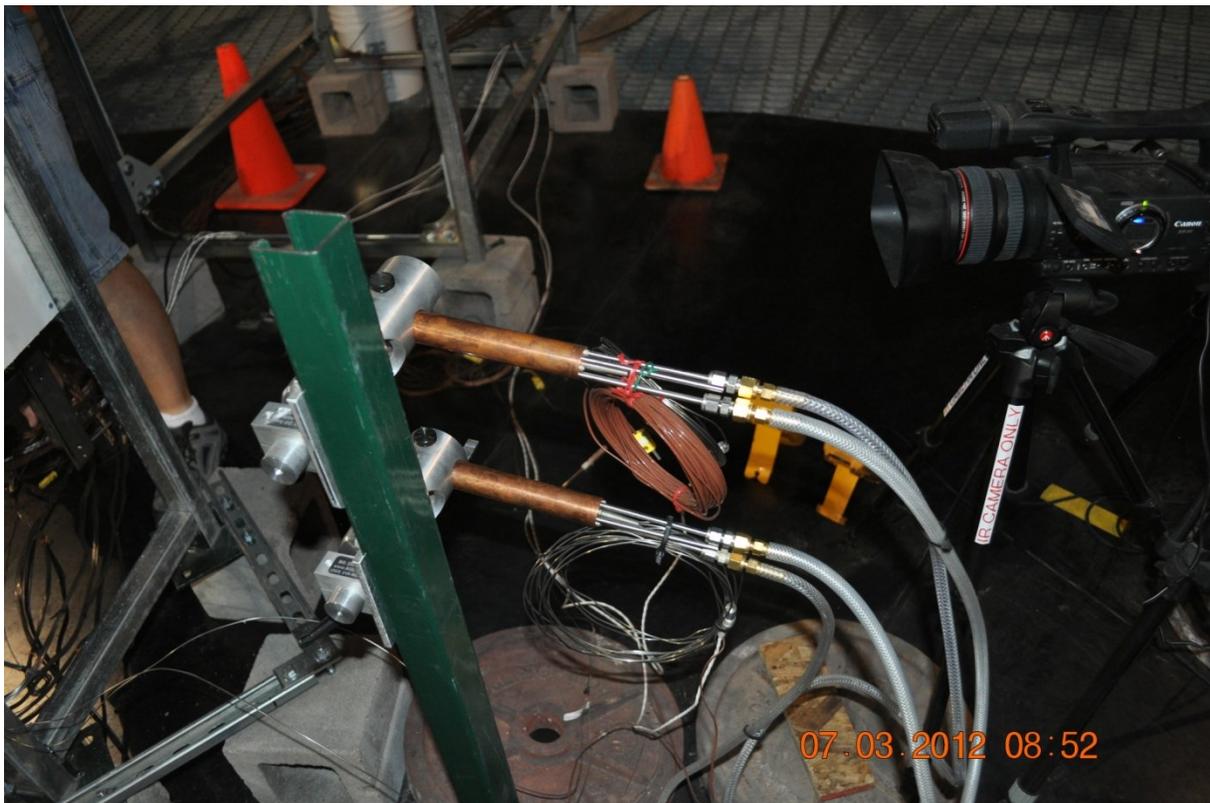
**Figure 22. Photographs of the radiometer towers.**

Unistrut® stands were constructed and used to mount the radiometers. Photographs of the front and back radiometer towers are shown in Figure 22.

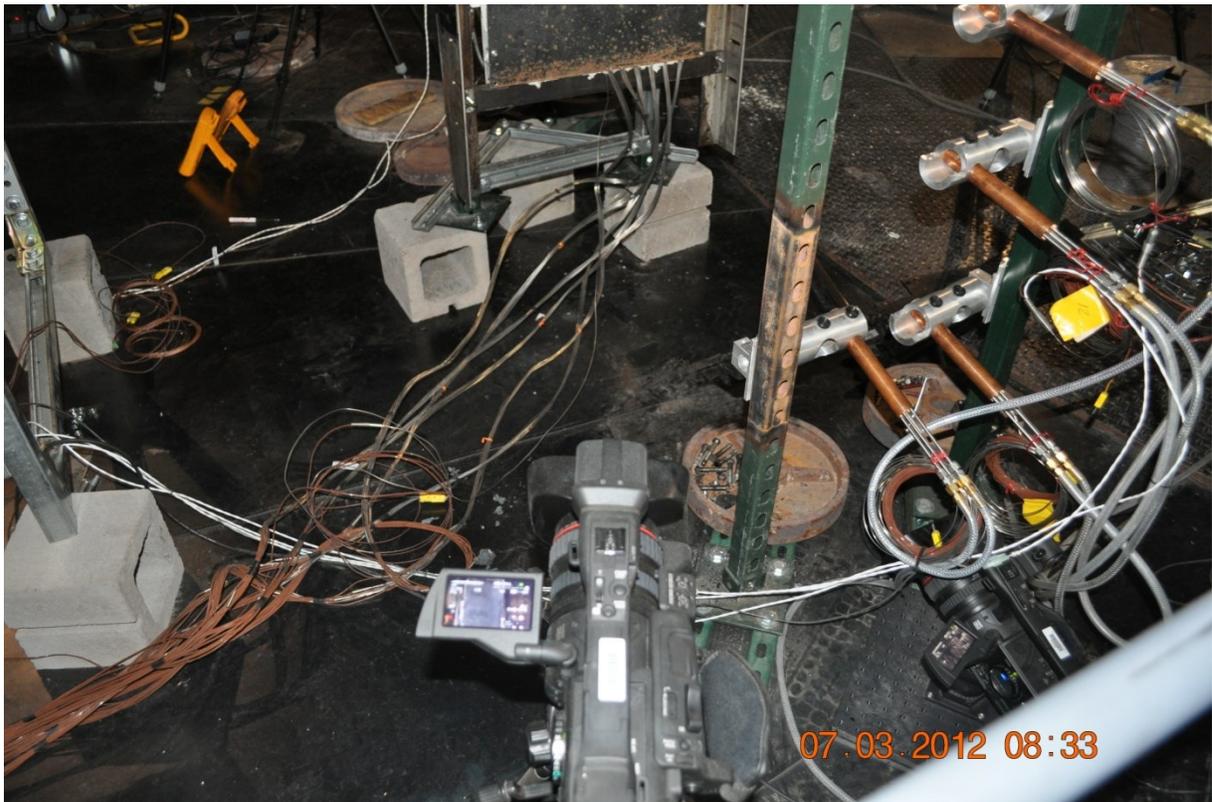
**Figure 23. Photographs of the test set-up for the oven characterization.**

Video was recorded with a series of Cannon XHA1 video cameras. Between three and four cameras were used, with a front, back, oblique, and spring camera recording the dynamics during the test. Data were recorded to tape media, with a capacity per tape of a little beyond one hour. In six instances, testing went beyond the duration of the tapes. In these cases, technologists would enter the chamber (otherwise vacant of personnel) and change out the tapes as necessary. Two of the video cameras are visible (#1 and #2) in the photograph found in Figure 23. The thermocouple instrumented metal panel is in the test holder in this photograph.

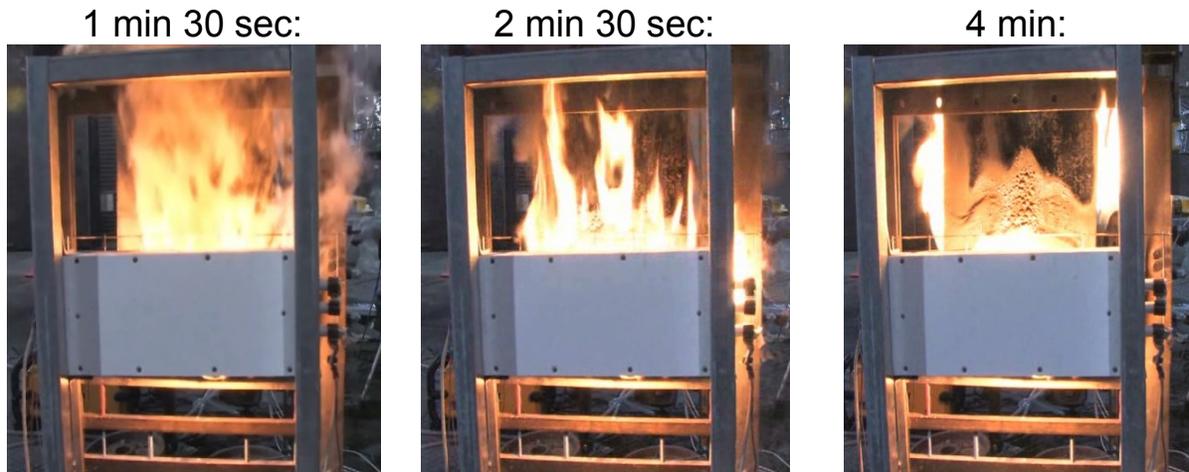
**Figure 24. Front side images for ABDR compression Test 24.**

periodically moving across the face, or at isolated locations along a fiber. A series of stills have been extracted during smoking, front face burning, and burning on the sides for each test. These are found in Figure 24 through Figure 30.

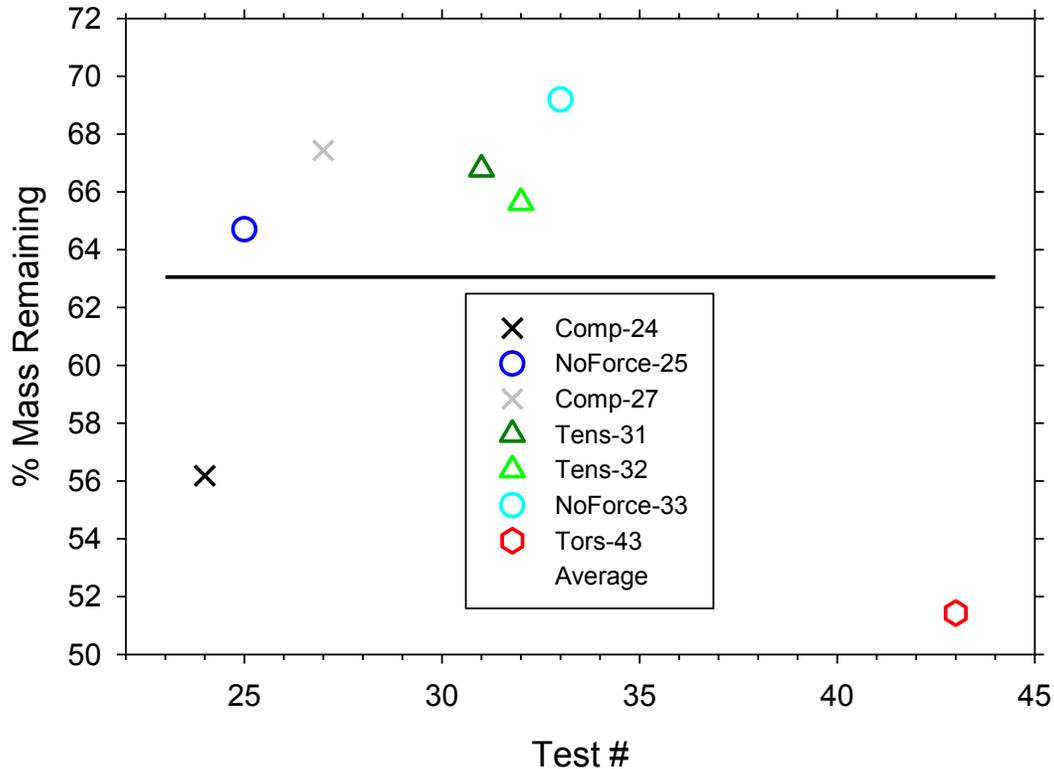
**Figure 31. Total mass loss summary for the ABDR panels.**

ABDR panels lost the most mass on a percentage basis, an average of 63.1% mass remaining with a variability between 51% and 69% mass remaining. Figure 31 shows the percentage of mass remaining for the ABDR panel tests. The torsion tests had the most mass lost, compared to compression and tension tests. The total mass lost varied widely for these tests. This is perhaps partly reflective of the variation in the amount of adhesive applied from panel to panel.

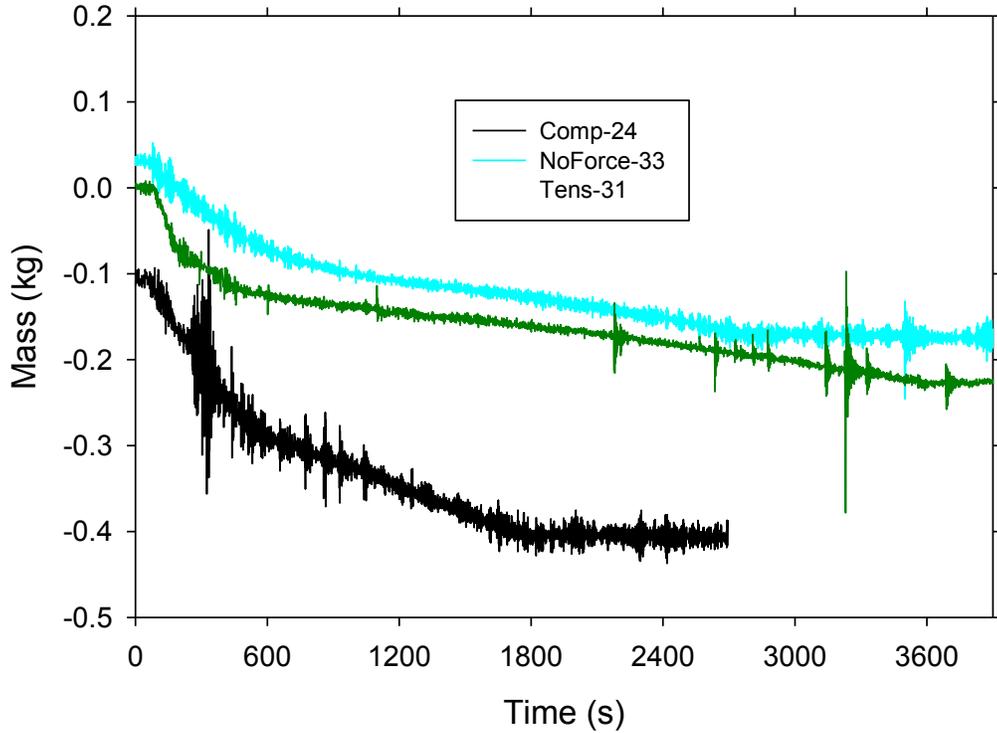
**Figure 32. Typical mass loss raw data for the ABDR panels.**

Example mass loss curves are shown in Figure 32 to illustrate typical raw data. Some amount of noise is found in the data, more so in the tests with structural loading.

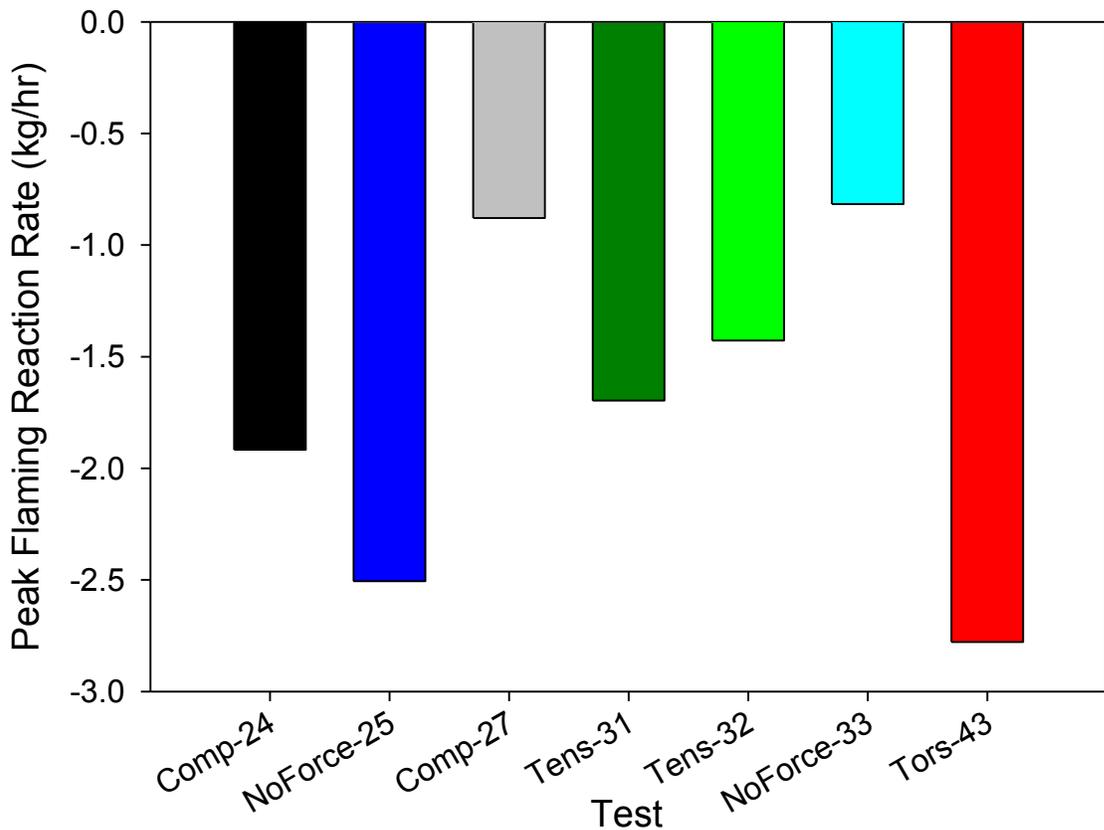
**Figure 34. Peak flaming reaction rate for the ABDR sandwich panels.**

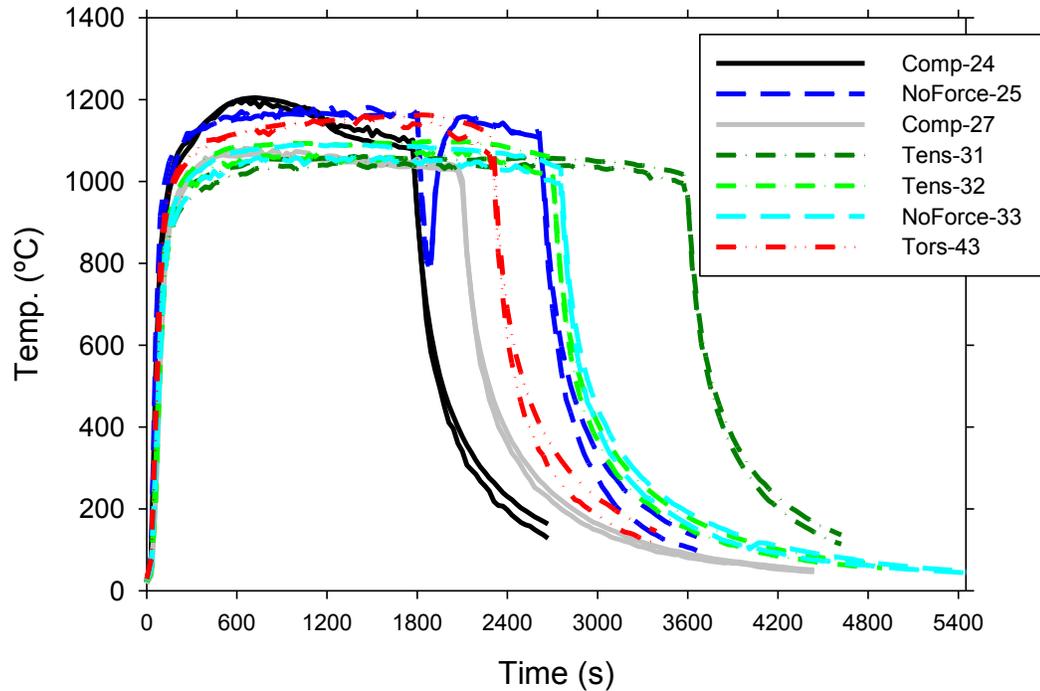
**Figure 37. Oven temperatures for the ABDR panel tests.**

In these tests, there was a lack of uniformity (most pronounced from test to test) in the oven temperature, as measured by two thermocouples located in the oven, with the range of steady-state oven temperatures falling between 1000-1200°C. Thermocouple locations are found in Figure 10, and are symmetrically oriented at the top and bottom of the furnace. Figure 37 shows the thermocouple readings for each ABDR panel test. Steady-state temperatures were typically constant, and the two thermocouples agree reasonably closely with each other for each test. Two features of this plot are of interest. First, Test 25 lost power briefly just after 1800 seconds. This was because one of the electrical components controlling the power supply went to sleep. This feature was disabled in future tests. Power was promptly restored, as is evident in the data. Also, notice that the thermocouple readings decrease slightly before the steep decline at the end of the test when the power to the furnace is turned off. This is because as a hole is formed in the panel, the oven is less able to maintain its steady-state temperature as when the panel was whole.
