# SANDIA REPORT

SAND2015-2369

## Intermediate-scale Fire Performance of Composite Panels under Varying Loads

## Abstract

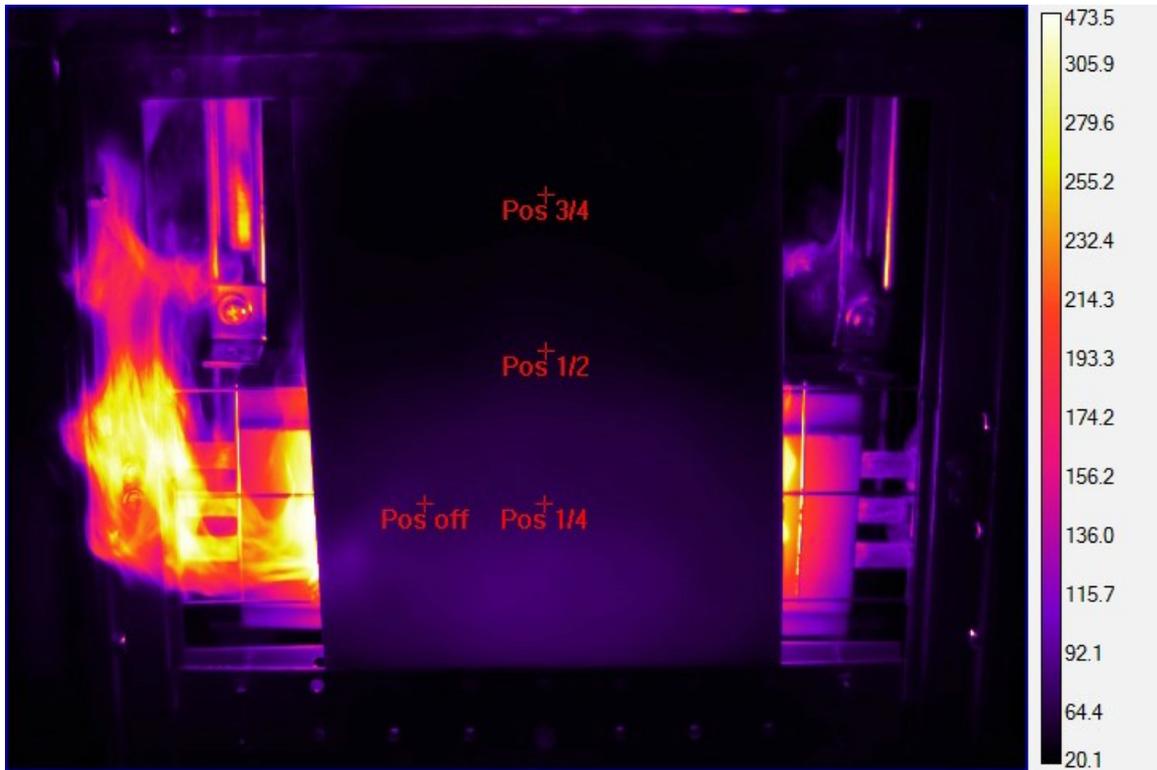
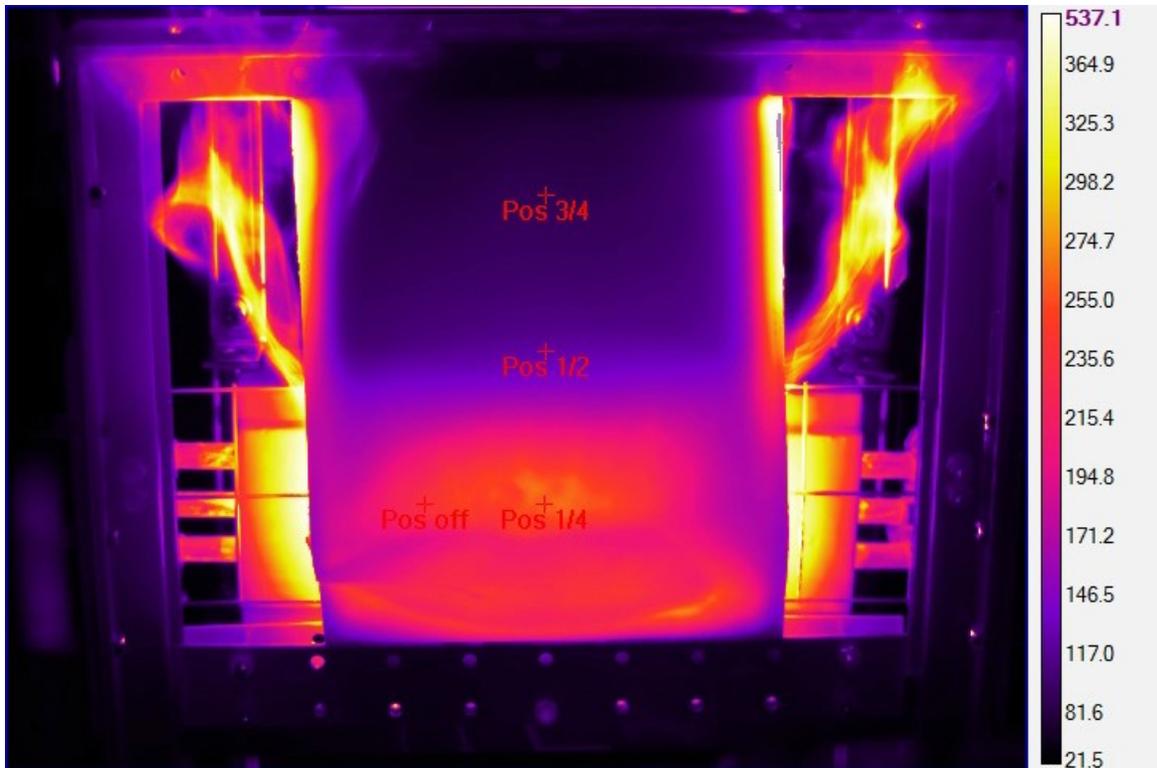
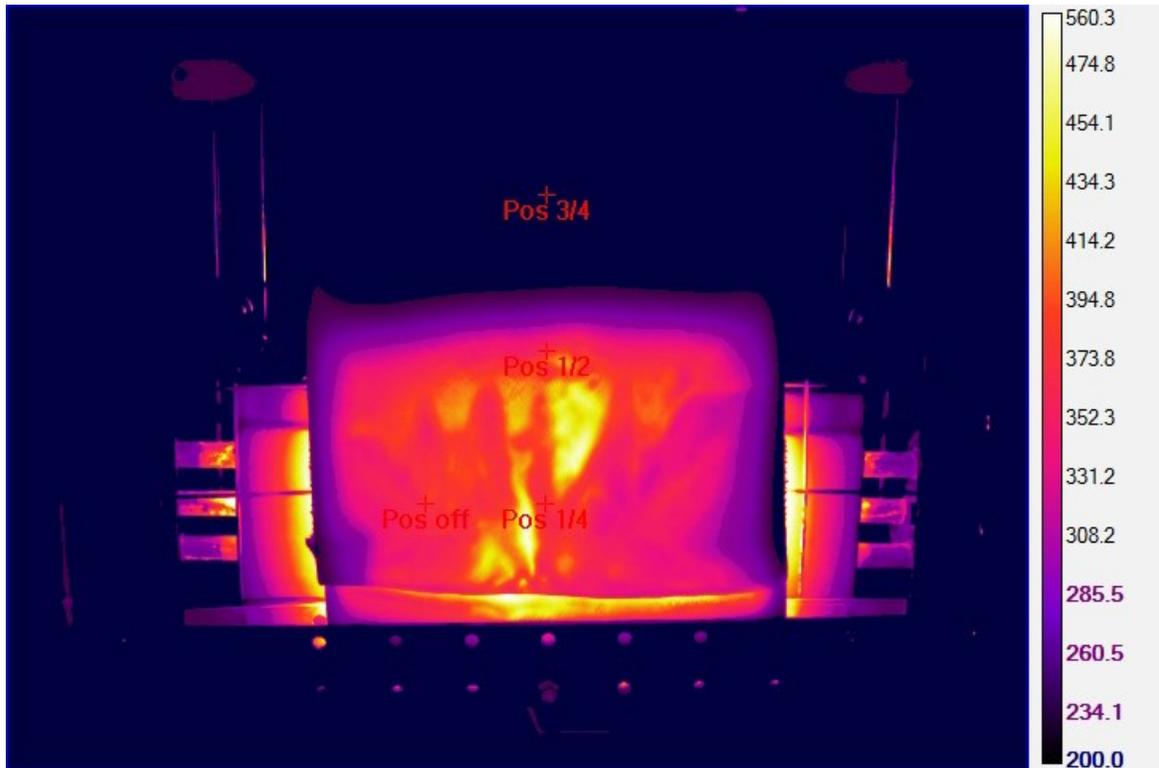
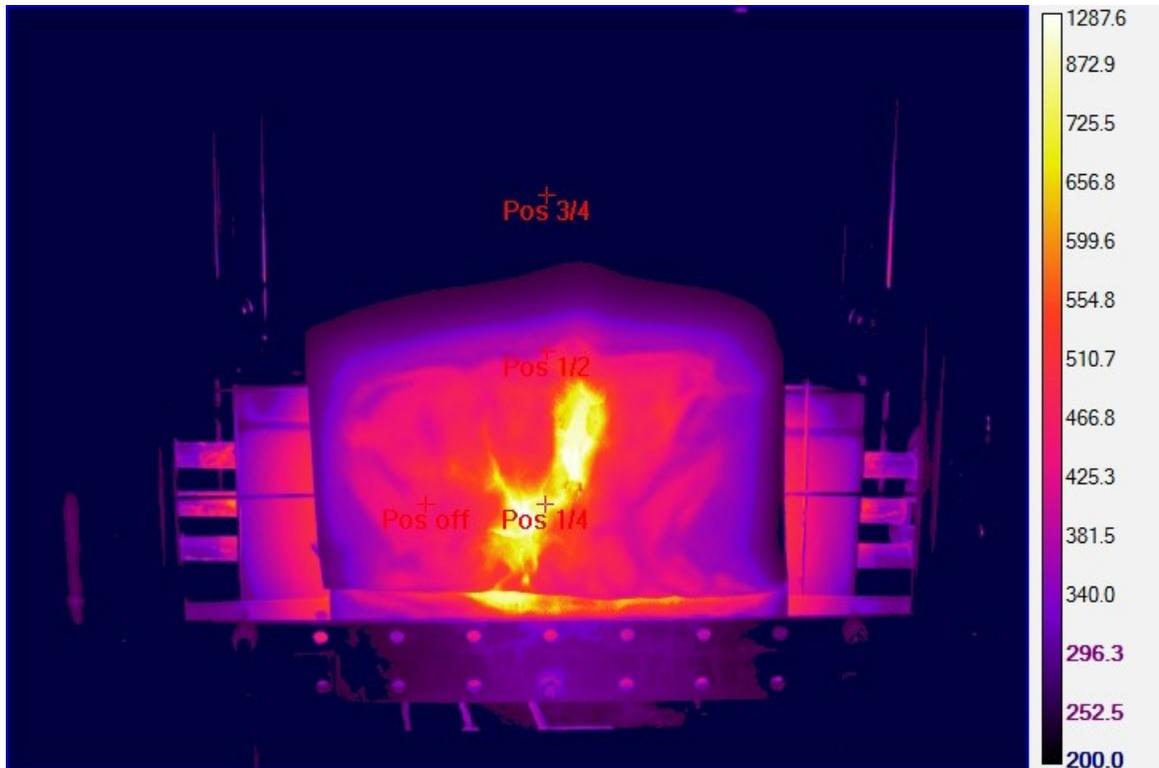
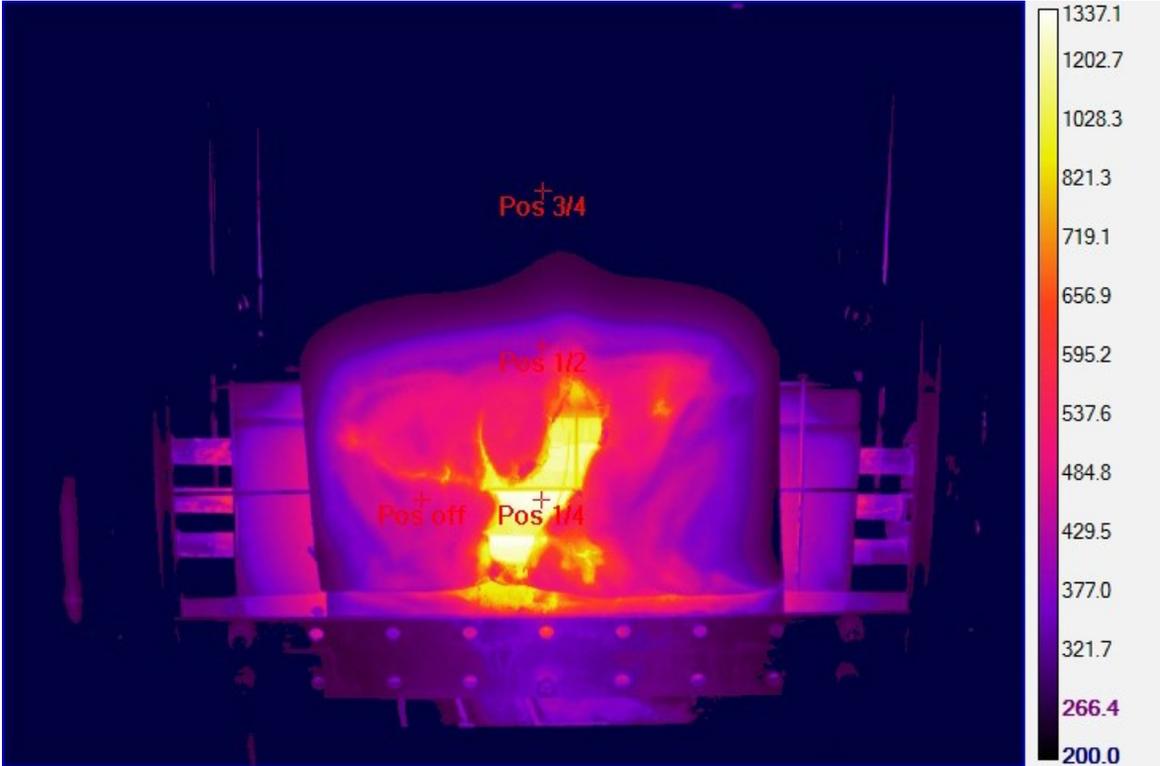
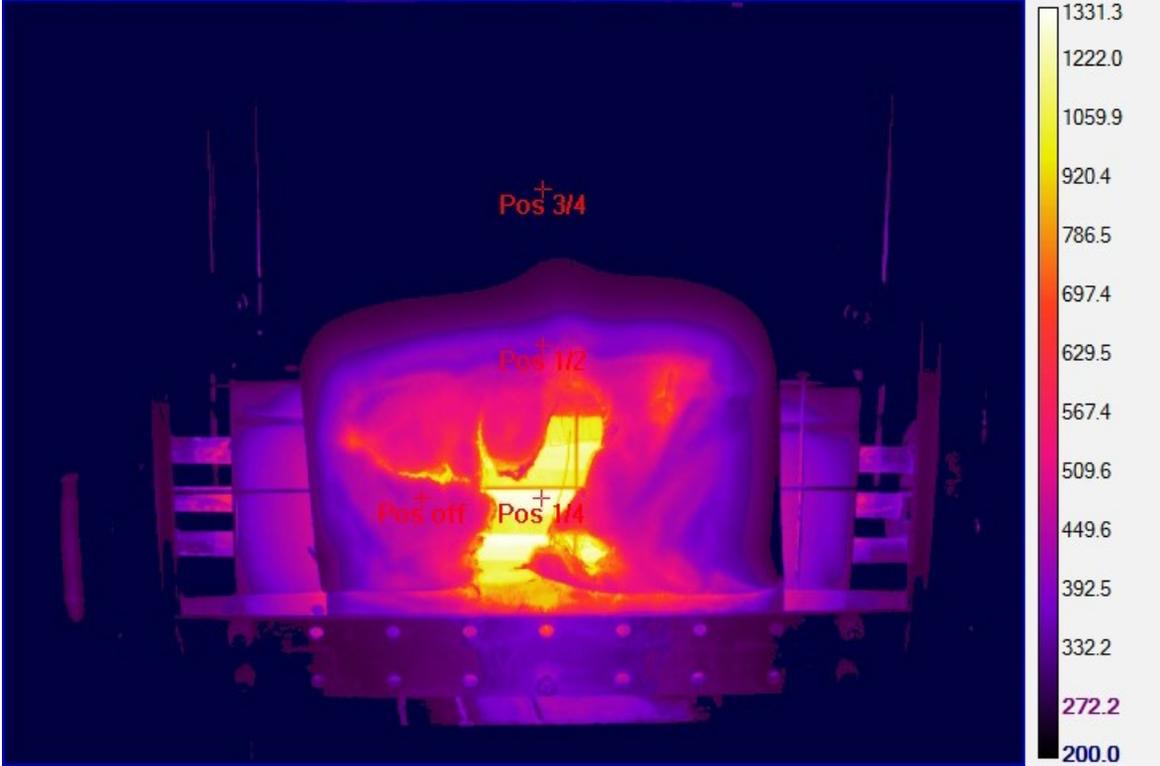
**Figure 44. IR camera images from Test 24, the ABRD sandwich panel is in compression.**

Figure 44 shows a series of selected images from the IR camera exhibiting a range of results found during Test 24. These and all subsequent IR images show a reproduction of the temperature in degrees Celcius that is based on a material emissivity of 1.0 assumption. Please note that the scale is dynamic, and different for every image frame.

The first image at 2 minutes and 17 seconds shows the back side shortly after the appearance of visible flaming on the sides of the panel. The ABDR panels were prone to burn at the sides due to the exposed honeycomb at the edges. At this time, flaming was predominantly to one side, and significant jetting is seen. The panel is in the early phases of heat-up.

At 10 minutes, there is a significant fold that can be seen on the back side that was caused by the compressive force near the bottom of the panel. The back-side thermal contours are not smooth. Rather, random hot points appear to suggest some irregularities in the decomposition of the panel despite a presumably somewhat smooth oven heating profile.

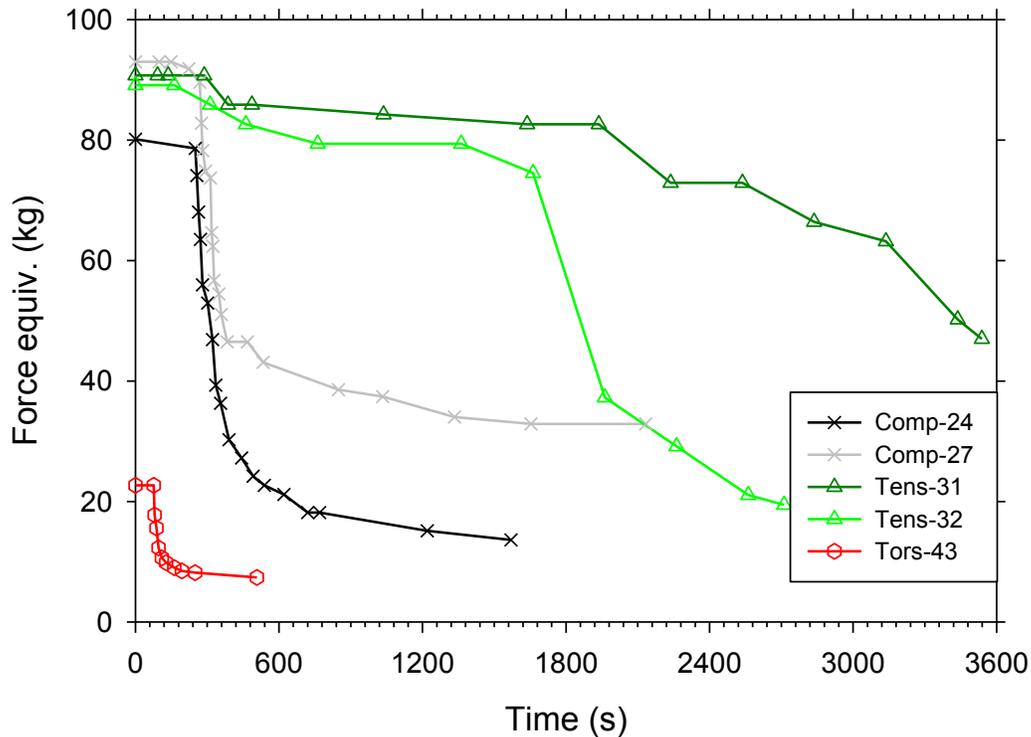
**Figure 45. Mass equivalent force on the ABDR panels as a function of time.**

Some discrepancies exist between the results of Table 6 and Figure 45. The start times were subjective and based on a wider angle view in the table. The figure reflects a more detailed view of the occurrence. More subtle motion is captured in the figure.

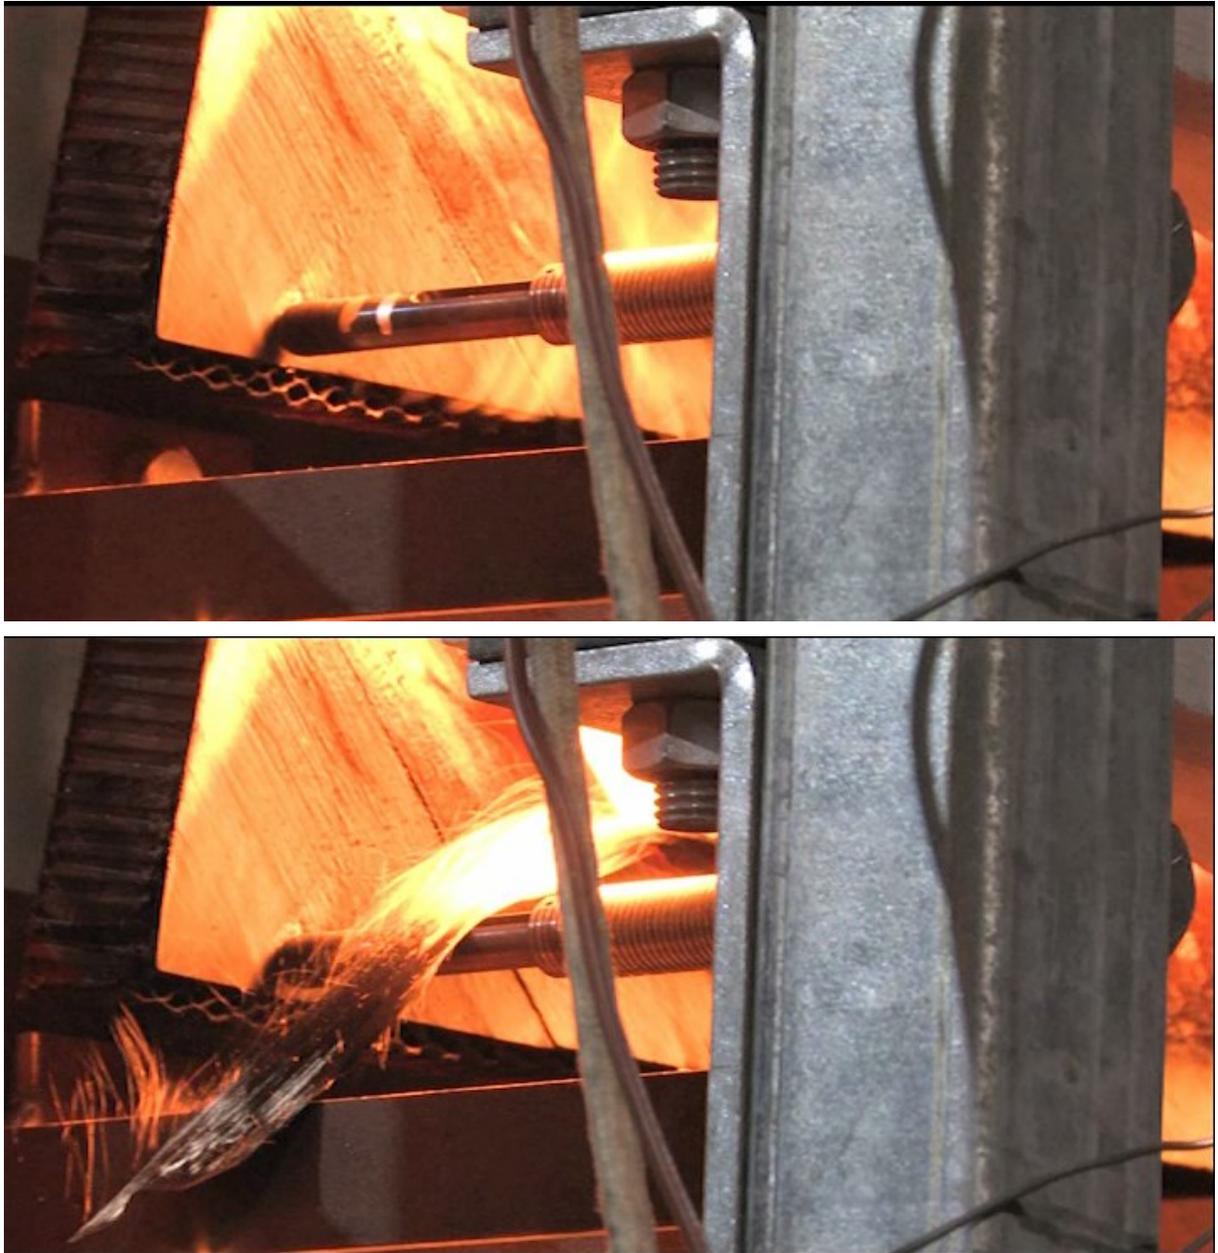
**Figure 46. Photographs of the Test 43 ABDR panel in torsion before and after the first significant movement of the fibers.**

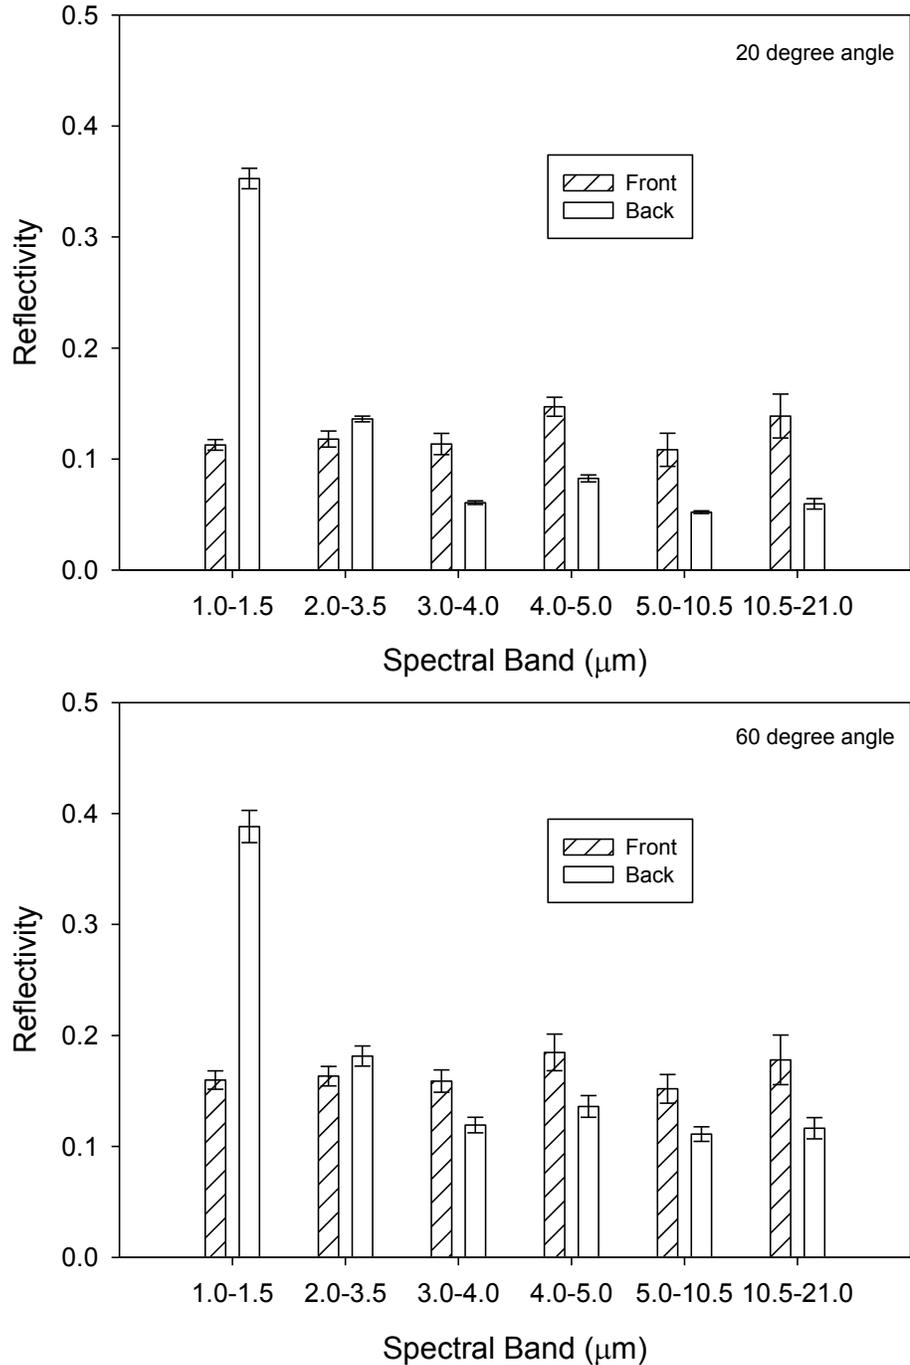
**Figure 47. Reflectivity of the ABDR panels at 20° (top) and 60° (bottom) from normal. Error bars are a single standard deviation.**

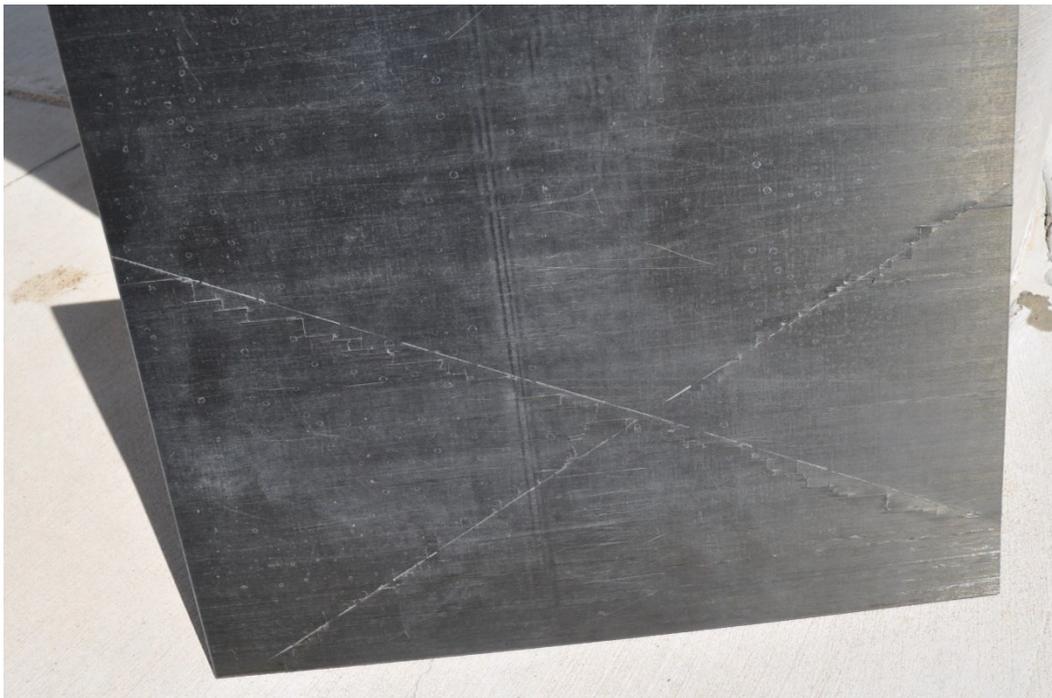
**Figure 48. A photograph of the broken panel before testing.**

This series of panel tests contained two compressive tests, a tension test, a torsion test, two tests with no force, and one test with no force with a panel that was pre-damaged. The pre-damaged panel was placed in a device designed to shear sheets of metal. A force was placed on the panel until it cracked. This was done twice, with a photograph illustrating the X-shaped breaks in the panel just prior to testing being shown in Figure 48. The center of the break was positioned such that it would be in direct exposure to the oven.

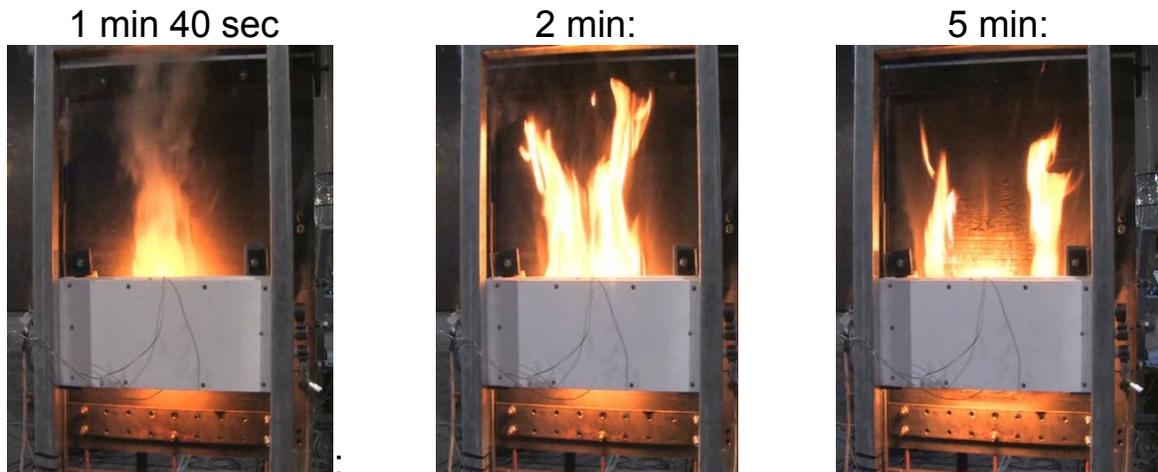
**Figure 49. Front side images for 19x24 thin Test 37.**

In general, between the first 1-1.5 minutes the first smoking started. Between 9 to 45 seconds later, flaming on the front face began. Active burning got stronger, diminished, and was finally done by between 6-8 minutes. Final flaming was usually small fluctuating flames around the perimeter of the peak zone of thermal intensity. A series of stills have been extracted during smoking, front face burning, and burning on the sides for each test. These are found in Figure 49 through Figure 55. At peak flaming, the front face of the panel was generally covered in flames. At later times (the 5 minute frames), the flaming was generally more restricted to localized parts of the panel face.

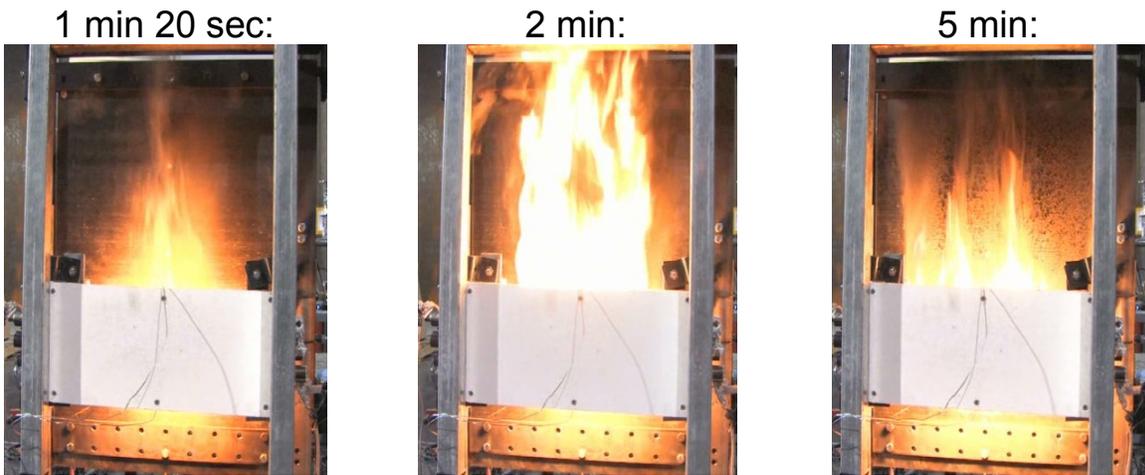
**Figure 54. Front side images for 19x24 thin broken panel Test 44.**

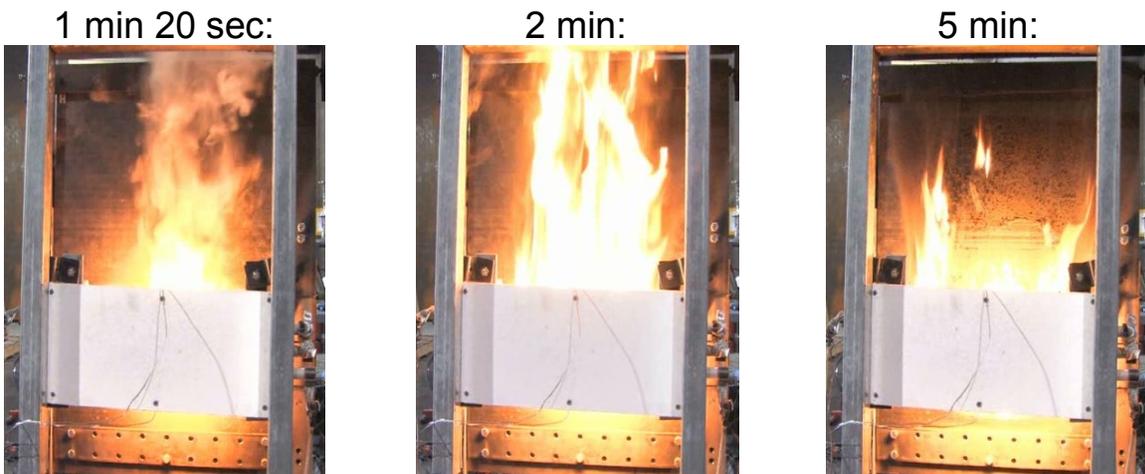
**Figure 55. Front side images for 19x24 thin compression Test 45.**

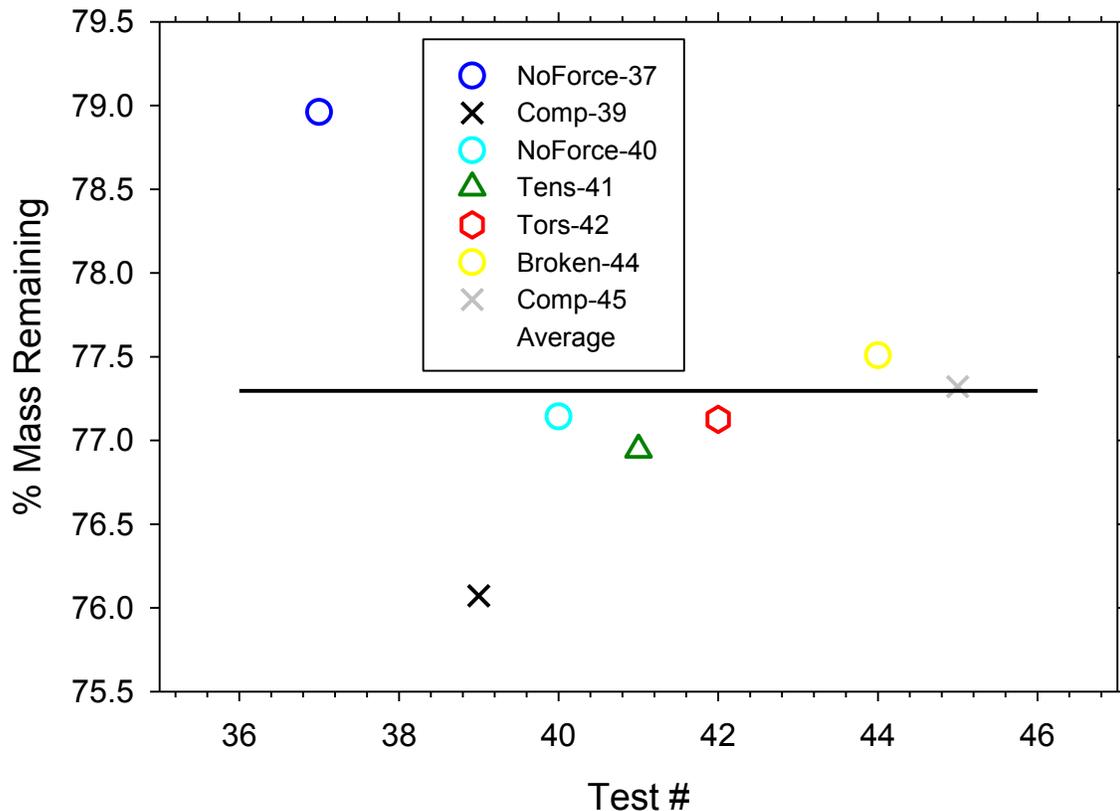
**Figure 56. Total mass loss summary for the 19x24 thin panels.**

Panels on average lost 22.7% of their mass during the test (77.3% mass remaining). Percentage of the mass remaining is shown in Figure 56. These tests were fairly repeatable in terms of mass loss (within 3%), and there are no trends associated with the nature of the force on the panel.

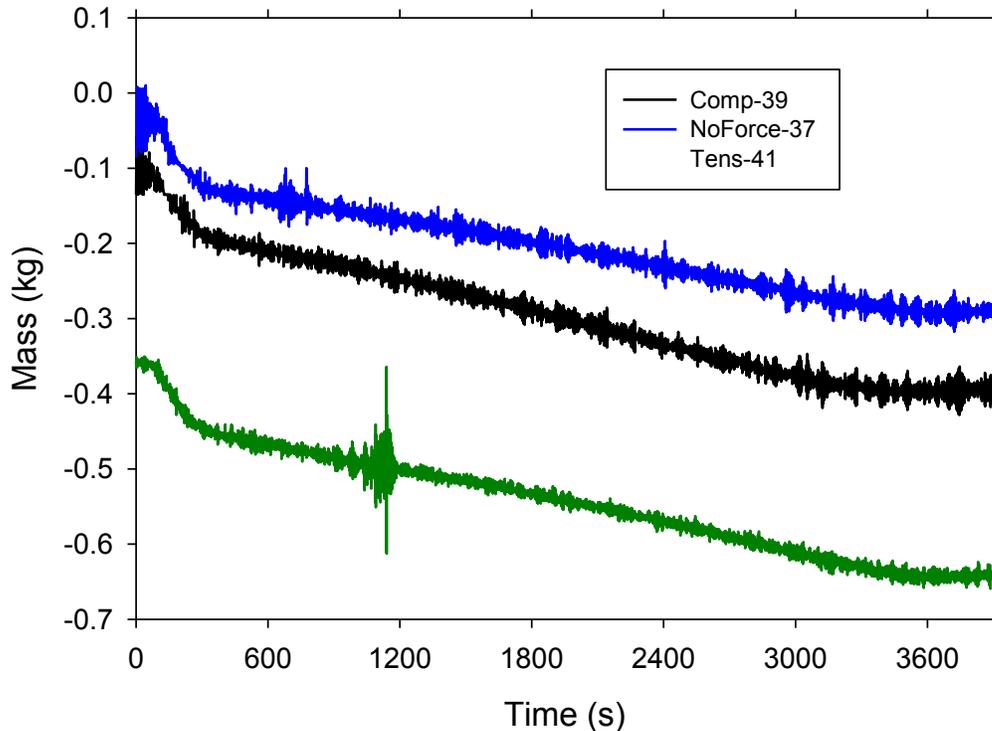
**Figure 57. Typical mass loss raw data for the 19x24 thin panels.**

Typical panel response involved a short period of flaming on the front face of the panel. Unlike the ABDR sandwich panels, these panels did not exhibit significant flaming on the edges. These panels had more mass, and consequently were less susceptible to noise. Typical raw mass traces are found in Figure 57. In this plot, raw data for test 39 were transposed down by about 0.1 kg to make them more visible in the plot.

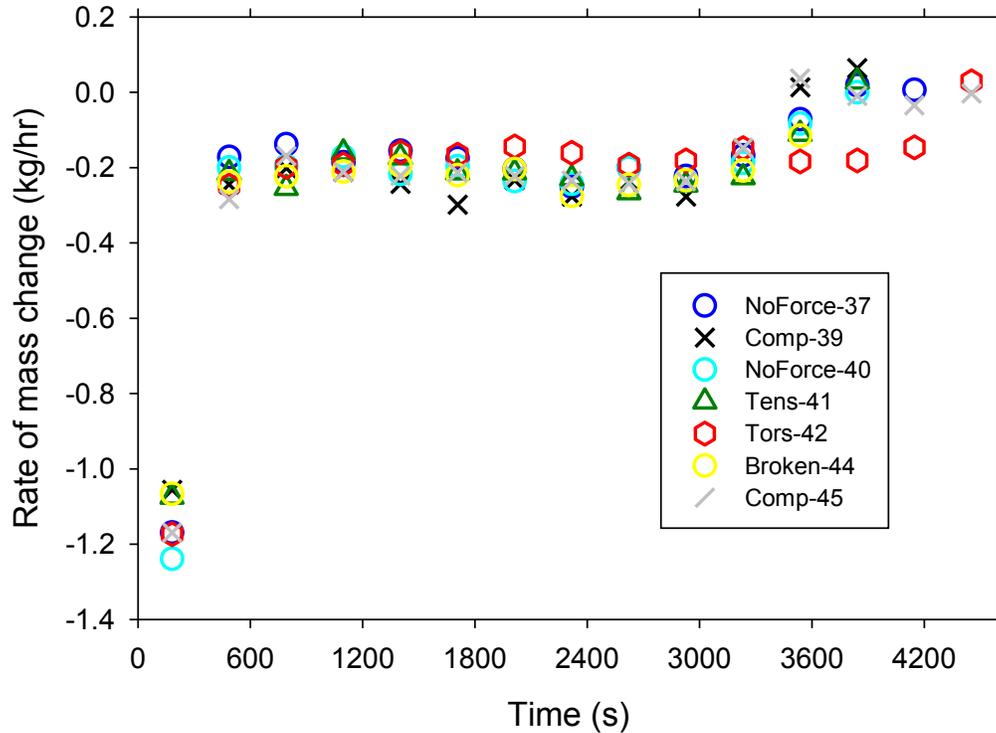
**Figure 58. Rate of mass change summary data for the 19x24 thin panels.**

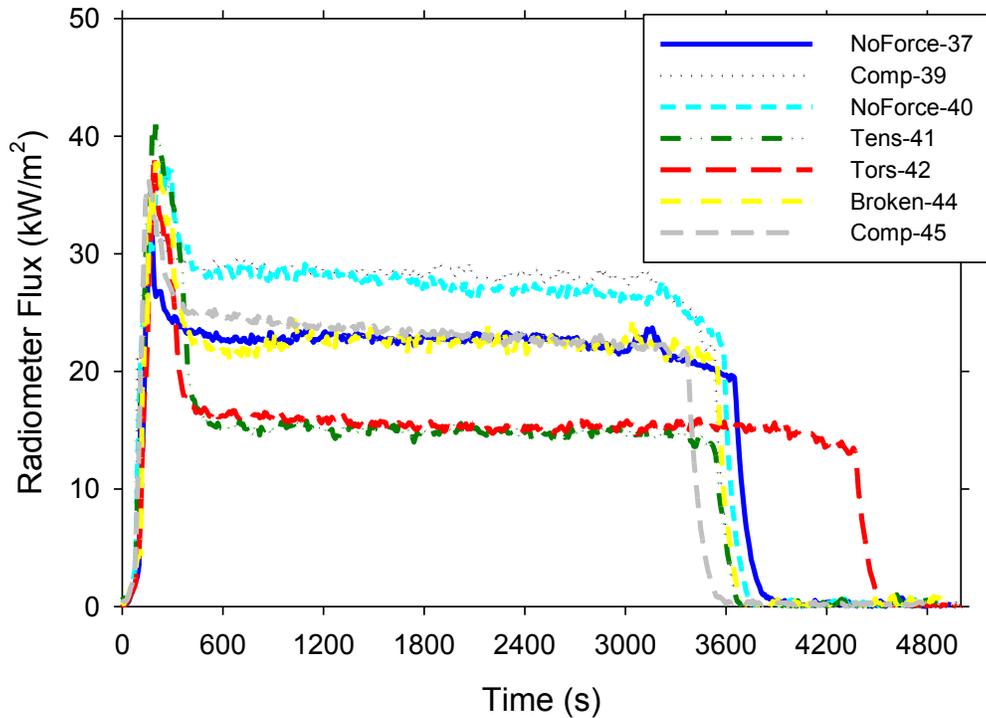
**Figure 63. 19x24 thin panel radiometer readings from the front of the panel at  $\frac{1}{2}$  way up the panel from the bottom.**

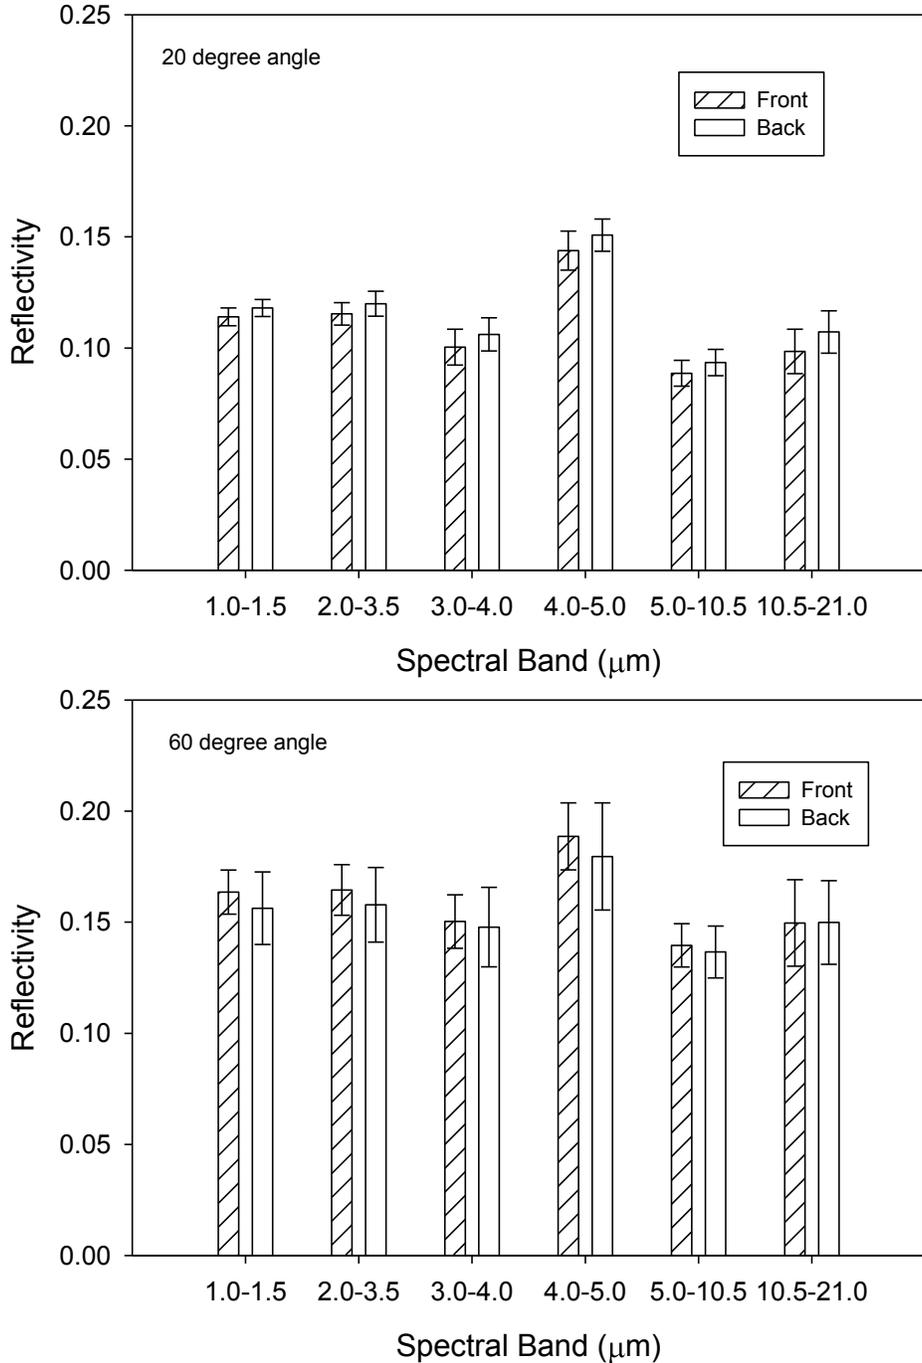
**Figure 71. Reflectivity of the 19x24 thin panels at 20° (top) and 60° (bottom) from normal. Error bars are a single standard deviation.**

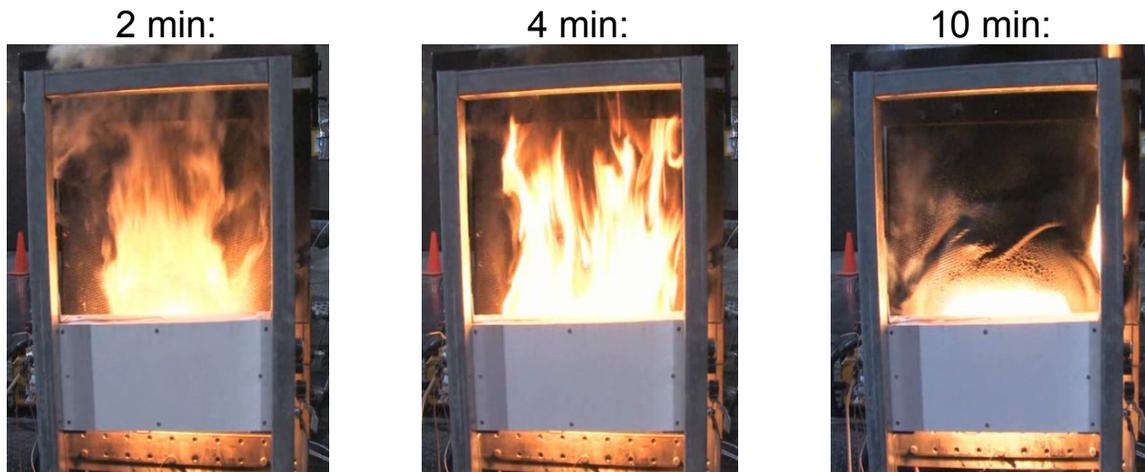
**Figure 73. Front side images for 18x24 thick compression Test 26.**

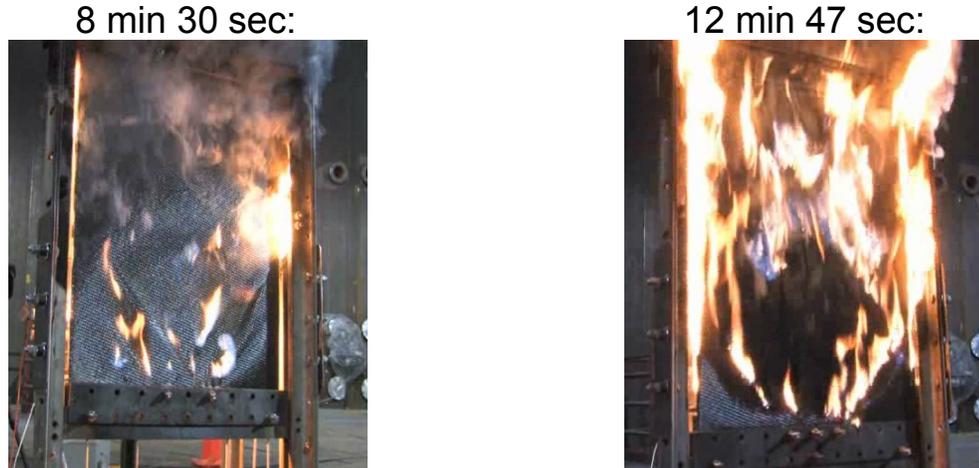
**Figure 78. Back side images for 18x24 thick tension Test 29 (Left: early flaming) and Test 35 (Right: late flaming).**

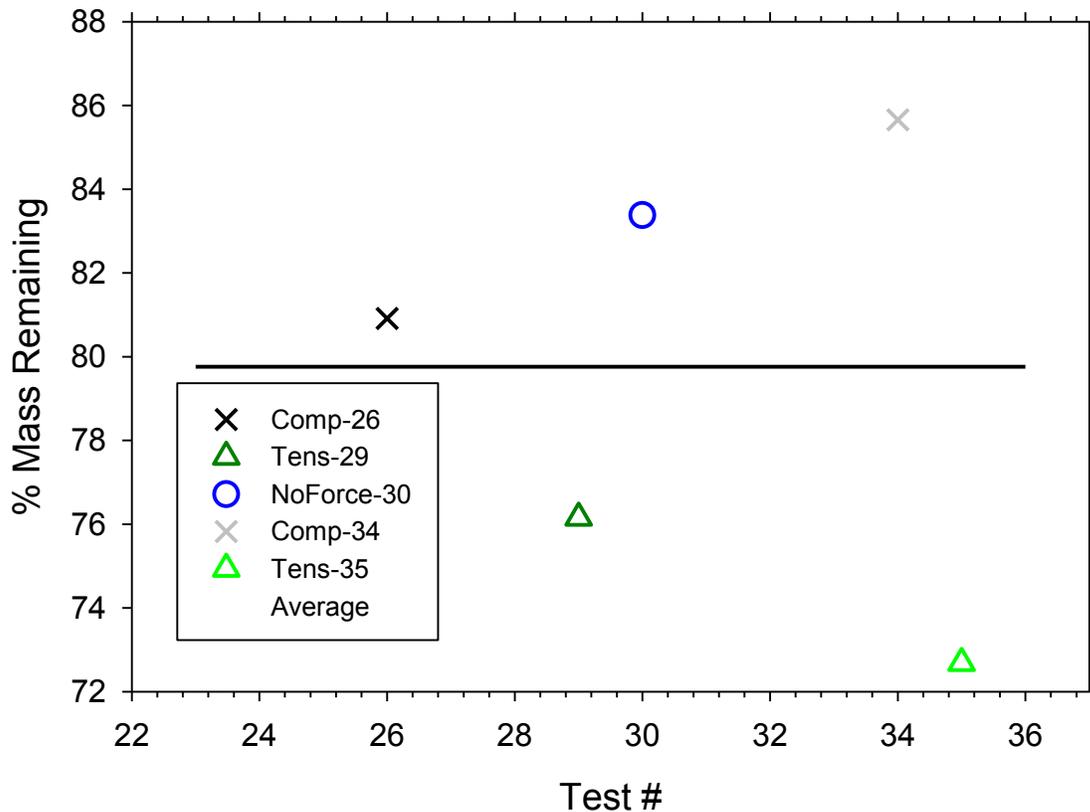
**Figure 79. Total mass loss summary for the 18x24 thick panels.**

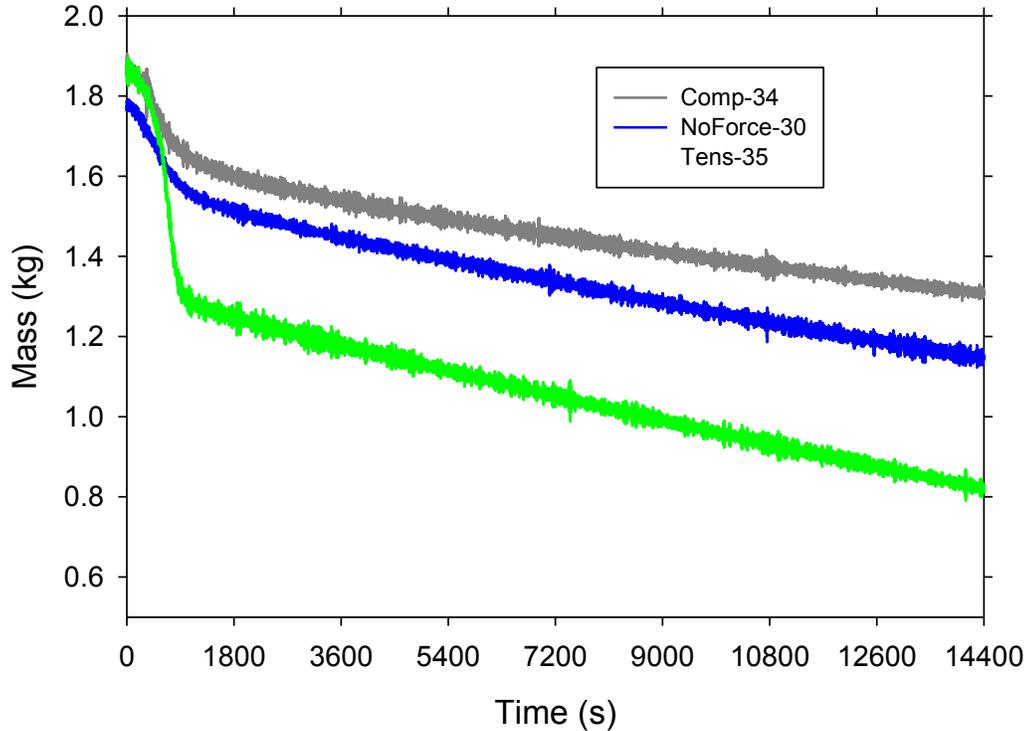
**Figure 80. Typical mass loss raw data for the 18x24 thick panels.**

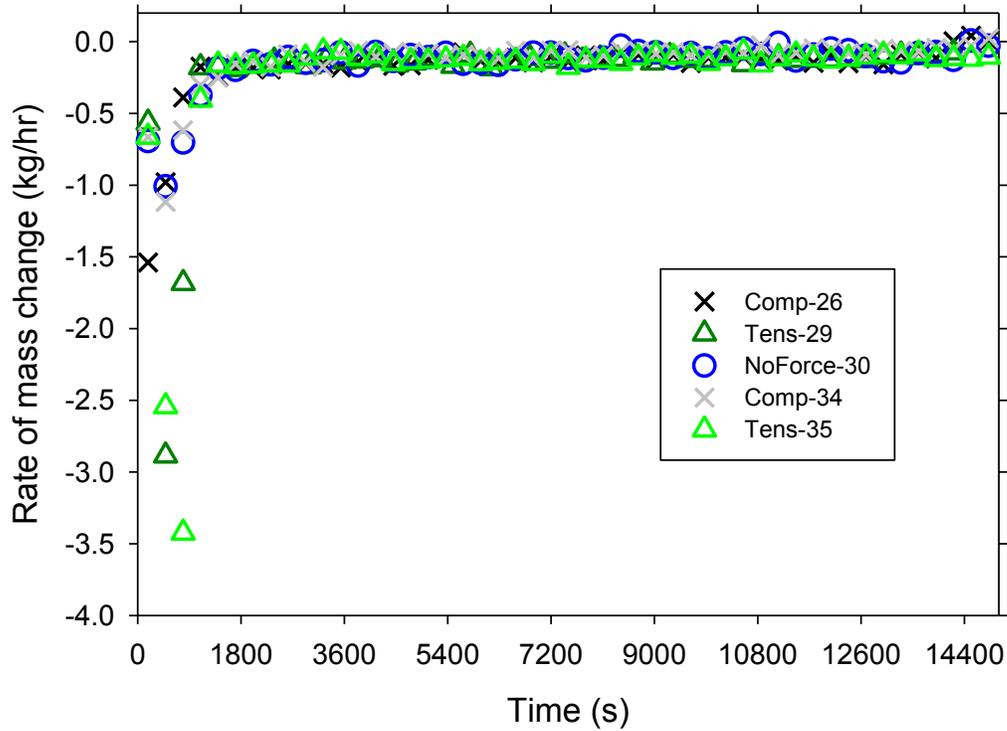
**Figure 81. Rate of mass change summary data for the 18x24 thick panels.**

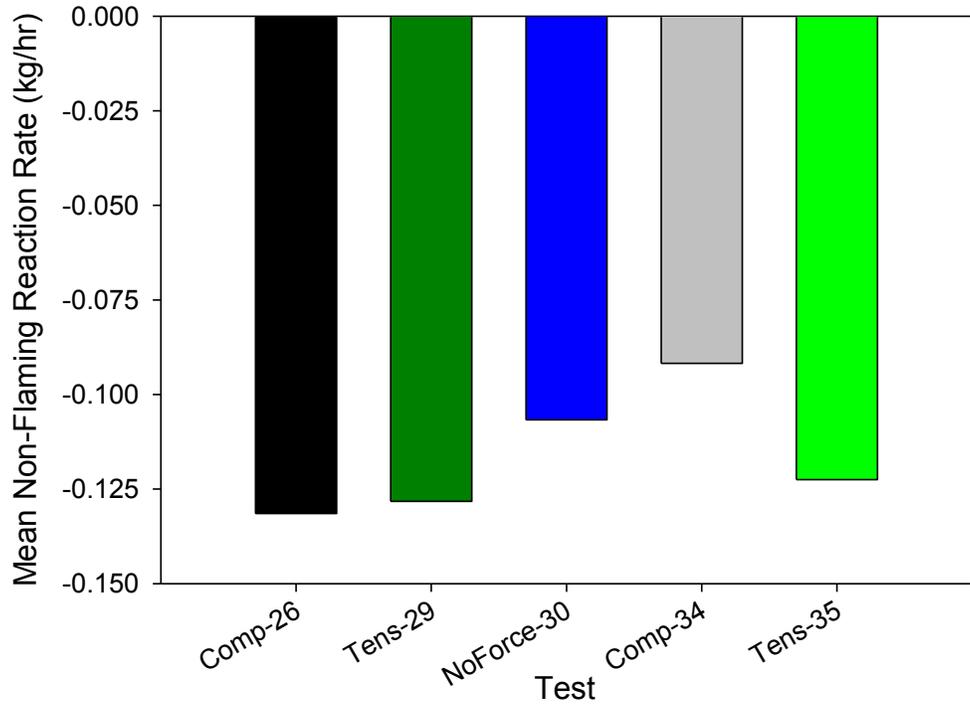
**Figure 83. Mean surface reaction rates for the 18x24 thick panels.**

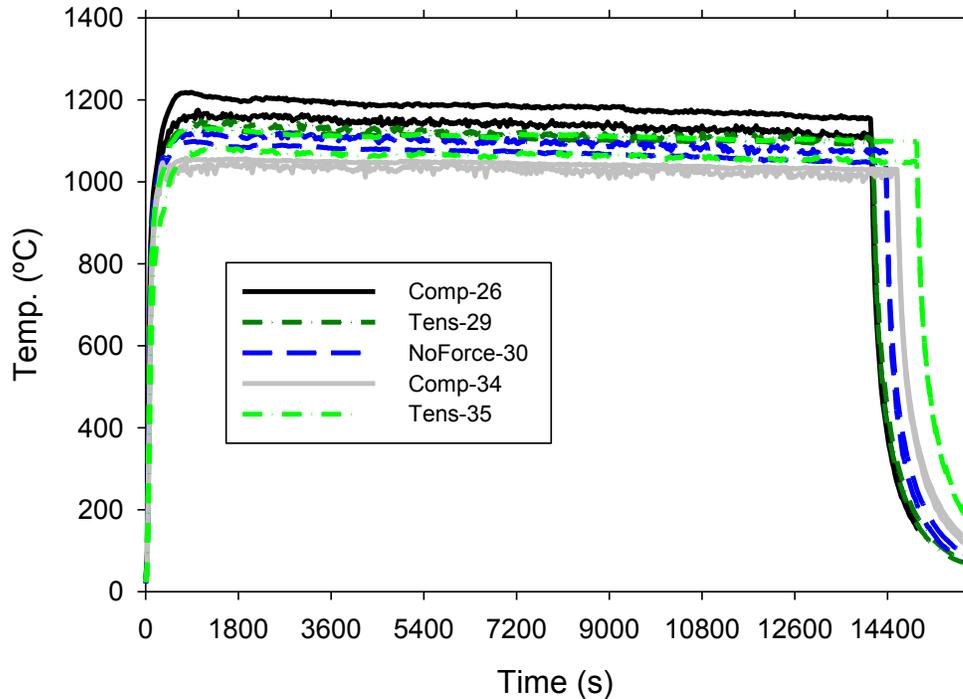
**Figure 84. Oven temperatures for the 18x24 thick panel tests.**
