# SANDIA REPORT

SAND2015-2369

## Intermediate-scale Fire Performance of Composite Panels under Varying Loads

## Abstract

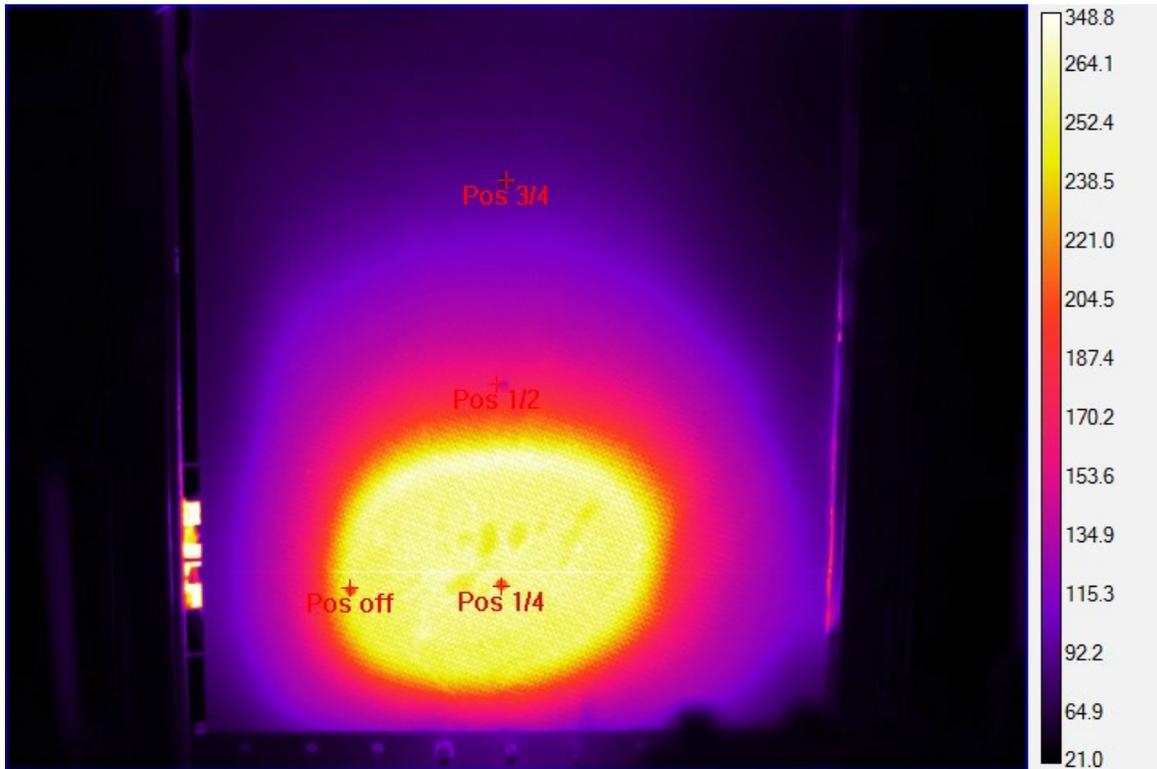
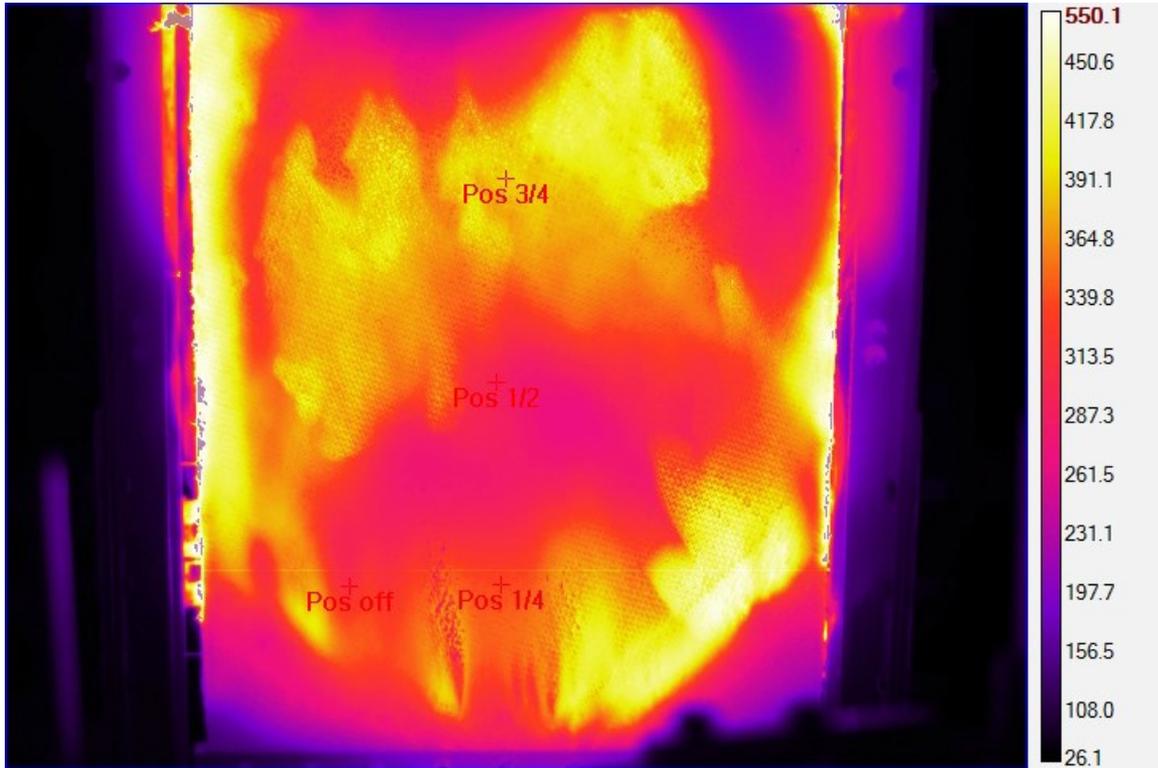
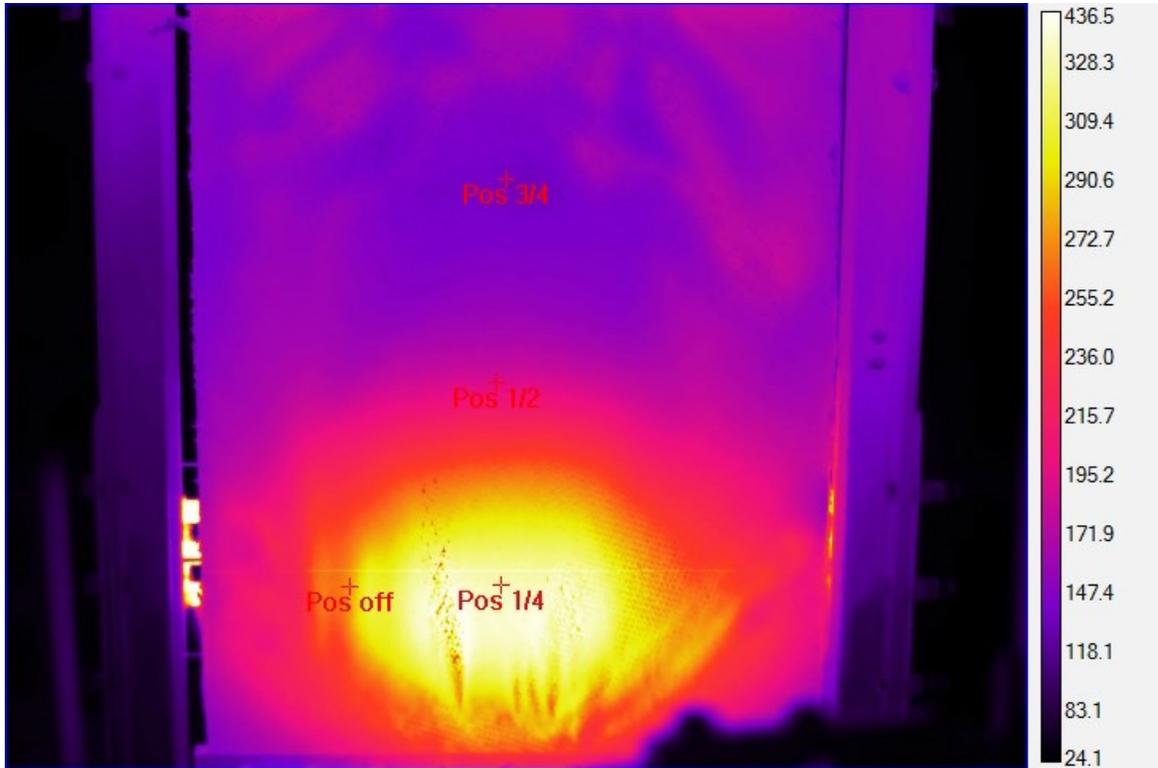
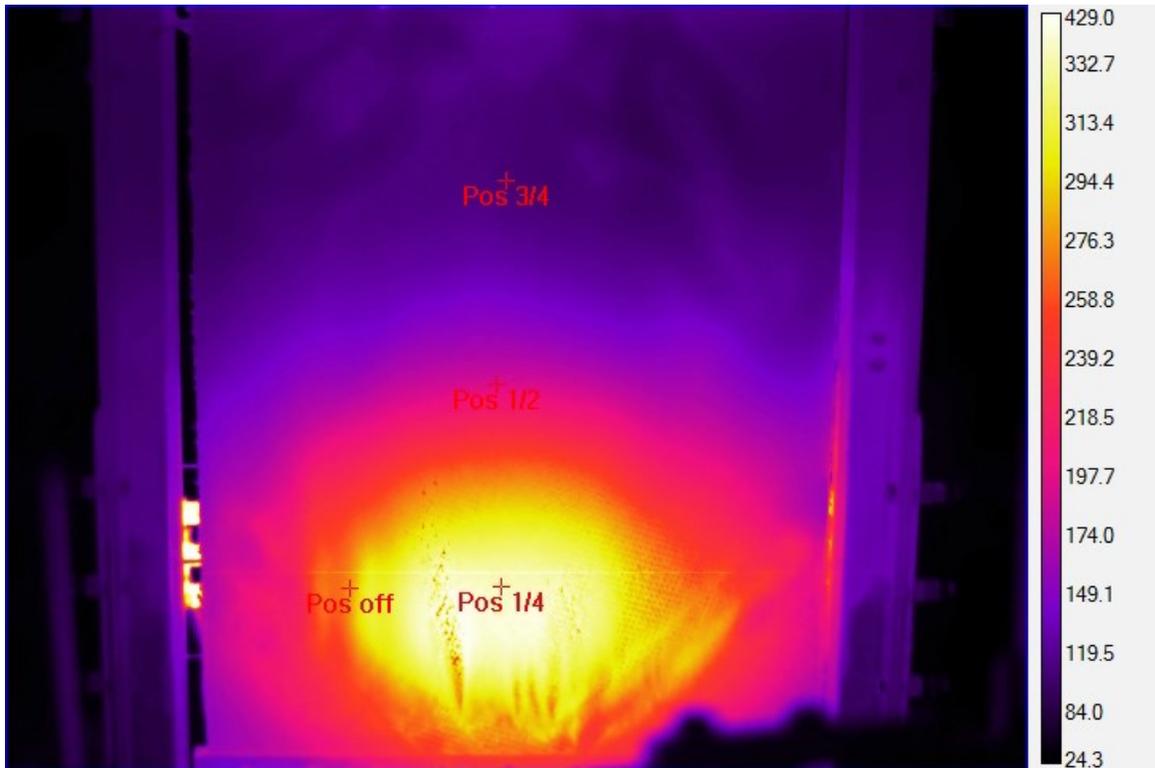
**Figure 91. IR camera images from Test 35, the 18x24 thick panel in tension.**

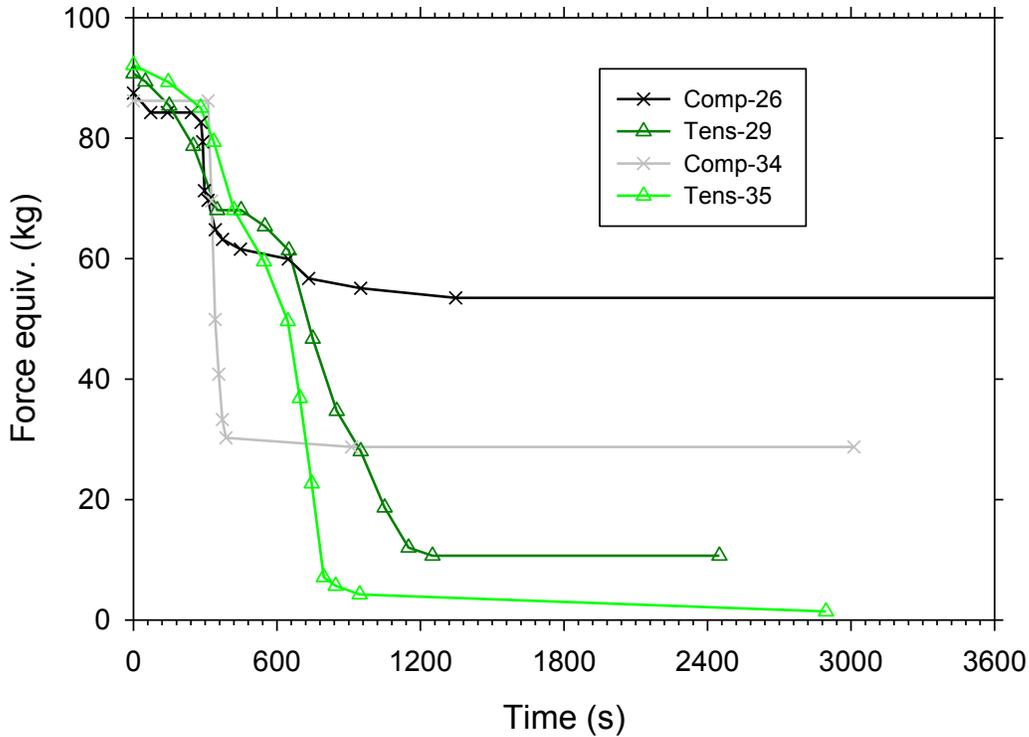
**Figure 92. Mass equivalent force on the 18x24 thick panels as a function of time.**

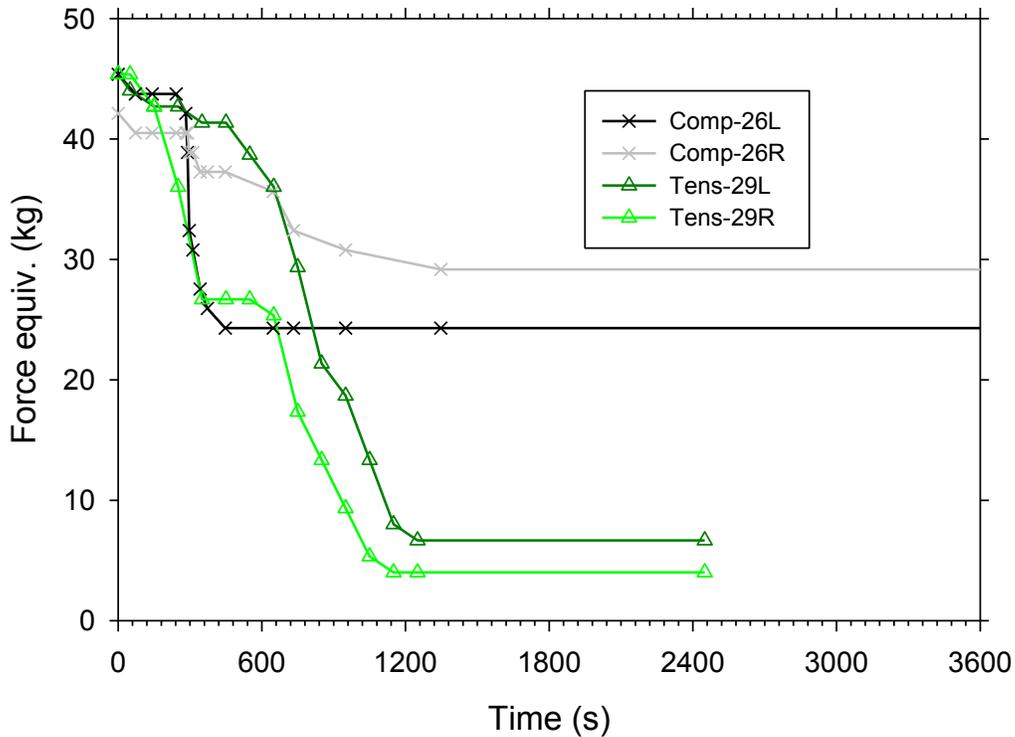
**Figure 93. Force mass equivalent broken out by side of panel for two tests to show details of the uneven force distribution.**

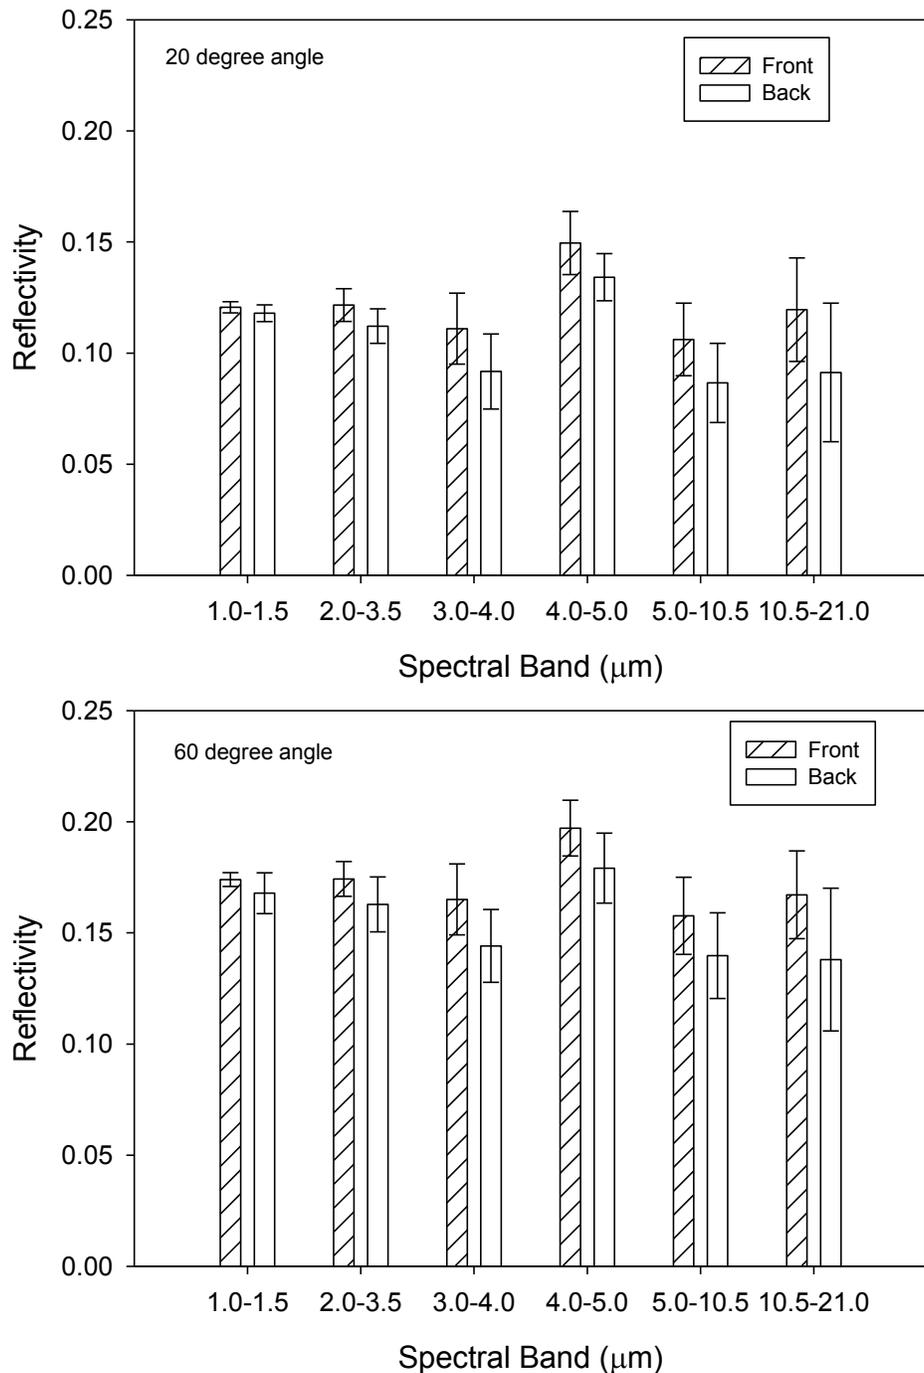
**Figure 94. Reflectivity of the 18x24 thick panels at 20° (top) and 60° (bottom) from normal. Error bars are a single standard deviation.**

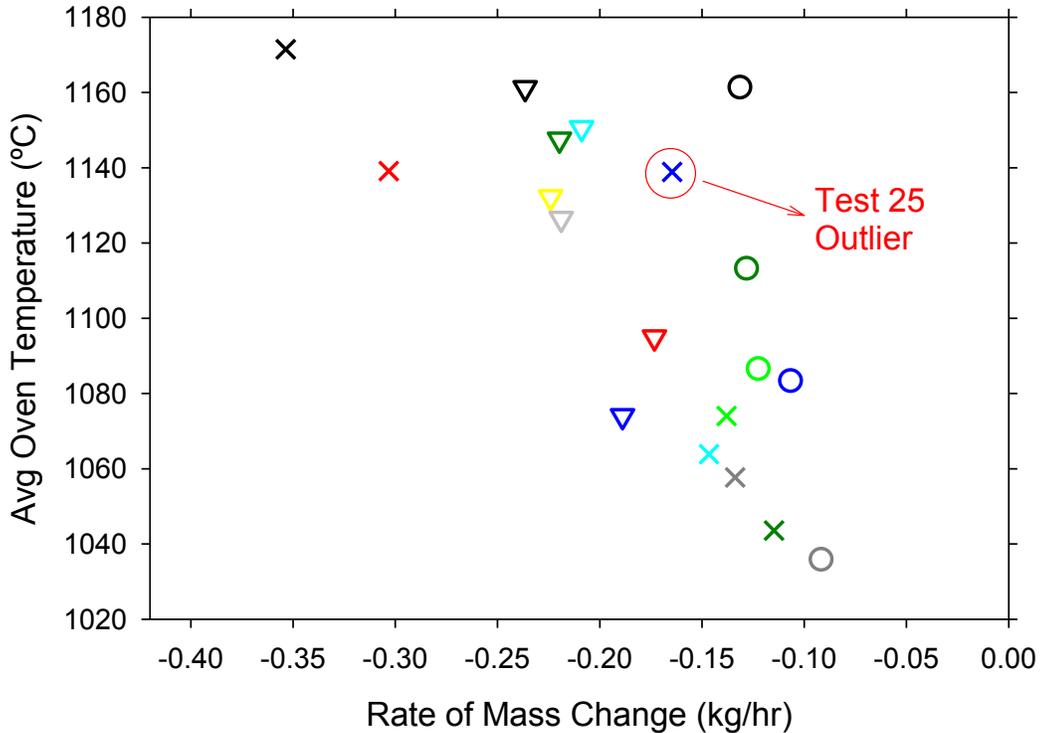
**Figure 95. Rate of mass change summary for glowing combustion. Colors indicate type of loading (standard scheme), while symbols suggest the material used in the test (x=ABDR, o=18x24 thick, ▼=19x24 thin).**

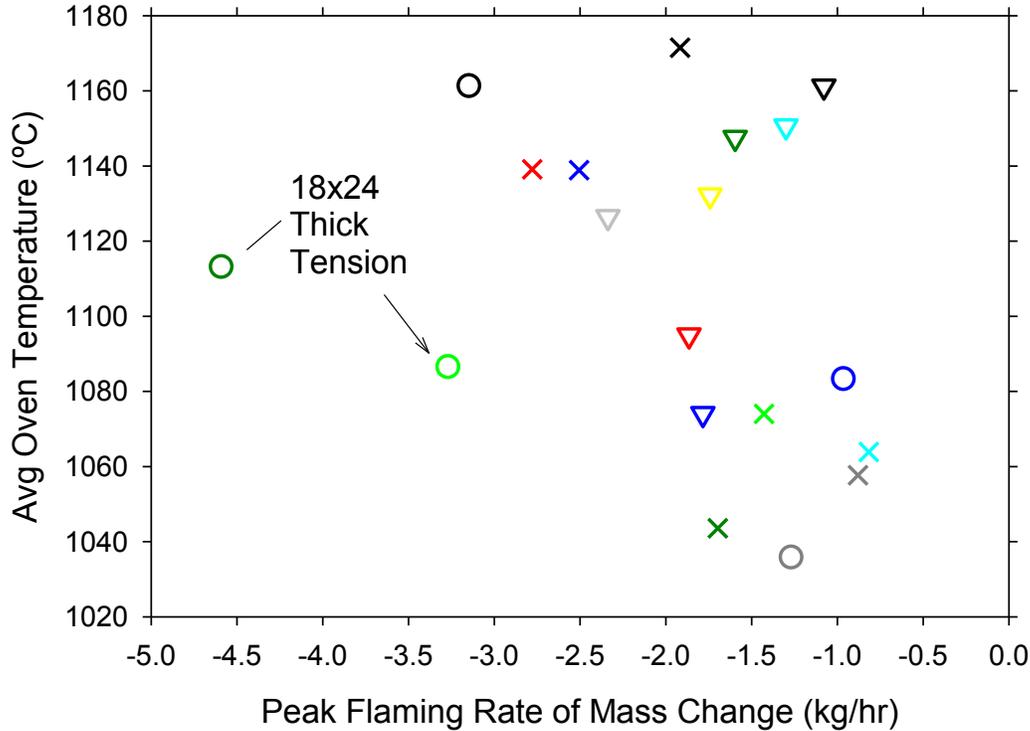
**Figure 97. Rate of mass change summary for peak flaming combustion. Colors indicate type of loading (standard scheme), while symbols suggest the material used in the test (×=ABDR, ○=18x24 thick, ▽=19x24 thin).**

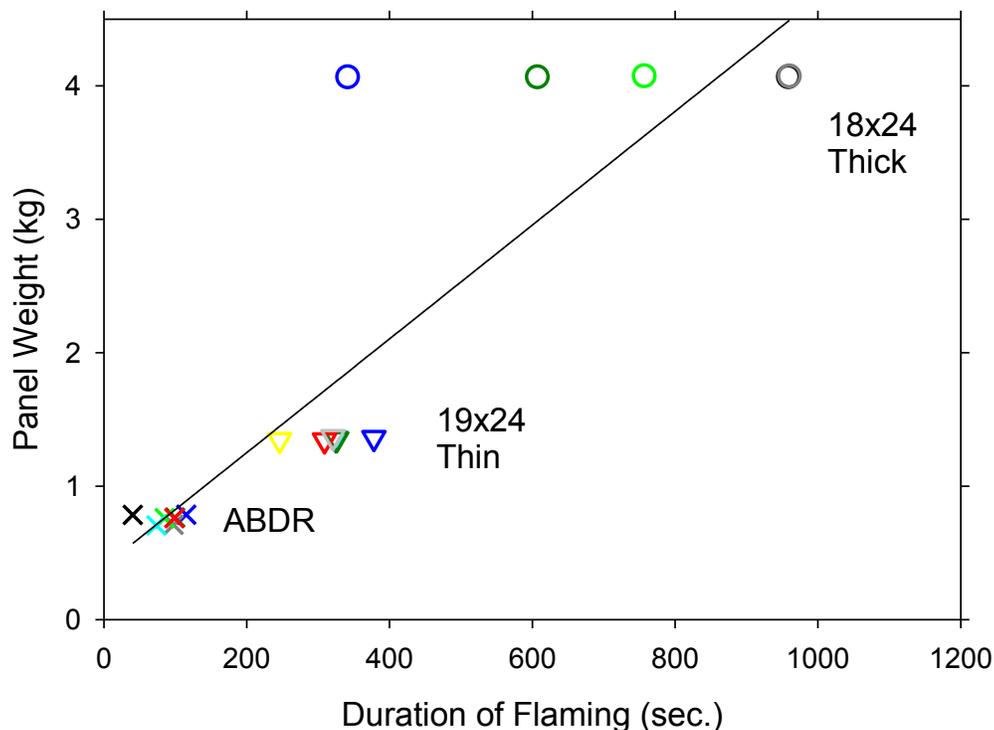
**Figure 98. Panel weight versus duration of flaming. Colors indicate type of loading (standard scheme).**

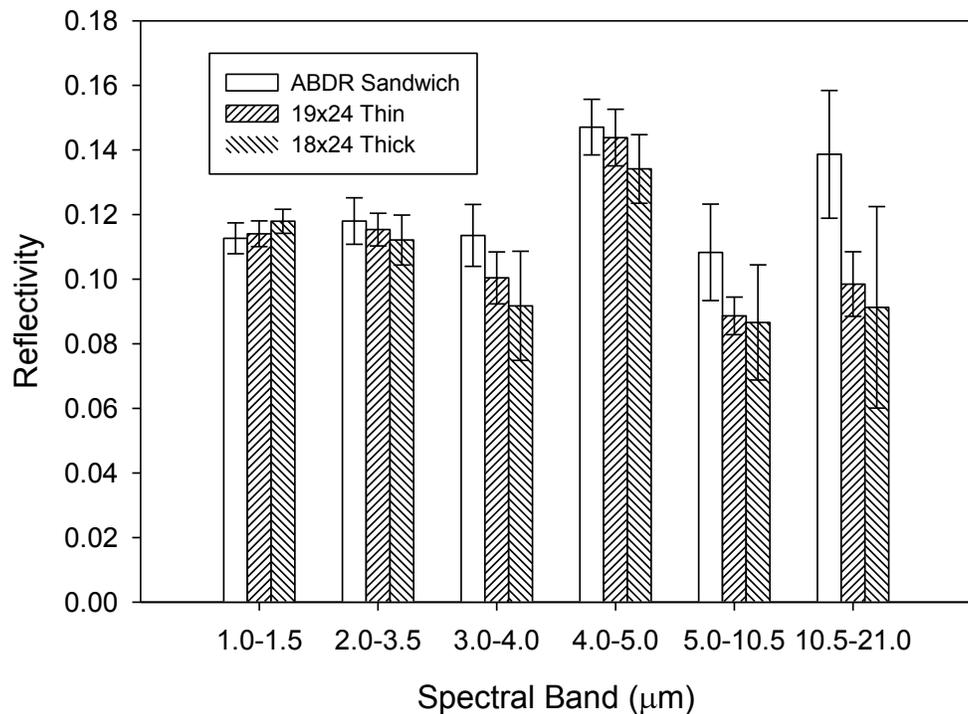
**Figure 99. Reflectometer comparison for the three panels at 20 degrees.**

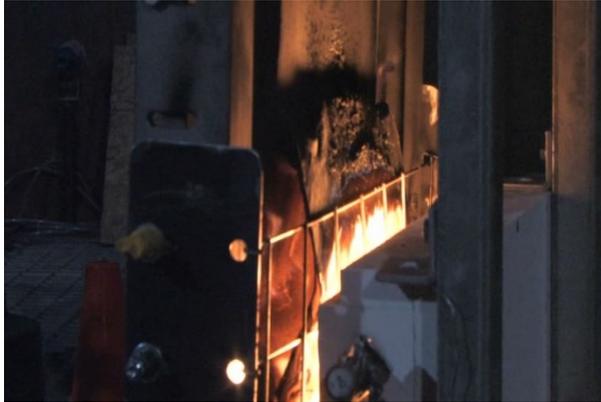
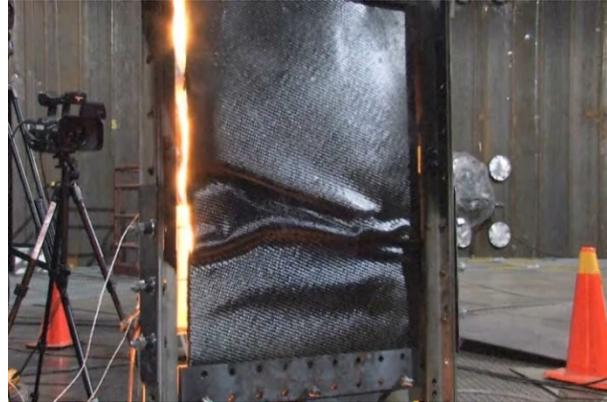
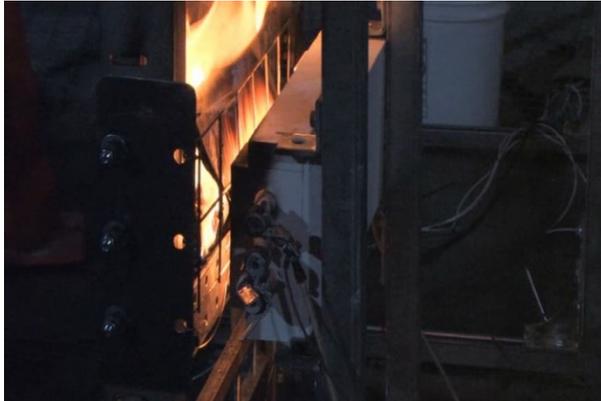
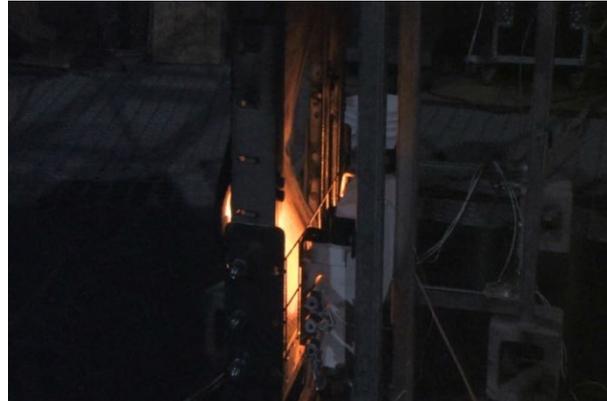
**Figure 101. Stills illustrating the shape of the deforming panels under compression.**

Aspects of the tests that were not particularly repeatable do not make as good of comparison points. The shape of the deforming panel in compression was not particularly repeatable. Since this feature has not yet been reported, these results are included from visual frames from video cameras in Figure 101. What may be discernable in these is that the ABDR panels under compression (Test 24 and 27) tended to separate, with the front face bending towards the heat source and the other two layers bending away. Mixed results were found from the 18x24 thick panels (Test 26 and 34), as in one case the panel wrinkled, and the other bent away from the heat source. The flaming reaction rate was also quite variable, and will be difficult to use as a comparison metric for model validation.

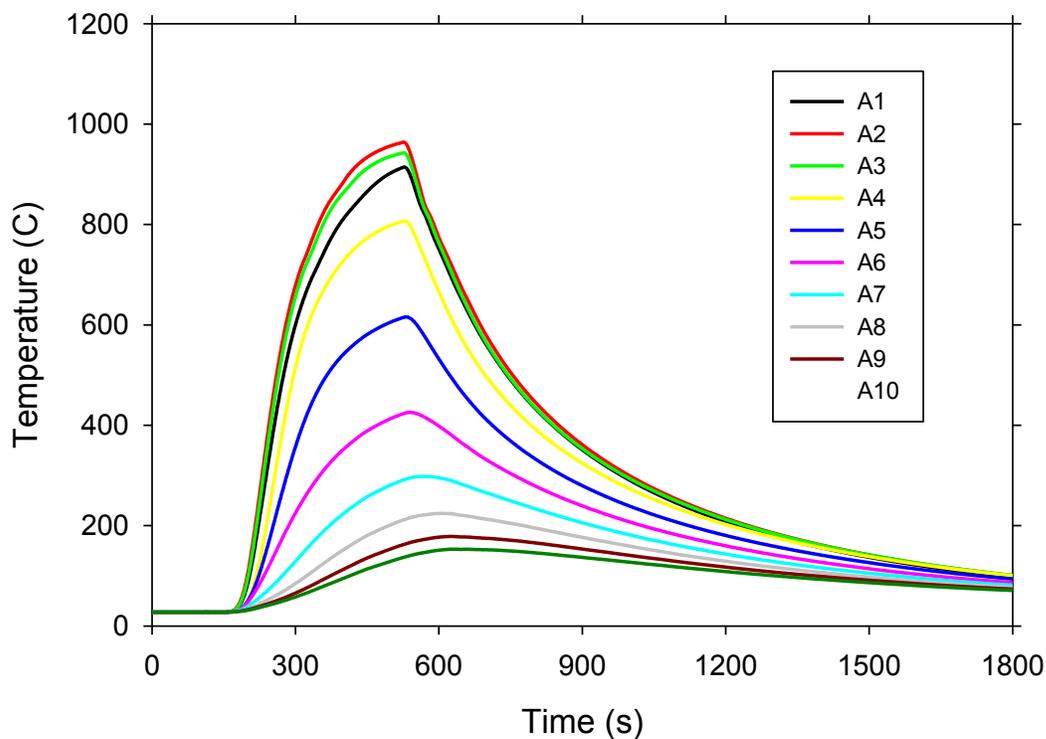
**Figure 102. Oven characterization column A temperatures.**

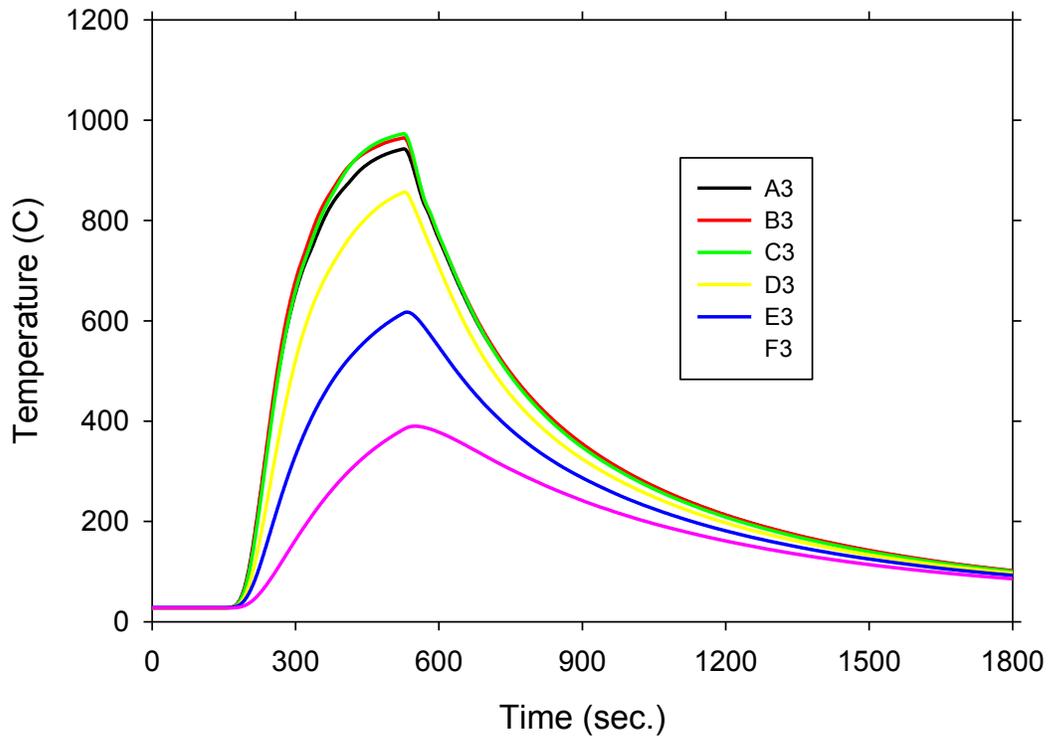
**Figure 106. Oven characterization row 3 temperatures.**

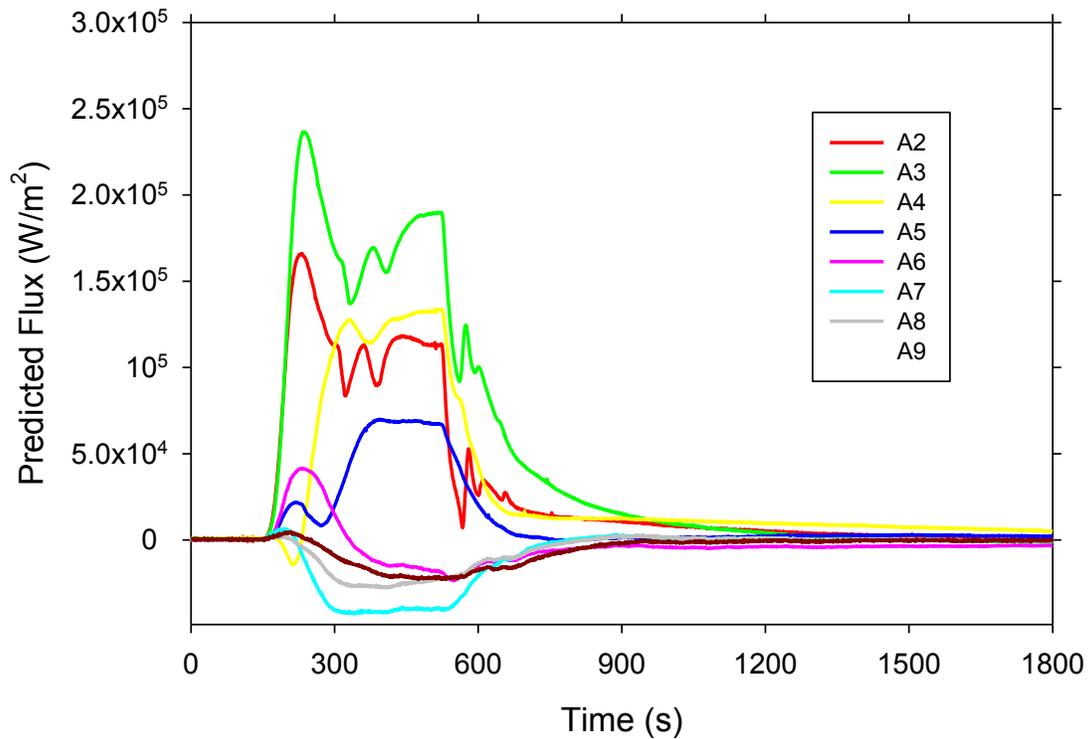
**Figure 107. Oven characterization column A fluxes.**

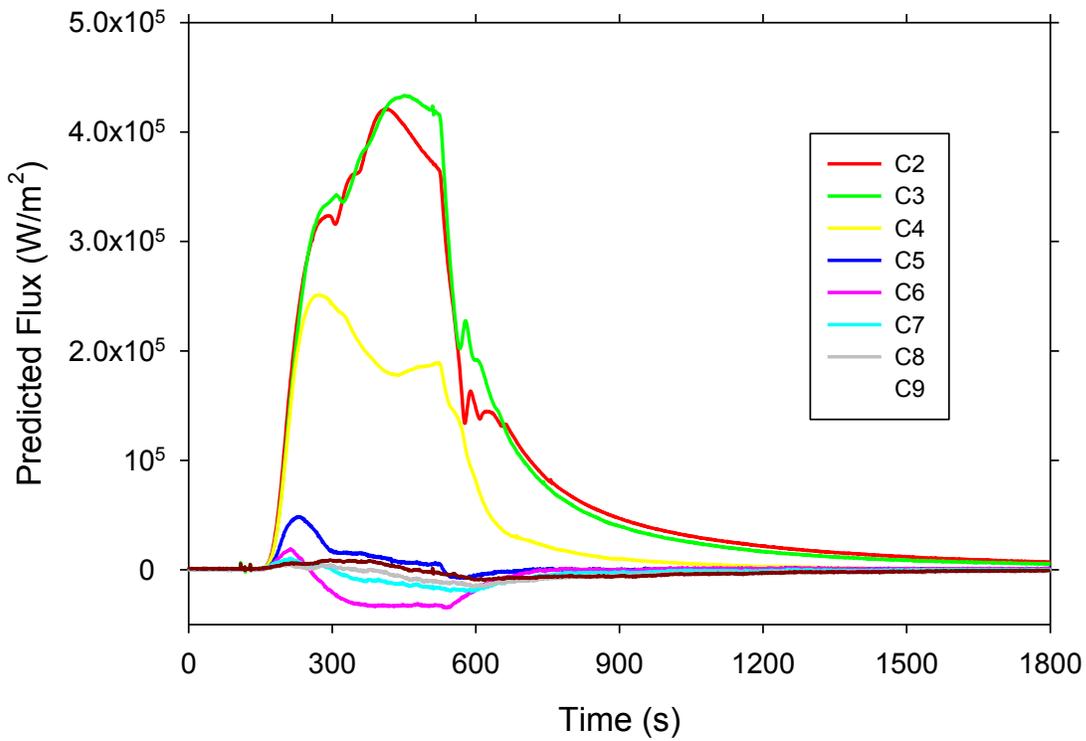
**Figure 109. Oven characterization column C fluxes.**

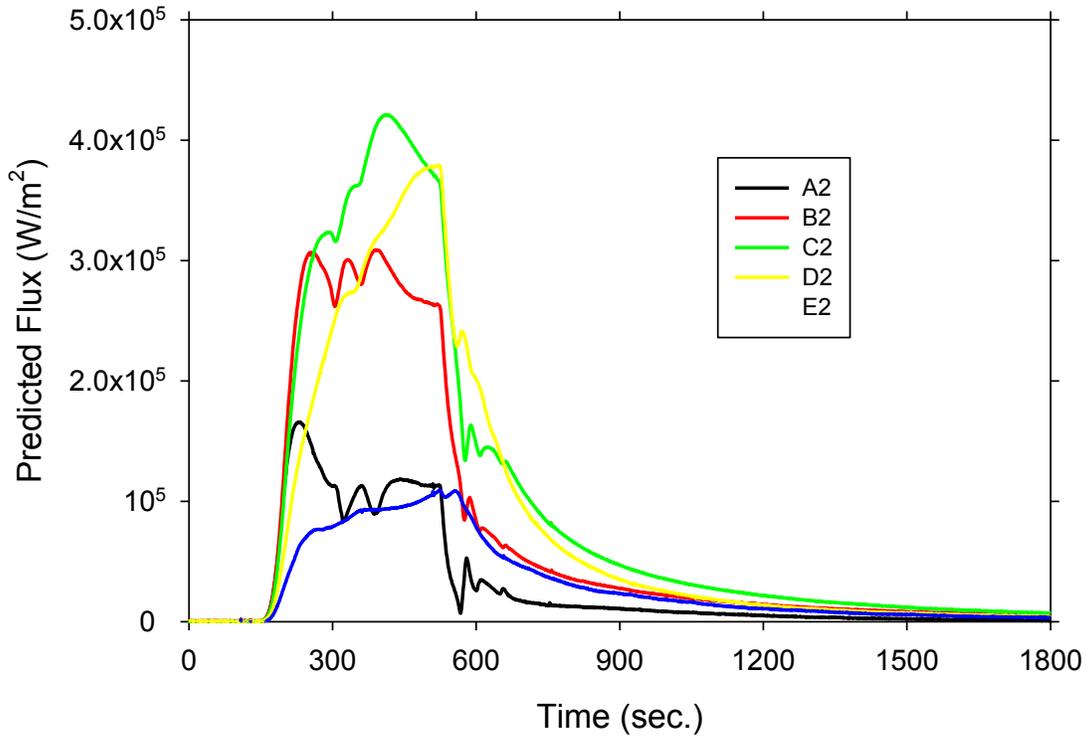
**Figure 110. Oven characterization row 2 fluxes.**

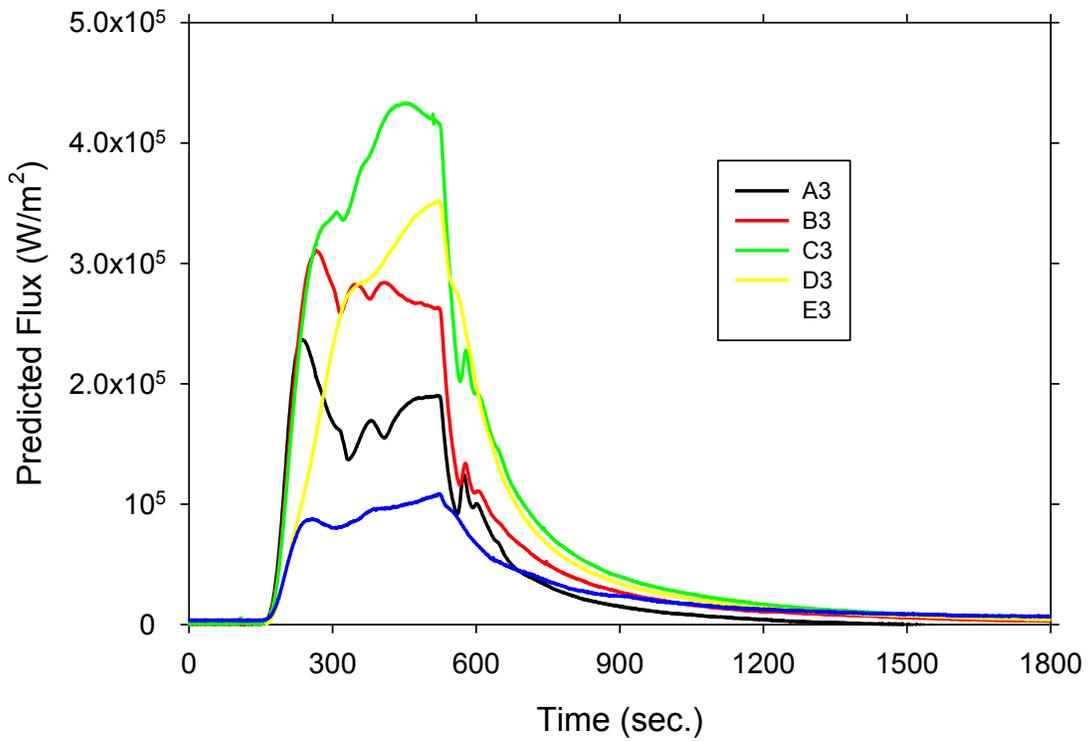
**Figure 111. Oven characterization row 3 fluxes.**

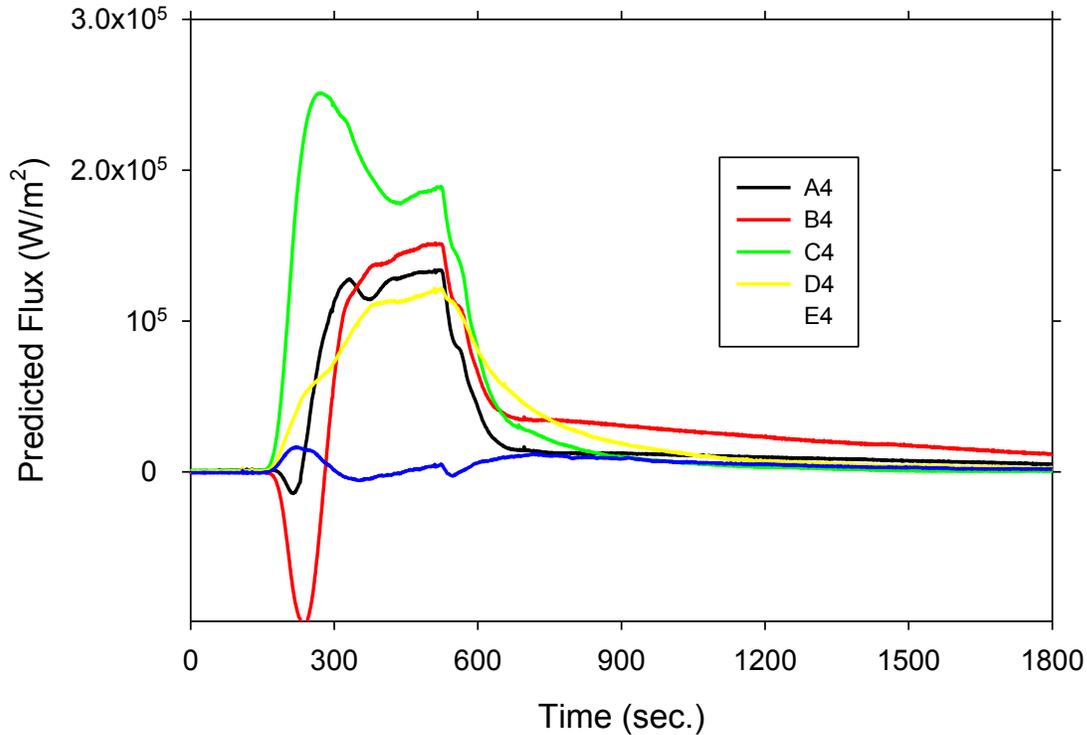
**Figure 112. Oven characterization row 4 fluxes.**

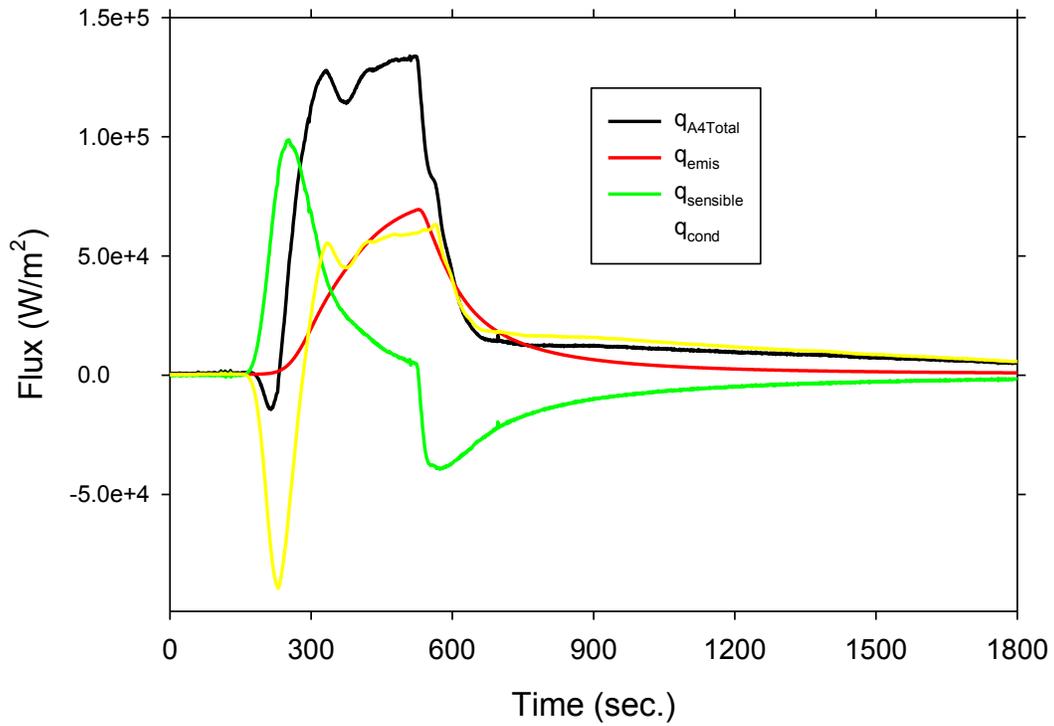
**Figure 113. Oven characterization A4 fluxes.**

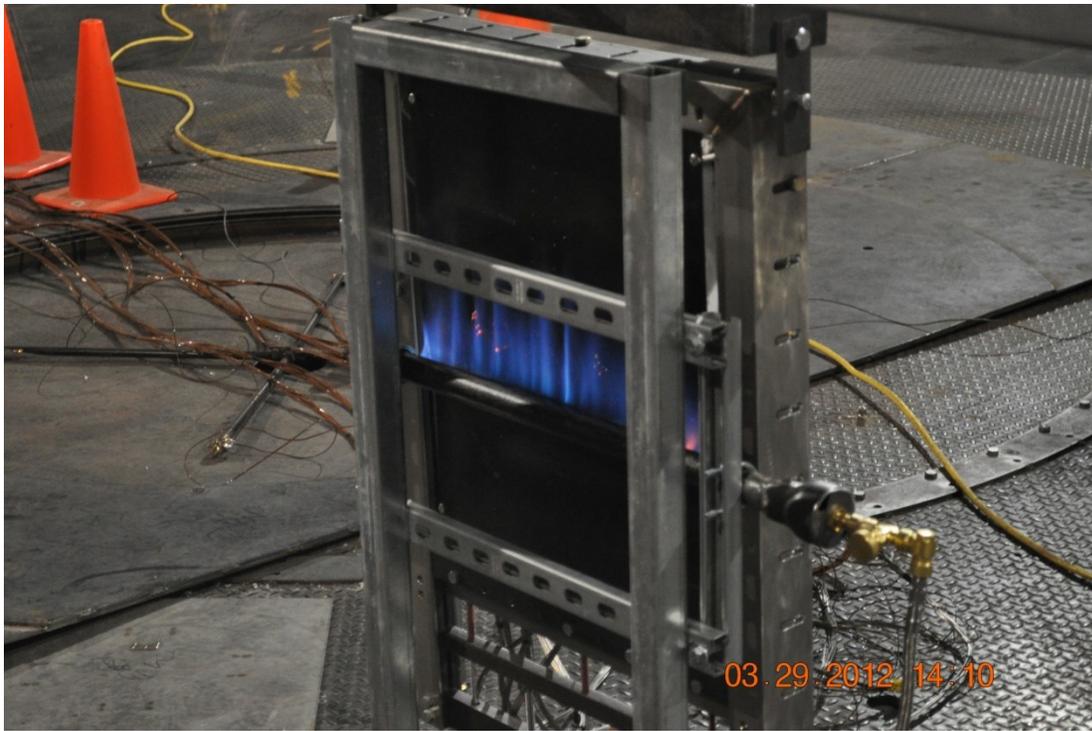
**Figure 116. A photograph of the pipe burner.**

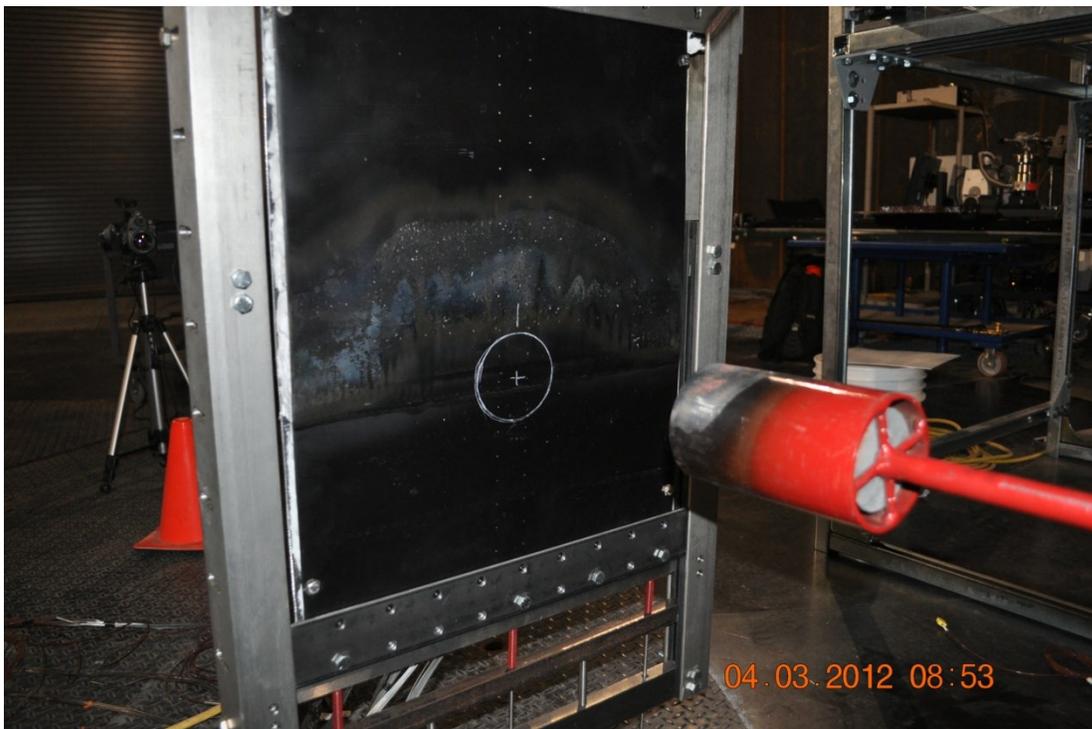
**Figure 117. A photograph of the weed burner.**

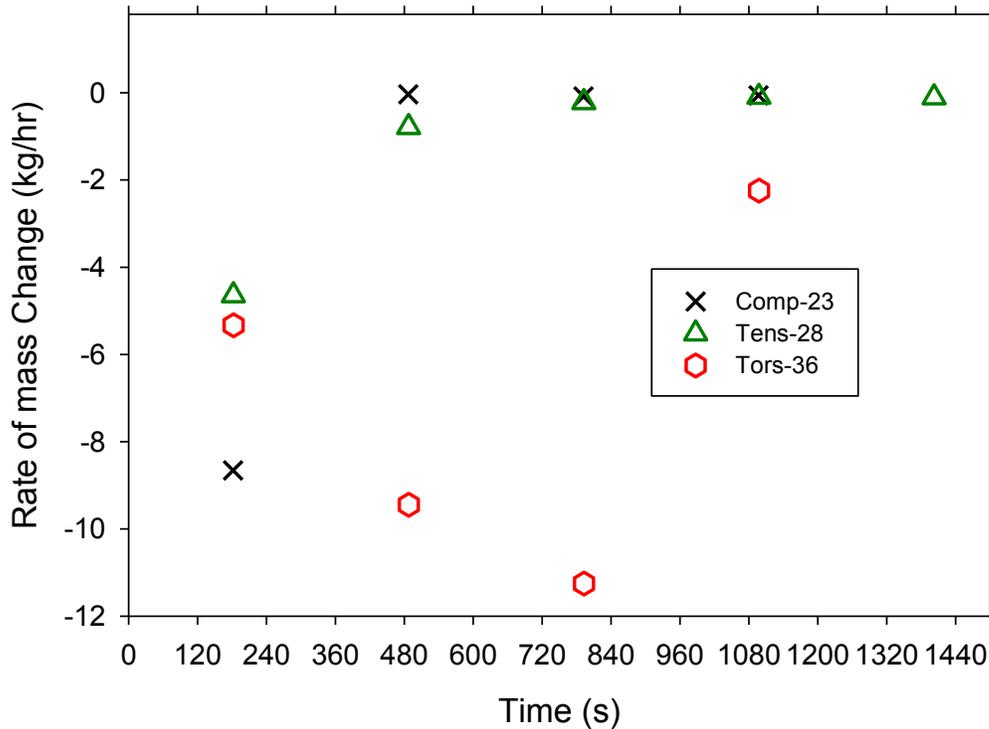
**Figure 118. Rate of mass change summary data for the OSB wood panels.**

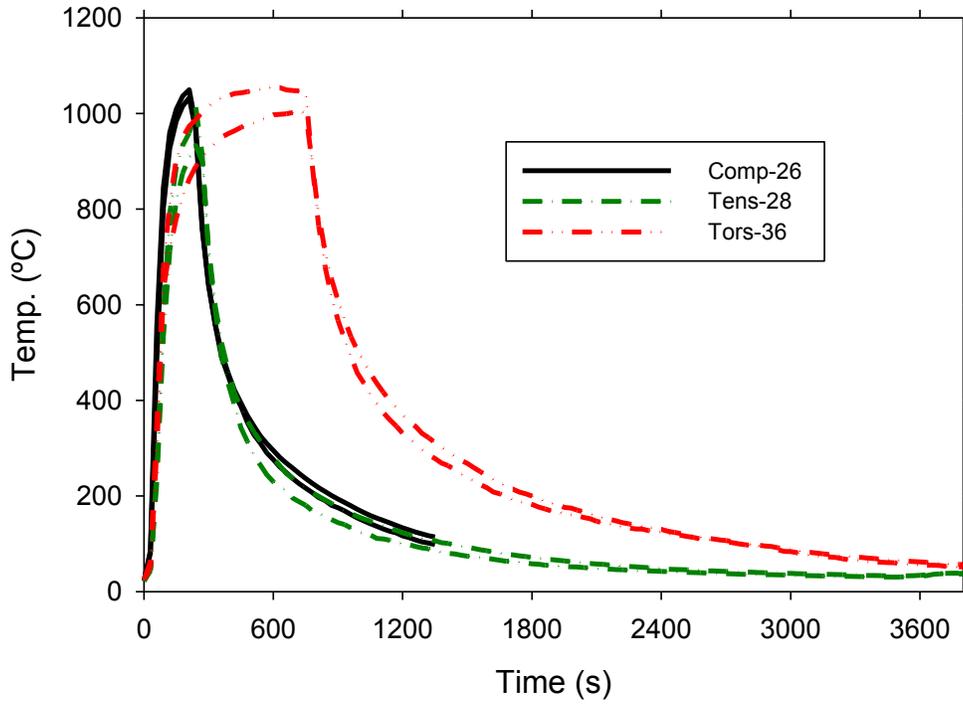
**Figure 119. Oven temperatures for the OSB wood panel tests.**
