Defect Characterization for Material Assurance in Metal Additive Manufacturing (FY15-0664)

B. Salzbrenner, B. Boyce, B. Jared, J. Rodelas, J. Laing
Materials Mechanics and Tribology, 1851

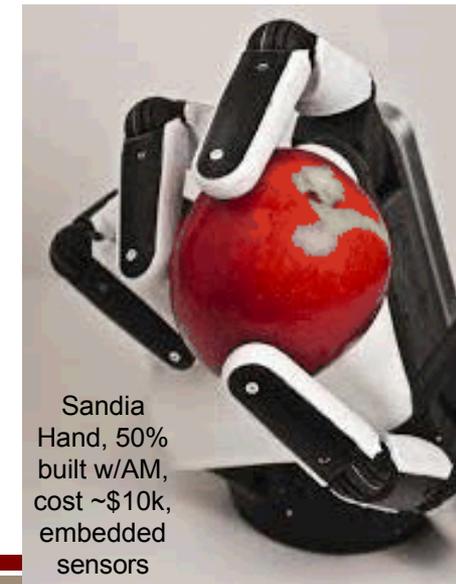
Sandia Hand, 50% built w/AM, cost ~\$10k, embedded sensors

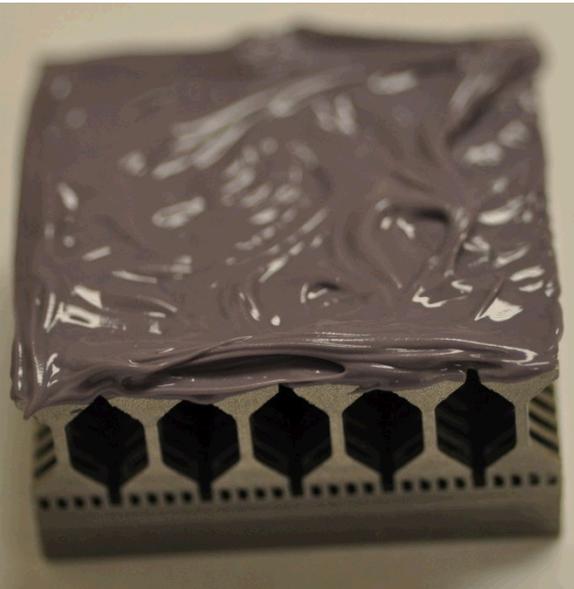
Built on Pro-X 300
No heat treatment

Tensile samples removed using diamond saw

Dental putty was applied to the top of the 'cooling fin' to capture samples and keep them positioned during cutting.

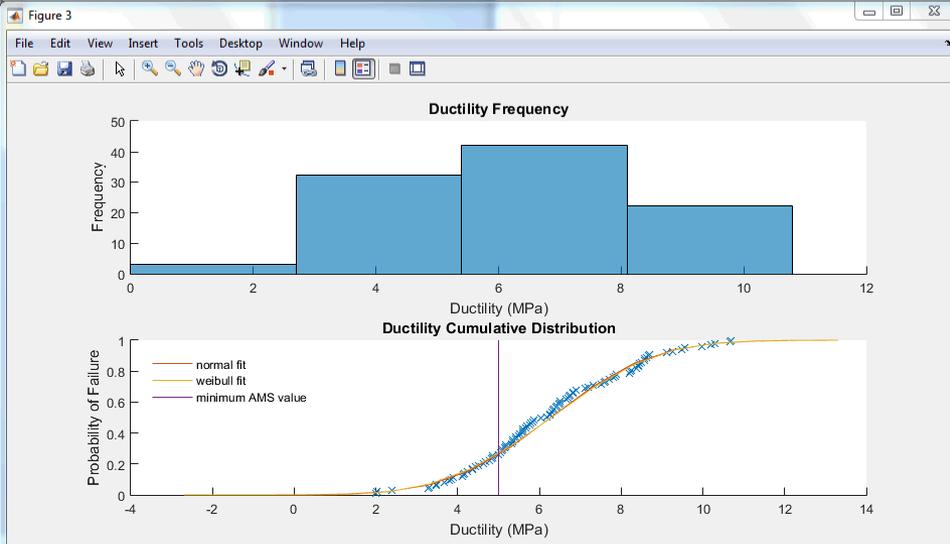
Fineline 2 statistics using all data

```
The probability the yield stress will be below the AMS spec=
0.9971

The probability the UTS will be below the AMS spec=
1

Since the AMS spec for condition A states the YS and UTS as maximums, not minimums, the yield and ultimate stresses pass spec. Using a weibull 2 parameter fit, there will be a 8.4e-6% chance the ductility will be below the AMS spec. This includes all 'bad' data where VICgauge lost tracking.

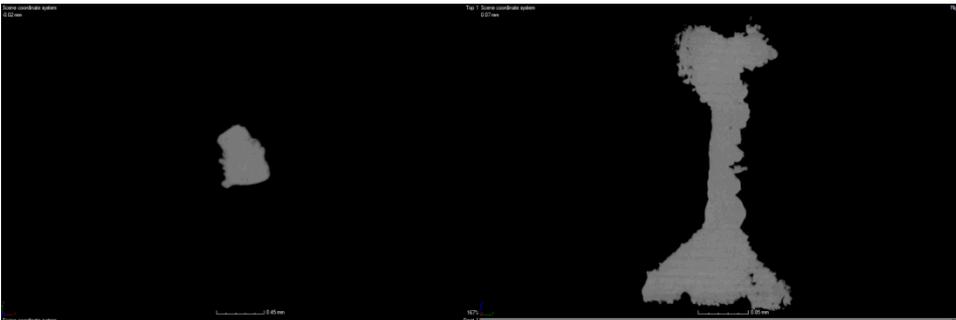
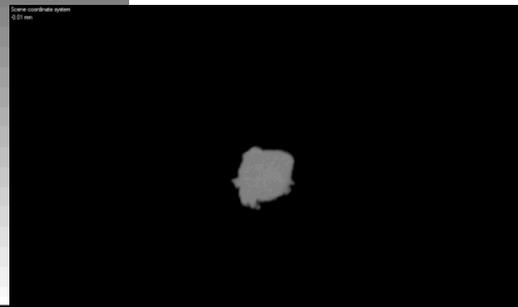
Zintech CT scans

Sample E geometry
0.4mm square cross section

The rough surface finish and presence of internal voids can drive failure
