NUREG/CR-4596
SAND86-0394
RP
Printed June 1986

Screening Tests of Representative Nuclear Power Plant Components Exposed to Secondary Environments Created by Fires

Mark J. Jacobus

Sandia National Laboratories
Albuquerque, NM 87185
operated by
Sandia Corporation
for the
U. S. Department of Energy

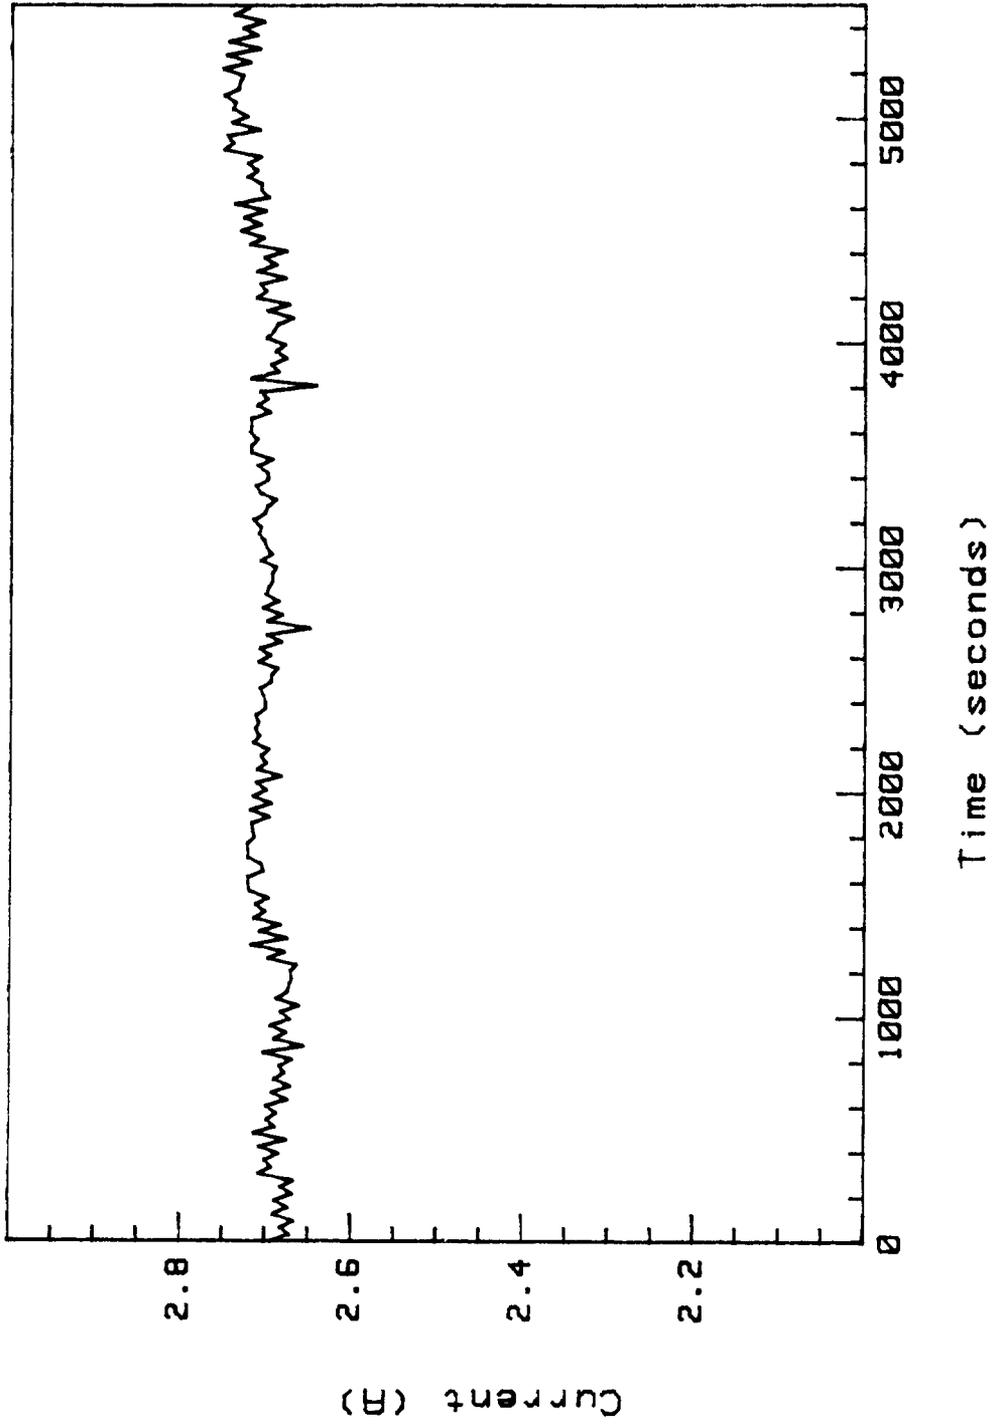
Fig. 7 Load Current to Switch in Test 4

One switch was powered and monitored during each of tests 4 and 5. Both were located about four feet from the floor at sector 1 (see Fig. 2). The ac supply voltage remained between 108 and 116 Vac in both tests. The load current to the switch in test 4 is shown in Fig. 7 and to the switch in test 5 is shown in Fig. 8. Both show no evidence of the switch failing to carry its load. Leakage current for the switches never reached the level detectable by the ac current sensors used in the tests (0.25 mA) and therefore the data is not presented. Contact resistances and insulation resistances showed no evidence of problems except one of the contacts of the switch in test 4 took about 15 Vac stress to get a normal value in the milliohm range (original value was about 100 kohms).

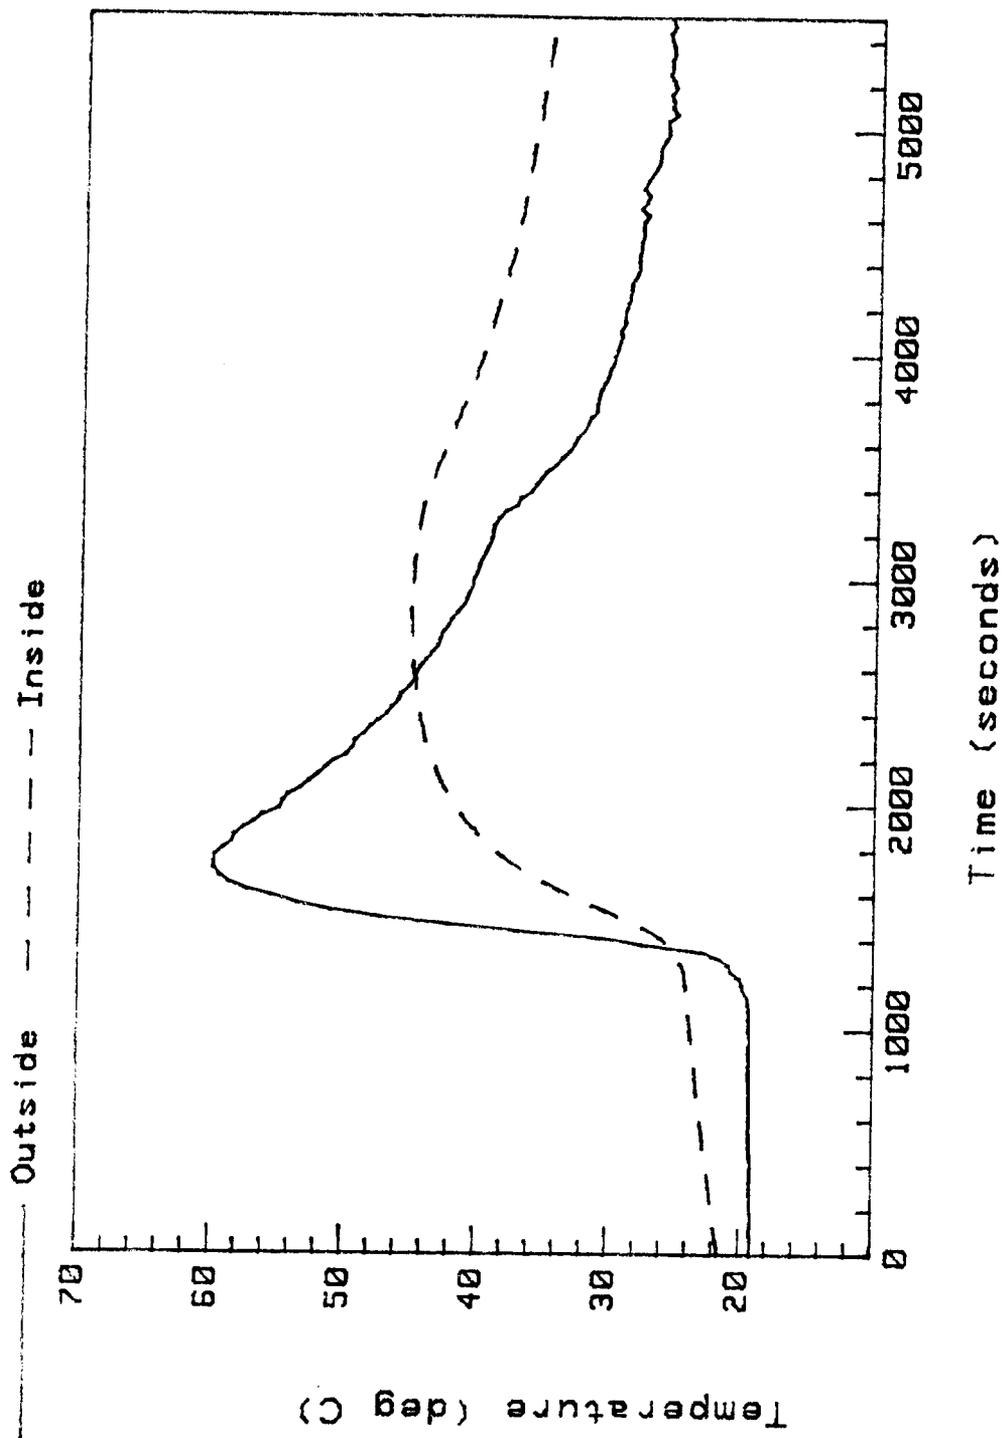
Fig. 9 Air Temperature Inside and Outside of Relay in Test 4

Plots of the temperature environment outside the relay and inside the relay near the contacts from test 4 are shown in Fig. 9. These plots give an idea of the amount of thermal lag caused by the cover being on the relay. The current flowing to the load on the relay contacts is shown in Fig. 10. The relay was operated in both directions every minute, accounting for the drop to zero load current every minute. The two sections of lost load current shown on the plot were the result of a sticking relay on the datalogging system and are not failures of the test relay. (The datalogger relay was found with severely pitted contacts and was verified to be sticking after the test.) A similar plot for the relay in test 5 is shown in Fig. 11. The relay in test 5 was operated every 5 minutes. Neither plot showed any indication of failure of the relay to pick up and carry its load. In neither test did the leakage currents measured to the normally-closed contact (open when the relay was energized) ever exceeded the detection threshold of the ac current sensors used (0.25 mA). The coil currents showed expected behaviors and are not shown. The values of coil current when energized were nominally 50 mA for the Agastat GPI relays and 210 mA for the General Electric HFA series relay.

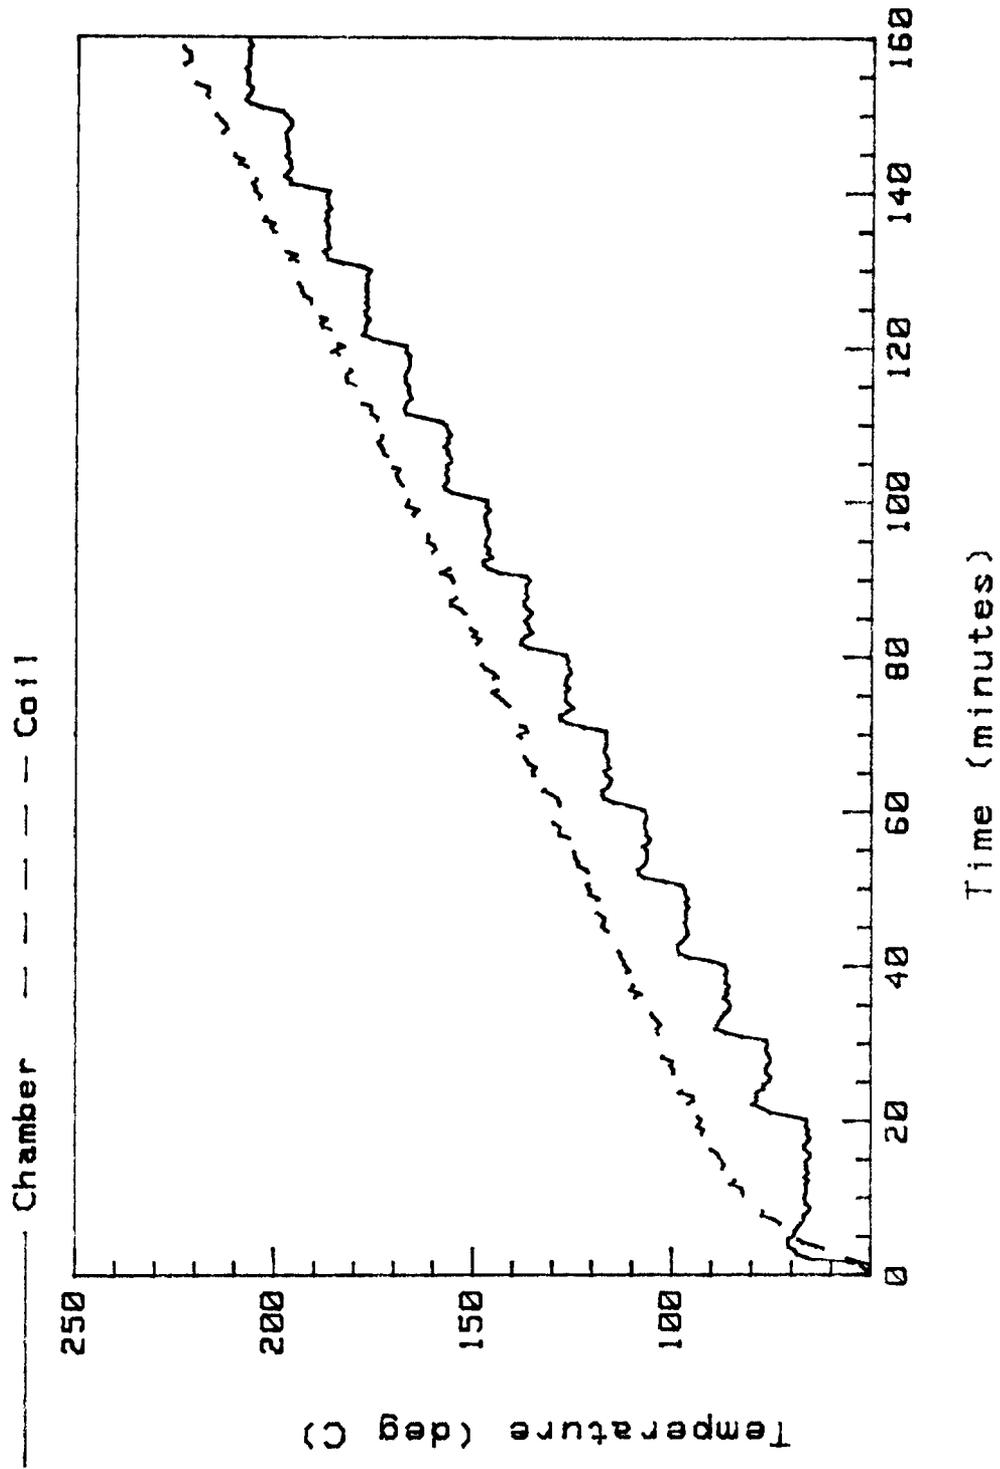
Fig. 12 Coil and Chamber Temperatures for First Thermal Failure Test

The temperature profile for the first relay is shown in Fig. 12. The coil temperature is higher than the chamber temperature because of self-heating effects. Fig. 13 shows the leakage current for contact #2 as a function of time, Fig. 14 shows the coil current as a function of time, and Fig. 15 shows the motor starter current as a function of time. These plots (Figs. 13,14,15) show that at approximately 155 minutes into the test, the contact #2 leakage current went from 0 to 0.84 amps (maximum value limited by the 120 ohm resistor), the motor starter current went to 0, and the coil current jumped to about 0.94 amps from an initial value of about 0.03 amps. Operation of the motor starter became erratic and the test was terminated. It should be noted that the location of the sensor measuring motor starter current really measures the current supplied to the contact #2 common connection.

Post test analysis of the relay indicated several apparent failures. First, a short had occurred between one of the coil power leads and the normally closed terminal of contact #1. The two power leads to the coil were not specifically identified during the test since ac power was being used. Consequently, it is not known whether the short occurred to the hot side of the coil power or the neutral side. A slight decrease in the contact #1 current and a slight increase in the coil current which could not otherwise be explained were observed, indicating the short was probably to the hot side of the coil. However, the amount of the current changes indicates only a partial short (on the order of 100 ohms). The short found after the test was a more complete short which could have been caused by the fairly rapid cooldown after the test was over. The short was between two adjacent wires used for connections in the socket. A photograph of the failure area is shown in Fig. 16.

The second failure mode observed was apparently caused by the rapid cooldown after the test. An open circuit was indicated between the two coil terminals and between several of the terminals which should have been connected when the relay was in the deenergized position. Post test examination revealed severe socket warpage which apparently caused a loss of some connections between the socket and the relay.

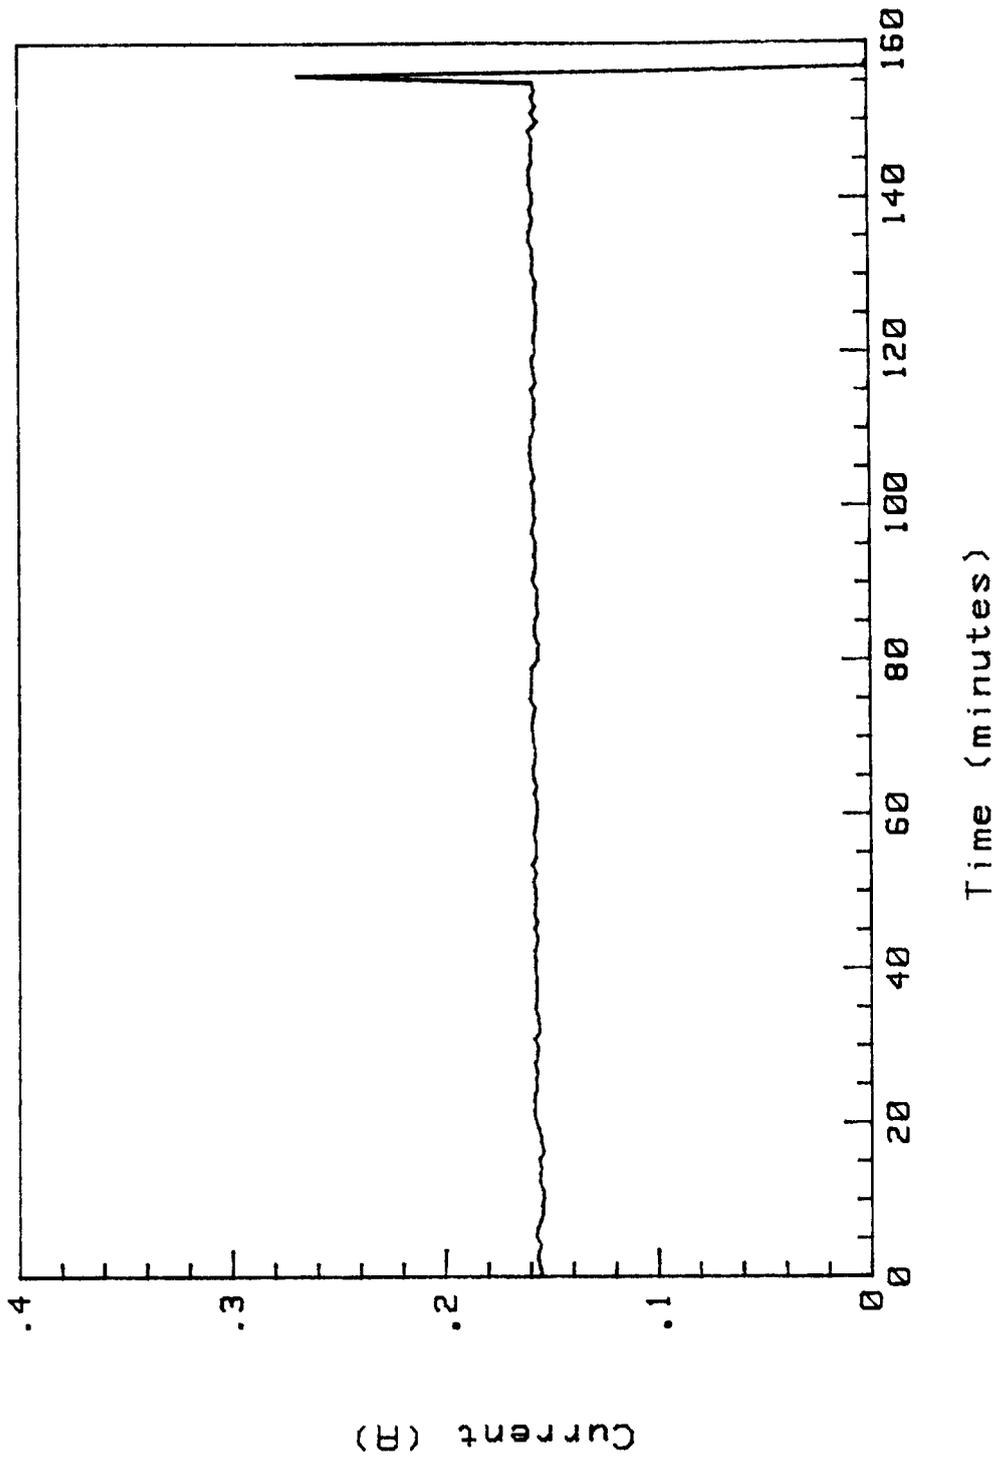
Fig. 15 Motor Starter Current for First Thermal Failure Test

The failures discussed thus far cannot account for the primary failure which resulted in the test being terminated. The cause of the primary

failure had to be a short between the hot side of the relay coil and the normally closed terminal of contact #2. No such failure could be found in examining the relay after the test. However, the base of the relay was so severely warped that apparently two or more of the terminal screws on the socket came into contact with the metal baseplate and shorted together. This was partially confirmed by checking continuity of different terminals when the socket was held onto a metal plate; several definite possibilities of shorting terminals were found.

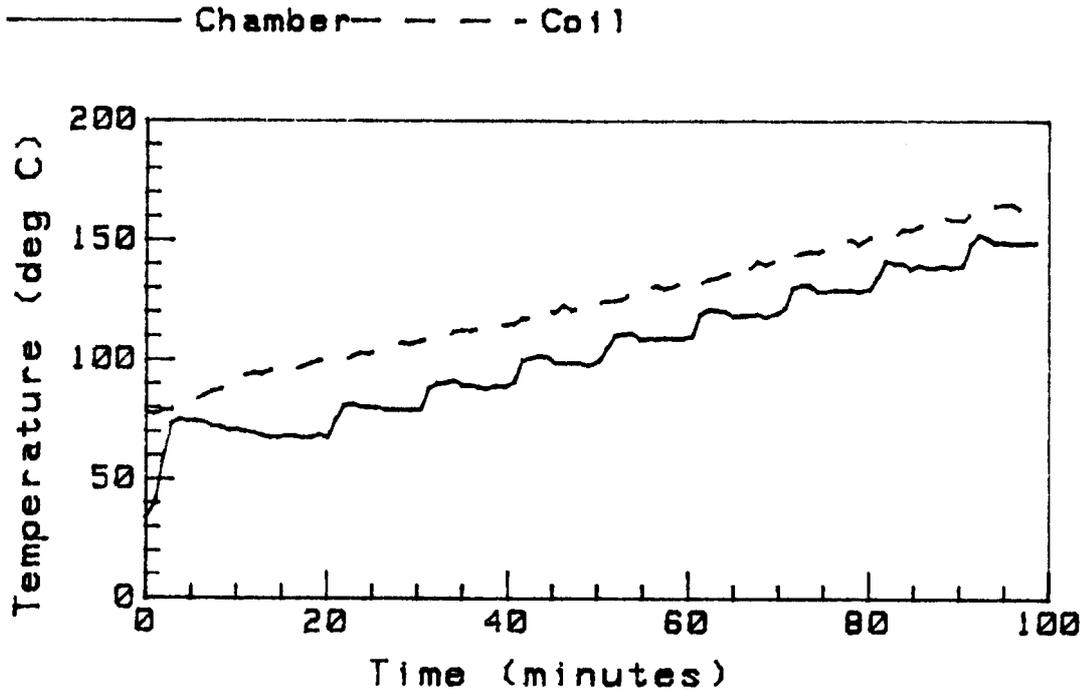
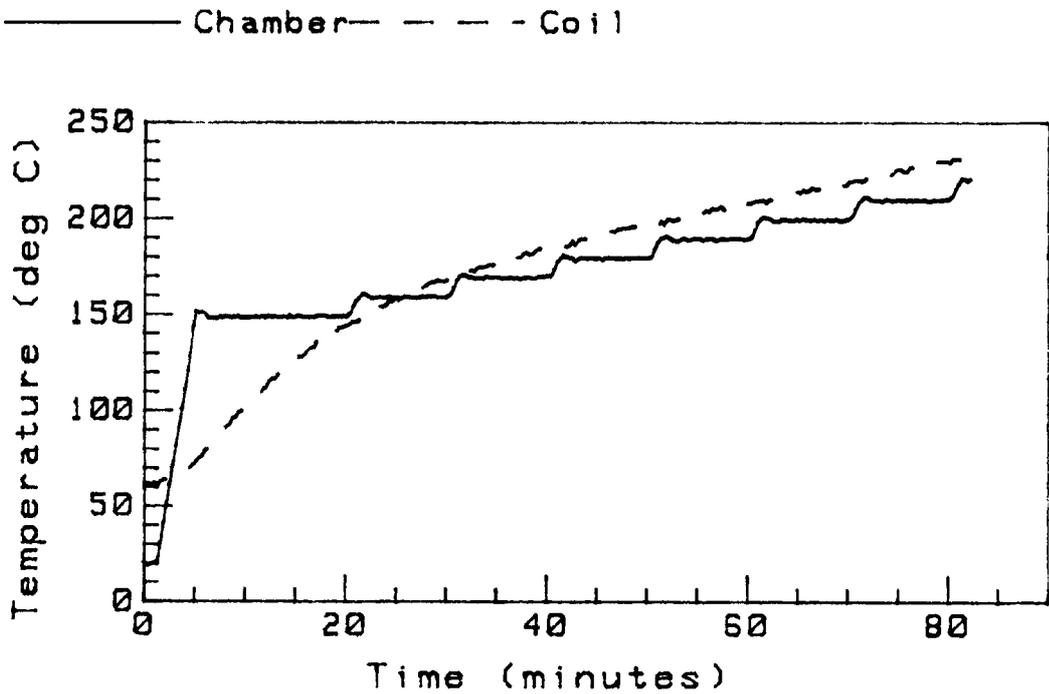
Fig. 17 Coil and Chamber Temperature for Second Thermal Failure Test

During the test of the second relay, a fuse blew at 99 minutes into the test. The cause of the blown fuse was traced to a relay in the datalogging system having fused contacts. The fuse and datalogger relay were replaced and since the test relay still seemed to be operating normally, the test was continued. The temperature profiles for the test and the coil temperature are shown in Fig. 17.

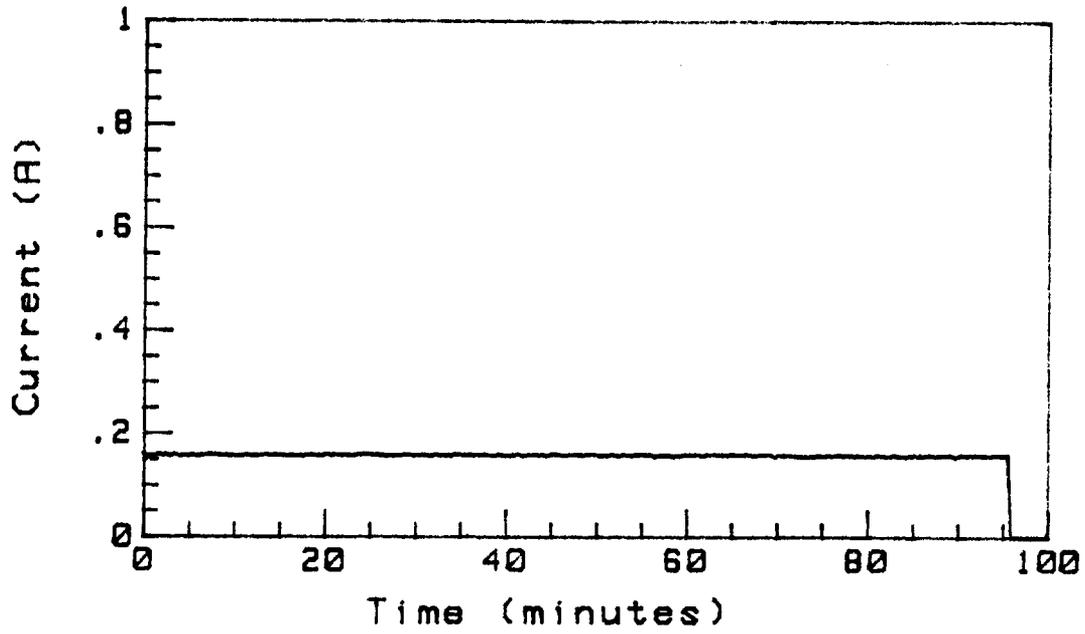
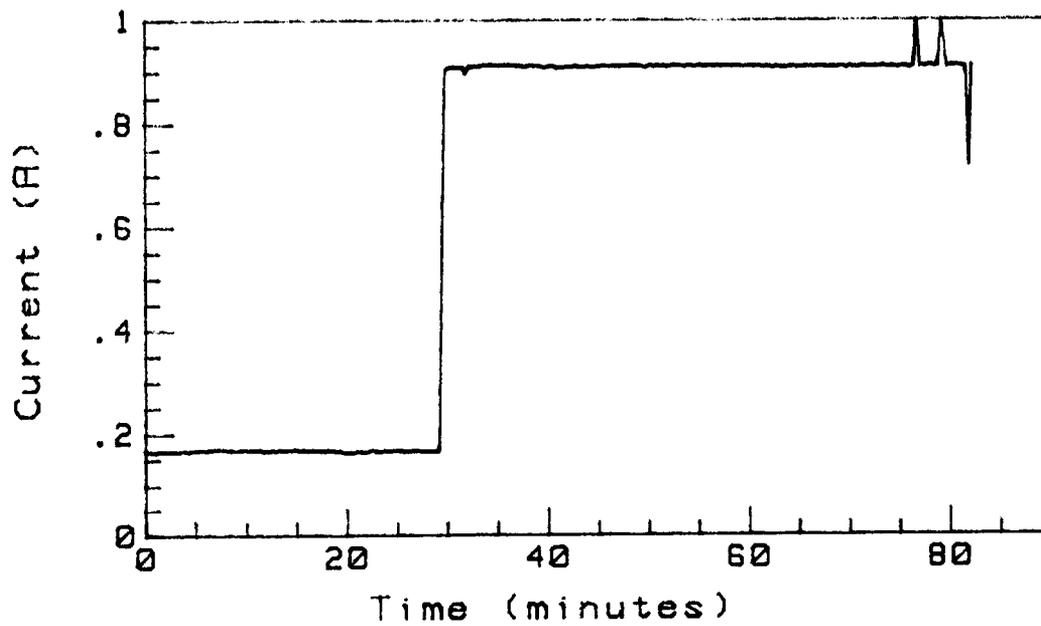
Fig. 18 Motor Starter Current for Second Thermal Failure Test

A plot of the motor starter current (actually current supplied to common terminal of contact #2) is shown in Fig. 18, the contact #1 load current is shown in Fig. 19, the coil current is shown in Fig. 20, and the contact #2 leakage current is shown in Fig. 21. About 30 minutes into the second part of the test, the current supply to contact #2 and the contact #2 leakage current both increased by approximately the same amount, indicating a dead short connecting the common and normally closed (open at the time) terminals of contact #2. The test was continued until between 75 and 80 minutes, the load current was lost twice and the test was terminated.

Post test analysis of the relay indicated some failure modes similar to the first relay. Immediately after the test, several contacts which

should have been connected indicated open on an ohmmeter and all of the contact #3 terminals were effectively shorted together. This short was later found to be in the socket. Insulation resistance measurements on the socket produced what appeared to be breakdown at some dc voltage levels (different locations appeared shorted at all test voltages including the low voltage of a hand-held meter and all voltages of the insulation resistance tester: 50, 500, and 1000 Vdc). However, the apparent breakdown would come and go at different voltage levels and sometimes even at the same voltage level after applications of other voltages. Shorting of terminal screws to the baseplate was not observed in the second test because of the different socket design. However, a new failure mode was observed. The contact support of contact #1 (the contact carrying the nominal 3 A load current) had become hot enough to melt as shown in Fig. 22. The melted support was the cause of the loss of load current observed at 75 to 80 minutes into the second part of the test. Because of the melted support, the coil would no longer energize after the test although it did draw rated current at rated voltage.

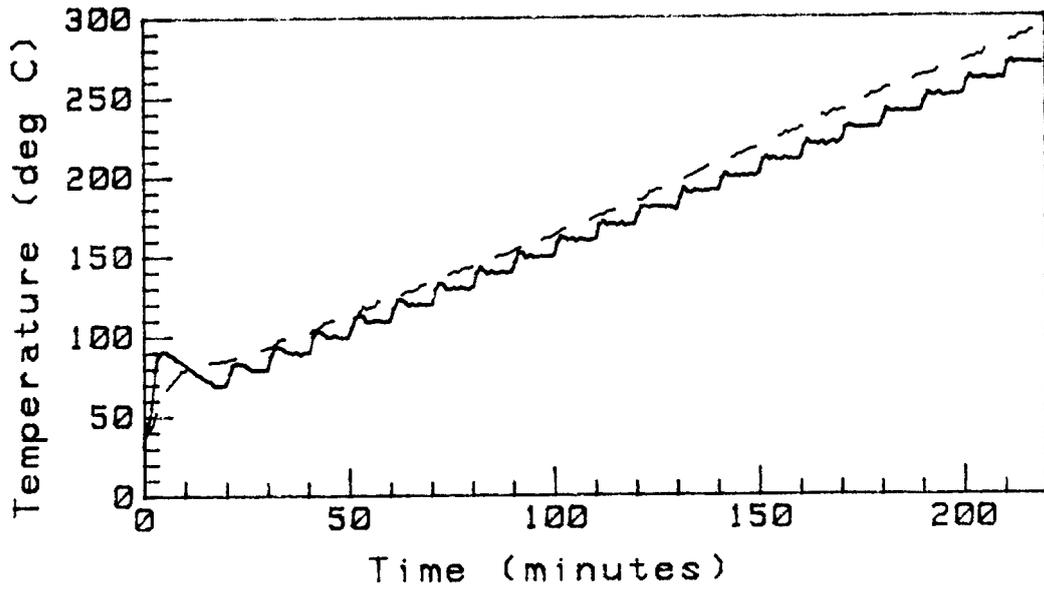
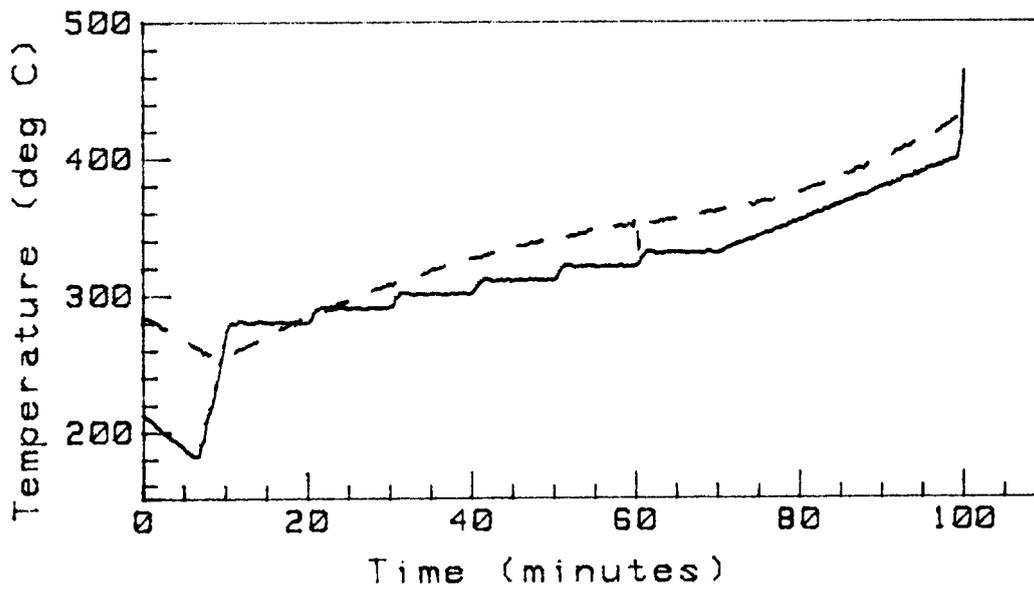
Fig. 23 Coil and Chamber Temperatures for Third Thermal Failure Test

One General Electric relay was tested in the environmental chamber. The relay was a model 12HMA111B9. Two profiles were run as shown in Fig. 23. The second profile was run because failure of the relay was not observed up to the first programmed maximum temperature of 270°C and the objective of the test was to continue until the relay failed. As can be seen from Fig. 23, the second profile was started when the chamber temperature was slightly above 200°C shortly after completion of the first profile. The coil current is shown in Fig. 24 and the load current is shown in Fig. 25. Leakage current is not shown since it never exceeded the ac current sensor detection limit of 0.25 mA. At about 92 minutes into the second test, the load current was lost and the coil current jumped significantly. The test was discontinued and when the chamber was opened, the lead wires to the relay were burning. After extinguishing with carbon dioxide and cooldown of the chamber, the relay was removed. The fire and extinguishment caused significant damage to the relay, as shown in Fig. 26. The fire was caused by the two coil lead wires shorting together and fusing as shown in Fig. 27. The fire apparently started at about 98 minutes, about 2 minutes after the load current was lost. The cause of the loss of load current could not be determined because of the fire damage.

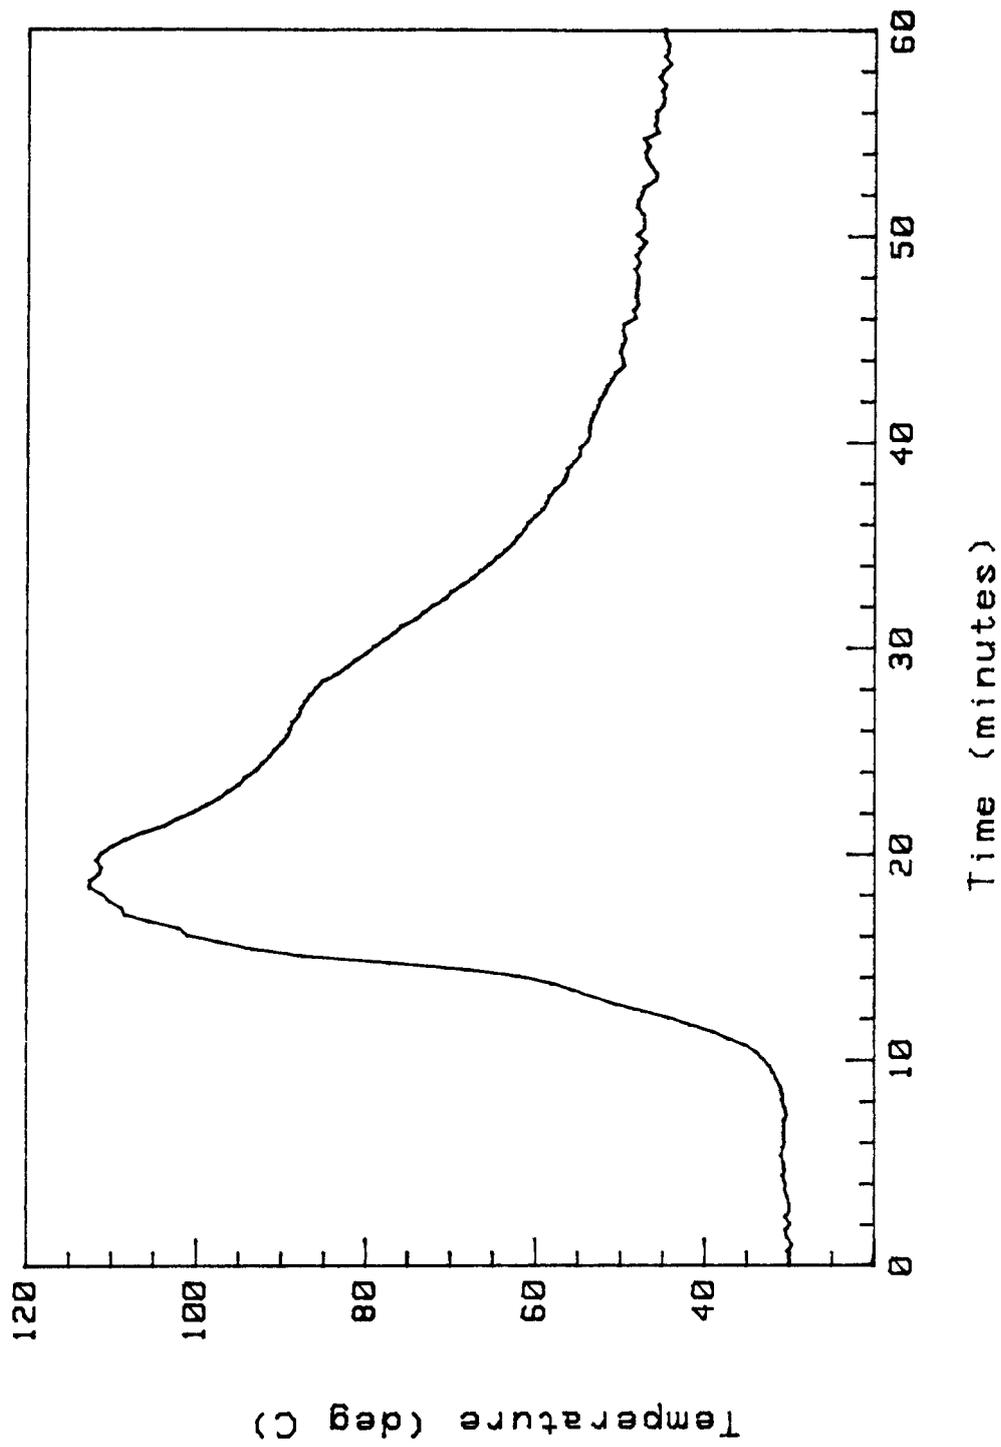
Fig. 34 Temperature Near Oscilloscope 4-channel Amplifier in Test 2

The 4-channel amplifier and power supply was powered with the same nominal 1 V input as the power amplifier. The temperature profile near the 4-channel amplifier is shown in Fig. 34. One channel of the amplifier was set for an amplification of 5 and the output was monitored. As the test progressed, the output signal error increased to about 20% and then was lost. After the test ended, the output returned for about 6 minutes with an initial error of less than 1% but increasing with time to about 16% after which the signal was again lost. After the test, the amplifier power light was found on and the cooling fan was running but no output was being produced. Post-test measurements soon after the test and several days later indicated the amplifier was working on both dc and ac with minimal error. Examination of the plug in unit power supply schematic led to the discovery of a thermal cutout switch which cuts the power off to everything except the on indicator and the cooling fan when the temperature exceeds 58°C (137°F). Fig. 34 shows that the temperature in the vicinity of the amplifier did exceed 58°C, resulting in the cutoff. No instances of similar thermal cutoffs being used in nuclear power plant components are known.
