SANDIA REPORT

SAND86-2710 • TTC-0704 • UC-71

Fire Testing and Analysis of TRUPACT-I Thermal Test Article

This report documents the fabrication and thermal test of a full-scale prototype of the revised TRUPACT-I design (herein referred to as a full-scale Thermal Test Article or Test Article). The fire test demonstrated that the response of the Test Article to a jet-fueled pool fire, subsequent to the impact and puncture tests defined in DOE Order 5480.3 and 10CFR71, meets the impact, puncture, and thermal performance requirements of the regulations governing transport of radioactive materials.

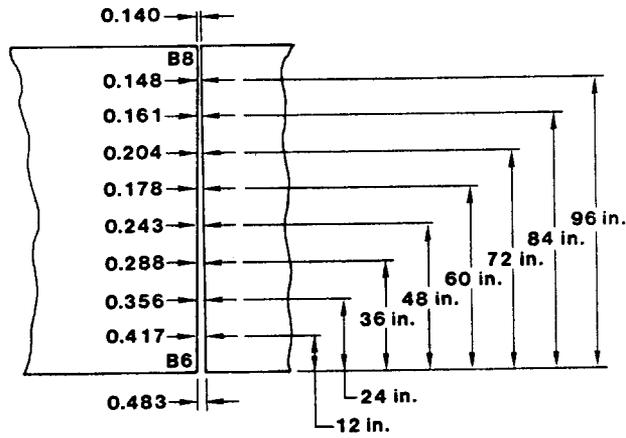
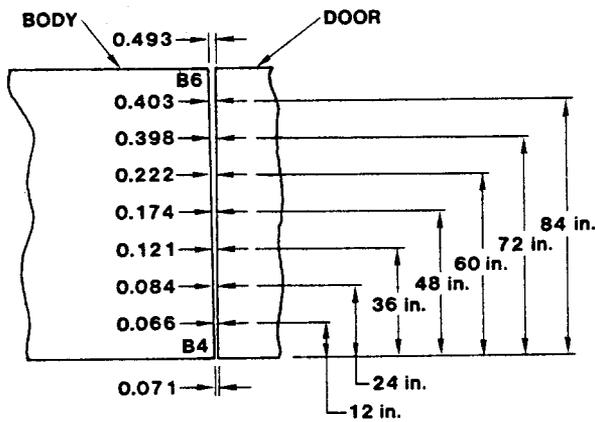
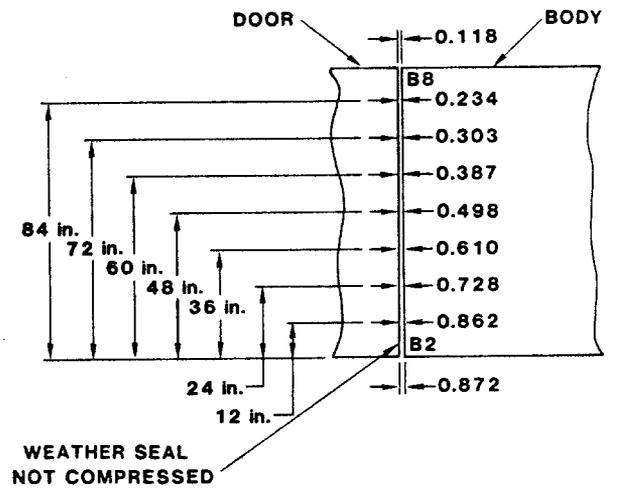
Figure 2.3-1. Unit 0--Outer Door Joint Deformations

1. Edge deformation: Retained in outer frame used from Unit 0.
2. Outer door gap: The outer door was fitted to the body and Unit 0 gaps were reproduced to the extent possible. Gaps recorded in Unit 0 testing are presented in Figure 2.3-1 and are taken from Ref. 1.

UZ-5: Outer Door Joint Deformations - Right Side

UZ-5: Outer Door Joint Deformations - Top

UZ-5: Outer Door Joint Deformations - Bottom

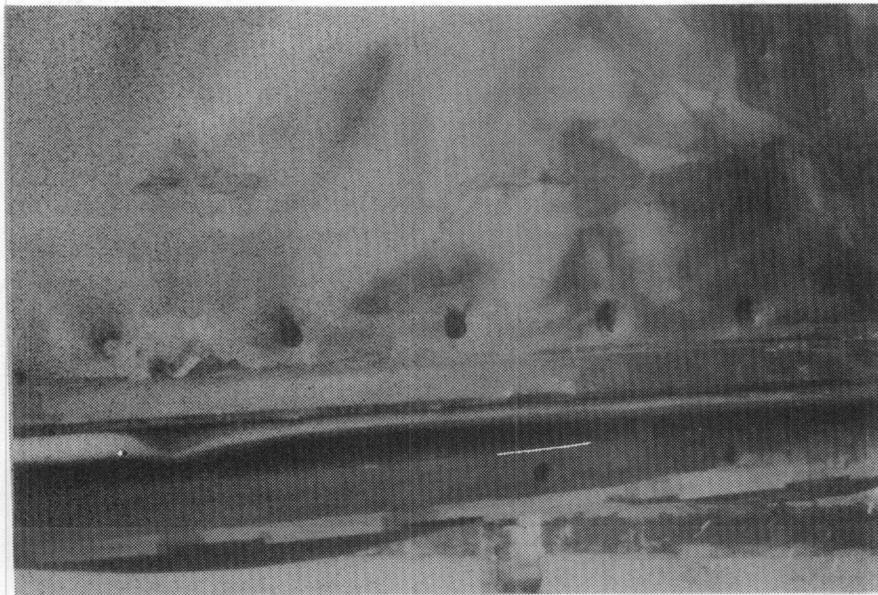
Figure 2.3-2. Inner Surface of Outer Door - Bolt Holes
From Unit 0

1. Corner footprint: Retained in the outer door frame that was tested in the Unit 0 tests.
2. Holes on inside surface of outer door: Holes on the inside surface of the outer door from the Unit 0 tests were retained in the Test Article as shown in Figure 2.3-2.

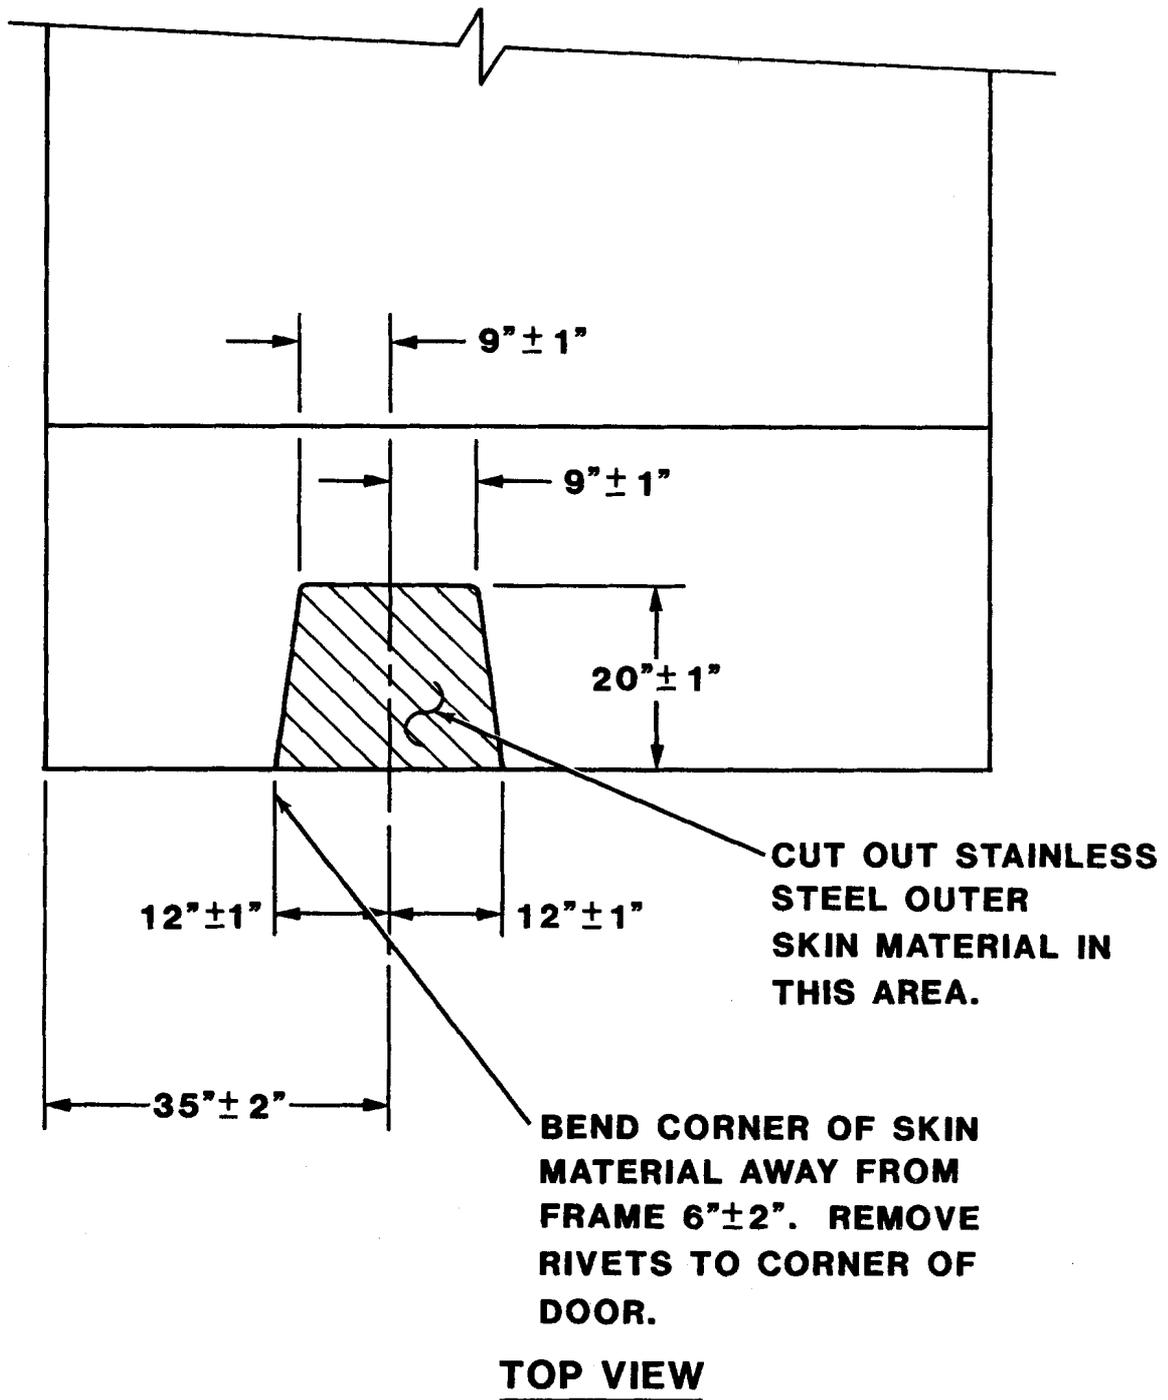
Figure 2.3-3. Puncture Damage Model for Outer Door Skin
(Continued)

1. Outer Door Hole: A hole was cut through the exterior skin on the top surface of the outer door and the honeycomb material was deformed to create a direct path for fire flames to reach the Kevlar in the outer door puncture protection system. The hole was the same size as the Unit 0 puncture hole. Dimensions of the opening in the outer skin are shown in Figure 2.3-3.
2. Outer door puncture plate: Based on results from 1/4-scale model puncture tests the redesigned outer door puncture plate attachment would not fail. Therefore, a puncture plate tear was not modeled in the Test Article. However, deformations in the puncture panel and outer frame were retained.

c. Test Article Damage Dimensions

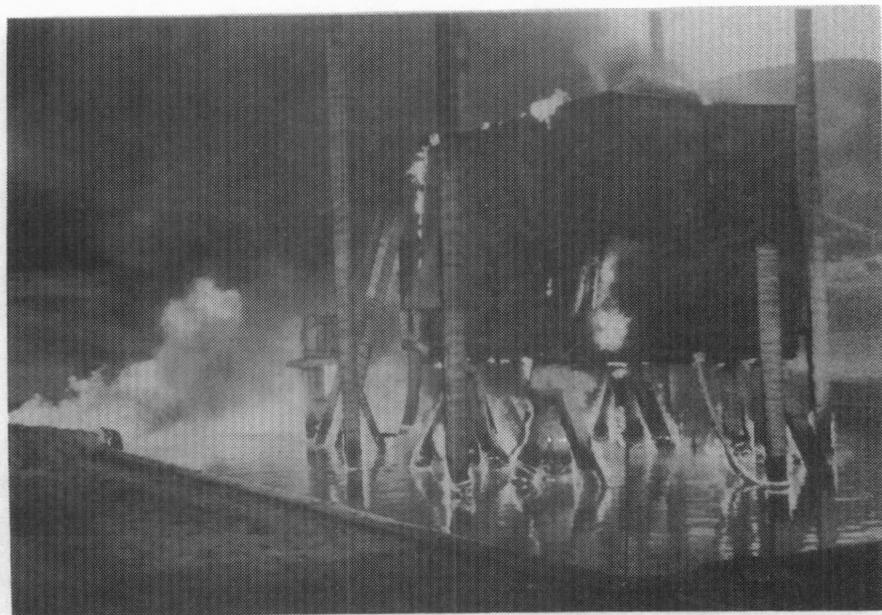
Figure 5.2-3. Outer Door Shortly After JP-4 Fuel Consumed

After flames ceased to engulf the Test Article, flames were still visible at numerous locations on the outer door and body. Heavy black smoke coming from the top of the outer door indicated that organic materials continued to burn (Figure 5.2-3). At the crushed corner of the outer door the heated structural members produced a white-hot glow (Figure 5.2-3). Molten material, later found to be aluminum, could be seen dripping from holes in the exterior stainless steel skins of the outer door and body.

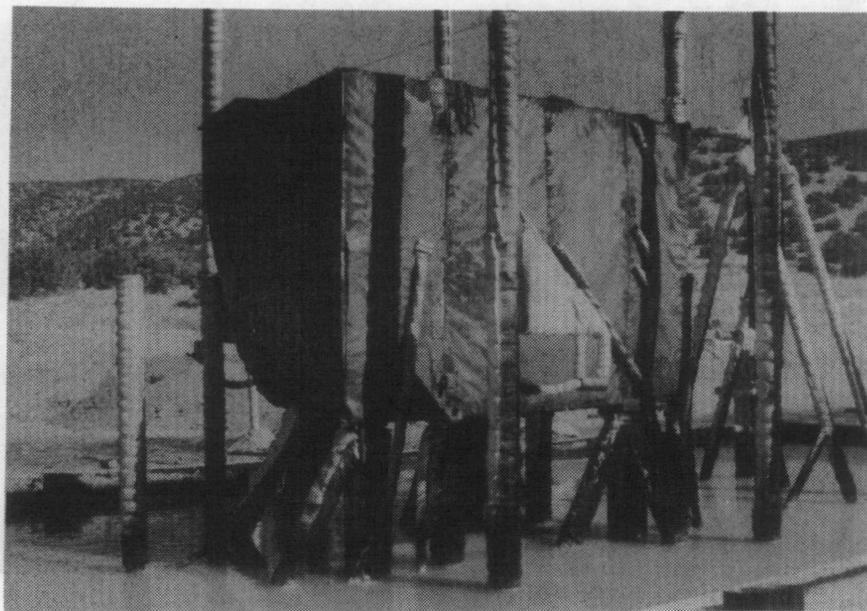
Figure 5.2-4. Test Article, Post-test (Cooldown Complete)

Two hours after the fire self-extinguished, smoke was still coming out of the top of the outer door. Figure 5.2-4 shows the Test Article post-test after complete cooldown of the hardware.

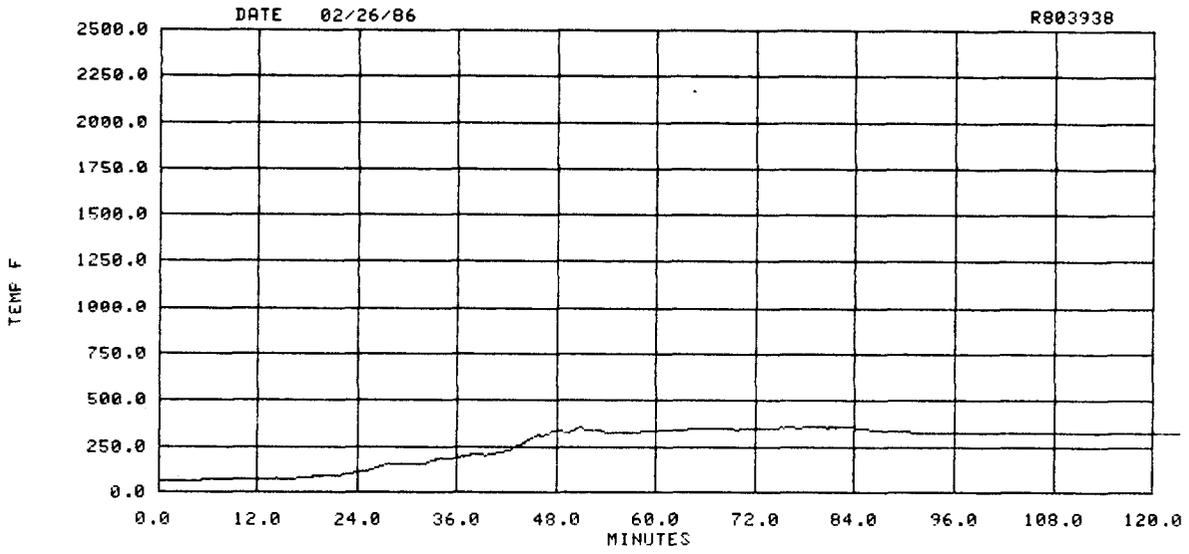
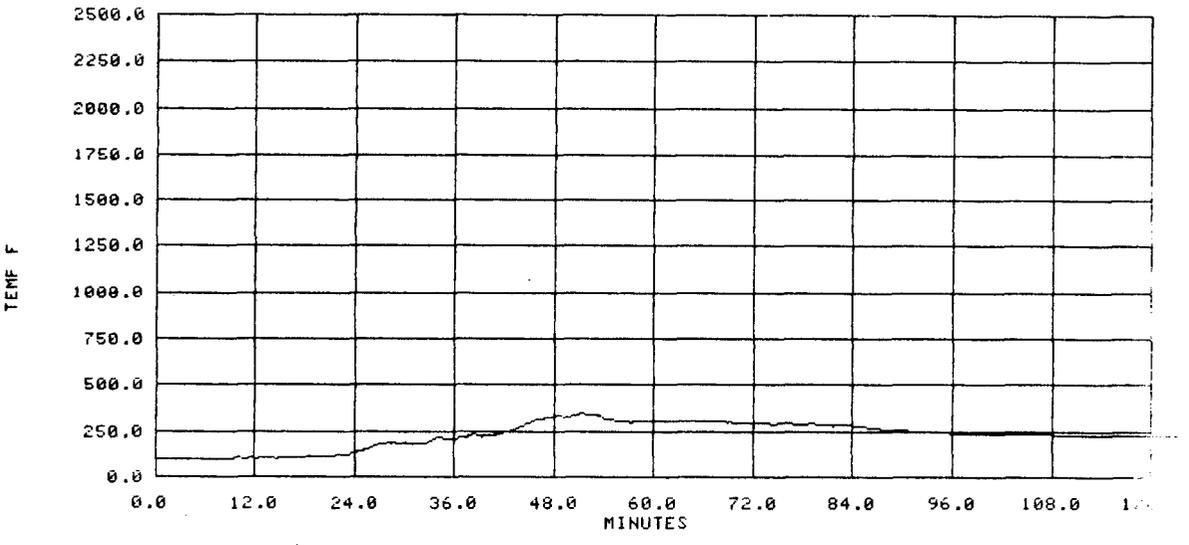
Figure 5.3-1. Temperature Distribution Through TRUPACT Body, Right Side Center

Thermocouples interior to the Test Article indicated peak temperatures significantly greater than temperatures of adjacent passive thermal indicators, see Table 5.3-1. Oven tests had been conducted prior to the fire test to confirm the response of the passive thermal indicators so an instrumentation error was suspected. The general appearance of the Test Article drums, dunnage, and polyurethane foam substantiated the assumption that the lower temperatures recorded by the passive indicators reflected the actual test environment. Figure 5.3-1 shows the temperature history of thermocouples at the same location on the containment liner and puncture plate. The containment liner response is almost identical to the puncture plate response. A significant temperature difference would be expected between the two temperature records due to the presence of insulating polyurethane foam between them.

a. Peak thermocouple temperatures listed in this table indicate incorrect maximums measured by the data recording system. See paragraph 5.3 for an explanation of the source of the error.

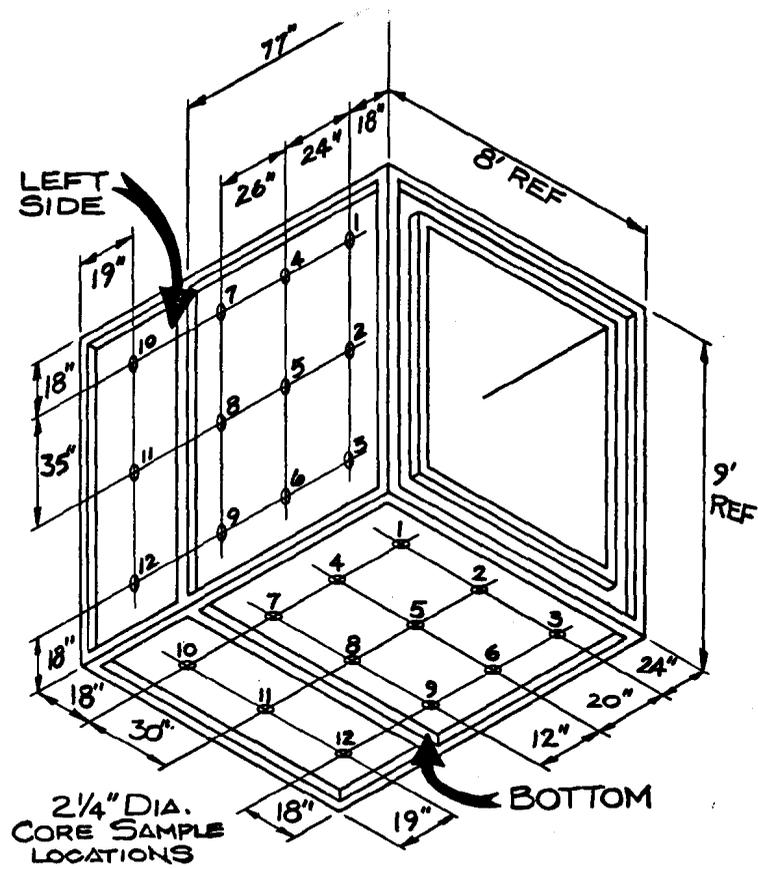
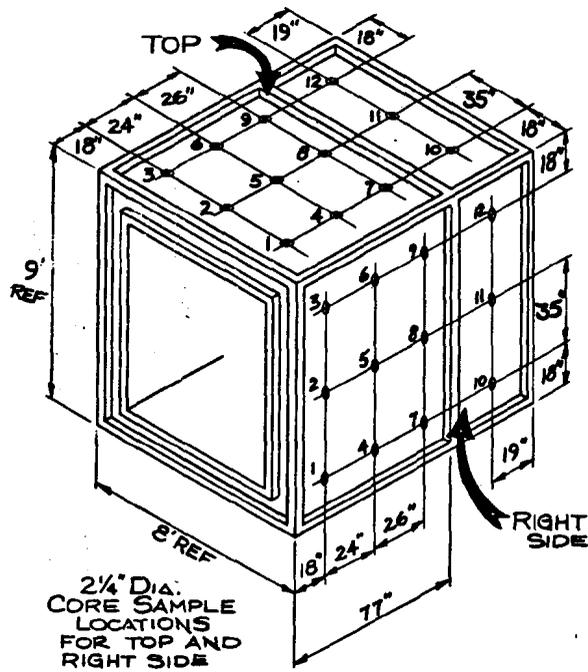
Figure 5.5.15. Foam Core Sample Locations

The insulation board behind structural members of the outer frame was examined. The exterior surface of the insulation boards had a hard crust but the interior material was soft. The surface of the insulation boards around the cutouts for release of pyrolysis gases had a hard black crust but the adjacent material was soft and pink in color.
