**NUREG/CR-6412  
SAND97-3170**

# **Aging and Loss-of-Coolant Accident (LOCA) Testing of Electrical Connections**

Prepared by  
C.F. Nelson

**Sandia National Laboratories**

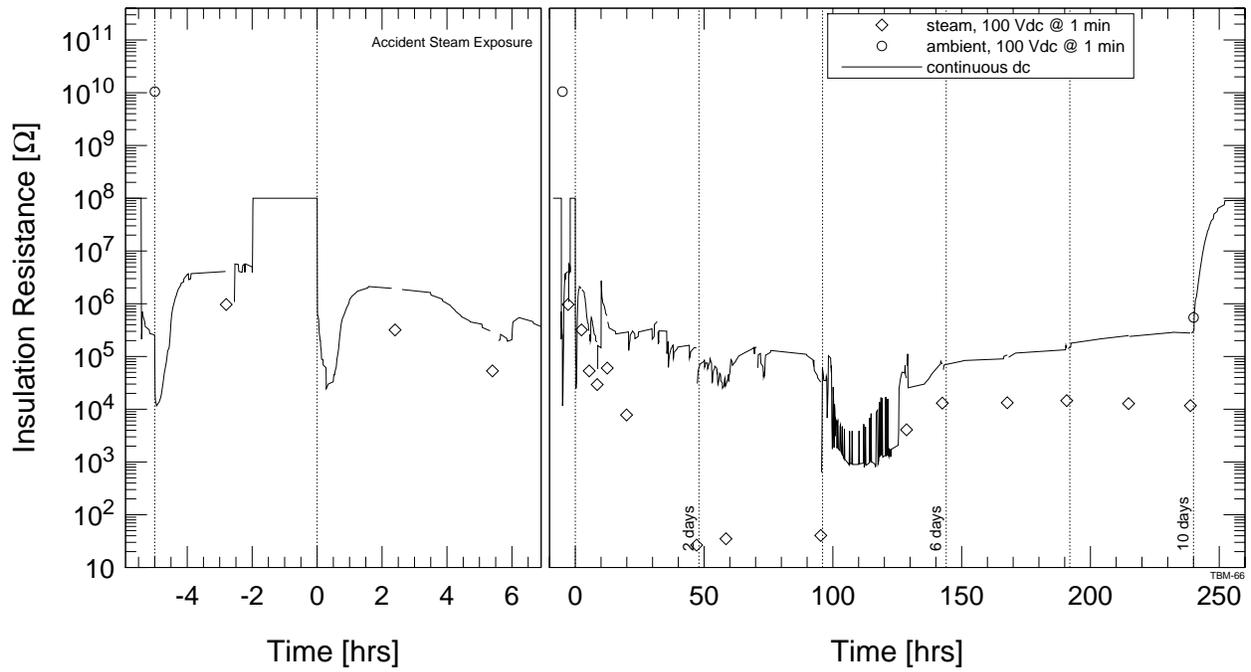
Terminal block conductor IR data during the accident steam exposure are shown in Figures A.7–A.20. The IR fell to low values during the steam exposure due to the presence of moisture. The slow partial filling of the test chamber with condensate that occurred through

Figure A.7: IR of conductor 66 during the accident steam exposure (Marathon dc ground plane, enclosure 1).

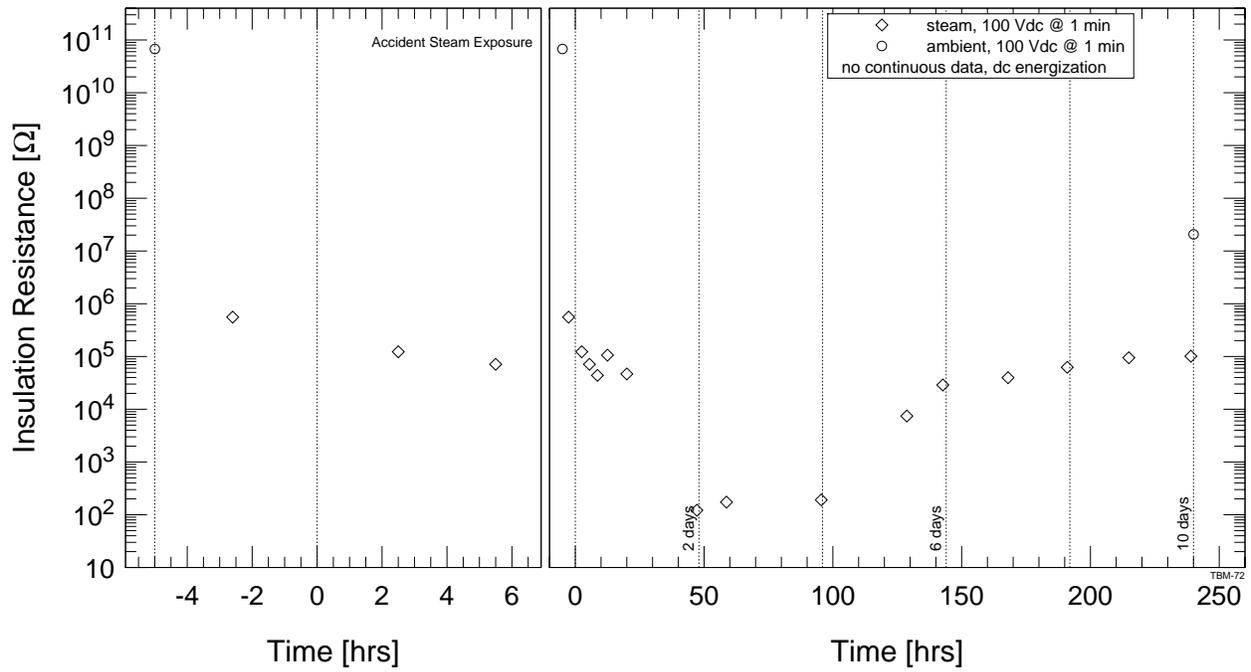
The two Marathon terminal blocks looked much better because they did not melt; however, they were stained a rusty color and the screw terminals and lugs were badly corroded. Just as for the States terminal blocks, the copper from the conductors used for dc excitation (72A and 72B) had formed large blue-green deposits and conductor 72B was corroded away and not connected to anything.

Figure A.13: IR of conductor 72 during the accident steam exposure (Marathon dc energization, enclosure 1).

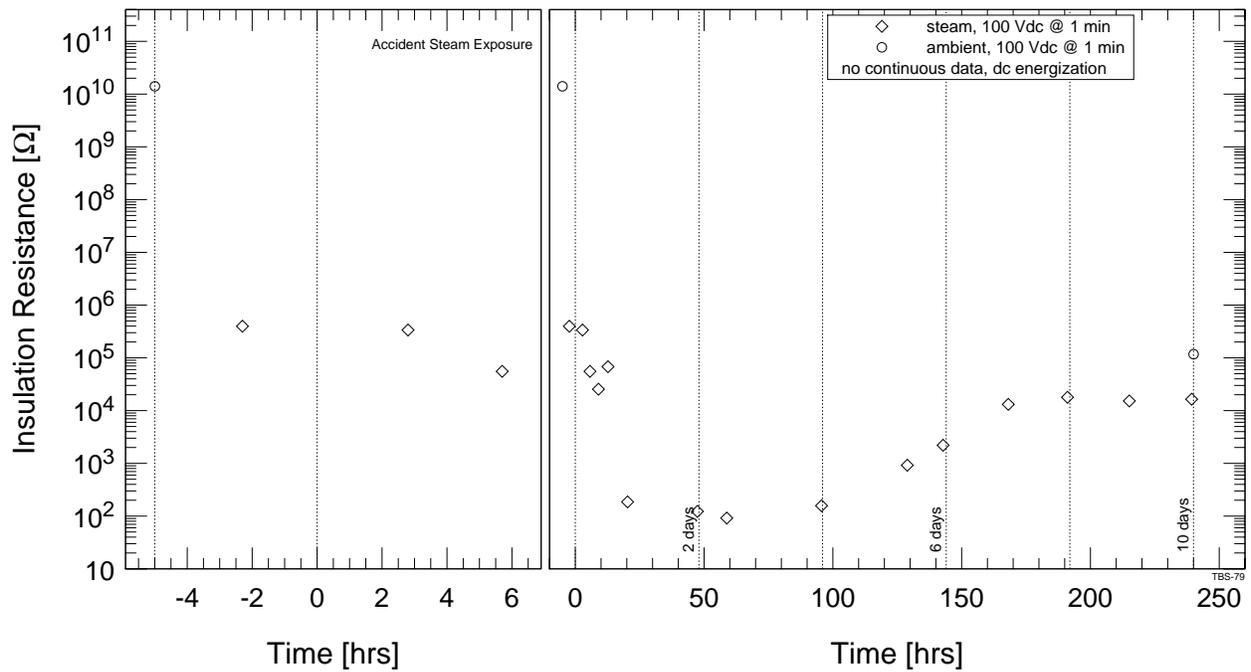
Physical examination of the terminal blocks at the end of the test showed severe degradation. The enclosures were severely rusted and it appears that there was a fair amount of moisture present in the enclosures during the test (even though they do not appear to have been submerged during the partial flooding of the test chamber); moisture may have accumulated by condensing inside the conduit and dripping down into the enclosures. The 2 States terminal blocks were severely degraded. The plastic shields between each pair of terminals had melted and collapsed downward. The screw terminals and lugs were badly corroded and were often covered by the collapsed plastic shields and label plate. The copper from the conductors used for dc excitation (79A and 79B) formed large blue-green deposits; in fact, conductor 79A was completely corroded away and was not connected to anything.

Figure A.20: IR of conductor 79 during the accident steam exposure (States dc energization, enclosure 2).

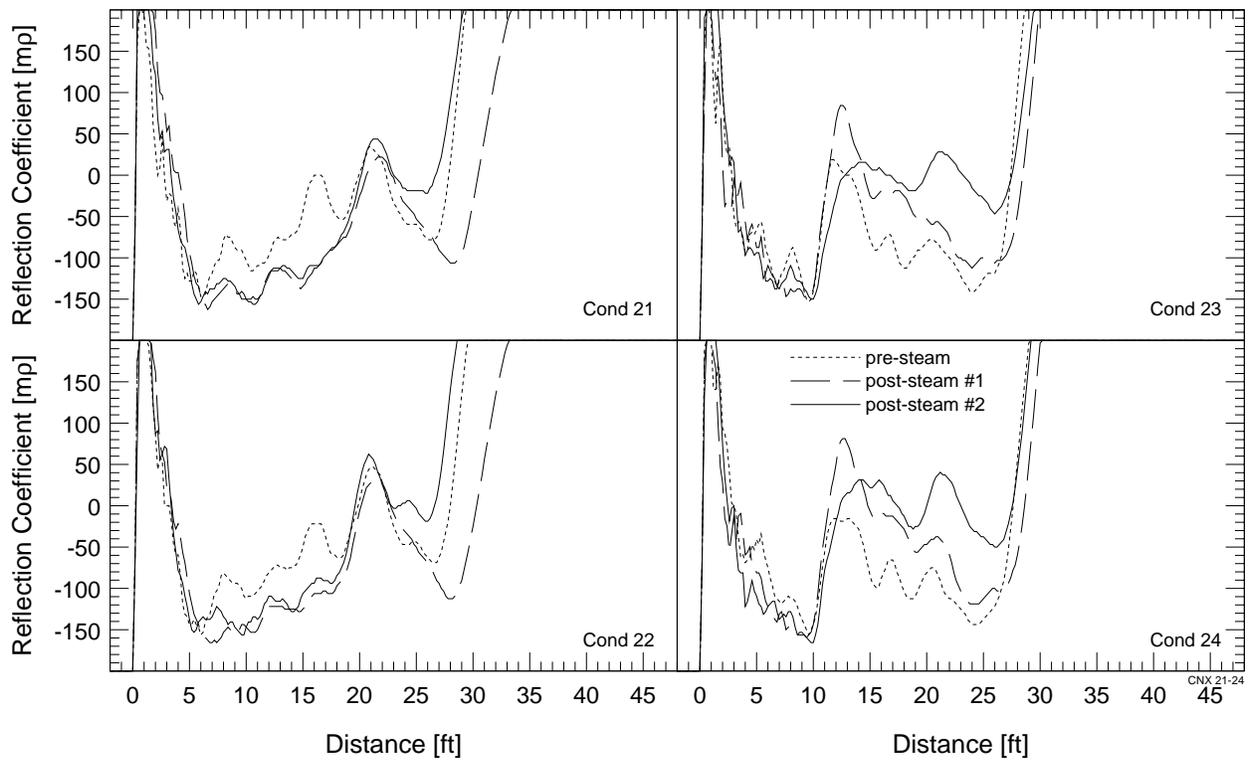
The IR for most of the connections also remained high during the accident steam exposure. Only the four Conax Buffalo ECSA conduit seal conductors gave extremely low IR values ( $< 100 \Omega$ ); the two nongrounded conductors repeatedly blew 1-A fuses when energized at 110 Vdc. However, post-test examination showed that these low IR values were produced by degraded Kapton-insulated cable leads; the IR of the actual conduit seals remained at levels above  $10^{10} \Omega$ . After the initial steam transients, only 3 of 6 Litton-VEAM connector conductors and all four Amphenol coaxial connector conductors had IR values that fell below  $10^7 \Omega$  (in addition to the four Conax Buffalo ECSA conduit seal conductors).

Figure C.2: TDR of the Conax Buffalo ECSA conduit seal conductors before and after the accident steam exposure.

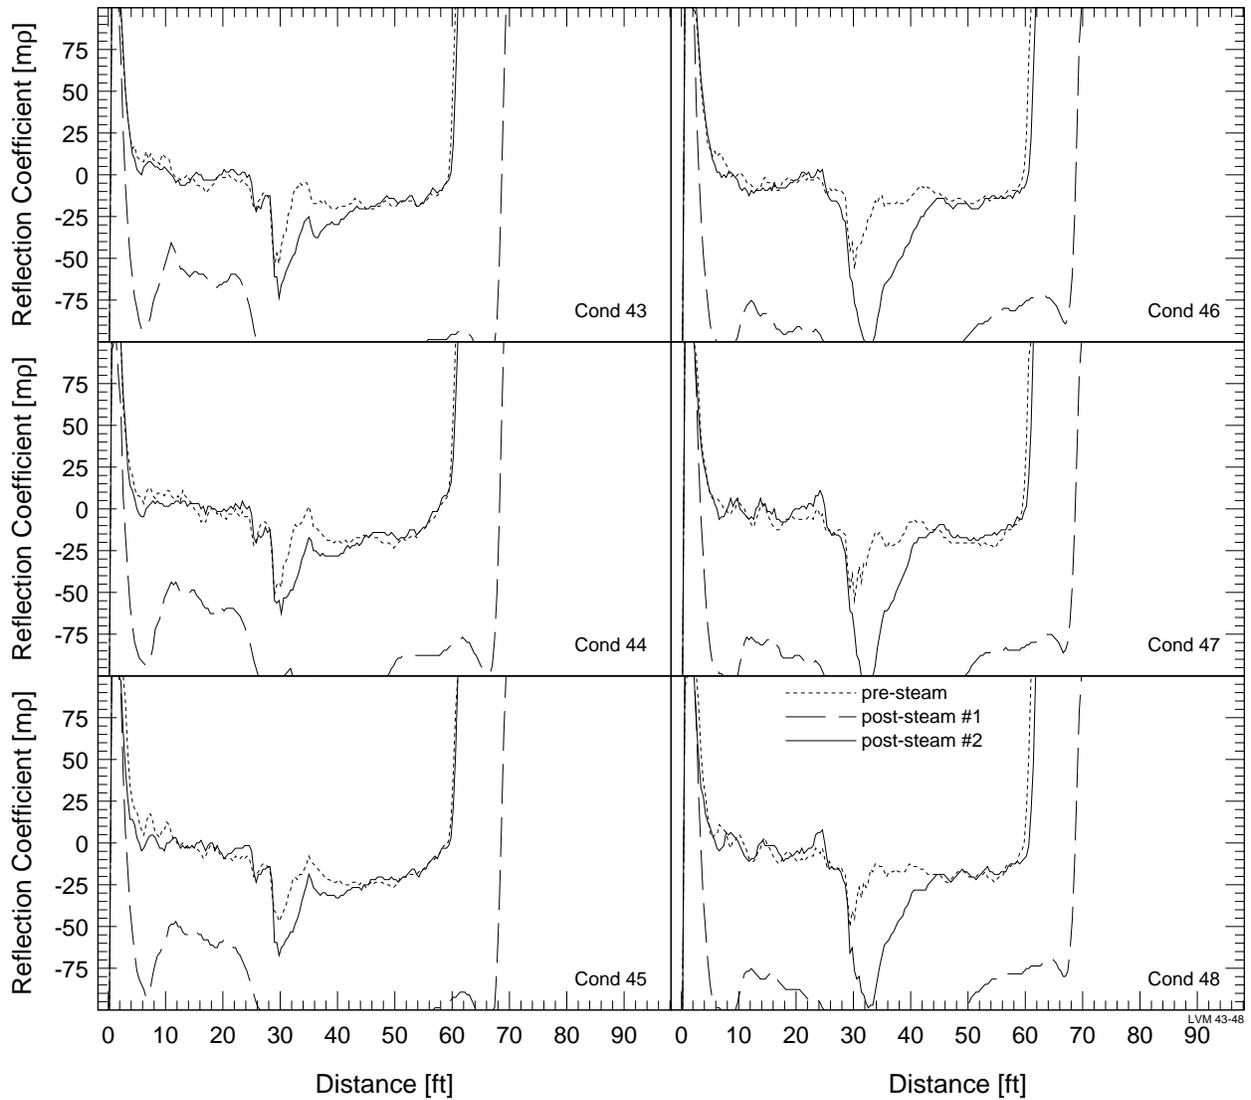
Post-test examination showed that the O-ring seals used in the Litton-VEAM connector were brittle and had experienced compression set, thereby reducing their sealing ability and allowing moisture to enter the connector body. The Rockbestos coaxial cable used with the Amphenol coaxial connector appears to allow moisture to permeate its jacket and then get into the unsealed connector by wicking along the braided shield. No explanation for the behavior of the Rosemount 353C conduit seal was found during the post-test examination.

Figure C.8: TDR of the Litton-VEAM connector conductors before and after the accident steam exposure.
