SANDIA REPORT

SAND98-1086

H1616 Supplemental Compliance Test Report

Sandia National Laboratories designed the H1616 container for transport of Type B quantities of radioactive materials. During the most recent recertification cycle, questions were raised concerning the ability of drum type containers with locking rings to survive the hypothetical accident sequence when the puncture test was oriented to specifically attack the locking ring. A series of tests has been performed that conclusively demonstrates that the specially designed locking ring on the H1616 performs adequately in this environment.

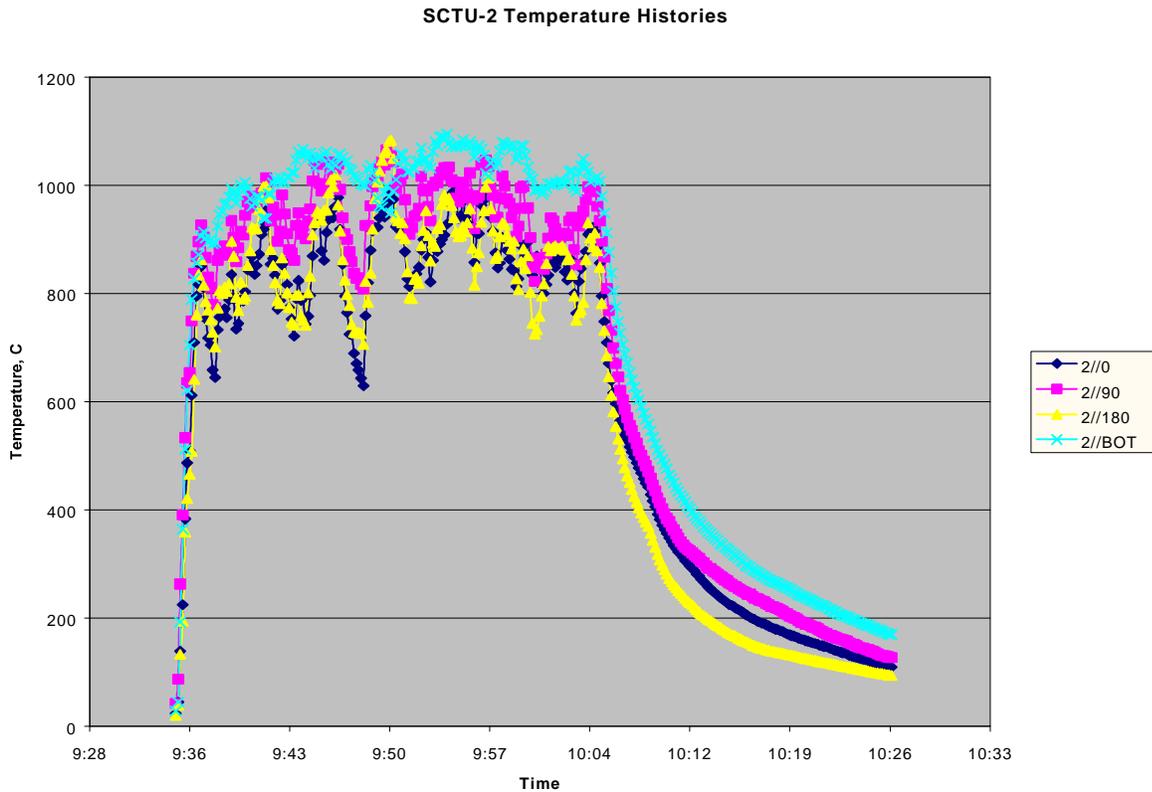
Figure 18: SCTU-2 Pool Fire Test Data

Figures 18, 19 and 20 show the temperature histories for each of the containers. These plots show the range of temperature variation within a given pool fire. These range from the tight variation and high temperatures in SCTU-4 to the relatively highly variable, cooler results seen for SCTU-3. In all events, the heat input to each container complied with the regulatory requirements.

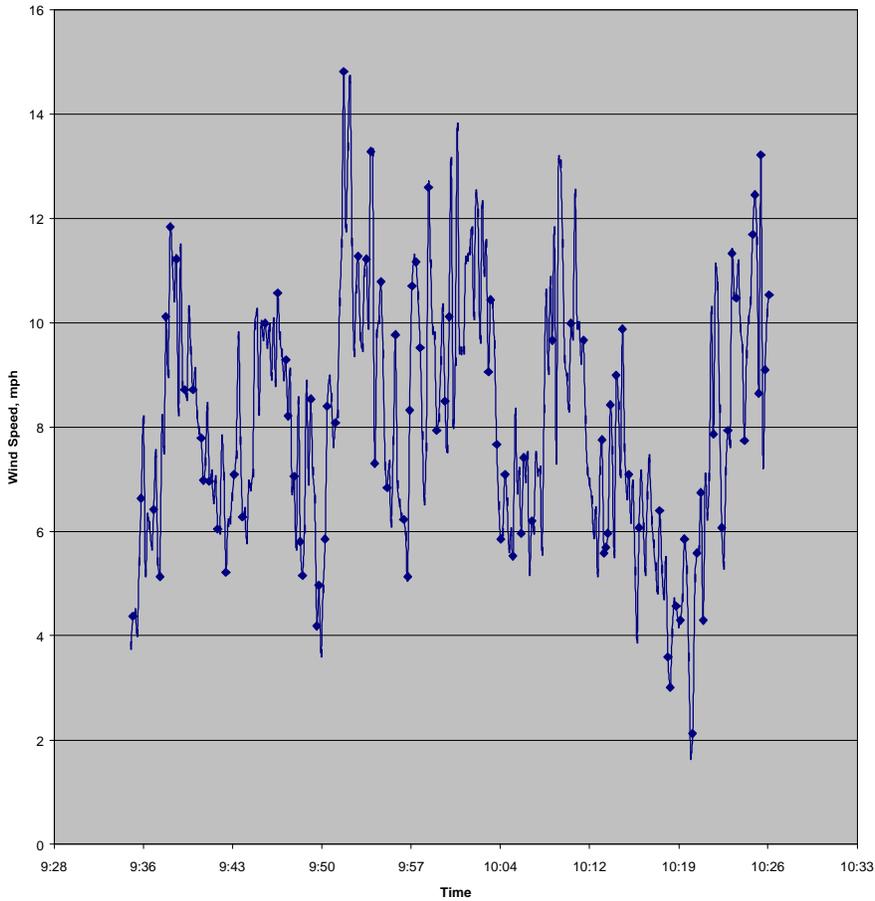
Figure 21: Wind Speed

The wind speeds for the pool fire test are shown in Figure 21. These wind speeds are measured outside of the windscreen that protects the fire. As is apparent from the previous temperature histories, these wind speeds did not adversely affect the pool fire.
