SAND2004-4584

Failure Analysis of Rutile Sleeves in MC3080 Lightning Arrestor Connectors

Chad S. Watson, Alice C. Kilgo, Terry L. Ernest, Sandy L. Monroe, Bruce A. Tuttle,
and Walter R. Olson

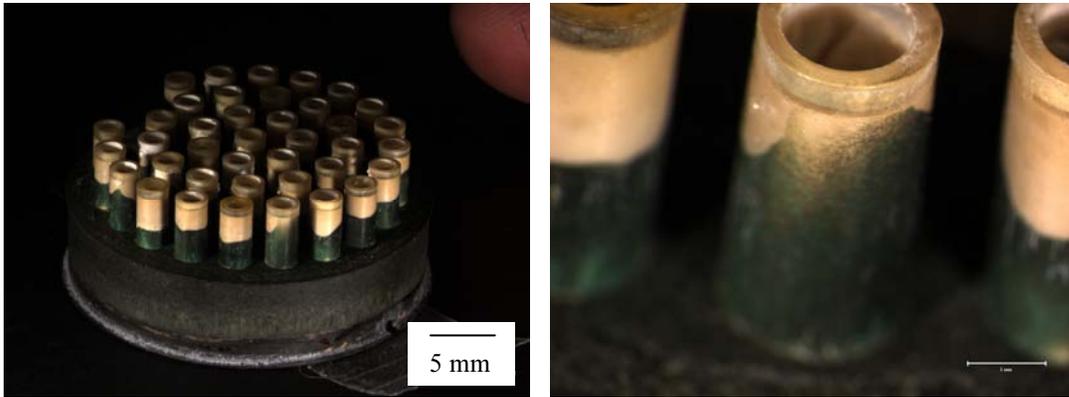
After the 2nd polish, the outer shell casing was removed to limit the amount of time the rutile sleeves were exposed to the aqua regia solution. After acid dissolution of the pins and webbing, representative images of the sleeves protruding from the amicon were made (Fig 12). The amicon wicked up on all of the rutile sleeves. Even though there is variability in the amicon height, all of the pins passed FRB/IR/DCW. The amicon height variability is typical of all the sleeves examined from the LACs and is a result of processing variables.

Fig. 12 Representative images showing rutile sleeves protruding from the amicon as well as the degree in which amicon wicked up the rutile sleeves.

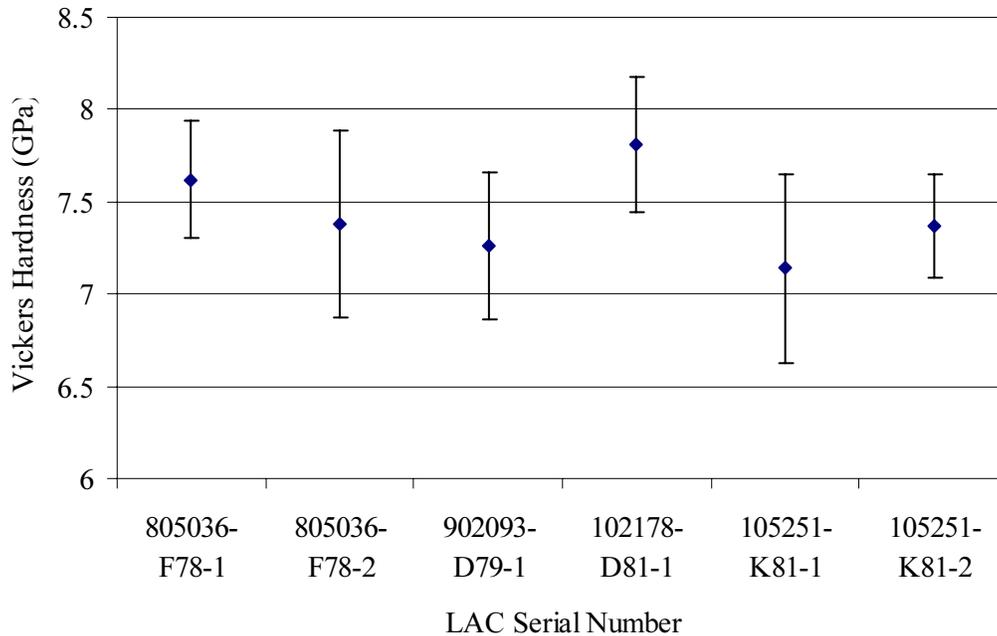
Fig. 27 Vickers hardness of rutile sleeves as a function of LAC serial number. The number at the end of each LAC serial number refers to the numbering convention used on the randomly selected sleeves.

listed in the database, direct comparisons to the published values cannot be made. Nonetheless, the hardness values (~7.4 GPa) are not drastically different than values obtained from the CenBASE Materials searchable database (~7.8 to 10 GPa). The average fracture toughness of rutile was calculated to be ~1.6 MPa·m^{1/2} for all the sleeves tested. This value is partially based on of the assumed elastic modulus of 192 GPa (The assumed elastic modulus was the lowest published value.). A value of 2.2 MPa·m^{1/2} was obtained from the CenBASE Materials searchable database. Because the value is based on manufacturers product catalogs where processing conditions of the rutile listed in the database are not known, direct comparisons cannot be made. However, the measured toughness values are not unusually low for a polycrystalline oxide ceramic. Also, there appears to be no systematic change in hardness (Fig. 27) and fracture toughness (Fig. 28) as a function of LAC fabrication date.

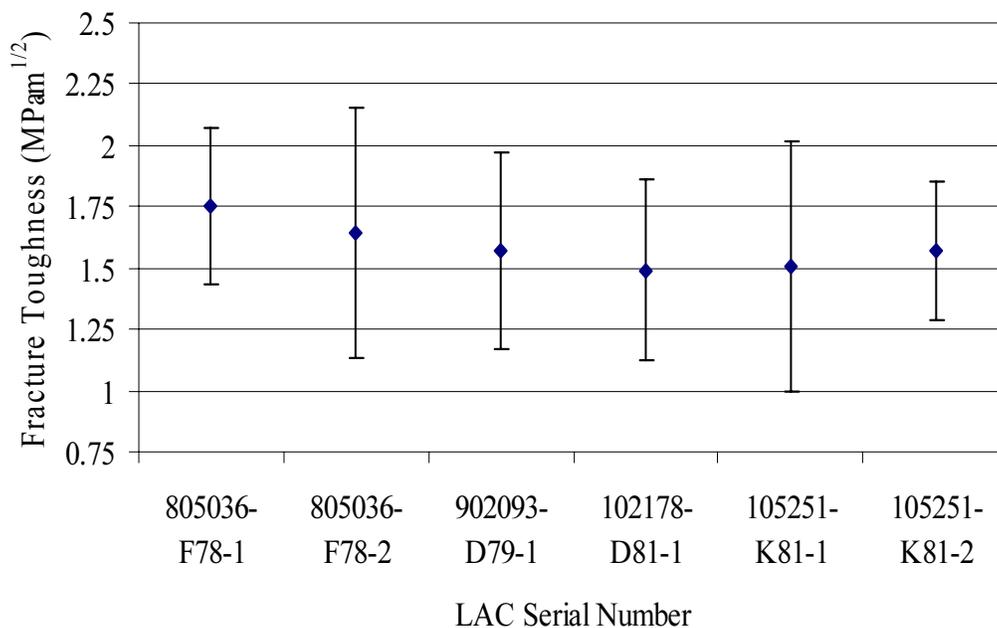
Fig. 28 Fracture toughness of rutile sleeves as a function of LAC serial number. The number at the end of each LAC serial number refers to the numbering convention of randomly selected sleeves.
