SAND2006-4154

An Evaluation of the Spring Finger Solder Joints on SA1358-10 and SA2052-4 Connector Assemblies (MC3617, W87)

Paul T. Vianco, Alice C. Kilgo, Gary L. Zender, and Paul F. Hlava

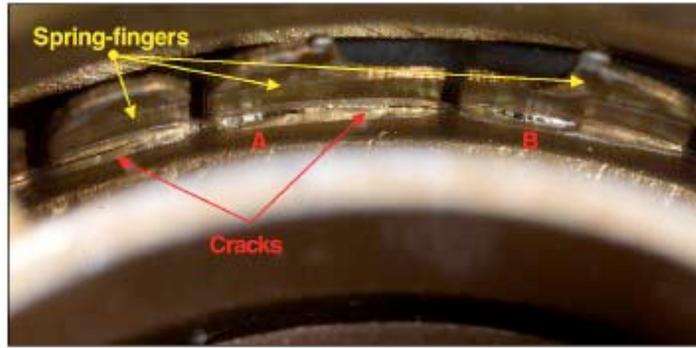
(a)

The following concerns were addressed in that earlier study and resulting report. (1) *Cracks were observed in the fillets of the solder joint that attached the spring fingers to the connector shell.* Cracks are illustrated both by optical microscopy and scanning electron microscopy (SEM) in Fig. 4. Although the assembly specification (AY357007) allowed such cracks to be present in the fillet region, it was necessary to confirm that the cracks terminated had not propagated through the entire section of the joint, thereby potentially causing the spring fingers to separate from the connector shell.

(2) *The morphology of some of the cracks (locations "A" and "B" in Fig. 4a) indicated that the tin-silver (Sn-Ag) solder used to attach the spring fingers to the shell had remelted during next-assembly processes performed at Honeywell/KCP.* The uncontrolled remelting of previously formed solder joints is not permitted in WR and JTA components or sub-assemblies¹. In the absence of a flux, the solder can dewet from the surface, resulting in an unacceptable fillet. The fact that the spring finger solder joints could not be visually inspected for such degradation lent further unacceptability to a remelting occurrence.

Fig. 4 Stereo photograph showing cracks in the top side fillet of the spring finger solder joint from an SA1358-10 connector (S/N6000). The locations “A” and “B” suggest remelting of the 96.5Sn-3.5Ag solder had occurred. (b) SEM photograph illustrating the cracking of the spring finger solder joint at higher magnification on a different SA1358-10 connector (S/N1430).

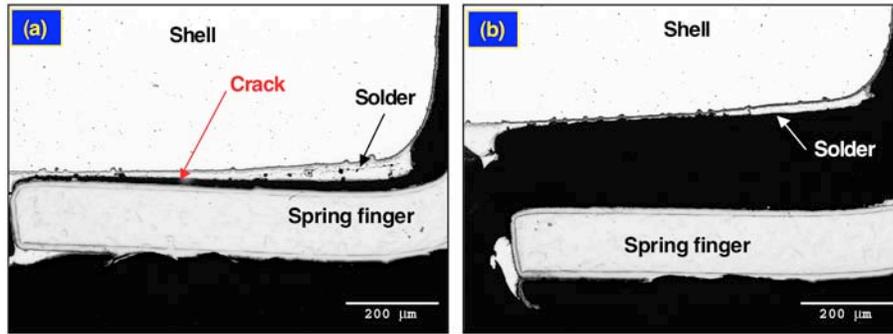
Physical evidence was obtained in that study, which confirmed the presence of each of the three listed defects. Shown in Fig. 5 are optical micrographs that identified a crack that propagated from the top side fillet (Fig. 4) through the gap and into the lower fillet, resulting in complete separation of the spring finger from the shell. For this particular connector, the 96.5Sn-3.5Ag (Sn-Ag) solder was used to attach the spring fingers to the connector shell.

Fig. 5 (a) and (b) Optical micrographs of cross sections of SA1358-10 connectors from S/N1782 that show cracks that had propagated from top side fillet, through the gap, and into the bottom side fillet. In case (b), the spring finger had fully separated from the connector shell.

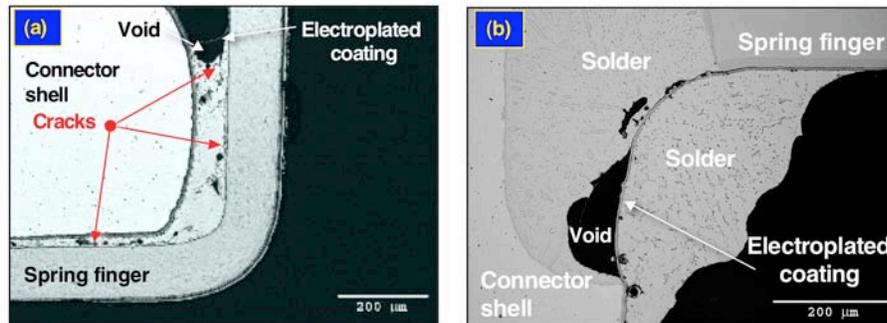
The second concern was remelting of the spring finger solder joints. The remelting of the Sn-Ag solder joint would have occurred during the attachment of the EMR adapter ring and/or EMR shell, which is performed with the low melting temperature, eutectic 63Sn-37Pb (Sn-Pb) alloy. The eutectic temperature is 183°C. Evidence to this effect is exemplified in Fig. 6.

Fig. 6 Optical micrographs of cross sections of SA1358-10 connectors from S/N1782 showing the evidence of remelting of the 96.5Sn-3.5Ag solder: (a) the unsupported electroplated Cd (Cr) layer at the top side fillet and (b) solder breaching through, and void formation underneath, the electroplated Cd (Cr) coating on the bottom side fillet.

The top side fillet in Fig. 6 (a) had remelted and then retreated, leaving the post-soldering electroplated Cd (Cr) layer suspended above the resulting void. In Fig. 6 (b), which depicts the bottom side fillet region, the optical micrographs clearly show that the electroplated Cd layer had been breached, and its external surface wetted, by the molten Sn-Ag solder.

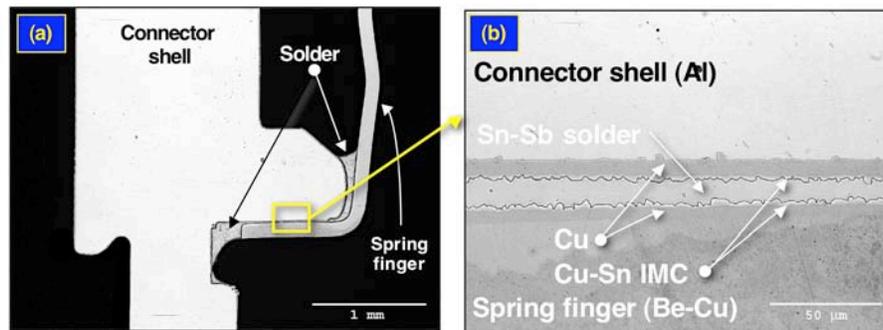
The analysis turned to the gap between the horizontal leg of the spring finger and the similar surface of the SA1358-10 connector shell (Fig. 14). A Cu-Sn IMC layer having the Cu_6Sn_5 stoichiometry (as determined by EPMA) was located between the Sn-Sb solder and the Cu plating layers of the respective structures. There were no indications of crack development within any feature of the gap structure.

Fig. 14 Optical micrograph showing the gap region between the horizontal sections of the connector shell and the spring finger of the Item #1 SA1358-10 connector. The Cu plating layers and Cu-Sn IMC layers were identified.

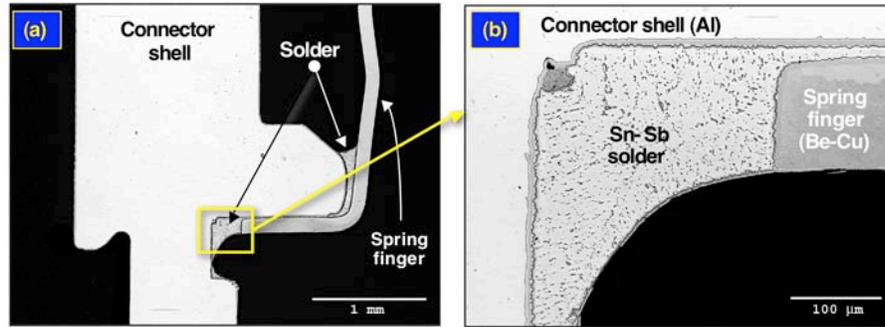
Next, the lower solder fillet was examined. The fillet structure is shown by the cross section micrographs in Figs. 15 and 16. The view of the lower fillet provided in Fig. 15 shows good integrity to the solder joint. Except for one location, the Ni and Cd (plus chromate) coatings adhered to the fillet surface. The view in Fig. 16 shows separation of the overplating (Ni + Cd + chromate layers) from the solder fillet, specifically, at the interface between the Ni layer and the Ni₃Sn₄ IMC layer. Similar to the case presented with reference to Fig. 13 above, the relatively large thickness as well as blocky morphology of the Ni₃Sn₄ layer, indicated its source as being contact between Ni and *molten* solder; the IMC layer was not the product of

the very slow solid-state reaction between Sn and Ni. This morphology implies that the solder in the lower fillet likewise remelted during processing.

Fig. 15 Optical micrographs showing the lower fillet region of the solder joint between the SA1358-10 connector shell and the spring finger. The Cu plating layers and Cu-Sn IMC layers were identified.

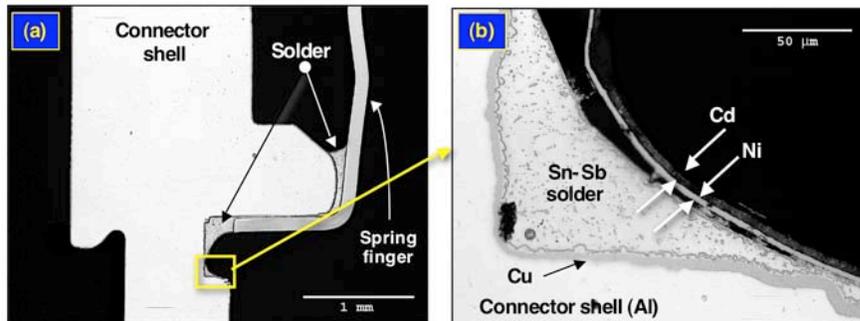
Fig. 16 Second set of optical micrographs showing the lower fillet region of the solder joint between the SA1358-10 connector shell and the spring finger.

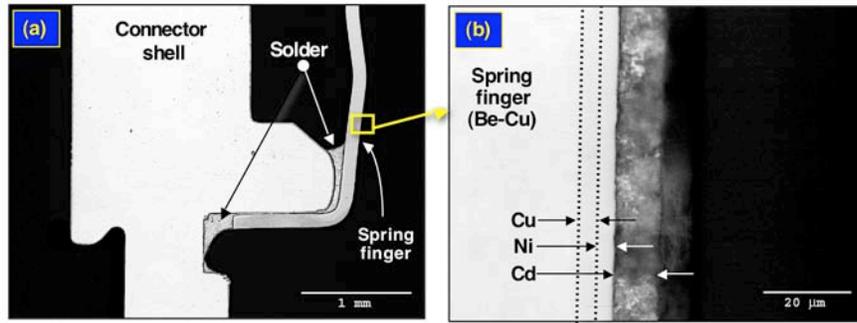
The coating layers on the spring finger were also evaluated. Shown in Fig. 17 is a micrograph identifying the Cu, Ni, and Cd electroplated layers on the spring finger. The interfaces between the Be-Cu base material and Cu layer, as well as that between the Cu and Ni layers, have been highlighted in view. Each of the Cu and Ni layers was 4 – 5 μm thick; the Cd layer was approximately 10 μm thick. The layers exhibited excellent adhesion between themselves as well as to the Be-Cu spring finger.

Fig. 17 Optical micrographs showing the Cu, Ni, and Cd layers on the spring finger of the Item #1 SA1358-10 connector at a location away from the solder joint. The chromate conversion coating was not visible on the Cd layer.

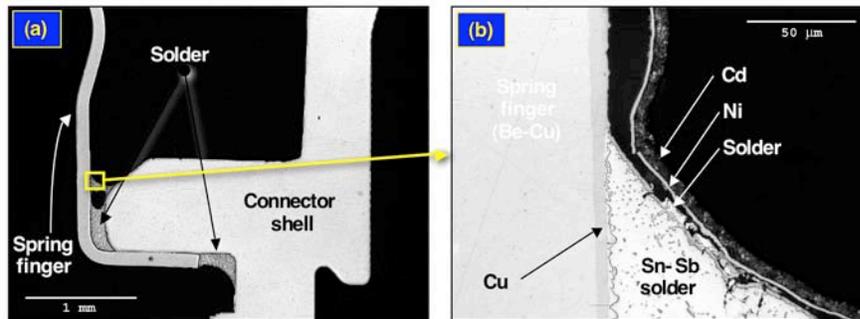
Shown in Fig. 18 is the second view of the connector shell/spring finger solder joint (F1b) that was provided by the diametrical cross section. A low magnification view is provided of the entire solder joint in (a); the higher magnification image in (b) revealed the top side fillet structure.

Fig. 18 (a) Optical micrograph showing the second solder joint of the diametrical cross section of the Item #1 SA1358-10 connector (F1b). (b) A high magnification view of the top side fillet). Spalling of the combined Ni and Cd layers was evident, resulting from separation between the Ni and Ni_3Sn_4 IMC layers over the solder and separation of the Ni layer from the Cu layer on the shell. There was also 95Sn-5Sb solder between the Ni_3Sn_4 layer and the Ni layer.

It was evident that a Ni_3Sn_4 layer had grown between the solder (that was molten at the time) and the Ni layer. Moreover, a thin film of solder was observed between the Ni_3Sn_4 layer and the spalled Ni layer. Because the former layer would only be wettable immediately after the disengagement of the Ni layer, the release of the Ni layer occurred while the solder was molten so that a breach in the Ni_3Sn_4 layer would cause the solder to wet its top surface.

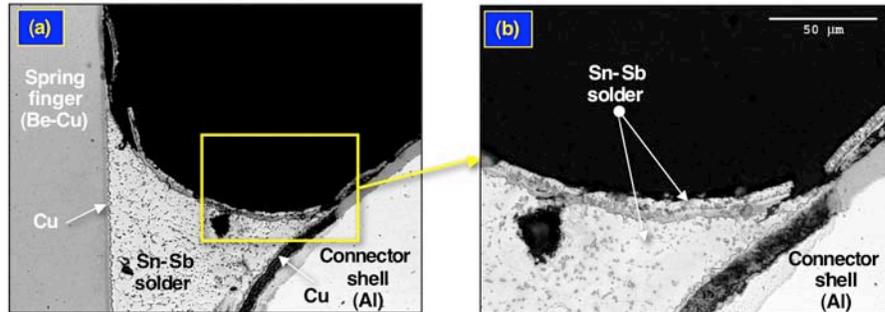
A closer examination was made of the spalled plating layers on the top fillet. Shown in Fig. 20 are low and high magnification views of the top fillet, (a), (b), respectively, of the F2 joint. The high-magnification image shows the presence of solder on top of the Ni layer, which is a clear indication of remelting of the joint. The solder had dissolved a significant portion of the Cd plating.

Fig. 20 Low (a) and high magnification (b) optical micrographs of the top fillet of the F2 solder joint on SA1358-10 connector shown in Fig. 19. The presence of solder on the top of the Ni layer provides a clear indication of remelting after the application of the latter and Cd layers.

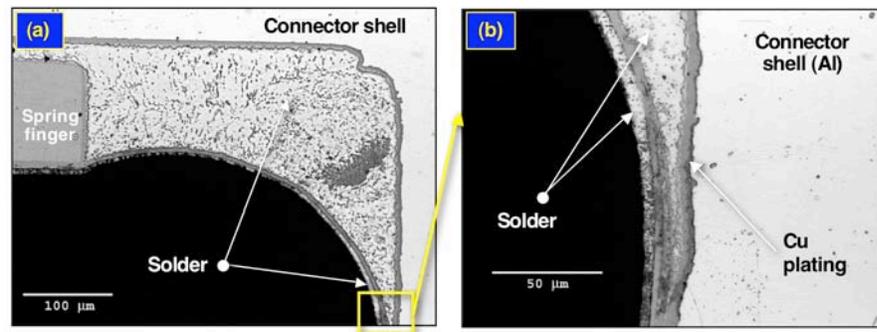
Evidence of remelting of the solder was also observed in the bottom side fillet of this joint. Low and high magnification optical micrographs are shown in Fig. 21.

Fig. 21 Low (a) and high magnification (b) optical micrographs of the bottom fillet of the F2 solder joint on SA1358-10 connector. The presence of solder on the top of the Ni layer provides a clear indication of remelting after the application of the latter and Cd layers.

The presence of a solder coating on top of the Ni layer is shown in (b). Again, a large part of the Cd layer thickness had been dissolved into solder.

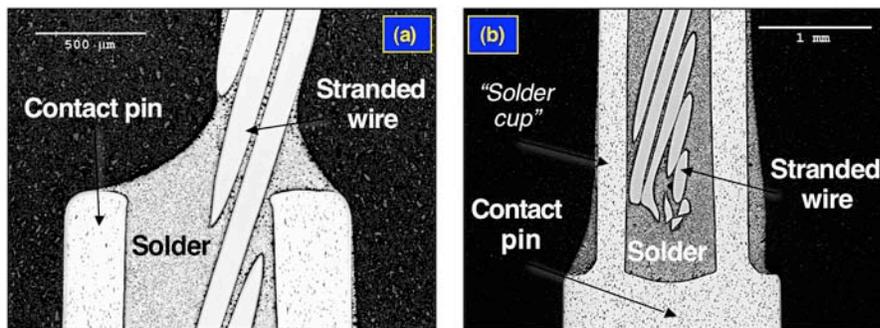
It was noted above that the diametric section through the connector also provided for an examination of the pin contact solder joints. Those interconnections were made between the “solder cup” on the termination end of the pin and the stranded Cu wire. Two cross section micrographs are shown in Fig. 22 that represent the excellent quality of those interconnections. The presence of voids was commensurate with historical observations concerning solder joints made to stranded wire. Solderability of the wire and connector pin were excellent. There were not indications of cracking in the joints that would have been caused by fatigue or an overload. There was clearly solder flow down the outside surface of the solder cup. It did not appear that the latter interfered with the overall construction of the connector. Also, there was no evidence of excessive Au contamination in the solder, which would have originated from the pin surface finish.

Fig. 22 (a) and (b): Optical micrographs of the pin contact solder joints on the Item #1, SA1358-10 connector (F1). The solder joints exhibited excellent quality.

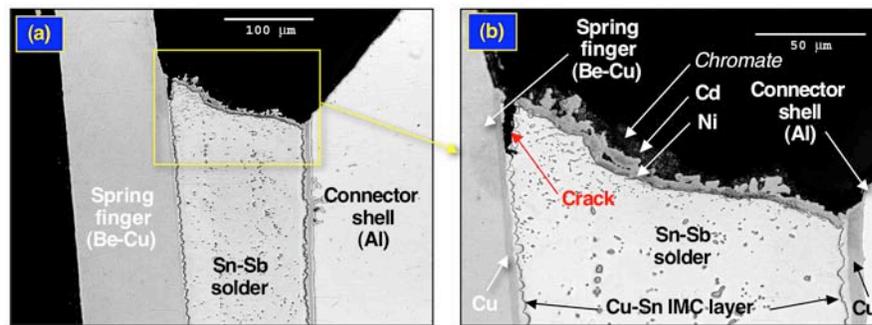
A low-magnification optical micrograph, which shows the section through the entire solder joint, was provided in Fig. 24 (b). There was no large-scale degradation to the solder or to the connector structures. The optical micrographs in Fig. 25 show the top side fillet microstructure. The crack at the solder/spring finger interface was located, specifically, in the IMC layer that formed between the Sn-Sb solder and the Cu plating on the spring finger. This crack morphology is indicative of an overload failure that would result from the spring finger being bent away from the connector housing, such as would occur when it was mated to its counterpart connector. A resulting peel force placed the top of the solder joint into a tension load, resulting in separation in the IMC layer.

Fig. 25 (a) and (b) Optical micrographs of the cross section performed through the spring finger solder joint of the SA2052-4 connector at location F1a.

The microstructures that were shown in Figs. 25 and 26, were scrutinized for indications that the solder joint had been remelted. No such evidence could be identified in the cross section image. The nodular morphology of the electroplated layer, which was evident in the SEM images, was also apparent in the cross section micrograph. In fact, that nodularity appears to be associated with the Ni layer, and was subsequently amplified by the Cd deposit. Irrespective of the irregular morphology, the coatings were free of any breaches (with the exception of the aforementioned crack) that would jeopardize the corrosion protection.

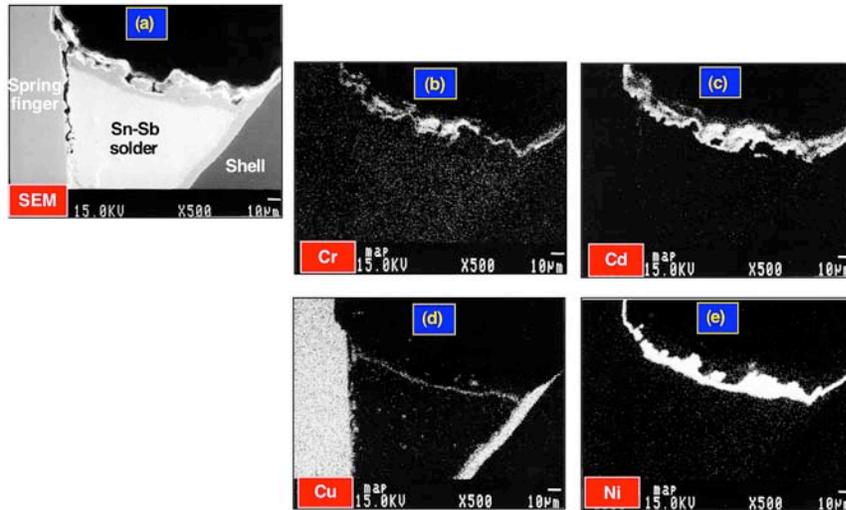
Electron probe microanalysis (EPMA) x-ray dot maps were used to qualitatively assess the spatial composition of the solder joints. Shown in Fig. 27 are the dot maps of the F2a location shown in Fig. 26, but reversed about a vertical plane. Specifically, there are the dot maps for Cr, Cd, Cu, and Ni in (b), (c), (d) and (e), respectively. The dot maps in Fig. 27 confirmed the structure of the post-soldering electroplated coating. A thin Cu layer was placed over the solder fillet (as well as spring finger and connector housing) followed by the Ni barrier layer. Then, the Cd layer was electroplated over the surfaces followed by the chromate (Cr signal) conversion coating. Not shown in Fig. 27 was the Sb map that confirmed the composition of the solder.

Fig. 27 Electron probe microanalysis x-ray dot maps showing the distribution of elements on the surface of the top fillet (SA2052-4, location F2a): (a) SEM/BSE of the fillet region; (b) Cr; (c) Cd; (d) Cu; and (e) Ni, the Cr layer being the chromate conversion coating.

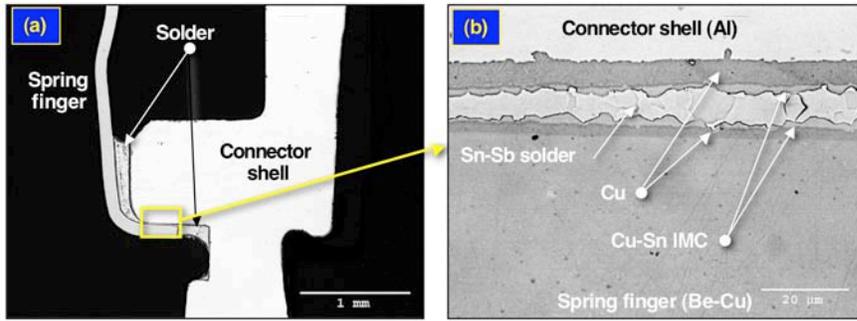
The next region of the solder joint that was examined was the gap between the horizontal sections of the spring fingers and the connector housing. Representative of this region were the optical micrographs in Fig. 28, which were from location F1a. Grain boundaries were prevalent in the Sn-Sb solder, indicating some grain boundary sliding, the cause of which, was thermal expansion mismatch between the connector housing and spring finger as well as between these structures and the Sn-Sb solder. Cracks were not observed in any of cross sections. An IMC layer was also prevalent in the joint. Both the Cu_6Sn_5 and Cu_3Sn stoichiometries comprised the layer. The total IMC layer thickness was measured on both sides of the gap (N=13 measurements per side); those data were listed in Table 2. Although the morphology of the Cu_6Sn_5 layer could not discern its source as being due to liquid Sn-Sb solder or solid-state aging, the presence of the Cu_3Sn layer was more indicative of solid-state growth rather than having developed by exposure to *molten* solder. However, the latter case could be completely ruled out as a contributing factor, because the confined geometry may have altered the IMC morphology that formed between molten solder and Cu.

Fig. 28 (a) Low magnification optical micrograph showing the gap region between the horizontal sections of the connector shell and the spring finger of the SA2052-4 connector. The cross section was at location F1a. (b) High magnification optical micrograph of the solder joint in that gap region.

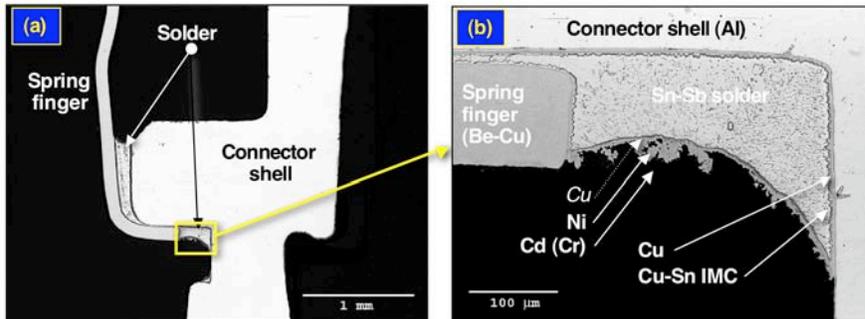
The bottom side fillet of the spring finger solder joint was examined via several cross sections. The F1a cross section was representative of the structures observed in the other locations; low and high magnification optical micrographs are shown in Fig. 29.

Fig. 29 (a) Low magnification optical micrograph showing the bottom side fillet region of the SA2052-4 connector. The cross section was at location F1a. (b) High magnification optical micrograph of the fillet. The Cd layer was also covered with a Cr (chromate conversion) coating.

layer. It was observed in Fig. 29 (b) that there was a significant number of Cu-based particles in the solder (along with the Sb component). The particles, which were likely Cu_6Sn_5 per the phase diagram and historical data, were generated by the dissolution of Cu from the spring finger as well as from the connector housing. The IMC layer that formed between the Sn-Sb solder and the Cu layers of the connector and spring finger was similar in thickness to that observed in the gap region (Fig. 28).

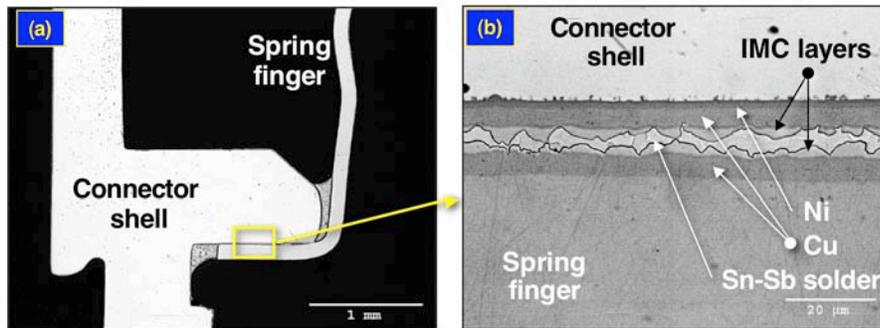
Next, the gap region between the horizontal sections of the connector shell and the spring finger was examined in metallographic cross section; the micrographs appear in Fig. 34. There was no evidence of the cracking or delamination to the solder joint structures in this location. A significant portion of the joint thickness was composed of the Cu_6Sn_5 IMC layer, albeit, there remained a thickness of Cu at both interfaces that would support joint function and any potential need for rework/repair activities.

Fig. 34 (a) Low magnification optical micrograph showing the gap region between the horizontal sections of the connector shell and the spring finger of the SA1358-10. The cross section was made at location F1a. (b) High magnification optical micrograph of the solder joint in that gap region.

The IMC layer thickness was measured at both interfaces of (N = 13 data points). At the solder/connector shell interface, the thickness was $1.30 \pm 0.98 \mu\text{m}$ and at the solder/spring finger interface, the thickness was $1.68 \pm 0.80 \mu\text{m}$ as listed in Table 2 (location F1). Based upon the same discussions above, the IMC layer thicknesses and variable morphology that was observed in Fig. 34, indicated that the layers were created by molten solder, most likely a combination of the solder process and follow-on assembly process.

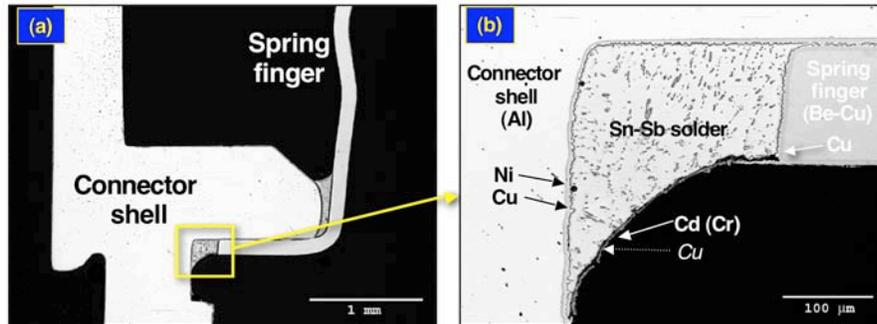
The bottom side fillet was similarly examined. Cross section micrographs were provided in Fig. 35. The images show that the Cu plus Cd (Cr) plating layers together had separated from the solder fillet as they did at the top side fillet. There was no direct evidence to

suggest that solder melting was responsible for the gap between the fillet and the plated layer(s). The primary exhibit was the fact that the separated, plated layers conformed to the surface shape of the fillet.

Fig. 35 (a) Low magnification optical micrograph showing the bottom side fillet region of the SA1358-10. The cross section was at location F1a. (b) High magnification optical micrograph of the bottom side fillet.

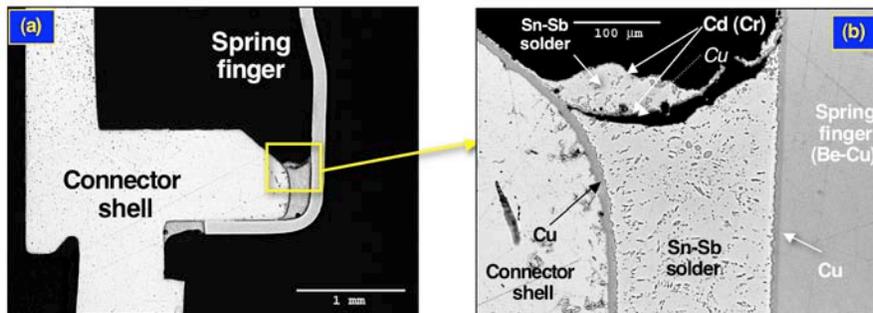
Two other locations were evaluated on this connector. Each of those locations exhibited evidence that the solder had melted after initial fabrication of the joint and subsequent electroplating operations. Shown in Fig. 36 are low and high magnification optical micrographs of the top side fillet at location F2 of the SA1358-10 connector. Solder was observed on the exposed surface of the plating layer, indicating that the solder had been remelted subsequent to the plating process.

Fig. 36 (a) Low magnification optical micrograph showing the top side fillet region of the SA1358-10. The cross section was at location F2. (b) High magnification optical micrograph of the top side fillet.

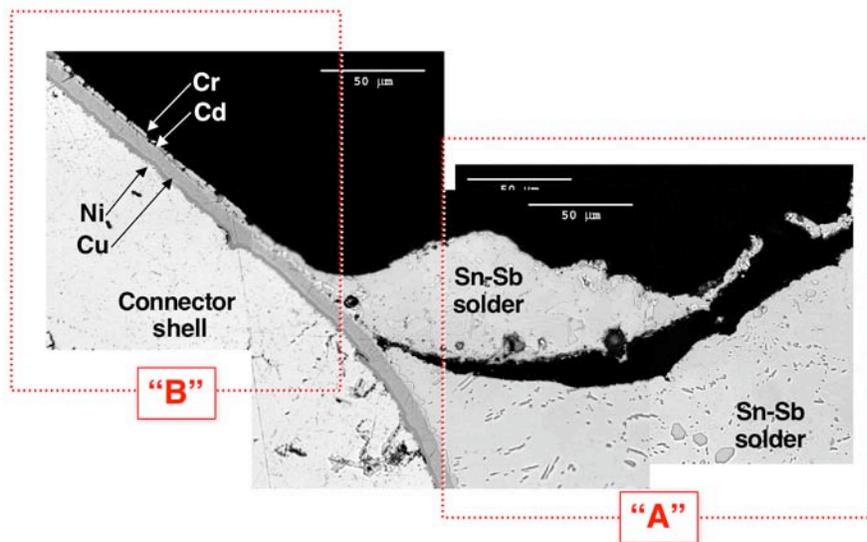
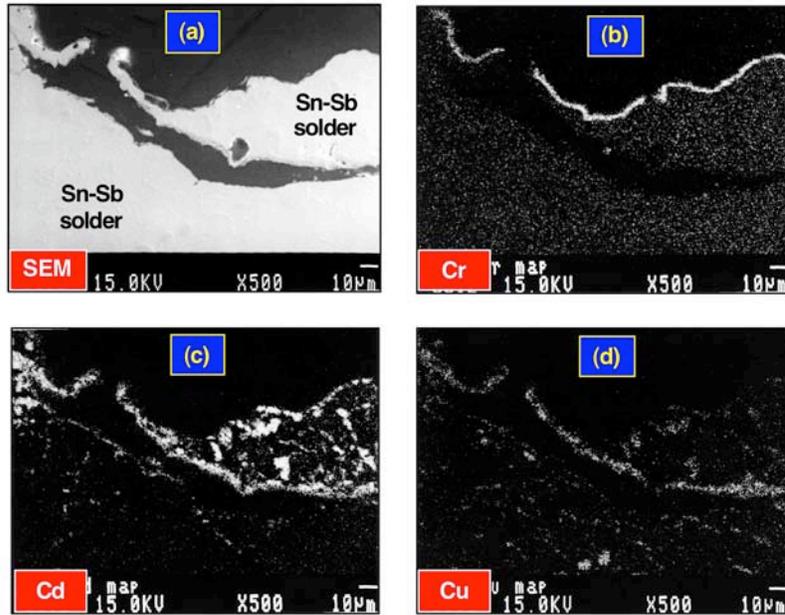
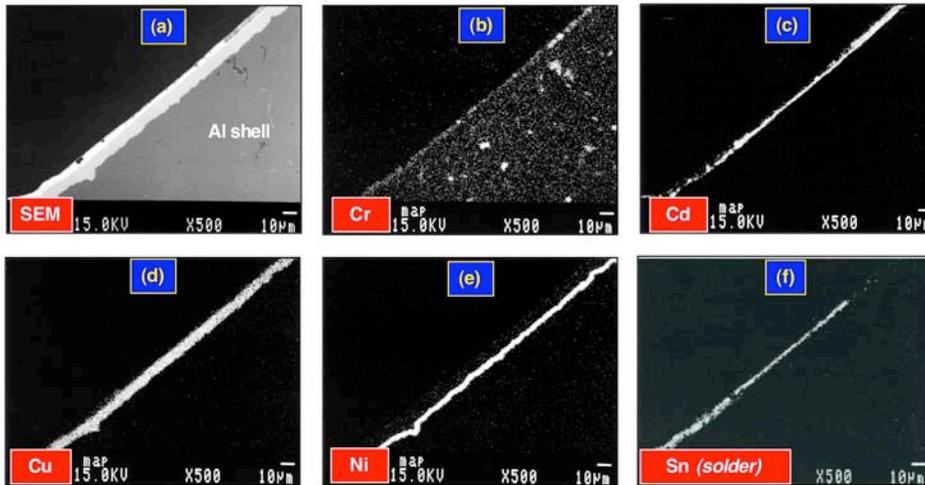
Further evidence was obtained to confirm that the Sn-Sb solder had remelted after application of the electroplated coatings. Electron probe microanalysis x-ray dot maps were used to determine the spatial distribution of the materials in the solder joint structure. Shown in Fig. 37a is a high magnification, composite optical micrograph showing the juncture between the top side fillet surface and the connector housing. Two locations were designated by “A” and “B”. First, location “A” was evaluated by the EPMA technique (Fig. 37b). It was confirmed from the maps that the Sn-Sb solder broke through the electroplated layer. The molten solder wet and then dissolved the Cd layer; it was unable to do either to the Cr layer and, as such, the latter remained as a coating “skin” that floated on the solder fillet surface when the latter was molten. Similarly, the Cu was dissolved into the solder, albeit, to a lesser extent than was the Cd, and so remained in its original position underneath the newly extruded solder. The lack of complete Cu layer dissolution suggests that the time that the solder was molten, was not excessively long < 1 – 2 minutes at worst.

Fig. 37 (a) High magnification, composite optical micrograph showing the juncture between the top side fillet and SA1358-10 connector housing (location F2).
(con't)

Fig. 37 ((b) SEM (SE) and EPMA x-ray dot maps of the top side fillet region at location “A” but reversed about a vertical plane: (a) SEM/SE image; (b) Cr map; (c) Cd map; (d) Cu map. (c) SEM (SE) and EPMA x-ray dot maps of the top side fillet region at location “B”: (a) SEM/SE image; (b) Cr map; (c) Cd map; (d) Cu map; (e) Ni map; and (f) Sn (solder) map.

The location “B” was along the connector shell (Fig. 37c). The molten solder migrated up the connector shell by dissolving away the Cd layer that it had breached in the fillet region. This analysis, along with the optical micrographs shown in Fig. 36, confirmed that the Sn-Sb solder had remelted following the application of the Cr-Cd-Ni-Cu over plated layer.

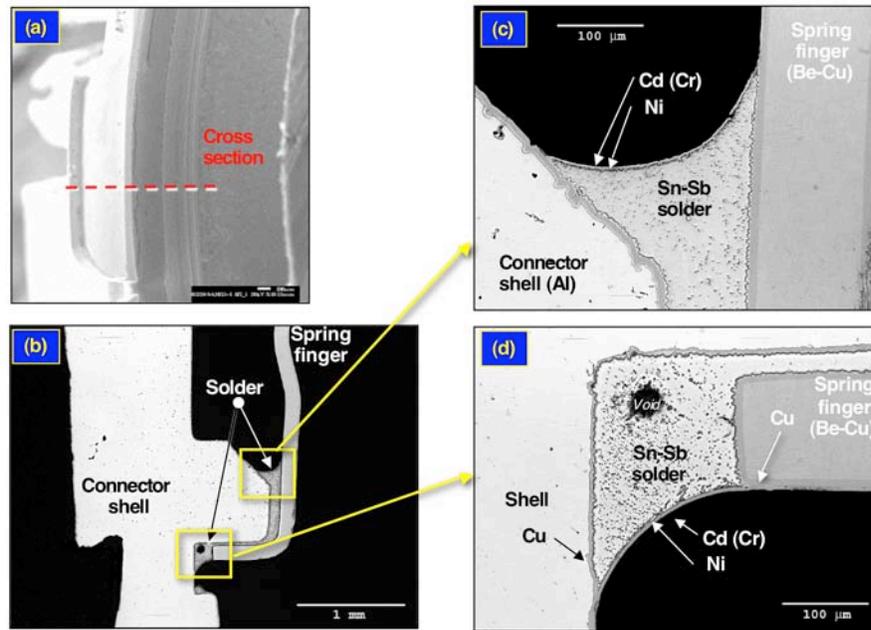
Metallographic cross section views of the F2 location on the SA2052-4 were provided Fig. 40. The SEM photograph in (a) showed the location of the cross section. Provided in the optical micrograph (b) are the locations of the top side and bottom side views in (c) and (d). The top side and bottom side fillets exhibited excellent integrity. There were no indications of mechanical damage to the solder joints. More importantly, the joint did not exhibit any signs of the Sn-Sb having been remelted after final assembly. It was noted that, when comparing Fig. 39 (b) and Fig. 40 (c), the crack in the former SEM image did not appear in the latter cross section micrograph. This difference indicated that the crack in Fig. 39 (b) was limited to the Ni-Cd (Cr) overplating layer or a minor delamination of the Ni-Cd (Cr) protective finish from the because the crack did not extend into the solder fillet. The fact that the delamination occurred near the spring finger suggested that it was likely caused by flexing of the spring finger during connector mating/unmating activities.

Fig. 40 (a) SEM photograph showing the top side fillet surface of section F2 on SA2052-4 showing the location of the cross section. (b) Optical micrograph showing the spring finger solder joint. (c) High magnification optical micrograph showing the top side fillet. (d) High magnification optical micrograph showing the bottom side fillet.

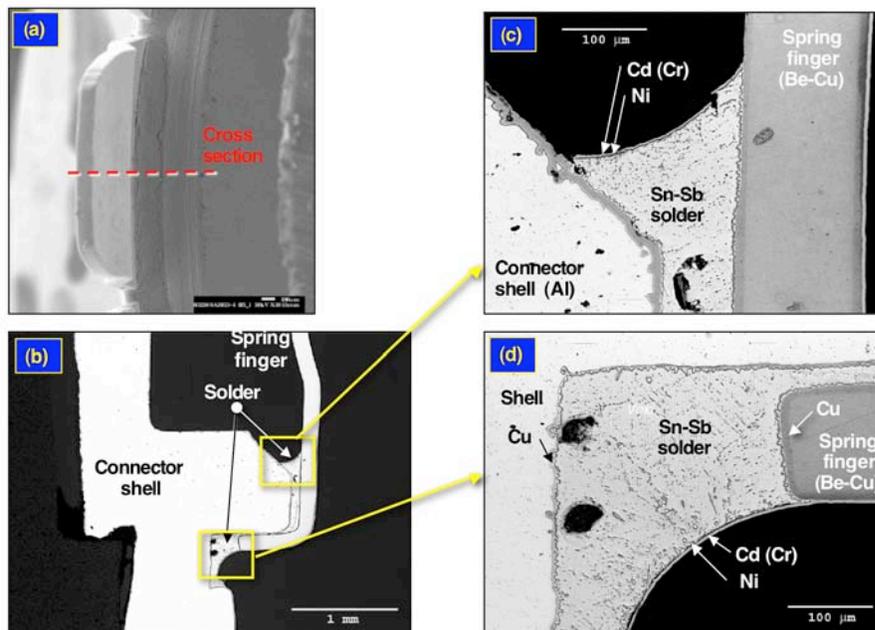
Fig. 42 (a) SEM photograph showing the top side fillet surface of section F3 on SA2052-4 showing the location of the cross section. (b) Optical micrograph showing the spring finger solder joint. (c) High magnification optical micrograph showing the top side fillet. (d) High magnification optical micrograph showing the bottom side fillet.

Although there was some indication of separation between the Ni-Cd (Cr) plating layer and the Sn-Sb solder surface, there were no signs that the latter had remelted after application of the overplating layer.

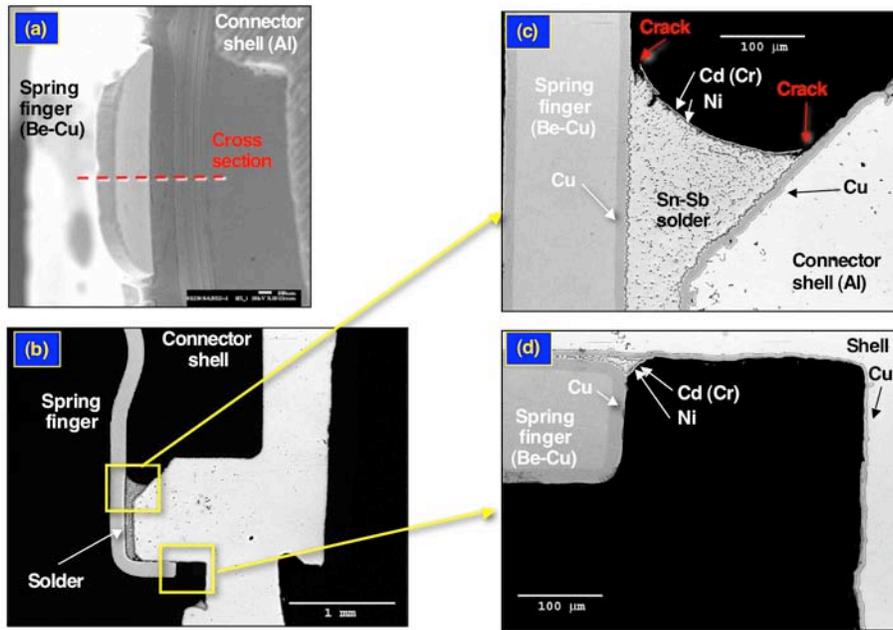
The same analysis was performed on the location F5 of the SA2052-4 connector. The corroborating SEM images and cross section optical micrographs were provided in Figs. 43 and 44 below. Two cracks were observed in the top side fillet (Fig. 43 (b)), which were then confirmed to have progressed only a small distance into the Sn-Sb solder (Fig. 44 (c)).

The similarity of the microstructures between F3 and F5 would not have warranted significant attention to the latter with the exception of the absence of a bottom side fillet in Fig. 44 (d). Failure of the bottom side fillet to form was caused by an insufficiently large gap between the bottom of the connector shell and spring finger; this situation was illustrated in Fig. 45. Growth of the IMC layer (during the soldering process, while the Sn-Sb alloy was in the molten state) closed the gap further, thereby restricting solder flow to create the bottom side fillet (Fig. 45 (b)). The bottom side fillet did not provide a significant contribution to the strength of the joint and, as such, its lack of development would not impair the reliability of the interconnection.

Fig. 44 (a) SEM photograph showing the top side fillet surface of section F5 on SA2052-4 showing the location of the cross section. (b) Optical micrograph showing the spring finger solder joint. (c) High magnification optical micrograph showing the top side fillet. (d) High magnification optical micrograph showing the bottom side fillet.

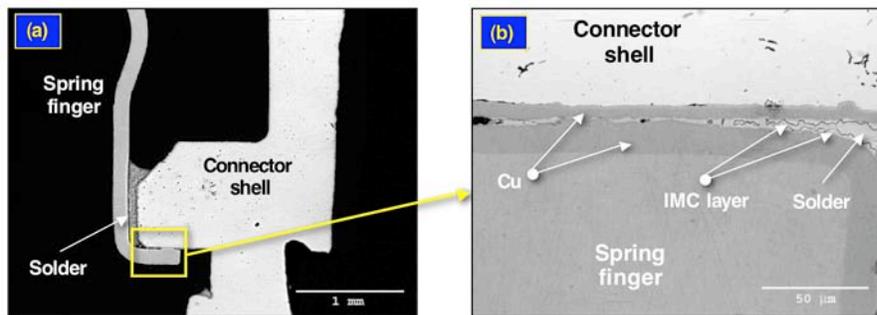
Fig. 45 (a) Optical micrograph showing the location of the gap between the connector shell and the spring finger for section F5 on SA2052-4. (b) High magnification, optical micrograph showing the restricted solder joint gap between the shell and spring finger solder joint.

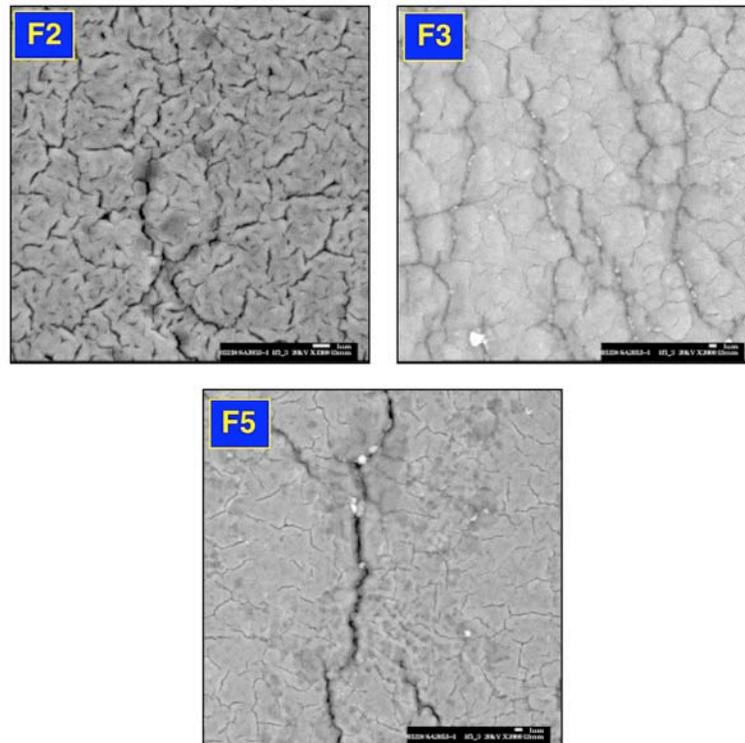
Lastly, a survey was made of the surfaces of the Ni-Cd (Cr) electroplated layer on the top side fillets at each of the three locations: F2, F3, and F5. High magnification, SEM (SE) images were compiled in Fig. 46. Aside from the larger scale cracks noted in the above discussion, the electroplated layer surface showed surface convolutions (hillocks and valleys) that are common to these types layers when observed at relatively high magnifications. The layer morphology did not indicate a potential for degradation in either the short- or long-term lifetime of the interconnection.

Fig. 46 High magnification, SEM (SE) photographs of the surface of the Ni-Cd (Cr) overplate layer at the three locations, F2, F3, and F5 on the top side fillet of the SA2052-4.

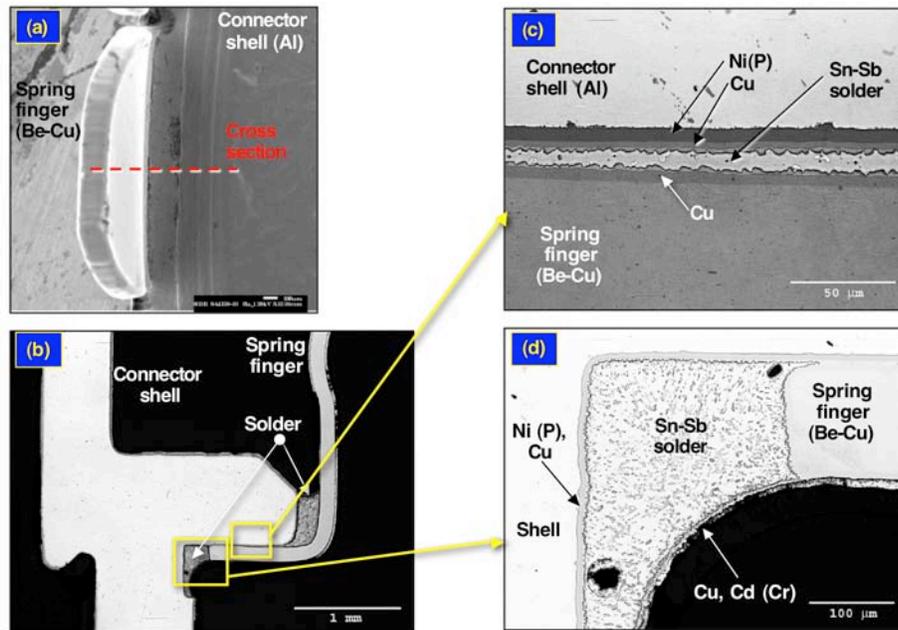
Next, metallographic cross sections were made of the solder joints at the selected locations F, the two sites on cross section F2, and F3. Shown in Fig. 51 (a) is the SEM (SE) image of the F1a location. Cross section micrographs show an overall view the spring finger solder joint (b), the horizontal gap region (c), and bottom side fillet (d). The cross section view in (b) showed no damage to the solder joint or substrate structures. The micrograph in (c) showed an excellent solder joint; no cracks were observed. The Cu_6Sn_5 IMC layer thickness was $1.96 \pm 0.63 \mu\text{m}$ on the spring finger side (electroplated Cu) and $2.02 \pm 0.46 \mu\text{m}$ on the connector shell side as measured at the F1 location. These values are similar to those measured on prior units and are indicative of a soldering process that requires a long-than-normal contact between the molten solder and the base material; in this application, the base material is the Cu electroplated layers. Therefore, it appeared that, although next-assembly processes may have reflowed the Sn-Sb solder on the SA1358-10 connectors, that added melting event did not cause a drastic change to the IMC layer thicknesses in the gap. The micrograph in (d) indicated that there was good flow of the Sn-Sb solder during the assembly. The overplating layer – Cu, Cd (Cr) – had excellent adhesion to the solder fillet surface.

Fig. 51 (a) Low magnification SEM (SE) photograph showing the top side fillet surface of location F1a on the SA1358-10. (b) Low magnification optical micrograph of the spring finger solder joint (F1a). (c) High magnification optical micrograph of the horizontal gap region between the spring finger and the connector shell. (d) High magnification optical micrograph of the bottom side fillet.

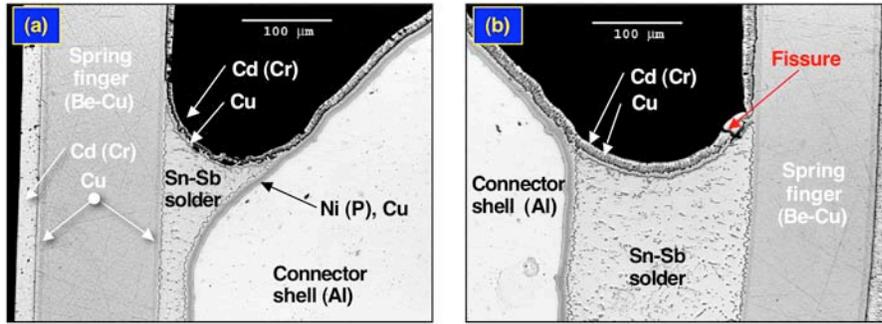
The top side solder fillets were documented for the two diametrically opposed solder joints made available in section F2c. Those micrographs are shown in Fig. 53. Similar observations pertained to these locations as were those made with reference to Fig. 52. Moreover, in general, observation similar to those documented for Fig. 51 that described the horizontal gap and bottom side fillets, were also applicable to the F2 and F3 cross sections.

Fig. 53 (a) and (b) High magnification optical micrograph of the top side fillets at the two diametrically opposed locations for cross section F2.

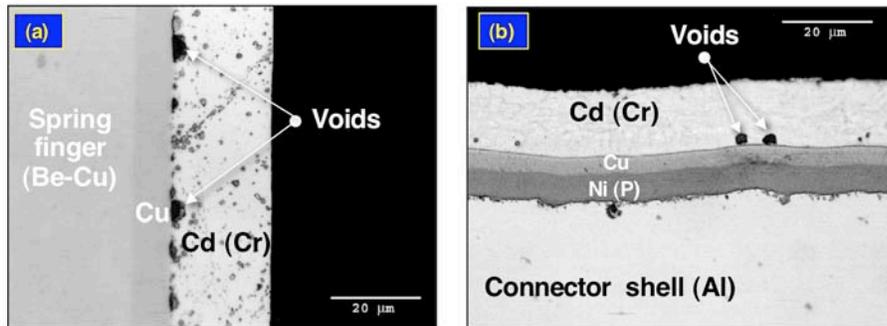
Lastly, the electroplated finishes were examined on the connector shell and spring finger structures. High magnification optical micrographs were provided in Fig. 54 that show the layer stack up for the two parts. It was observed that voids had formed between the Cu and Cd (Cr) layer in the overplating finish. (In the case of (a), it was difficult to distinguish between the Cu finish applied to the spring finger and the Cu layer that was part of the overplating finish.) The voids did not appear to be of an extent that would jeopardize the integrity of the overplating. All finishes exhibited excellent adhesion to the aluminum and Be-Cu substrates.

Fig. 54 (a) and (b) High magnification optical micrographs showing the electroplated layers on the spring finger and connector shell, respectively, at location F1a on the baseline SA1358-10 connector. Voids were observed between the Cd (Cr) layer and the Cu layer that was applied as part of the overplating finish.

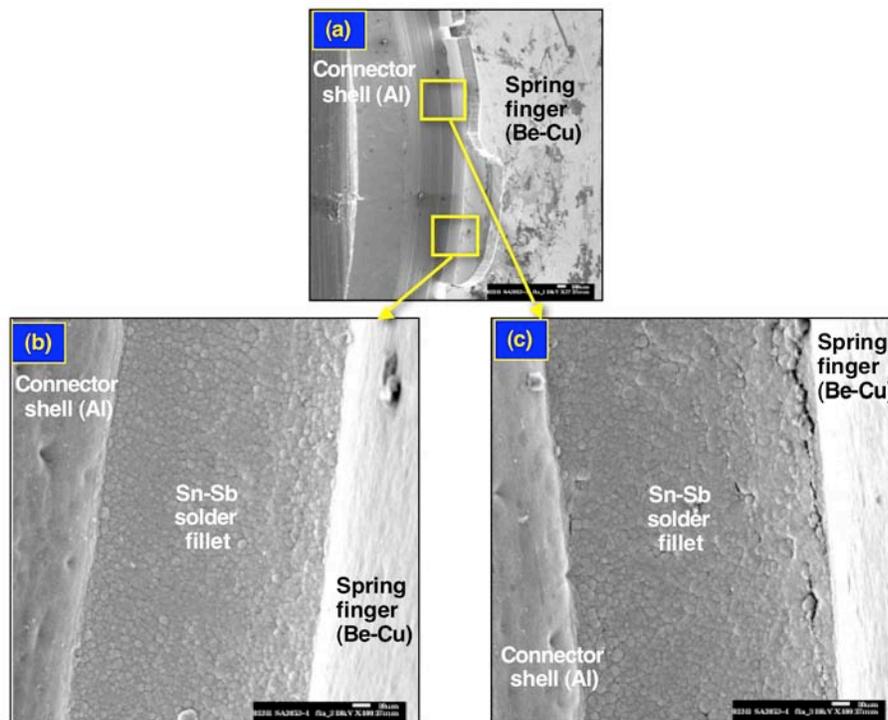
Fig. 55 (a) Low magnification SEM (SE) photograph showing the top side fillet surface of location F1a on the SA2052-4 baseline connector (no EMR shell or cable attachments were performed). (b) and (c) High magnification SEM (SE) images at two locations on the top side fillet.

Higher magnification SEM images, which were provided in Fig. 55 (b) and (c), showed the surface of the solder fillet at two locations. Recall that the electroplated finish was composed of the Cu, Cd (Cr) layers. There were no indications of significant crack formation in the fillet nor spalling of the electroplated coating. Some small fissures were observed on the coating surface; however, the cross section image provided in Fig. 56 (b) confirmed that they were only fissures in the Cu, Cd (Cr) layer and not cracks that reached into the solder joint.

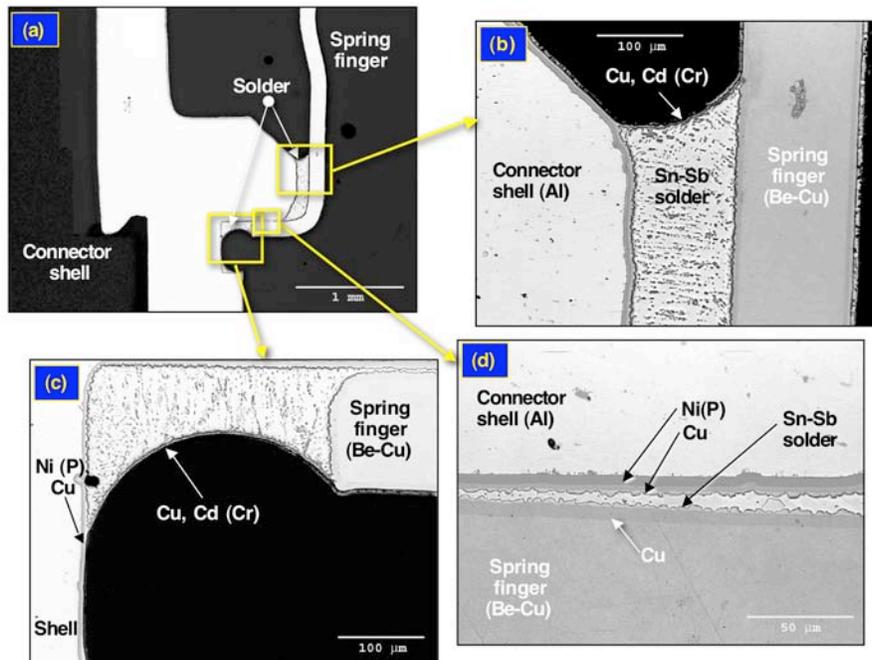
The Cu_6Sn_5 IMC layer thickness was measured in the horizontal gap between the connector shell and the spring finger [see Fig. 56 (d)]. The IMC thickness on the spring finger side (electroplated Cu layer) was $1.84 \pm 0.63 \mu\text{m}$. On the connector shell (electroplated Cu layer), the IMC layer thickness was $1.82 \pm 0.69 \mu\text{m}$. These values were very similar to those cited above for the SA2058, as well as for the newly designed, SA1358-10 connector.

Fig. 56 (a) Low magnification optical micrograph of the spring finger solder joint at location F1a on the SA2052-4 baseline connector. (b) High magnification optical micrograph of the top side solder fillet. (c) High magnification optical micrograph of the bottom side fillet. (d) High magnification optical micrograph of the solder joint horizontal gap between the shell and spring finger.

The optical micrographs showed no indications of significant damage to the solder. Solderability was excellent for all surfaces; void formation was almost non-existent. Similar evaluations were made of the other three cross sections made to this connector and the same observations were documented.

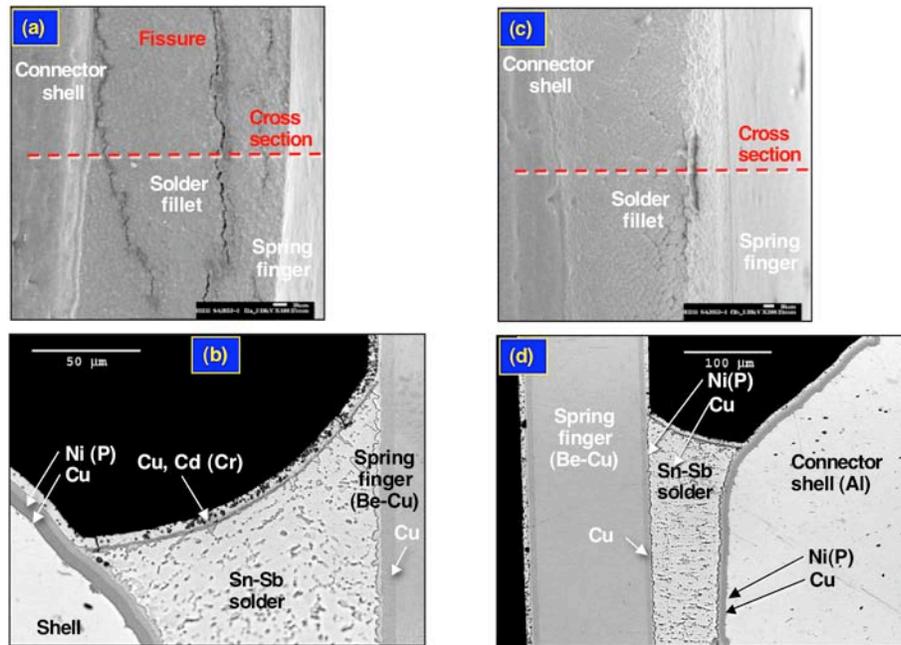
Shown in Fig. 57 are the SEM images and optical micrographs showing cross sections of the top side fillets at two other locations (F2a and F3b) in the spring finger solder joint. The integrity of the solder joints was sound with no indications of defects.

Fig. 57 (a) Low magnification SEM (SE) photograph of the top side fillet at location F2a on the SA2052-4 baseline connector. (b) High magnification optical micrograph of the top side solder fillet. (c) Low magnification SEM (SE) photograph of the top side fillet at location F3b on the SA2052-4 baseline connector. (d) High magnification optical micrograph of the top side solder fillet.

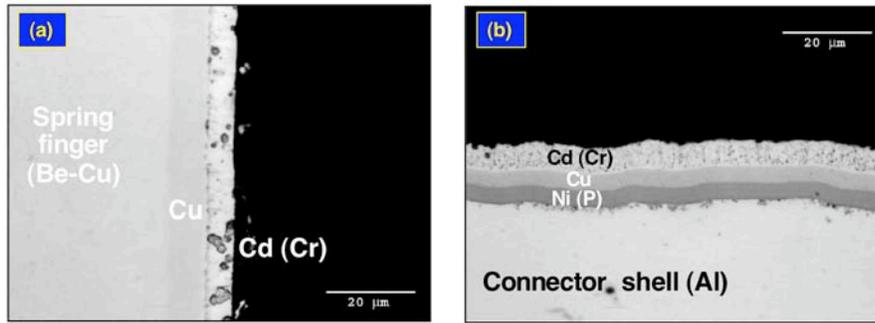
Lastly, the electroplated layers were documented for flaws on the connector shell and spring finger. No such defects were observed. Shown in Fig. 58 are representative optical micrographs of those layers on the two respective structures. Unlike the SA1358-10 baseline unit (Fig. 54), there were no voids observed between the Cu and Cd layers.

Fig. 58 (a) and (b) High magnification optical micrographs showing the electroplated layers on the spring finger and connector shell, respectively, at location F1a of the SA2052-4 connector.

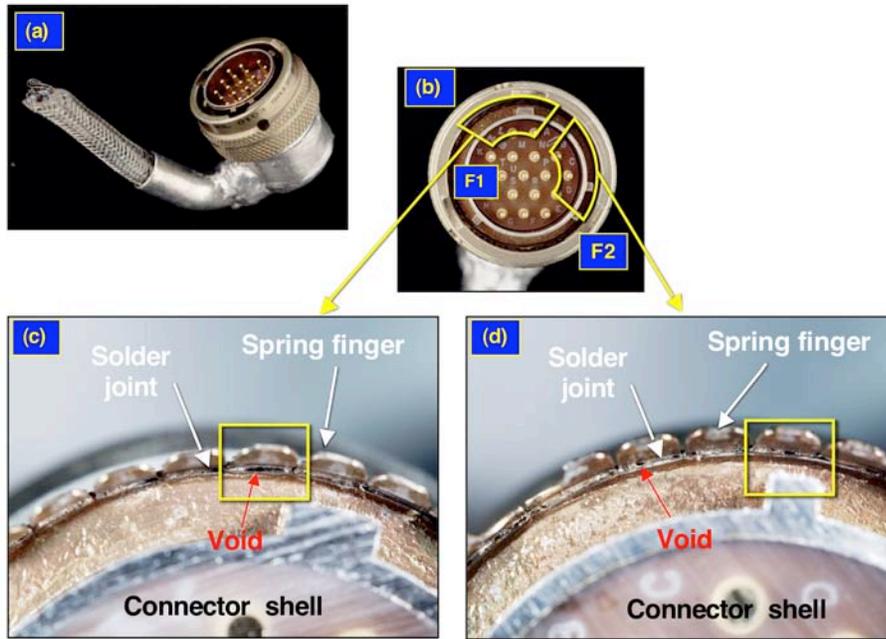
The SA1358-10 connector, having the new connector design, was assembled using the recent cable attachment process, including soldering of the EMR-related structures. The electroplated layers used on the connector shell and spring fingers as well as overplating finishes were the same as those of Item #4, as shown in Table 1. Shown in Fig. 59 are stereo photographs of the connector; that in (a) shows the shell and cable. The image in Fig. 59 (b) shows the two regions of the spring finger solder joint at the male end that were targeted for further analysis. The higher magnification images in (c) and (d) clearly show the presence of voids in the top side fillet of the solder joint at locations designated F1 and F2, respectively.

Fig. 59 (a) and (b) Low magnification stereo photographs of the entire connector-plus-cable assembly and male end of the Item #3, SA1358-10 connector, respectively. The stereo images in (c) and (d) clearly show the presence of voids in the top side fillet of the solder joint at locations F1 and F2, respectively.
