SAND2006-4154

An Evaluation of the Spring Finger Solder Joints on SA1358-10 and SA2052-4 Connector Assemblies (MC3617, W87)

Paul T. Vianco, Alice C. Kilgo, Gary L. Zender, and Paul F. Hlava

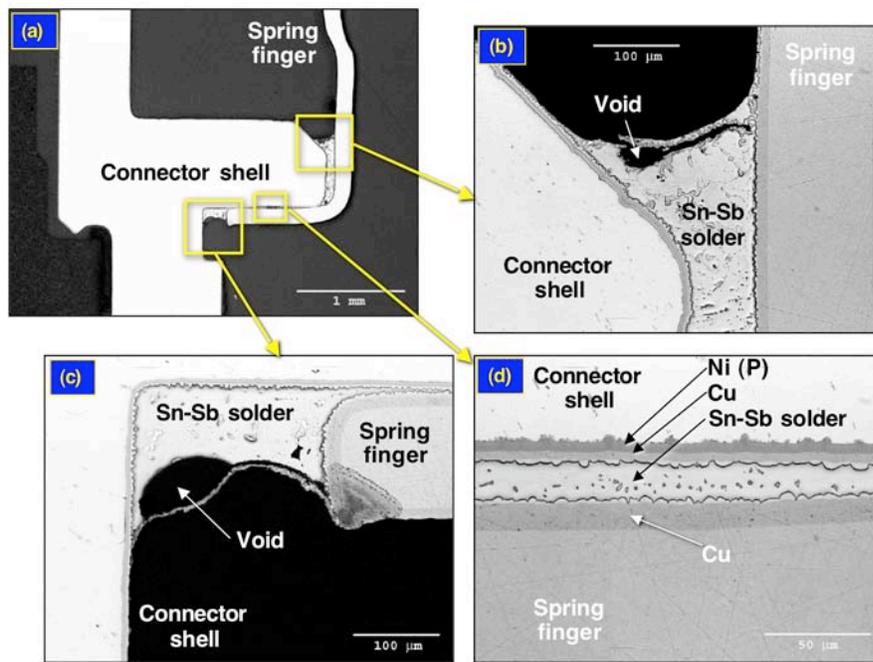
Metallographic cross sections were made of the spring finger solder joints. Shown in Fig. 64 is a cross section through the spring finger solder joint of the Item #3, SA1358-10 connector, and at location F1. This is the same location as that depicted by the SEM images in Fig. 60, but below the large void inside the yellow box. Voids were observed in both the top side and bottom side fillets as shown in Figs. 64 (b) and (c), respectively. The morphologies of those voids were indicative of Sn-Sb solder remelting after the application of the final Cd (Cr), Cu electroplated layer finish.

An evaluation of the horizontal gap region, Fig. 64 (d), showed good integrity. The IMC layer thicknesses of the F1 location, as well as those of the F2 and F3 locations, were listed in Table 2. The thickness values were very similar to those observed for other connectors and, in particular, the SA1358-10 unit of Item #4. Recall that the latter connector was not exposed to the EMR process steps. Therefore, it can be surmised that the EMR assembly process did not alter significantly the IMC thickness within the gap, even when remelting of the Sn-Sb solder was clearly in evidence. The insensitivity of the IMC layer to the second exposure to molten solder was likely a result of the confined geometry of the gap and the fact that the solder was already saturated with Cu from the initial assembly process.

Fig. 64 (a) Low magnification, optical micrograph showing the cross section of the spring finger solder joint at location F1c on the Item #3, SA1358-10 connector. High magnification, optical micrographs of the top side and bottom side fillets appear in (b) and (c), respectively. An optical micrograph of the horizontal gap appears in (d).

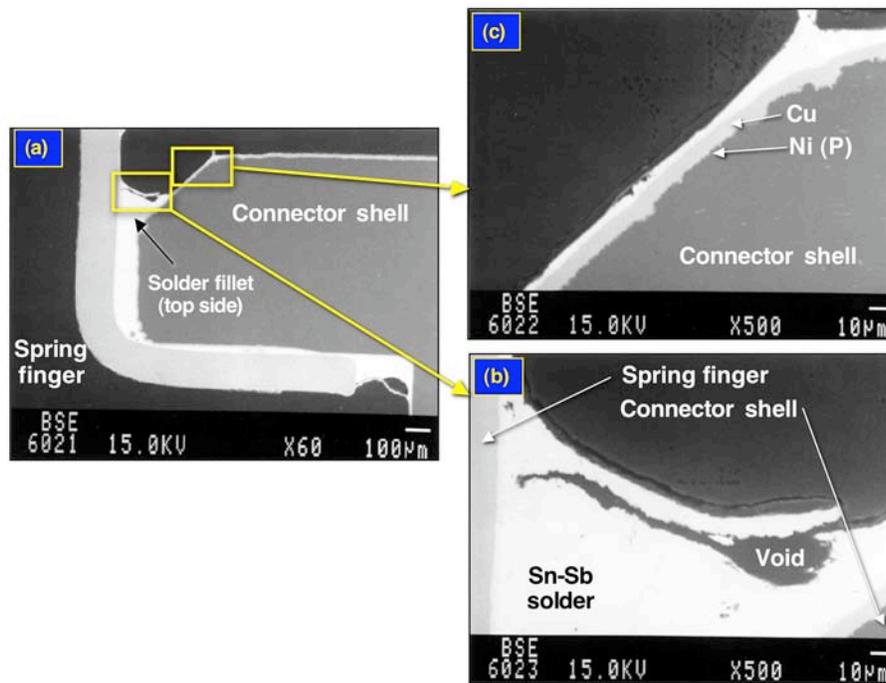
Additional evidence was sought that remelting of the Sn-Sb solder had occurred. Shown in Fig. 65 (a) is an SEM (BSE) photograph showing the top side fillet at location F1c. Two locations were targeted for the analysis: the top side fillet that included the void, Fig. 65 (b); and the adjoining surface of the connector shell away from the void, Fig. 65 (c). An EPMA was performed on the two locations, using X-ray dot maps to depict the elemental distributions in those regions. Shown in Fig. 66 are the EPMA results for the top side fillet area presented in 65 (b), that is, the immediate fillet region.

Fig. 65 (a) Low magnification, SEM (BSE) photograph showing the cross section of the spring finger solder joint at location F1c on the Item #3, SA1358-10 connector. (b) High magnification SEM (BSE) photograph showing the top side fillet. (c), High magnification, SEM (BSE) image of the connector shell surface adjoining the top side fillet.

The prevalence of Cd and Cu throughout the solder volume indicated that the solder had remelted and subsequently dissolved these layers into it. The Cr layer was not readily dissolved by the solder; it was sufficiently thick so as to form a “crust” that sat upon the molten solder fillet surface. The void created by the remelting event suggested that there was a loss of solder.

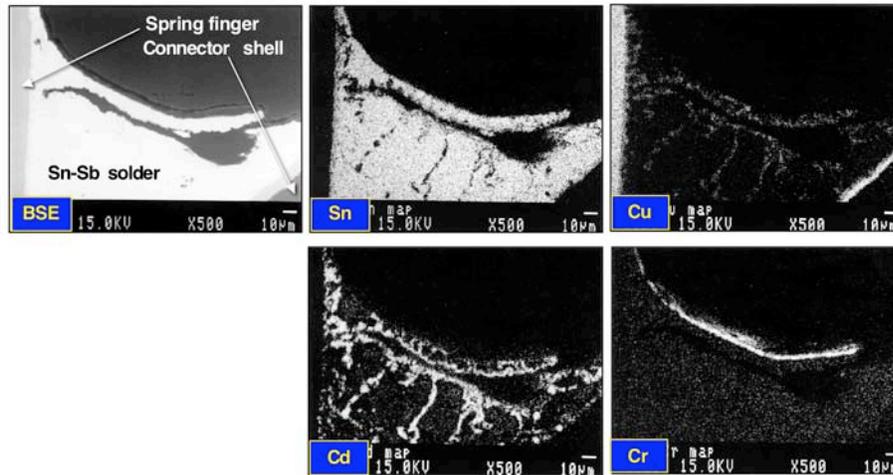
Fig. 66 EPMA of the top side fillet for the spring finger solder joint at location F1c on the Item #3, SA1358-10 connector. The photographs have been labeled with the appropriate imaging mode: **BSE**, **Sn**, **Cu**, **Cd**, and **Cr**.

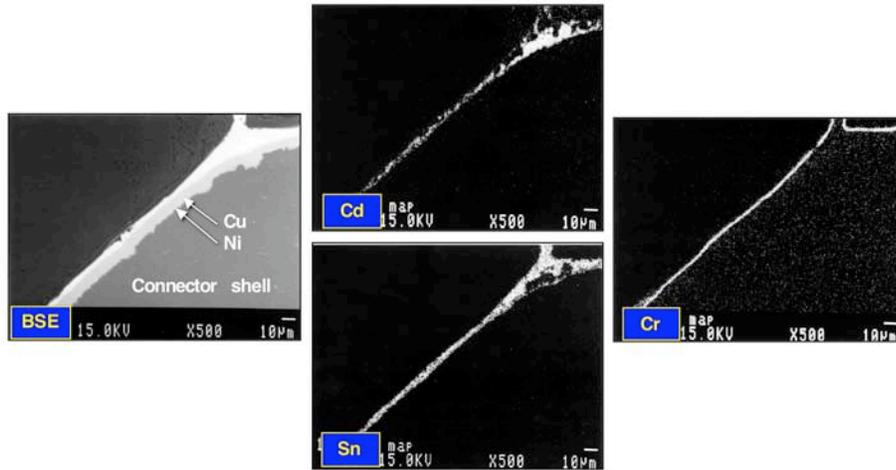
Once the solder had melted, it continued to dissolve away the Cd layer, even up and along the connector shell. This scenario was evidenced in the EPMA analysis of the second region in Fig. 65, now depicted in Fig. 67. The Sn signal was observed all along the surface, having partially dissolved away the Cd coating. The fact that the Cd layer had been partially dissolved away was evidence that the Sn-Sb solder had remelted after the final finish was applied, rather than having been there all along as a result of the initial soldering operation that attached the spring fingers to the shell. The Cr layer remained largely intact, simply resting upon the molten solder film. The Cu electroplated layer on the shell exhibited only minor dissolution that was caused by the molten solder.

Fig. 67 EPMA of the connector shell surface adjacent to the top side fillet for the spring finger solder joint at location F1c on the Item #3, SA1358-10 connector. The photographs have been labeled with the appropriate imaging mode: **BSE**, **Sn**, **Cd**, and **Cr**. The Cu layer was unaffected by the solder wetting.

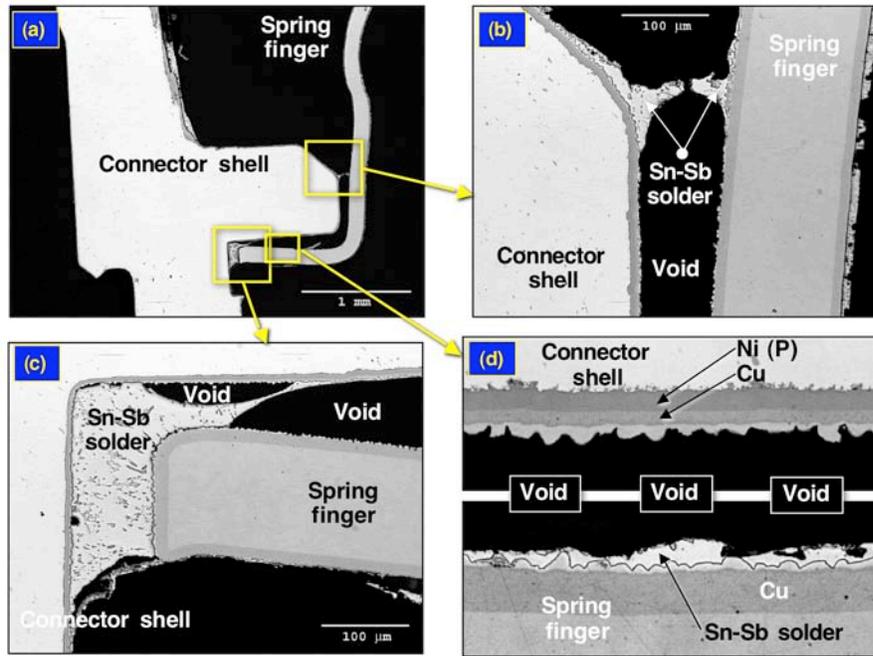
The metallographic cross sections revealed the extent of damage to the spring finger solder joints resulting from remelting of the Sn-Sb solder. Shown in Fig. 68 are optical micrographs showing the solder joint at the F2c location of the SA1358-10 connector. This is the same location that was observed by SEM in Fig. 62; those latter images certainly suggested the presence of a large void in the spring finger solder joint.

There was a catastrophic loss of solder from the joint at this location; hence, the large void that was observed in Fig. 62. There remained the surface of the top side fillet [Fig. 68 **(b)**]. A similar microstructure was observed for the bottom side fillet [Fig. 68 **(c)**]. Solder was absent from the horizontal gap. The observation of the IMC layers on either side of the void [(Fig. 68 **(d)**)] attested to the fact that solder was present, initially.

Fig. 68 (a) Low magnification, optical micrograph showing the cross section of the spring finger solder joint at location F2c on the Item #3, SA1358-10 connector. High magnification, optical micrographs of the top side and bottom side fillets appear in (b) and (c), respectively. An optical micrograph of the horizontal gap appears in (d); however, due to the size of the void, the image is a composite of two optical micrographs showing the opposing surfaces of the horizontal gap.

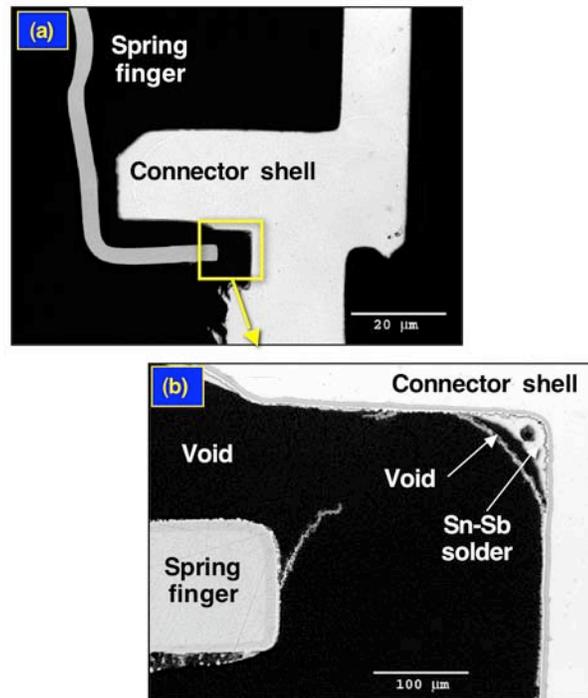
A similar situation prevailed at location F3a of the SA1358-10 connector. Optical micrographs are shown in Fig. 69, which illustrated the loss of solder from the interconnection. Because of the loss of solder, there was no connecting support between the spring finger and the connector shell. Therefore, upon cross sectioning, the spring finger separated from the shell. This large separation would not have occurred during the connector mating process. It is important to note that location F3b was depicted in Fig. 63 **(b)** and showed an intact fillet surface. This comparison demonstrates the variation in the extent of solder joint remelting that occurred along the circumference of the spring finger (and hence, the need to examine several locations about the structure).

Fig. 69 (a) Low magnification, optical micrograph showing the cross section of the spring finger solder joint at location F3a on the Item #3, SA1358-10 connector. High magnification, optical micrograph of the bottom side fillet appears in (b). A portion of the horizontal gap was also visible.

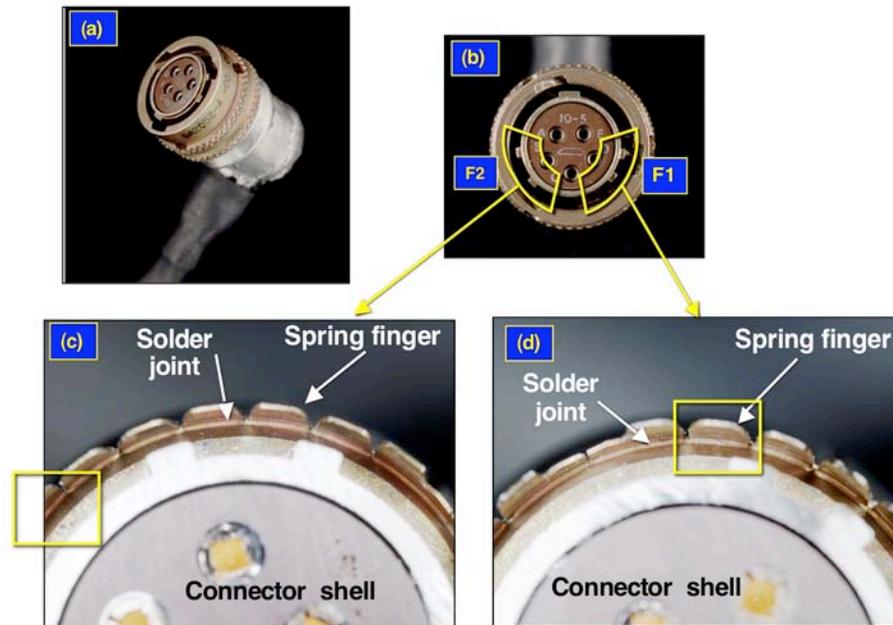
The spring finger solder joints on the SA2052-4 connector, Item #3, were evaluated. The electroplated finishes used on the connector shell, the spring finger, and the post-solder overplating were the same as those used on the SA1358-10 connector, as listed in Table 1. Stereo photographs were provided in Fig. 70 that show the top side fillet. The low-magnification view in Fig. 70 (a) shows the connector on-angle. Two sectors were examined as shown in Fig. 70 (b), identified as locations F1 and F2. Higher magnification images were provided in Figs. 70 (c) and (d); even in these images, there is no indication of degradation to the top side fillets.

Fig. 70 (a) and (b) Low magnification stereo photographs of the SA2052-4 connector-plus-cable assembly designated Item #3, showing the angled view and a view to the connector contacts, respectively. In the latter image, two sectors were identified as F1 and F2. The high magnification stereo images in (c) and (d) clearly show the absence of noticeable damage to the top side fillet at locations F1 and F2, respectively.

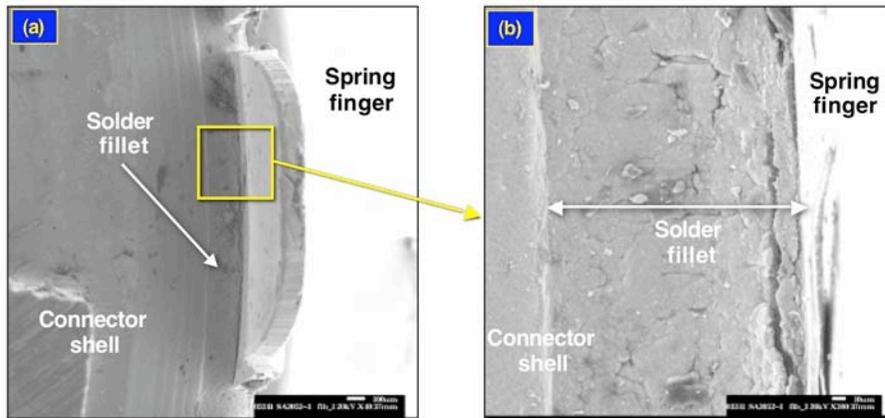
In Fig. 71, the top side fillet surface exhibited no significant degradation. A small fissure was observed near the spring finger. A similar observation was made of the images in Fig. 72, with the exception that the surface of the fillet became more nodular near the spring finger. The nodularity was likely a consequence of the electroplating process that administered the protective finish to the connector; metallographic cross sections will confirm this stipulation.

Fig. 71 SEM images of the top side solder fillet at the location F1b on the SA2052-4 connector of Item #3: (a) low magnification and (b) high magnification.

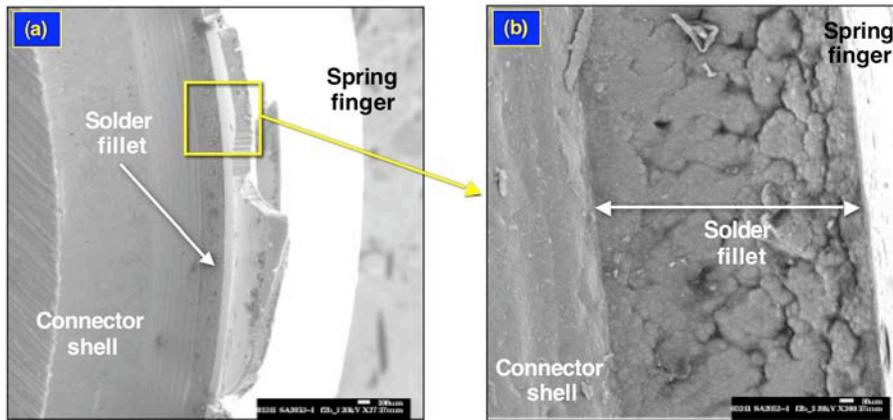
Fig. 72 SEM images of the top side solder fillet at the location F2b on the SA2052-4 connector of Item #3: (a) low magnification and (b) high magnification.

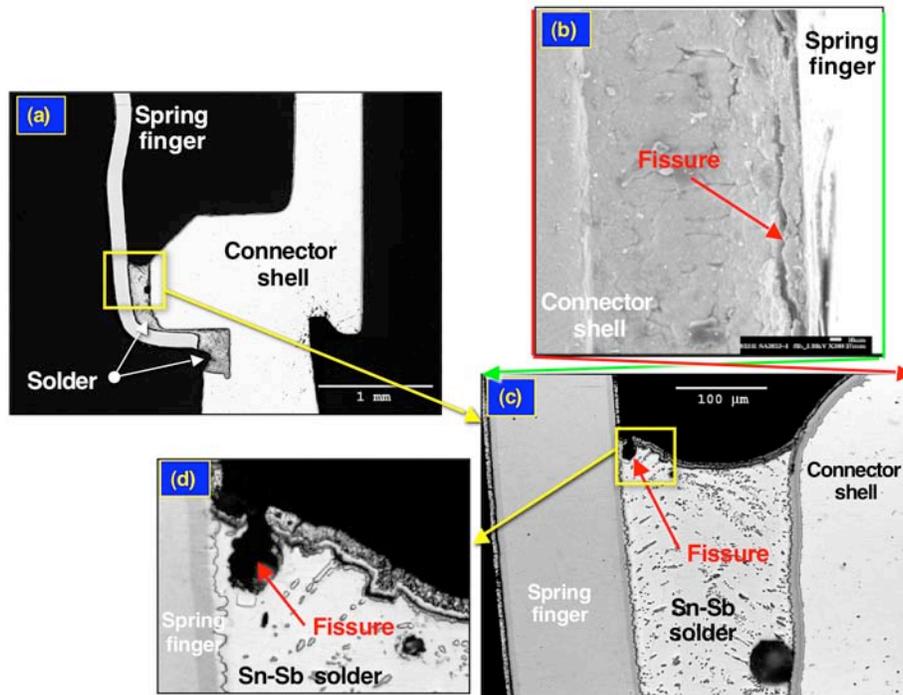
The F1b location of the spring finger solder joint depicted in Figs. 70 (d) and Fig. 71 was metallographically cross sectioned. The resulting optical micrographs were presented in Fig. 73, which besides the overall views in Fig. 73 (a) and (b)(SEM), examined the top side fillet structure. The fissure identified in Fig. 71 was situated over a larger discontinuity in the solder underneath the coating (c) and (d). The red and green arrows indicated that the SEM image and optical micrographs were rotated with respect to one-another about a vertical axis. Although discernable in the micrograph, closer examination of the discontinuity determined that Cd plating was present inside of it. This evidence indicated that the discontinuity was, in fact, a void present in the solder after assembly. The poor

throwing power of the electroplating process did not allow for complete coverage of the void interior with the Cu, Cd (Cr) final finish layers. The geometry of the discontinuity appeared to rule-out its source as having been a crack generated by the flexing of the spring finger. Moreover, neither the morphology of the void nor the remaining fillet microstructure indicated that the Sn-Sb solder joint had been remelted after initial connector fabrication.

Fig. 73 (a) Low magnification, optical micrograph showing the cross section of the spring finger solder joint at the F1b location for the SA2052-4 connector, Item #3. (b) Reproduction of the SEM image showing the top side fillet surface at the same location. The high magnification optical micrographs in (c) and (d) show the microstructure of the solder joint at the top side fillet. The fissure noted in the SEM image was atop a discontinuity in the Sn-Sb solder, the latter most likely originating as a void at the time of initial assembly. The red and green arrows indicate that the SEM image is rotated 180° about a vertical axis when compared to the optical micrographs.

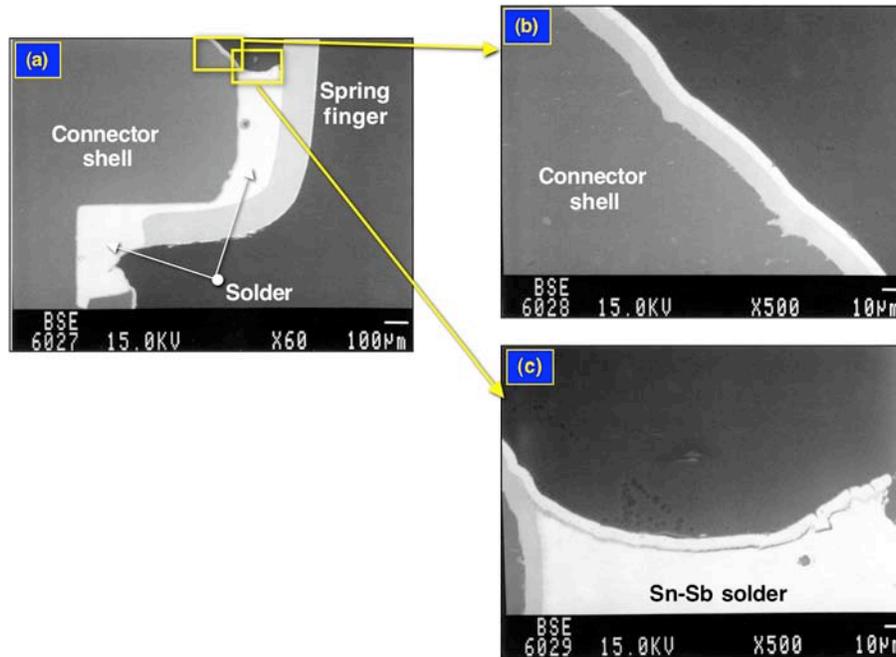
Electron probe microanalysis provided x-ray maps of the elemental distributions in the solder joint. The top side fillet was examined at location F1b. Shown in Fig. 74 are the SEM/BSE images that corresponded to the locations at which were taken the x-ray maps. The yellow boxes in Fig. 74 (a) indicate connector shell location just above the fillet surface (b) and the top side fillet surface (c), itself, including all of the electroplated finishes.

Fig. 74 (a) Low magnification, SEM/BSE image of the cross section of the spring finger solder joint at the F1b location for the SA2052-4 connector, Item #3. The two locations at which were performed the EPMA x-ray maps are delineated by yellow boxes. High magnification, SEM/BSE photographs of the connector shell and top side fillet surface are shown in (b) and (c), respectively.

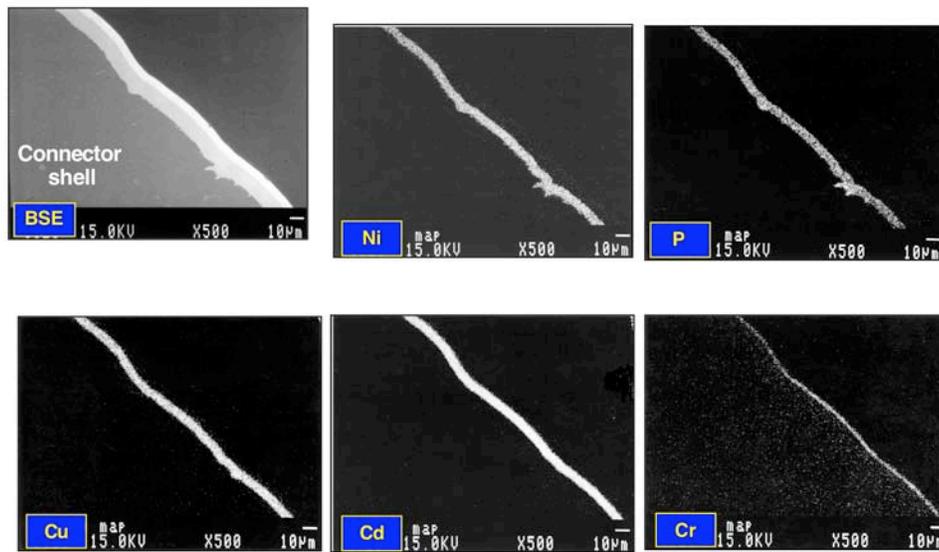
The x-ray maps of the connector shell at the location in Fig. 74 were shown in Fig. 75. Those maps confirmed the presence of the electroless Ni (P) finish on the Al shell, followed by a thick Cu layer. Although not distinguishable here, the Cu layer was actually composed of two layers: a thick Cu layer to which the soldering was performed elsewhere on the connector, and a second, thinner Cu layer that was deposited as part of the post-soldering, overplating layer. The Cd and Cr layers, which were also part of the overplating finish, were visible on the Cu layer. An important observation was that there was no Sn present along the connector shell surface. This point provided an indication that the solder joint had not been reflowed after the initial soldering process and application of the

overplating layers. This indication arose from the fact that, as has been observed above, when the inadvertent reflow of the Sn-Sb solder occurs, the solder wetted the connector shell above the top side fillet, readily dissolving the Cd layer ahead of it.

Fig. 75 SEM/BSE image and EPMA x-ray maps of the connector shell just above the top side fillet at the F1b location on the SA2052-4 connector, Item #3. The EPMA x-ray maps examined the elements Ni, P, Cu, Cd, and Cr.

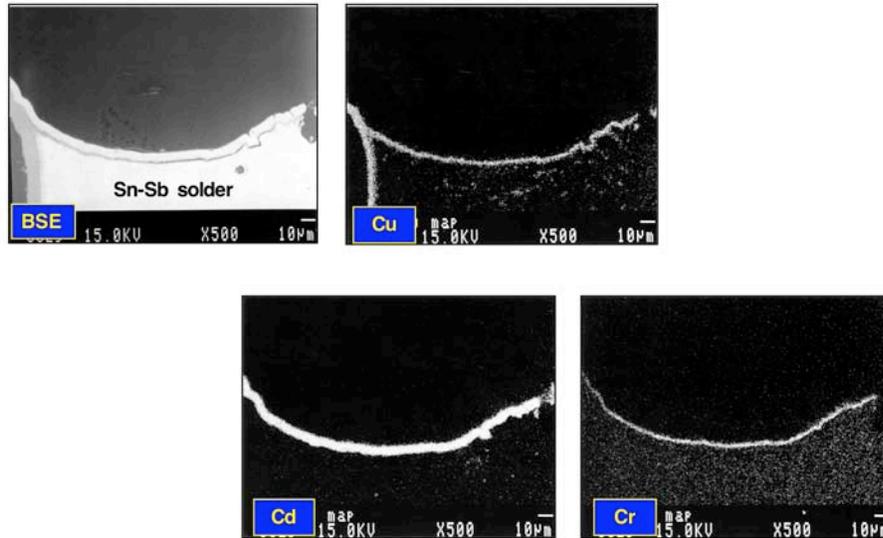
The same analysis was performed on the top side solder fillet. The solder was confirmed to be the Sn-Sb composition. The x-ray maps are shown in Fig. 76, which showed the Cu, Cd, and Cr layers that were deposited after the soldering process. An important observation that was made in Fig. 76 was that there was a contiguous Cd layer on the fillet surface. The same observation was made of the bottom side fillet through EPMA exercise, albeit, the data were not shown for brevity. The dissolution of Cd was a prominent artifact when the Sn-Sb solder was reflowed after fabrication of the joint and subsequent application of the overplating layers. This observation, together with the absence of Sn along the connector shell (Fig. 75) confirmed that, at the F1b location, the Sn-Sb solder had not experienced a second (undesirable) reflow step.

Fig. 76 SEM/BSE image and EPMA x-ray maps of the connector shell just above the top side fillet at the F1b location on the SA2052-4 connector, Item #3. The EPMA x-ray maps examined the elements Cu, Cd, and Cr.

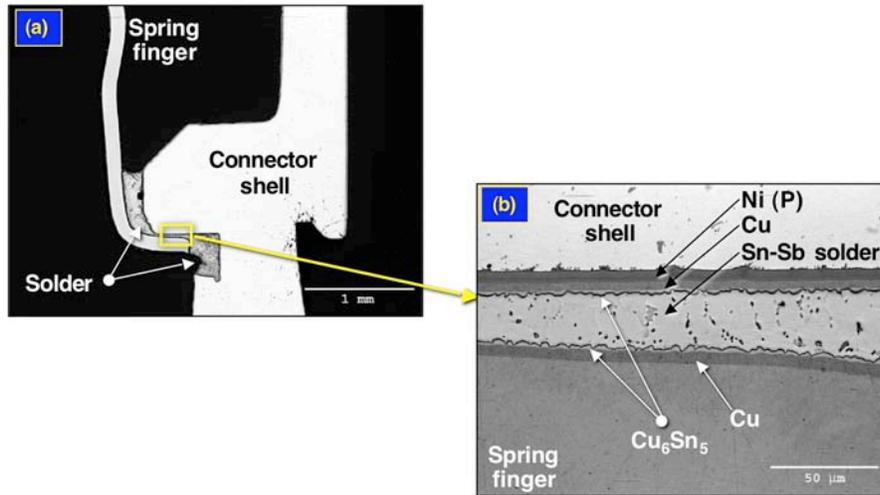
The horizontal gap region of the spring finger solder joint was also examined. An optical photograph of the gap at location F1b, SA2052-4, Item #3 was provided in Fig. 77. The gap solder joint appeared very similar at the other two locations, F2b and F3b. The Sn-Pb solder wetted to the Cu plating layers on the spring finger and connector shell structures. The IMC layer thickness was measured on both structures and all three locations designated F1b, F2b, and F3b. Those data were provided in Table 2. The Cu_6Sn_5 stoichiometry predominated; albeit, there appeared to also be a thin Cu_3Sn layer. Only the former was measured. The thicknesses were commensurate with those measured on the other (item) units in this study.

Fig. 77 Optical micrographs depicting the horizontal solder joint gap at the F1b location on the SA2052-4 connector, Item #3: (a) low magnification view and (b) high magnification view showing the electroplated layers as well as IMC layers.

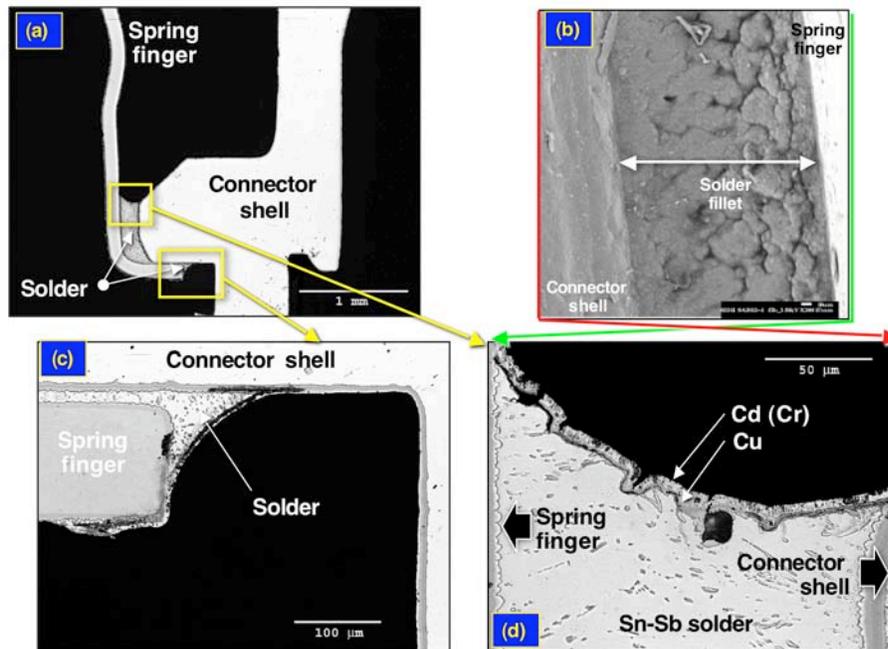
The SEM/SE photograph in Fig. 78 (b) indicated that the top side fillet surface was rougher than at location F1b. The added roughness was investigated further by metallographic cross section (discussed below). The bottom side fillet (Fig. 78 (c)) was minimally formed. A close examination of the solder fillet surface revealed a gap between the solder and Cd (Cr) layer. The Cd layer was fully intact, indicating that the Sn-Sb solder was unlikely to have reflowed after application of the overplating finish. The separation occurred in the Cd plating was likely a spalling defect related to the latter coating.

Fig. 78 Optical and SEM micrographs showing the spring finger solder joint at the F2b location on the SA2052-4 connector, Item #3: **(a)** low magnification view with the yellow boxes indicating the top side and bottom side fillets that were of interest; **(b)** SEM/SE photograph showing the top side fillet surface morphology; **(c)** optical micrograph of the bottom side fillet; and **(d)** optical micrograph of the top side fillet. The red and green arrows indicate that the SEM photograph and cross section micrograph are reversed to one-another about a vertical (mirror) plane.

The top side fillet shown in Fig. 78 **(d)** did not reveal a microstructure that was indicative of remelting of the joint. The added roughness observed in Fig. 78 **(b)** was caused by a combination of solder fillet roughness and the electroplating process used to deposit the Cd layer, not so much the Cu flash or Cr layers. The roughness of the solder fillet surface was surprising, suggesting that it was possible that the solder joint just barely reached the Sn-Sb liquidus temperature (pseudo-cold joint). The fact that the electroplated layers follow the contours of the surface and covered over a small void indicated that the top side fillet did not reflow after the initial connector fabrication.

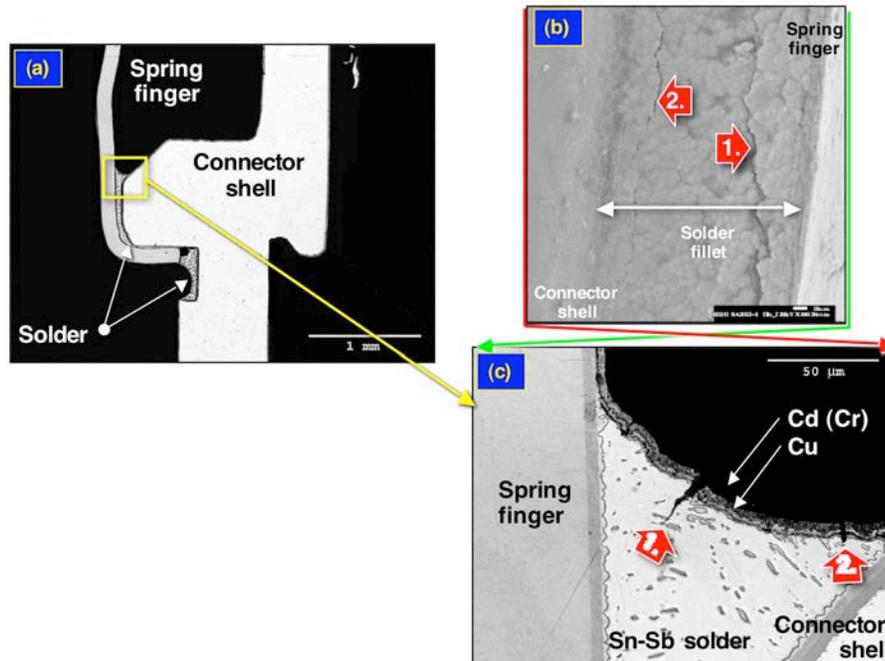
The third location on the SA2052-4, Item #3 connector, was that designated as F3b. A high magnification optical micrograph provided in Fig. 79 **(c)** showed a cross section of the

top side fillet. The surface cracks **1** and **2** that were observed on the top side fillet surface in the SEM image (Fig. 79 **(c)**), extended a short distance into the solder, more so in the former case. The cracks likely originated from flexure of the spring finger; however, the crack **1** was further from the spring finger than has typically been observed for cracks of that origin². Otherwise, no other degradation was observed in the solder joint, including the horizontal gap and bottom side fillet, except for a void at the latter that was attributed to the initial connector assembly process, *not* a remelting of the joint.

Fig. 79 Optical and SEM micrographs showing the spring finger solder joint at the F3b location on the SA2052-4 connector, Item #3: **(a)** low magnification view with a yellow box indicating the top side fillet; **(b)** SEM/SE photograph showing the top side fillet surface morphology; and **(c)** optical micrograph of the top side fillet. The red arrows indicated cracks observed in the SEM image and optical micrograph.

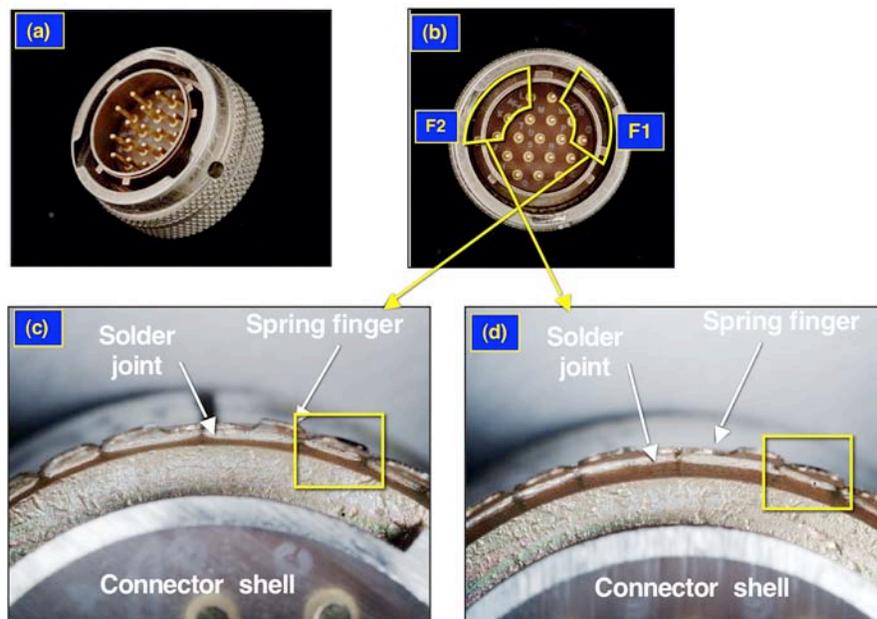
Fig. 80 (a) and (b) Low magnification stereo photographs of the SA1358-10 connector assembly designated Item #5, showing the angled view and a direct view of the connector pins, respectively. In the latter image, two sectors were identified as F1 and F2. The high magnification stereo images in (c) and (d) clearly show noticeable damage to the top side fillet at locations F1 and F2, respectively.

The latter views clearly identified damage to the top fillet of the spring finger solder joints at both locations. The extent of damage was further documented using SEM. The SEM micrographs in Fig. 81 were taken at the F1 location, specifically, the spring finger tine at F1c. The top side fillet at location F2 was shown in Fig. 82.

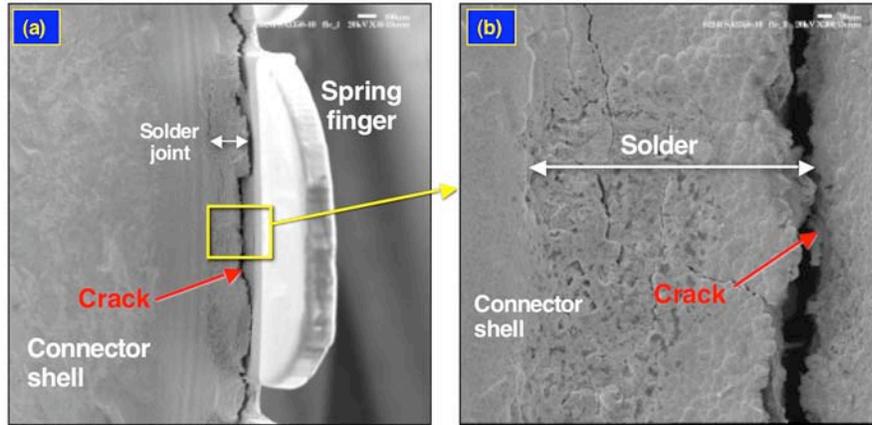
Fig. 81 (a) and **(b)** are low and high magnification SEM photographs of the SA1358-10 connector (Item #5) showing the extent of degradation to the top side fillets at locations F1c.

These two cases – Figs. 81 and 82 – represented the greatest and least cases of degradation, respectively, that were observed on this connector. A third location was also evaluated, F3; it showed degradation that were between the degrees shown in Figs. 81 and 82.

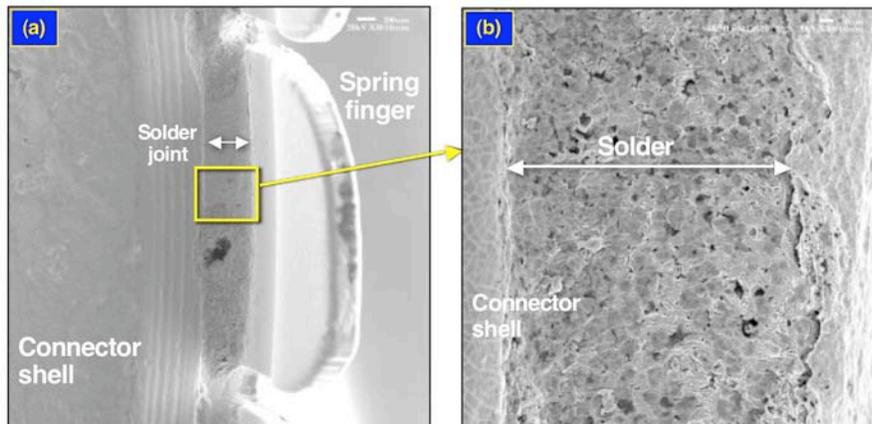
Fig. 82 (a) and **(b)** are low and high magnification SEM photographs of the SA1358-10 connector (Item #5) showing the extent of degradation to the top side fillets at locations F2.

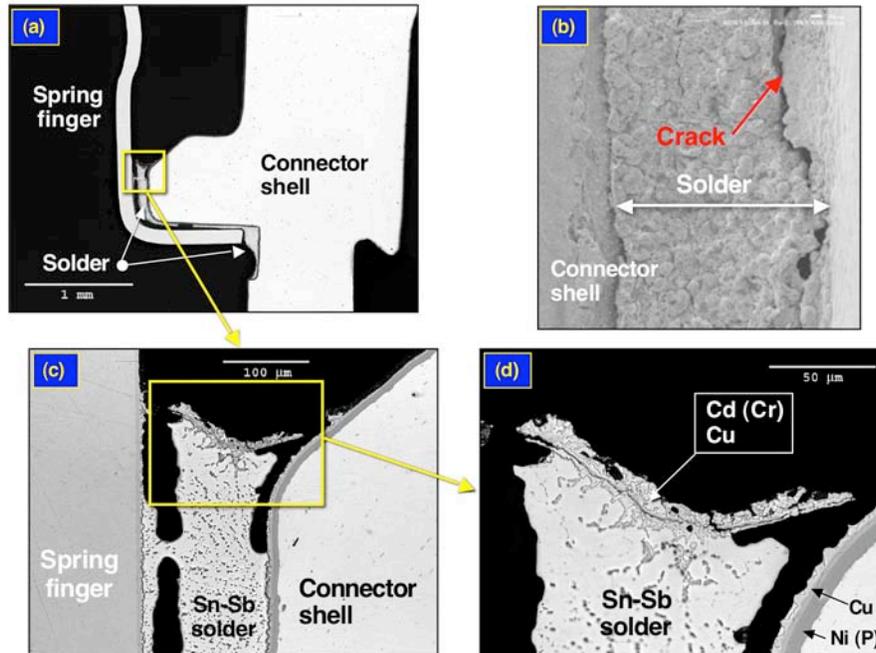
As has previously been the case, metallographic cross sections were required to determine whether the cracks observed by SEM were, in fact, cracks generated by overload stress conditions or were indicative more extensive degradation that underlie the fillet surface, i.e., remelting of the solder. Shown in Fig. 83 (a) is a low magnification, optical micrograph showing the cross section of the spring finger solder joint at location F1a. The SEM photograph corresponding to the location of the metallographic cross section appears in Fig. 83 (b) and shows a significant crack at the spring finger. A lesser crack was observed next to the connector shell.

Fig. 83 (a) Low magnification optical micrograph showing the cross section of the spring finger solder joint of the SA1358-10 connector (Item #5) at location F1a. (b) SEM of the F1a location at which the metallographic cross section was taken. (c) and (d) High magnification optical micrographs of the top side fillet.

The high magnification, optical micrographs in Figs. 83 (c) and (d) clearly showed more extensive degradation below the fillet surface. The expanse of voids observed in (c) and

(d) indicated that the solder joints had been reflowed subsequent to their initial fabrication and applications of the overplating layers. The image in (d) showed significant diffusion of Cu and Cd into the Sn-Sb solder that formed the fillet.

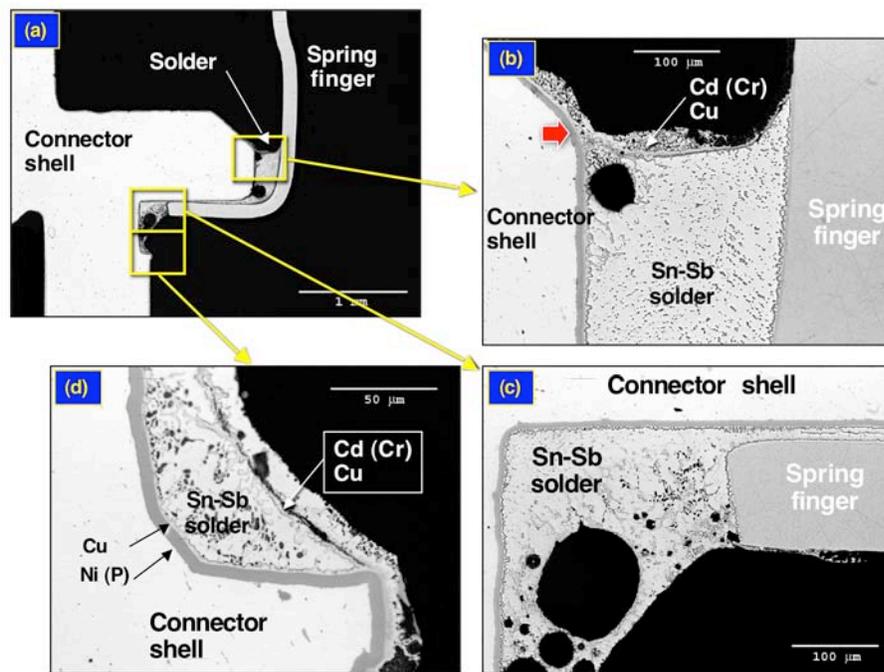
Other locations along the spring finger solder joint were evaluated, specifically, at location F2 as noted in Fig. 80. It was observed at these locations that the extent of re-melting of the spring finger (Sn-Sb) solder varied considerably around the circumference of the joint, there by substantiating the need to examine multiple locations in these joints for evidence of defects. Shown in Fig. 84 are micrographs showing a cross section of the solder joint at location F2a.

Fig. 84 (a) Low magnification optical micrograph showing the cross section of the spring finger solder joint of the SA1358-10 connector (Item #5) at location F2a. (b) Optical micrograph of the top side fillet. The red arrow indicated a region of flow-out by the Sn-Sb solder. (c) and (d) High magnification optical micrographs of the bottom side fillet.

The view of the top side fillet, which was shown in Fig. 84 (b), indicated a small void, the source of which, was the loss of Sn-Sb solder out of the fillet. The lost solder flowed both on top of the fillet as well as up the connector housing (red arrow). Partial dissolution of

Referring to Figs. 84 (c) and (d), the large voids and solder covering the Cd plating indicated that the bottom side fillet had also remelted after completion of the connector. Confirmation to this effect was provided by the EPMA x-ray dot maps in Fig. 86 that show, specifically, the presence of Cd in the Sn-Sb solder fillet. That Cd would have dissolved into the fillet when the Sn-Sb solder was molten. Therefore, the Sn-Sb solder had remelted in both the top side and bottom side fillets at this location.

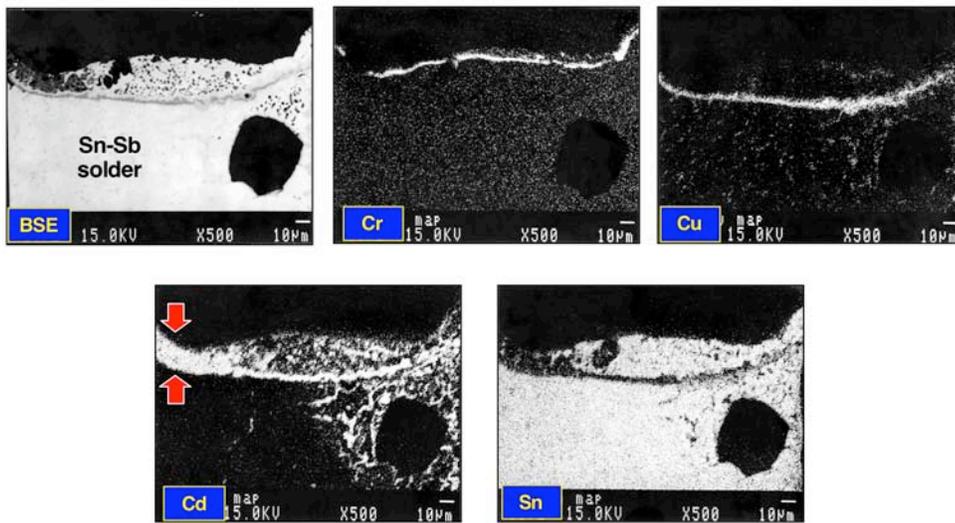
the Cd plating over the top side fillet had also occurred. Confirmation of this scenario was provided in Fig. 85, which shows an SEM/BSE image as well as EPMA x-ray dot maps of the elements: Cr, Cu, Cd, and Sn. The Sn dot map shows the flow of Sn-Sb solder on top of the Cu layer, dissolving the Cd coating into it. The reduced thickness of the Cd layer under the solder was evident, when that thickness was compared to the undissolved Cd layer thickness at the red arrows. The dissolution process also resulted in Cd being dissolved into the top side fillet around the void as indicated by the Cd map. Lastly, it was also interesting to note that the chromate conversion layer (Cr map) remained relatively intact. The Cr layer appeared to float on top of, what was, the molten Sn-Sb solder as the latter readily wetted to the Cd layer, forming a “crust” over the solder.

Fig. 85 SEM/BSE image and EPMA x-ray maps of the top side fillet of the SA1358-10 Item #5 connector shell at location F2a. The EPMA x-ray maps were for the elements Cr, Cu, Cd, and Sn.

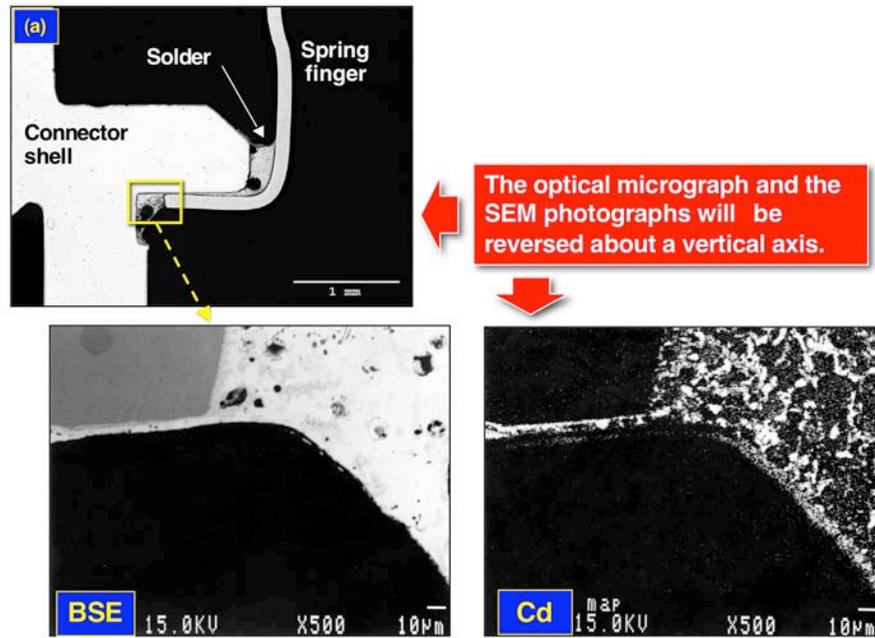
Fig. 86 Electron probe microanalysis of the bottom side fillet of the spring finger solder joint of the SA1358-10 connector (Item #5) at location F2a. Only the BSE image and Cd x-ray dot map were shown for this case.

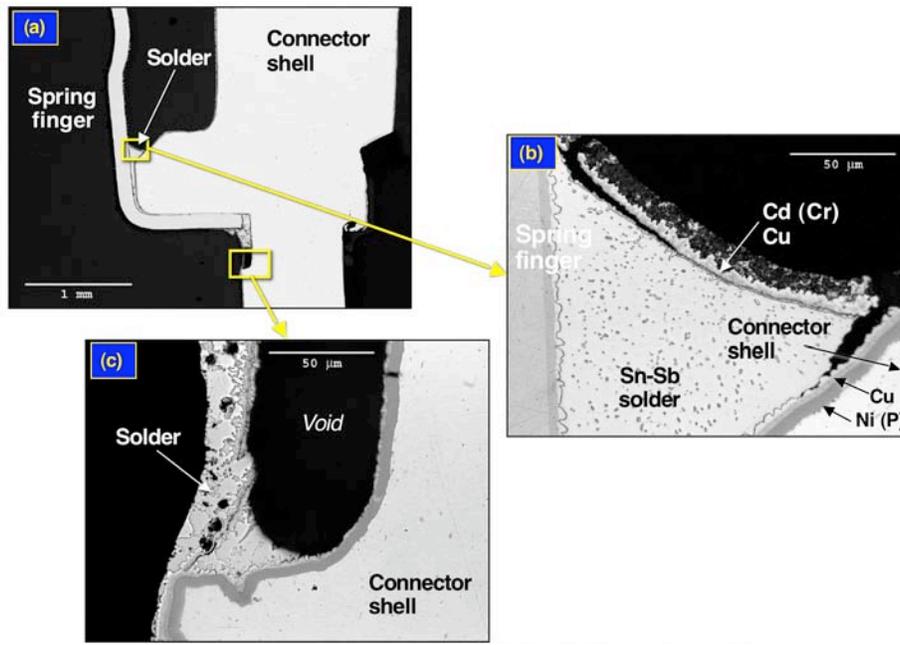
The distinction that the Sn-Sb spring finger solder joint had remelted was not as obvious in the top side fillet at the third location, F2b. Shown in Fig. 87 (a) is a low magnification optical micrograph of the F2b location on SA1358-10 (item #5). The high magnification image in Fig. 87 (b) showed cracks between the Sn-Sb solder and the connector shell, which may have been caused by an overload condition, as well as between the solder and Cd (Cr) and Cu overplating layers, that appeared to be caused by a delamination. These areas were identified by red boxes. The microstructure of the top side fillet did not indicate reflow of the solder. And, in fact, an EPMA was performed on the top side fillet. Low and high magnification BSE images, as well as Cr, Cd, Cu, and Sn dot maps, were provided in Fig. 88.

Fig. 87 (a) Low magnification optical micrograph showing the cross section of the spring finger solder joint of the SA1358-10 connector (Item #5) at location F2b. (b) High magnification optical micrograph of the top side fillet. (c) High magnification optical micrograph of the bottom side fillet.

On the other hand, the image in Fig. 87 (C) showed a large void and breaching of the Cd layer by the Sn-Sb solder, which were indicative of remelting of the solder. The remelting event was confirmed by the EPMA results in Fig. 89, which showed the extensive diffusion of Cd into the Sn-Sb solder when the latter had remelted. Therefore, at this location, the bottom side fillet had extensive evidence of Sn-Sb remelting as opposed to the top side fillet that did not exhibit remelting.

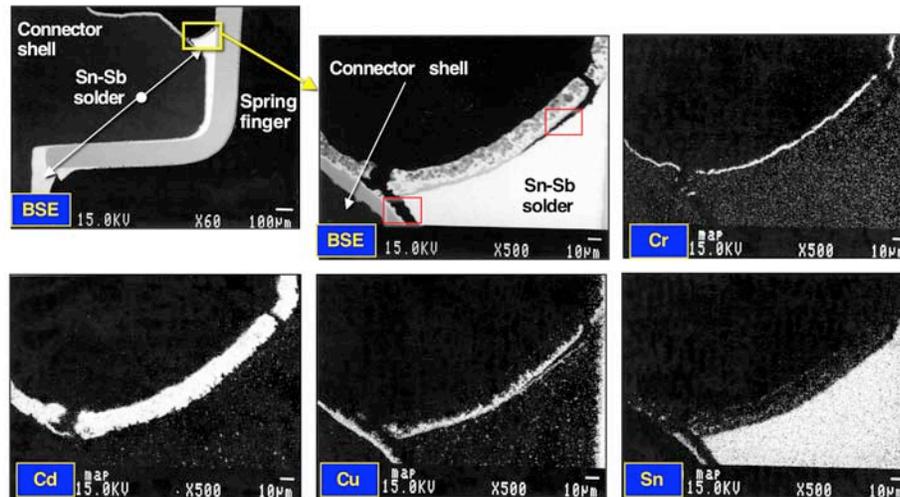
Fig. 88 Electron probe microanalysis of the top side fillet of the spring finger solder joint of the SA1358-10 connector (Item #5) at location F2b. Low and high magnification BSE images as well as dot maps of Cr, Cu, Cd, and Sn were shown.

There was no presence of Cd in the solder, nor solder on top of the Cd layer. The Cr and Cu layers were similarly intact. These observations implied that the Sn-Sb solder had not remelted. In fact, the Cu and Sn signals indicated that the crack at the connector shell wall had occurred between the solder and the Cu-Sn IMC layer there, which is a characteristic of an overload event.

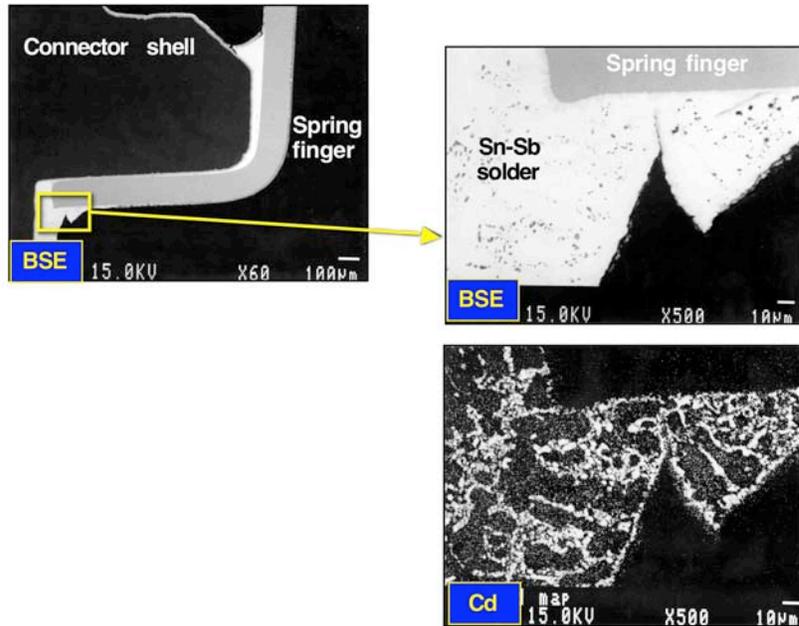
Fig. 89 Electron probe microanalysis of the bottom side fillet of the spring finger solder joint of the SA1358-10 connector (Item #5) at location F2b. Low and high magnification BSE images as well as the dot map of Cd, and Sn were shown.

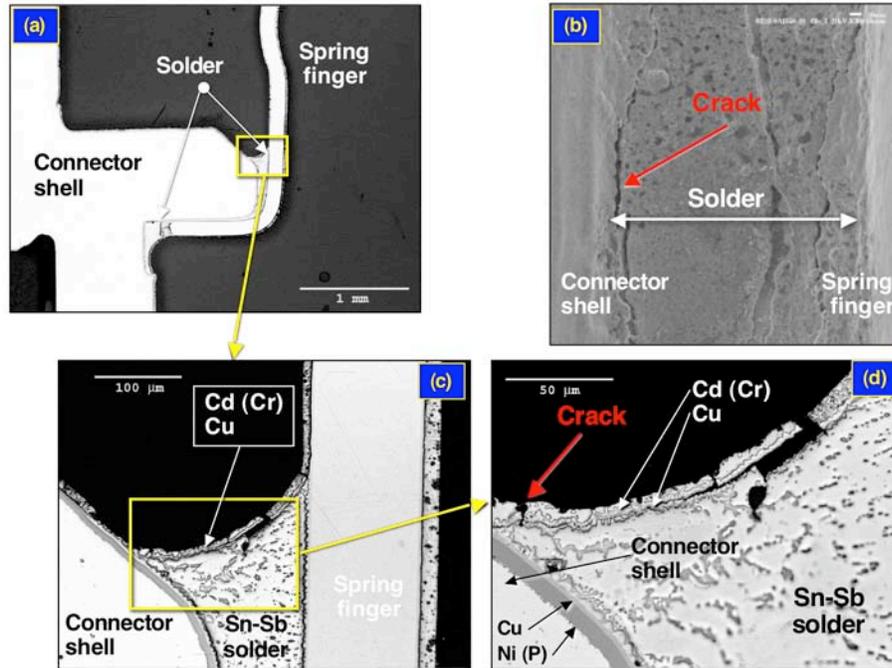
The final evaluation of SA1358-10, item #5, was performed at location F3b. A low magnification optical micrograph and SEM photograph of the solder joint were provided in Fig. 90 (a) and (b), respectively.

Fig. 90 (a) Low magnification optical micrograph showing the cross section of the spring finger solder joint of the SA1358-10 connector (Item #5) at location F3b. (b) SEM of the F3b location at which the metallographic cross section was taken. (c) and (d) High magnification optical micrographs of the top side fillet.

The damage observed in Fig. 90 (b) was not as extensive as it appeared in that SEM image, and certainly did not indicate remelting of the Sn-Sb solder. The cracks were limited to the Cd (Cr) plating layer and/or only the very-near surface of the solder fillet. A similar observation was made of the bottom side fillet. The EPMA (not shown) also did not indicate the dissolution of Cd into the fillets that was indicative of remelting of the Sn-Sb solder.

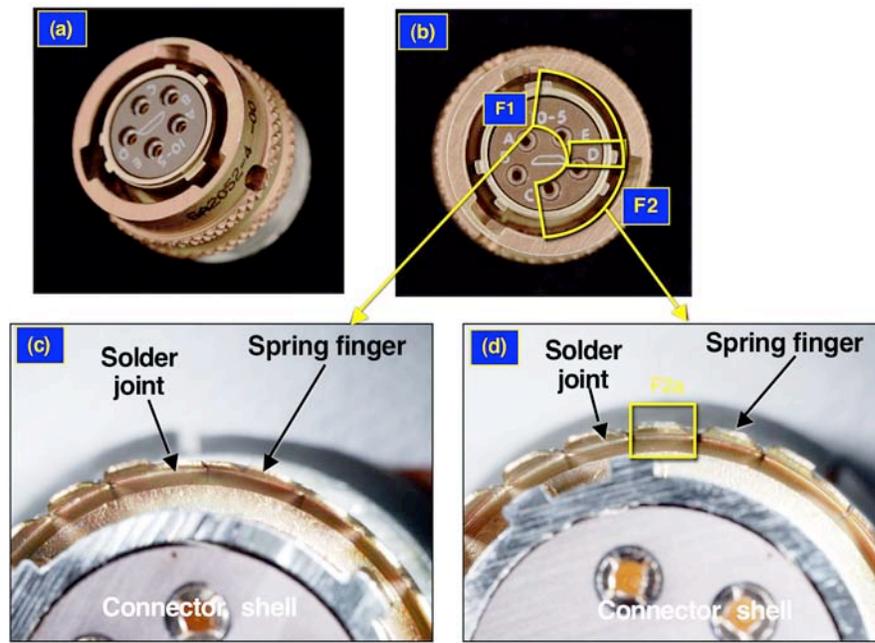
Stereo photographs of the connector were shown in Fig. 91. Examination of the spring finger solder joint did not reveal indications of significant damage to the top side fillet nor to the Cd plating that would have been indicative of mechanical loading (bending) or remelting of the Sn-Sb solder.

Fig. 91 (a) and (b) Low magnification stereo photographs of the SA2052-4 connector assembly designated Item #5, showing the angled view and a direct view of the contacts, respectively. In the latter image, two sectors were identified as F1 and F2. The high magnification stereo images in (c) and (d) show the top side fillet locations F1 and F2a, respectively, of the spring finger solder joints.
