SAND2006-4154

An Evaluation of the Spring Finger Solder Joints on SA1358-10 and SA2052-4 Connector Assemblies (MC3617, W87)

Paul T. Vianco, Alice C. Kilgo, Gary L. Zender, and Paul F. Hlava

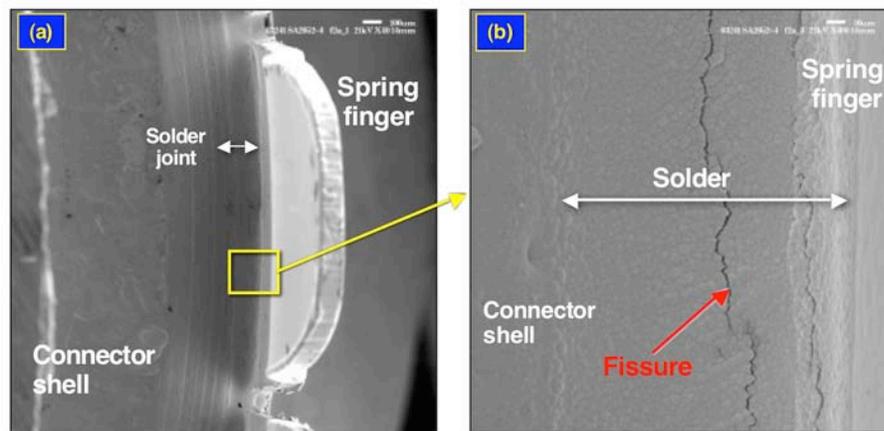
Shown in Figs. 92 and 93 are low and high magnification SEM photographs at the F2a and F4b locations, respectively, targeting the top side fillet of the spring finger solder joint. Those photographs are representative of other SEM analyses performed on this connector, which indicated only what appeared to be, small fissures in the Cd (Cr) overplating layer on the fillet surface.

Fig. 92 (a) and (b) Low and high magnification SEM/SE photographs of the F2a location on the SA2052-4 connector assembly designated Item #5. A small fissure has been identified in the overplating layer.

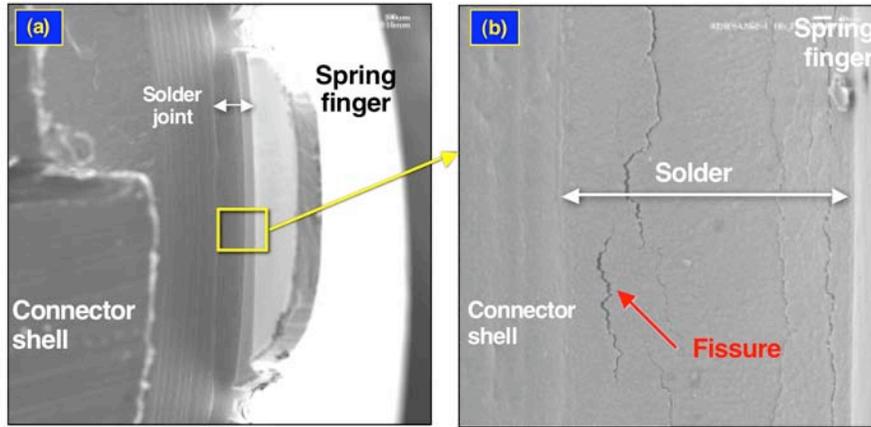
Fig. 93 (a) and (b) Low and high magnification SEM/SE photographs of the F4b location on the SA2052-4 connector assembly designated Item #5. Small fissures were identified in the overplating layer.

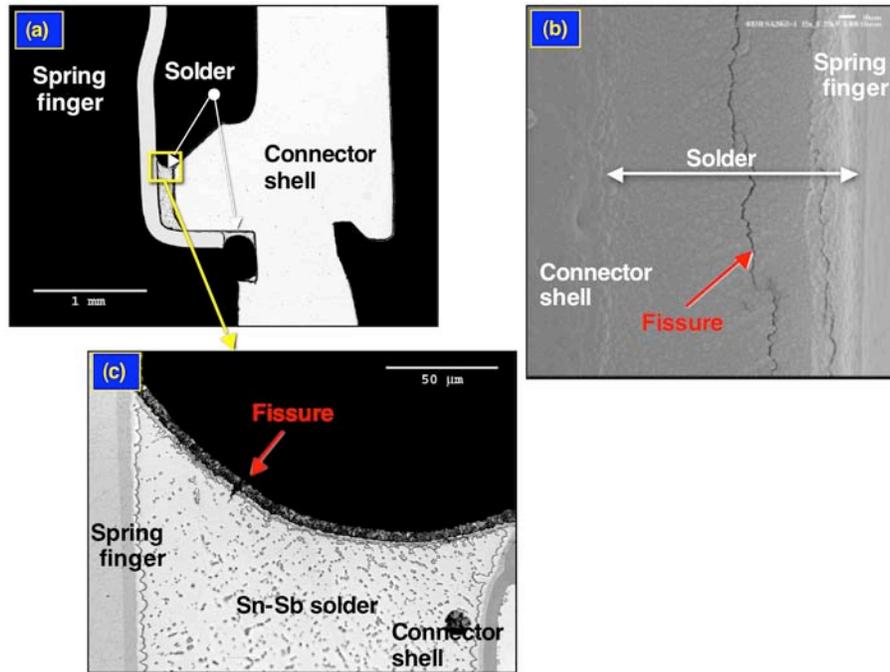
Metallographic cross sectional analysis was used to confirm the structural integrity of the spring finger solder joint. The optical micrograph in Fig. 94 (a) showed a low magnification view of the solder joint. There were no voids nor indications of damage to the solder joint. The fissures detected in the SEM photograph, which were reproduced in image (b) of Fig. 94, were shown in a cross section view through Fig. 94 (c). The fissures propagated from the Cd layer, through the Cu overplating layer and only a short distance into the Sn-Sb solder fillet. The images in Fig. 94 did not show evidence that the solder had been remelted after fabrication of the joint nor that there was crack damage due to flexing of the spring finger.

Fig. 94 (a) Low magnification optical micrograph showing the spring finger solder joint of the SA2052-4 connector designated Item #5. The location is F2a. (b) Low magnification SEM/SE photograph of the top side fillet surface at F2a, showing the small fissures. (c) High magnification optical micrograph of the top side fillet, showing the origins of the fissures.

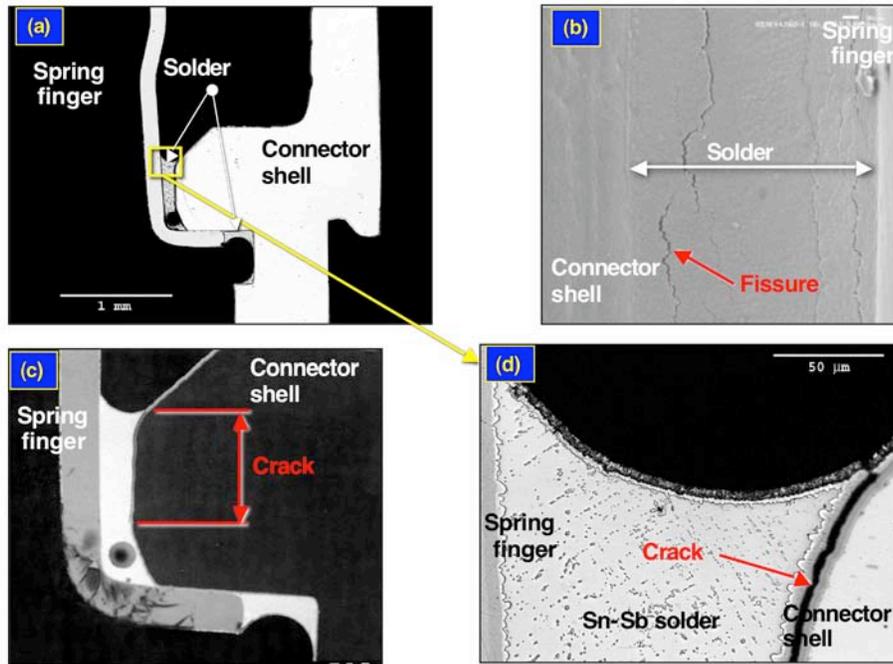
A second region of the spring finger solder joint was similarly investigated; this region was designated F4b. The associated micrographs were provided in Fig. 95. The top side microstructure did not show signs that the Sn-Sb solder had remelted after the overplating had been applied to the assembly. Therefore, the fissures observed by the SEM photograph in Fig. 95 (b) were limited to the Cd layer. The absence of remelting of the spring finger solder joint was confirmed by the EPMA dot maps that are provided in Fig. 96. The overplating layers and, in particular, neither the Cd nor Cu layers showed indications of having been dissolved into the Sn-Sb solder.

Fig. 95 (a) Low magnification optical micrograph showing the spring finger solder joint of the SA2052-4 connector designated Item #5. The location is F4b. (b) Low magnification SEM/SE photograph of the top side fillet surface at F4b. (c) High magnification optical micrograph of the top side fillet.

An unexpected feature in Fig. 95 (d) was the crack in the electroplated layer on the connector shell. The extent to which the crack extended into the spring finger solder joint was depicted in Fig. 95 (c). The morphology of the crack, together with the EPMA results in Fig. 96, showed it to have propagated entirely within the electroless Ni (P) layer. The morphology of the crack was shown in further detail by the SEM/BSE images Fig. 97, which documented the crack at the top side fillet and further down into the joint. The image in Fig. 97 (b) indicated that the crack occurred *after* the Cd (Cr) overplating layers had been deposited. Also, the fracture did not appear to be based upon a general delamination of the Ni (P) layer since the separation did not extend upwards on the connector shell past the solder fillet. This is the first instance in which this defect was observed. Typically, the mechanical overload of the spring finger solder joint was reflected by cracks along the solder/IMC interface at the spring finger side of the joint. Occasionally, the crack would be at the same interface along the connector shell side of the joint. Therefore, the crack in Fig. 97 likely indicated a weakness in the Ni (P) layer.

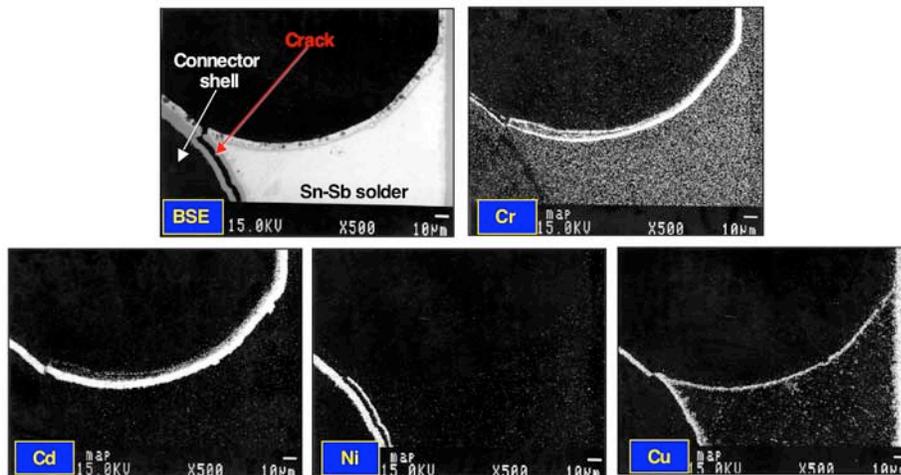
Fig. 96 Electron probe microanalysis of the top side fillet of the spring finger solder joint of the SA2052-4 connector (Item #5) at location F4b: BSE image as well as dot maps of Cr, Cd, Ni, and Cu were provided.

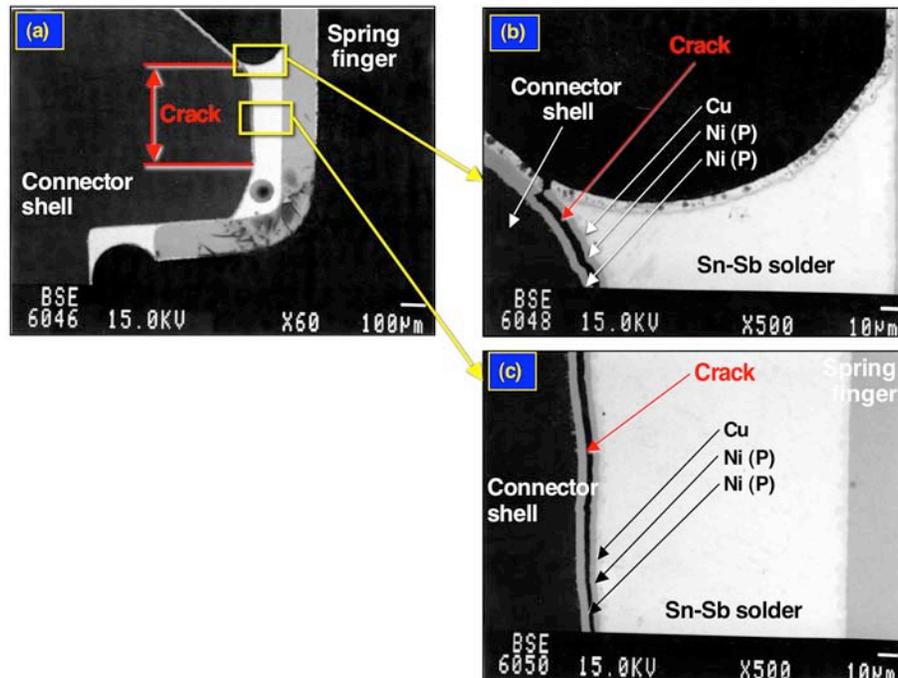
Fig. 97 (a) Low magnification SEM/BSE photograph of the spring finger solder joint of the SA2052-4 connector designated Item #5 at location F4b. Close views of the top side fillet as well as further into the solder joint were provided by the SEM images in (b) and (c), respectively.

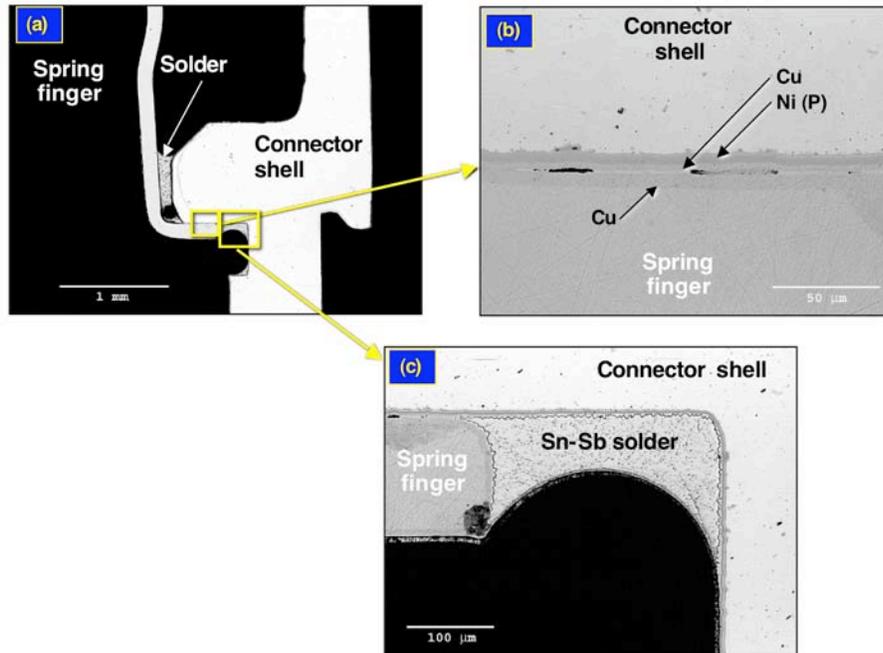
The horizontal solder joint and bottom side fillet was similarly analyzed. The associated optical micrographs were provided in Fig. 98.

Fig. 98 (a) Low magnification optical micrograph showing the spring finger solder joint of the SA2052-4 connector designated Item #5. The location is F4b. (b) High magnification optical micrograph of the horizontal gap region. (c) High magnification optical micrograph of the bottom side fillet.

The horizontal gap was very thin in most of the cross sections made of the SA2052-4, Item #5 spring finger joints as shown in Fig. 98 (b). In fact, it was observed that IMC layer growth had actually bridged between the Cu plated layers of the connector shell and spring finger structures. No cracks were observed in the IMC layers. The IMC layer thicknesses were listed in Table 2 and were very similar to those observed on the other SA2052-4 connector assemblies. The bottom side fillet, which is shown in Fig. 98 (c), exhibited excellent integrity. The overplating layers remained “stacked” on top of the Sn-Sb solder with no indications of being dissolved into the latter due to remelting of the joint. The cracking of the Ni (P) finish, which was observed in the top side fillet as depicted in Fig. 97, was not noted in either the horizontal gap or bottom side fillet locations. Therefore, it was concluded that the aforementioned crack was a localized defect in the electroless layer.
