SANDIA REPORT

SAND2007-3531
Unlimited Release
Printed May 2007

An Investigation of Corrosion in Semiconductor Bridge Explosive Devices

Sandra E. Klassen & N. Robert Sorensen

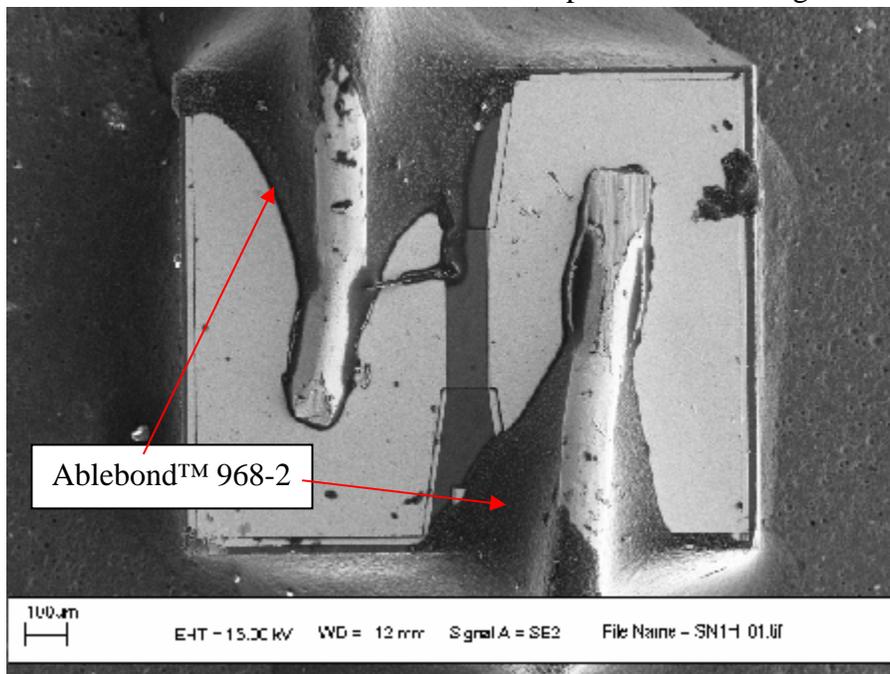
The aluminum corrosion products, such as those seen on the corroded SCB dies, are related to the presence of both moisture and chloride. Aluminum will not corrode if one or the other is missing. The presence of moisture was inferred from the appearance of the corrosion products and knowledge of corrosion processes, but direct evidence for the presence of chlorine was obtained from Energy Dispersive X-Ray (EDS) analyses of the corroded areas of the dies. Several sources of chloride were considered, and Ablebond™ 968-2 was considered one of the most likely sources. Ablebond™ 968-2 was used as an adhesive to bond SCB dies to headers in both the detonator and igniter designs, and a fact sheet published by Ablestick Laboratories lists the chloride content of Ablebond™-968-2 as 215 ppm. Ablebond™ was also liberally applied to support the bond wires in both of these devices so that the wires would not deform from the pressure of loading the powder into the device. This practice, of course, places the adhesive in direct contact with the dies. An example is shown in Figure 8.

It is common for the adhesive to wick around and onto the land and occasionally onto the bridge area. Fourier Transform Infrared (FTIR) spectroscopy was used to confirm that the material on the lands was, indeed, Ablebond™ adhesive but without the silica filler material.

Figure 8. An example of the use of Ablebond™ 968-2 to support the wirebonds.

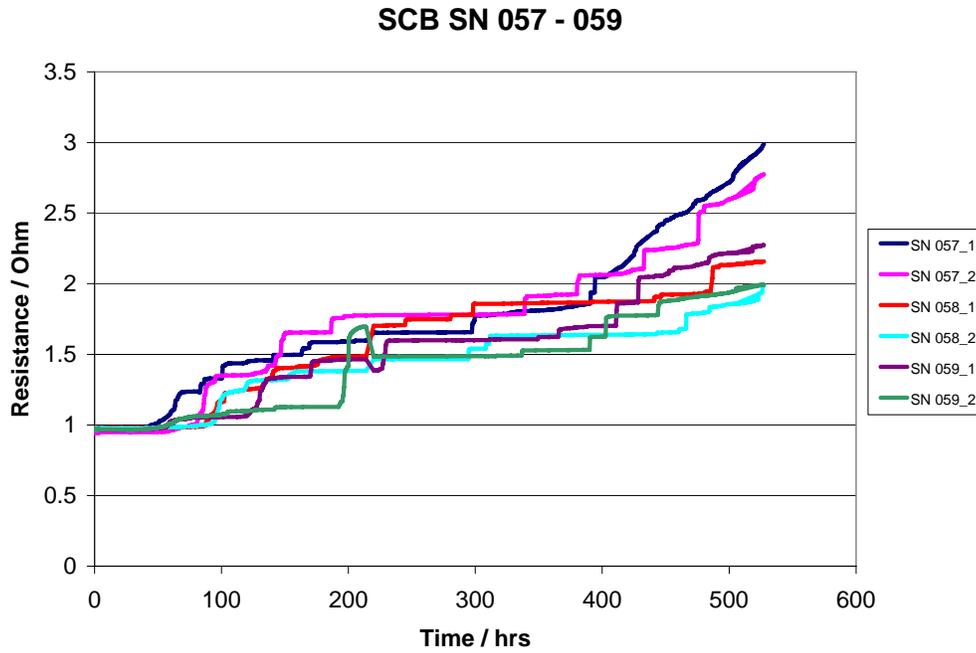
Figure 16 shows resistance plots for three headers (six bridges) exposed to a humidity / chlorine environment. As can be seen, the resistance increases with exposure time, indicating that the device is undergoing corrosion. At the conclusion of the exposure, the samples were photographed (Figure 17). As can be seen, there is extensive attack of all of the structures. The attack is not uniform across the surface. Rather, it initiates at specific locations (where

defects in the gold layer expose the underlying aluminum) and spreads outwards from each initiation site. Corrosion products are visible across the surface of the device. The SEM image (lower right) shows that the corrosion sites (dark regions) are, in fact, isolated.

Figure 16. Resistance measurements for SCB headers exposed to 10 ppb chlorine gas (Cl_2) and 70% RH and 30C.

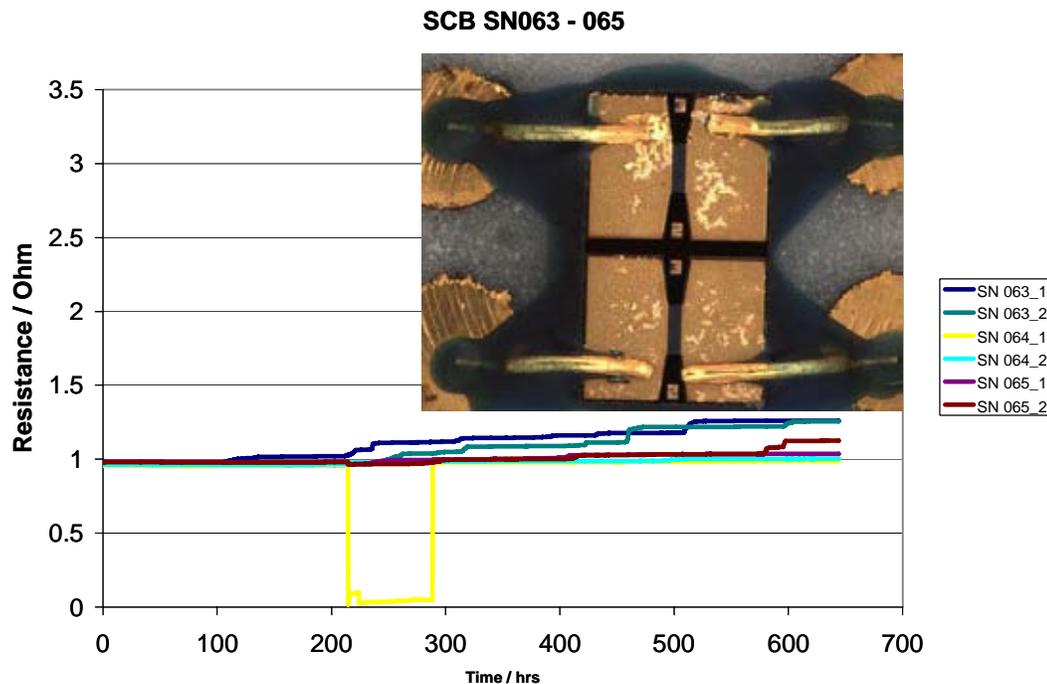
The resistance data and micrographs in Figure 19 and Figure 20 show the effect of chlorine concentration on the corrosion process. The data shown in Figure 19 were obtained after the concentration was reduced from 10 ppb to 2 ppb chlorine. The result is a substantial decrease in the rate of attack. In fact, the inset image shows limited attack of the surface, confirming the decrease in corrosion rate. The extent of attack is clearly less than that observed at 10 ppb chlorine (Figure 17). The data shown in Figure 20 are the result of a test run with only moisture (no chlorine). In this case, no increase in resistance was observed. The SCB surfaces show no evidence of attack. These results illustrate that exposure to humidity alone does not initiate corrosion. Notice that the wire bonds of these headers were liberally supported with Ablebond™ adhesive, and recall that Ablebond™ is suspected of being the most likely source of chloride. Perhaps the experimental conditions were not amenable to leaching chloride from the adhesive, or perhaps this particular lot of Ablebond™ did not contain as much chloride as the manufacturer’s literature states. We do not know the lot to lot variability of Ablebond™ chloride content.

Figure 19. Resistance data for gold-plated SCBs that were exposed to 70% humidity and low concentrations (2 ppb) of chlorine. An optical image of one of the headers is inset. Note the lack of corrosion of the header.

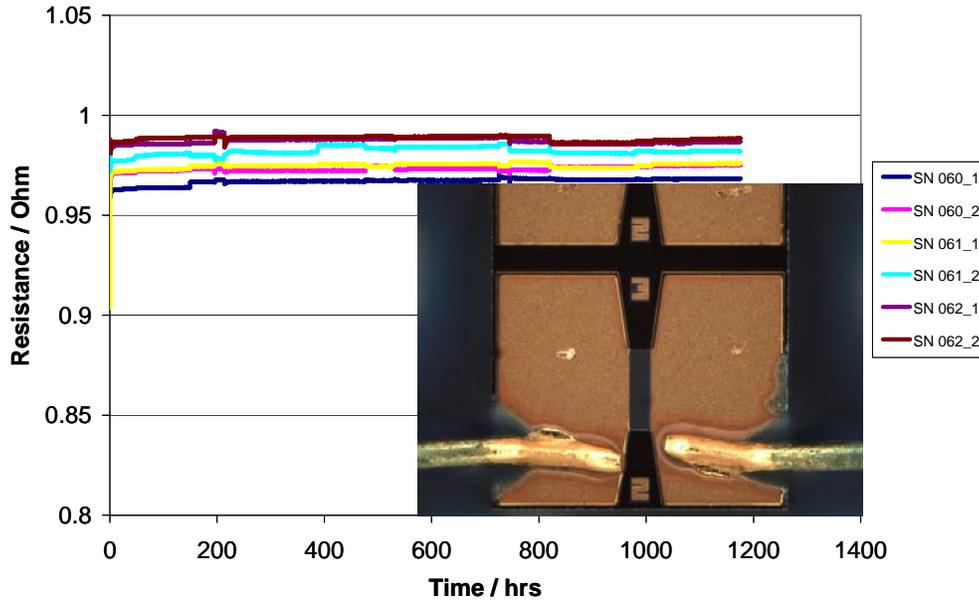
Figure 20. Resistance plot for SCB headers exposed to 70% humidity at 30 C with no chlorine.

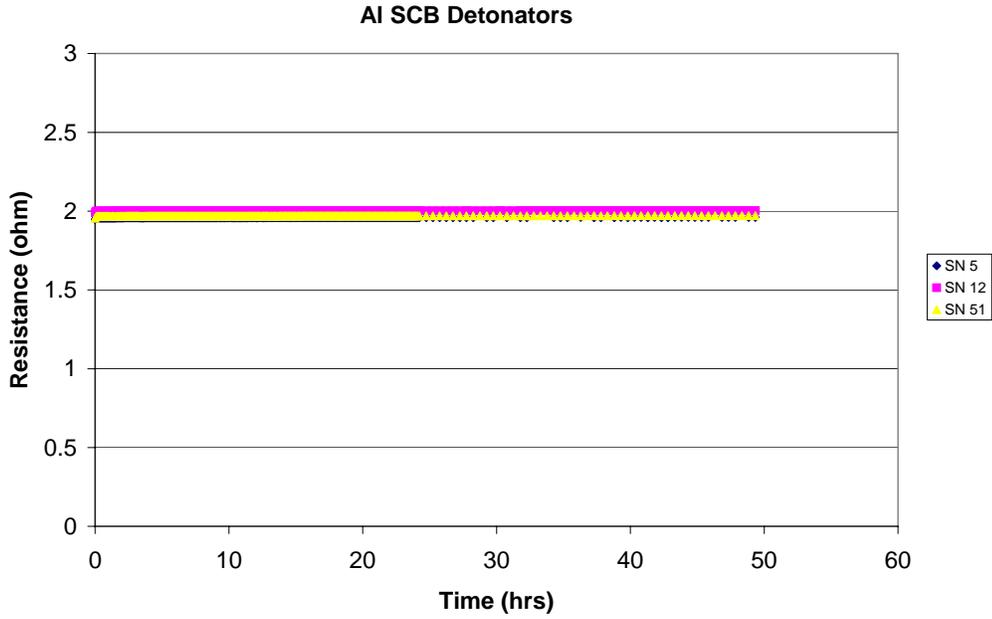
In the absence of the gold-aluminum galvanic couple, the rate of aluminum corrosion is expected to be slower. In order to test this, detonator headers with Type 52 aluminum SCBs (no gold layer) were subjected to environments containing various amounts of chlorine. The resistance results for 2 ppb Cl exposure are shown in Figure 21. In one of the more aggressive tests, the chlorine level was held at about 60 ppb (considerably more than for the gold-plated SCB devices shown previously). The humidity was 70%. There was no observed change in resistance throughout until more than 3000 hours of exposure. Optical images of the headers taken after 300 hours of test are shown in Figure 23. Note that there is no observable attack of either the aluminum land or the aluminum bond wire. The only area of attack was on the electrodes (posts) which are gold-plated iron-nickel. The corrosion is localized, presumably to defects in the gold plating. The color of the corrosion products is consistent with attack of an iron-based alloy. Thus, the conclusion is that the presence of gold on the lands significantly accelerates attack of the aluminum whenever defects in the gold are present.

Figure 21. Resistance measurements from all aluminum SCB detonators exposed to low levels (2 ppb) of chlorine at 70% humidity and 30C.

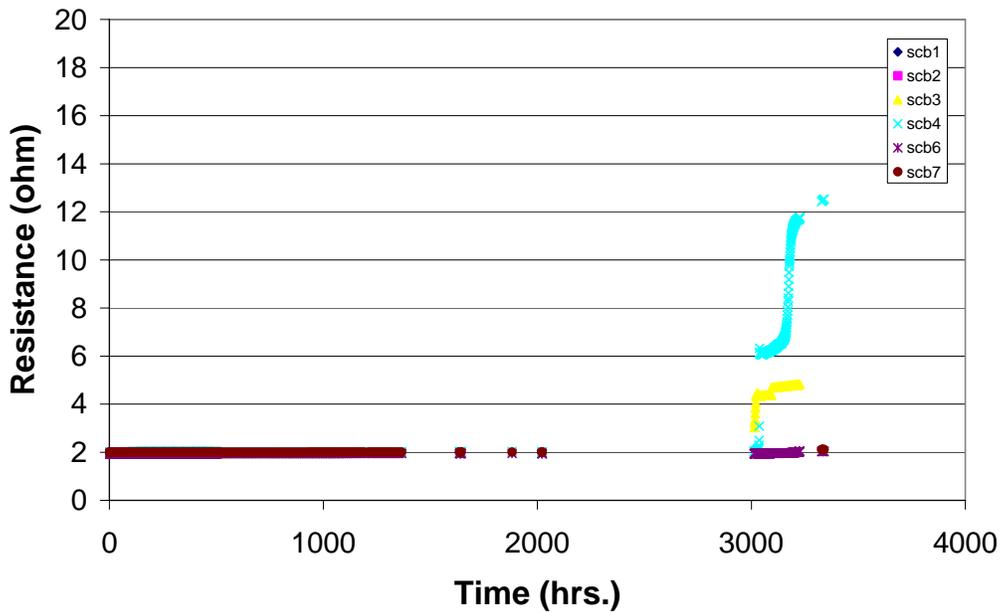
Figure 22. Resistance values for all aluminum SCB headers exposed to 60 ppb chlorine at 70% humidity.

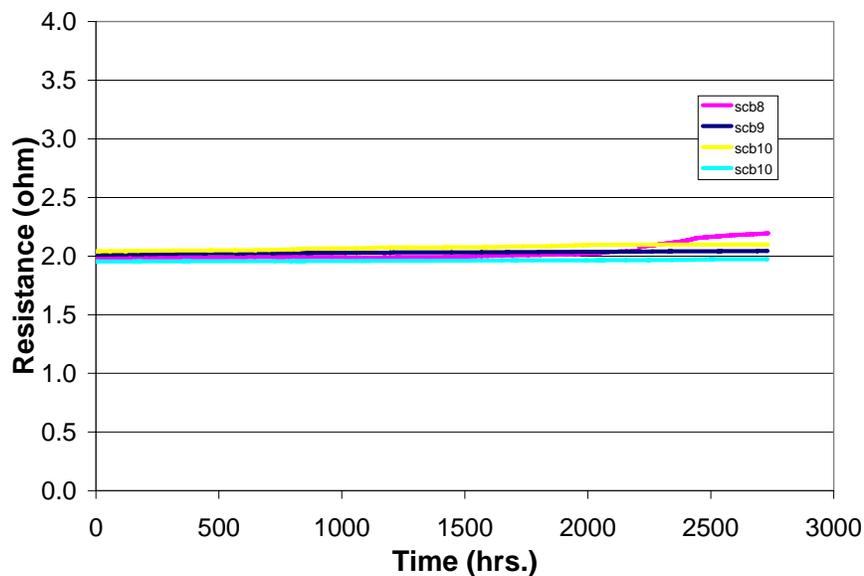
A second test was run with Type 52 all aluminum headers. The results are shown in Figure 24. These results are consistent with the previous test. At exposure times between 2500 and 3000 hours, an increase in resistance is beginning to be observed. Compare these results with those shown in Figure 16, where the resistance increases after about 100 hours of exposure at a chlorine level of 10 ppb. These results clearly demonstrate that the presence of a porous gold layer significantly accelerates the corrosion process.

Figure 24. Resistance values for all aluminum SCB headers exposed to 60 ppb chlorine at 80% RH.
