SANDIA REPORT

SAND2007-4347
Unlimited Release
Printed July 2007

Copper Corrosion and Its Relationship to Solar Collectors: A Compendium

David F. Menicucci and A. Roderick Mahoney

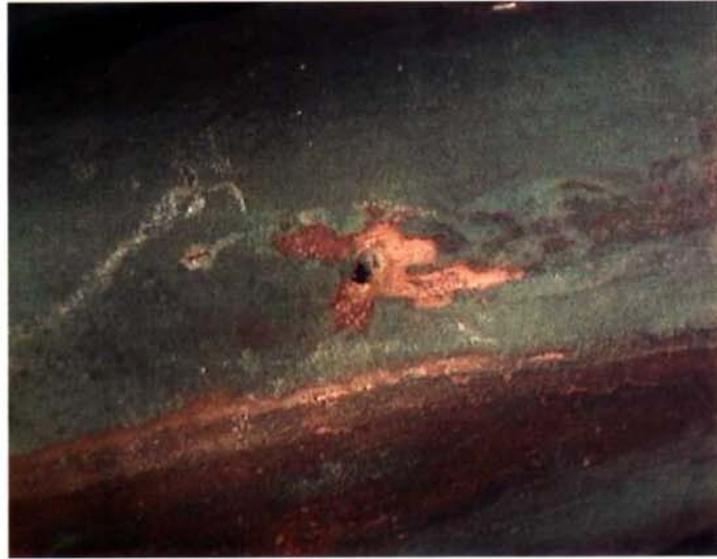
Figure 1 - Sample 1

Figure 1 indicates a typical penetration from the exterior side of the pipe. Figure 2 shows the same penetration from the interior of the pipe. There was major nodule development in many places on the interior of the pipe. Nodules are best defined as mounds of corrosion products in localized areas of the pipe. Pits are always found beneath the nodules. In figure 2 the copper is covered first with a red-grey layer, and on top of this a green layer. The Electron Dispersive X-ray Analyses of the module confirmed the presence of copper. Chemical tests confirmed the green material to be copper carbonate. The gray surface deposited directly over the copper metal is copper oxide exhibiting a small amount of copper chloride. The green deposit over the entire surface in addition to being copper carbonate also had a small amount of copper silicate. There were also copper oxide, copper carbonate, and ferric oxide found within the pits.

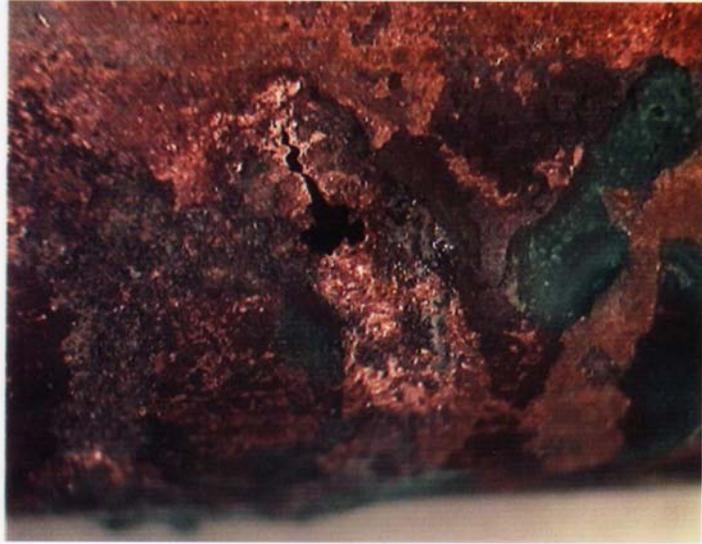
Figure 5 - Sample 3

Sample 3 was obtained from Continental Ranch, 7050 Safflower, and labeled "Waterline leading to ice maker Piece A". The exterior of this pipe was seriously corroded as compared with the other pipes where all of the corrosion was on the interior. Figures 5 and 6 show the extent of external corrosion on the pipe. The figure 6 illustrates in good detail the typical attack site for this sample. Graphically depicted are a rim or raised ridge of green material surrounding a wide pit which includes exposed metal, copper oxide crystals, and a white deposit. The analyses confirms the green rim to be copper carbonate, moderate silicon, and minor amounts of aluminum, potassium, calcium, and iron. The red crystals are copper oxide.

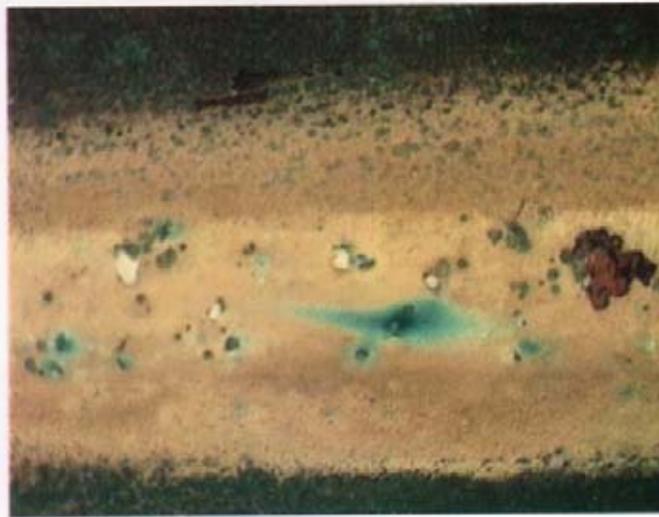
Figure 7 - Sample 4

The analyses of the pipe submitted is labeled Sample 4, "Saddlebrook". The exterior section of pipe had virtually no corrosion. There was some interior corrosion. A yellowish track of deposit exists along one area of the pipe that represents the bottom of a horizontally installed pipe. Within this track there are discrete pits which fit the classic description of under deposit corrosion, or differential oxygen cell corrosion. Figure 7 shows a typical area of the deposit track and small corrosion sites along the deposit.

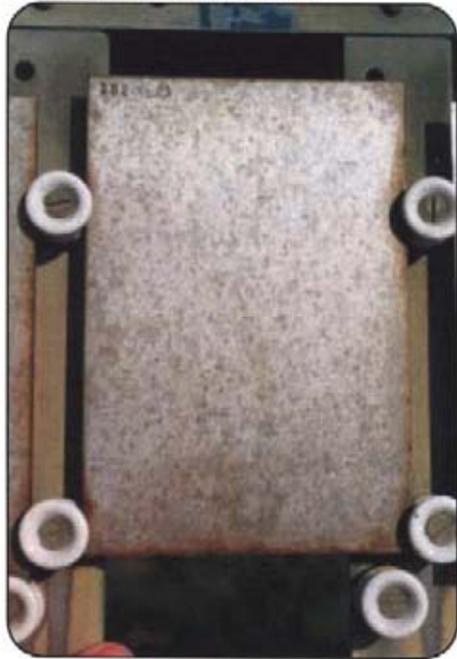
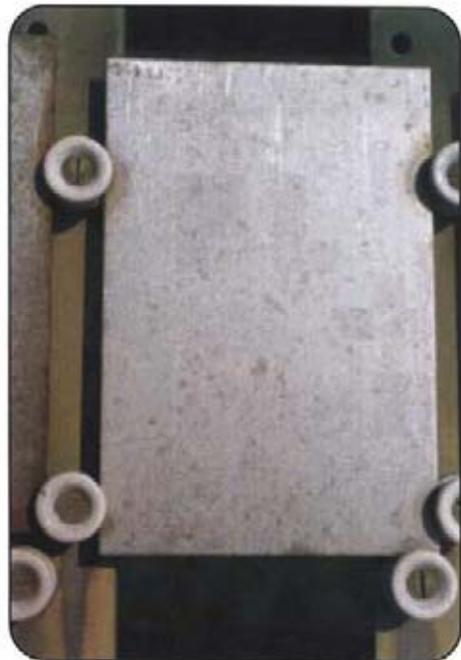
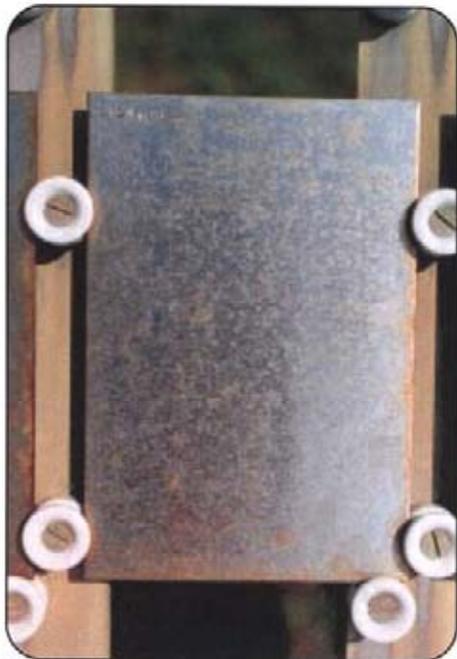
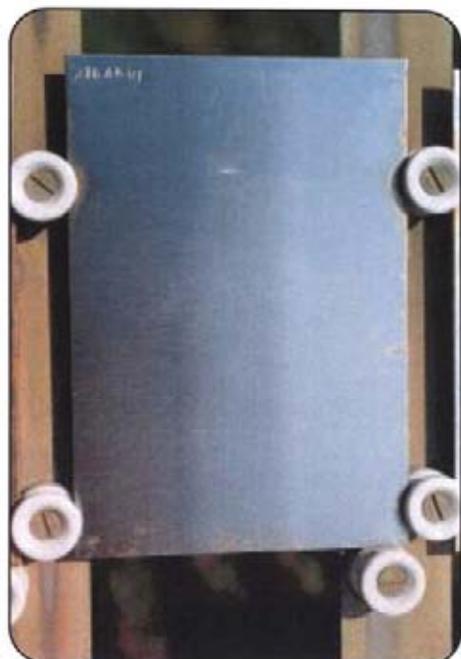
Type 302,
2B finish.

Type 316,
2B finish.

Type 302,
No. 4 polish.

Type 316,
No. 4 polish.

These Type 316 and 302 samples were exposed 800 feet (250 metres) from the ocean for forty years at Kure Beach, North Carolina with only natural rain cleaning.

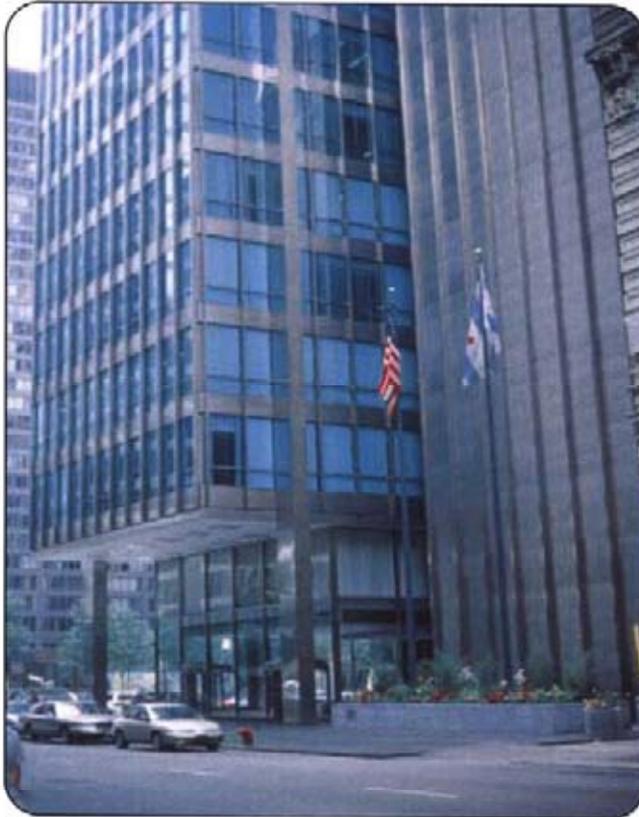
The Inland Steel Building (completed in 1957) is on a busy street in downtown Chicago and has Type 302 exterior wall panels with a No. 4 polish.

They are exposed to deicing salt and pollution. The panels have always been cleaned three to four times per year when the windows are washed.

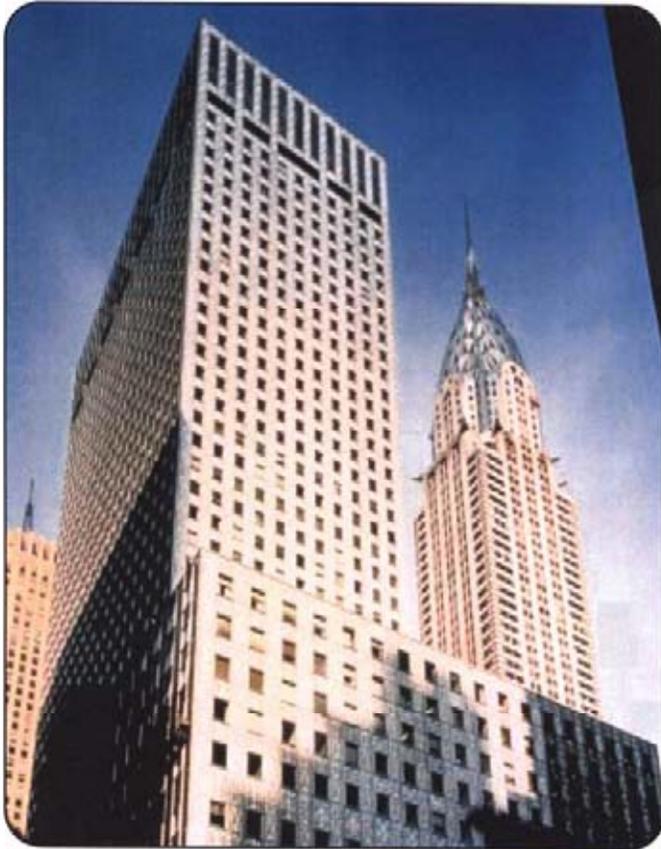
Above the third floor, New York City's 150 East 42nd Street (completed in 1954) has Type 302 exterior wall panels with a 2B finish (surface roughness of R, 15 micro inches or R, 0.3 μm). Although their height protected them from deicing salt, they were exposed to pollution and coastal salt. They were cleaned for the first time in 1995, restoring their appearance. The Chrysler Building can be seen in the background. It is also Type 302 and has the same finish and surface roughness. It has been cleaned twice since 1930.

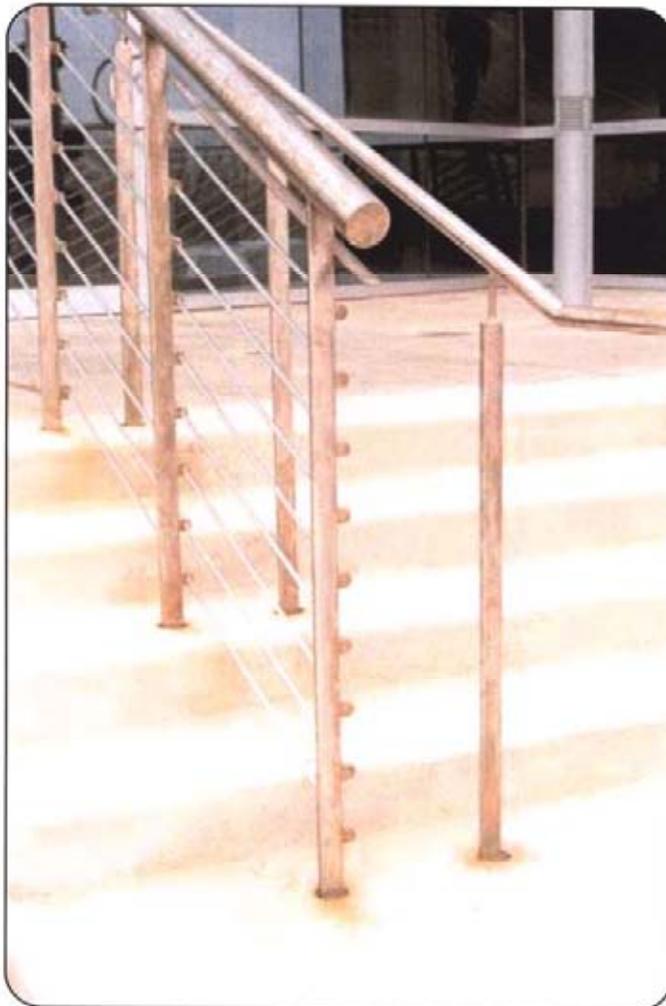
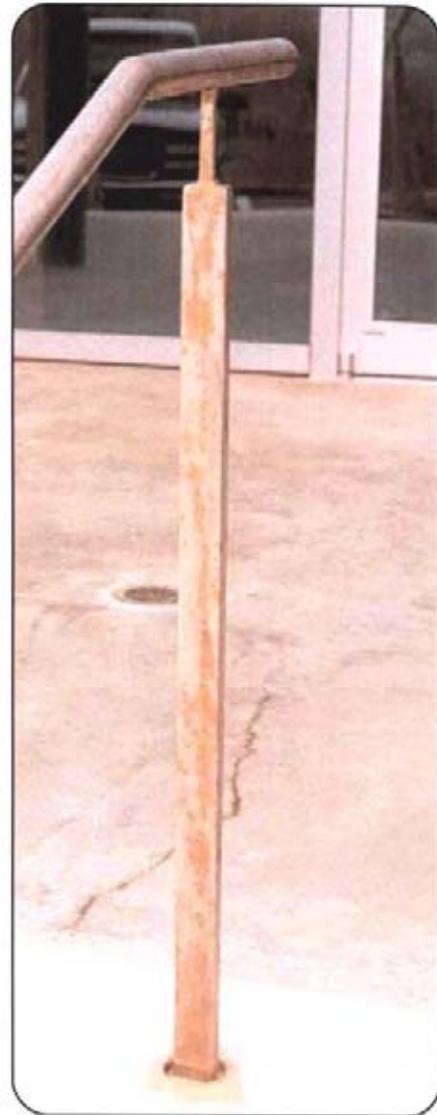
wind and deposited salt. The rough mill finish increased salt adherence. The discolouration was removed with a mild abrasive cleaner. Corrosion damage could have been avoided or minimized with frequent cleaning or selection of Type 316L with smooth finish.

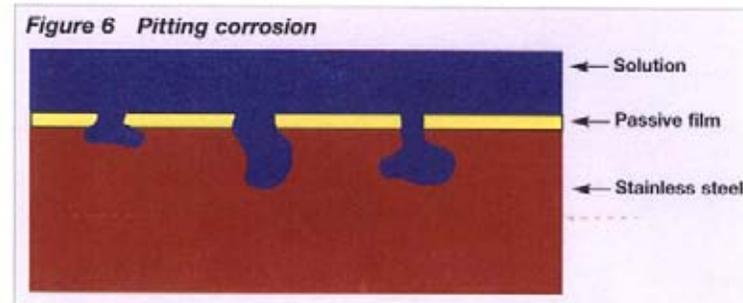
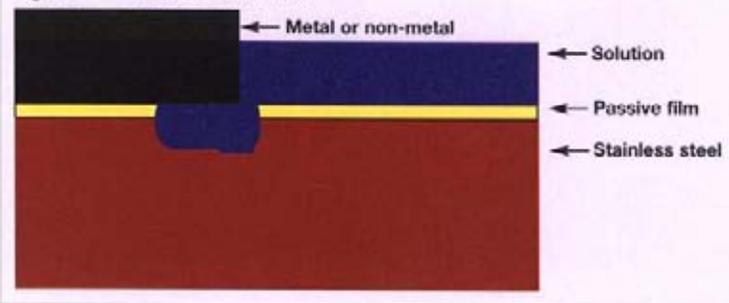
Figure 7 Crevice corrosion

Crevice corrosion is similar to pitting but occurs over a larger area when deposits or other materials block the oxygen access needed to maintain the passive film. Corrosion can occur if chloride-containing rainwater or condensation is present in a tight crevice and conditions are created which exceed the corrosion resistance of a particular stainless steel. It is more likely with lower-alloyed stainless steels, particularly where the crevice gap is very small (a tight washer) and the path to free oxygen is long (a large diameter washer). Correct design reduces the potential for crevice corrosion. In areas exposed to water, designers should minimize crevices, seal them, or consider a more corrosion-resistant, higher-alloyed grade. See Figure 7.

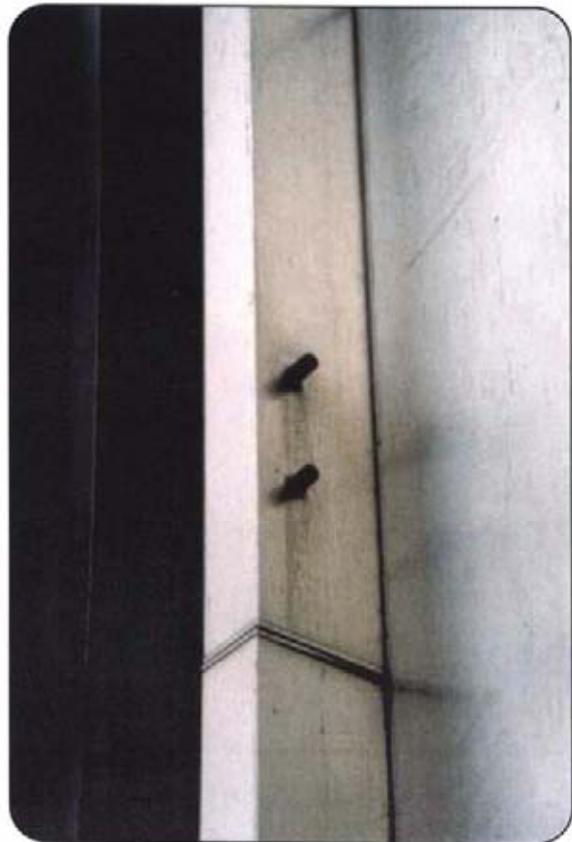
The ratio between the dissimilar metals is important in evaluating the potential for galvanic corrosion. The fastener should always be of equivalent or higher corrosion resistance. Stainless steel fasteners with inert washers are often used for weathering steel (left), carbon steel, copper aluminum and zinc roof and wall panels. Galvanized steel fasteners should never be used for stainless steel panels (below).

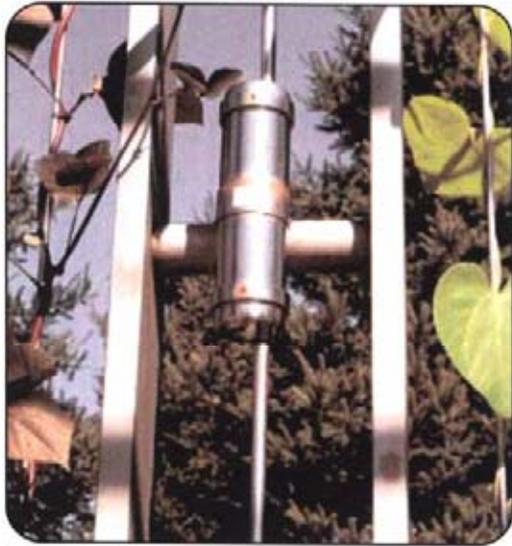
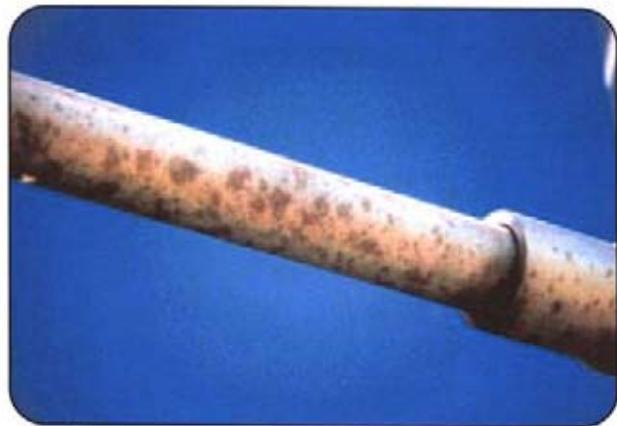
All the arbour's components are rough, abrasive blasted Type 304 (surface roughness of R_a 281 micro-inches or $7.3 \mu\text{m}$) except for the tension rods and lights which are highly polished Type 316. Photo A shows Type 304 deicing salt damage. The rough finish retains more salt, making natural rain washing less effective. Sheltered surfaces experienced significantly more corrosion than components boldly exposed to rain. The Type 316 was untouched by the deicing salt except where crevices trapped salt and water. Photo B shows crevice corrosion. Photo C shows embedded iron on one of the Type 304 vertical support members.

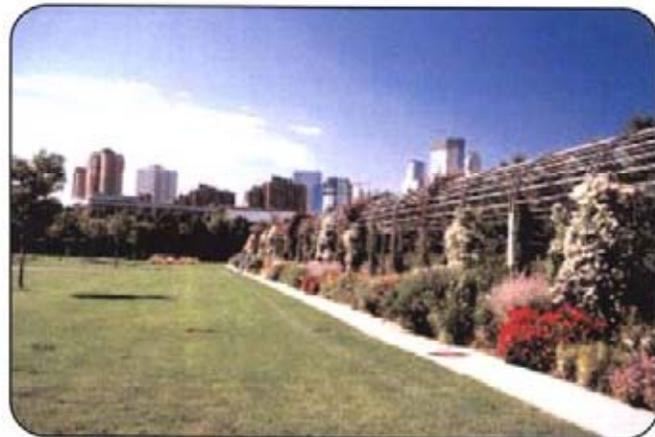
Careful evaluation of a site is important because factors that influence the corrosiveness of a site may not be immediately apparent. This stainless steel arbour is in a park in a suburban area adjoining downtown Minneapolis. Normally a location of this type would be considered a low to moderately corrosive urban environment, but this park is beside an elevated highway and deicing salt laden road mist blows into the park, making the environment more aggressive.
